TECHNICAL BULLETIN INDEX
Sorted by Bulletin Number
04/03/86

BULLETIN NO: II:1

PRODUCT: 26-4001/2 Model II

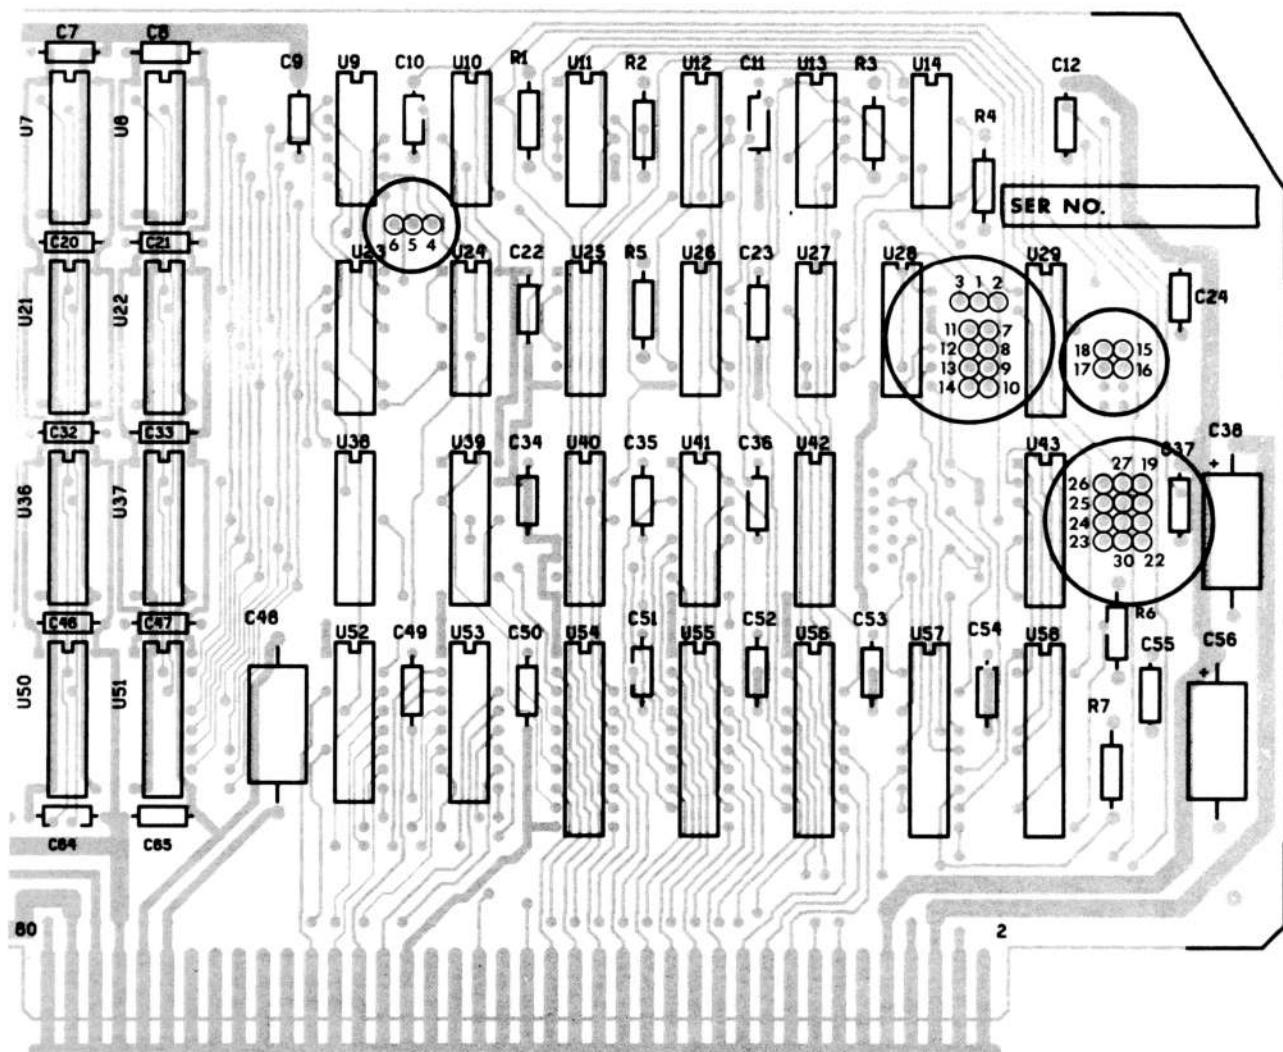
Figure 1

- 1-2 Pulls up an input to U27 that was floating
- 5-6 Pulls up an input to U9 that was floating

Use MEMII Diagnostic to check each memory board for correct jumpering and proper operation.

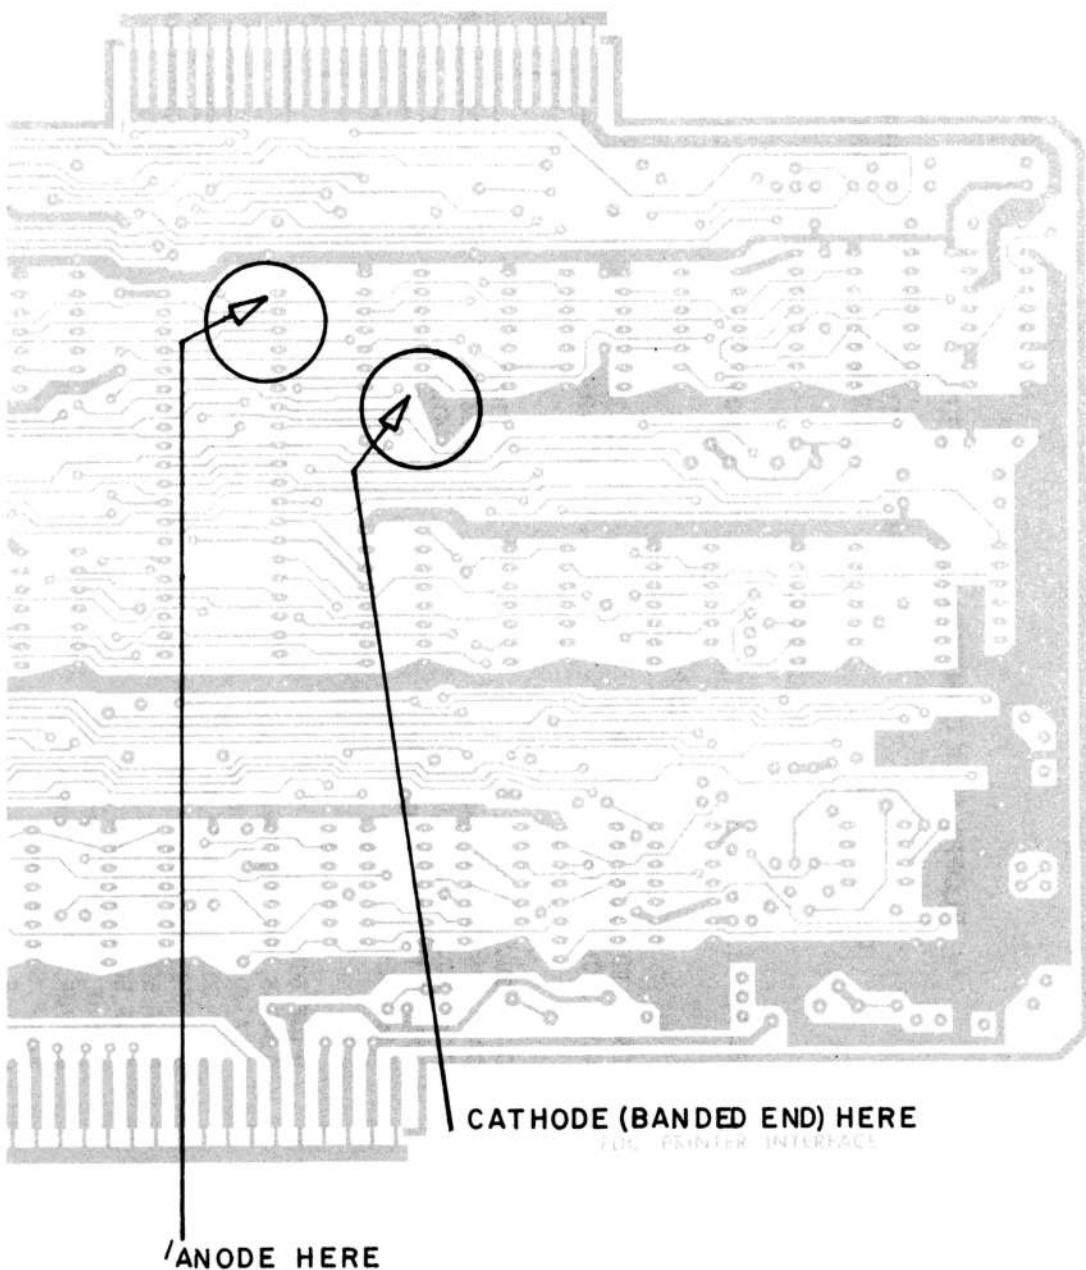
Figure 1

PURPOSE: To correct thermal failure of FDC IC (U6) causing Read/Write errors, and other intermittent disk I/O failures.

DISCUSSION: Early FDC chips developed thermal failures causing disk I/O failures and Read/Write errors. To correct this problem a 2.7V Zener diode MUST be installed from U6 Pin 1 to U5 Pin 7. On new and factory repaired assemblies this change will already have been installed.

PROCEDURE: Check to see if this modification has been done, if not, install diode as per Figure 1. Be sure to use sleeving for insulation of leads to prevent shorts. This diode can be ordered from National Parts using part number ADX-1382 and catalog number 26-4001.

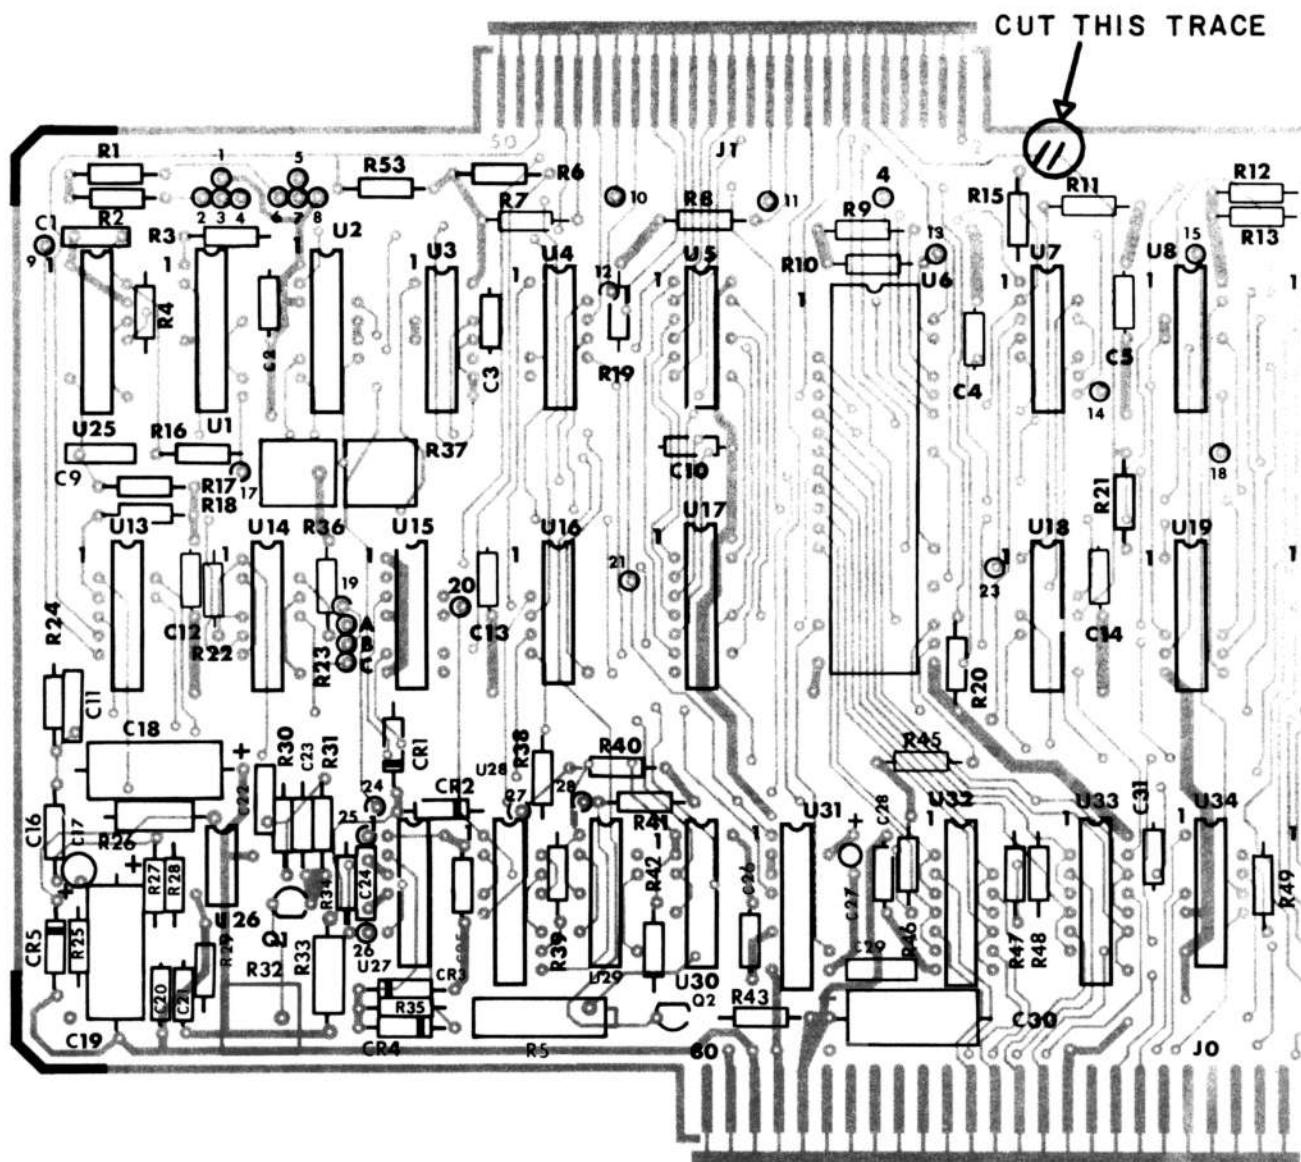
Figure 1

NOTE: This modification will cause the PIO SYSTEM test to fail. In cutting this trace you are removing a signal path connected to PIO channel A pin 14 through an inverter IC U18. This signal is A1 from the PIO. The PIO SYSTEM test will output a write out of channel B and then read the data back in channel A. With this trace cut, channel A will have bit A1 stuck high and thus the incorrect data read back in will produce an error in the SYSTEM test. The fact that this error will occur after this modification needs to be noted by the technician and therefore the SYSTEM test should be run before the modification is done.

PROCEDURE: Locate and cut the trace connected to pin 1Ø of the disk drive connector on the FDC board (Refer to Figure 1).

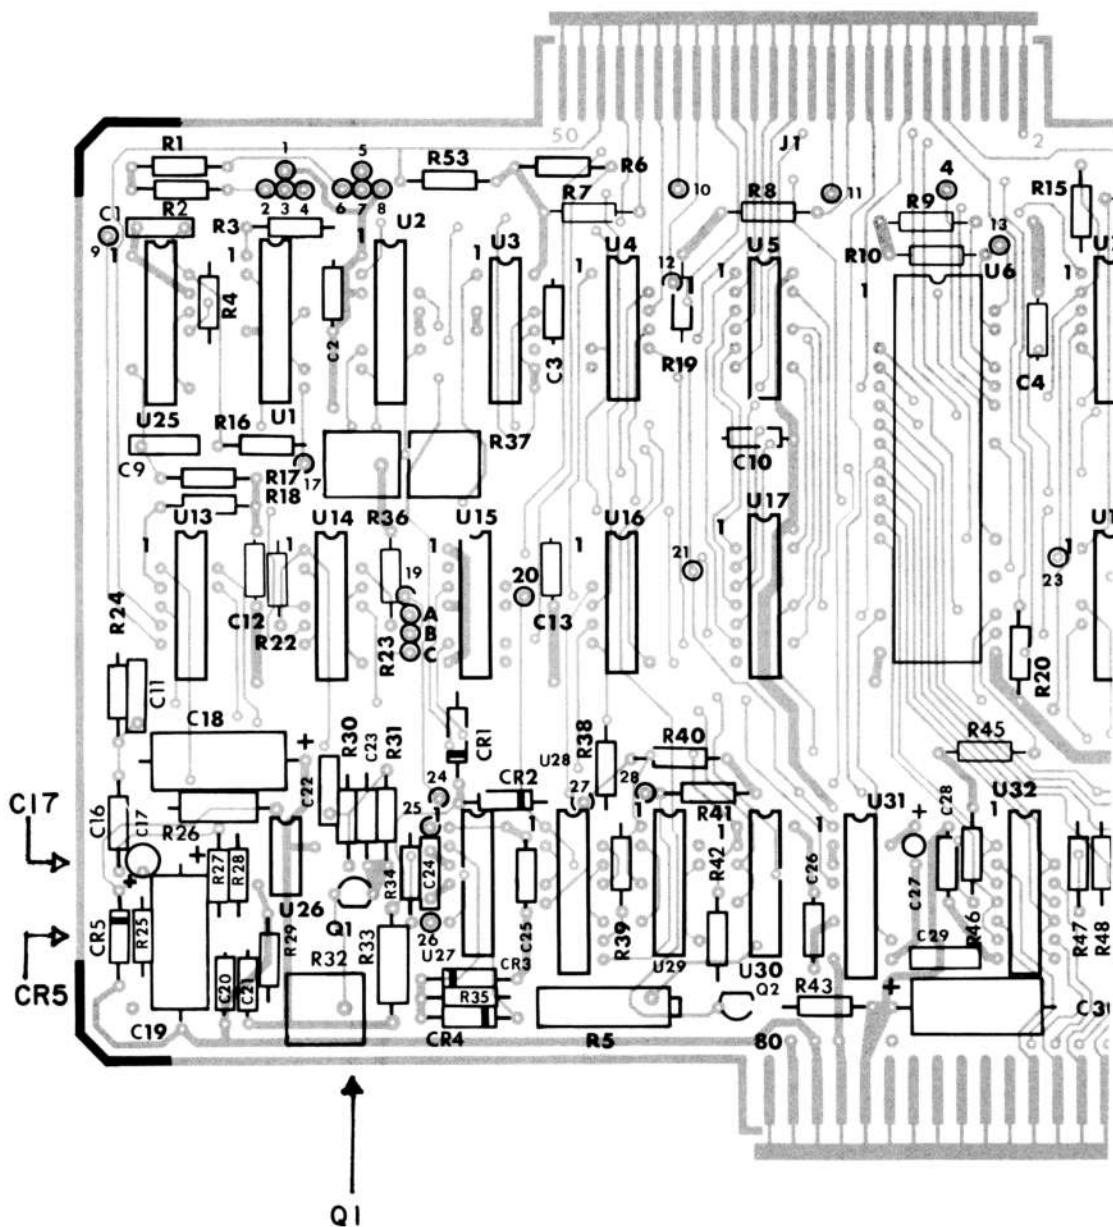
Figure 1

DISCUSSION: Early FDC boards had a problem with C17 installed backwards. Rev A boards were not marked with polarity. Rev B boards and early Rev C boards were marked with the polarity backwards. This problem was corrected on later Rev C boards. C17 is a .47 ufd tantalum capacitor with a 33V rating. Installed backwards it will eventually break down due to approximately -6V across the capacitor. Note that CR5 is referenced to -12V. This capacitor installed backwards can cause intermittent problems and will eventually cause circuit failure. Over a period of time the capacitor will smoke causing CR5 and possibly Q1 to be damaged.

PROCEDURE: Check C17 on all units in for service to insure the positive(+) lead is going to ground. The most accurate method of checking this is by actually checking with an ohm meter continuity between the positive lead of C17 to ground. If capacitor is installed backwards replace with a new .47ufd tantalum capacitor(ACC-474MGTP). Do not just turn the old capacitor around as it has started degrading and life expectancy shortened.

If the capacitor actually smoked then you must replace it and the diode CR5 (ADX-1279). Also check Q1, a 2N2222A transistor (AMX-4263), because it may have been damaged also, replace if necessary.

If any parts are replaced check the alignment and full operation of the FDC Board.

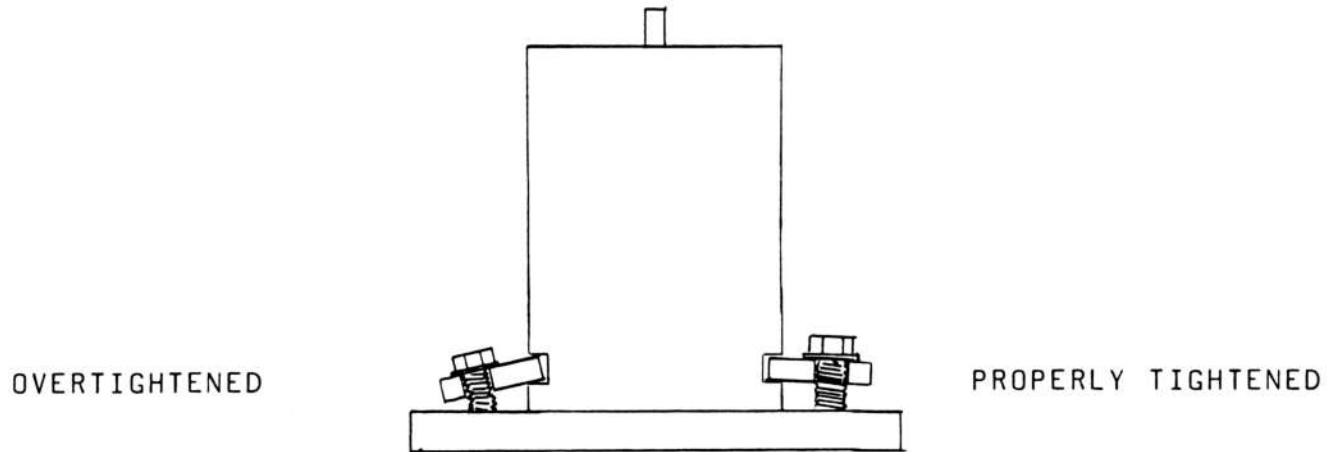
FIG. 1

DISCUSSION: After aligning Head Radial DO NOT OVERTIGHTEN bracket screws when securing the stepper motor. Excessive tightening will cause bracket and screws to bend and eventually damage the screw holes in the stepper motor plate, making proper alignment almost impossible.

PROCEDURE: After Head Radial Alignment tighten bracket screws only enough to secure stepper motor. If the stepper motor cannot be secured without excessively bending the bracket (Refer to Figure 1), or if the screw holes in the plate are damaged, replace the drive chassis.

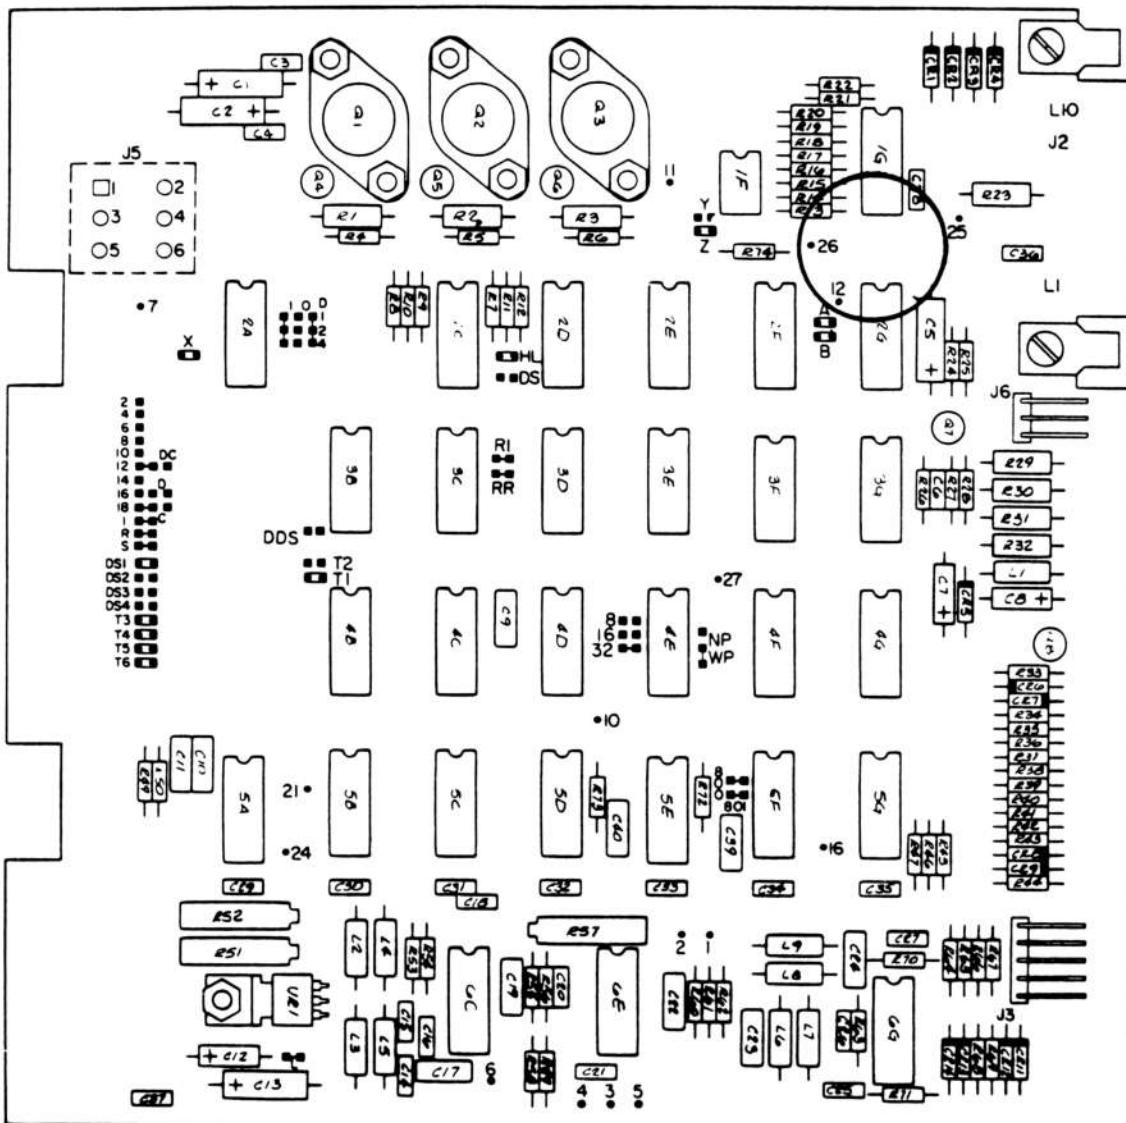
DISCUSSION: To correct booting errors the Ready line on the Shugart discrete logic board should be bypassed to ground with a .0lufd disc capacitor. All discrete boards should have this capacitor installed as a preventive measure. Any system that exhibits an unexplained booting problem not related to a hardware fault should be checked for this capacitor. This is now being done at the factory to new discrete boards. This capacitor is NOT to be added to Shugart LSI logic boards.

PROCEDURE: Check Ready line for .0lufd installed to ground. If capacitor is not present install .0lufd disk capacitor to ground (Refer to Figure 1).

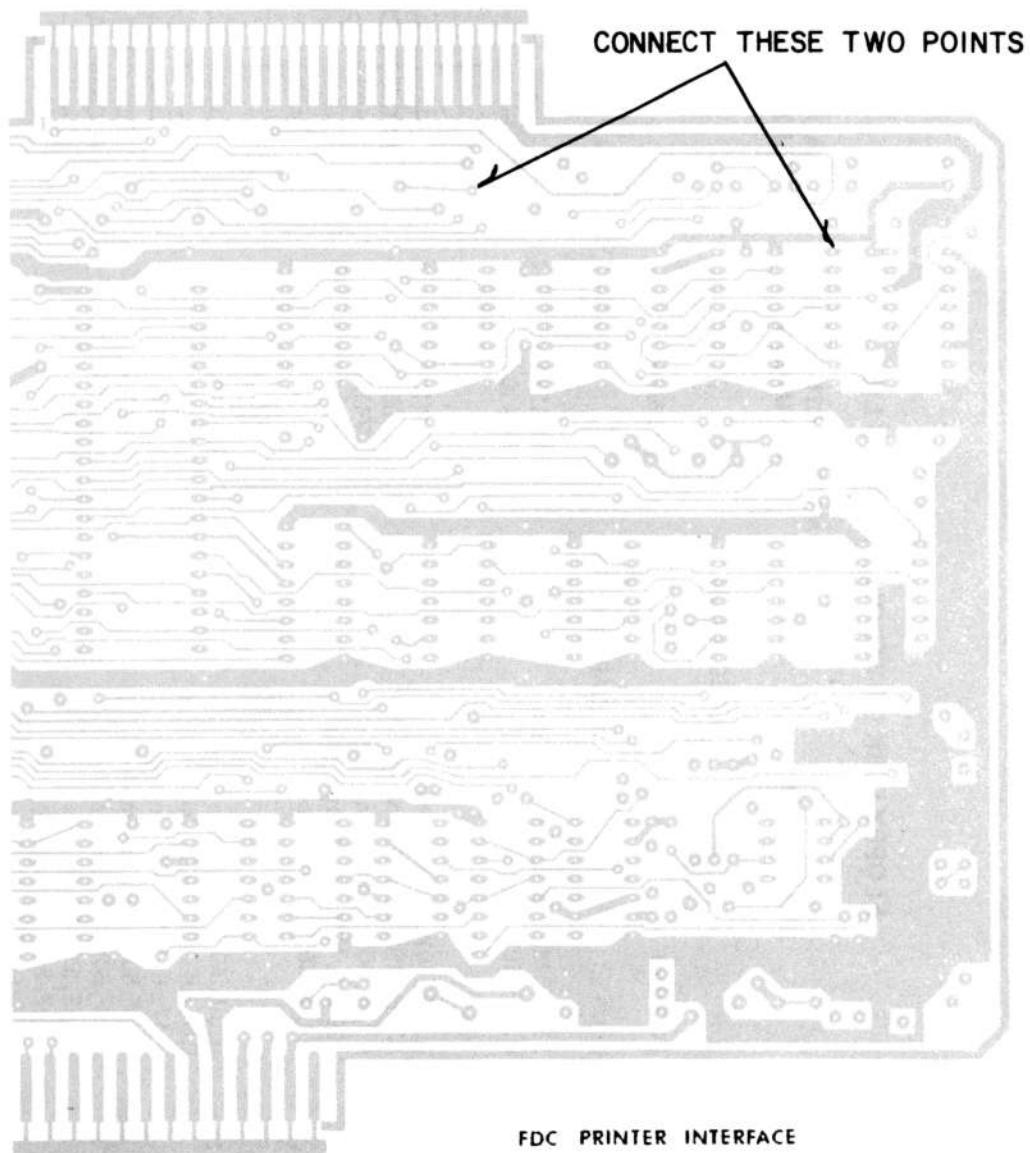
FIG 2

DISCUSSION: Some early FDC boards may not be able to format past Track 43 with precomp set at the required specification of 250 nsec. This problem will occur ONLY with the SY1791-02 FDC chip (not the FD1791-02 FDC chip) because the EARLY pulse ends slightly sooner on the SY1791-02. This could lead to a double pulse being picked off the shift register. To correct this problem the data out is tied to the RESET of the shift register. As soon as the data triggers the one-shot, it then clears the shift register, preventing double data pulses (Refer to Figure 1).

PROCEDURE: On unmarked, Rev A, or Rev B boards make sure the "one shot" modification has been installed (Refer to Technical Bulletin II:9), or that long jumpers are installed on the back of the board running to U37. Disregard this step on Rev C and D boards as they have this modification incorporated into their circuitry. On ALL revisions of the current board with a SY1791-02 FDC chip installed, add a jumper wire on the back side of the board from U1 pin 1 to the trace connected to TP10 (Refer to Figure 2).

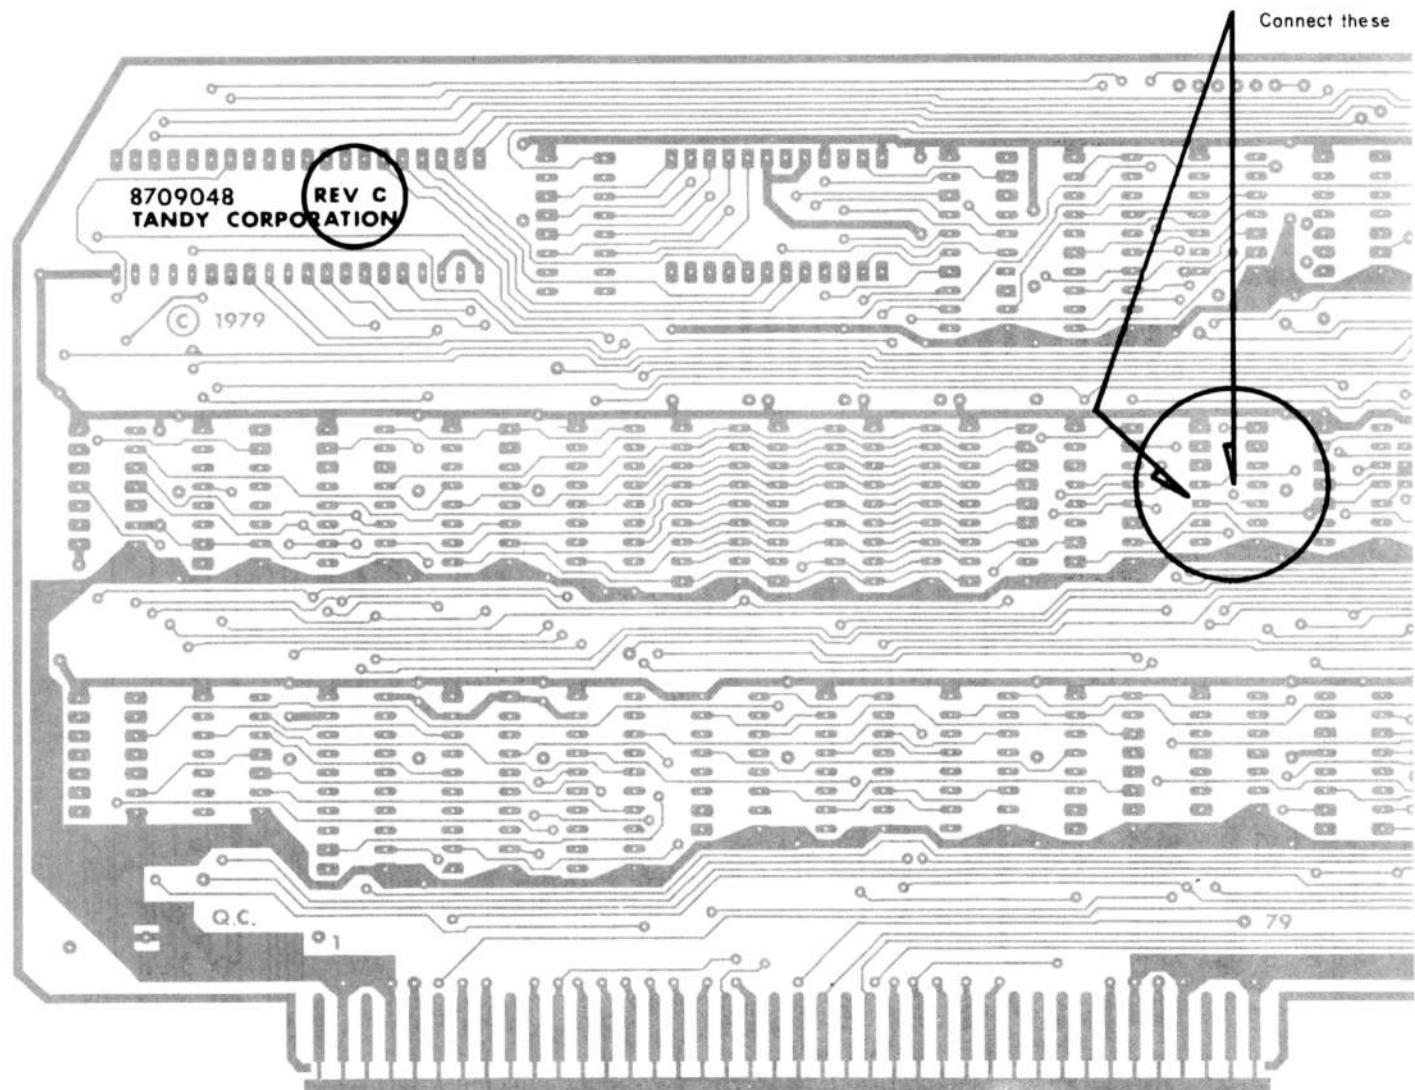
Figure 1

DISCUSSION: On Rev C VDG boards made by Lika there is a trace missing to the clear line on the latch (U17) that generates KBIRQ*. This can generate random interrupts that may or may not be fatal. To correct this problem a jumper is added to correct the missing trace which is a pullup to the clear line of U17. To identify the board as being manufactured by Lika, look for the Rev C marking on the solder side of the board under the 6845 chip and by LEI etched also on the solder side the crystal. This is the ONLY board to which this fix applies.

PROCEDURE: On the solder side of the board there is a feedthru located beneath the middle of U17 that is not connected to anything. Run a short piece of wire from that feedthru to U17 Pin 10 (Refer to Figure 1).

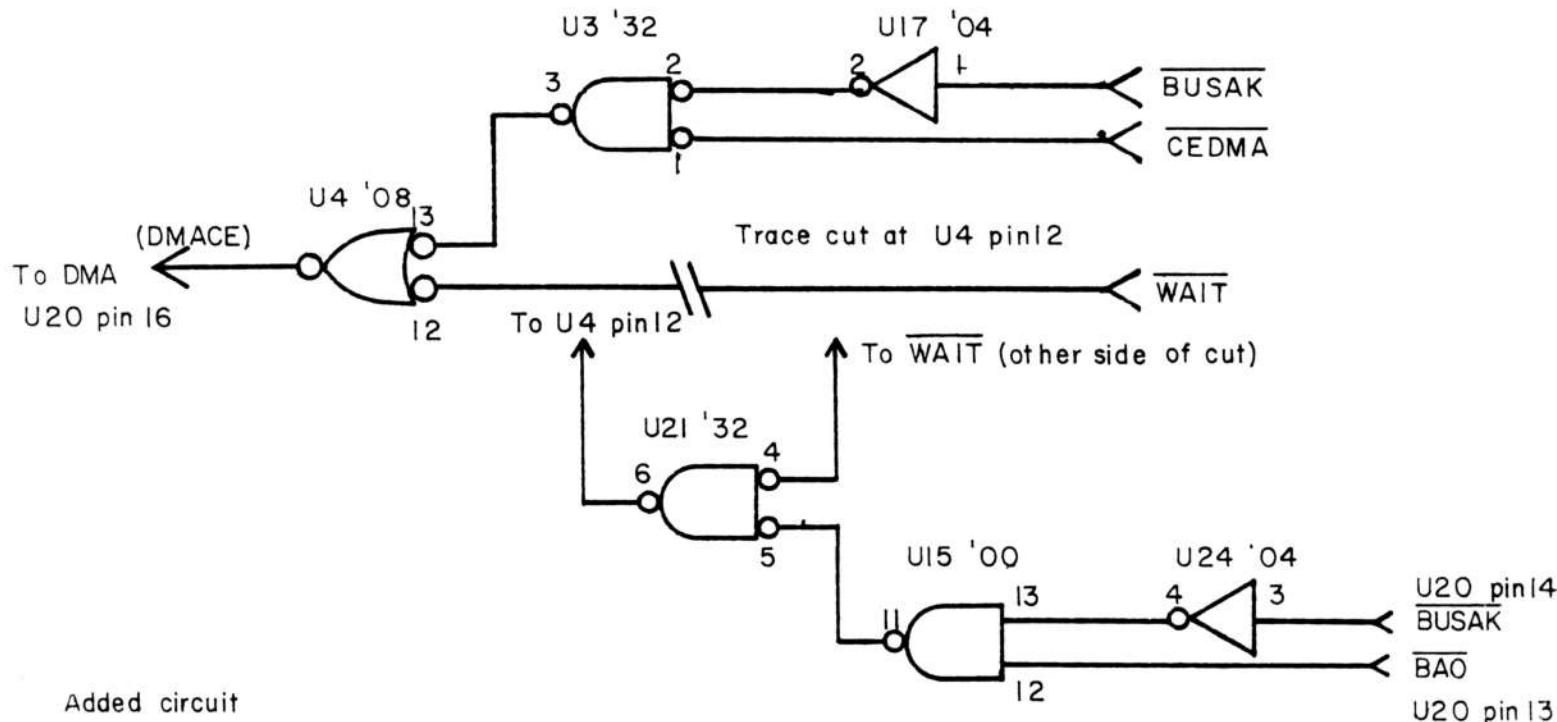
Figure 1

Existing circuit

U21 pin 1 to U24 pin 8
U4 pin 12 to U21 pin 6
U21 pin 4 to WAIT* (the first feedthru after the cut at U4 pin 12)
U21 pin 5 to U15 pin 11
U15 pin 12 to U20 pin 13
U15 pin 13 to U24 pin 4
U24 pin 3 to U20 pin 14

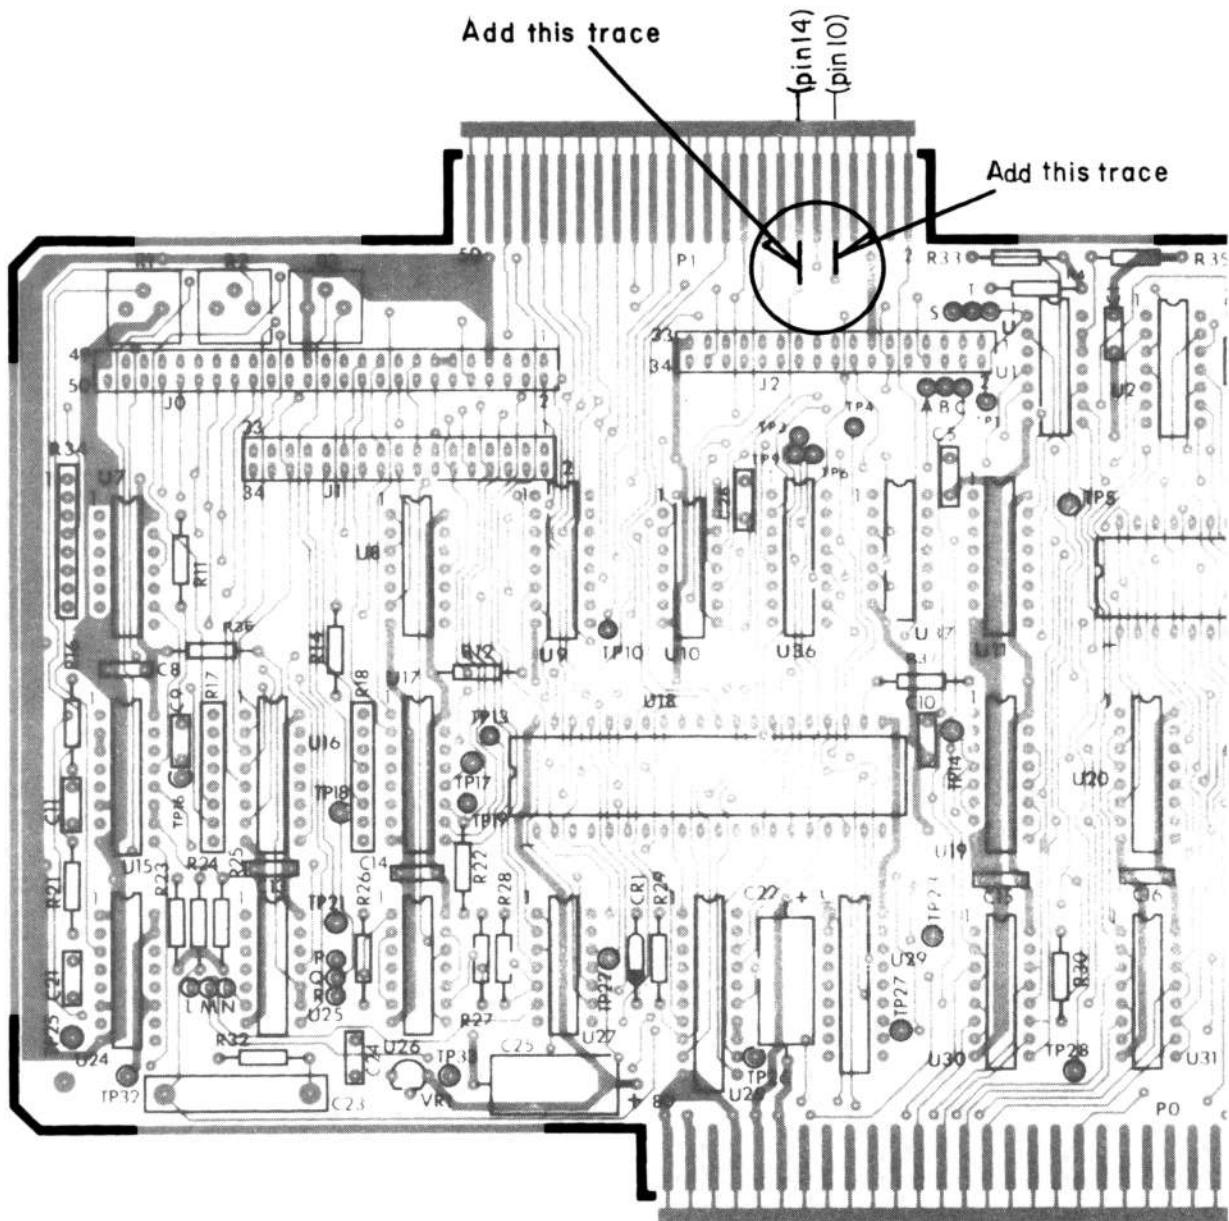
DISCUSSION: The trace that supplies the side select signal to the external drive connector on the Late Design FDC board (Rev Blank) is missing. Also, on some boards the trace that supplies the TWOSIDE* signal from the external drives to the FDC board is not present. Without these traces double sided drives cannot be used externally with the computer and will cause a problem with some diagnostics.

PROCEDURE: Refer to Figure 1 for the location of these traces. Run a jumper from pin 14 of connector P1 to the feedthru on the PCB that is directly in from the connector. Also run a jumper from pin 10 of connector P1 to the feedthru that is directly in from the connector.

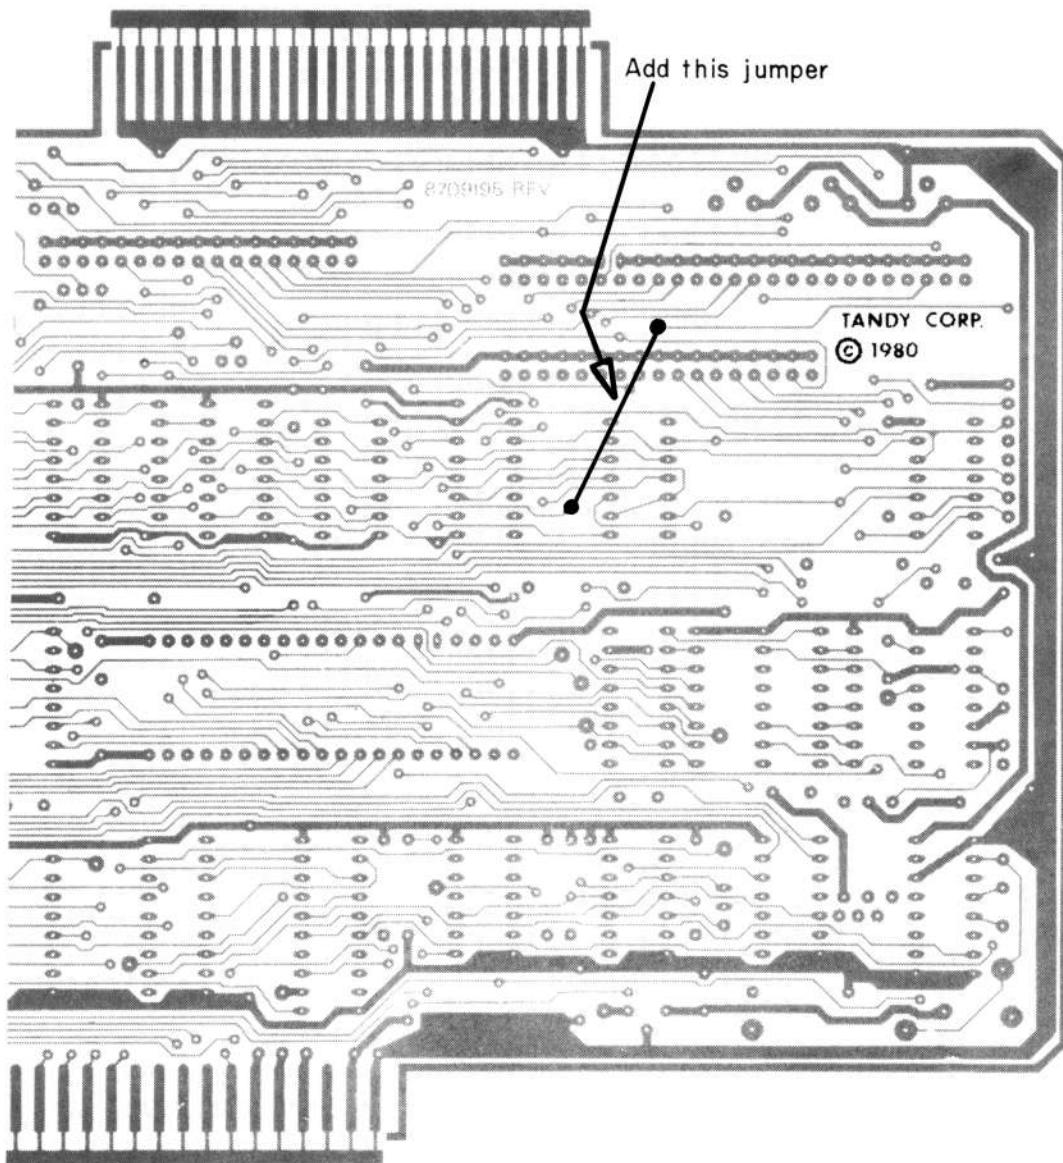
Figure 3

PURPOSE: To correct Head Load termination on FDC board (Late design/Rev Blank).

1. On the component side, cut the trace that goes to pin 18 of J0 (the 50 position pin header connector) RIGHT AT the connector so that the feedthru can still be used on the reverse side to go to the external head load signal (Refer to Figure 2).
2. Turn the board over to the solder side and solder a jumper from the feedthru referenced in step 1 (this is the pullup resistor line) to the feedthru between U8 and U9 that is closest to pin 8 and 9 of U8. This feedthru is the Head Load external signal external signal and goes over to U10 on the solder side of the board (Refer to Figure 3).

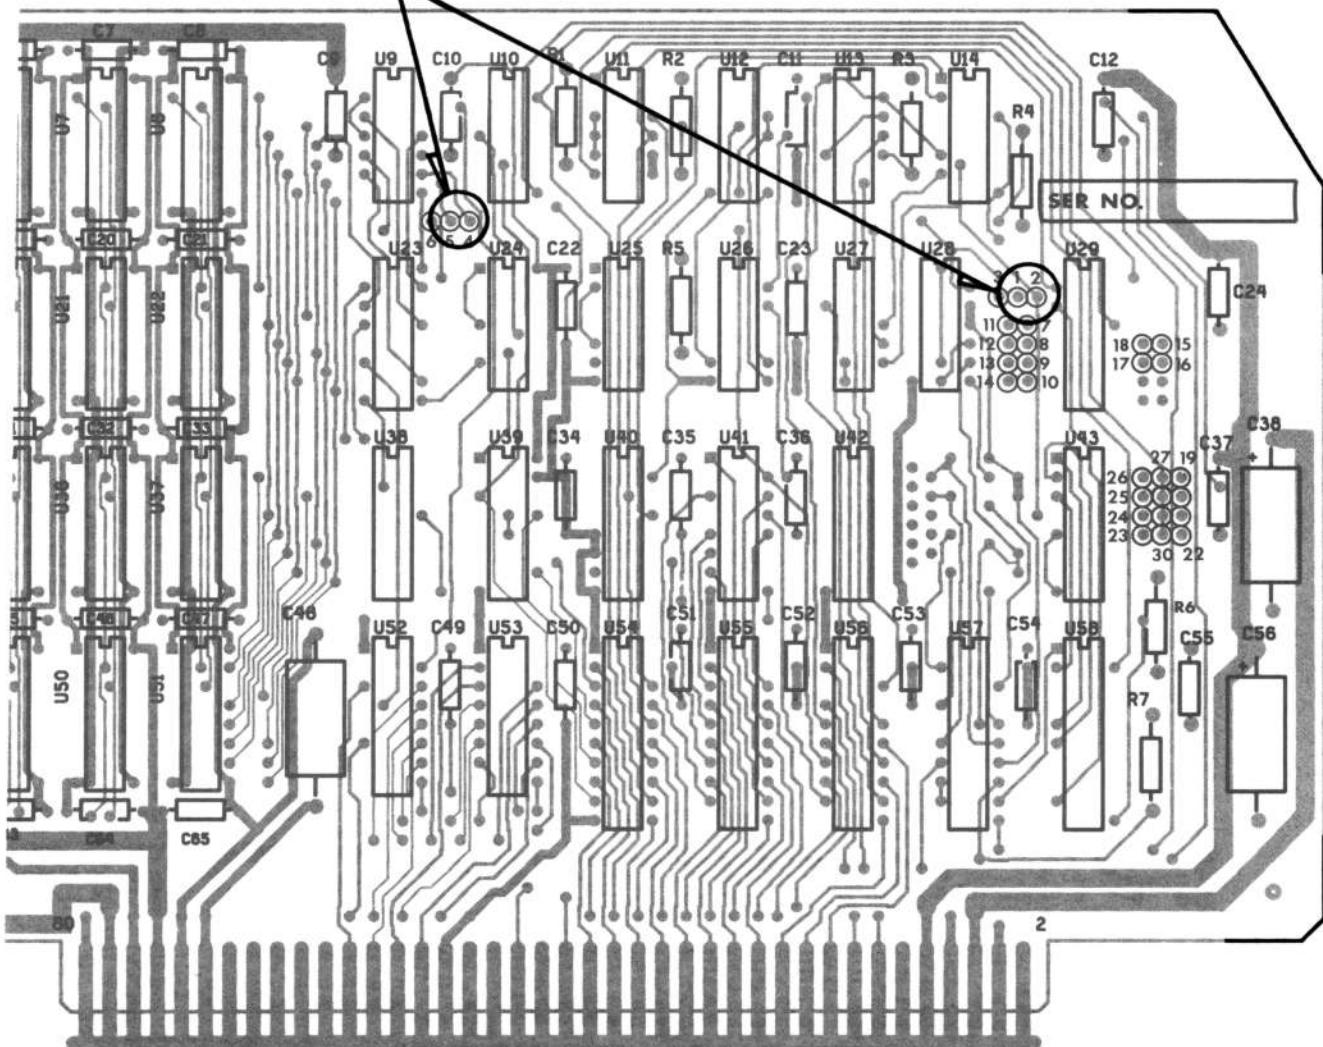
DISCUSSION: Pullups are needed on memory boards for inputs to gates. Intermittent problems can occur without these pullups installed. Some of the Model II memory boards may be missing staking pins for push on connectors and appropriate markings. In this case, use wirewrap to jumper the pads and refer to Figure 1 for pad locations.

PROCEDURE: Check boards for proper jumpering and install jumpers if they are missing. For physical locations of jumpering positions refer to Figure 1 for the memory board and Figure 2 for the Interface board.

Model II Memory boards:
Jumper 1-2 and 5-6

Add these jumpers

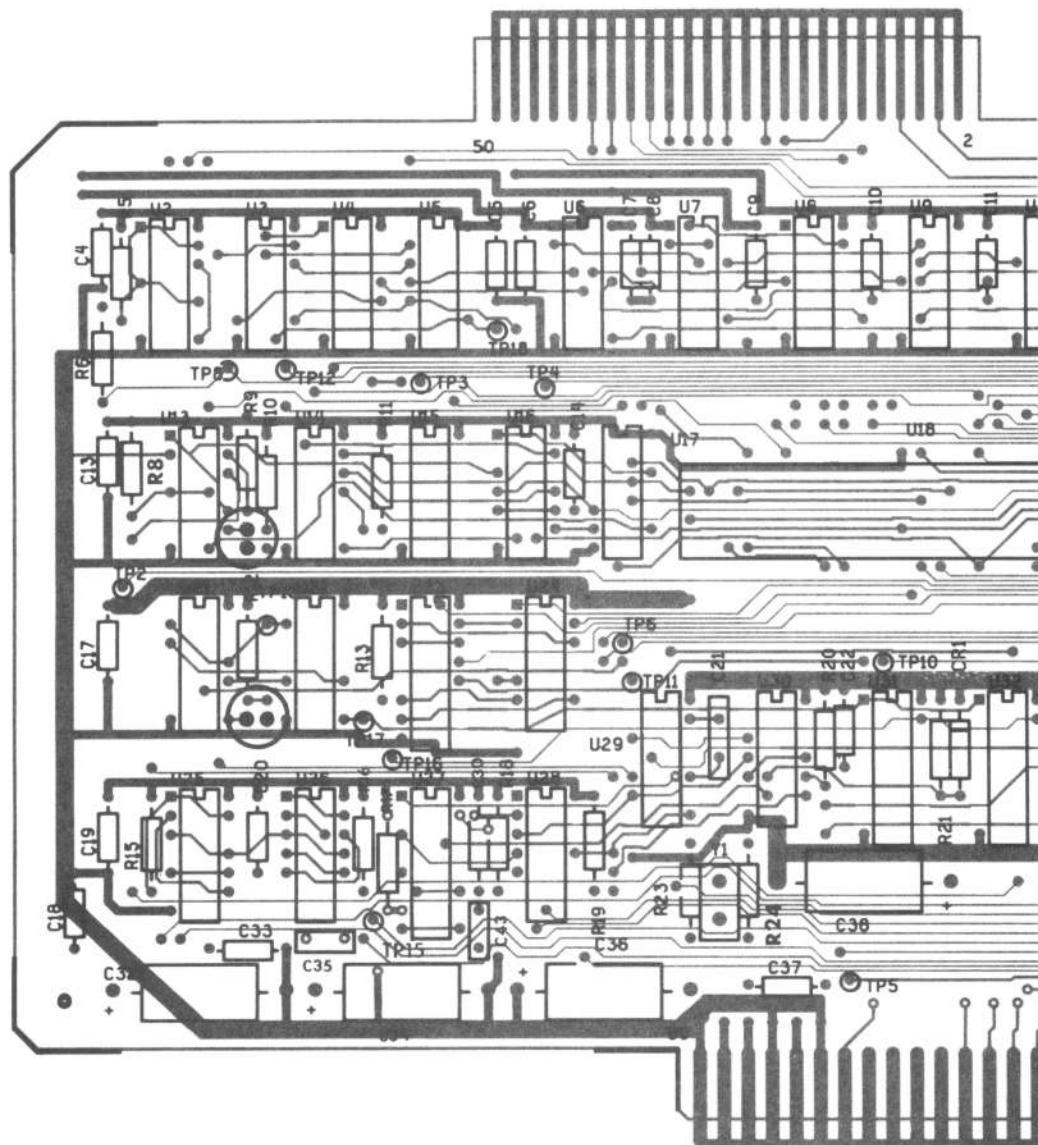
Figure 1

DISCUSSION: Problems using wait states and software timing loops may be caused by two missing jumpers on the CPU board. The jumper locations are physically the same on all revision boards, but may be marked differently or not marked at all.

PROCEDURE: Check all CPU boards for jumpers and install if missing.

E3-E4 and E0-E1

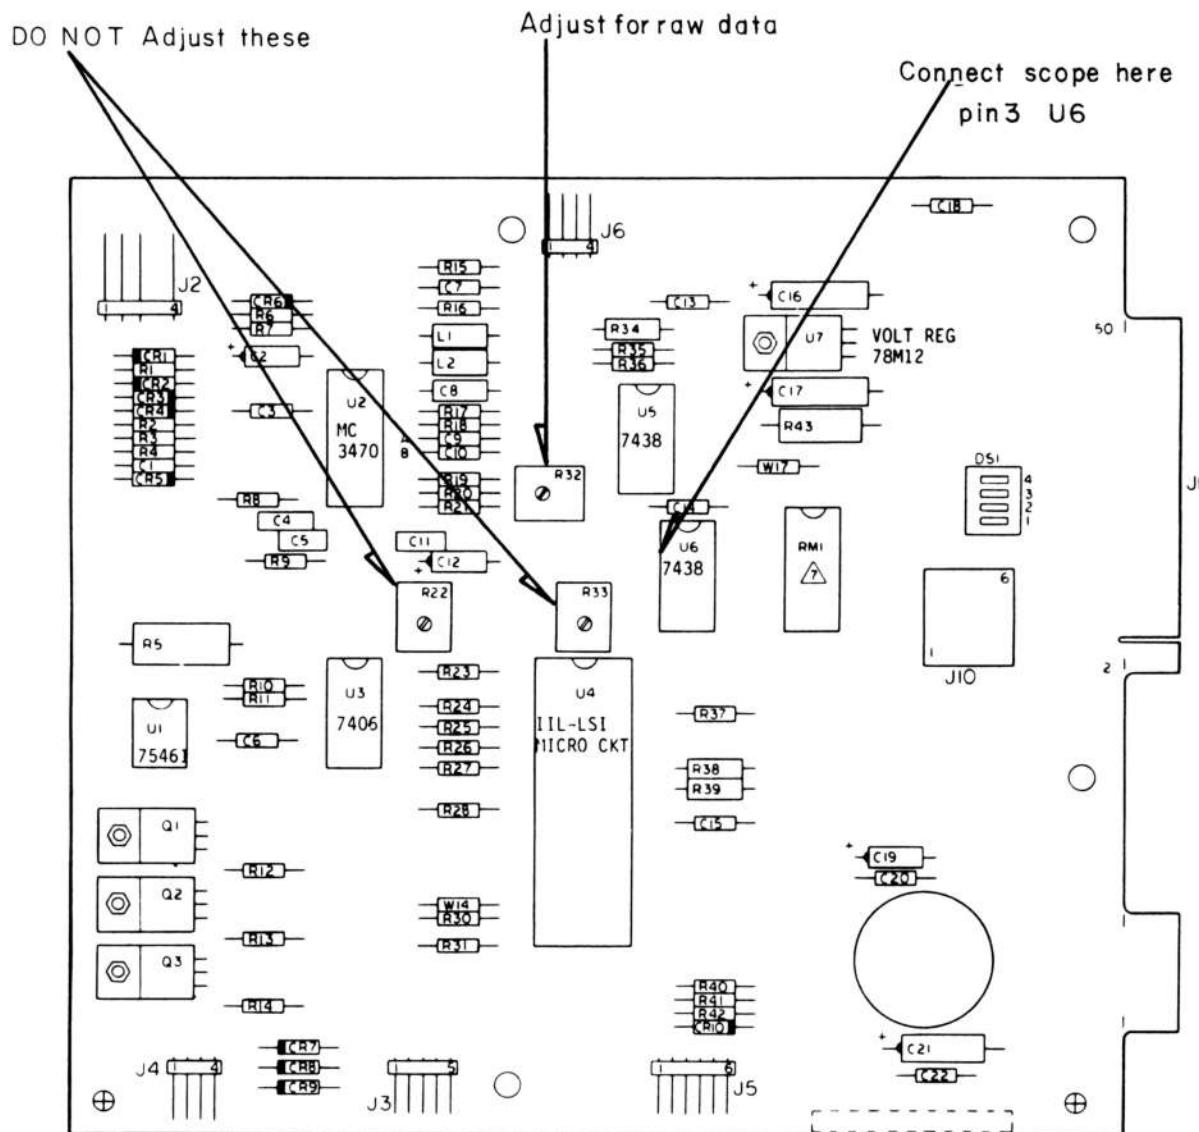
Figure 1

DISCUSSION: The LSI board has three adjustments R22, R23, and R32 (Refer to Figure 1). R22 and R33 are for adjusting the oscillator and write current to the head. These adjustments ARE NOT to be done in the field. The reason for this is because a test jig is needed, excessive time is required to complete the adjustments, and there is a high probability of damaging the head or the LSI chip. Once these adjustments have been done by the factory there is no reason for them to change unless the LSI chip fails. R32 controls the read symmetry (raw data) adjustment and it should be adjusted in the field.

PROCEDURE: Whenever doing drive alignment raw data should be checked with a blank BULK ERASED diskette. Connect scope to U6 pin 3 and proceed to step 8 of the TDC diagnostic. Adjust R32 so that the jitter of the first data pulse is less than 200nsec.

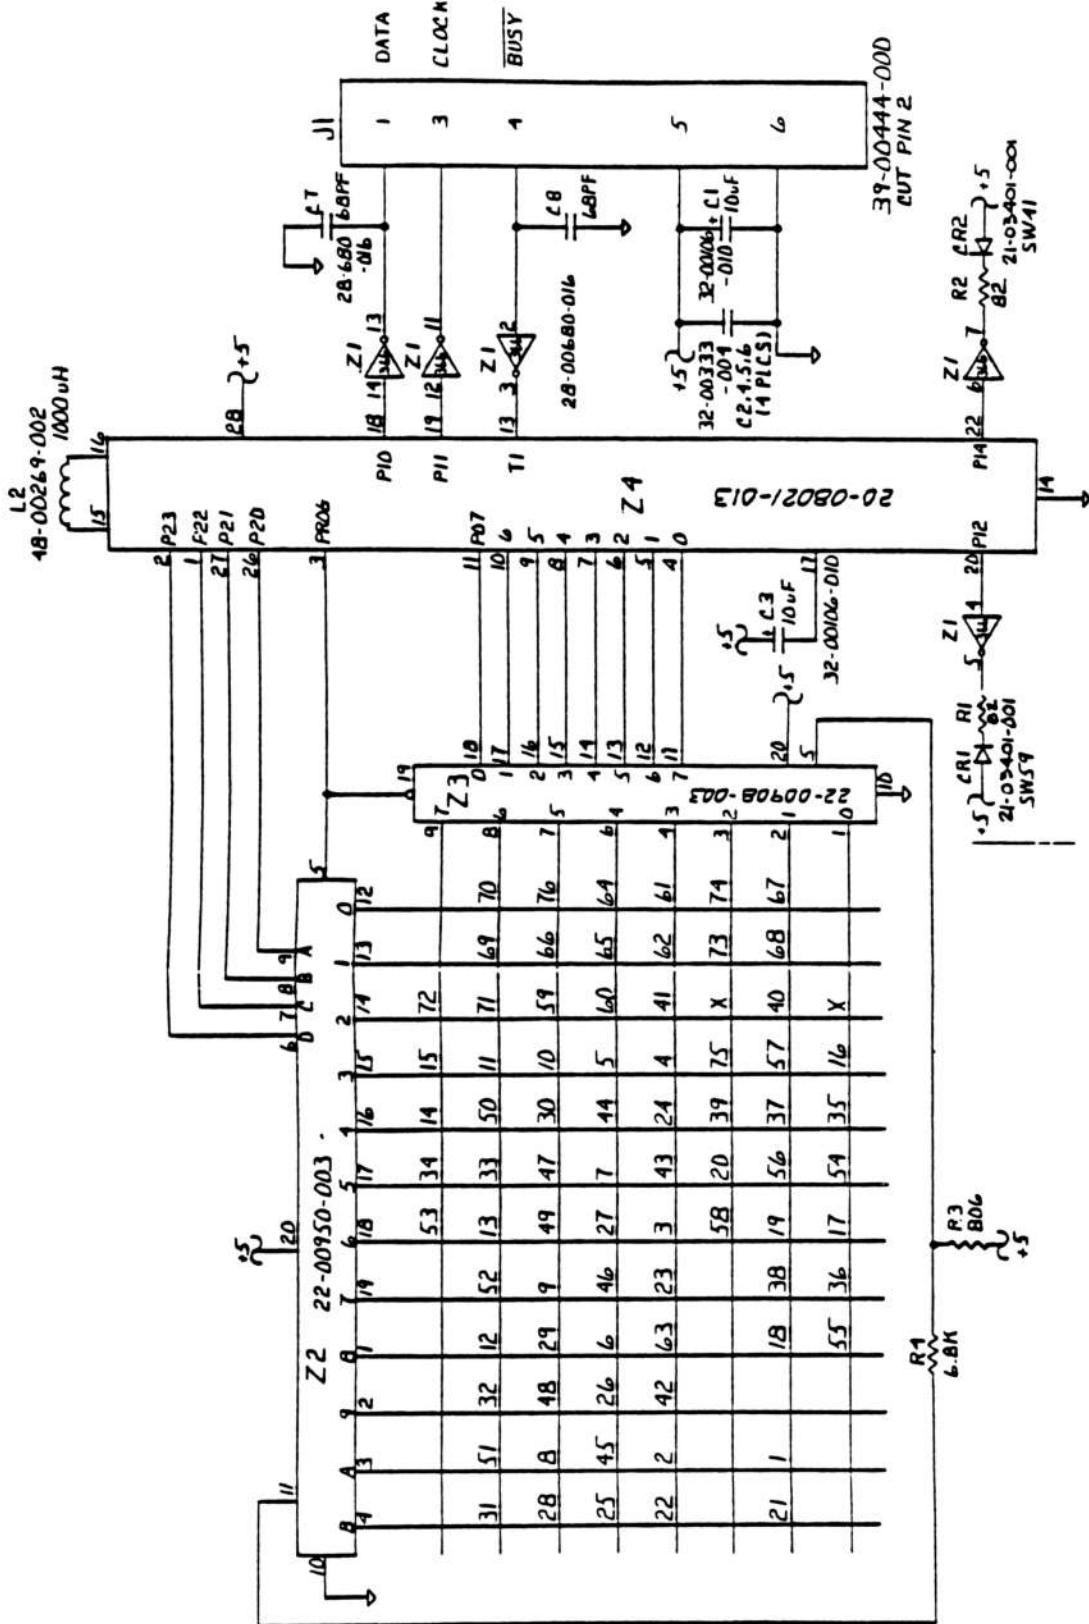
DISCUSSION: The Schematics for the Model II/16 keyboards in the Model II Technical Reference Manual are incorrect. Attached is the correct schematic and component location diagram.
