# PIMS PRO

Pipeline Corrosion Assessment & Remaining Life Calculator

| Report Number | PIMS-2026-165000 |

| Pipeline Name | Crude Oil Transfer Line |

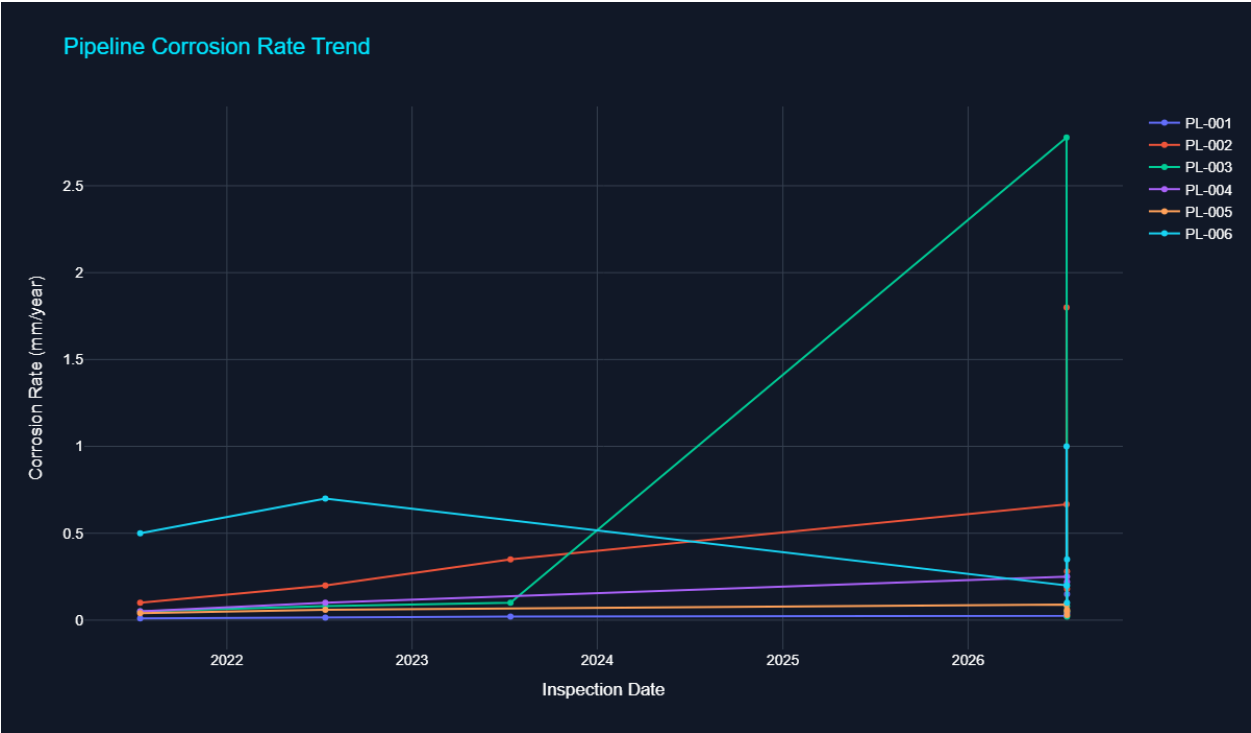
# Corrosion Trend

| Corrosion Rate | 0.15 mm/year |

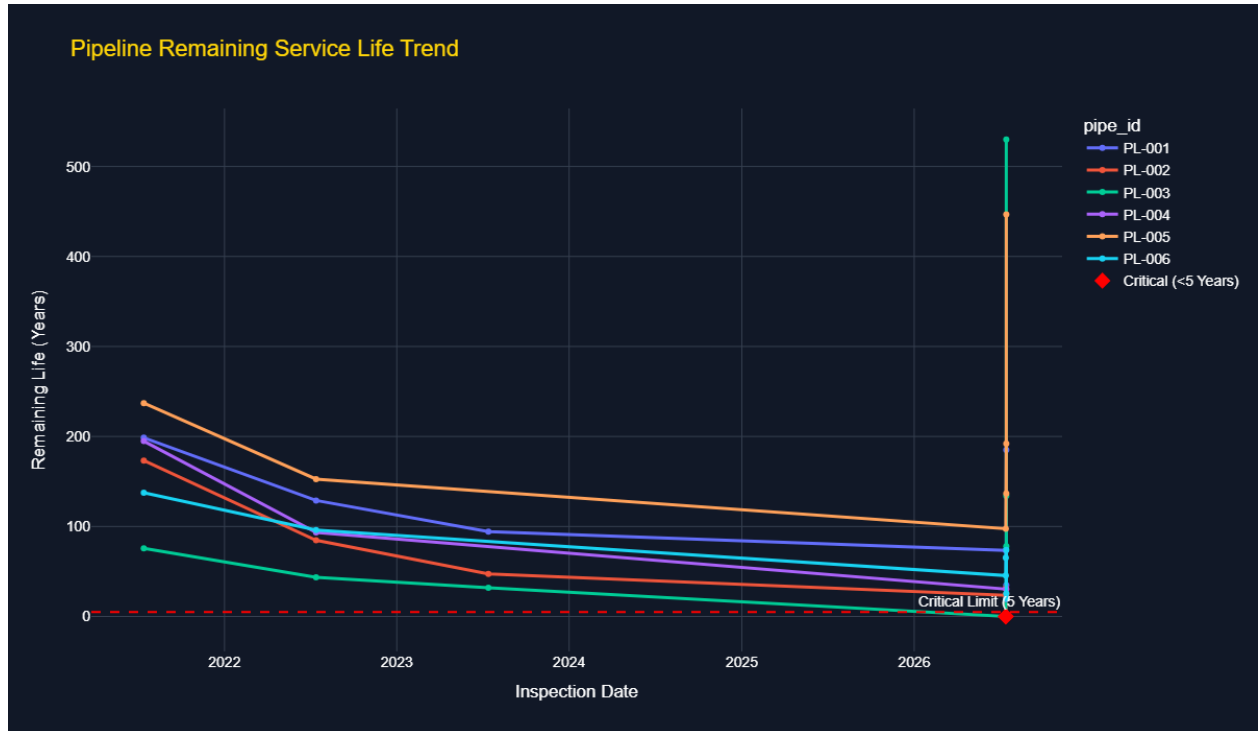
## Remaining Life Trend

| Remaining Life | 22.10 years |
