# PIMS PRO

Pipeline Corrosion Assessment & Remaining Life Calculator

| Report File | PL-001_Inspection_Report_2026-07-16.pdf |

| Pipe ID | PL-001 |

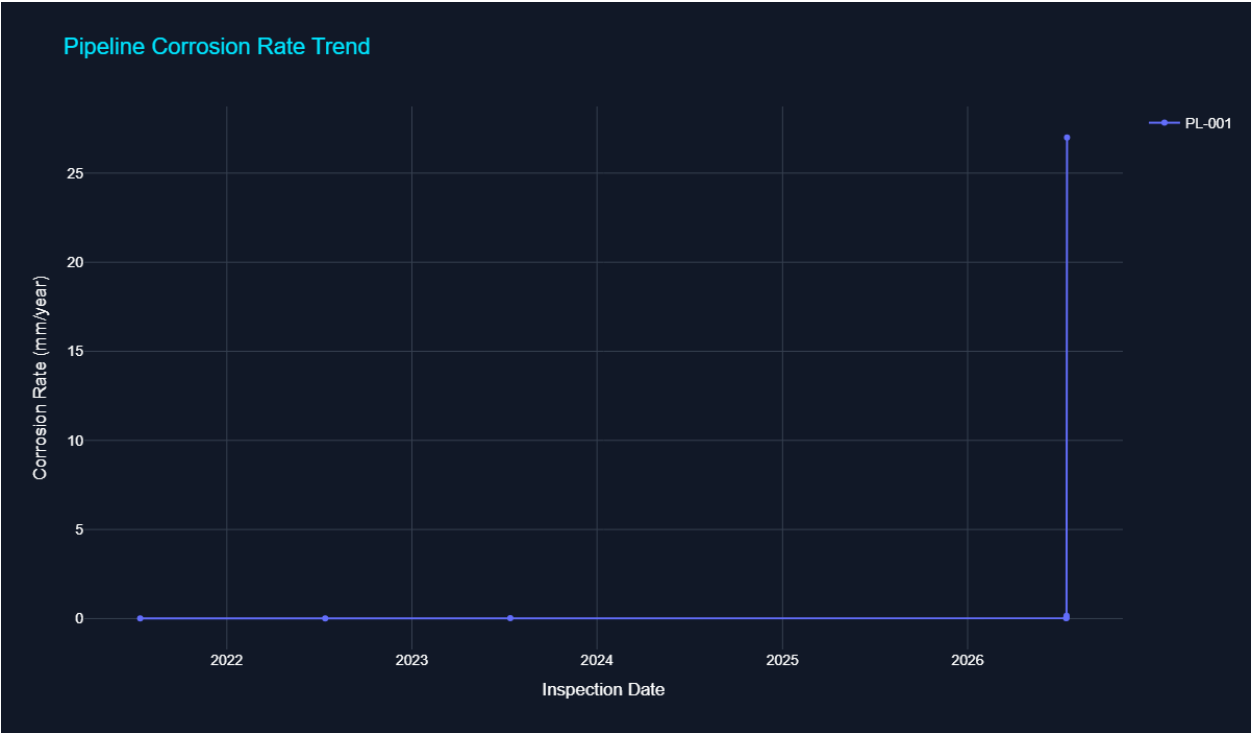
# Corrosion Trend

| Corrosion Rate | 27.00 mm/year |

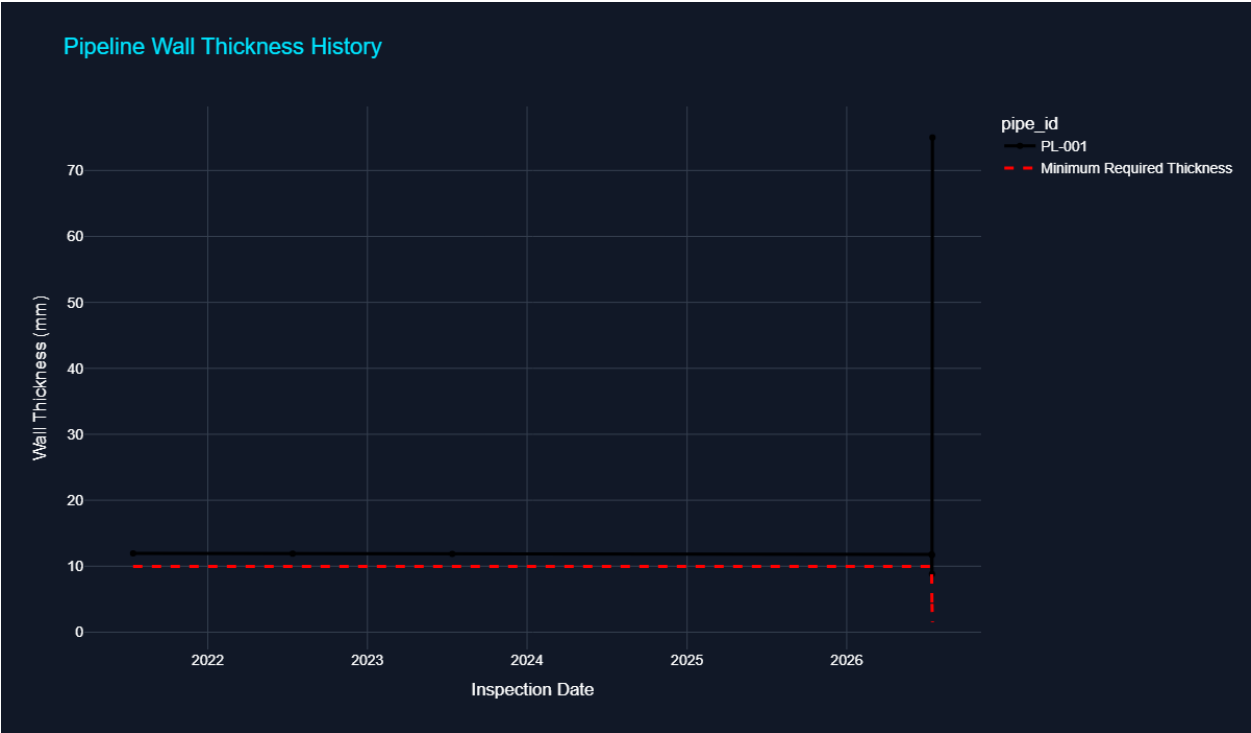
# Thickness History

| Corrosion Loss | 64.29 % |

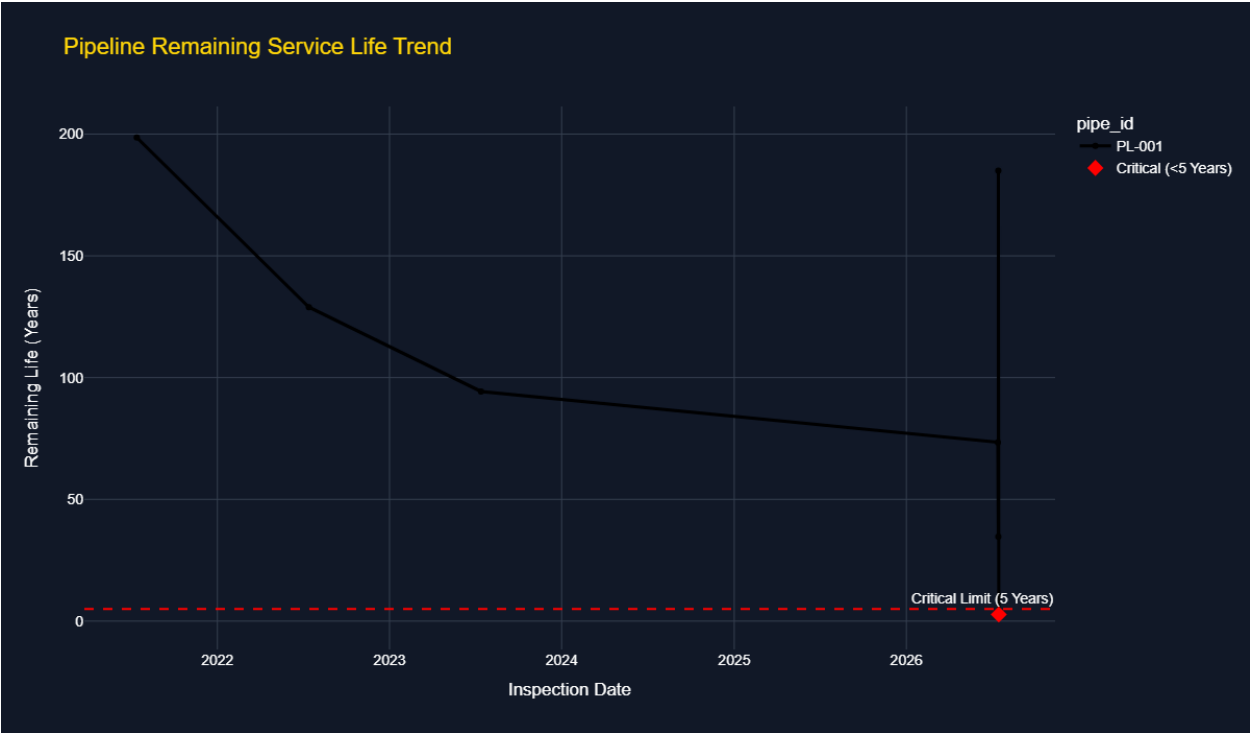
# Remaining Life Trend

| Remaining Life | 2.72 years |

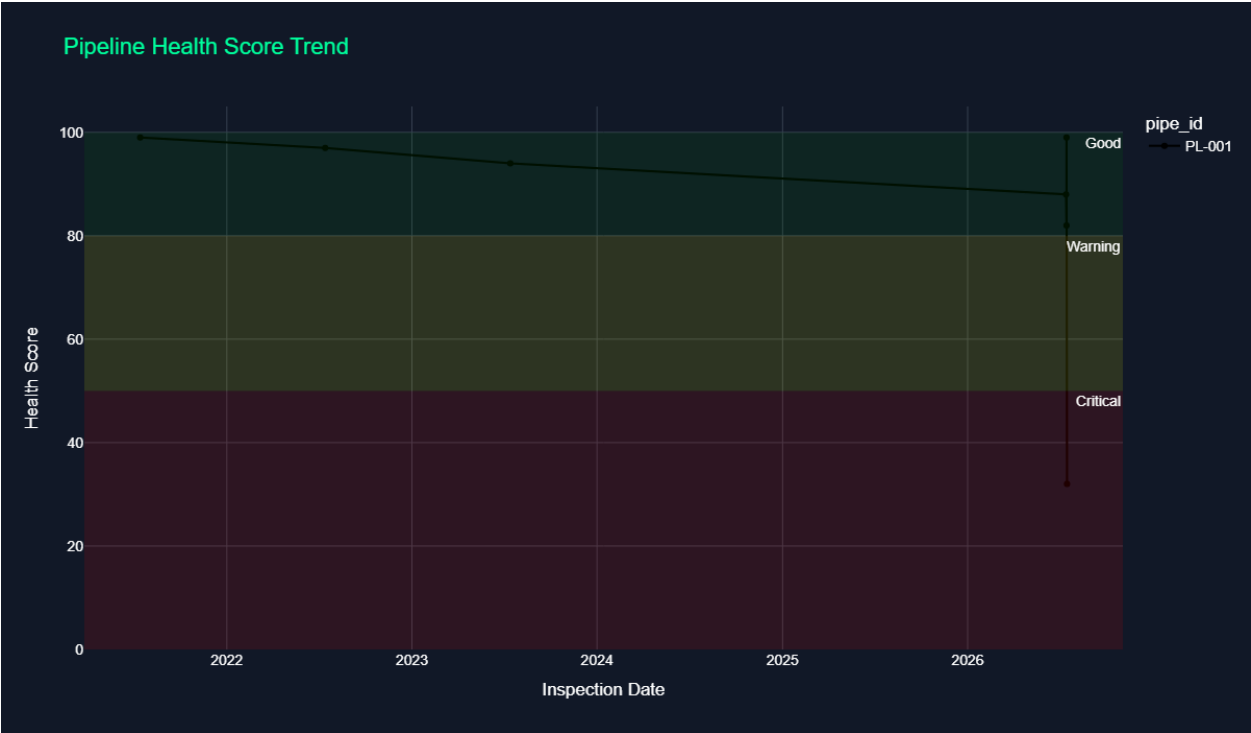
# Health Trend

| Health Score | 32.00 % |

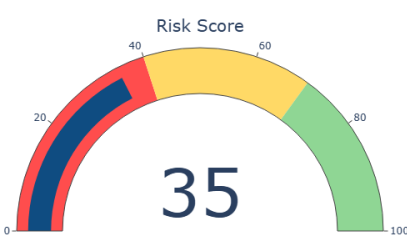
# Engineering KPI Gauges

| Risk Level | Critical |
| Remaining Life | 2.72 Years |
| Corrosion Rate | 27.00 mm/year |

| Overall Decision | Pipeline Unsafe for Service |
| Maintenance Suggestion | Immediate shutdown and replacement. |

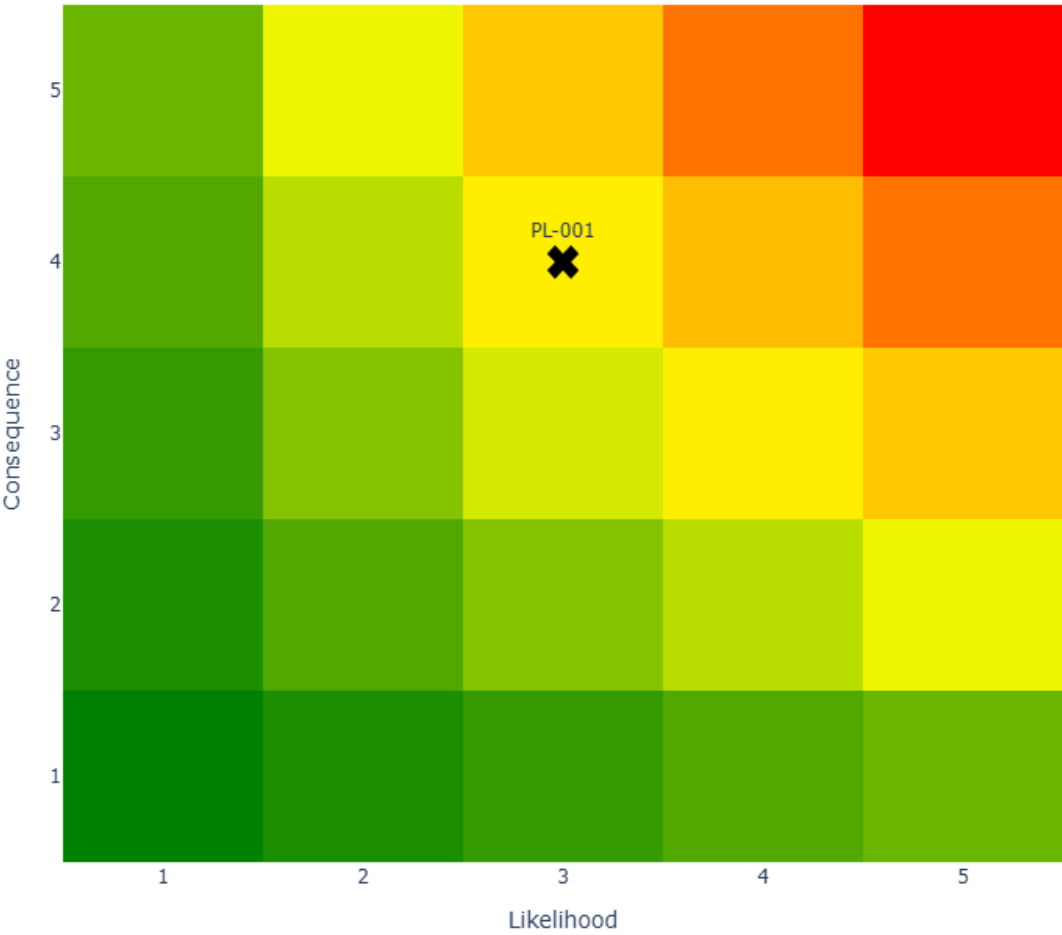
5 × 5 Pipeline Risk Matrix

| Parameter | Value |
|---|---|
| Likelihood | 5 |
| Consequence | 4 |
| Risk Score | 20 |
| Risk Category | Critical |

| Inspection Interval | Immediate inspection required. |
