# PIMS PRO

Pipeline Corrosion Assessment & Remaining Life Calculator

| Report File | PL-006_Inspection_Report_2026-07-16.pdf |

| Pipe ID | PL-006 |

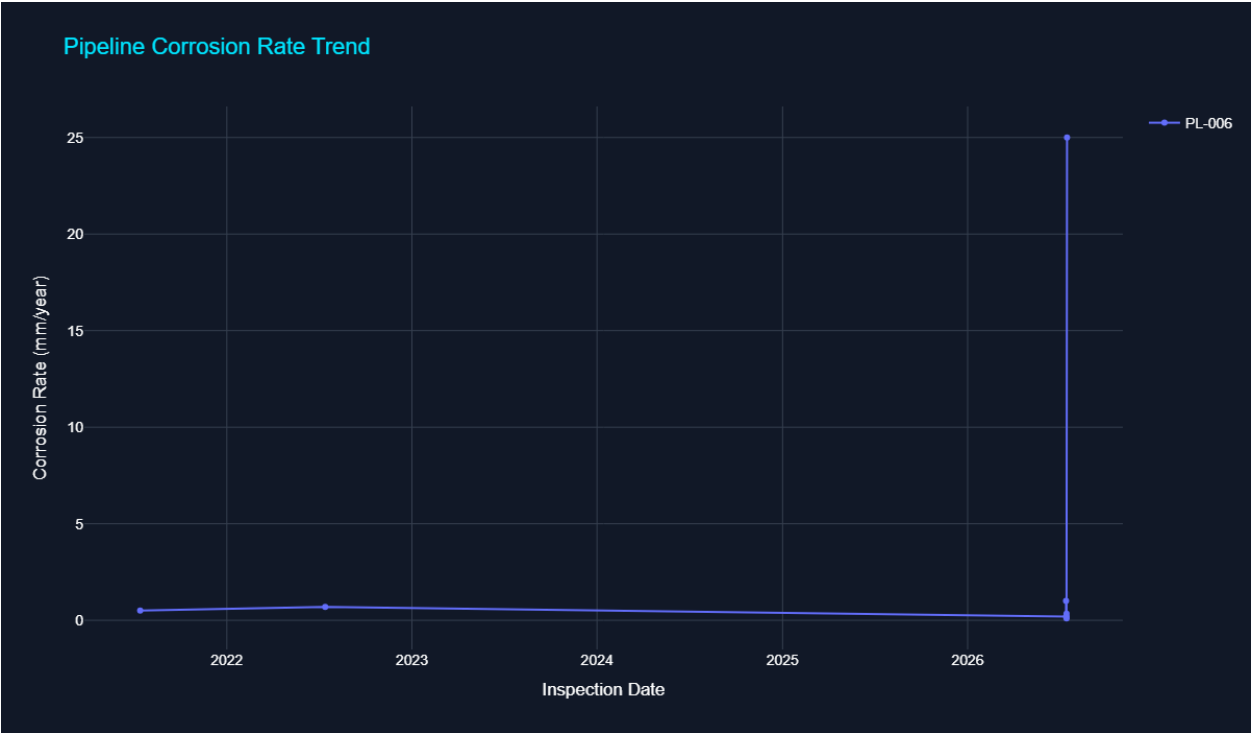
# Corrosion Trend

| Corrosion Rate | 25.00 mm/year |

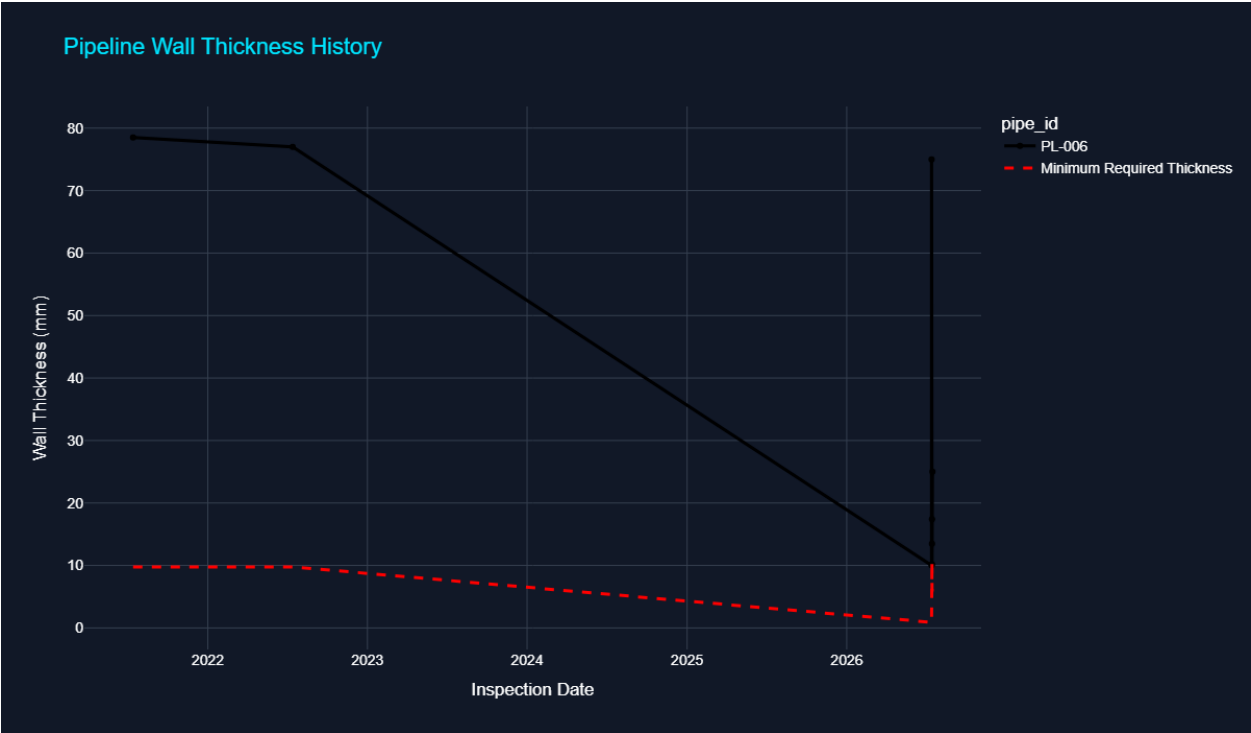
# Thickness History

| Minimum Thickness | 6.19 mm |
| Corrosion Loss | 75.00 % |

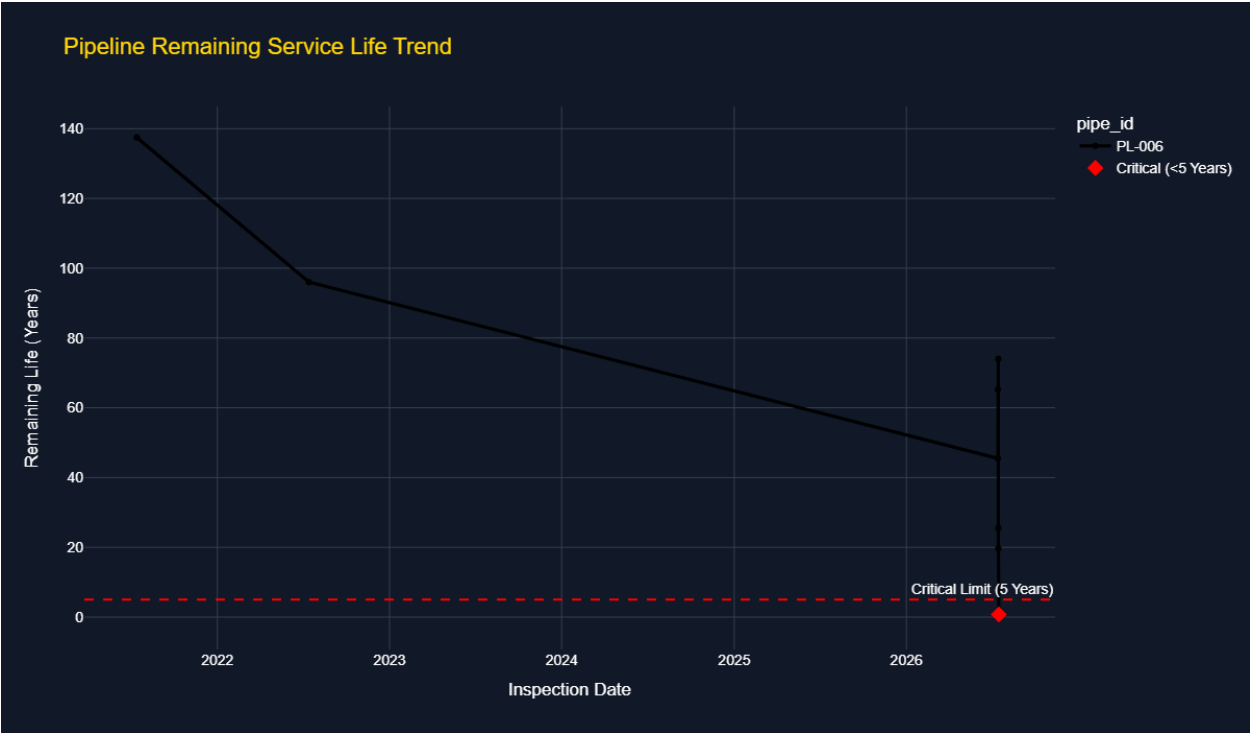
# Remaining Life Trend

| Remaining Life | 0.75 years |
| Failure Year | 2027 |

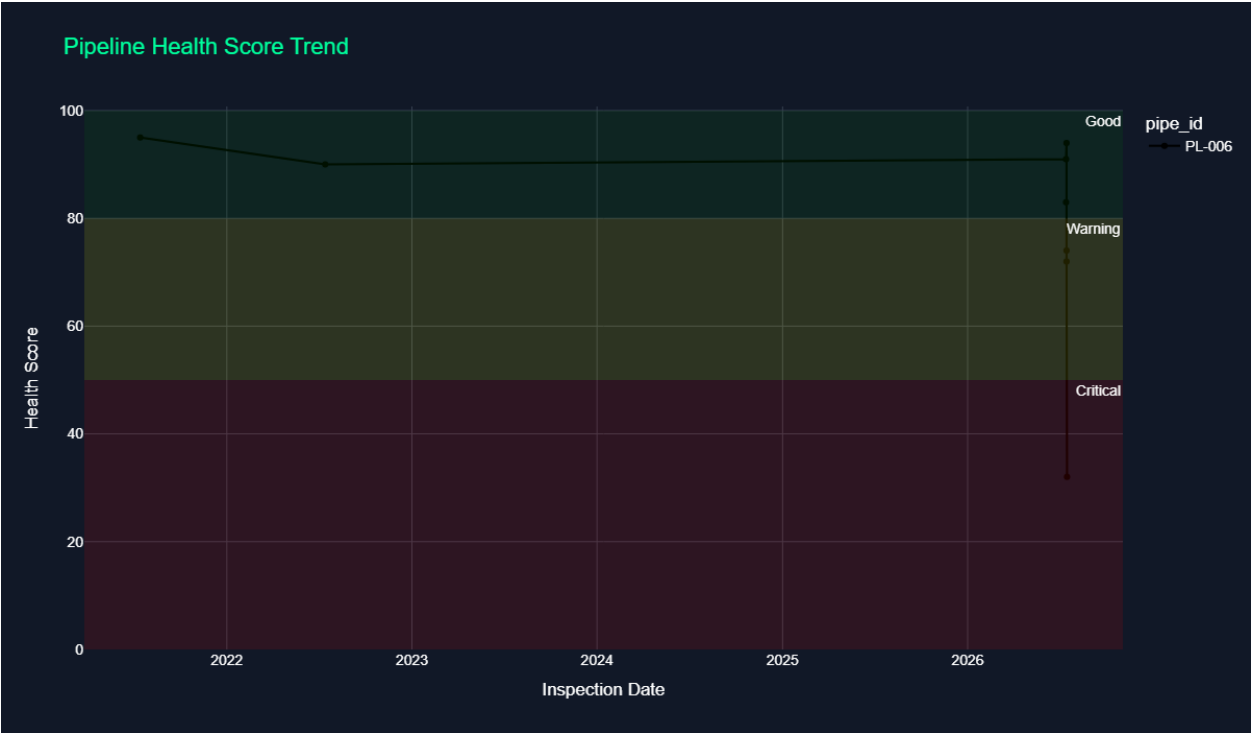
# Health Trend

| Health Score | 32.00 % |

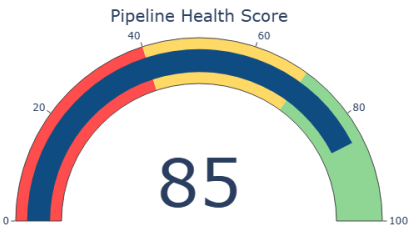
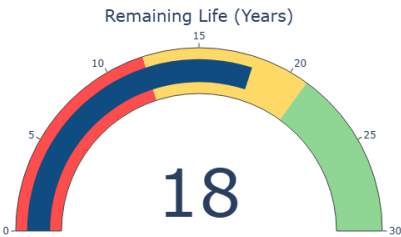
# Engineering KPI Gauges

| Risk Level | Critical |
| Remaining Life | 0.75 Years |
| Corrosion Rate | 25.00 mm/year |

| Maintenance Suggestion | Immediate shutdown and replacement. |

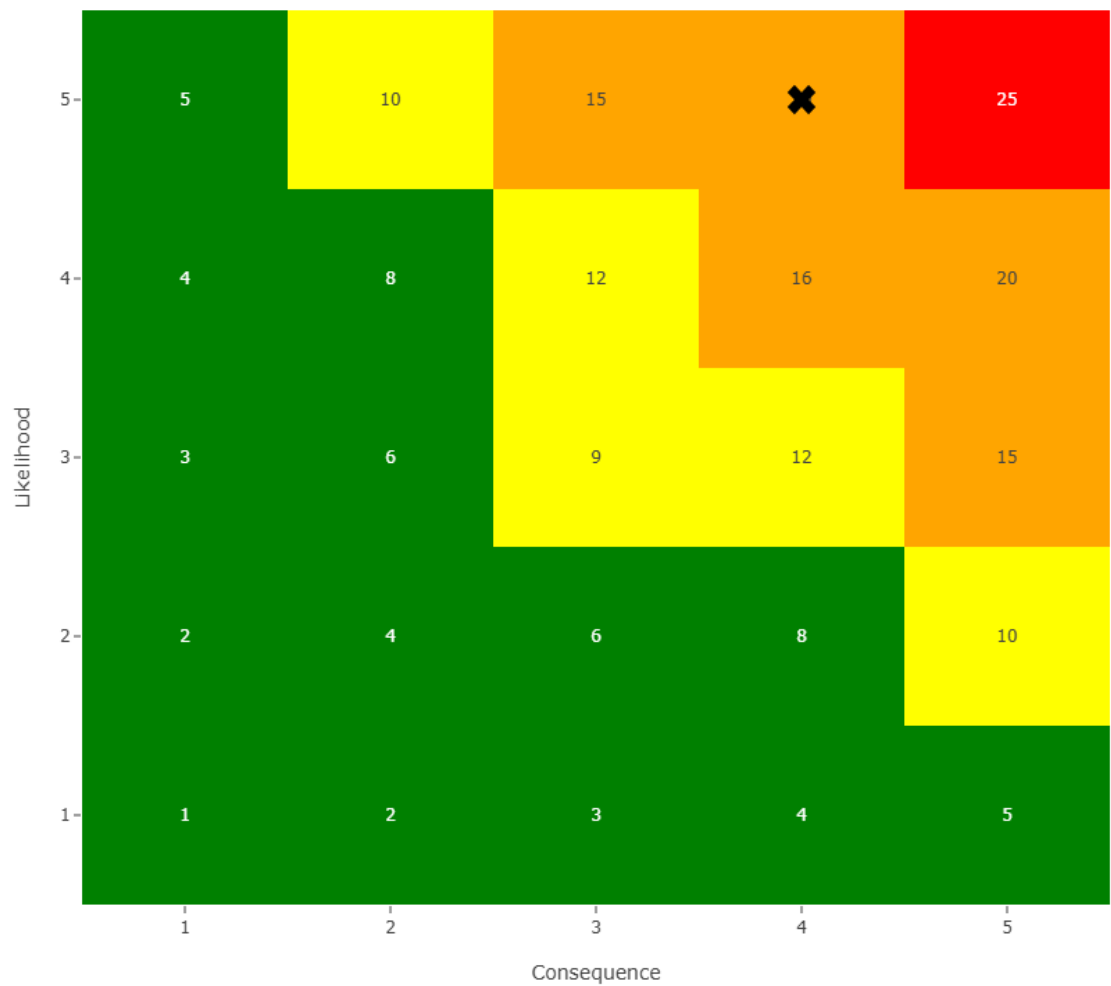
5×5 Pipeline Risk Matrix

| Parameter | Value |
|---|---|
| Likelihood | 5 |
| Consequence | 4 |
| Risk Score | 20 |
| Risk Category | Critical |

| Overall Decision | Pipeline Unsafe for Service |
| Inspection Interval | Immediate inspection required. |
