Dimension Mould JB 4730

Repair Mould JB 4730

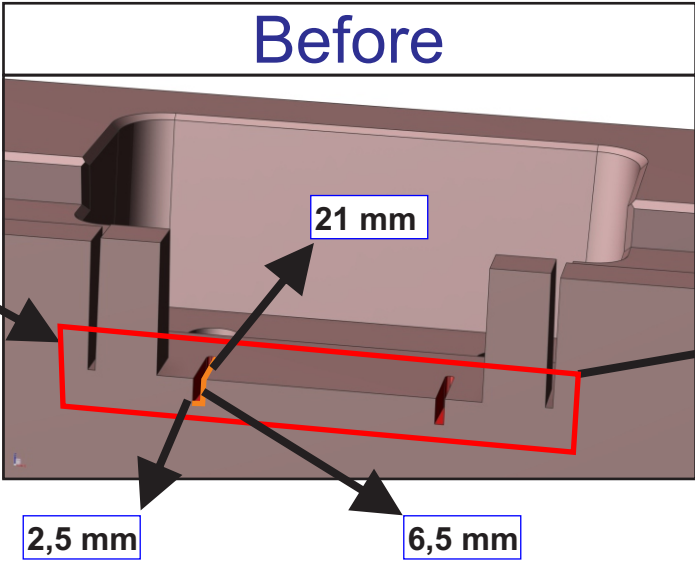
Before

Penutupan 2 Celah di Area Hijau  
Penambahan 4 Celah di Area Kuning
