# EQUITY BANK OTHAYA BRANCH CALLOUT REPORT

09th January, 2025

Site: Equity Bank Othaya Branch

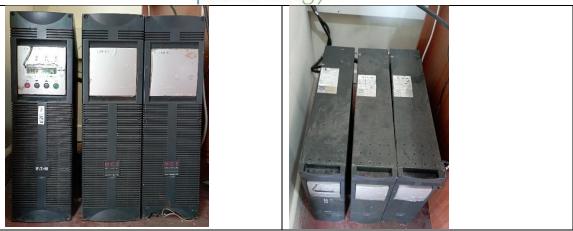
## 4. Photos

- a. On arrival, the UPS was on. The UPS had and an error of *Thermal Overload*.
- **b.** The UPS was turned off and disconnected but the server next to the backup system was still on. This indicated that there was a different source powering the clean power loads. The UPS was also indicating a load capacity of 0kVA on its screen.
- **c.** On further troubleshooting of the UPS, the UPS had raised alarms of *Inverter* failure and Bad connection.
- **d.** The wiring of the UPS was traced and it was discovered a cable that was live had earlier on been connected the clean power consumer unit. This caused back feeding of power to output side of the UPS hence the *Bad connection* alarm. That specific cable was disconnected from the clean power consumer unit and insulated.
- e. The UPS was then able to support the loads on clean power

- **a.** The ATM, CDM and server located next to the backup system are currently supported by the UPS. The UPS is working well.
- **b.** Some of the workstations and the servers insider the containers are not connected to clean power. The electrician responsible for that task has been notified of the pending connection of work stations and servers that haven't been connected to clean power.
