# SRRR FAILURE MEETING

## Ritty/ Ferris

# TOM 45 1

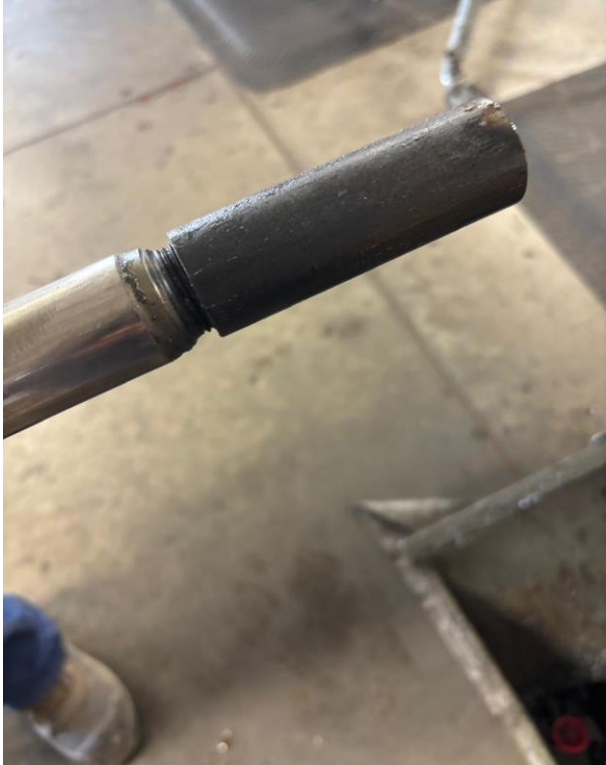
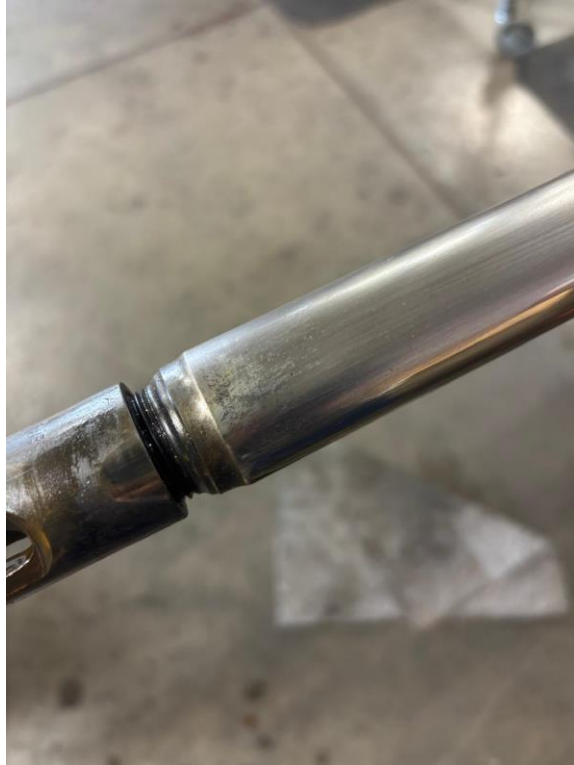
Inspection Summary: Inspection revealed the plunger mic readings measured up to .007 and the barrel mic readings measured up to .006, indicating excessive wear. The balls and seats did not hold vacuum during testing, reflecting loss of sealing integrity and reduced pump efficiency.

1-1/4" X 5', -.005 FIT, PLUNGER,M.P Body, Worn.

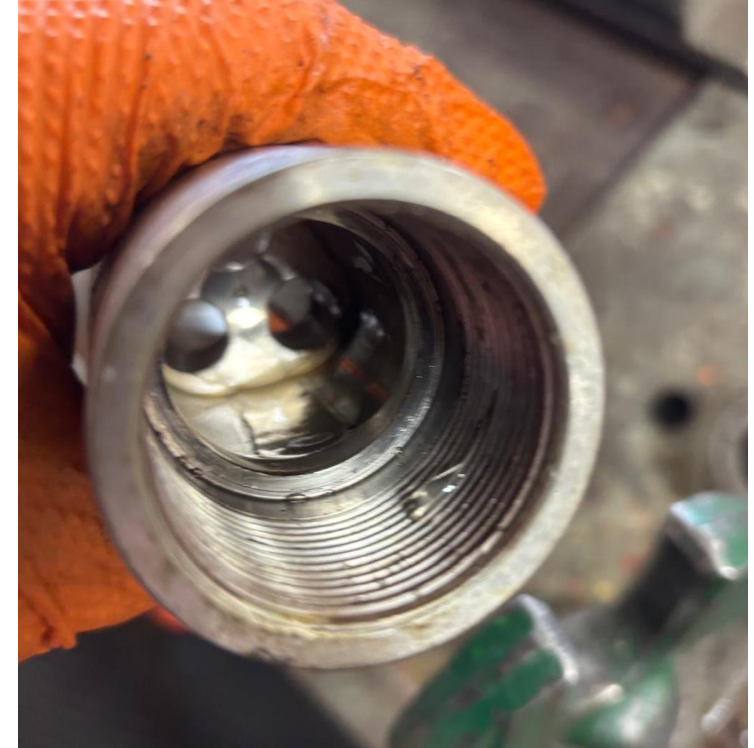
Traveling cage, beat out

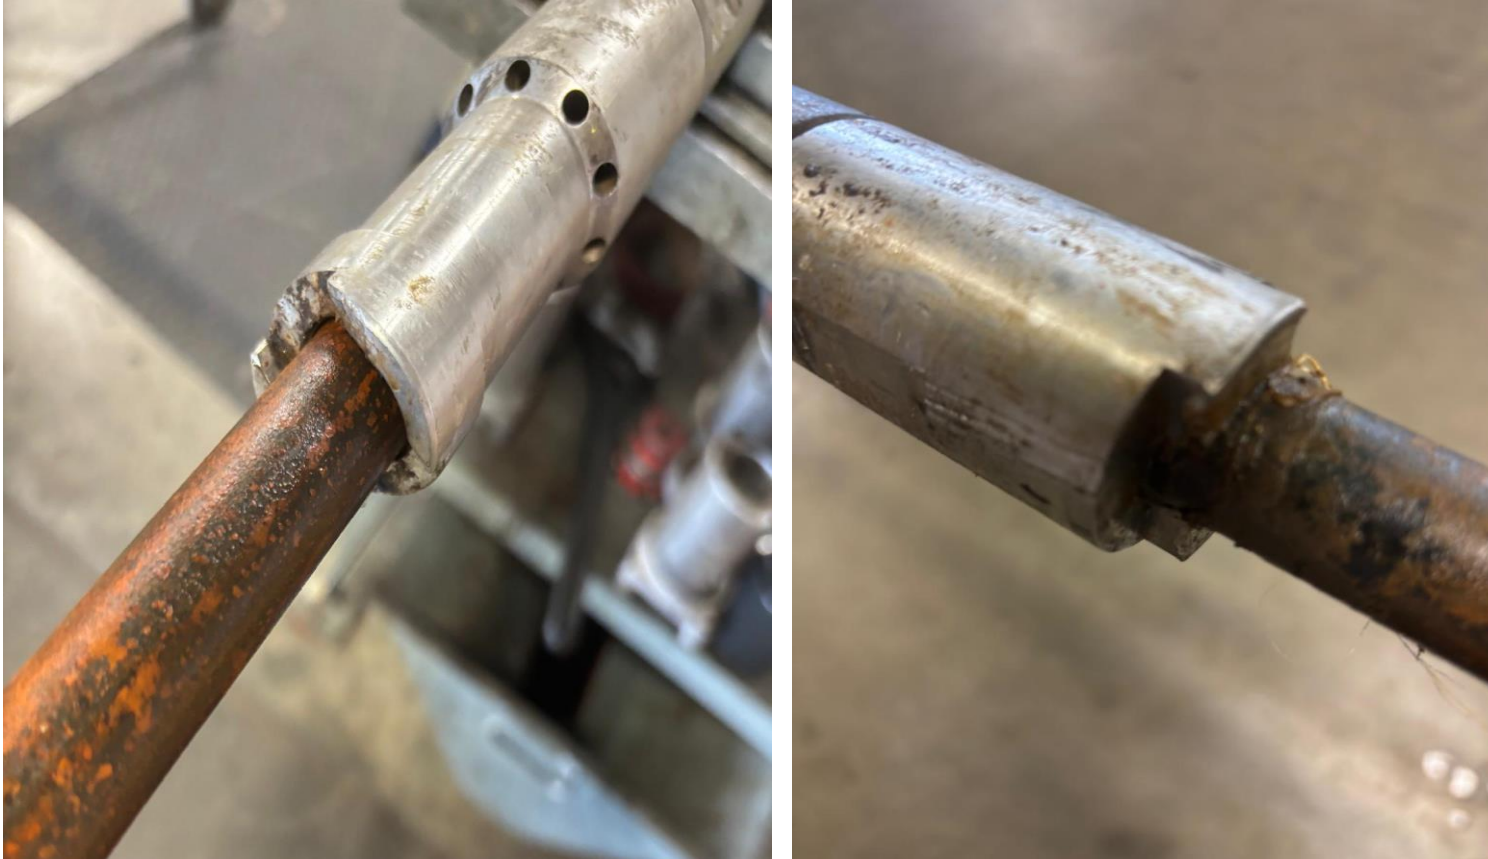
Slightly Tagged, Guide Rod, Vertical Discharge & Bushing.

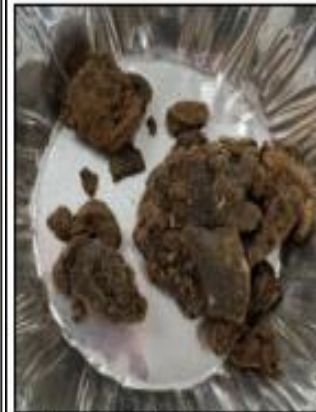
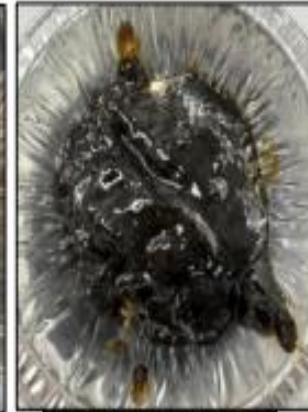
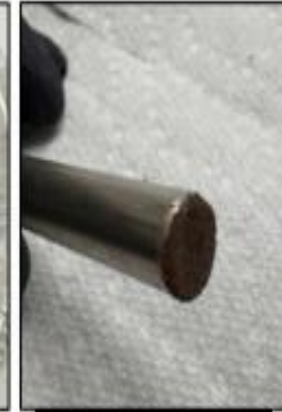
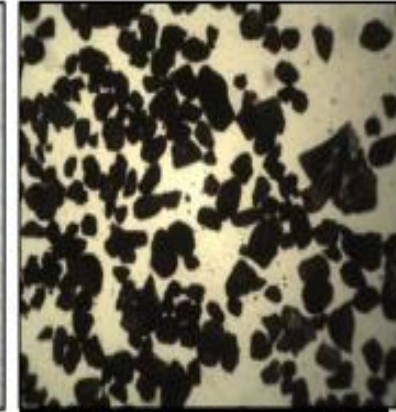
A high Paraffin wax content was detected and isolated, with a melting point of 60 – 63 °C. Small amounts of scale deposits composed of calcium carbonate and iron sulfide were also detected in the sample, with calcium carbonate confirmed by FTIR analysis.

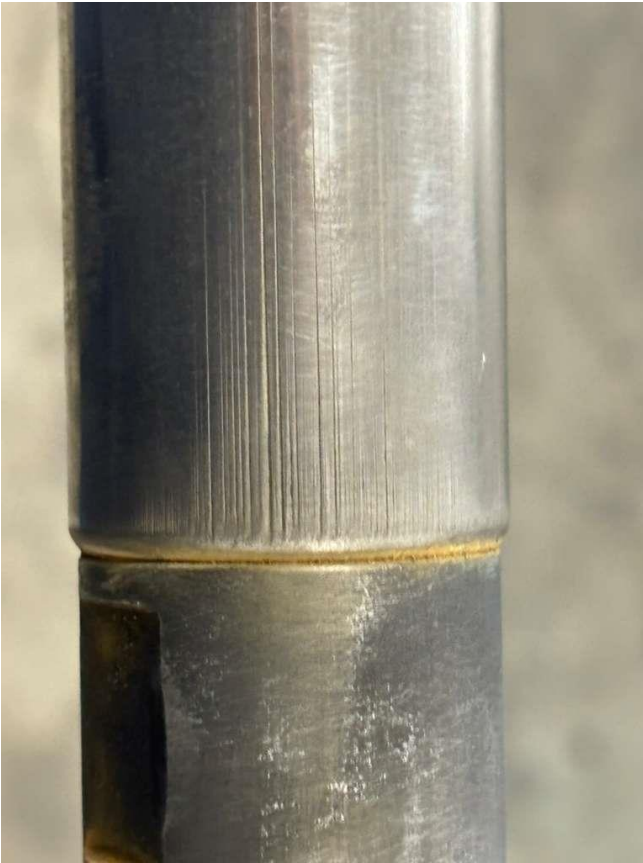
Plunger — Scored Surface.

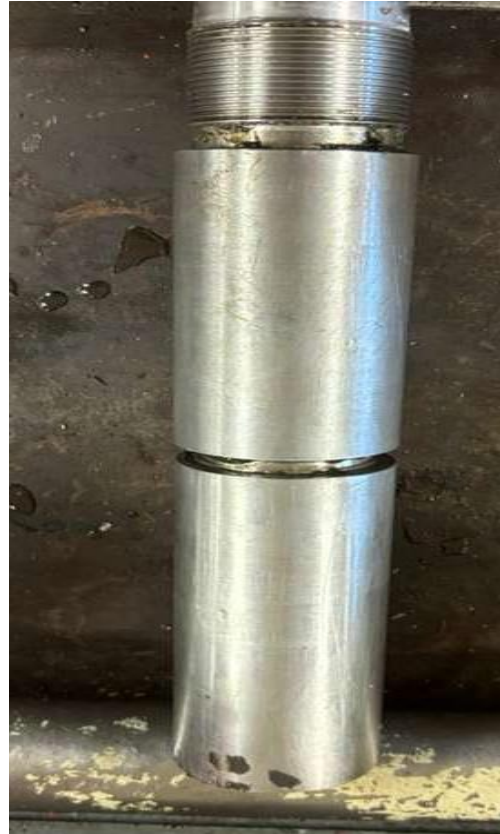
Standing Valve — galled.

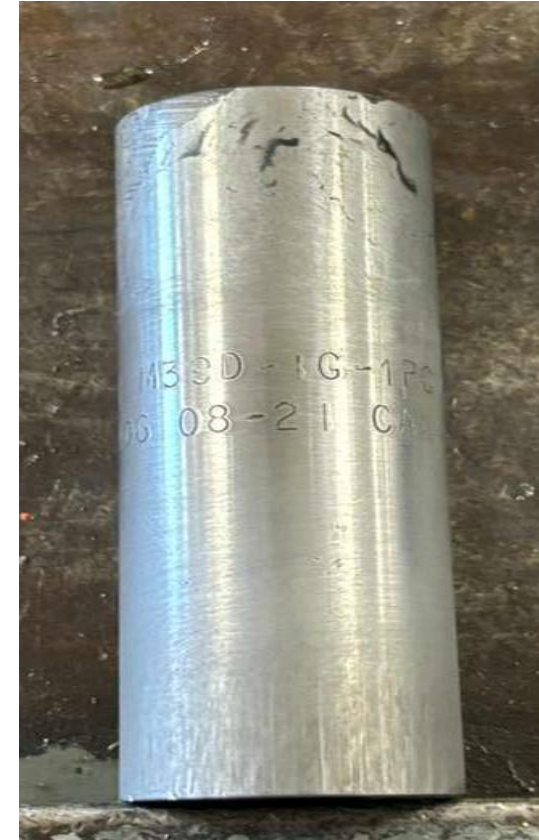
Exceeded recommended  
Run Life cage.

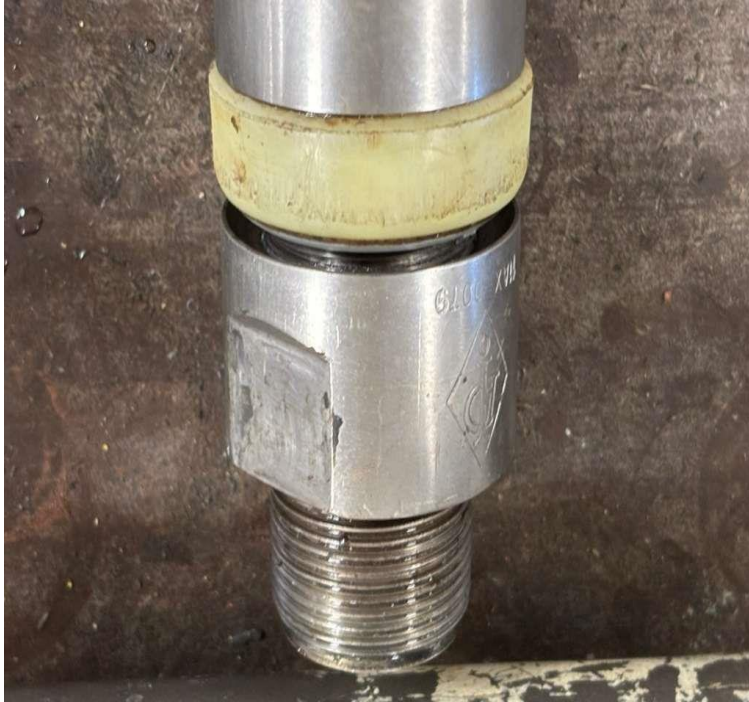
Lock Nut galled to the hold  
down.

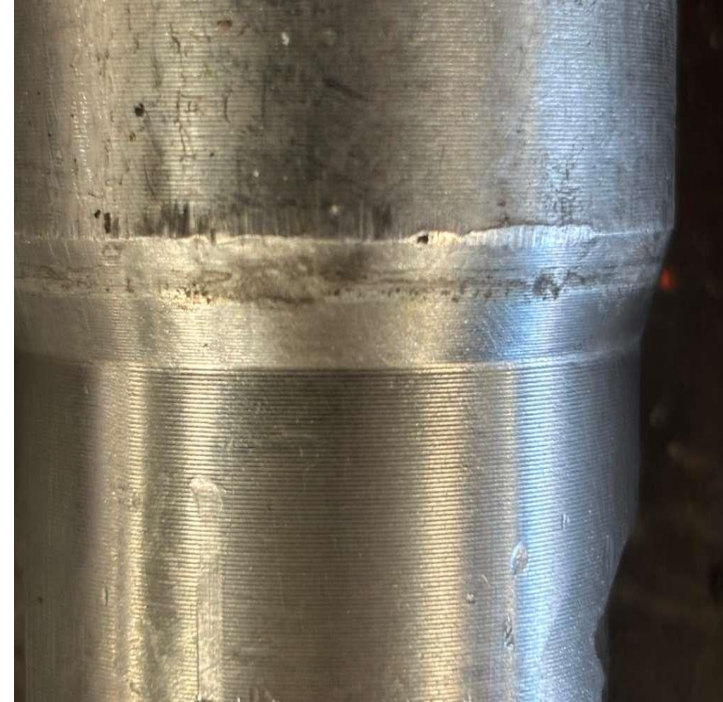
NO-GO – Worn

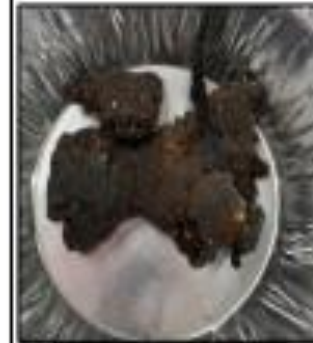
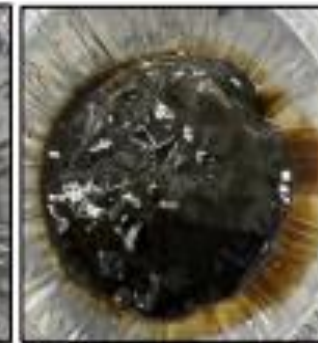
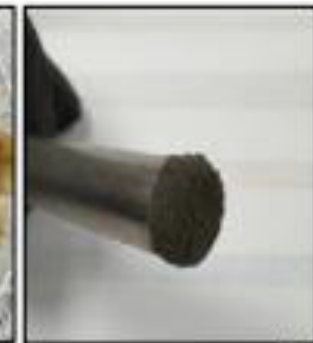
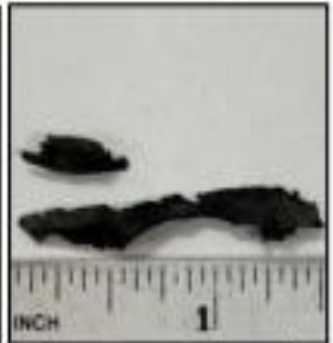
A high paraffin wax content was observed, with the isolated paraffin exhibiting a melting point of 60–63 °C. Scale deposits composed of calcium carbonate and iron sulfide were also detected in the sample, with calcium carbonate confirmed by FTIR analysis. Additionally, rubber-like material was identified in the sample.

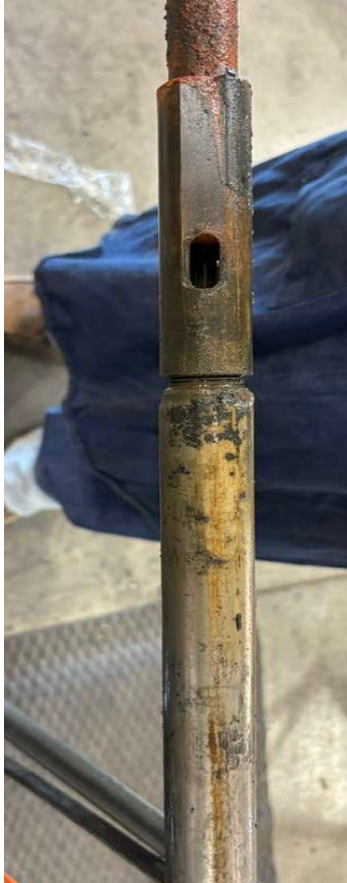
Plunger / Worn – TPA Galled

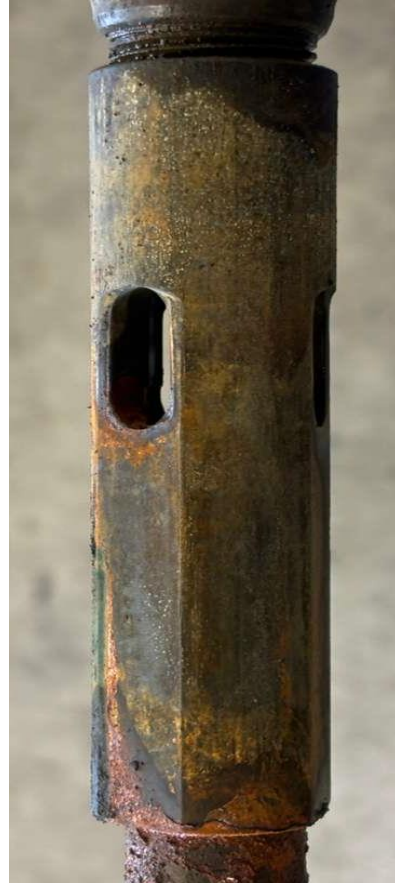
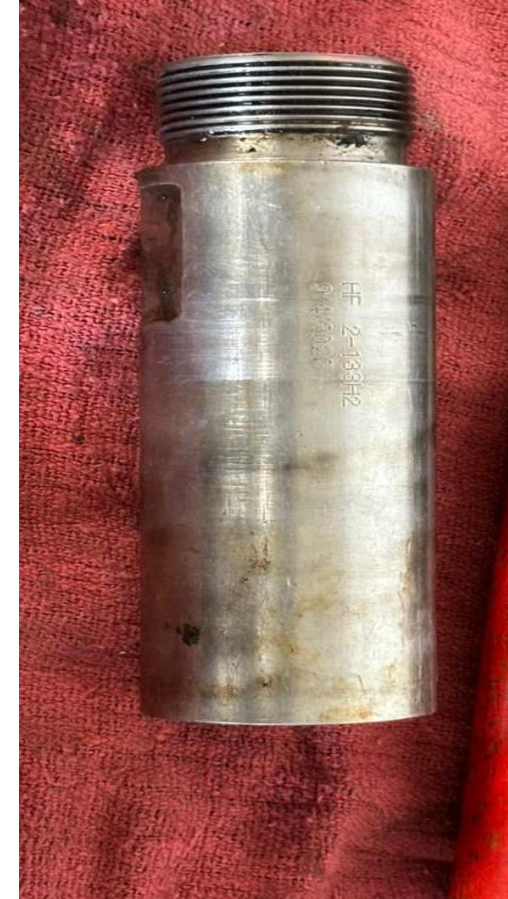
Exceeded recommended Run Life cage.

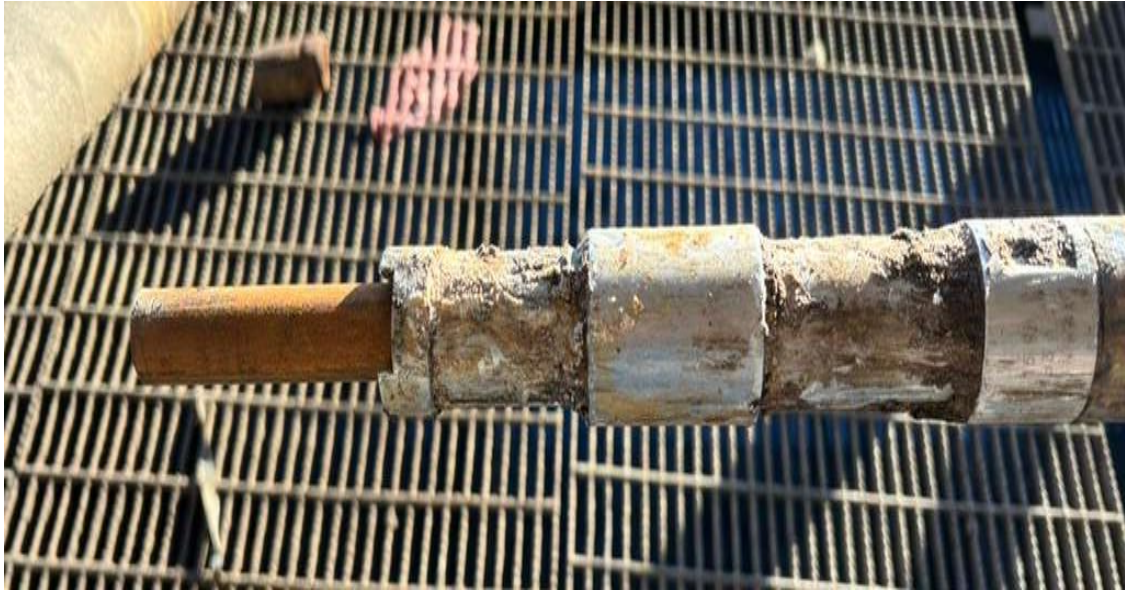
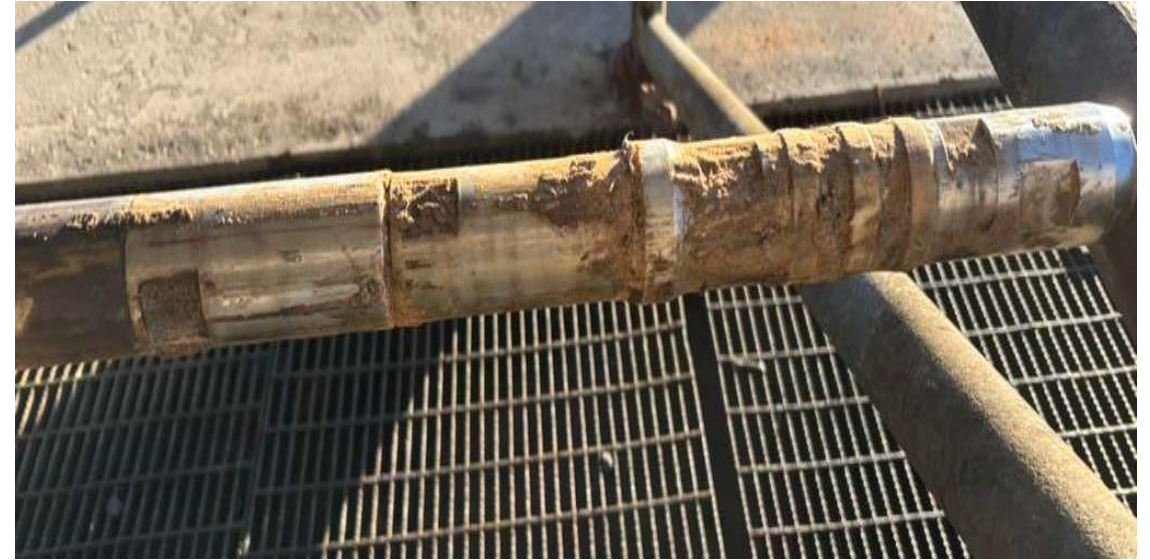
Valve Rod was cut on location.

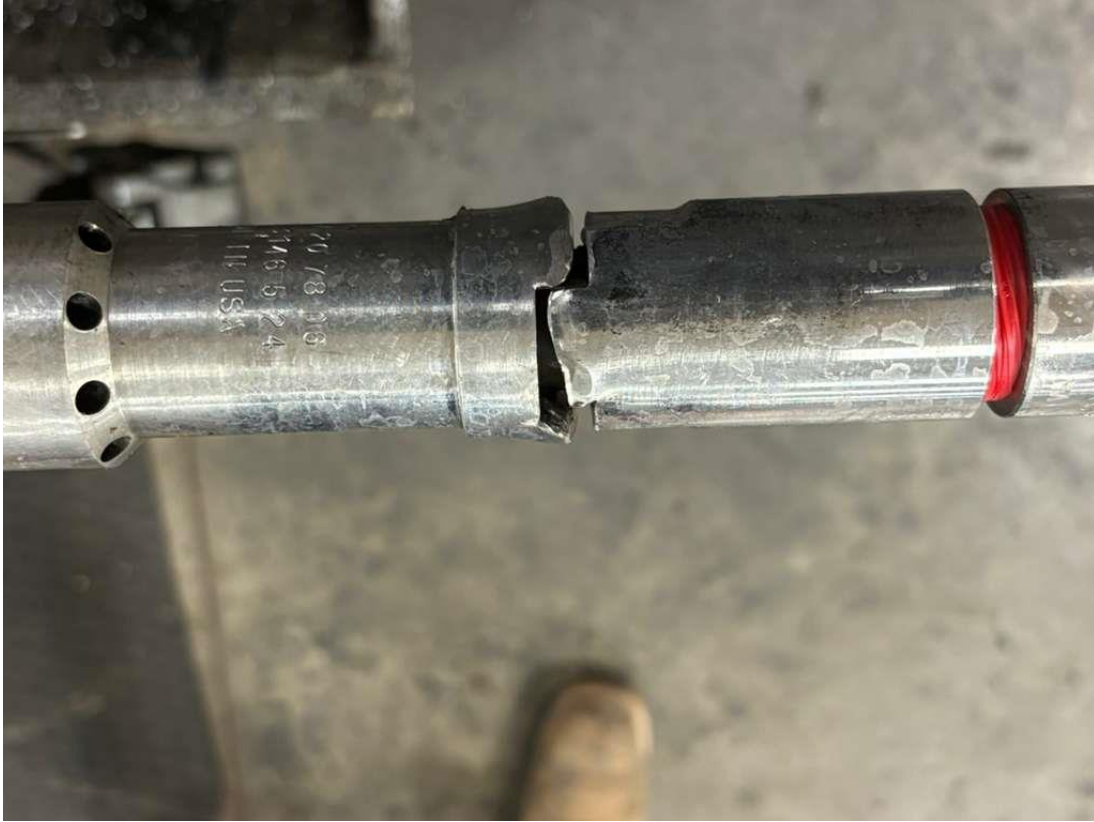
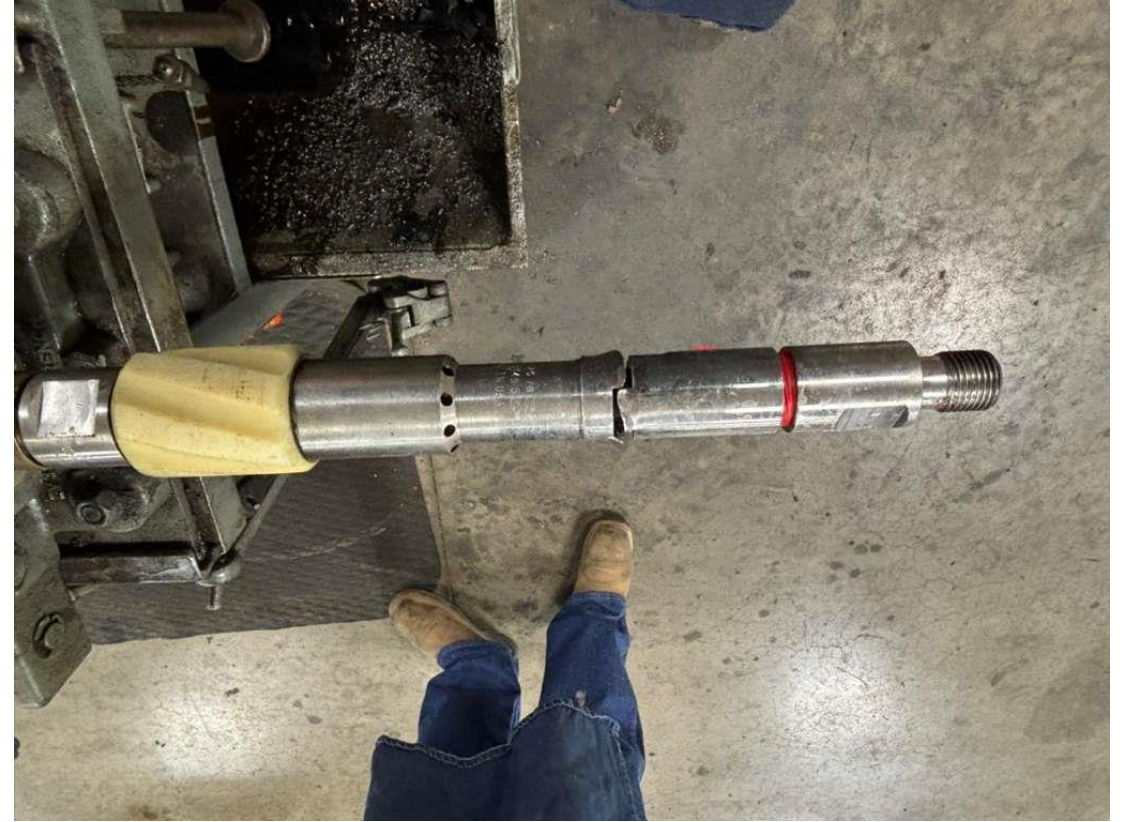
# EILAND 34 2

| WEAR (THOUSANDTHS INCH AT FEET FROM TOP) | | | | | | | | | | | | | | | | | | | | | | | | | | | | | | | | | | | | | | |
|---|---|---|---|---|---|---|---|---|---|---|---|---|---|---|---|---|---|---|---|---|---|---|---|---|---|---|---|---|---|---|---|---|---|---|---|---|---|--|
| Remark/Notes: VROD BUSHING GALLED,CUT COLLET NUT, POUNDED VROD PITTED , TPA POUNDED PLUNGER WORND TV CAGE WORN ALL BALLS + SEAT LEAKED VROD POUNDED BARREL WORN ALL HOLD DOWN PARTS WORN PUMP THAT CAME IN WAS ALL LOSE CAUSE OF TAGGING IN WELL MADE NEW PUMP DBO-29 | | | | | | | | | | | | | | | | | | | | | | | | | | | | | | | | | | | | | | |

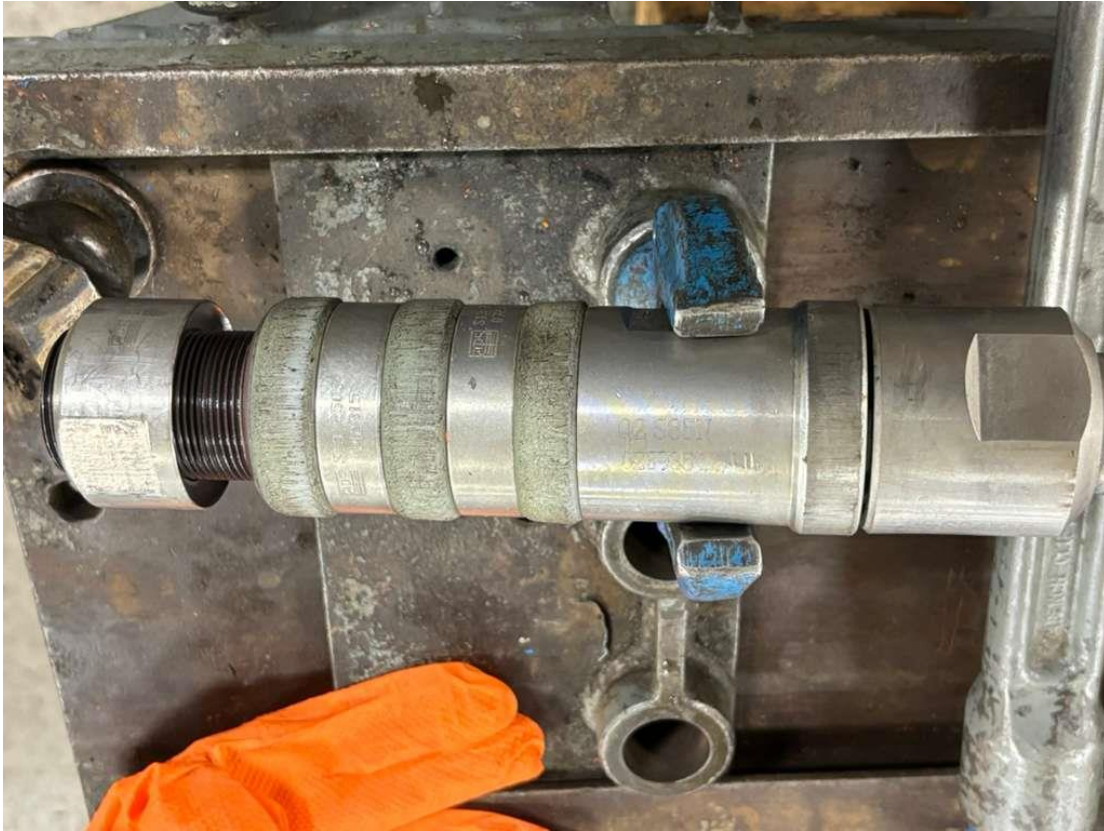
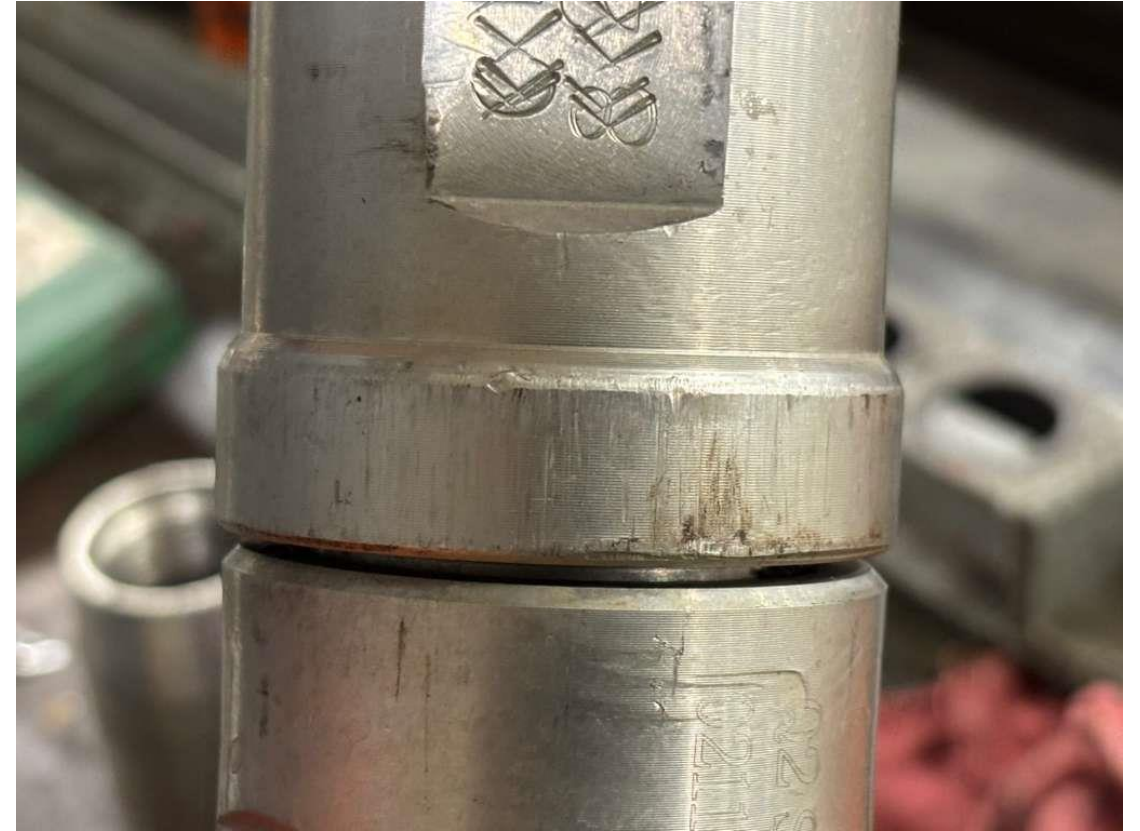
Lock Nut galled to the hold down.

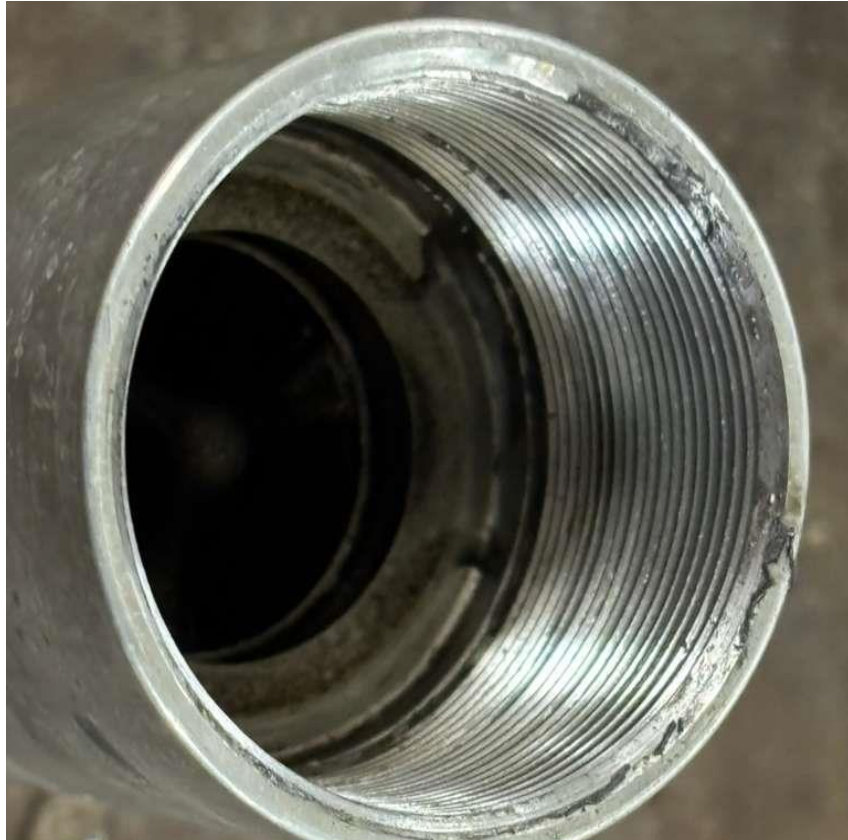
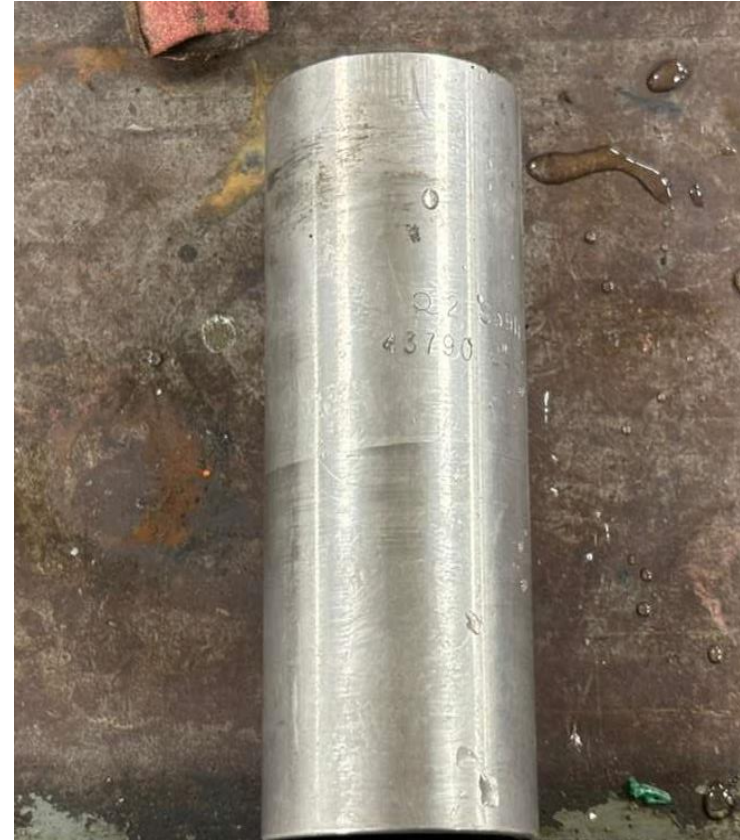
Thread damage and Exceeded recommended Run Life of cage.

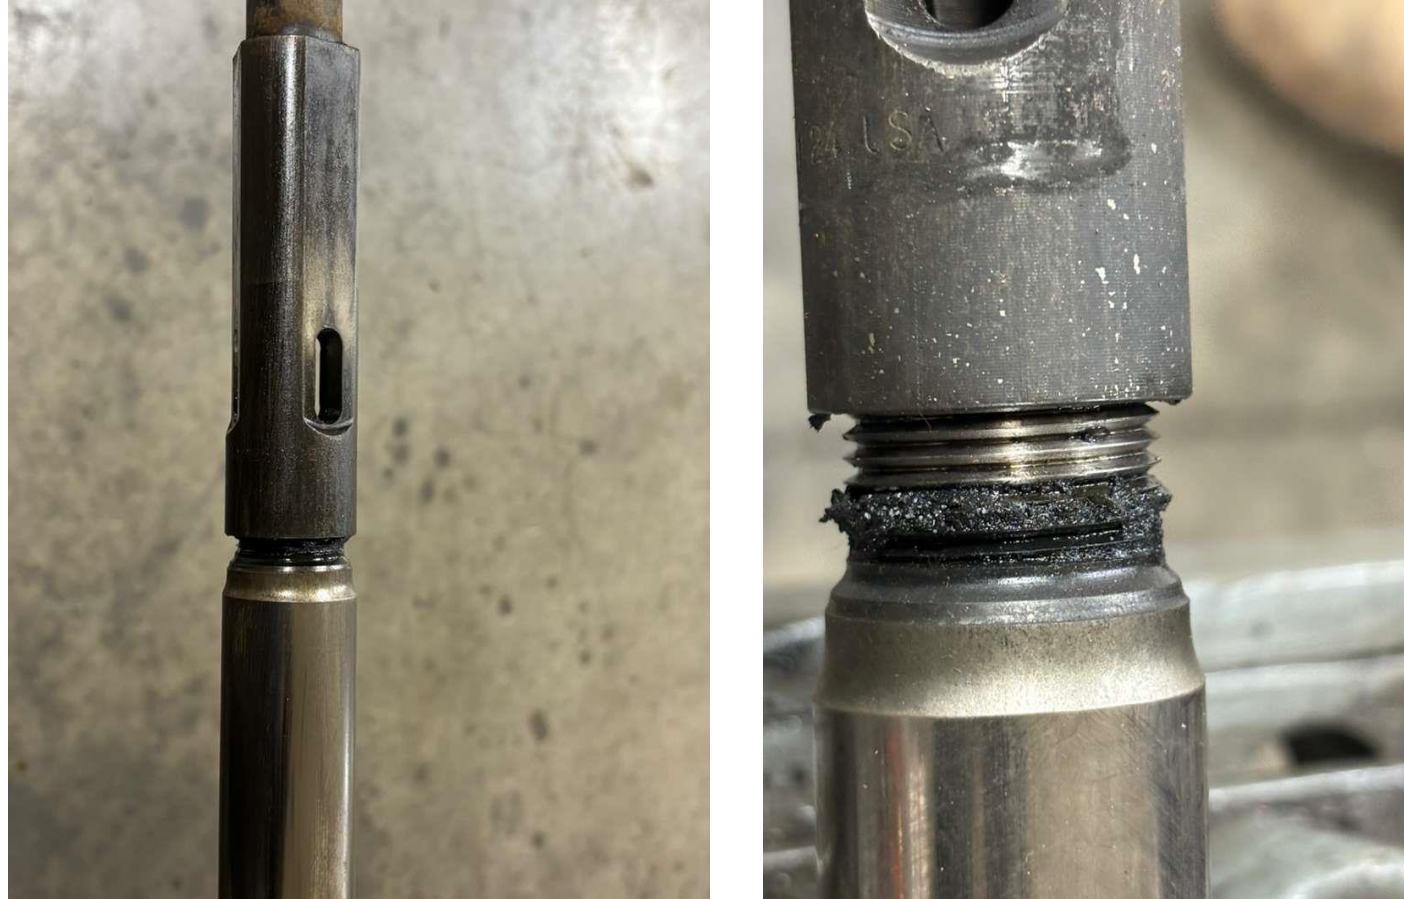
Worn plunger / TPA galled to plunger .

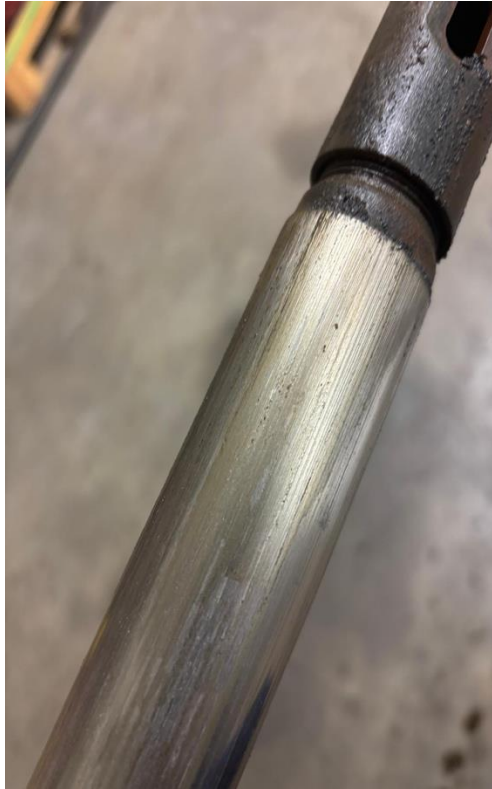
Plunger/ grooved / worn.

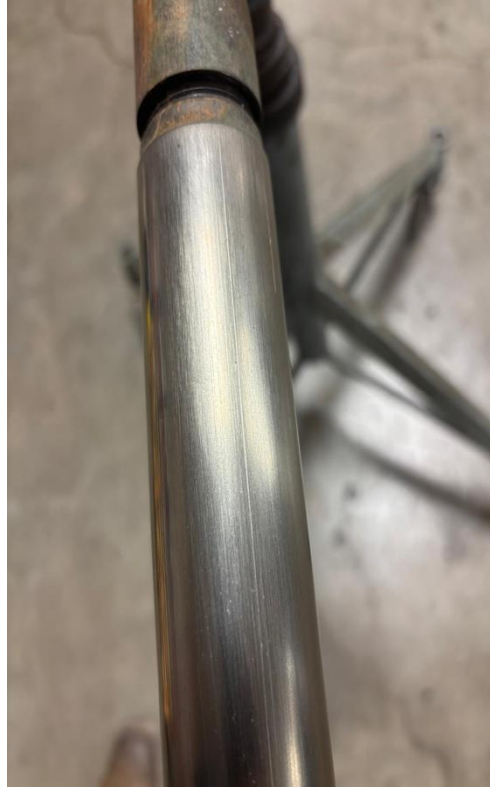
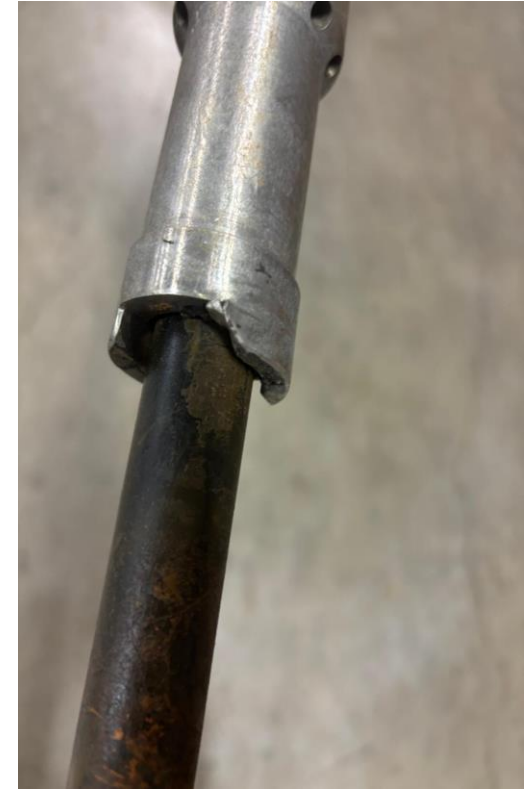
Tagged, valve rod  
guide.

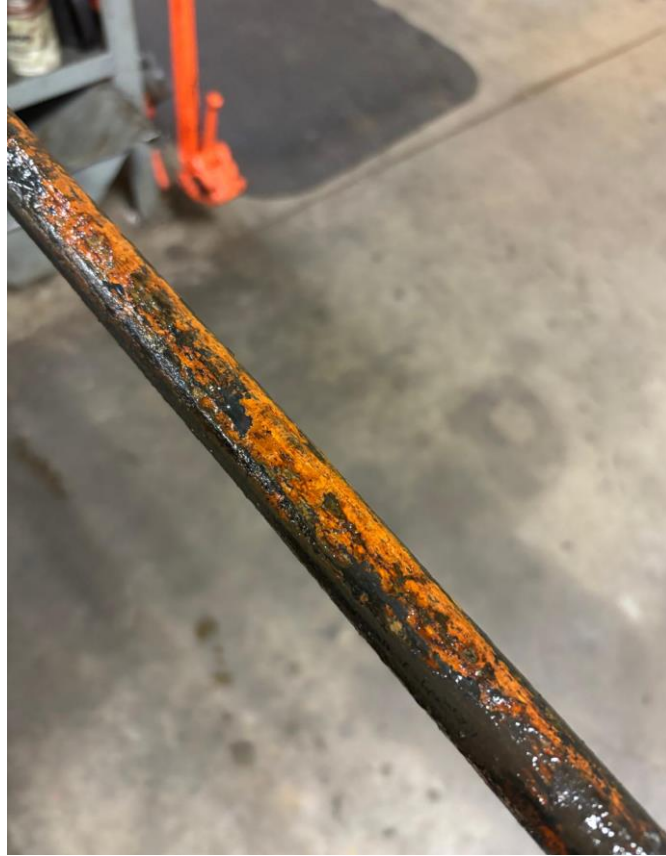
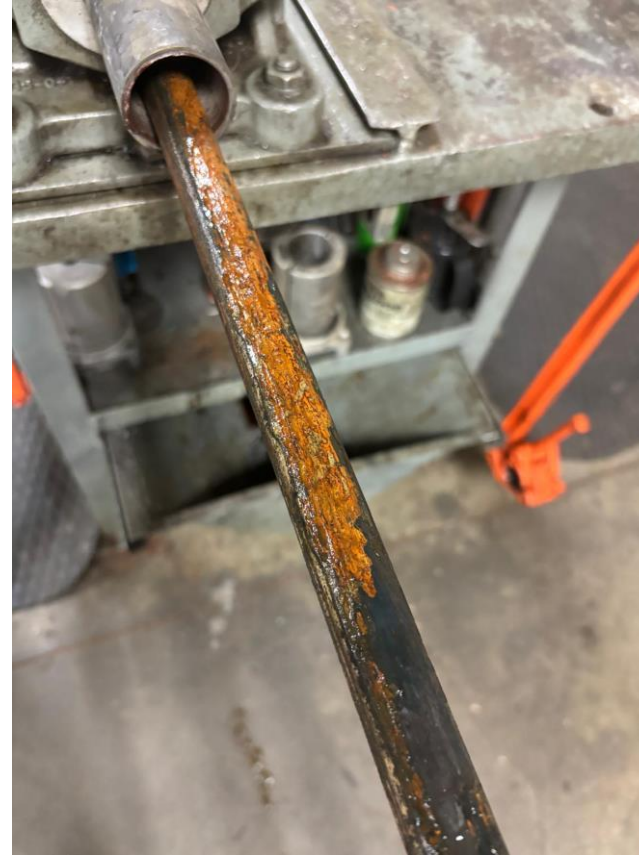
Pitted Valve Rod.

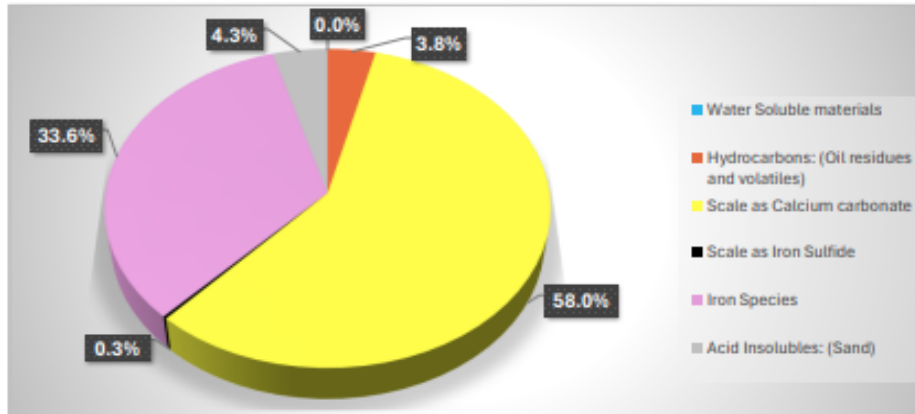
| Acid Insolubles: (Sand) | 4.3% |

Solid Appearance: **Dark gray solid**

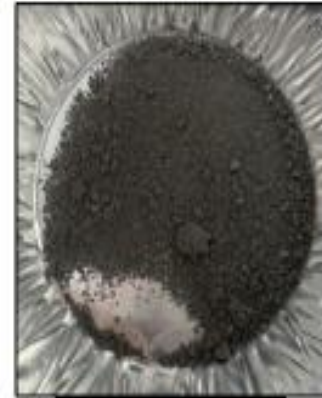
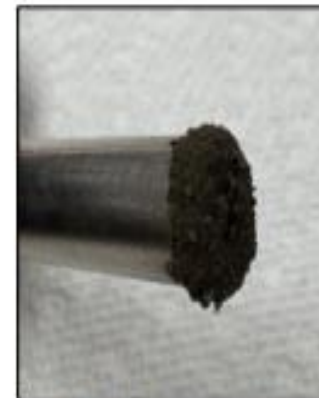
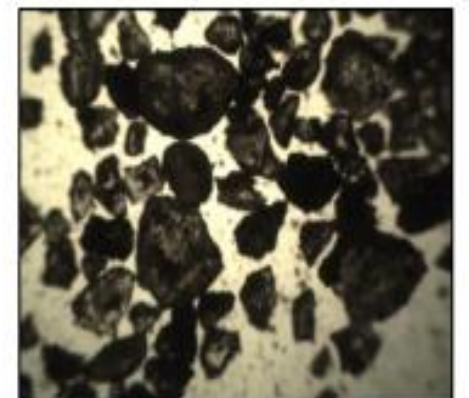
A high quantity of scale deposits composed of calcium carbonate was detected in the sample, with its presence confirmed by FTIR analysis. Traces of iron sulfide scale were also detected. Additionally, a significant amount of iron species was observed, likely resulting from a corrosive environment.
