How was the coffin of Heta-User made?

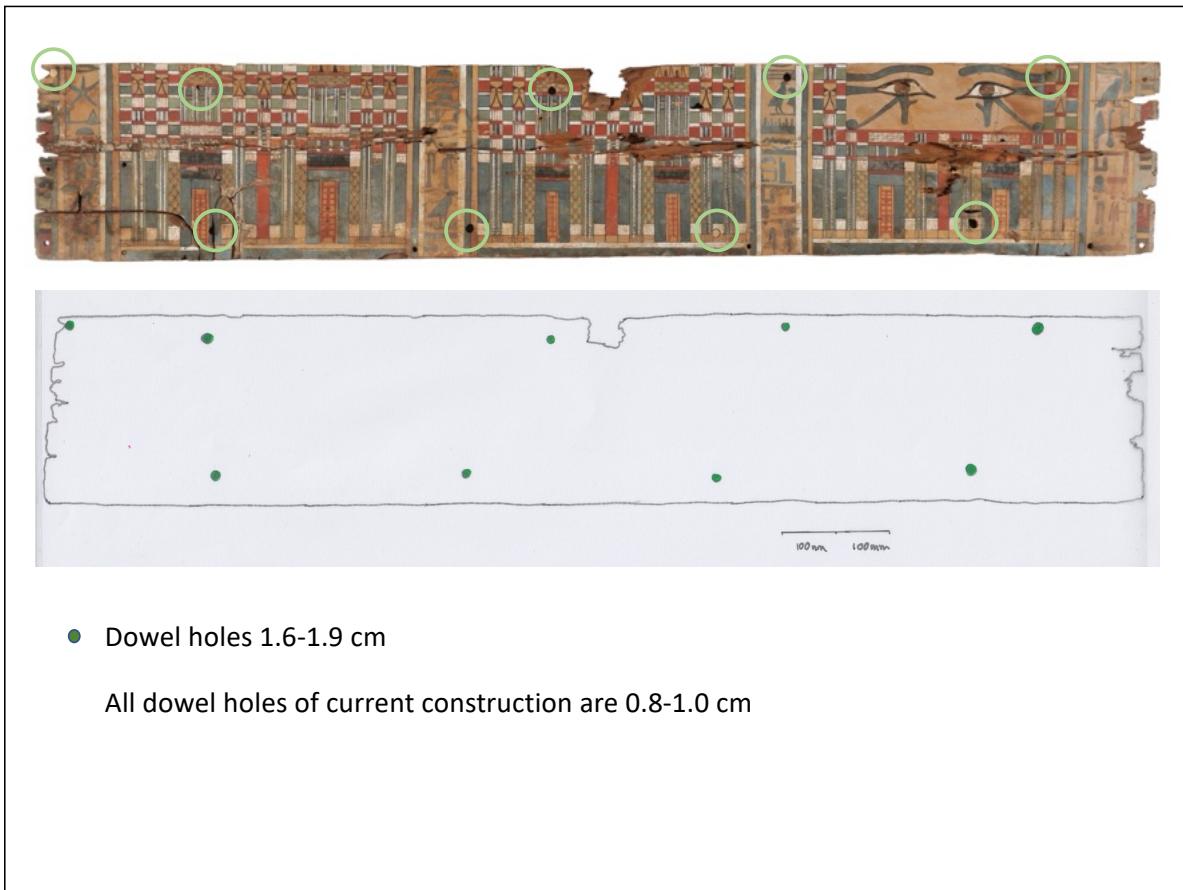
Figure 5 The nine large dowel holes that penetrate the front panel of the coffin are circled in green.

Across the four surviving sections of the coffin, there are 17 large dowel holes penetrating the boards. All of these have a diameter of 1.6–1.9 cm, in contrast to the dowel holes of the current construction, which all have a diameter of around 0.8–1.0 cm. These large holes variously retain wooden plugs, the surfaces of which were painted as part of the coffin decoration, or are filled with a coarse white paste or are now empty. On the front panel there are nine of them, six of which are situated in a distinct and regular pattern. This pattern appears to be disrupted at the foot end of the panel – a feature that may be related to the weakness inherent in the plank here, caused by the grain irregularities noted above.

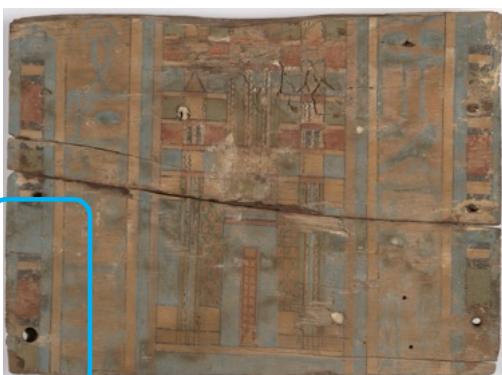
Foot end panel front

The blue rectangle marks the position of another old mortise and tenon.

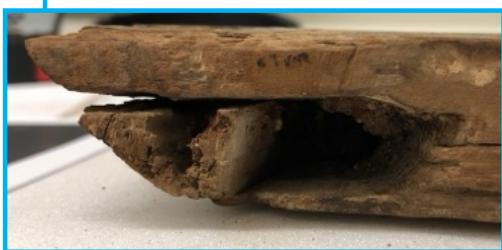
This detail of the bottom edge of the panel shows how the entire depth of the old mortise and tenon joint has been sawn through to form the mitred edge of the coffin board.

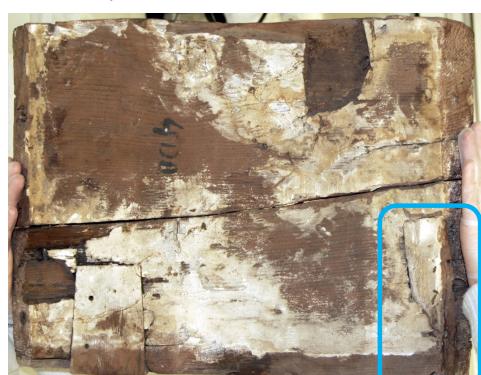
Foot end panel reverse

In this case the back surface of the old mortise has been only partially lost in the thinning process, exposing just a part of the tenon.

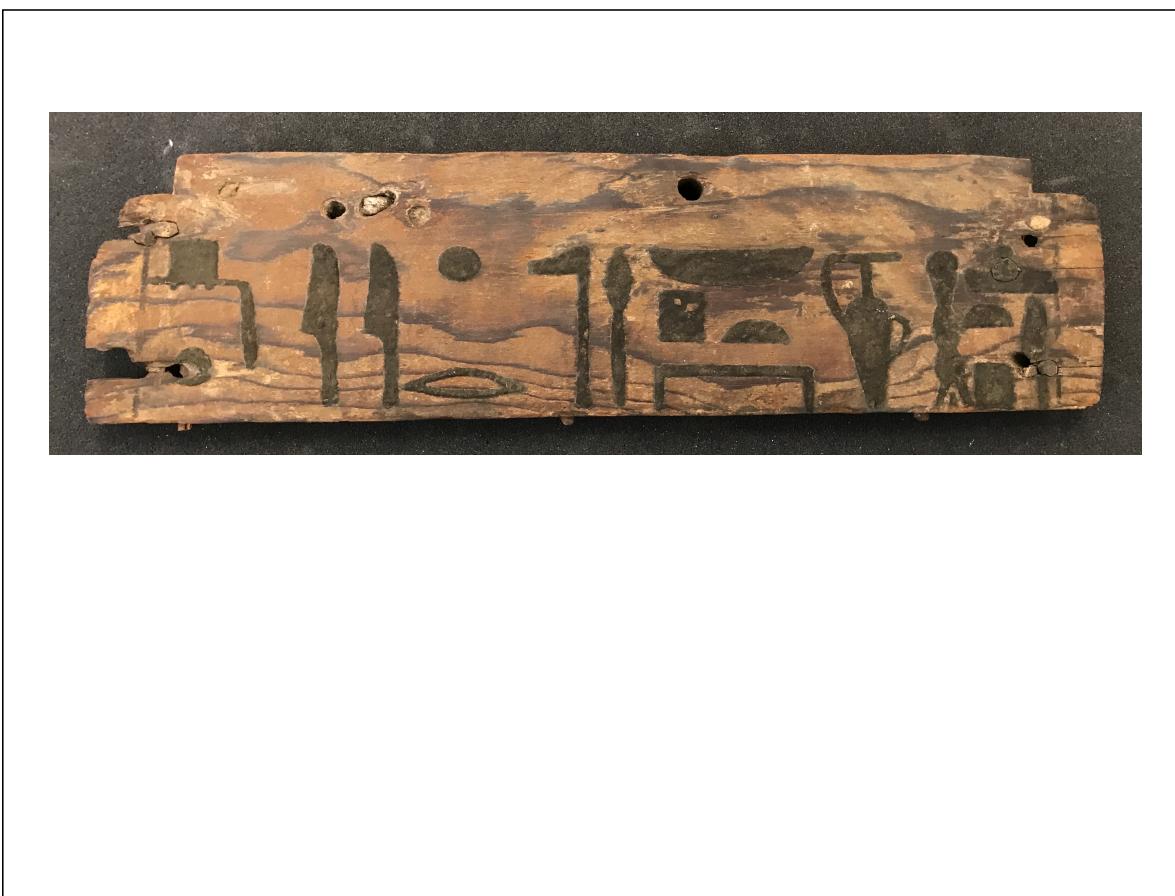
Further mapping, measuring, imaging and research into other large wooden structures are required. So far in this study, one piece of wood bearing similar features and also excavated by Garstang at Beni Hasan, has been identified. Figures 16 and 17 show the top section of an end panel from a box coffin. On the back there are two cavities which echo those on the planks of Heta-User's coffin. Penetrating the front surface, there is also a dowel hole of larger diameter than all the others found on the plank.⁷ There appears to be the cut-through remnant of another large dowel hole on the damaged mitred corner of the plank.

Figure 16. Top section of an end board of a box coffin, from Garstang's excavations at Beni Hasan.
H. 10.5 x W. 40.3 x D. 1.5–2.5 cm. Garstang Museum, University of Liverpool, E7105
Image: © Julie Dawson

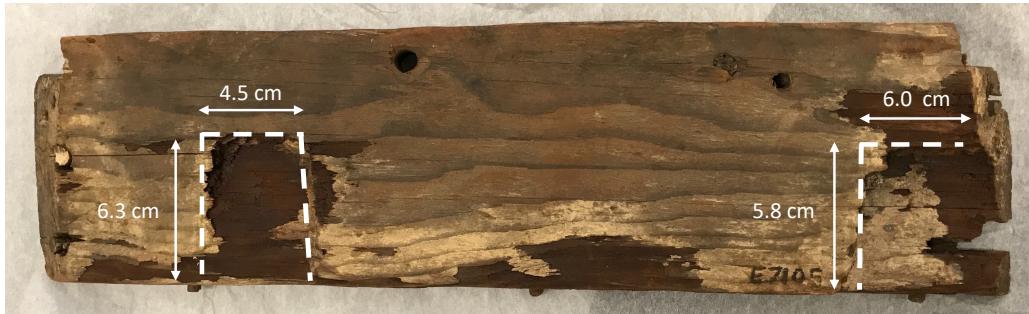
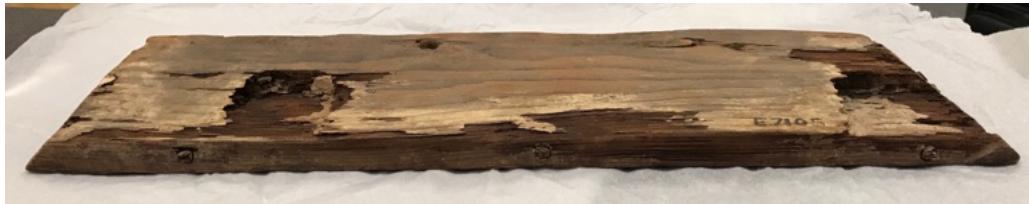
Figure 17. Back of Garstang Museum, University of Liverpool, E7105, showing the two cavities which resemble those on the panels of Heta-User's coffin. Image: © Julie Dawson
