REPORT ON

**BGIS - Edmonton-HVAC Assessment Floor 5 – 10205 101 Street NW**

04/06/2026

File # 226-0489

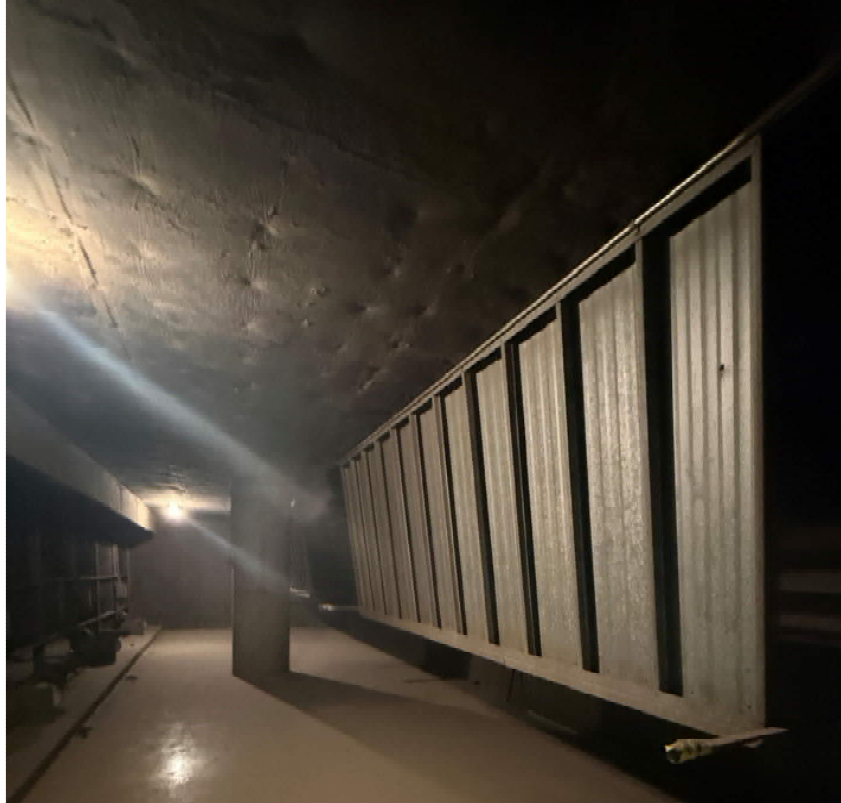
- (1) Cooling and ventilation to the floor are provided by older central air handling/VAV distribution systems serving the tenant floor plate.

*Figure 1 –Mechanical Room AHU compartment*

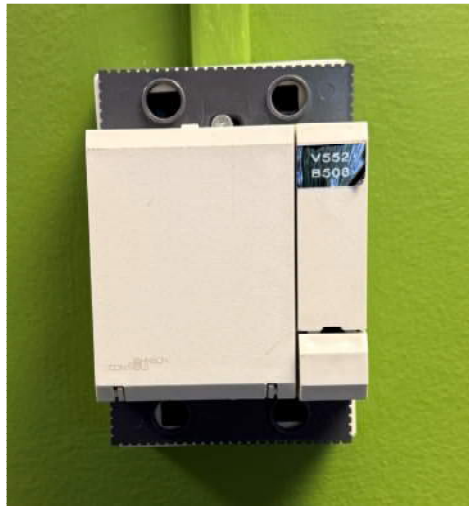
- (7) Multiple generations of thermostats, sensors, VAV controllers, and controls hardware were observed on the 5th floor.

Figure 4 – Thermostat #1 (Generation 1)

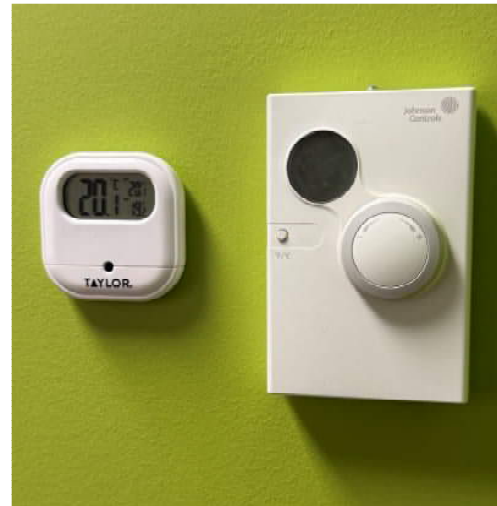
Figure 5 – Thermostat #2 (Generation 2)

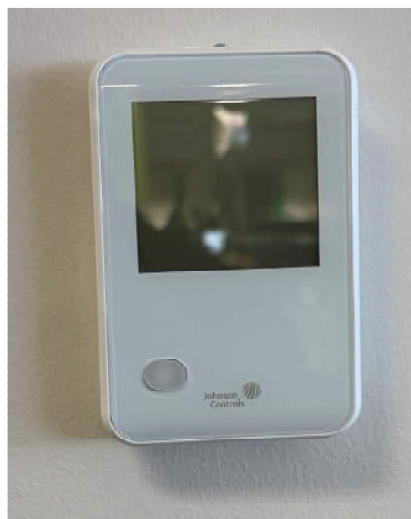
Figure 6 – Thermostat #3 (Generation 3 – Newest upgrade)

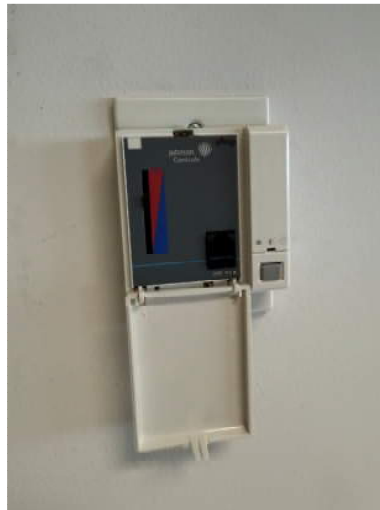
- (8) Several older thermostats reportedly remain onsite despite no longer being actively utilized. This raises the possibility that portions of the existing systems may include abandoned controls devices, abandoned ductwork, undocumented zoning changes, or legacy installations that are no longer fully understood.

*Figure 7 – Older Inactive Thermostat (Generation 1)*

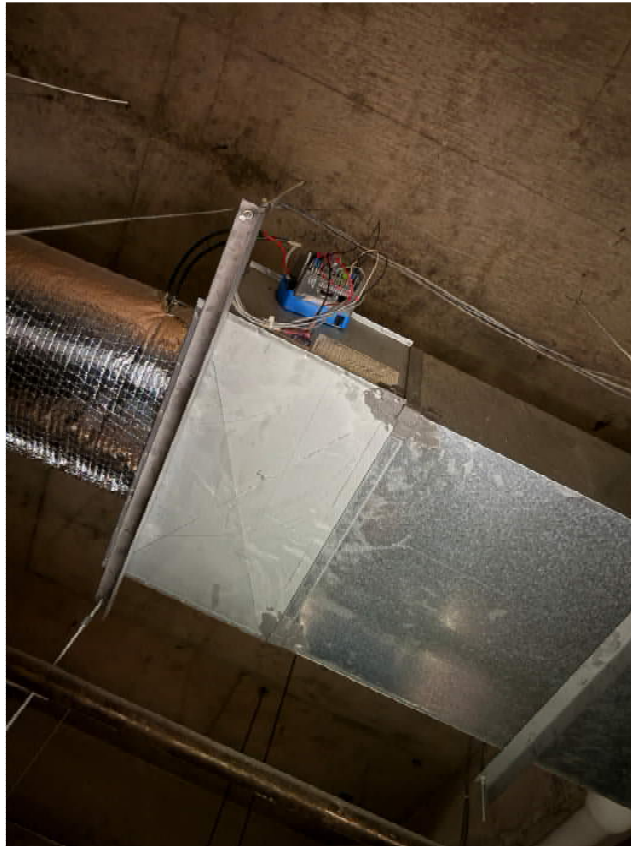
- (2) Based on site observations and discussions onsite, the affected perimeter offices are served by a single VAV terminal unit shared with adjacent interior/open office areas.

Figure 9 – VAV Serving Perimeter Offices from Figure 8

3.01.1 It is recommended that the north perimeter offices be separated from the existing shared VAV zone and provided with dedicated perimeter zoning control.

- Installation of a new dedicated VAV terminal unit
- Installation of a dedicated perimeter thermostat
- Rebalancing/downsizing of the existing shared VAV airflow quantities as required
- Review of perimeter solar loading conditions and blind operation practices
