# Apparel Inspection Report

| Factory | TBDAG | Sample Size Mode | WH AQL |
| Inspector Name | PQC Mahadi Hasan | Inspection Date | 14 Jan 2026 |

| 1. | ACTIVE SPORTS AOP Shorts Set B | 680317 | 14 | 128 | 569 | 569 | 60 | 3 | 26 Adjust... |

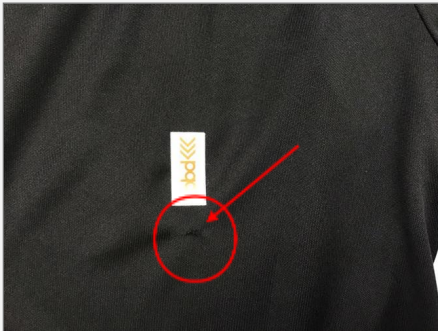
680317 - 01 - 152

Pilling / shedding / snagging

Pull yarn.

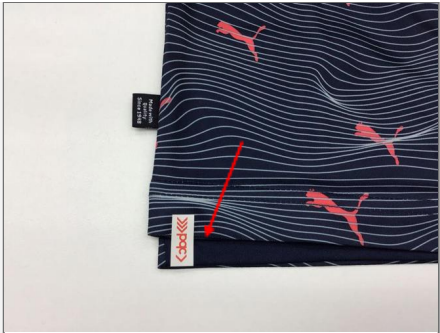
680317 - 14 - 140

Others - Workmanship

Asymmetric side seam length.

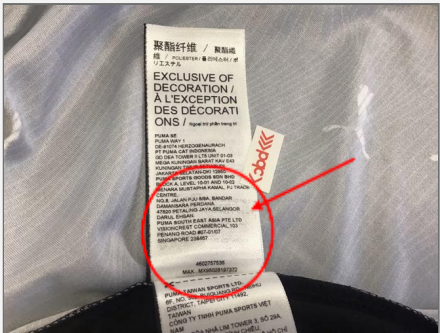
| Others - Sticker/ Label | Major | Minor |
|---|---|---|
| 680317 - 01 - 140 | 1 | 0 |

| Others - Sticker/ Label | Major | Minor |

Care label letter print colour migration.
