# Apparel Inspection Report

| Factory | TBDAG | Sample Size Mode | WH AQL |
| Inspector Name | PQC Mahadi Hasan | Inspection Date | 14 Jan 2026 |

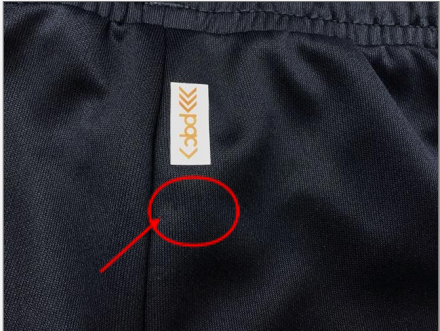
| C. | Finishing & Pressing | Defects Found | 1 | 0 |
| <div> <div>Dirty mark / soiling</div> <div> <div>Others - Dirty; soil marks</div> <div> <div>694286 - 16 - 140</div> <div> <div>Major</div> <div>Minor</div> </div> </div> </div> <div> <div>Dirty spot.</div> <div> <div> <div>Major</div> <div>A</div> </div> </div> </div> </div> | | | | |
