NARRATIVE REPORT

DWELLING / UNIT OWNER

Carrier:	Assurant Flood Insurance	Date of Loss:	9/27/2024
Insured:	JOHN THOMAS	Assigned:	10/1/2024
CID:	240204	Contacted:	10/3/2024
Claim Number:	7800040227	Inspected:	10/16/2024
Policy Number:	7800040227	Inspected With:	MARY & JOHN THOMAS
Loss Address:	165 RAVEN BLVD LAKE LURE NC 28746	Mailing Address:	912 YORKMONT RD CHARLOTTE NC 28217
Coverage A:	\$ 250,000.00	Mortgage:	Towne Bank
Coverage B:	\$ 0.00	Verified with:	MARY & JOHN THOMAS
Policy Term:	12/1/2023 to 12/1/2024

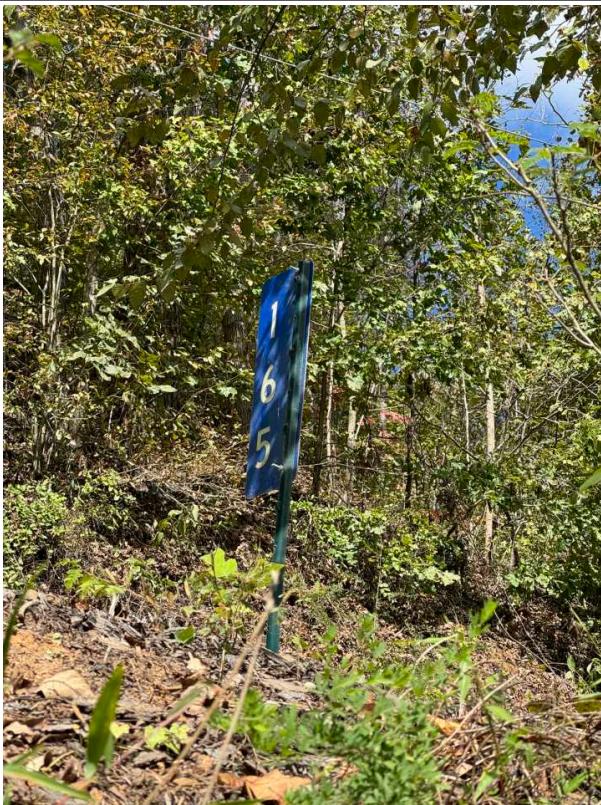
Exterior - 1-Insured Risk

Address Verification

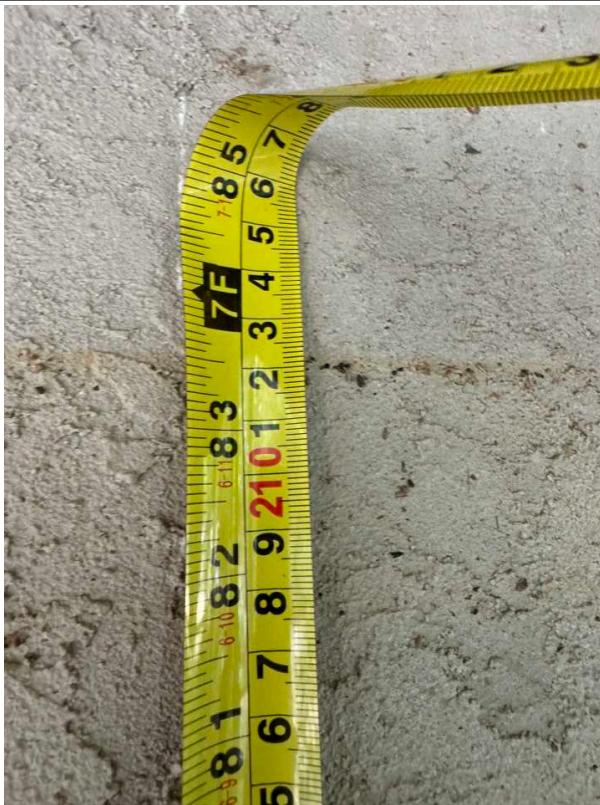
Exterior - 3-Insured Risk

Date Taken: 10/16/2024
Taken By: Dina Bullard
Exterior flood line 83.5 inches

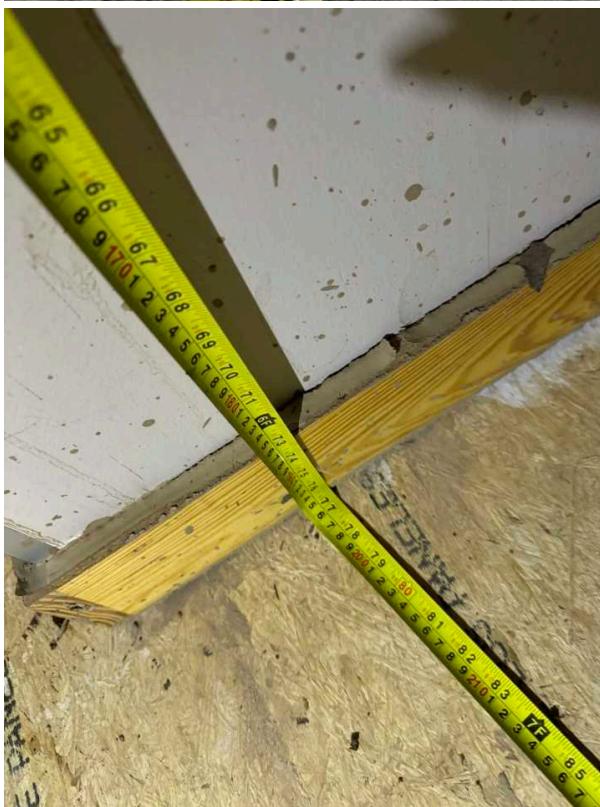
Exterior - 4-Insured Risk

Date Taken: 10/16/2024
Taken By: Dina Bullard
Interior flood line - 77 inches

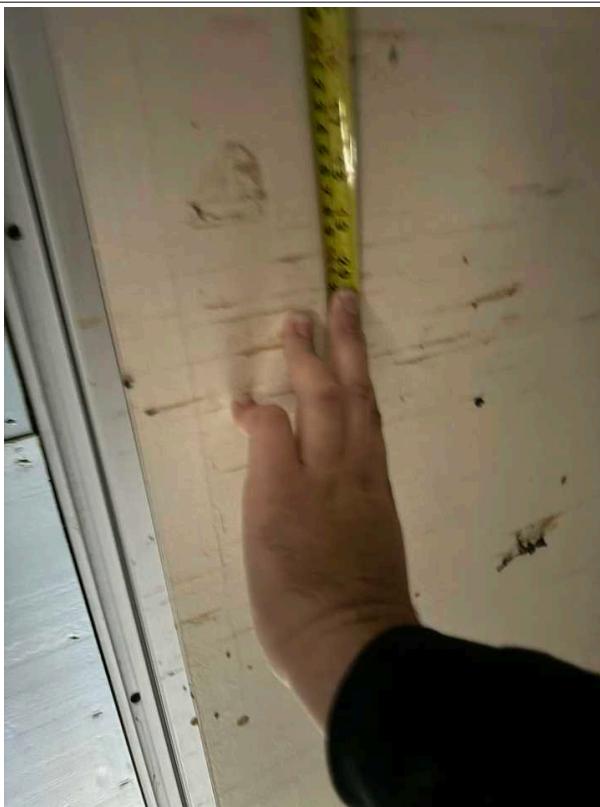
Exterior - 5-Insured Risk

Interior flood line

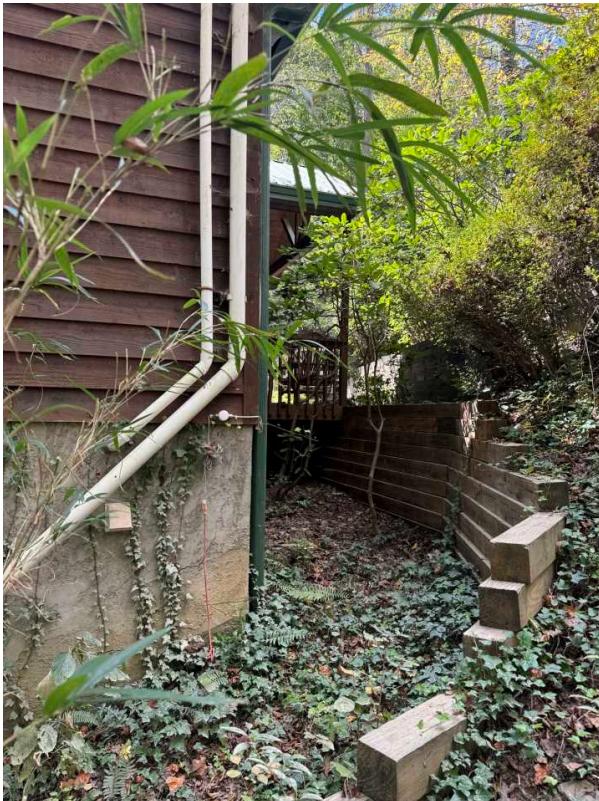
Exterior/Exterior - 12-Insured Risk

Date Taken: 10/16/2024
Taken By: Dina Bullard
Radon pump submerged in cat 3 water

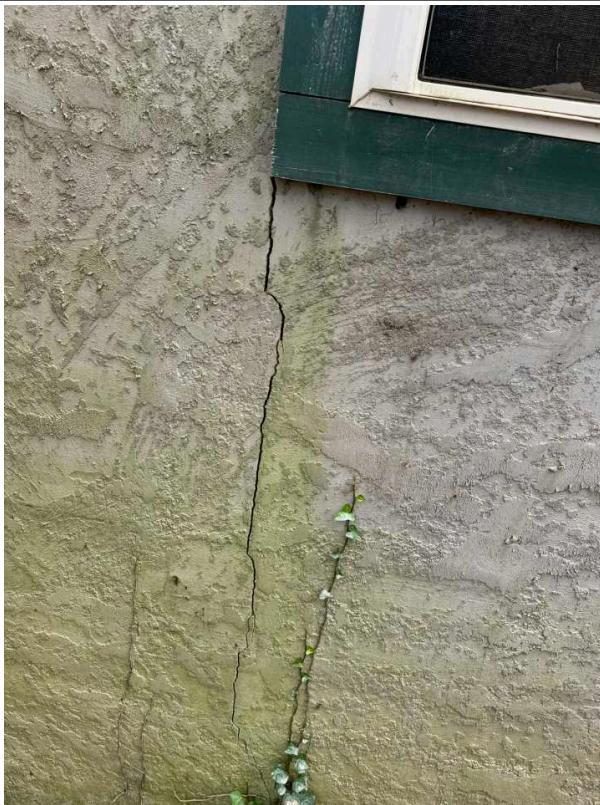
Exterior/Exterior - 13-Insured Risk

Foundation walls cracked from hydrostatic pressure

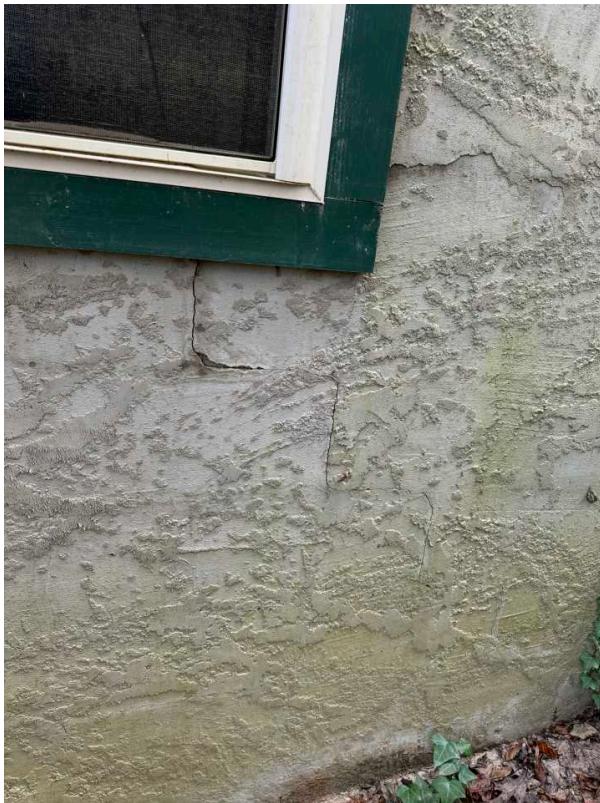
Exterior/Exterior - 14-Insured Risk

Foundation walls cracked from hydrostatic pressure

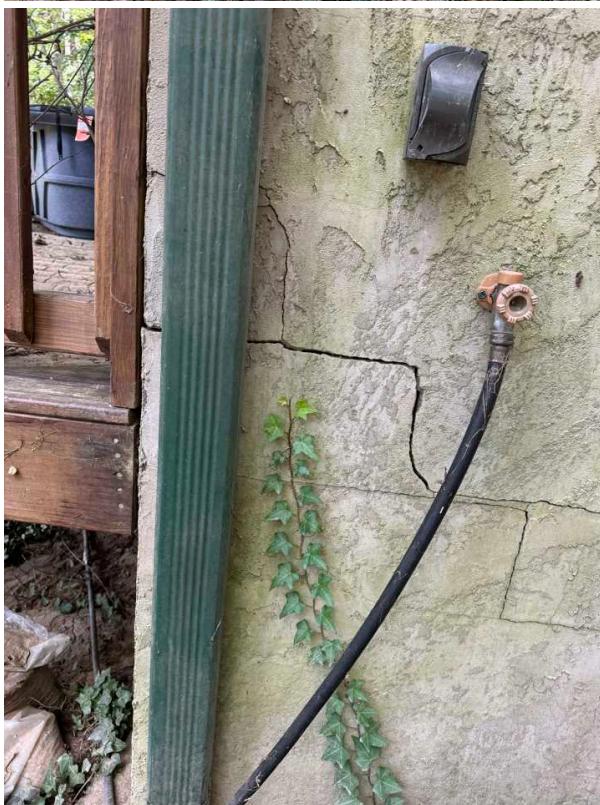
Exterior/Exterior - 16-Insured Risk

Foundation walls cracked from hydrostatic pressure

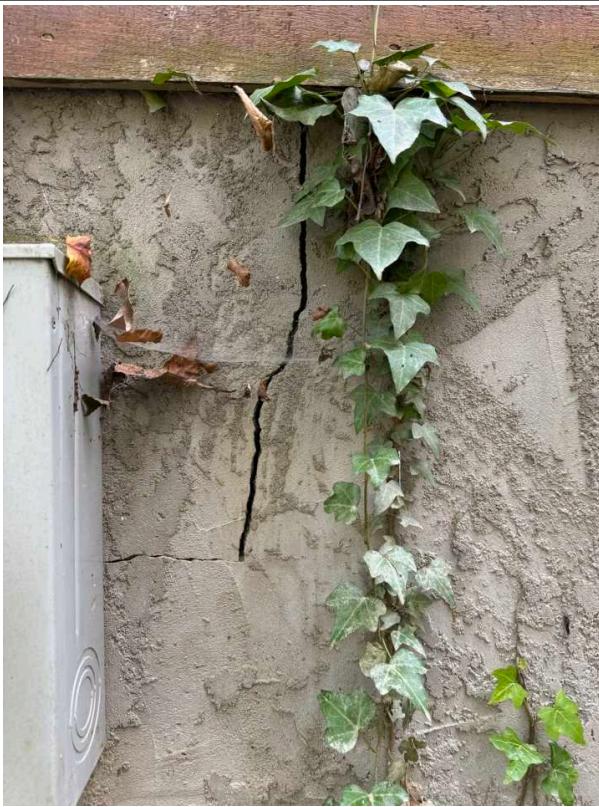
Exterior/Exterior - 17-Insured Risk

Based on the cracking observed to the exterior brick at the rear of the home that appeared to be recent and cracks on the interior drywall, adjuster submitted a request for an engineer to inspect the home to determine if the cracking was caused by flood.

Foundation walls cracked from hydrostatic pressure

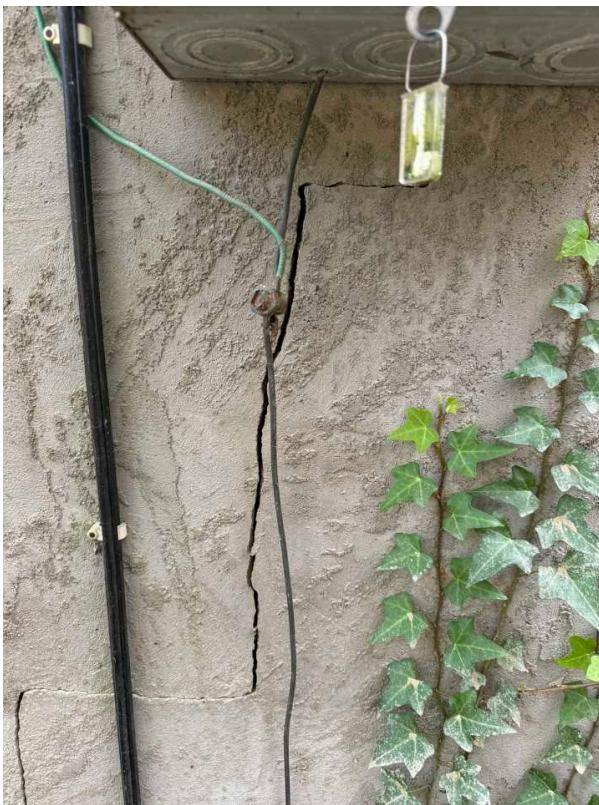
Exterior/Exterior - 18-Insured Risk

Foundation walls cracked from hydrostatic pressure

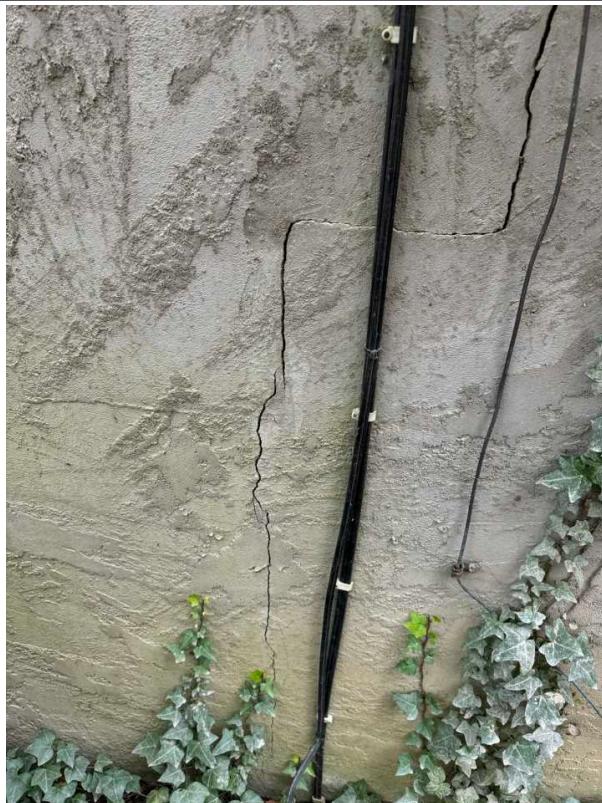
Exterior/Exterior - 19-Insured Risk

Foundation walls cracked from hydrostatic pressure

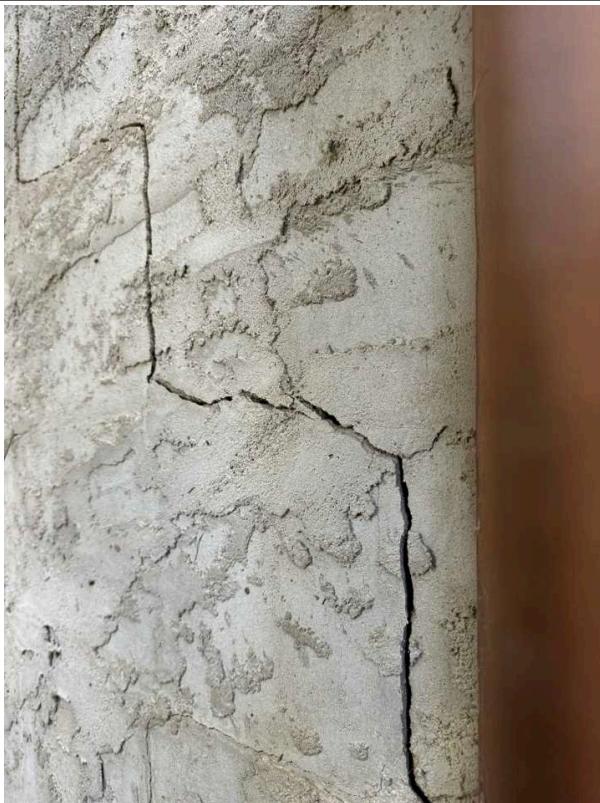
Exterior/Exterior - 21-Insured Risk

Foundation walls cracked from hydrostatic pressure

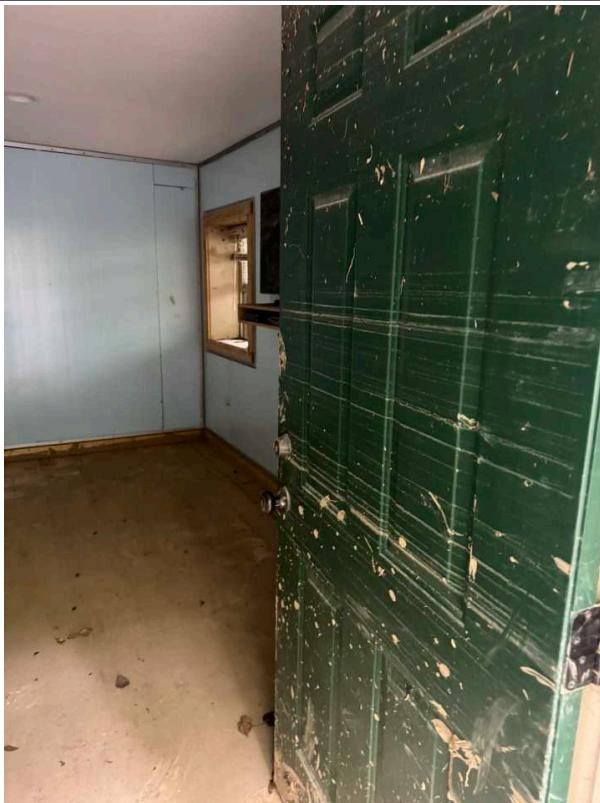
**Main Level/Lower Enclosure -
37-Insured Risk**

Lower enclosure - damaged by flood waters

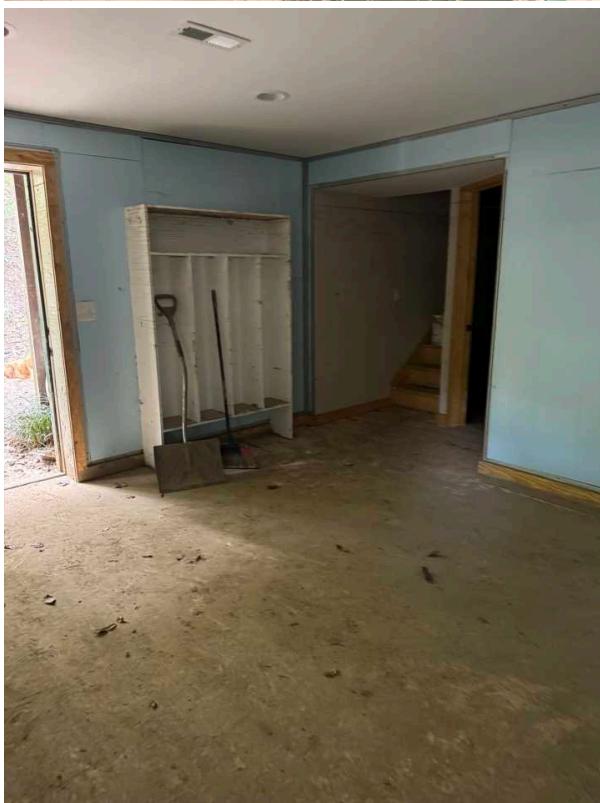
**Main Level/Lower Enclosure -
38-Insured Risk**

Lower enclosure - damaged by flood waters

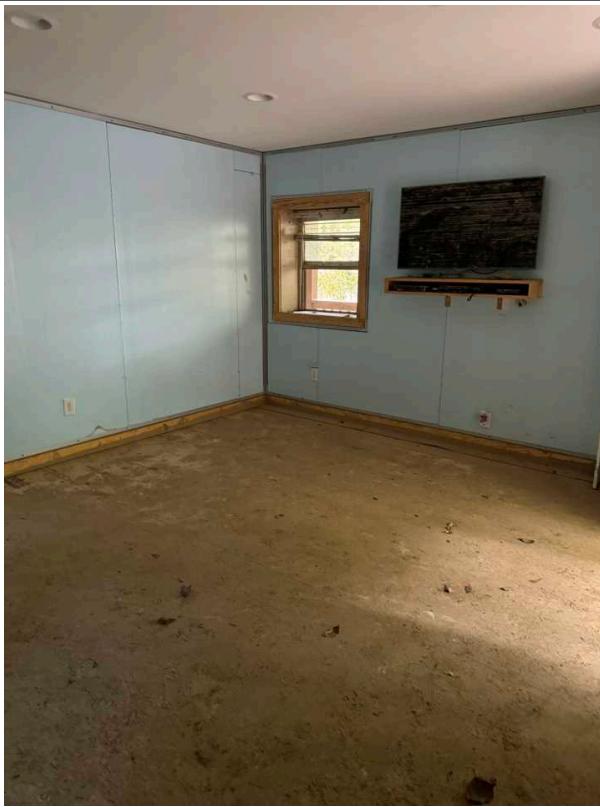
**Main Level/Lower Enclosure -
39-Insured Risk**

Lower enclosure - damaged by flood waters

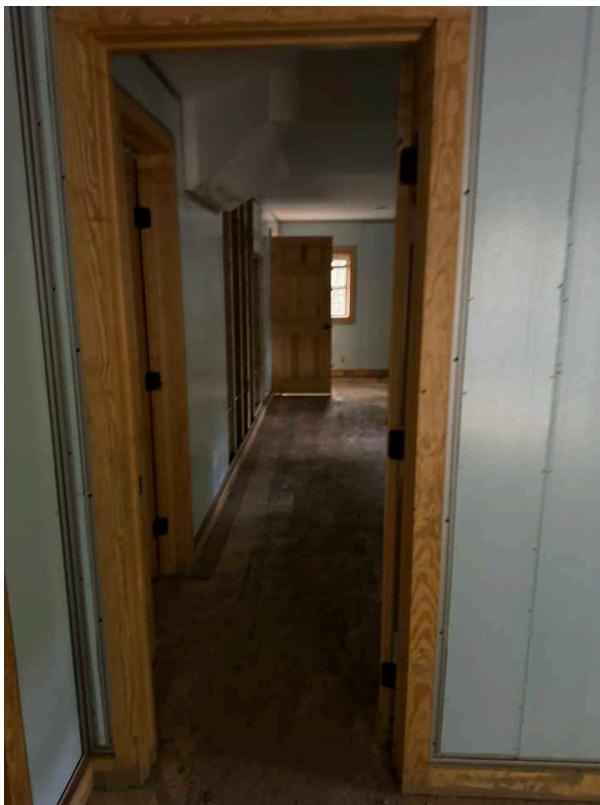
**Main Level/Lower Enclosure -
40-Insured Risk**

Lower enclosure - damaged by flood waters

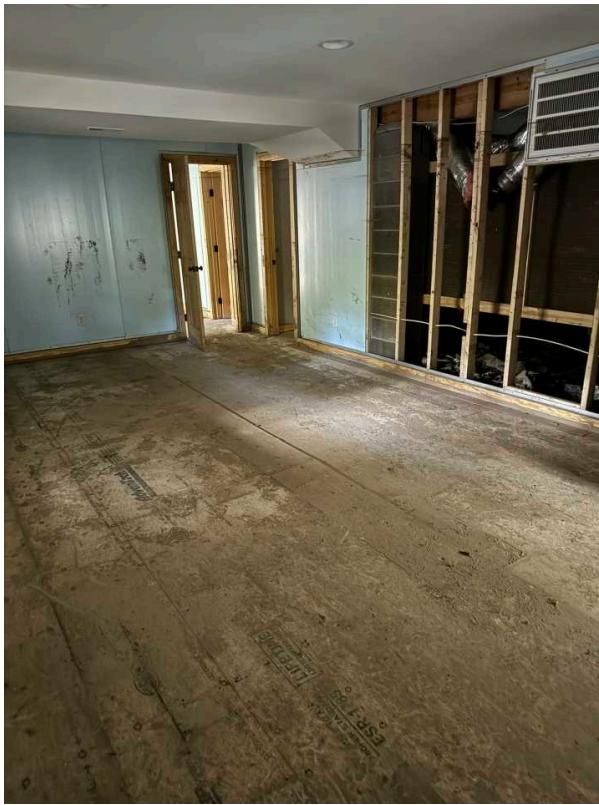
**Main Level/Lower Enclosure -
42-Insured Risk**

Lower enclosure - damaged by flood waters

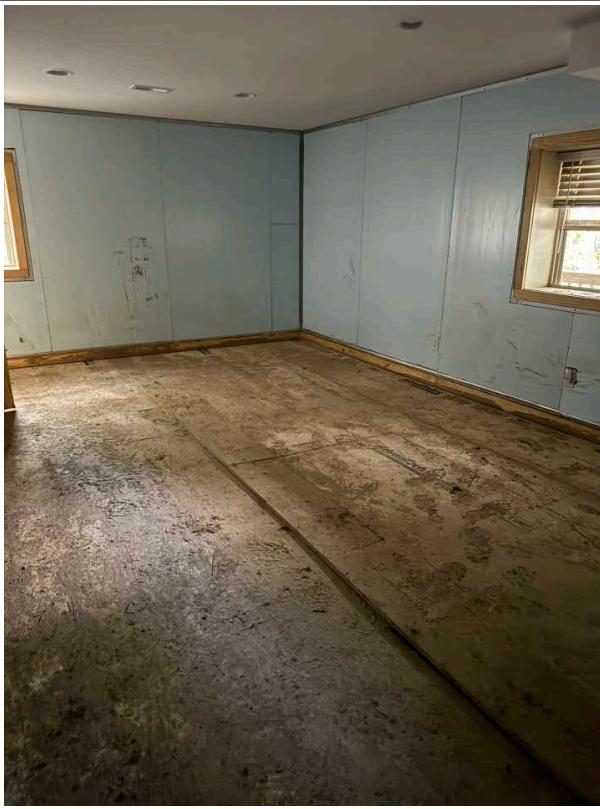
**Main Level/Lower Enclosure -
43-Insured Risk**

Lower enclosure - damaged by flood waters

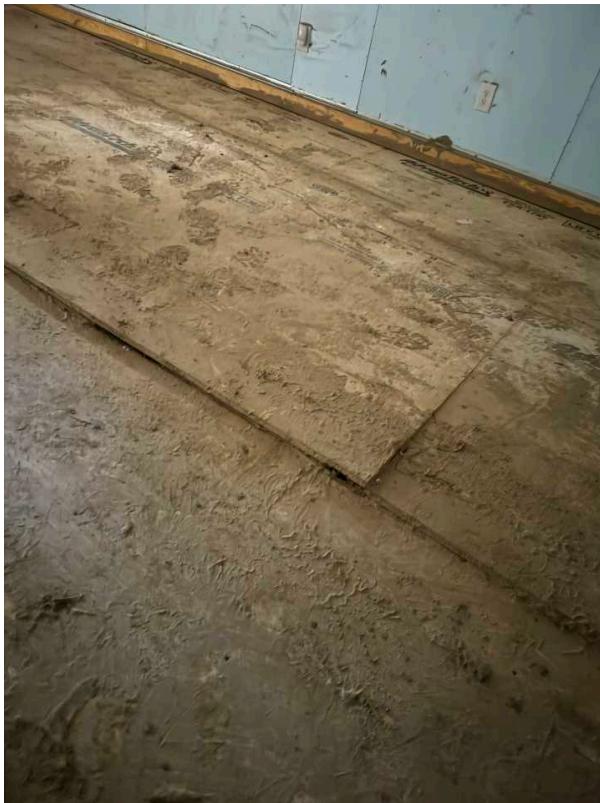
**Main Level/Lower Enclosure -
44-Insured Risk**

Lower enclosure - damaged by flood waters

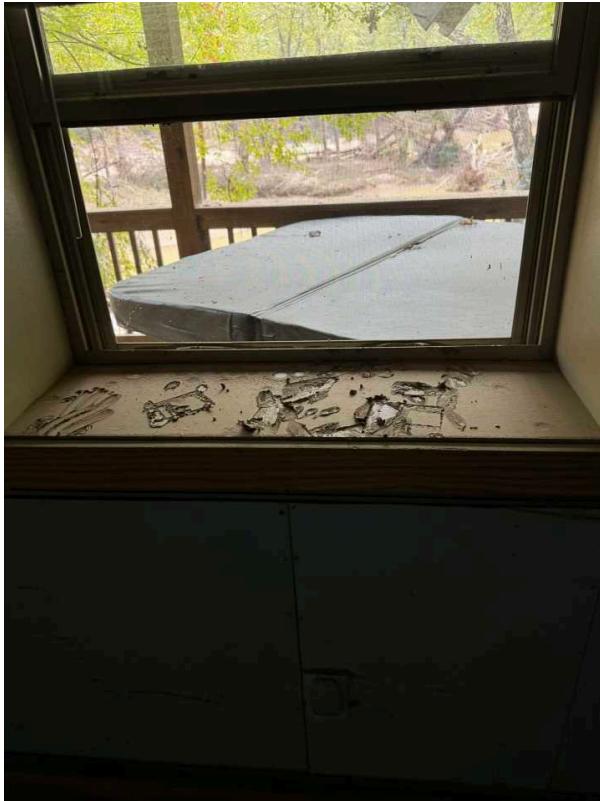
**Main Level/Lower Enclosure -
46-Insured Risk**

Lower enclosure - damaged by flood waters

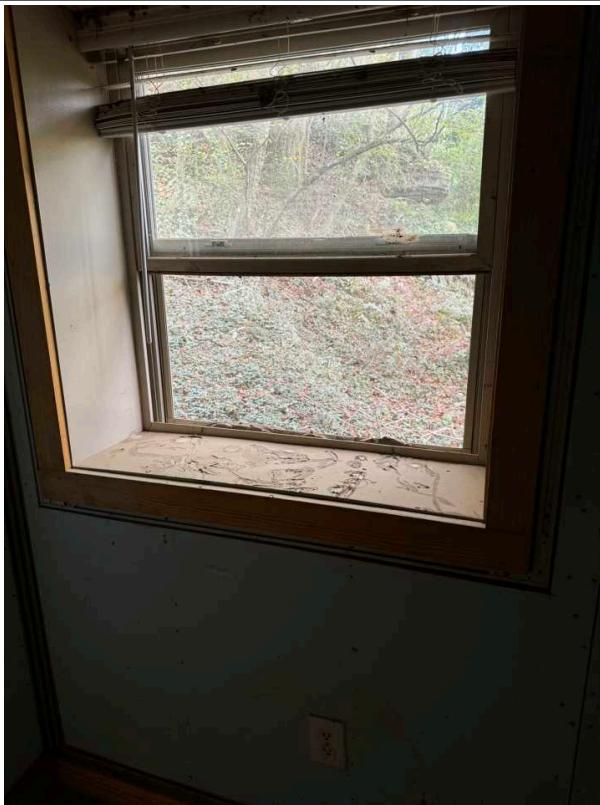
**Main Level/Lower Enclosure -
47-Insured Risk**

Lower enclosure - damaged by flood waters

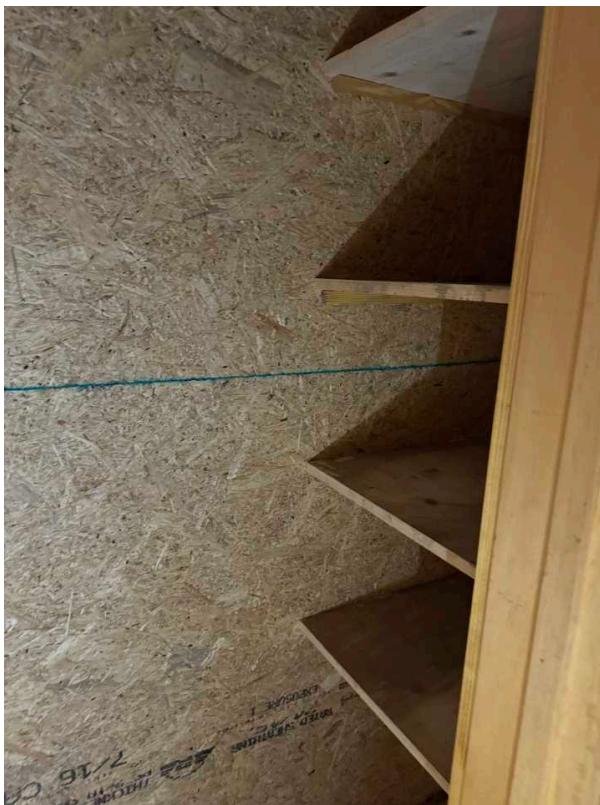
**Main Level/Lower Enclosure -
48-Insured Risk**

Lower enclosure - damaged by flood waters

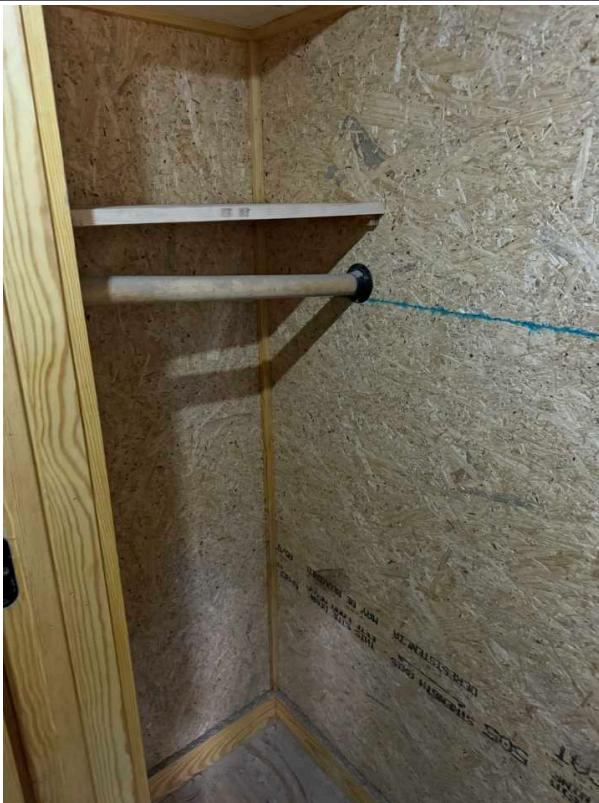
**Main Level/Lower Enclosure -
49-Insured Risk**

Lower enclosure - damaged by flood waters

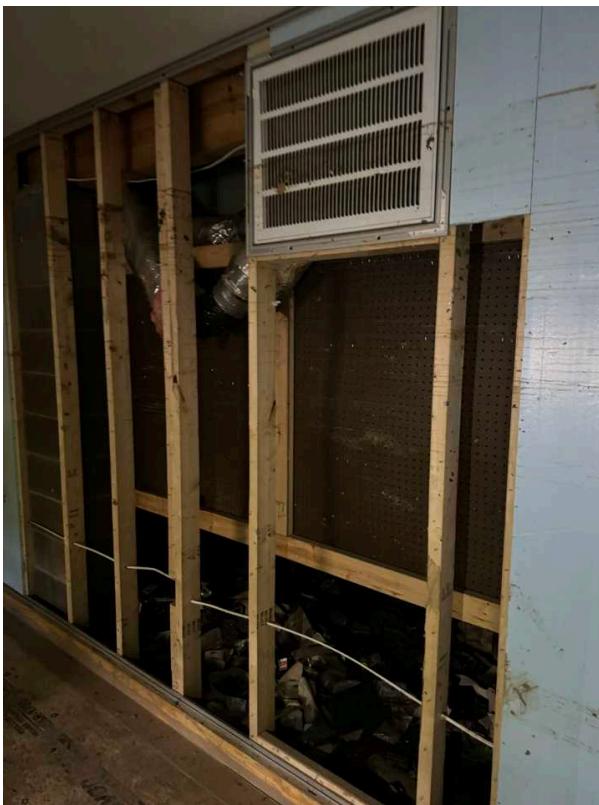
**Main Level/Lower Enclosure -
50-Insured Risk**

Lower enclosure - damaged by flood waters

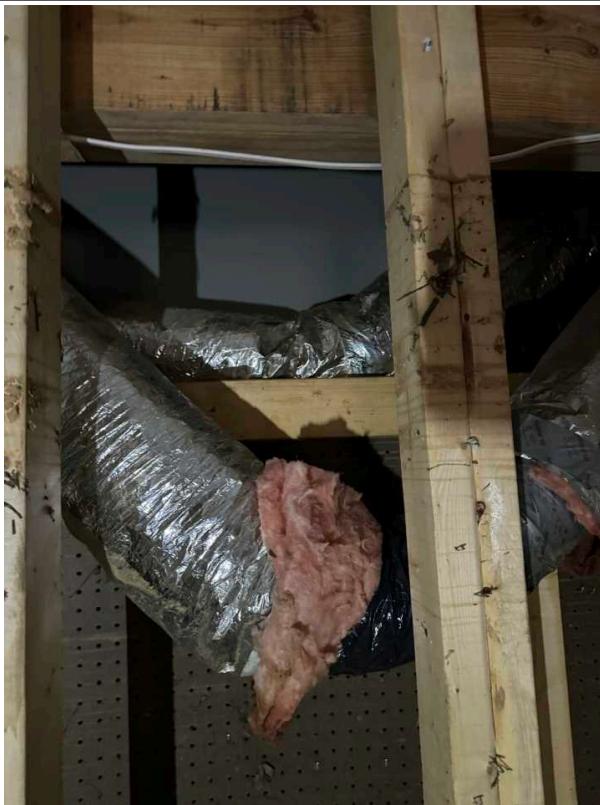
**Main Level/Lower Enclosure -
51-Insured Risk**

Lower enclosure - damaged by flood waters

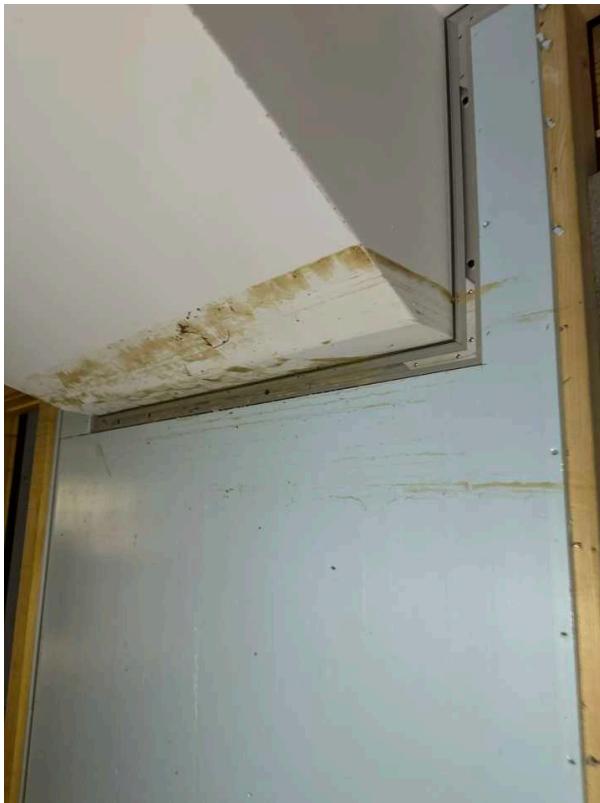
**Main Level/Lower Enclosure -
52-Insured Risk**

Lower enclosure - damaged by flood waters

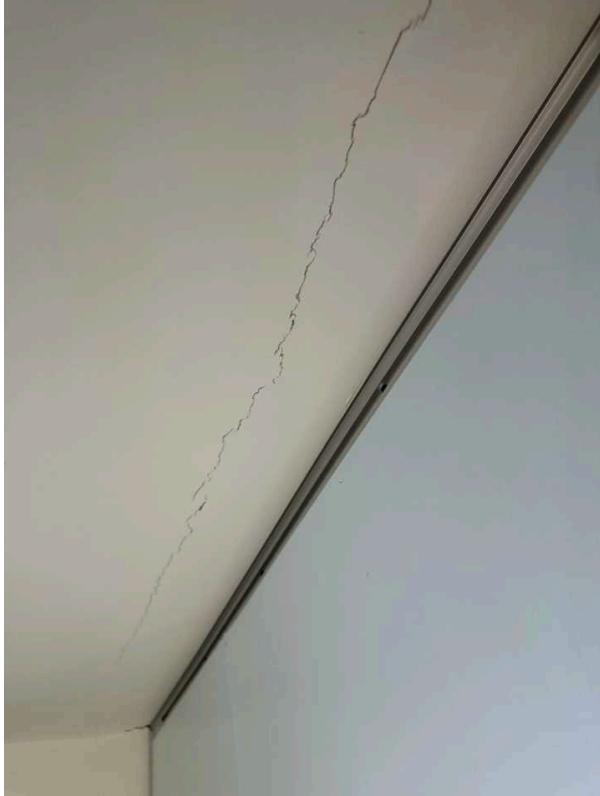
**Main Level/Lower Enclosure -
54-Insured Risk**

Lower enclosure - damaged by flood
waters

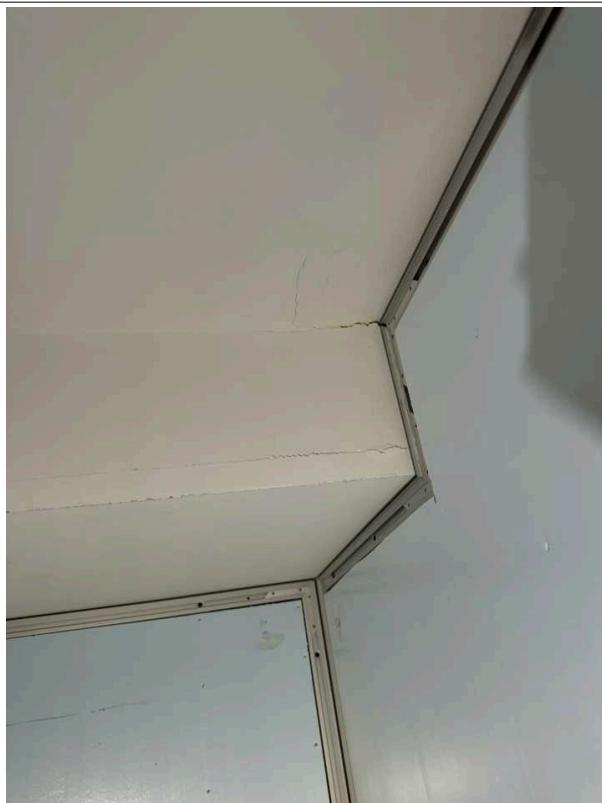
**Main Level/Lower Enclosure -
55-Insured Risk**

Lower enclosure - damaged by flood waters

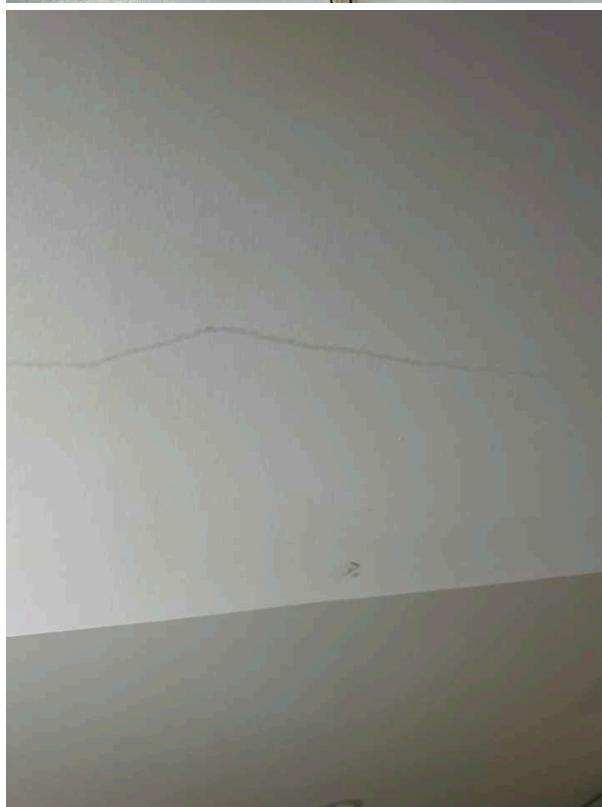
**Main Level/Lower Enclosure -
56-Insured Risk**

Lower enclosure - damaged by flood waters

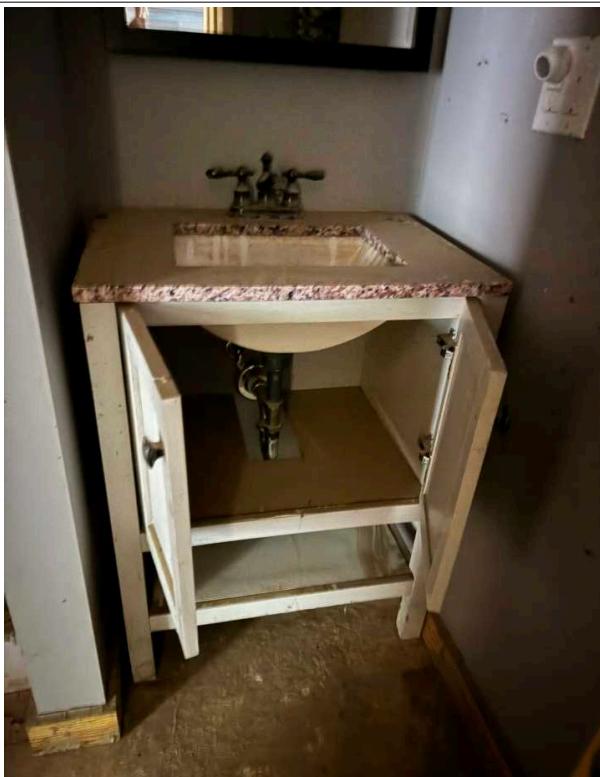
**Main Level/Lower Enclosure -
57-Insured Risk**

Lower enclosure - damaged by flood waters

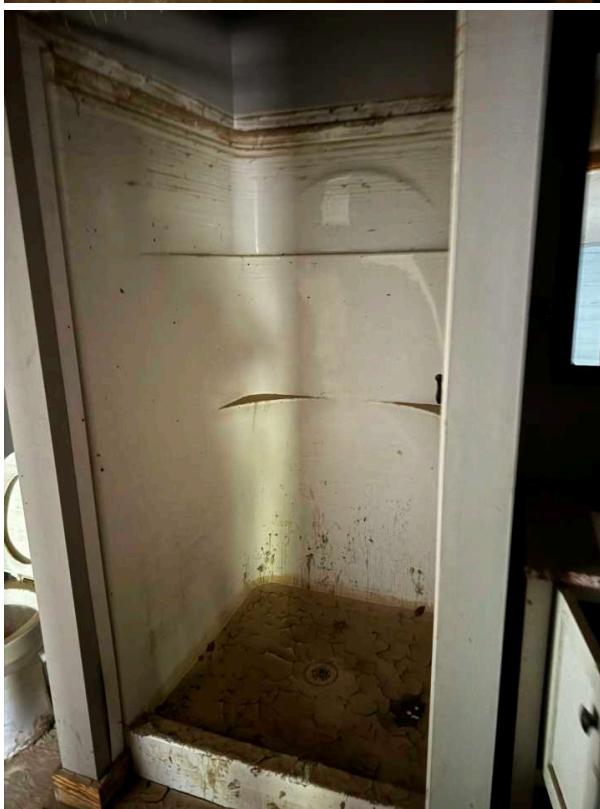
**Main Level/Lower Enclosure -
58-Insured Risk**

Lower enclosure - damaged by flood waters

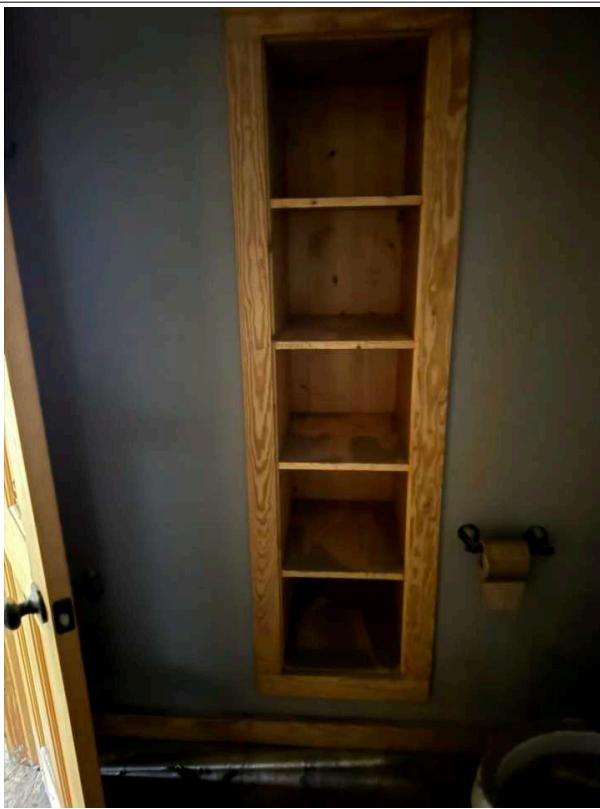
**Main Level/Lower Enclosure -
59-Insured Risk**

Lower enclosure - damaged by flood waters

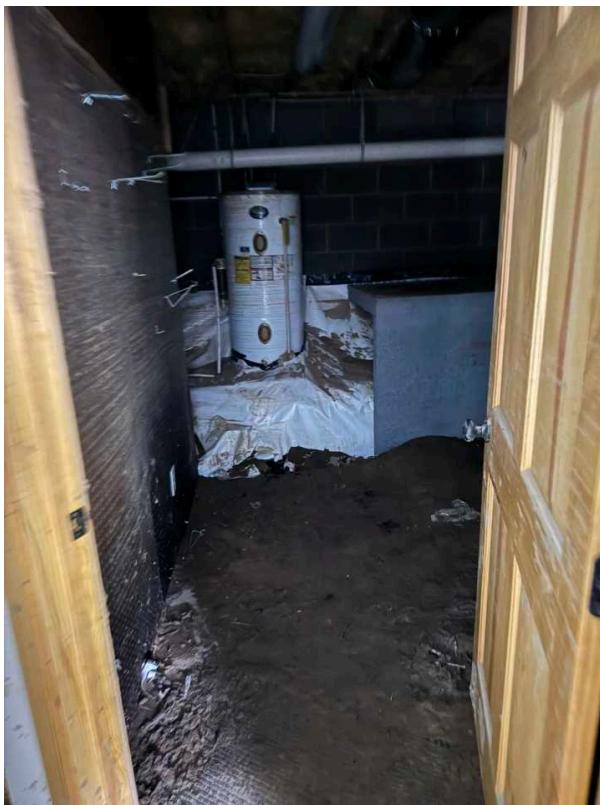
**Main Level/Lower Enclosure -
60-Insured Risk**

Lower enclosure - damaged by flood waters

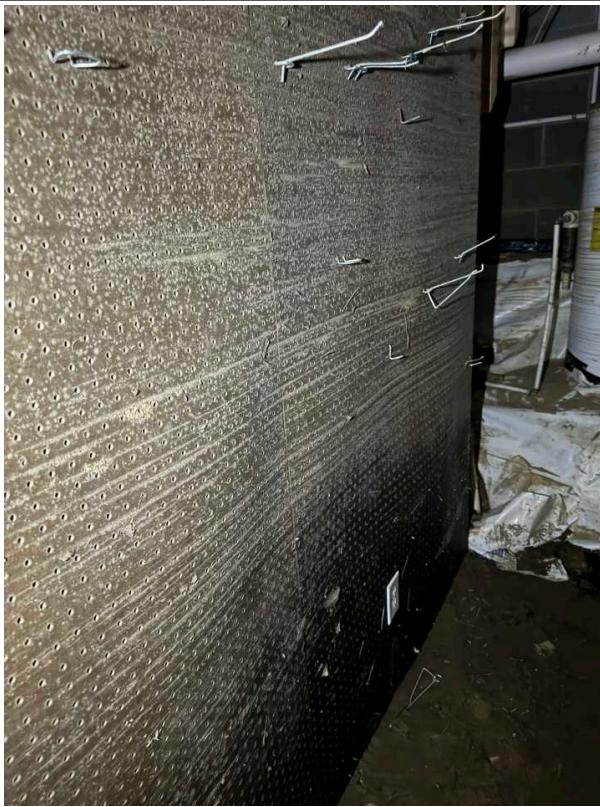
**Main Level/Lower Enclosure -
61-Insured Risk**

Lower enclosure - damaged by flood waters

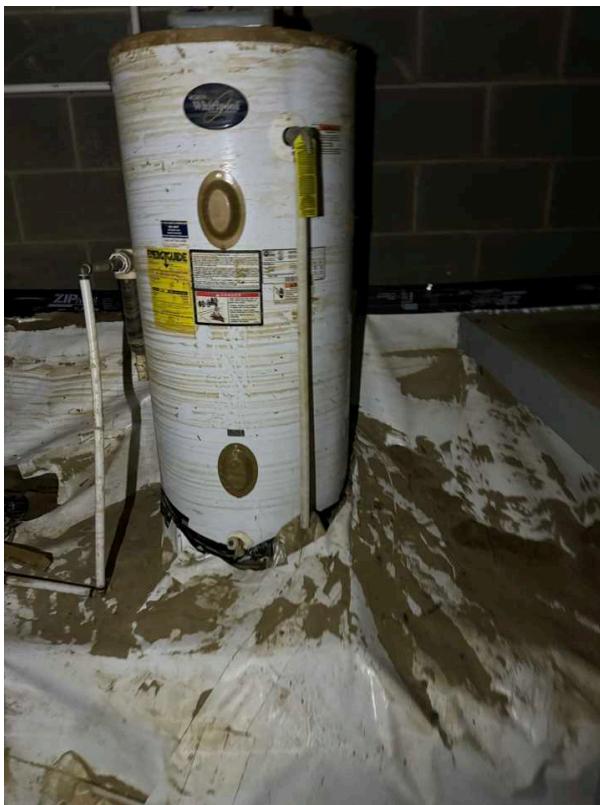
**Main Level/Lower Enclosure -
62-Insured Risk**

Interior flood damage - bottom level

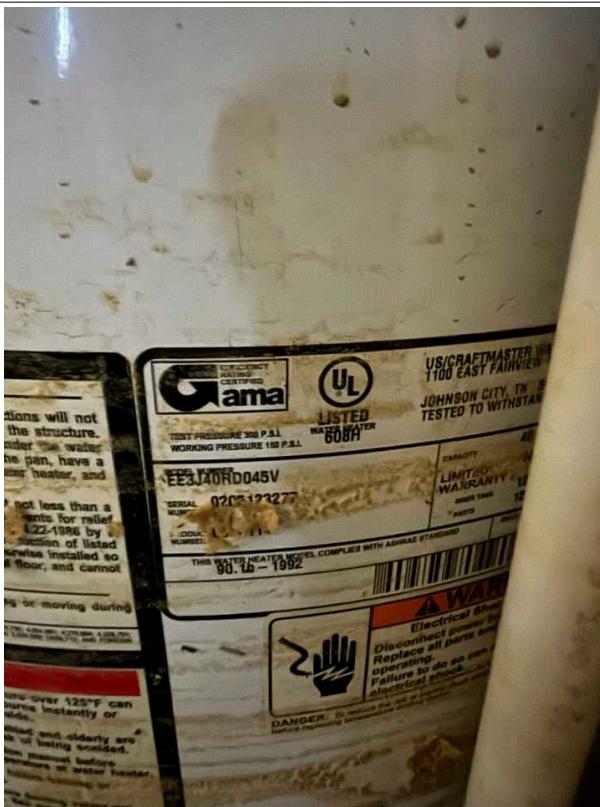
Main Level/Lower Enclosure -
63-Insured Risk

Lower enclosure - damaged by flood waters

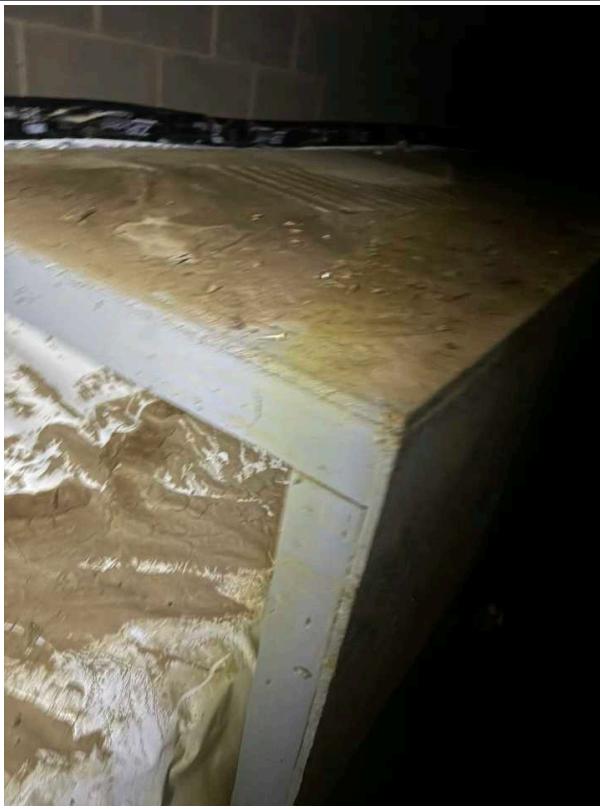
**Main Level/Lower Enclosure -
65-Insured Risk**

Lower enclosure - damaged by flood waters

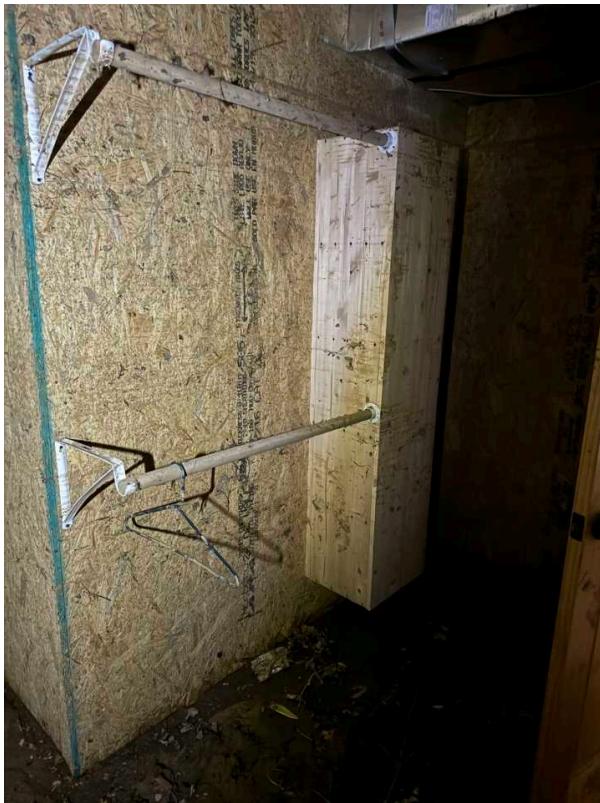
**Main Level/Lower Enclosure -
66-Insured Risk**

Lower enclosure - damaged by flood waters

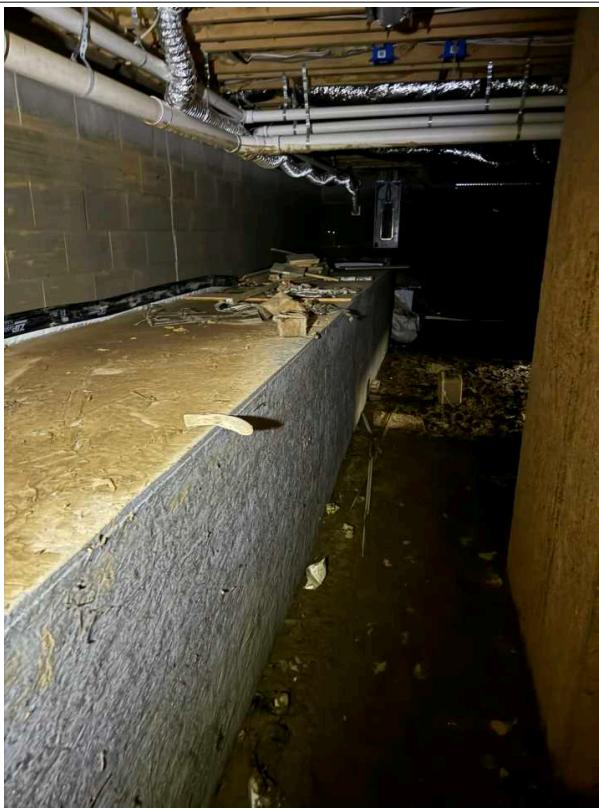
**Main Level/Lower Enclosure -
67-Insured Risk**

Lower enclosure - damaged by flood waters

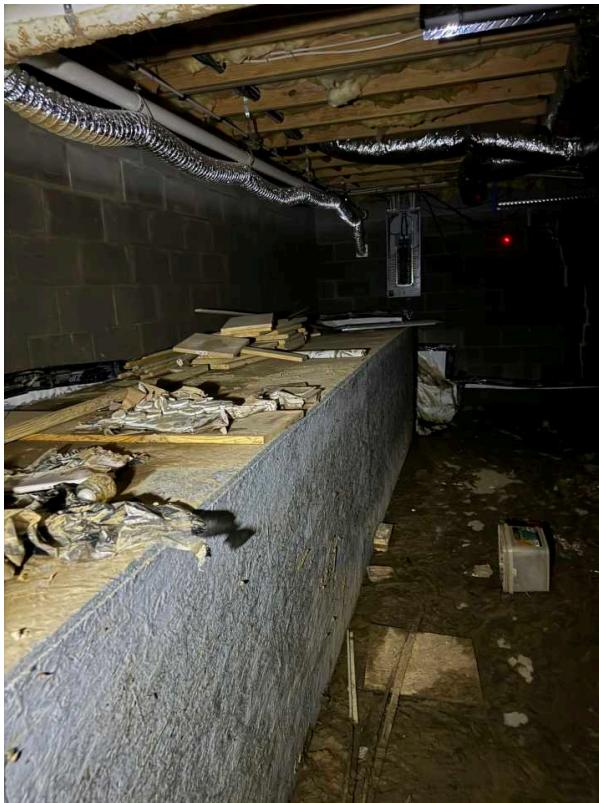
**Main Level/Lower Enclosure -
68-Insured Risk**

Lower enclosure - damaged by flood waters

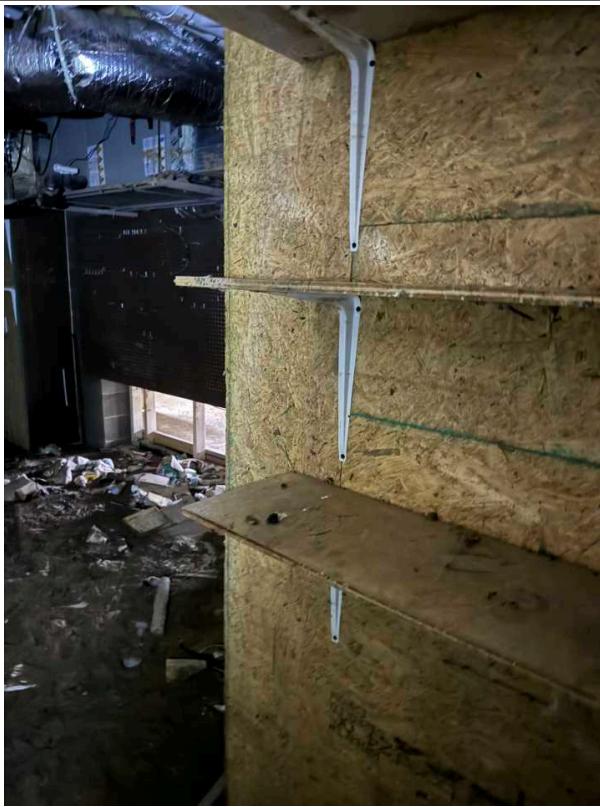
**Main Level/Lower Enclosure -
69-Insured Risk**

Lower enclosure - damaged by flood waters

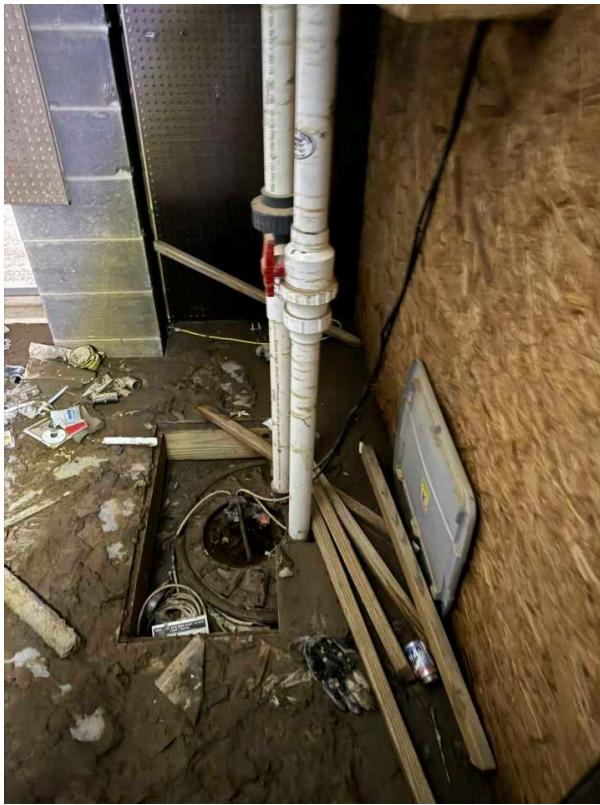
**Main Level/Lower Enclosure -
70-Insured Risk**

Lower enclosure - damaged by flood waters

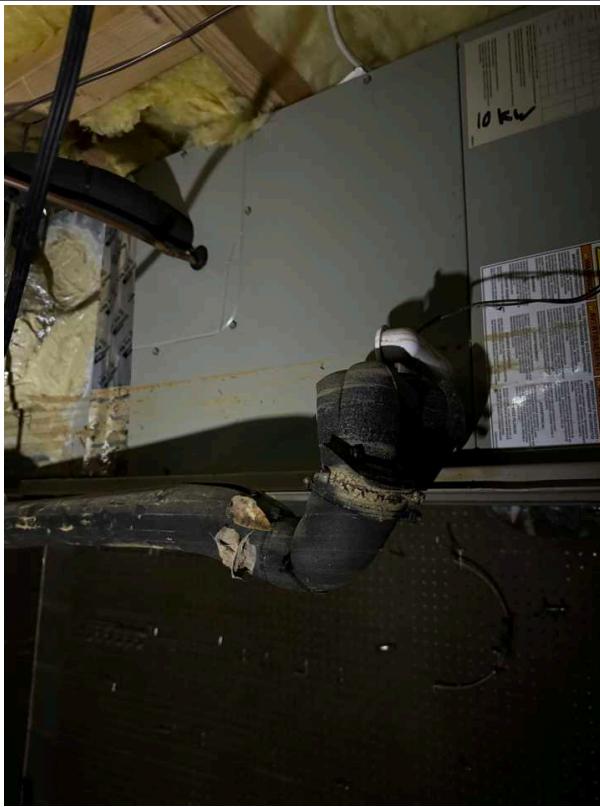
**Main Level/Lower Enclosure -
71-Insured Risk**

Lower enclosure - damaged by flood waters

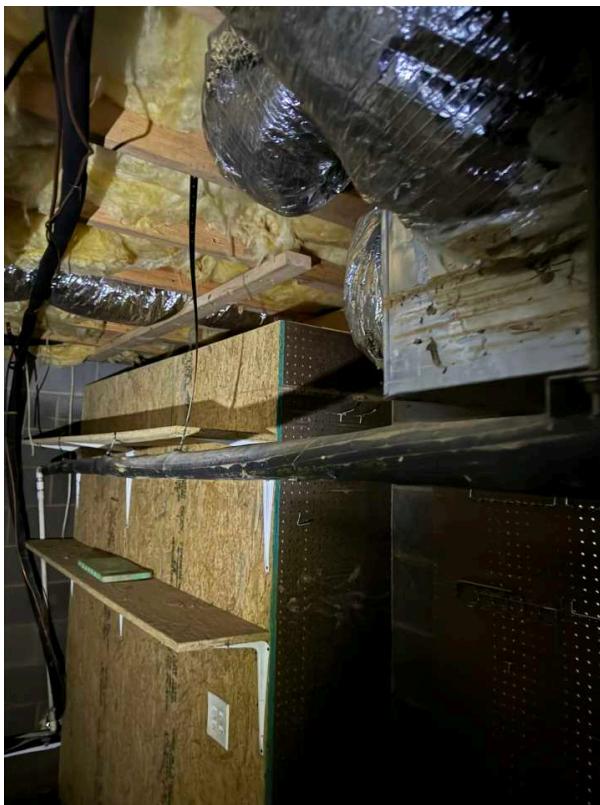
**Main Level/Lower Enclosure -
72-Insured Risk**

Lower enclosure - damaged by flood waters

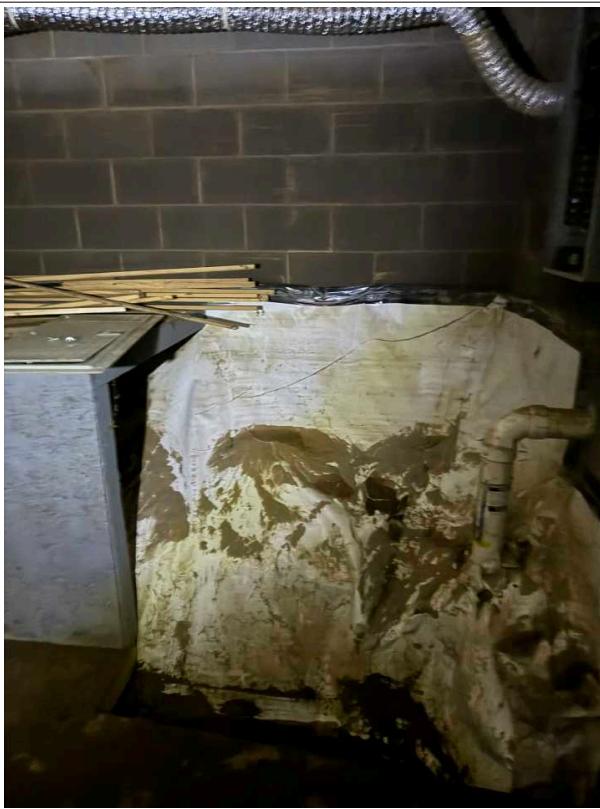
**Main Level/Lower Enclosure -
73-Insured Risk**

Lower enclosure - damaged by flood waters
