NARRATIVE REPORT

DWELLING / UNIT OWNER

Carrier:	Assurant Flood Insurance	Date of Loss:	9/27/2024
Insured:	JOHN THOMAS	Assigned:	10/1/2024
CID:	240204	Contacted:	10/3/2024
Claim Number:	7800040227	Inspected:	10/16/2024
Policy Number:	7800040227	Inspected With:	MARY & JOHN THOMAS
Loss Address:	165 RAVEN BLVD LAKE LURE NC 28746	Mailing Address:	912 YORKMONT RD CHARLOTTE NC 28217
Coverage A:	\$ 250,000.00	Mortgage:	Towne Bank
Coverage B:	\$ 0.00	Verified with:	MARY & JOHN THOMAS
Policy Term:	12/1/2023 to 12/1/2024

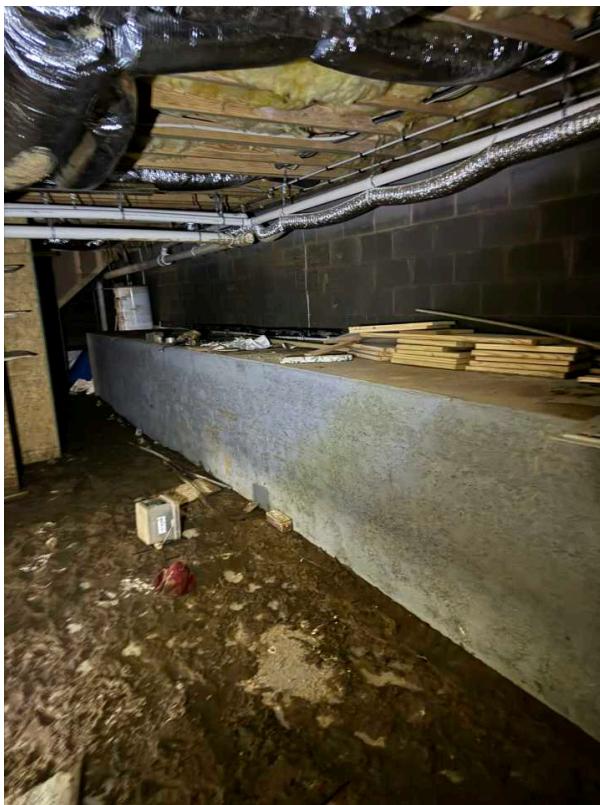
**Main Level/Lower Enclosure -
74-Insured Risk**

Lower enclosure - damaged by flood waters

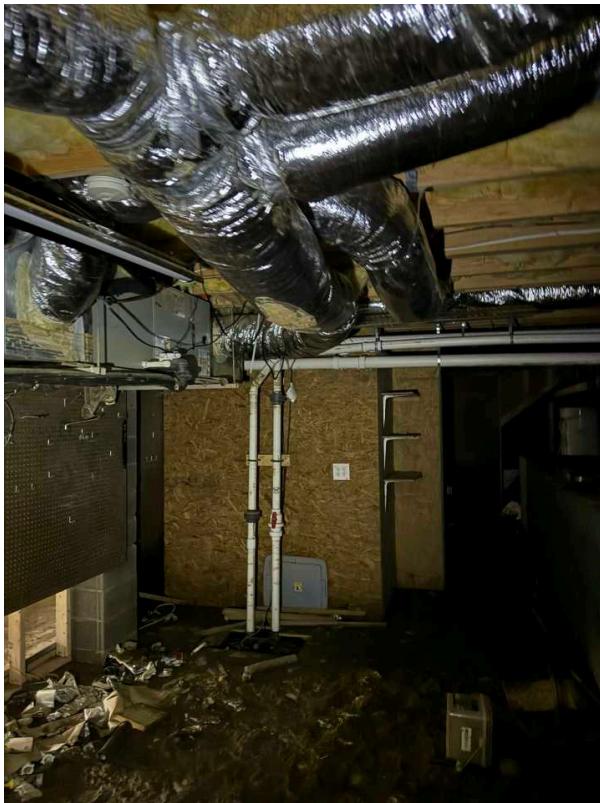
**Main Level/Lower Enclosure -
76-Insured Risk**

Lower enclosure - damaged by flood waters

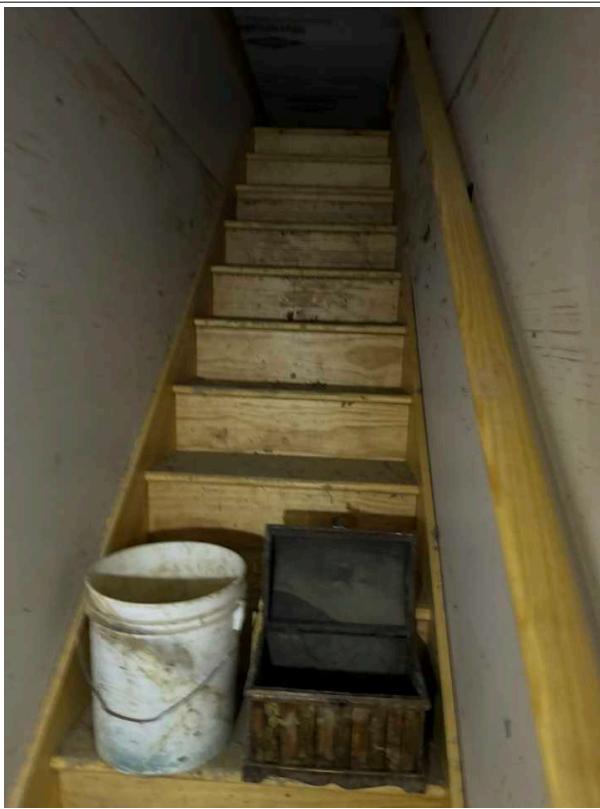
**Main Level/Lower Enclosure -
77-Insured Risk**

Lower enclosure - damaged by flood
waters

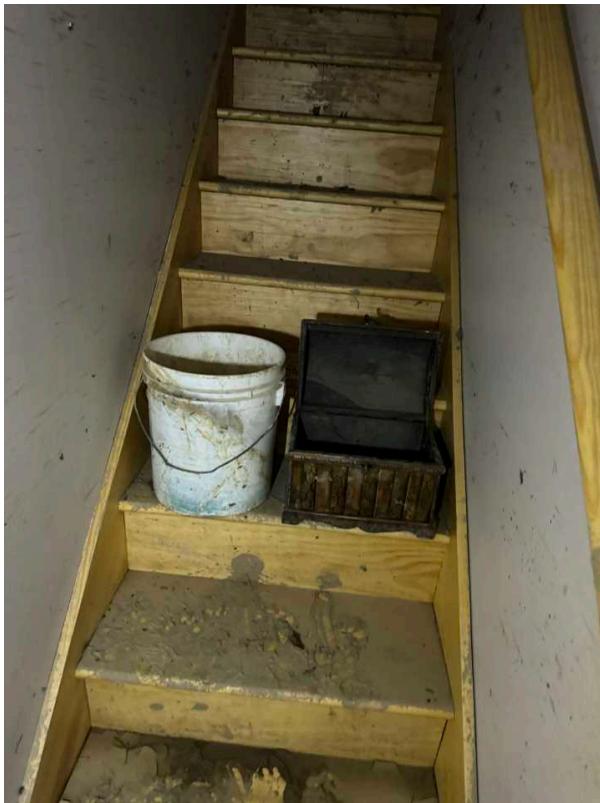
**Main Level/Lower Enclosure -
78-Insured Risk**

Lower enclosure - damaged by flood
waters

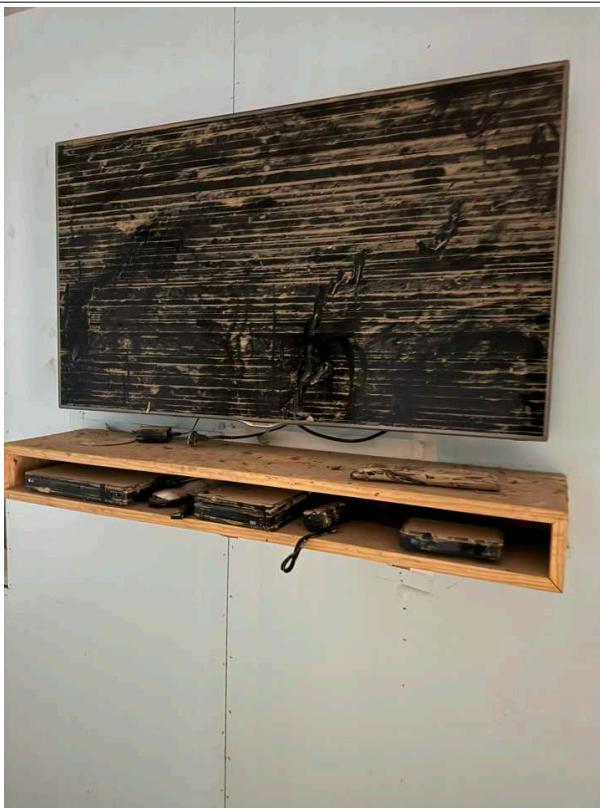
**Main Level/Lower Enclosure -
79-Insured Risk**

Lower enclosure - damaged by flood waters

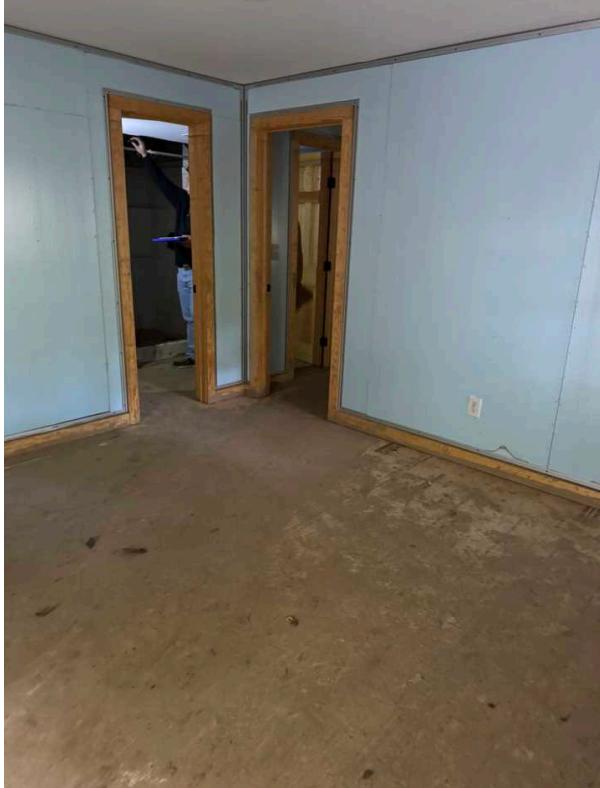
**Main Level/Lower Enclosure -
80-Insured Risk**

Lower enclosure - damaged by flood waters

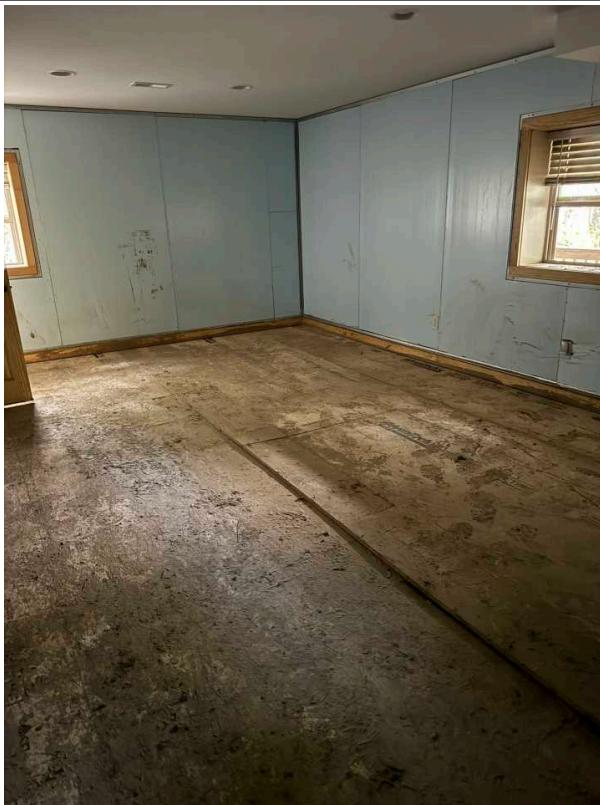
**Main Level/Lower Enclosure -
81-Insured Risk**

Lower enclosure - damaged by flood waters

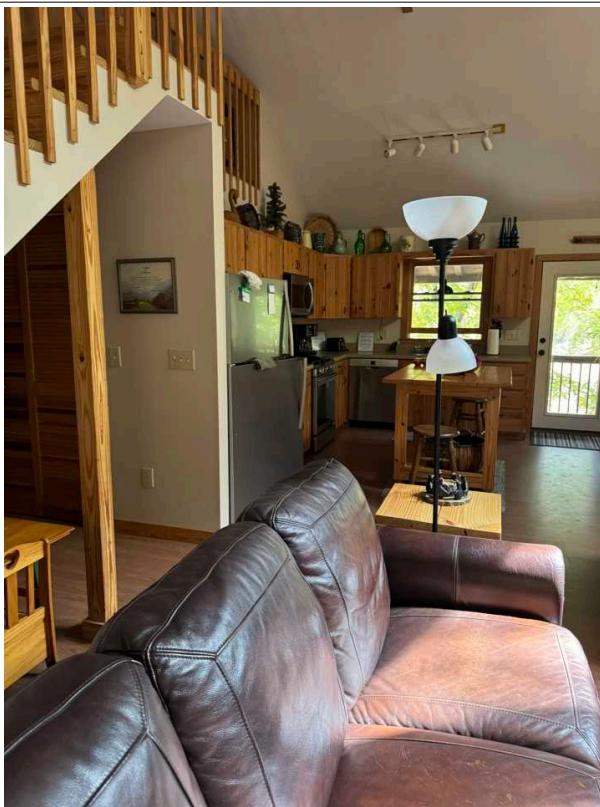
85-IMG_6341

Upstairs - no direct physical loss

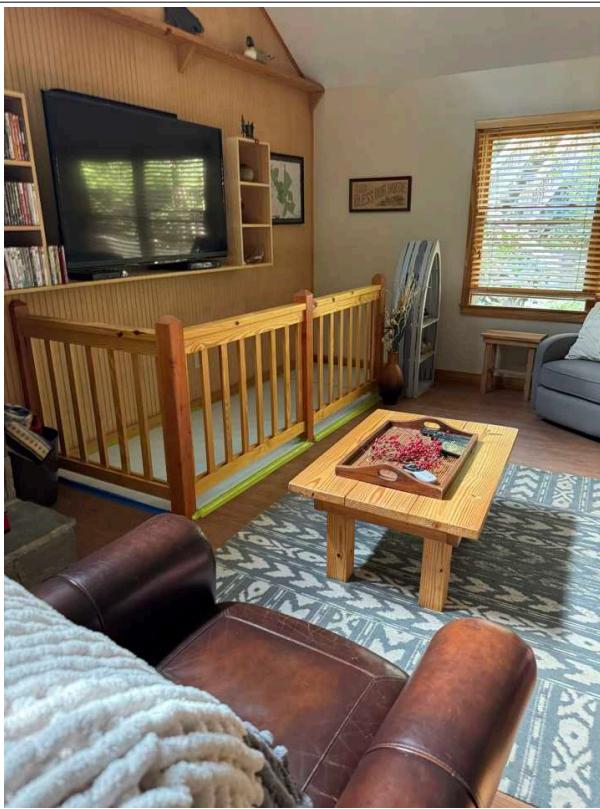
87-IMG_6343

Upstairs - no direct physical loss

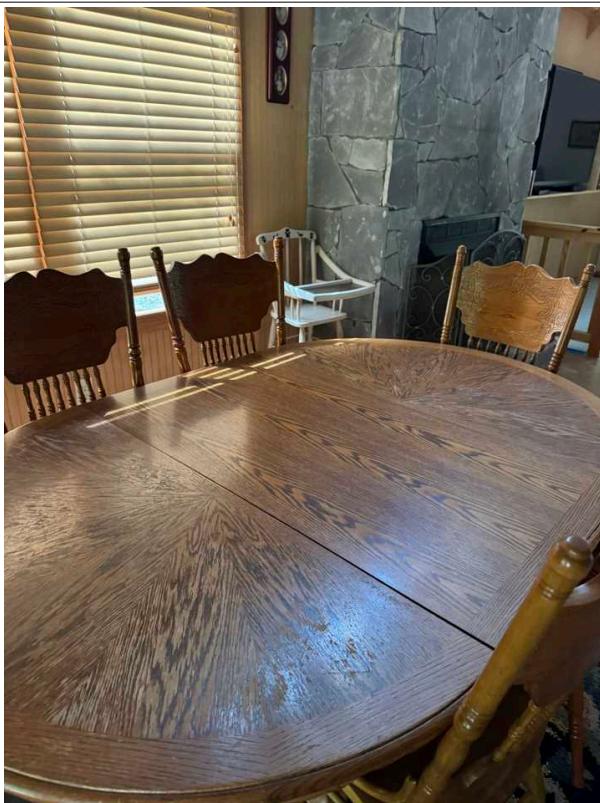
89-IMG_6345

Upstairs - no direct physical loss

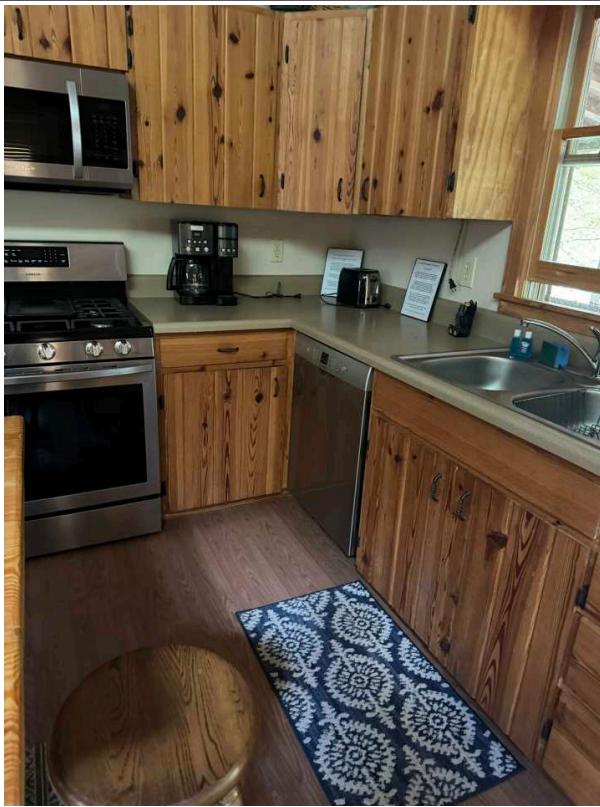
91-IMG_6347

Upstairs - no direct physical loss

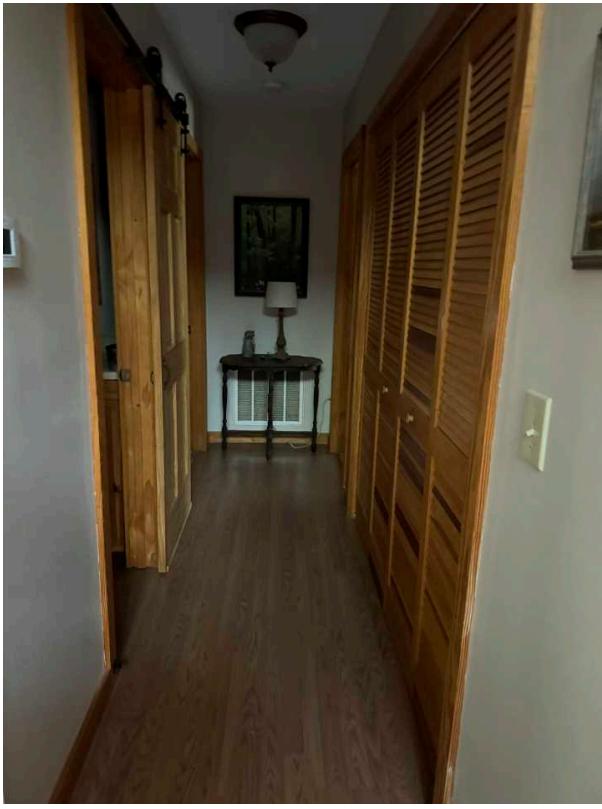
93-IMG_6349

Upstairs - no direct physical loss
