NARRATIVE REPORT

DWELLING / UNIT OWNER

Carrier:	Assurant Flood Insurance Program	Date of Loss:	9/26/2024
Insured:	ELIZABETH WRIGHT/WRIGHT CAROLYN	Assigned:	10/15/2024
CID:	243519	Contacted:	10/15/2024
Claim Number:	7406040448-09262024	Inspected:	10/24/2024
Policy Number:	7406040448	Inspected With:	CAROLYN WRIGHT
Loss Address:	400 N FORK RD BARNARDSVILLE NC 28709	Mailing Address:	41 N COLLEGE ST WEAVERVILLE, NC 28787
Coverage A:	\$ 185,000.00	Mortgage:	LOANCARE LLC
Coverage B:	\$ 0.00	Verified with:	CAROLYN WRIGHT
Policy Term:	9/25/2024 to 9/25/2025

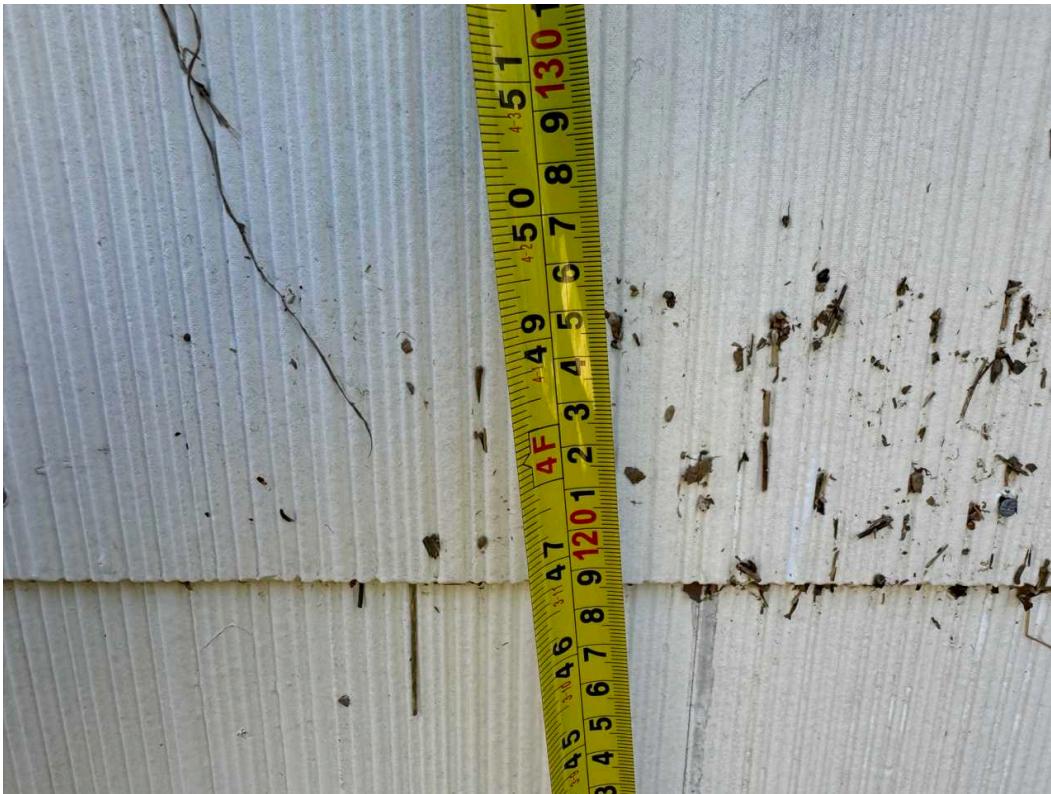
Exterior - 3-Insured Risk

Exterior flood line - 49 in

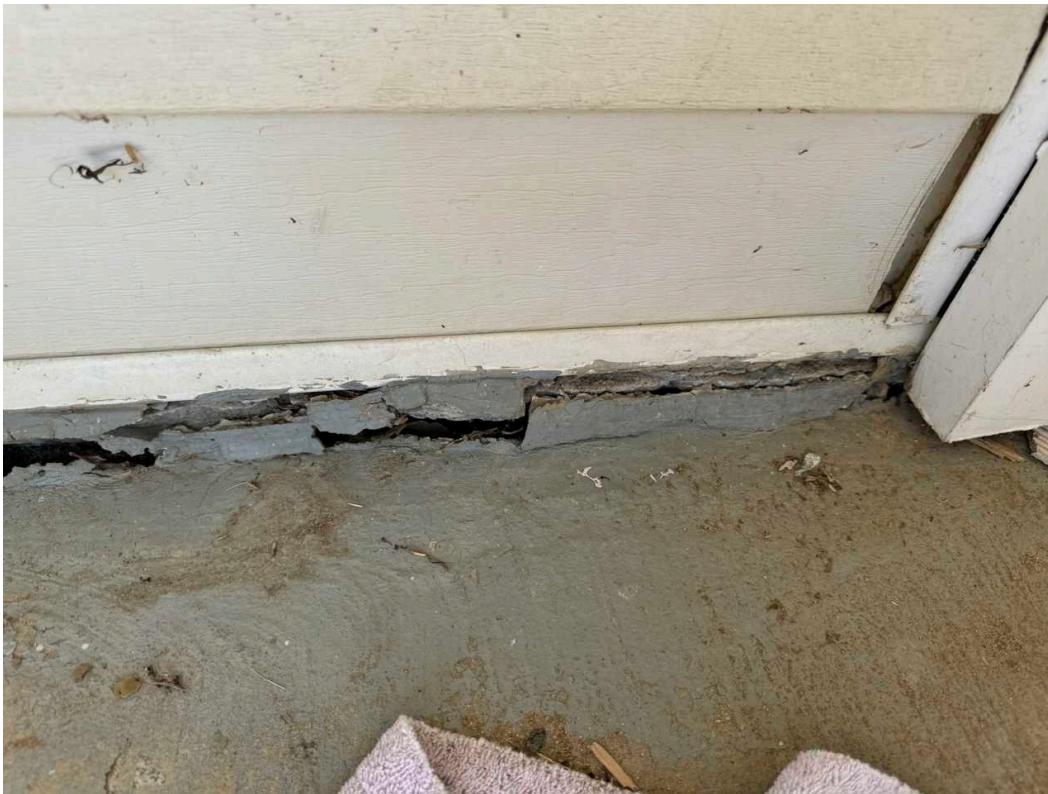
Exterior /Exterior - 7-Insured Risk

Based on the cracking observed to the exterior stone wall of the foundation wall. The home also appears to be unlevel and is sinking. We have requested an engineer to inspect the home to determine if the cracking was caused by flood

Date Taken: 10/24/2024
Taken By: Dina Bullard
crack - Porch pulling away from wall

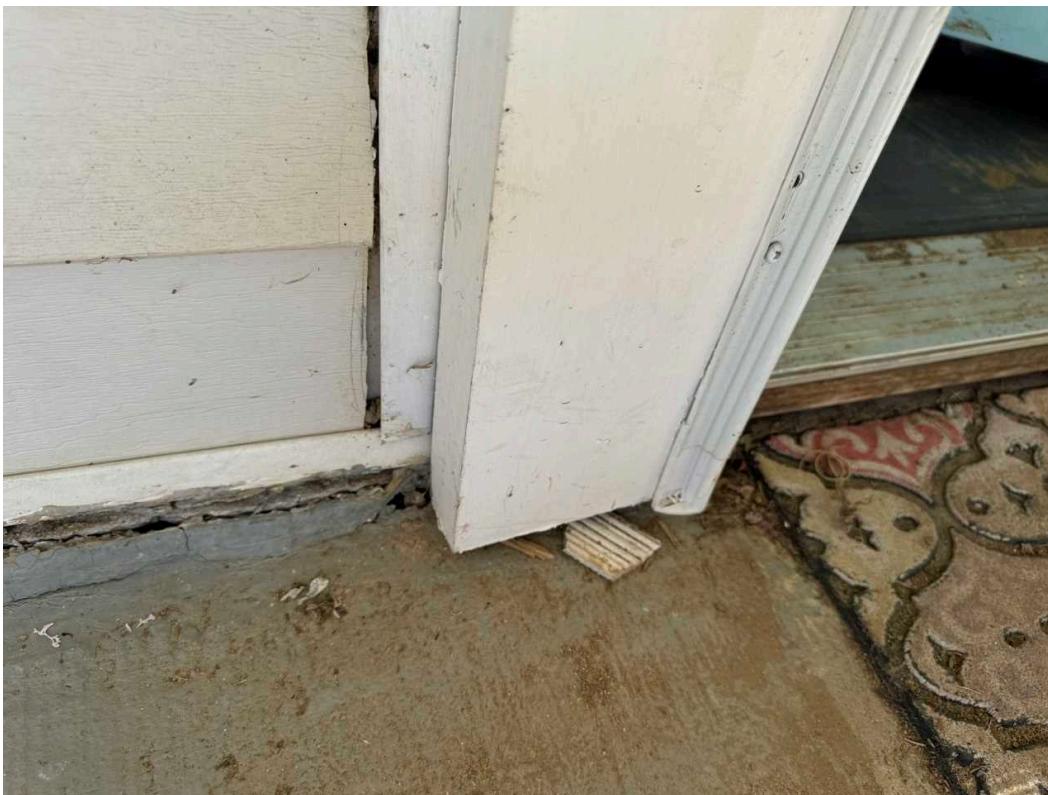
Exterior /Exterior - 8-Insured Risk

Date Taken: 10/24/2024
Taken By: Dina Bullard
crack - Porch pulling away from wall

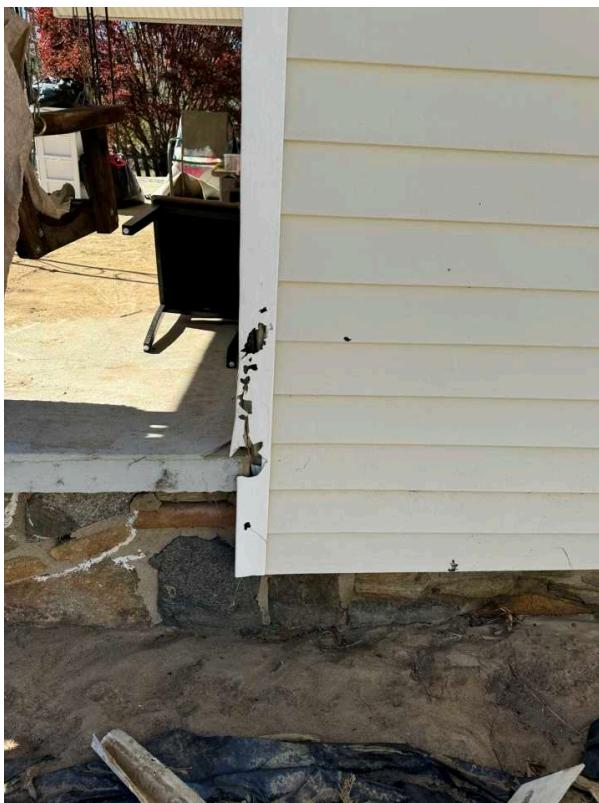
Exterior /Exterior - 10-Insured Risk

Date Taken: 10/24/2024
Taken By: Dina Bullard
Siding damage from flood debris

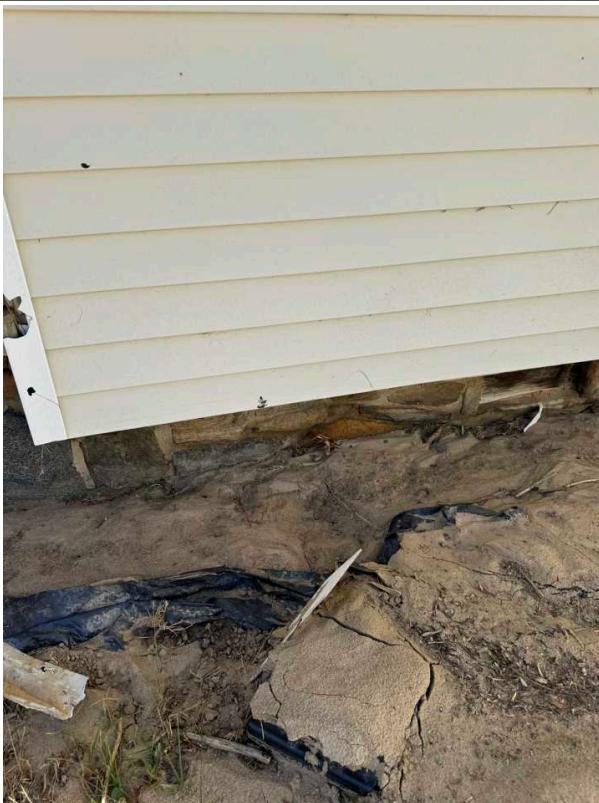
Exterior /Exterior - 11-Insured Risk

Siding damage from flood debris

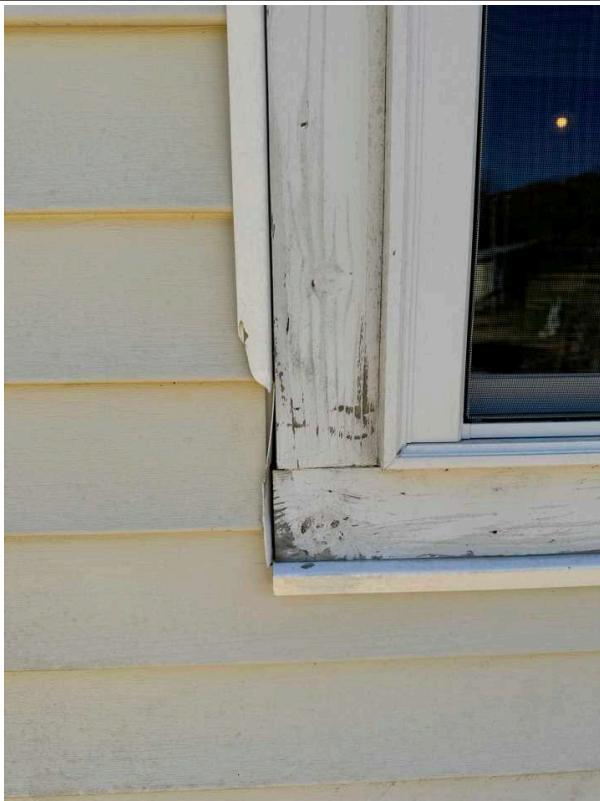
Exterior /Exterior - 13-Insured Risk

Siding damage from flood debris

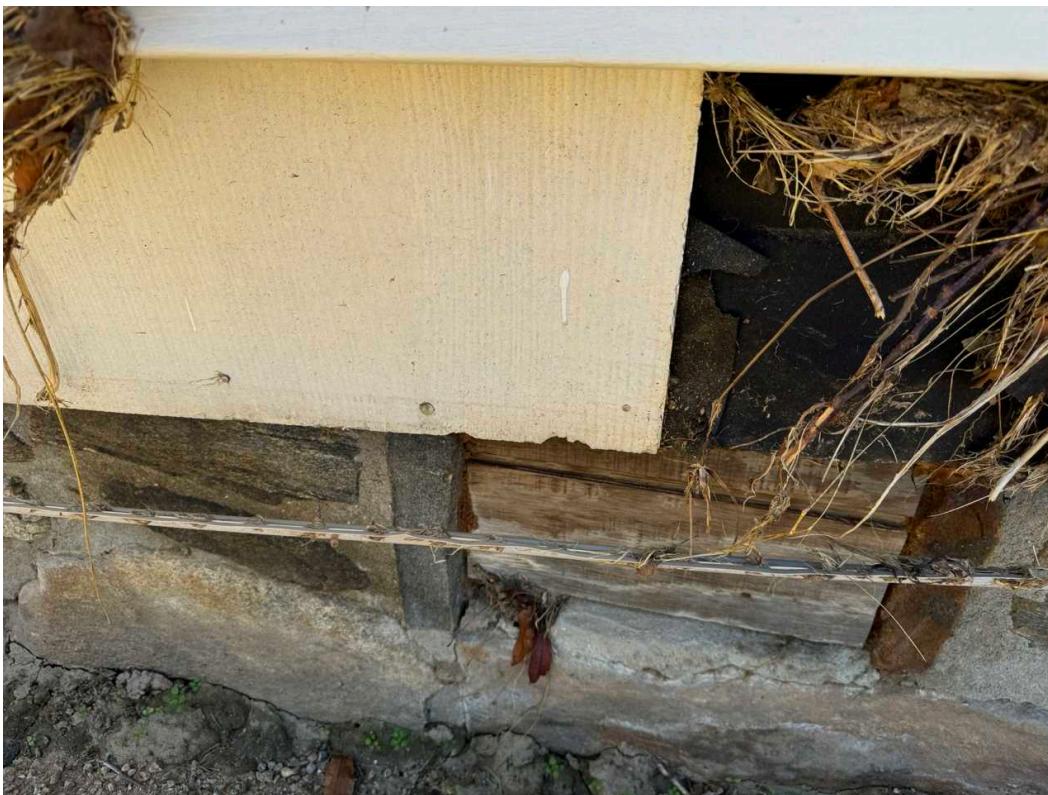
Exterior /Exterior - 16-Insured Risk

Date Taken: 10/24/2024
Taken By: Dina Bullard
Siding damage from flood debris

- Elevations – remove, replace vinyl siding on the front, right, left and portion of the rear elevation to 5.25 feet due to water and floating debris damage. The rear elevation has fiber cement siding – we have allowed to remove, replace up to 5.25 ft.
- Mechanical & Equipment – remove, replace HVAC compressor as it was inundated in flood water for substantial amount of time.
- Gutter downspouts – remove, replace downspouts damaged by flood debris
- Wood windows – paint casing around the exterior windows
- Plumbing – tankless water heater is installed on the exterior of the rear elevation.
- Metal columns – paint columns due to water damage, paint is peeling.

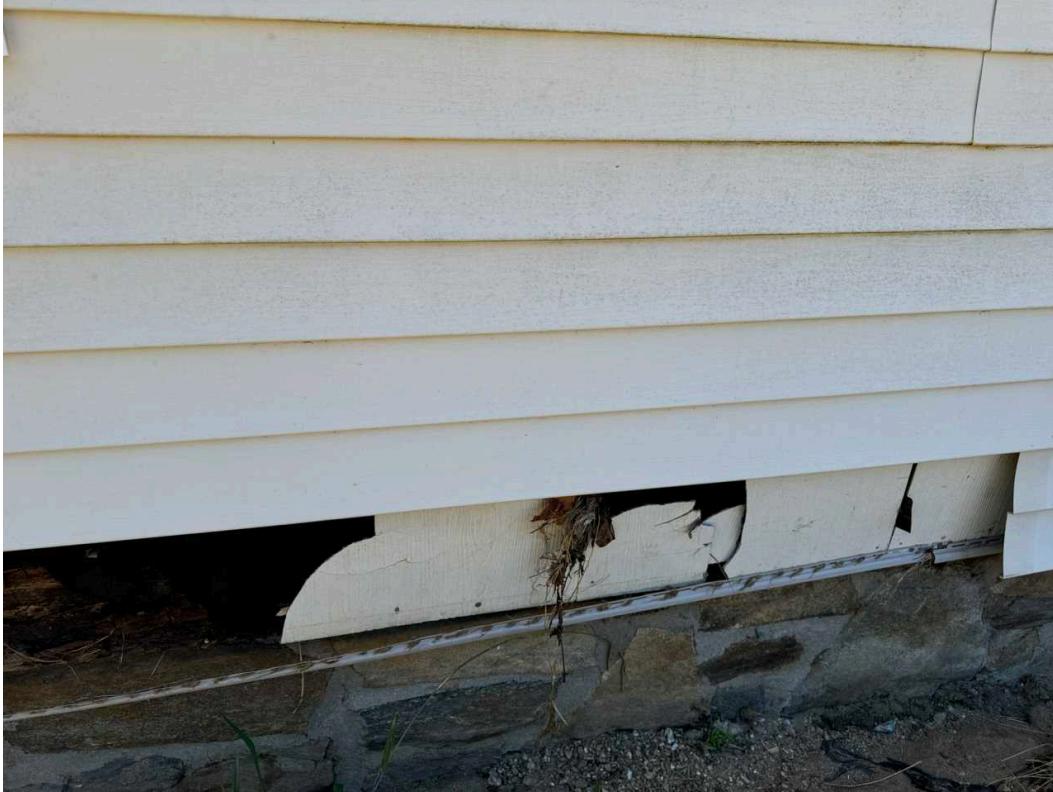
Exterior /Exterior - 17-Insured Risk

Siding damage from flood debris

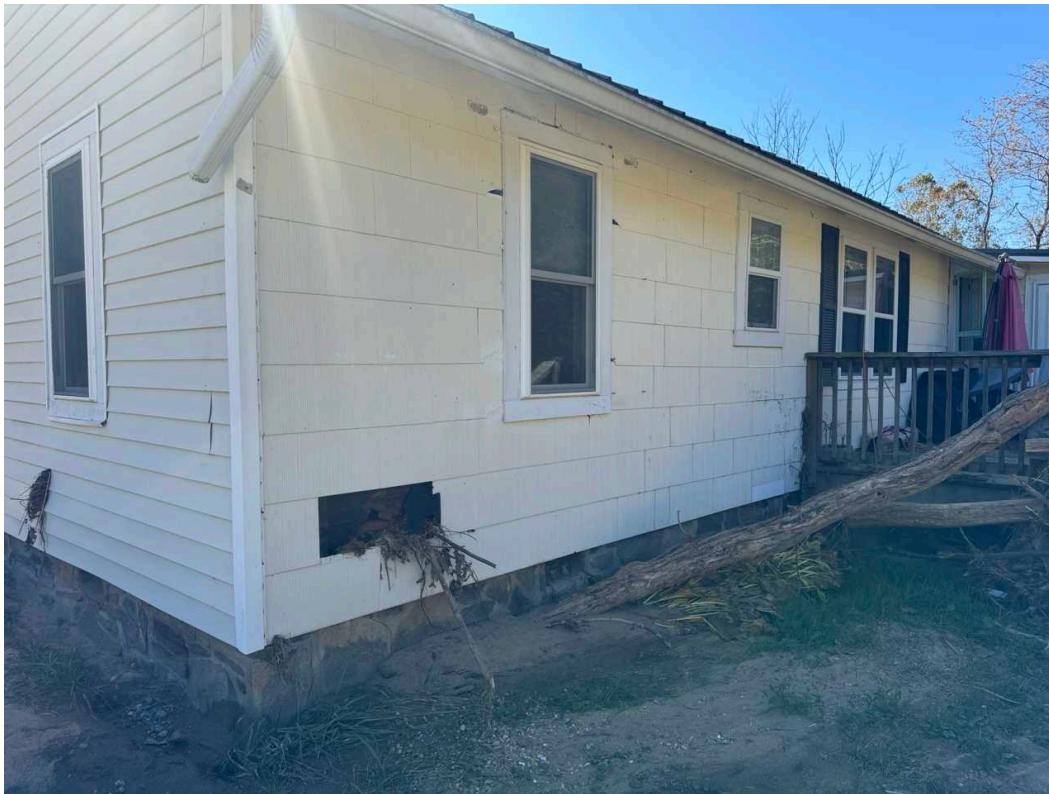
Exterior /Exterior - 19-Insured Risk

Siding damage from flood debris

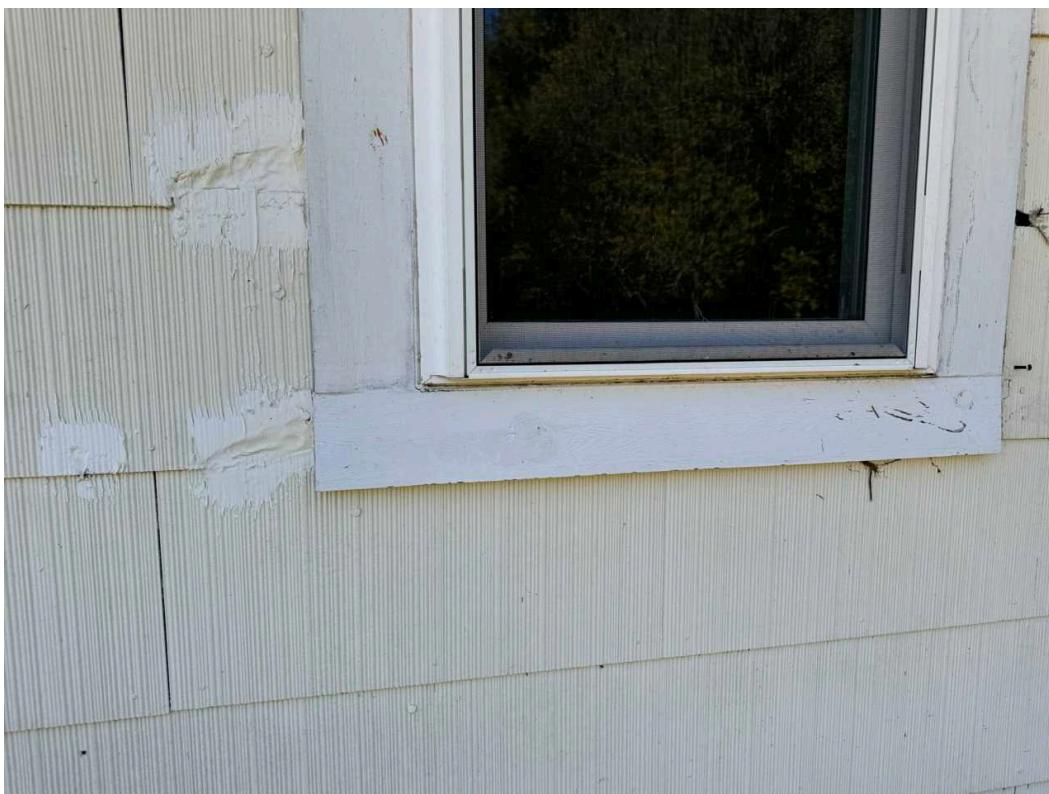
Exterior /Exterior - 20-Insured Risk

Siding damage - possible asbestos siding

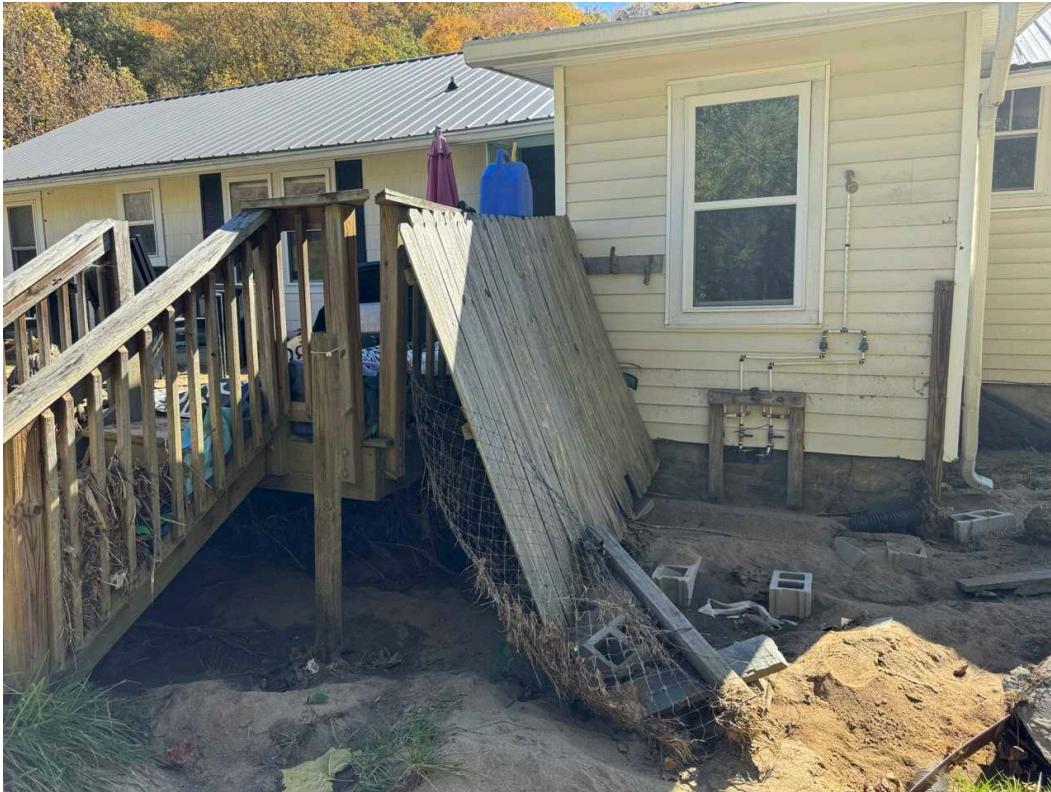
Exterior /Exterior - 23-Insured Risk

Rear deck damage

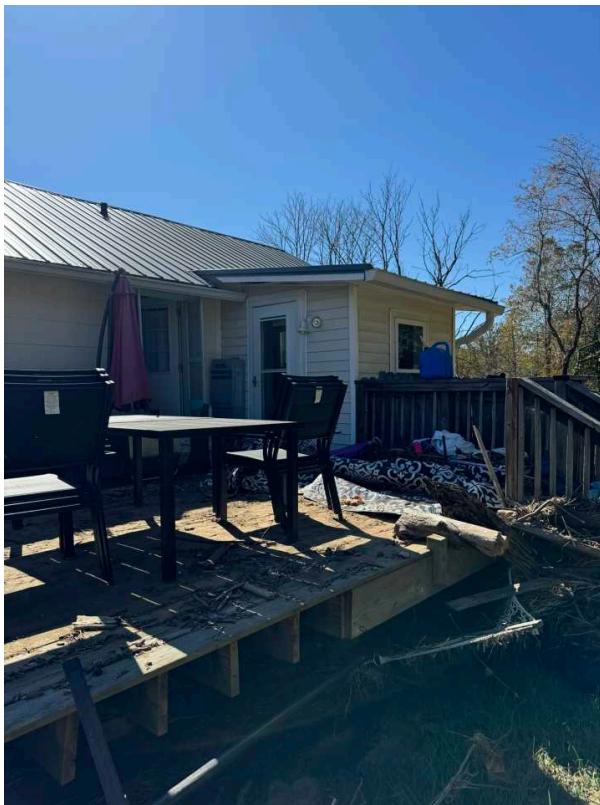
Exterior /Exterior - 24-Insured Risk

Rear deck damage

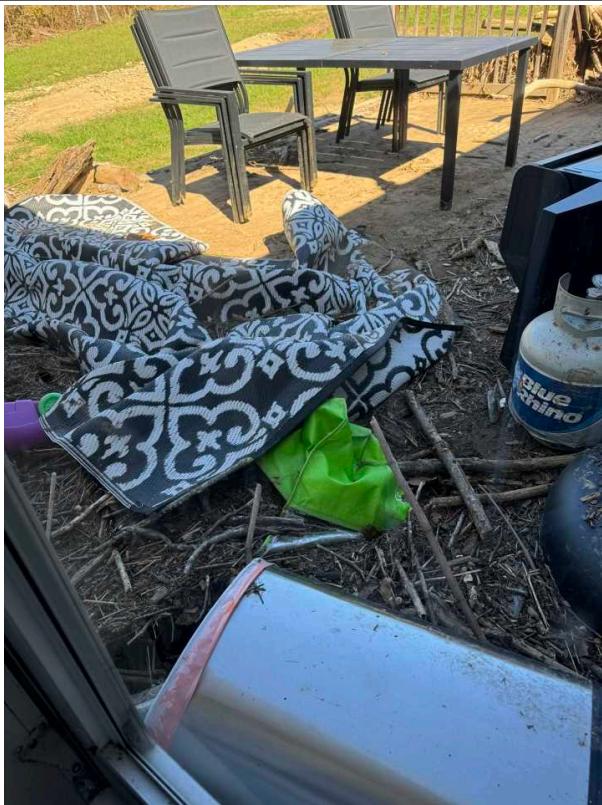
Exterior /Exterior - 25-Insured Risk

Date Taken: 10/24/2024
Taken By: Dina Bullard
Rear deck damage

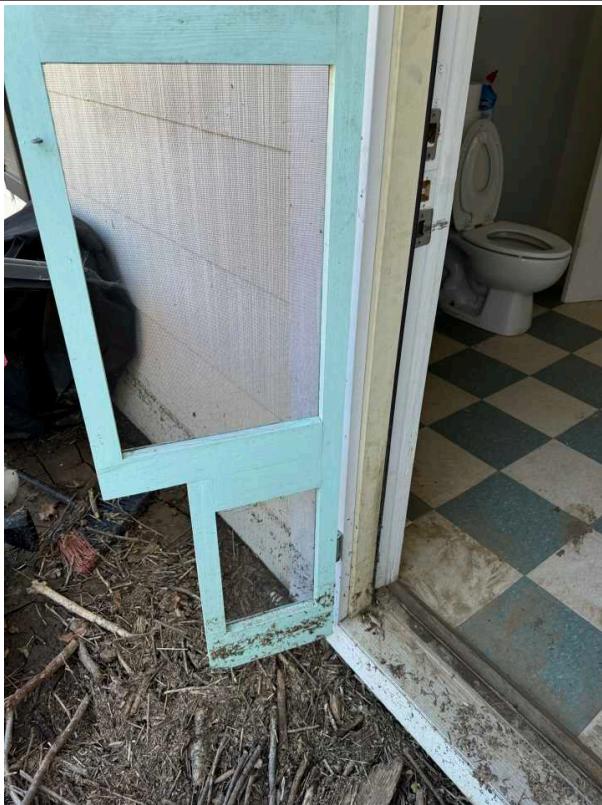
Exterior /Exterior - 27-Insured Risk

Date Taken: 10/24/2024
Taken By: Dina Bullard
Rear deck damage

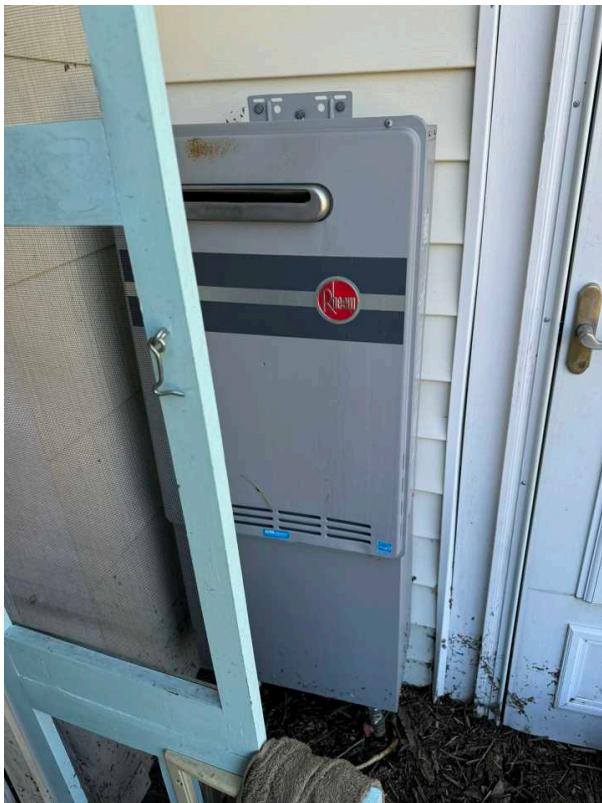
Exterior /Exterior - 28-Insured Risk

Date Taken: 10/24/2024
Taken By: Dina Bullard
Water heater damage by flood water

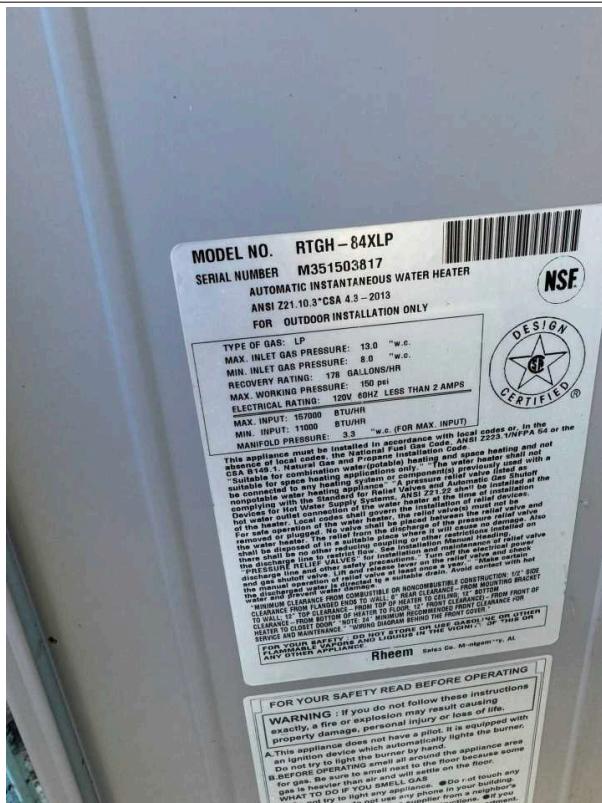
Exterior /Exterior - 29-Insured Risk

Water heater damage by flood water
mn#RTGH-84XLP sr#M351503817

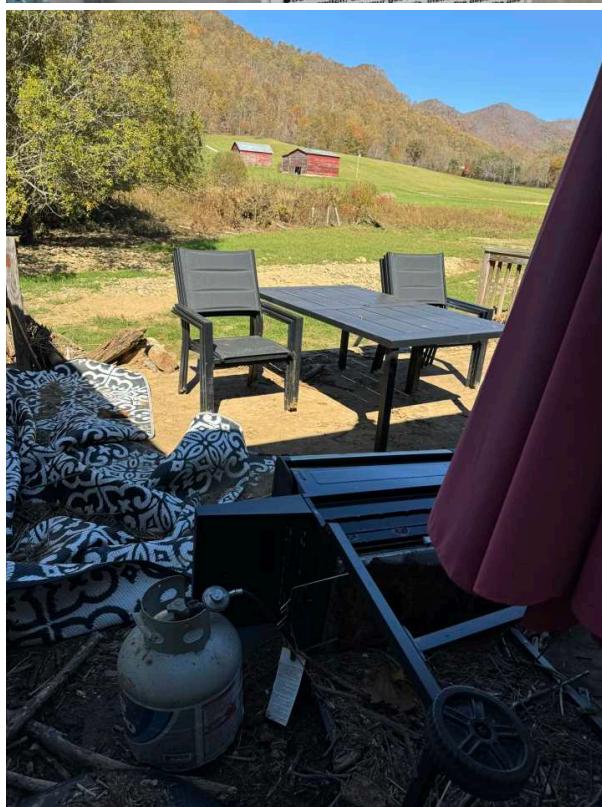
Exterior /Exterior - 30-Insured Risk

Rear deck damage

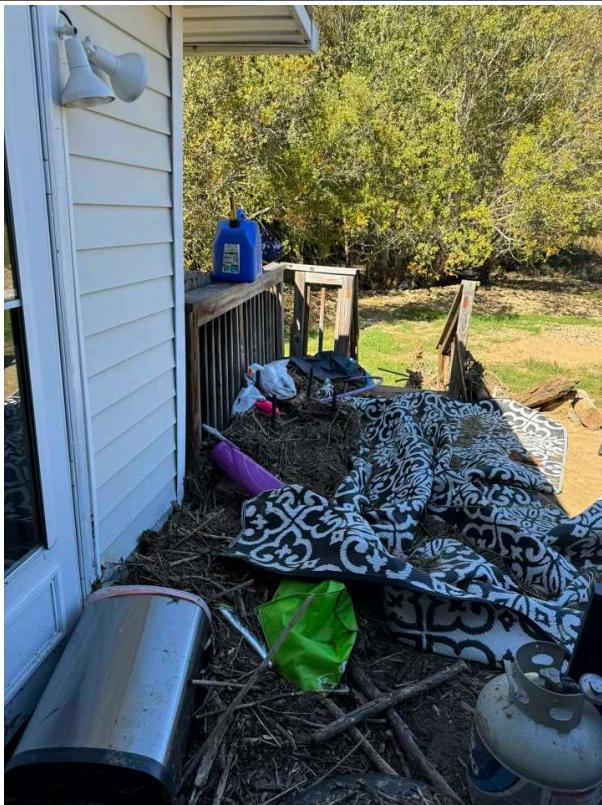
Exterior /Exterior - 31-Insured Risk

Date Taken: 10/24/2024
Taken By: Dina Bullard
Rear deck damage

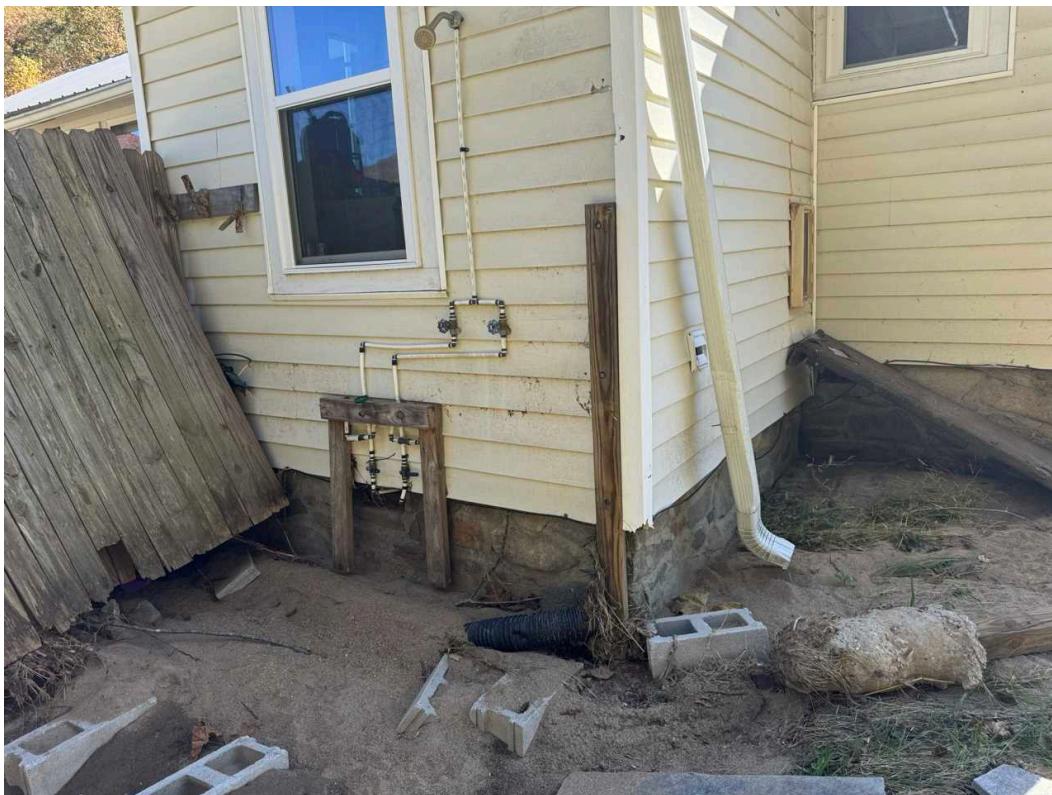
Exterior /Exterior - 32-Insured Risk

Date Taken: 10/24/2024
Taken By: Dina Bullard
Rear elevation - siding damage

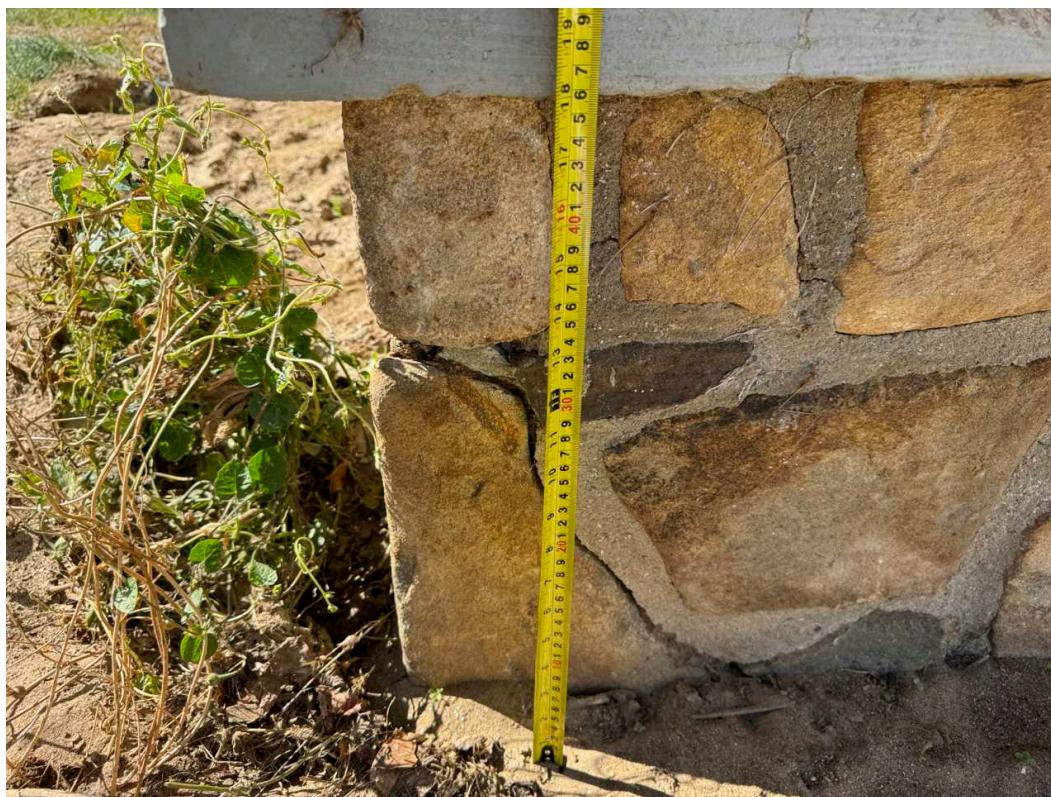
Exterior /Exterior - 34-Insured Risk

Date Taken: 10/24/2024
Taken By: Dina Bullard
Crack in foundation

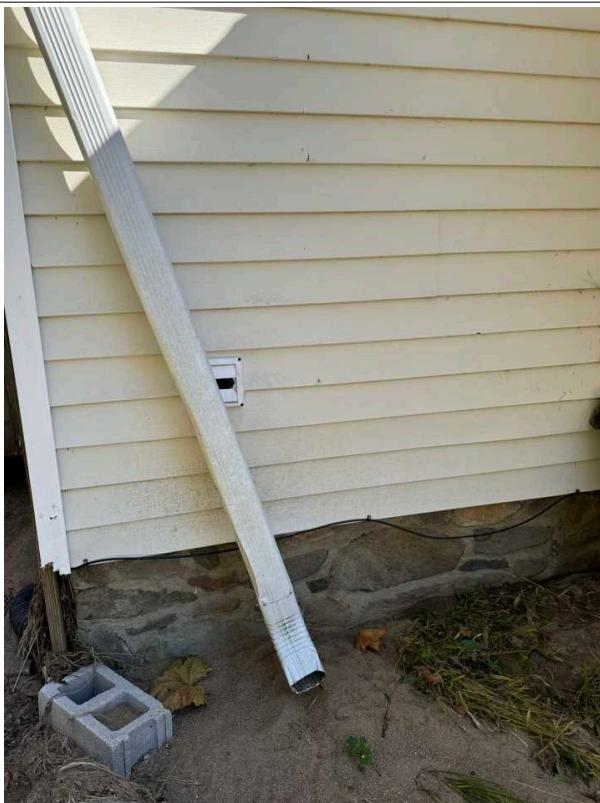
Exterior /Exterior - 35-Insured Risk

Left elevation - siding, gutter, and vent damage

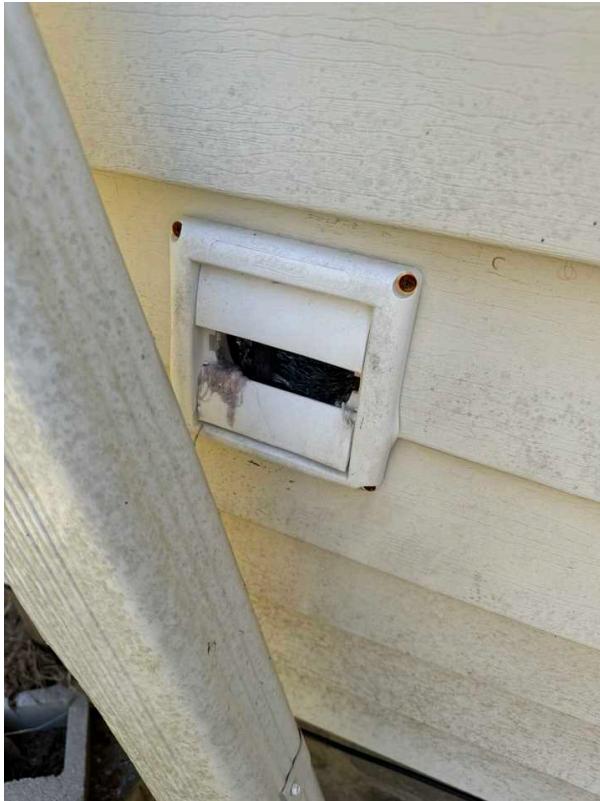
Exterior /Exterior - 36-Insured Risk

Left elevation - siding, gutter, and vent damage

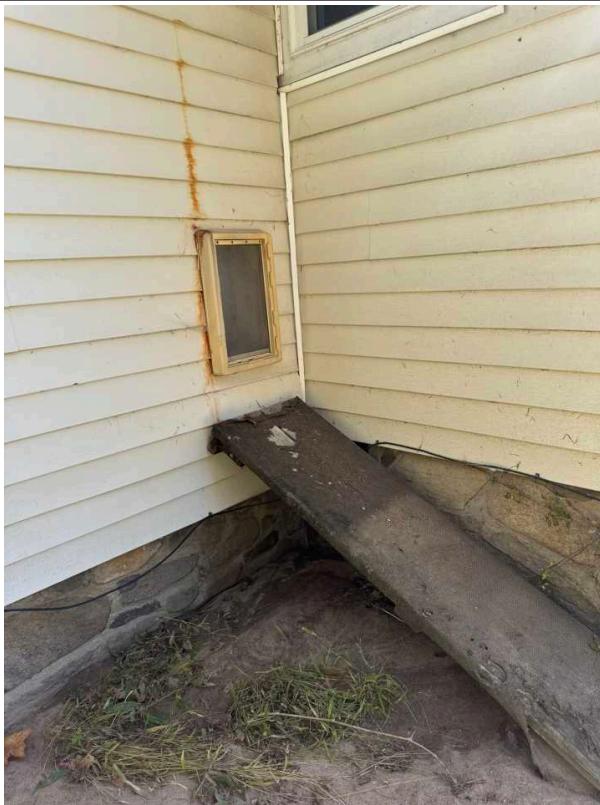
Exterior /Exterior - 37-Insured Risk

Left elevation - siding, dog door

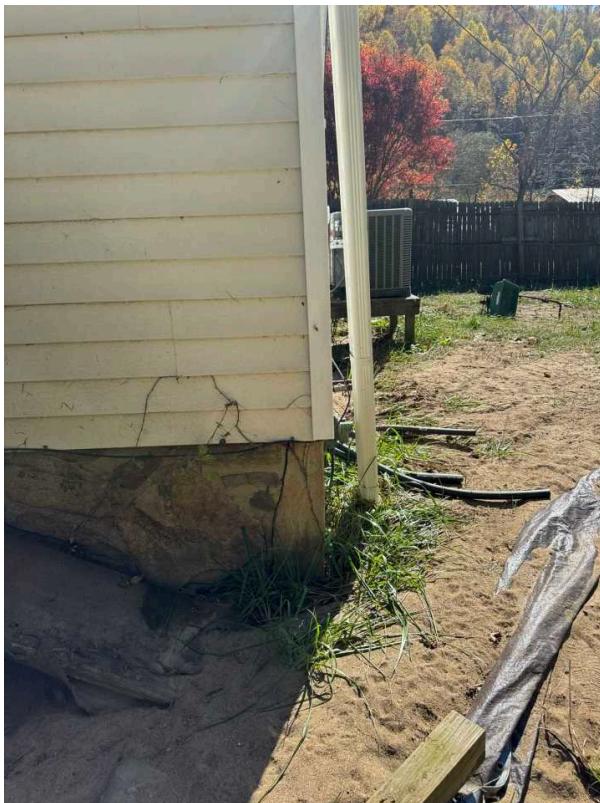
Exterior /Exterior - 38-Insured Risk

Left elevation - siding damage

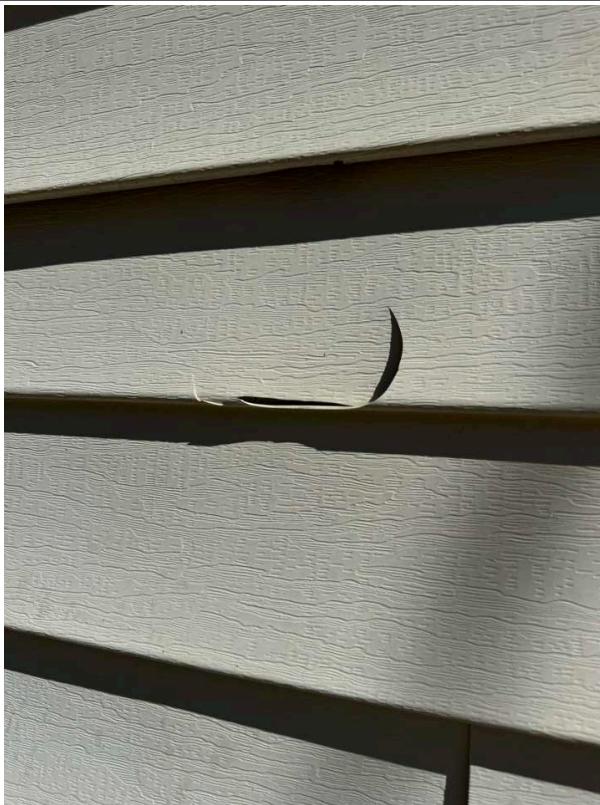
Exterior /Exterior - 39-Insured Risk

Date Taken: 10/24/2024
Taken By: Dina Bullard
Left elevation - siding damage

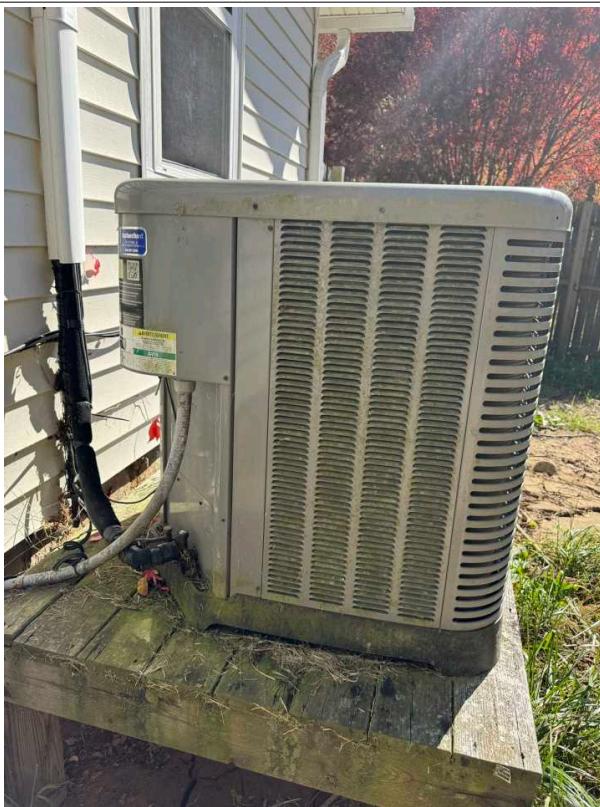
Exterior /Exterior - 41-Insured Risk

Date Taken: 10/24/2024
Taken By: Dina Bullard
HVAC damage by flood water

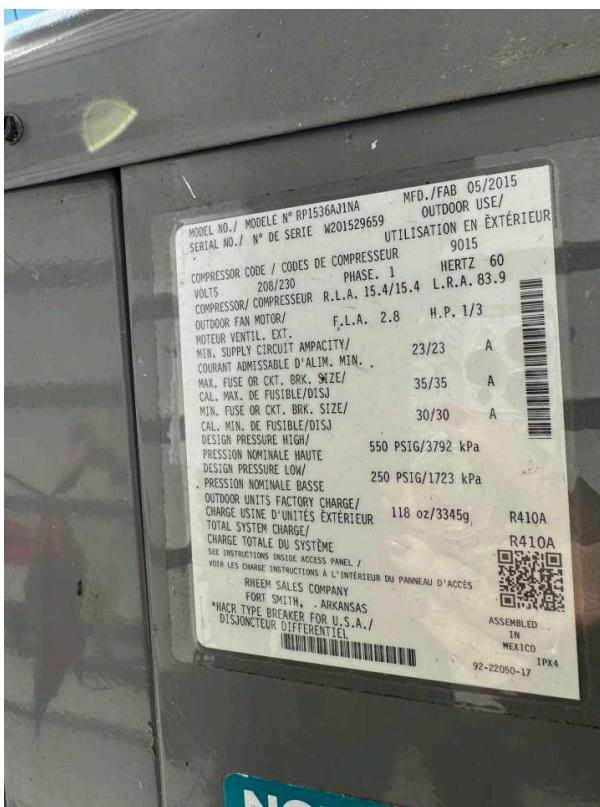
Exterior /Exterior - 42-Insured Risk

Date Taken: 10/24/2024
Taken By: Dina Bullard
HVAC damage by flood water
mn#RP1536AJINA sr#W201529659

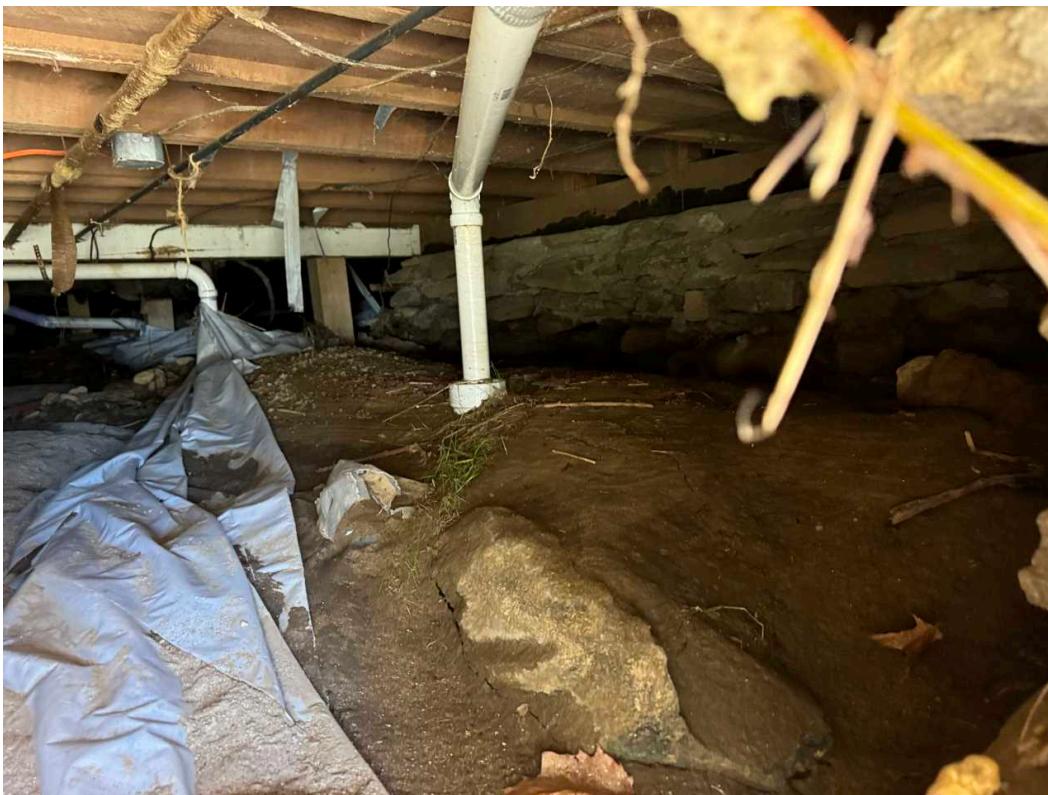
**Exterior /Crawlspace - 44-
Insured Risk**

Crawlspace damage by flood waters

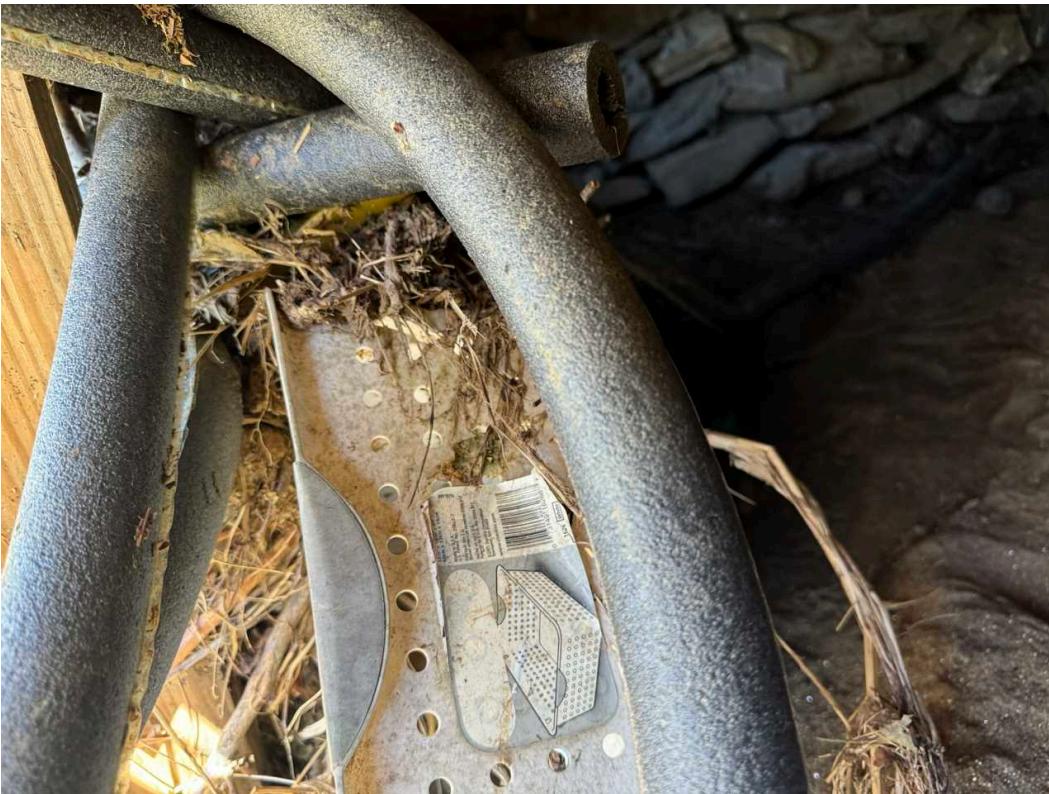
**Exterior /Crawlspace - 45-
Insured Risk**

Date Taken: 10/24/2024
Taken By: Dina Bullard
Crawlspace damage by flood waters

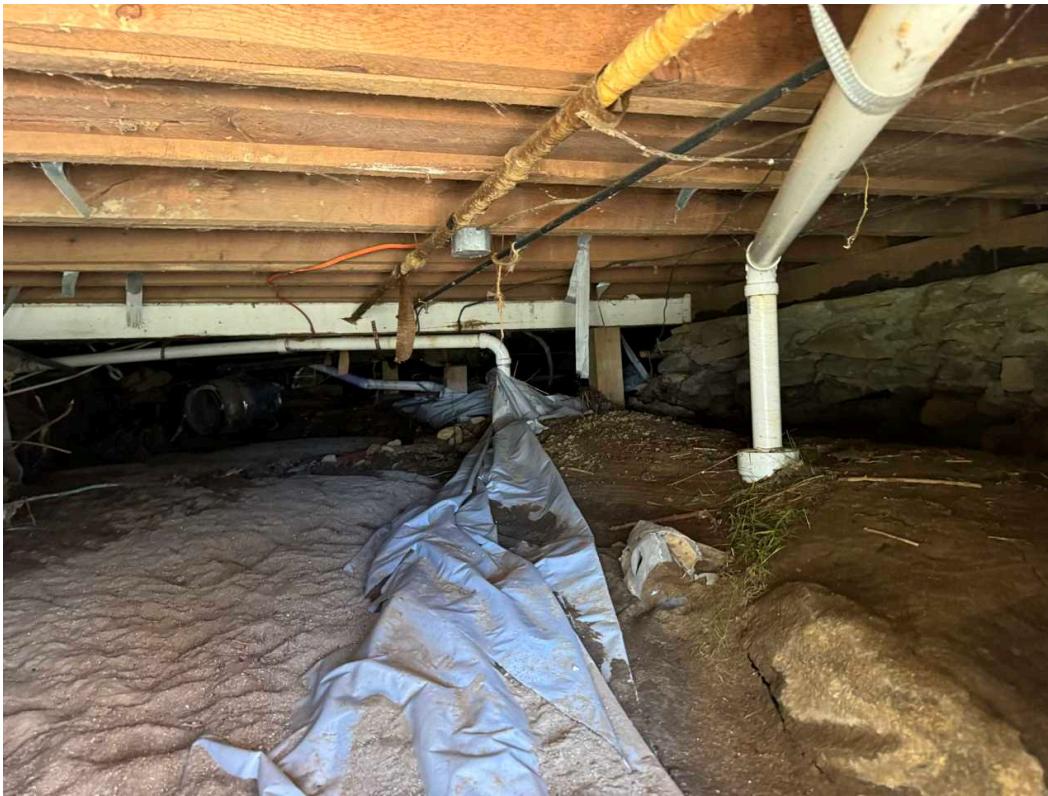
**Exterior /Crawlspace - 47-
Insured Risk**

Crawlspace damage by flood waters

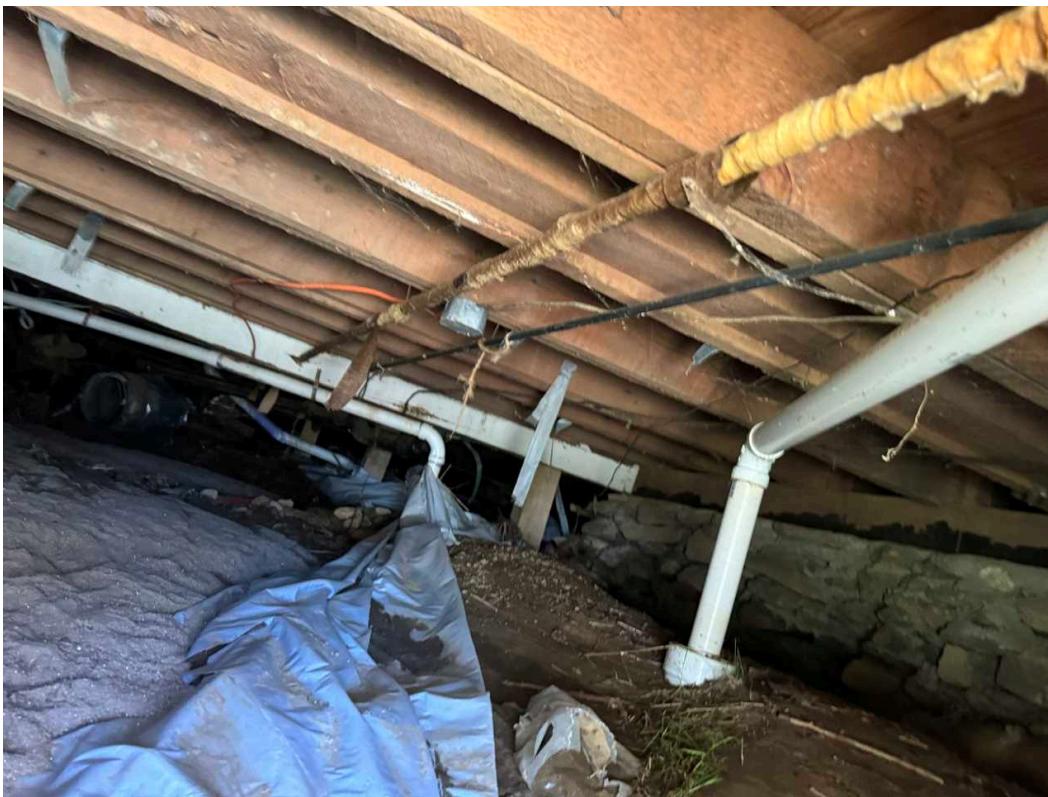
**Exterior /Crawlspace - 48-
Insured Risk**

Crawlspace damage by flood waters

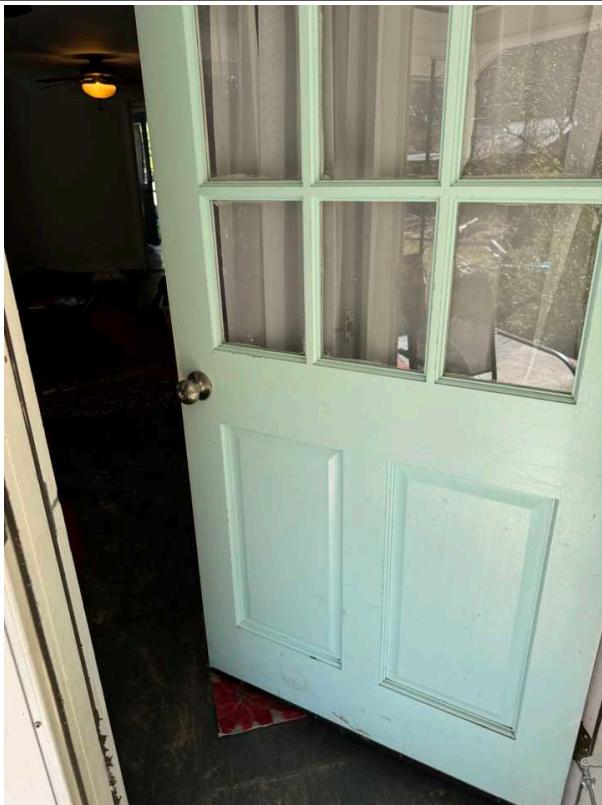
**Main Level/Living Room - 49-
Insured Risk**

Date Taken: 10/24/2024
Taken By: Dina Bullard
Floor, wall, baseboard and door damage

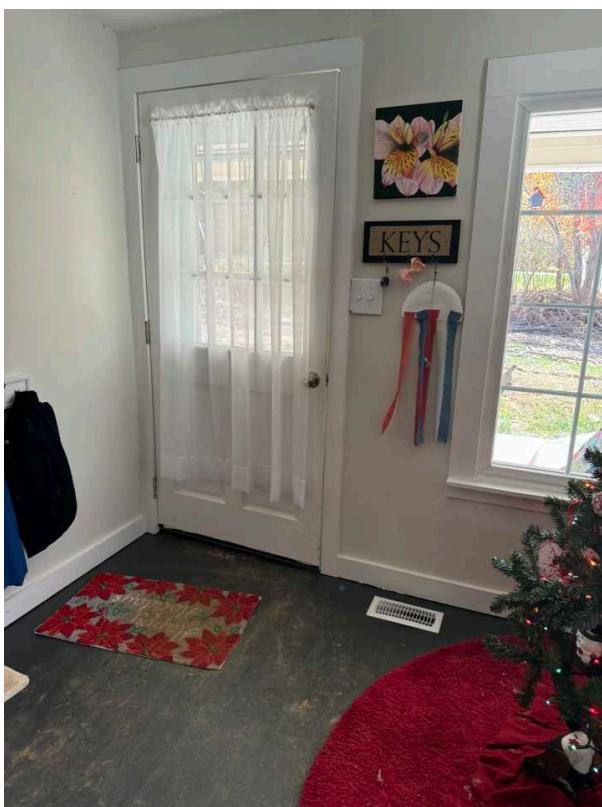
**Main Level/Living Room - 50-
Insured Risk**

Date Taken: 10/24/2024
Taken By: Dina Bullard
Floor, wall, baseboard and door damage

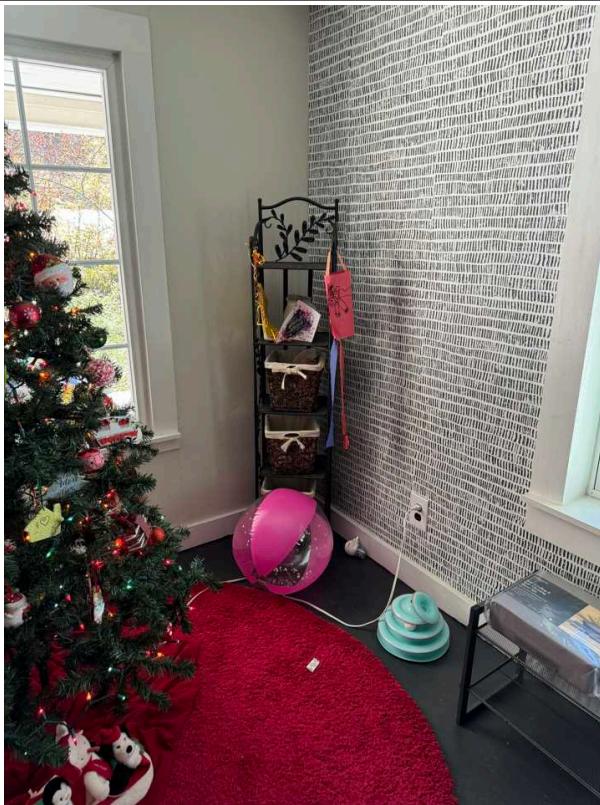
**Main Level/Living Room - 51-
Insured Risk**

Date Taken: 10/24/2024
Taken By: Dina Bullard
Floor, wall, baseboard and door damage

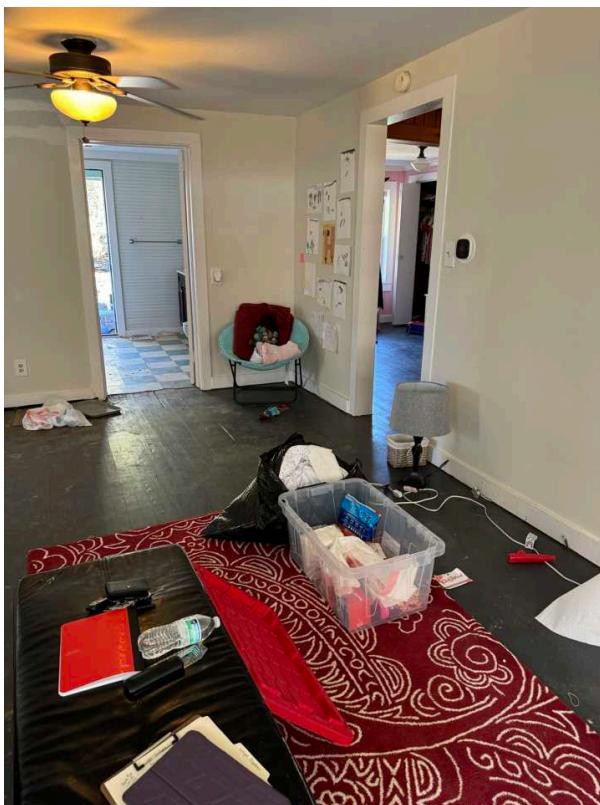
**Main Level/Living Room - 52-
Insured Risk**

Date Taken: 10/24/2024
Taken By: Dina Bullard
Floor, wall, baseboard and door damage
