NARRATIVE REPORT

DWELLING / UNIT OWNER

Carrier:	Assurant Flood Insurance Program	Date of Loss:	9/26/2024
Insured:	ELIZABETH WRIGHT/WRIGHT CAROLYN	Assigned:	10/15/2024
CID:	243519	Contacted:	10/15/2024
Claim Number:	7406040448-09262024	Inspected:	10/24/2024
Policy Number:	7406040448	Inspected With:	CAROLYN WRIGHT
Loss Address:	400 N FORK RD BARNARDSVILLE NC 28709	Mailing Address:	41 N COLLEGE ST WEAVERVILLE, NC 28787
Coverage A:	\$ 185,000.00	Mortgage:	LOANCARE LLC
Coverage B:	\$ 0.00	Verified with:	CAROLYN WRIGHT
Policy Term:	9/25/2024 to 9/25/2025

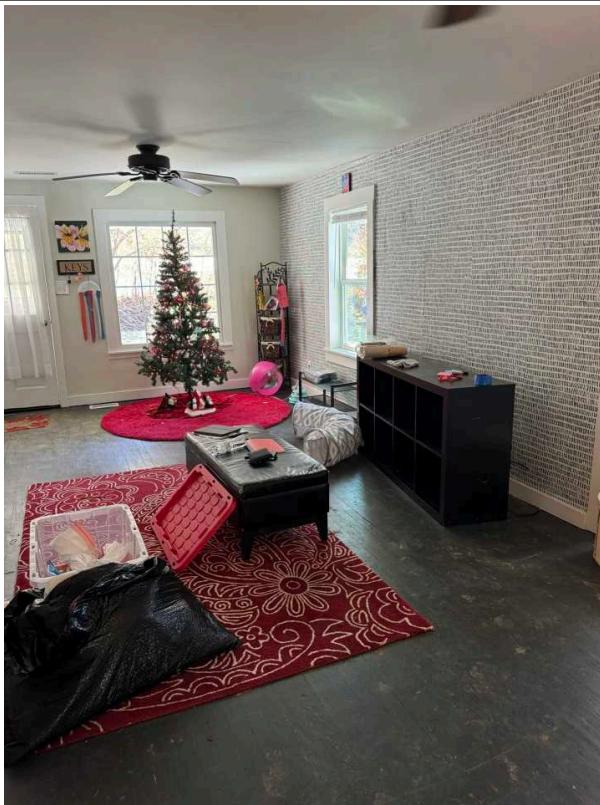
**Main Level/Living Room - 53-
Insured Risk**

Date Taken: 10/24/2024
Taken By: Dina Bullard
Floor, wall, baseboard and door damage

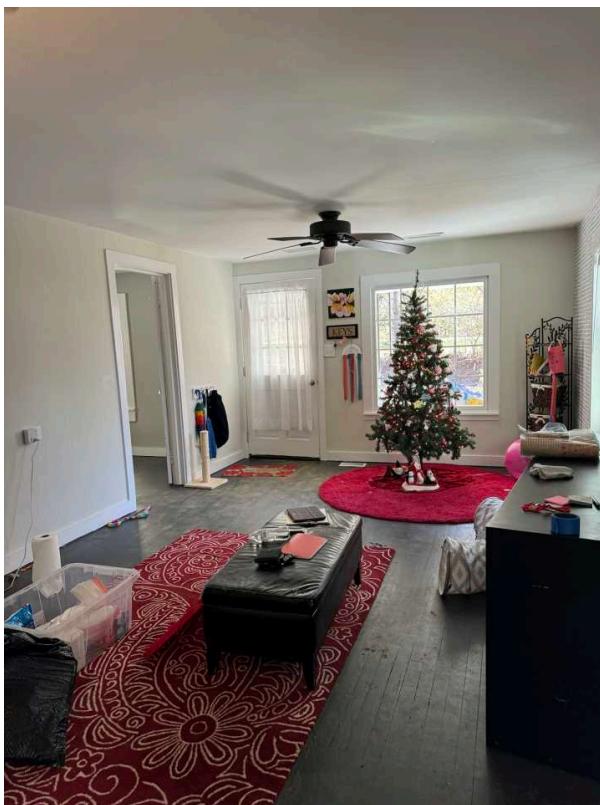
**Main Level/Living Room - 54-
Insured Risk**

Date Taken: 10/24/2024
Taken By: Dina Bullard
Floor, wall, baseboard and door damage

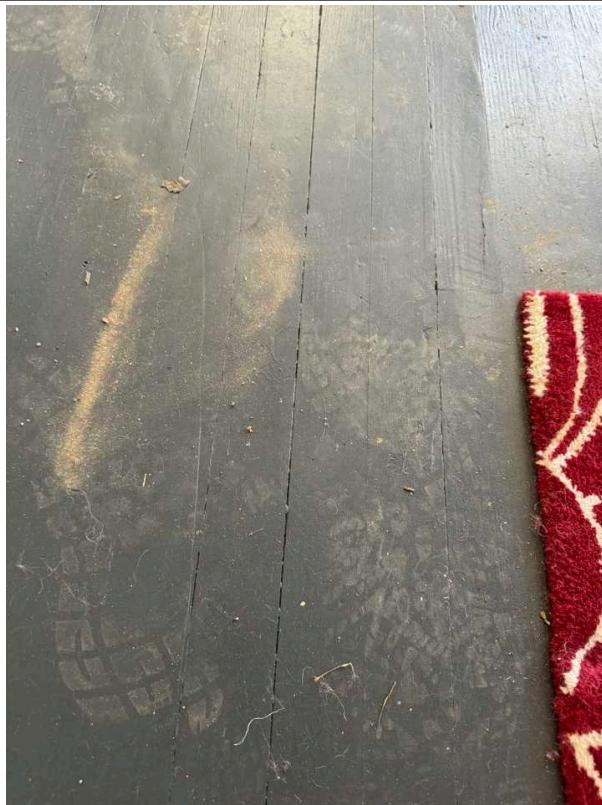
**Main Level/Living Room - 55-
Insured Risk**

Date Taken: 10/24/2024
Taken By: Dina Bullard
Floor damage

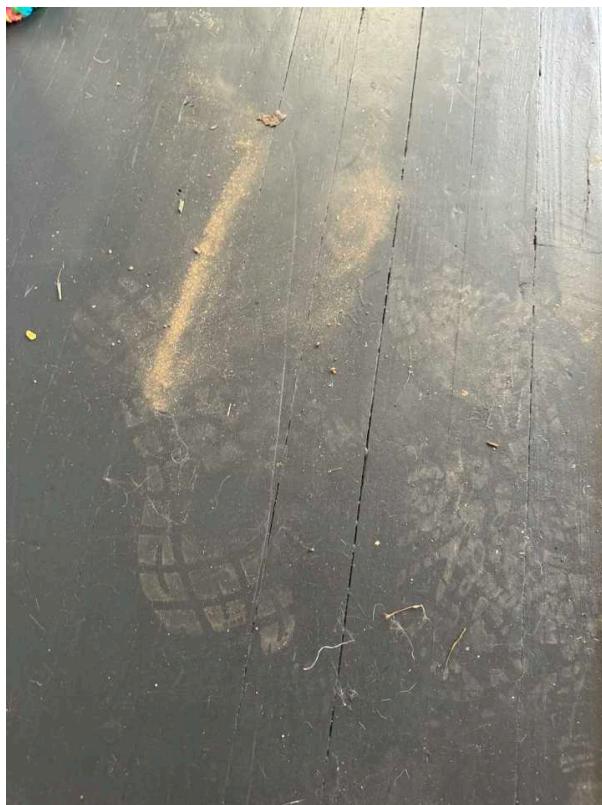
**Main Level/Living Room - 56-
Insured Risk**

Date Taken: 10/24/2024
Taken By: Dina Bullard
Floor damage

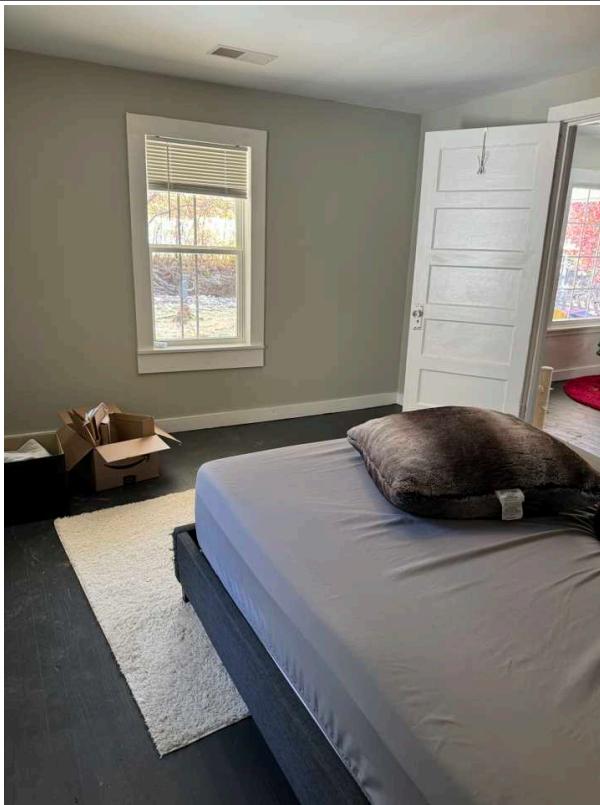
**Main Level/Bedroom1 - 61-
Insured Risk**

Overview of bedroom 1

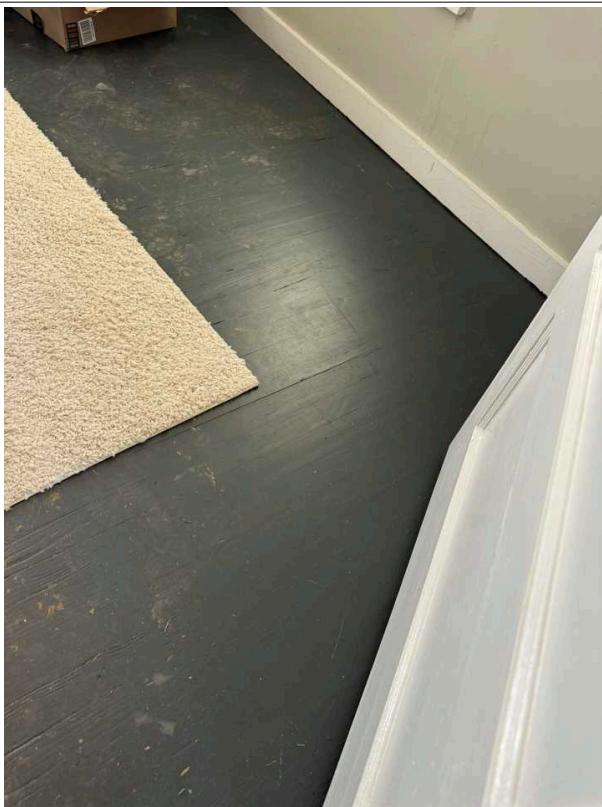
**Main Level/Bedroom1 - 63-
Insured Risk**

Floor, baseboard, wall and door damage

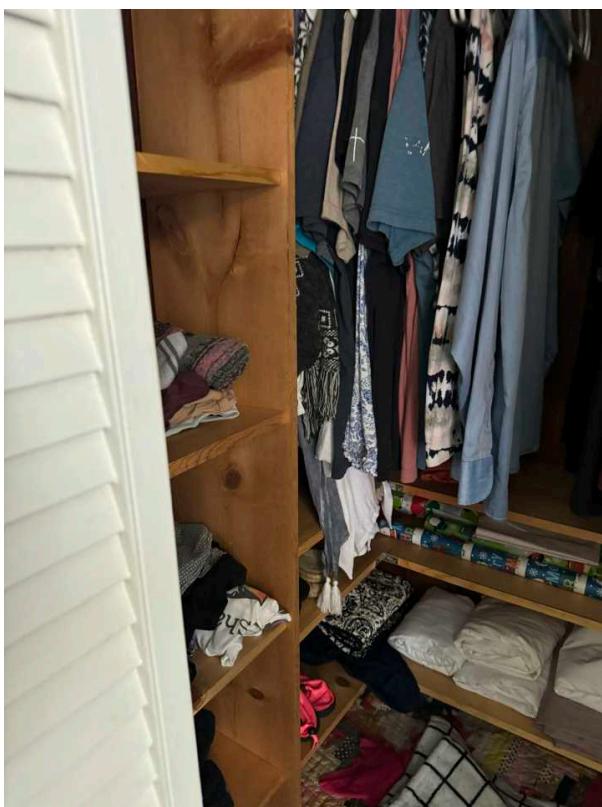
**Main Level/Closet1 - 64-Insured
Risk**

Floor, baseboard, wall and door damage

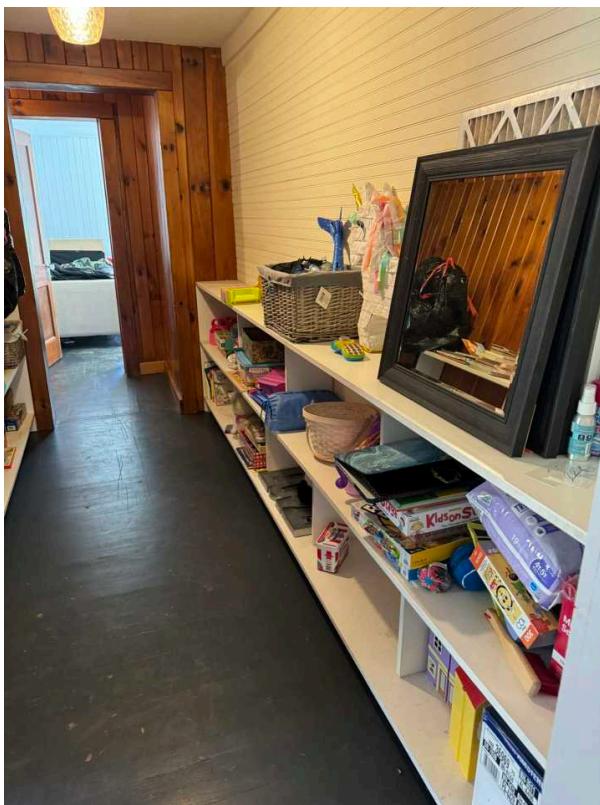
Main Level/Hallway - 66-Insured Risk

Floor, baseboard, wall and door damage

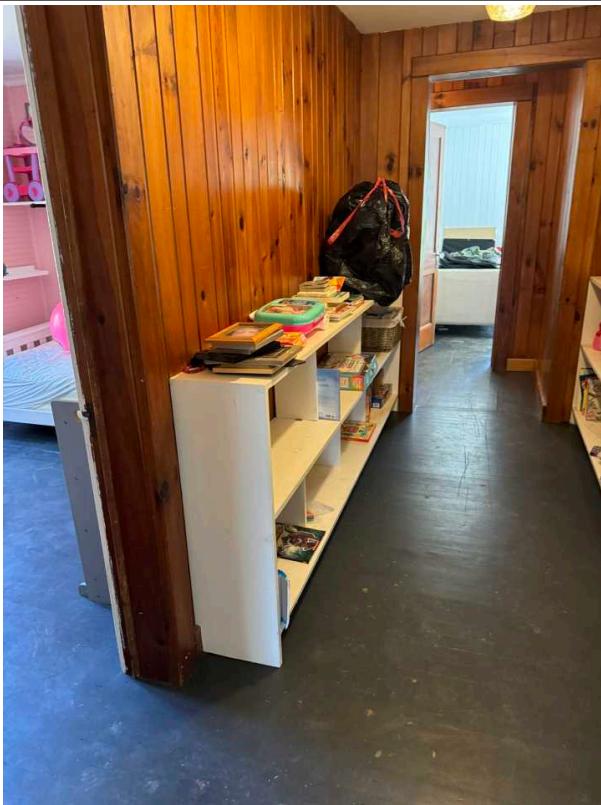
Main Level/Hallway - 67-Insured Risk

Floor, baseboard, wall and door damage

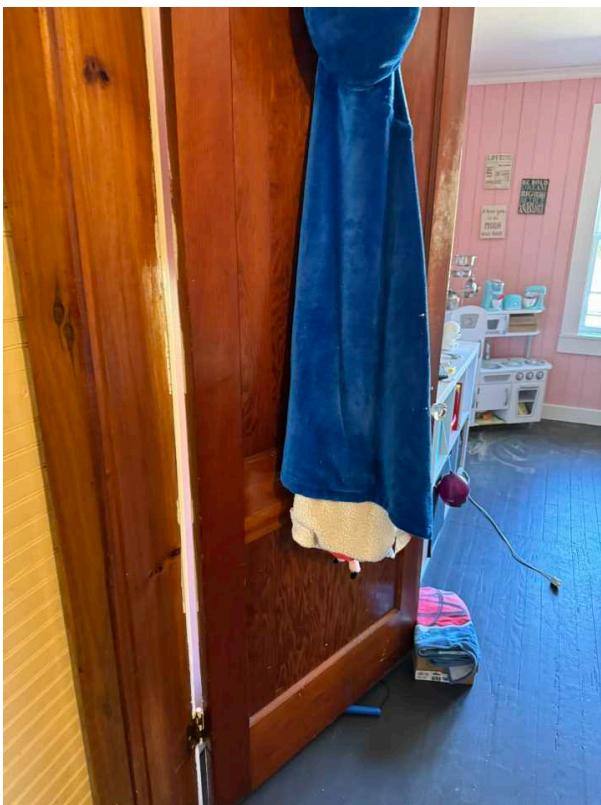
Main Level/Bedroom2 - 68-Insured Risk

Floor, baseboard, wall and door damage

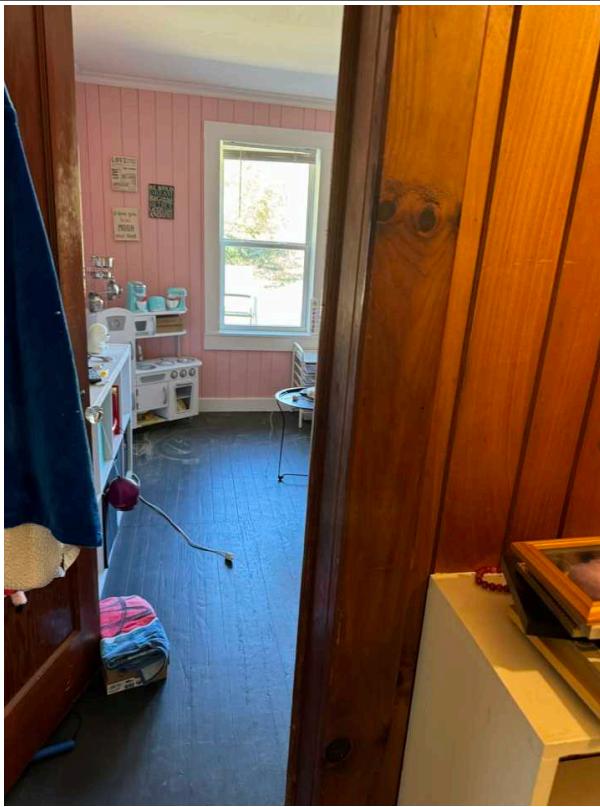
**Main Level/Bedroom2 - 69-
Insured Risk**

Date Taken: 10/24/2024
Taken By: Dina Bullard
Floor, baseboard, wall and door damage

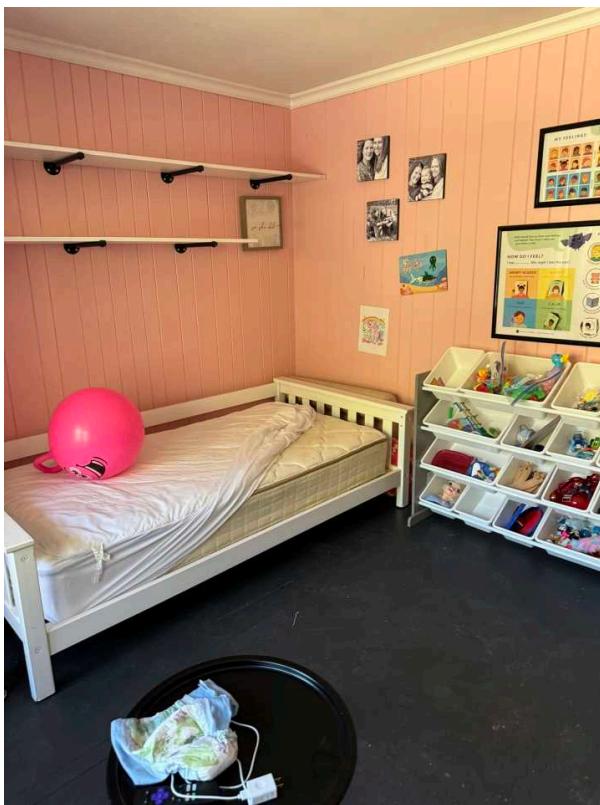
**Main Level/Bedroom2 - 72-
Insured Risk**

Date Taken: 10/24/2024
Taken By: Dina Bullard
Floor, baseboard, wall and door damage

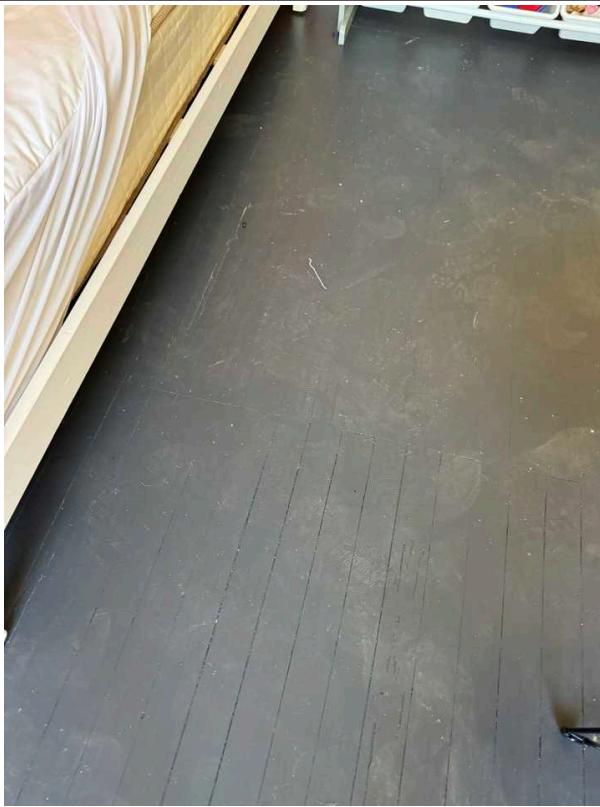
**Main Level/Bedroom2 - 73-
Insured Risk**

Floor, baseboard, wall and door damage

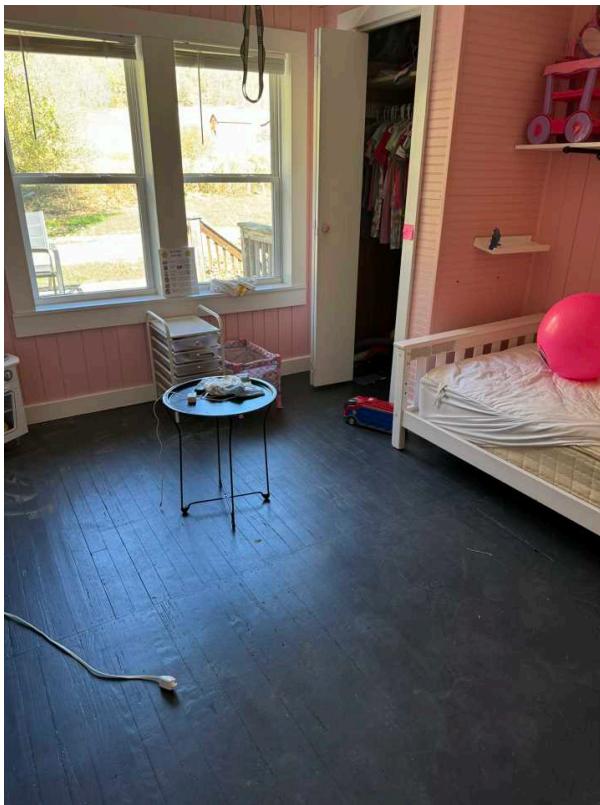
**Main Level/Bedroom2 - 74-
Insured Risk**

Floor, baseboard, wall and door damage

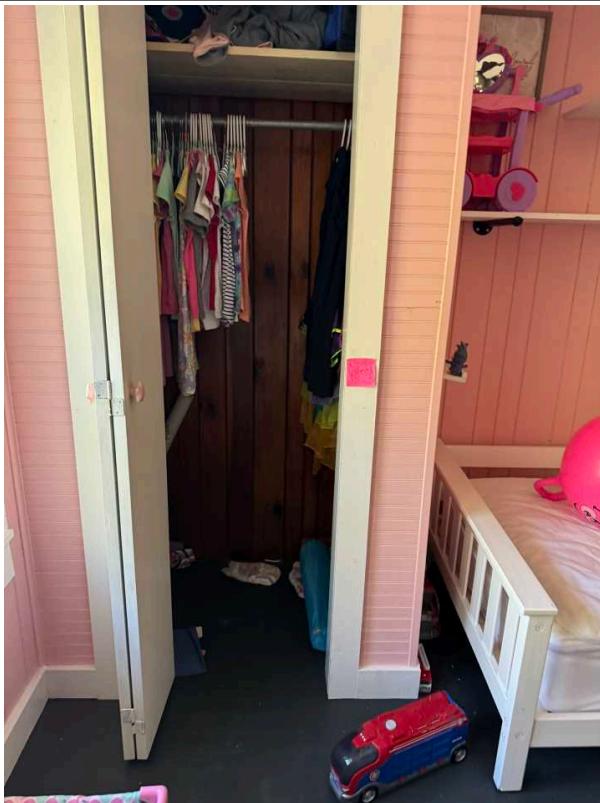
Main Level/Closet2 - 75-Insured Risk

Floor, baseboard, wall and door damage

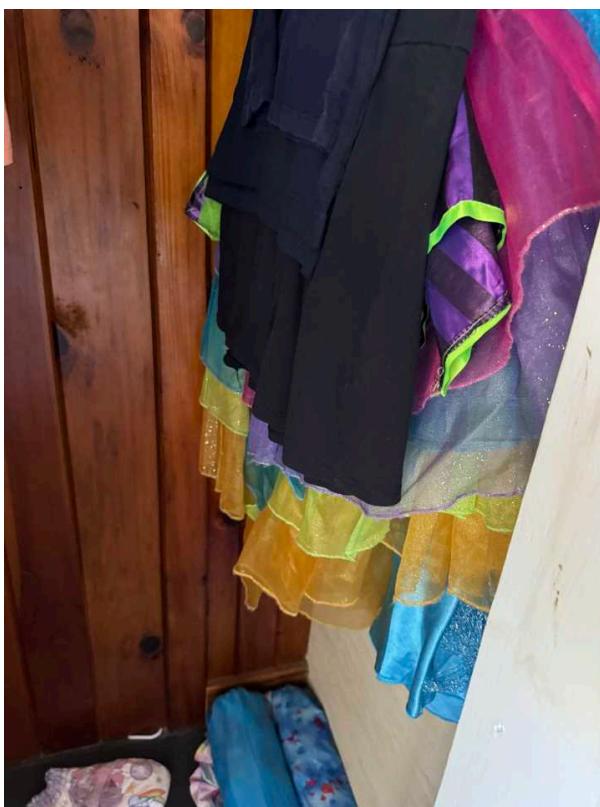
Main Level/Closet2 - 76-Insured Risk

Floor, baseboard, wall and door damage

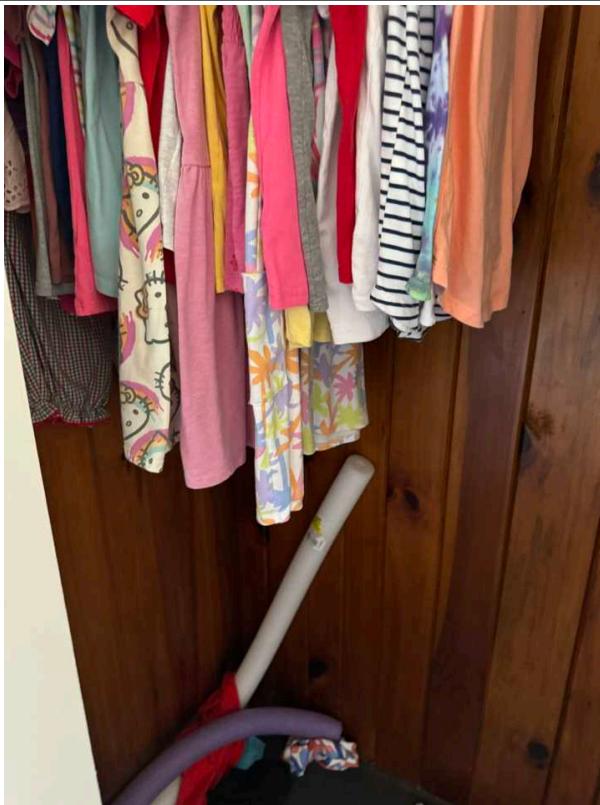
Main Level/Closet2 - 77-Insured Risk

Floor, baseboard, wall and door damage

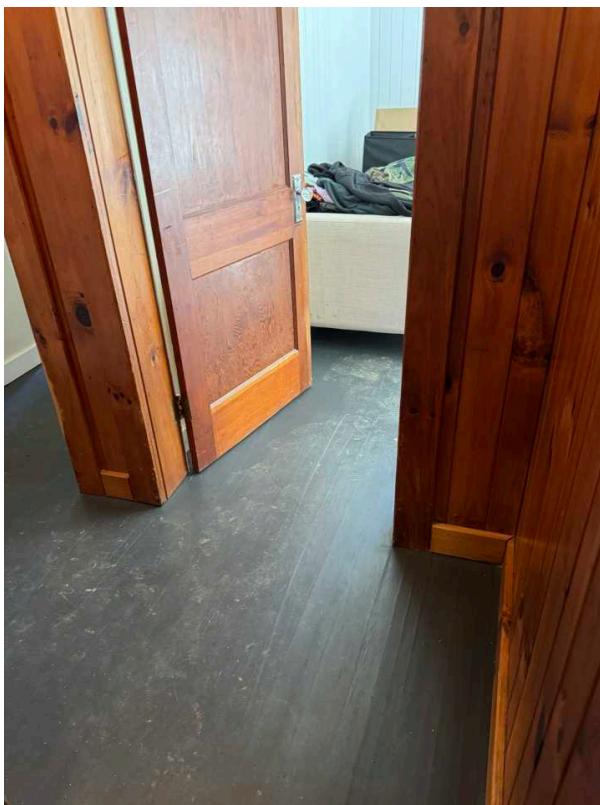
Main Level/Hallway2 - 78-Insured Risk

Floor, baseboard, wall and door damage

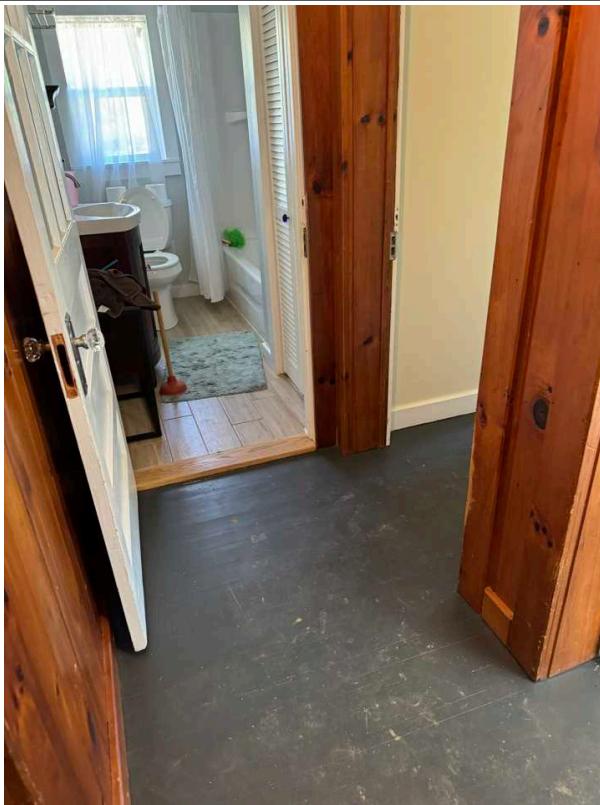
**Main Level/Hallway2 - 79-
Insured Risk**

Floor, baseboard, wall and door damage

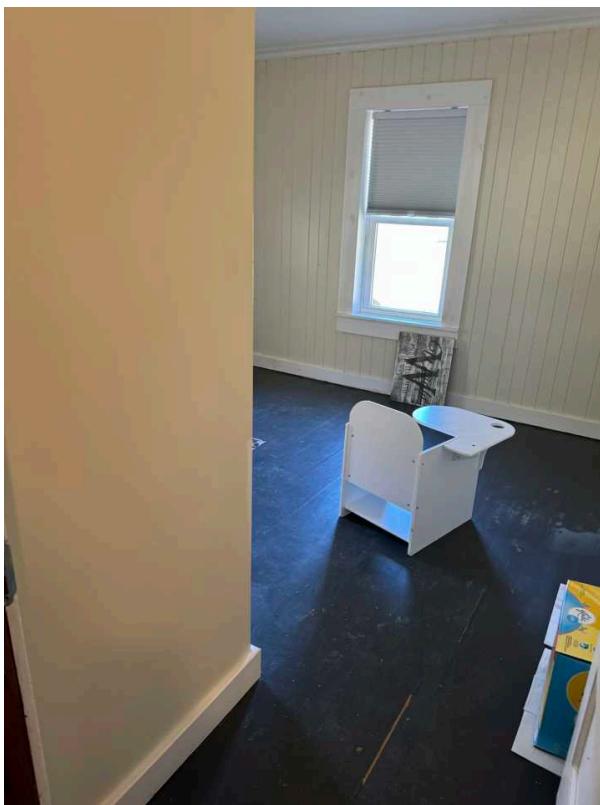
**Main Level/Bedroom3 - 80-
Insured Risk**

Floor, baseboard, wall and door damage

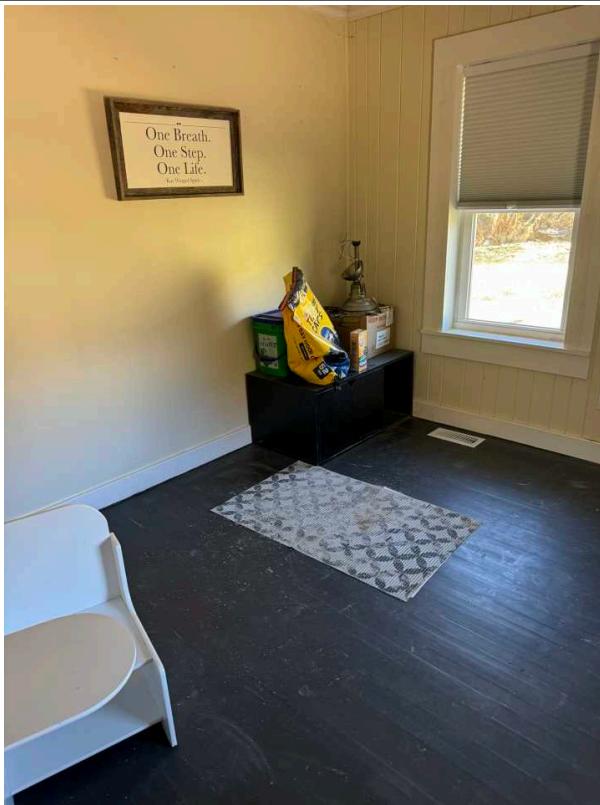
**Main Level/Bedroom3 - 81-
Insured Risk**

Floor, baseboard, wall and door damage

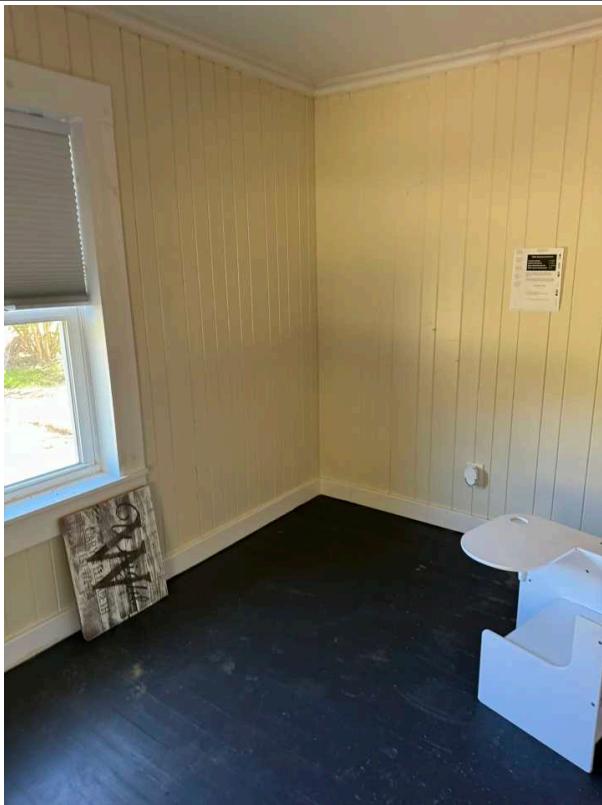
**Main Level/Bedroom3 - 83-
Insured Risk**

Floor, baseboard, wall and door damage

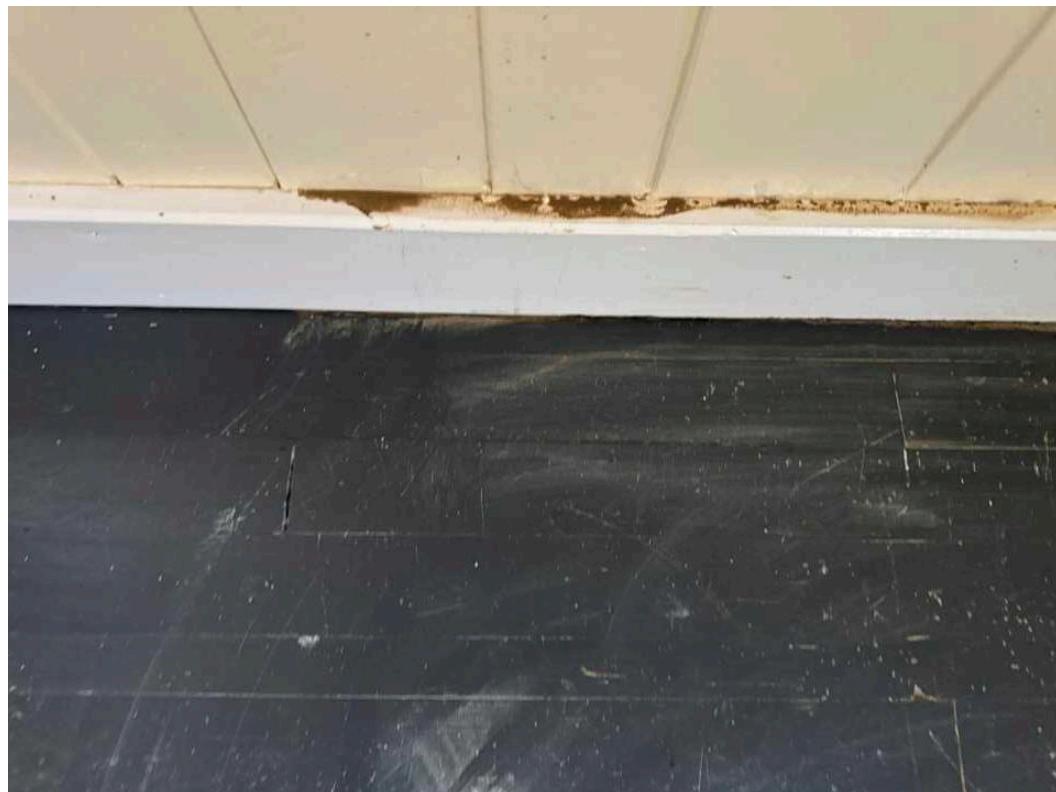
**Main Level/Bedroom3 - 84-
Insured Risk**

Floor, baseboard, wall and door damage

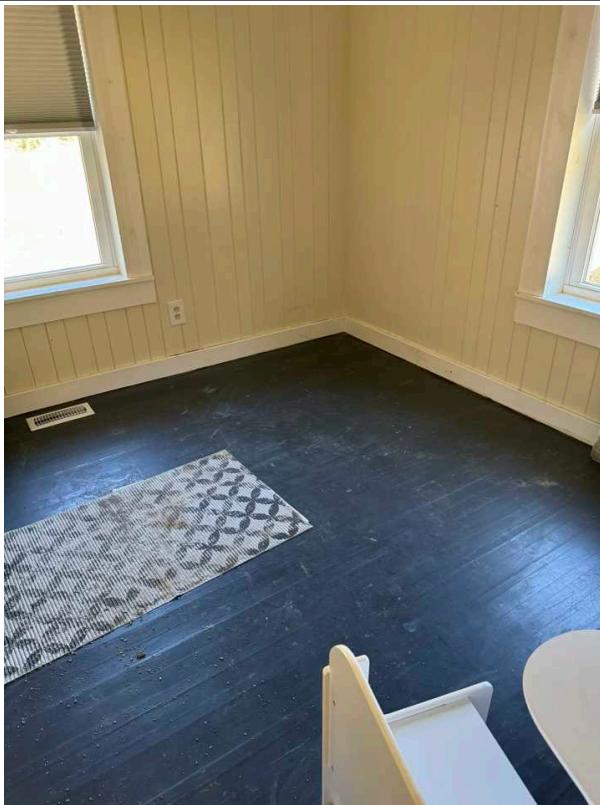
**Main Level/Bedroom3 - 85-
Insured Risk**

Date Taken: 10/24/2024
Taken By: Dina Bullard
Floor, baseboard, wall and door damage

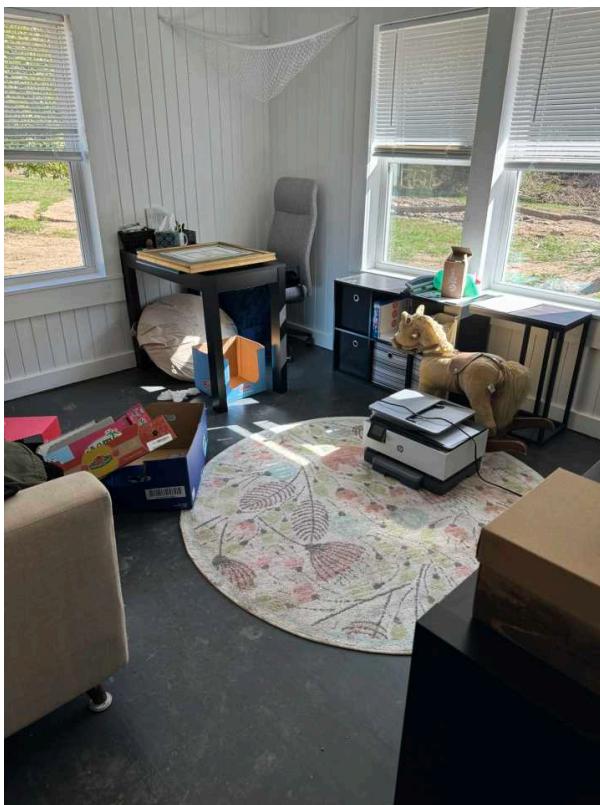
**Main Level/Bedroom4 - 86-
Insured Risk**

Date Taken: 10/24/2024
Taken By: Dina Bullard
Floor, baseboard, wall and door damage

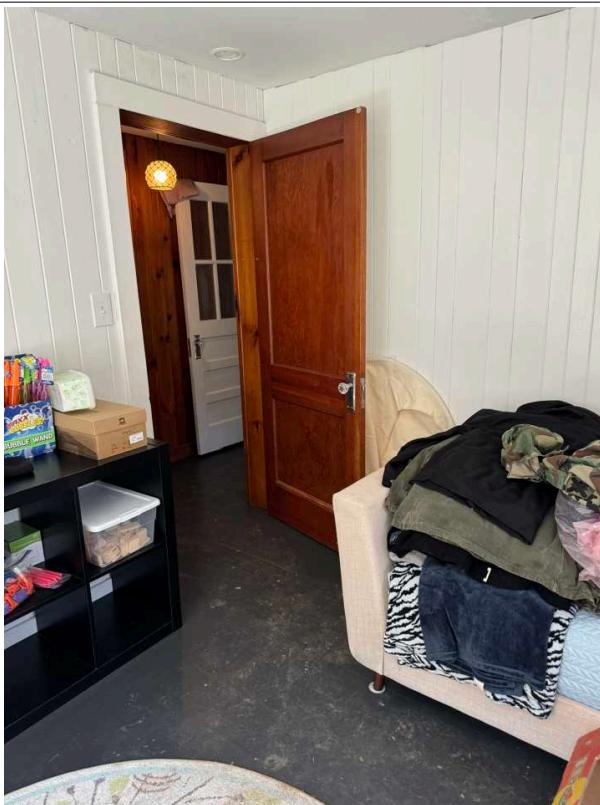
**Main Level/Bedroom4 - 89-
Insured Risk**

Floor, baseboard, wall and door damage

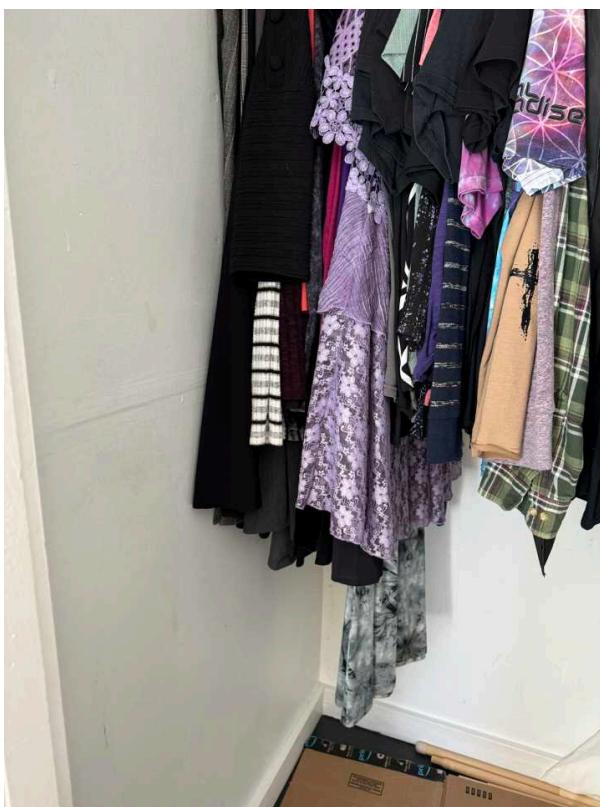
**Main Level/Closet4 - 90-Insured
Risk**

Floor, baseboard, wall damage

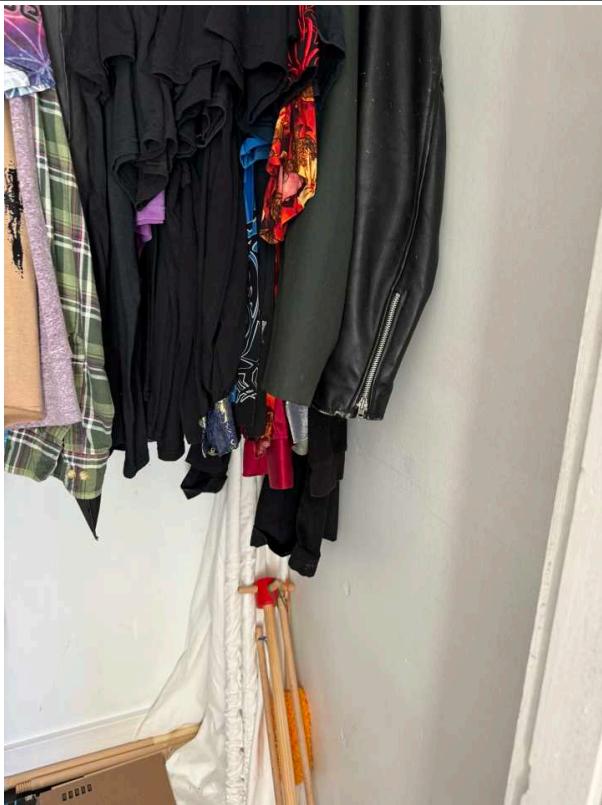
Main Level/Closet4 - 91-Insured Risk

Floor, baseboard, wall damage

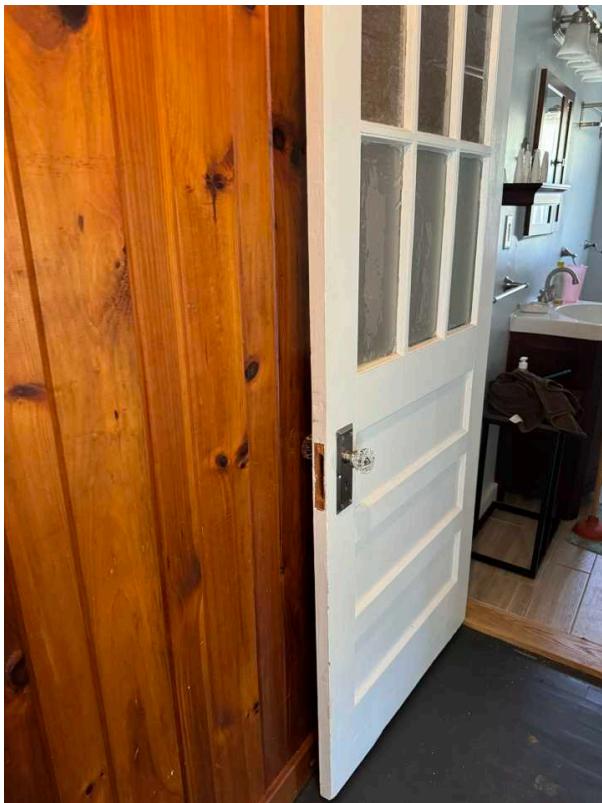
Main Level/Bathroom2 - 92-Insured Risk

Floor, baseboard, wall and door damage

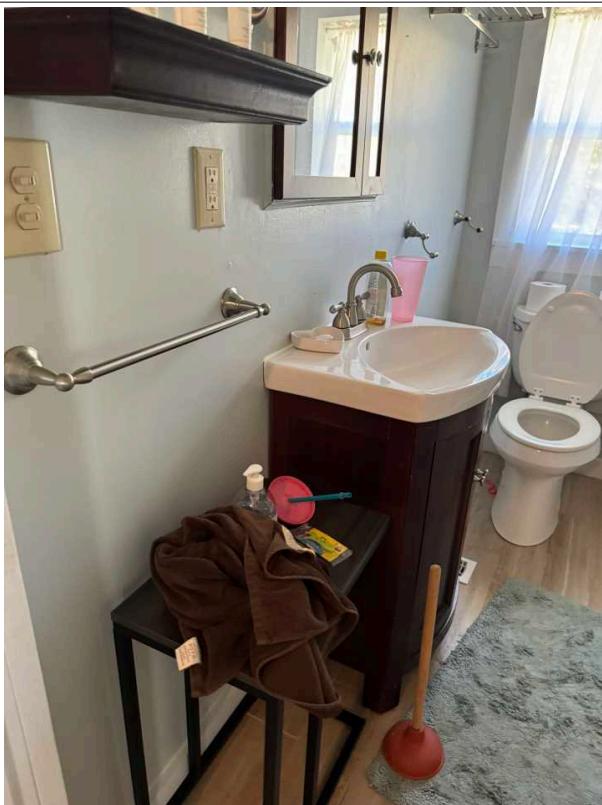
**Main Level/Bathroom2 - 93-
Insured Risk**

Floor, baseboard, wall and door damage

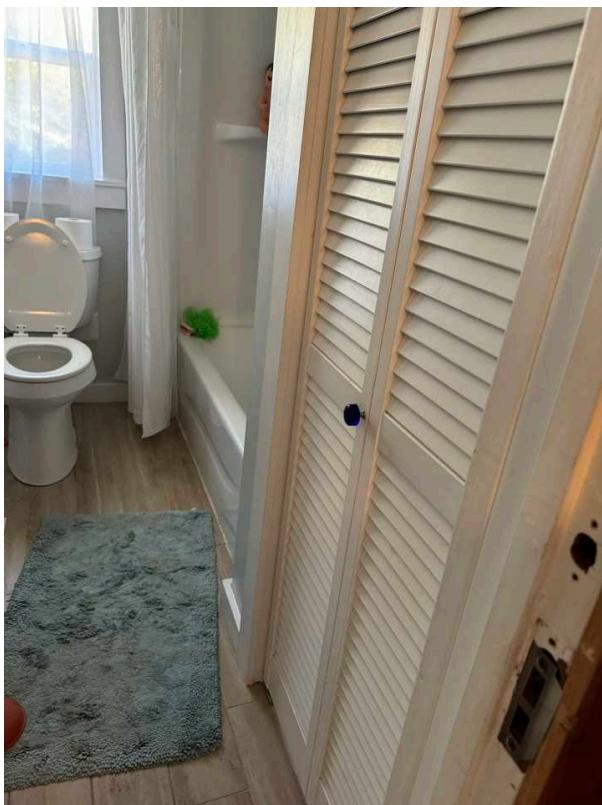
**Main Level/Bathroom2 - 94-
Insured Risk**

Floor, baseboard, wall and door damage

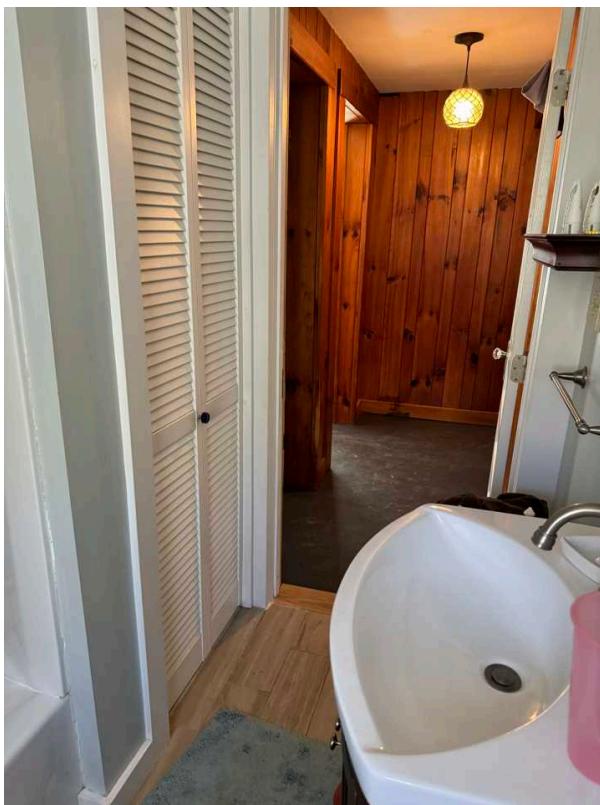
**Main Level/Bathroom2 - 96-
Insured Risk**

Floor, baseboard, wall and door damage

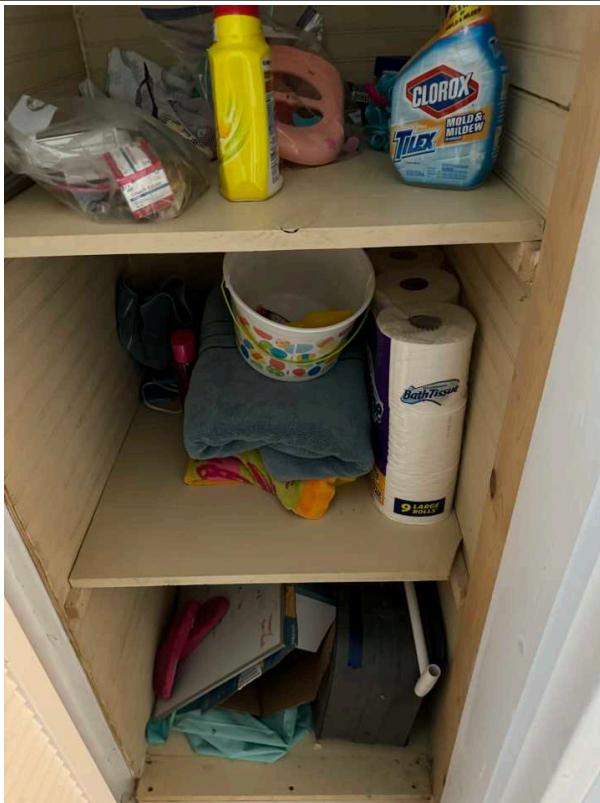
**Main Level/Linen Closet2 - 99-
Insured Risk**

Linen closet - wall, door damage

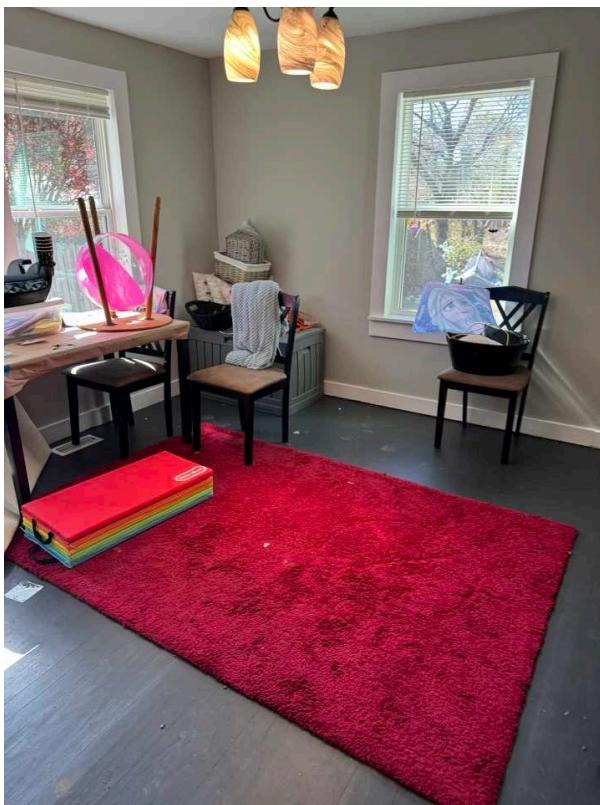
**Main Level/Dining Room - 100-
Insured Risk**

Floor, baseboard, wall and door damage

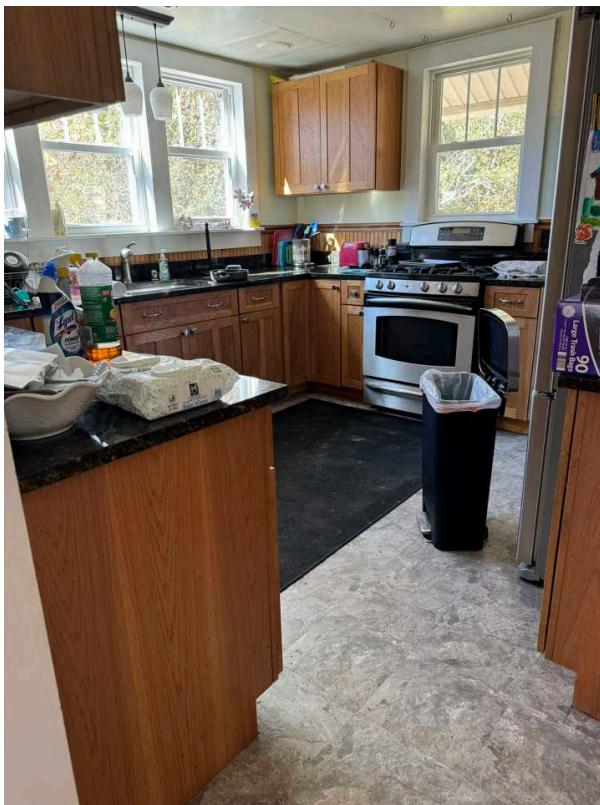
**Main Level/Kitchen - 106-
Insured Risk**

Floor, baseboard, wall, cabinets,
appliances and door damage

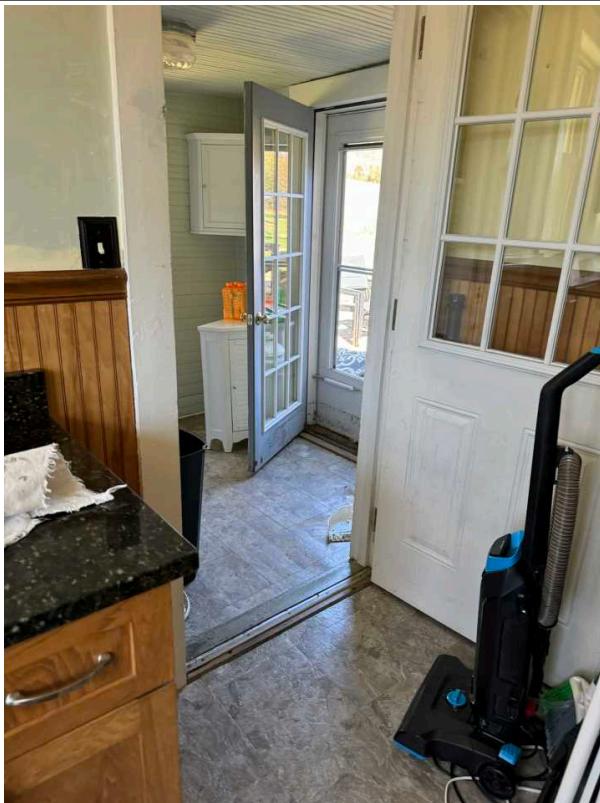
**Main Level/Kitchen - 107-
Insured Risk**

Floor, baseboard, wall, cabinets,
appliances and door damage

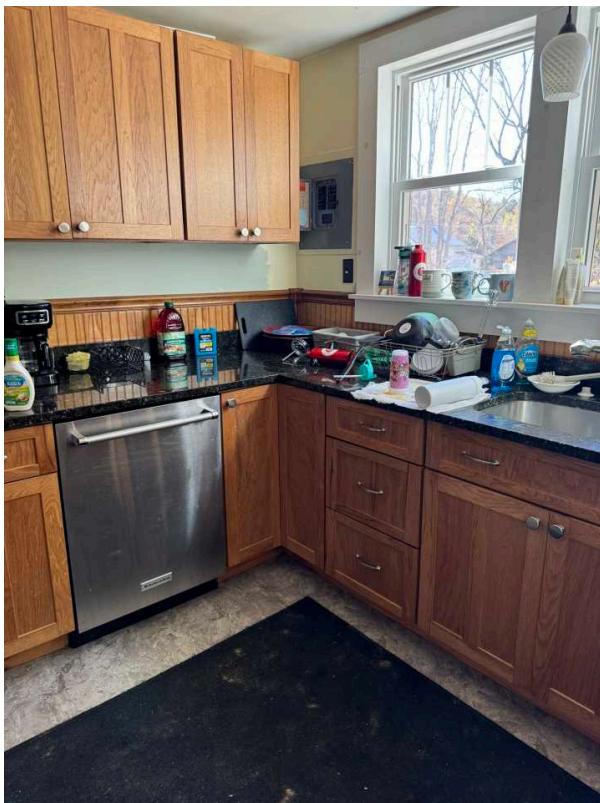
**Main Level/Kitchen - 108-
Insured Risk**

Floor, baseboard, wall, cabinets,
appliances and door damage

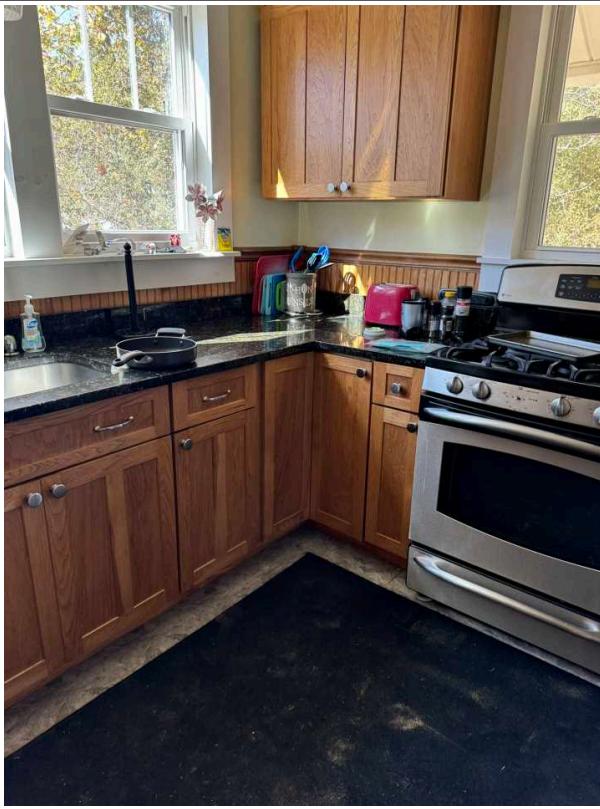
**Main Level/Kitchen - 109-
Insured Risk**

Floor, baseboard, wall, cabinets,
appliances and door damage

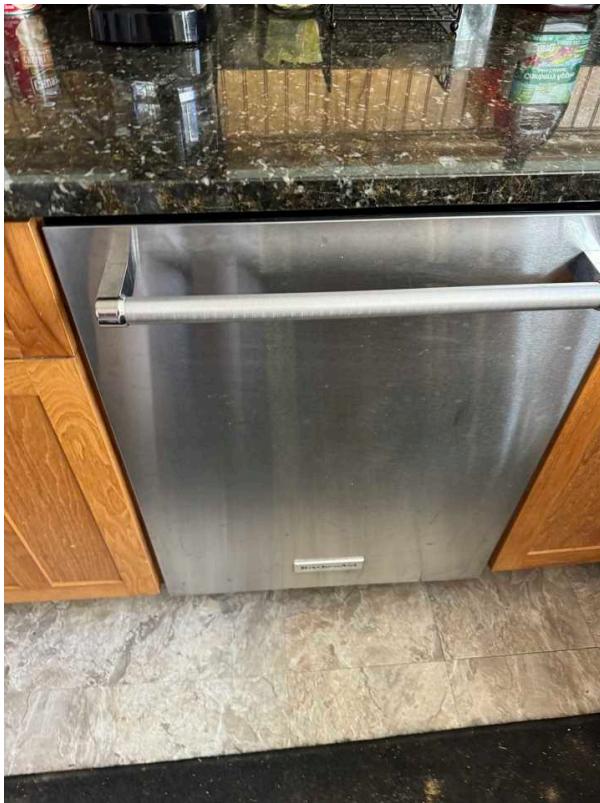
**Main Level/Kitchen - 110-
Insured Risk**

Floor, baseboard, wall, cabinets,
appliances and door damage

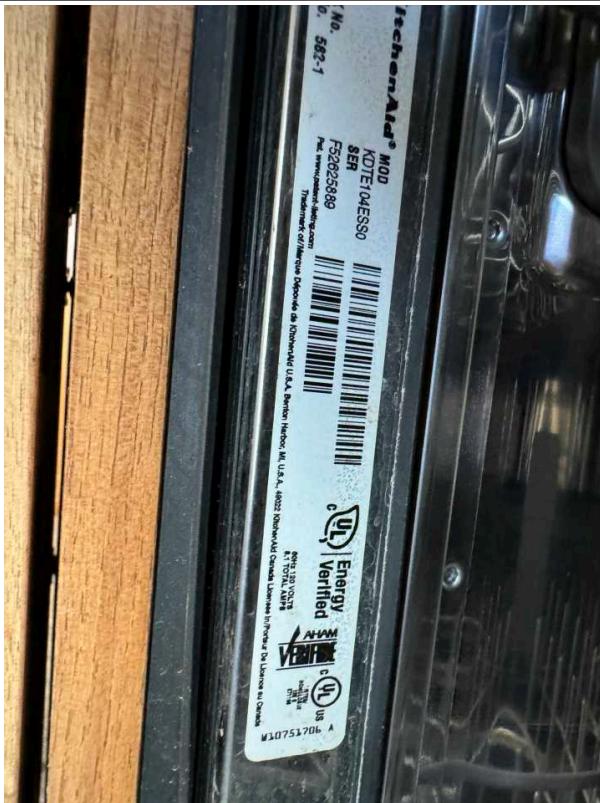
Main Level/Kitchen - 111- Insured Risk

Floor, baseboard, wall, cabinets,
appliances and door damage

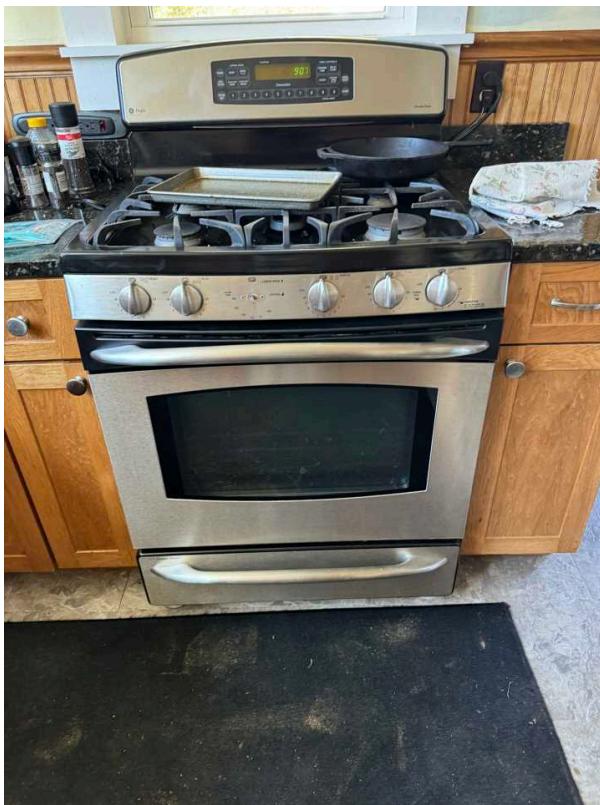
Main Level/Kitchen - 112- Insured Risk

Floor, baseboard, wall, cabinets,
appliances and door damage

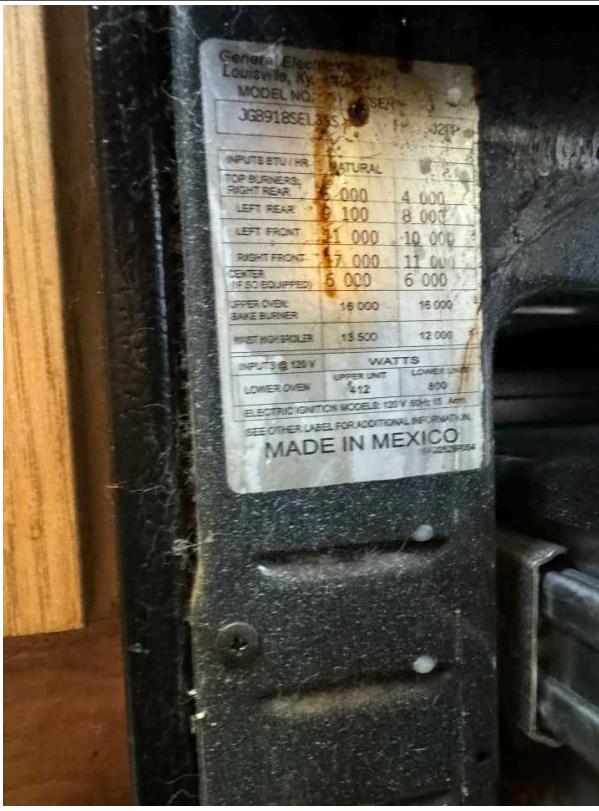
Main Level/Kitchen - 113- Insured Risk

Floor, baseboard, wall, cabinets,
appliances and door damage

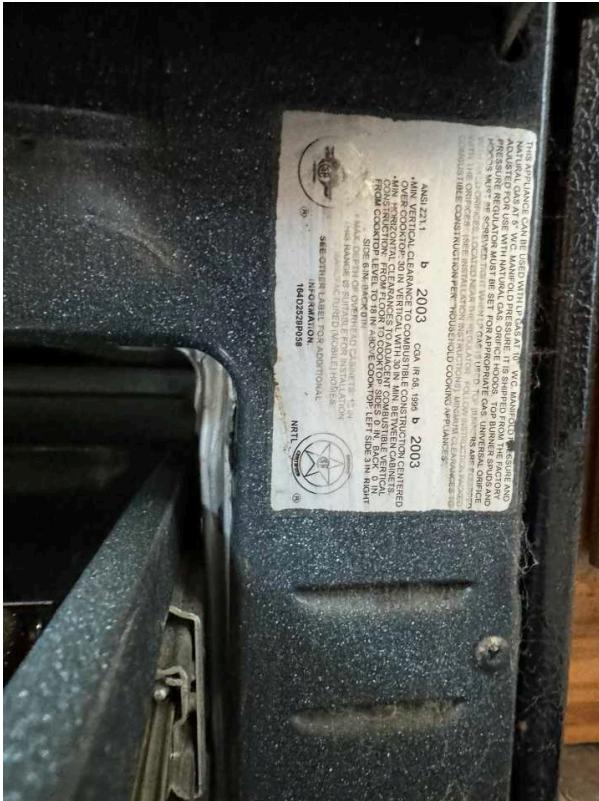
Main Level/Kitchen - 114- Insured Risk

Floor, baseboard, wall, cabinets,
appliances and door damage

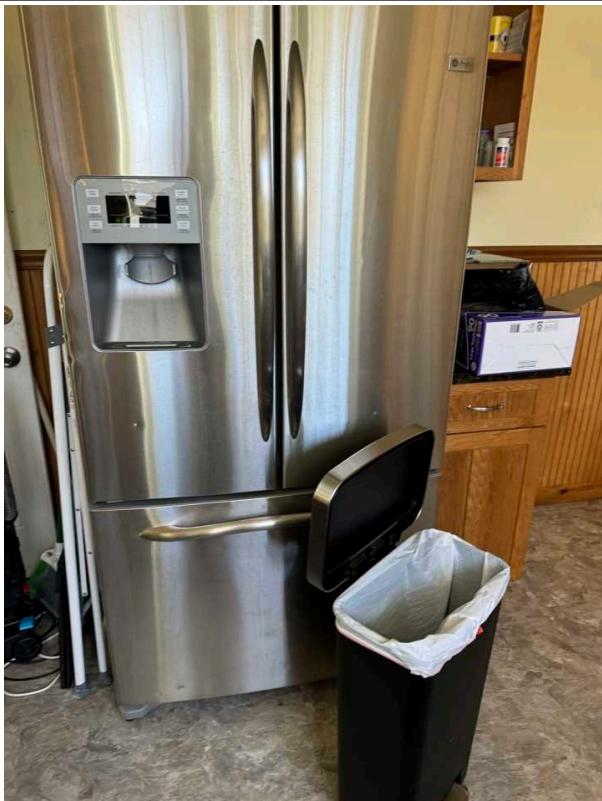
**Main Level/Kitchen - 115-
Insured Risk**

Floor, baseboard, wall, cabinets,
appliances and door damage
