NARRATIVE REPORT

DWELLING / UNIT OWNER

Carrier:	Assurant Flood Insurance Program	Date of Loss:	9/26/2024
Insured:	ELIZABETH WRIGHT/WRIGHT CAROLYN	Assigned:	10/15/2024
CID:	243519	Contacted:	10/15/2024
Claim Number:	7406040448-09262024	Inspected:	10/24/2024
Policy Number:	7406040448	Inspected With:	CAROLYN WRIGHT
Loss Address:	400 N FORK RD BARNARDSVILLE NC 28709	Mailing Address:	41 N COLLEGE ST WEAVERVILLE, NC 28787
Coverage A:	\$ 185,000.00	Mortgage:	LOANCARE LLC
Coverage B:	\$ 0.00	Verified with:	CAROLYN WRIGHT
Policy Term:	9/25/2024 to 9/25/2025

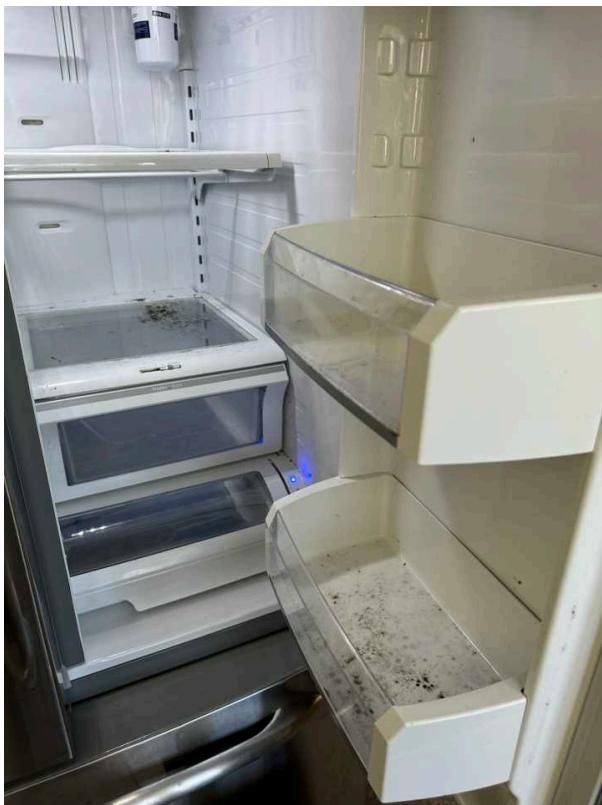
**Main Level/Kitchen - 116-
Insured Risk**

Floor, baseboard, wall, cabinets,
appliances and door damage

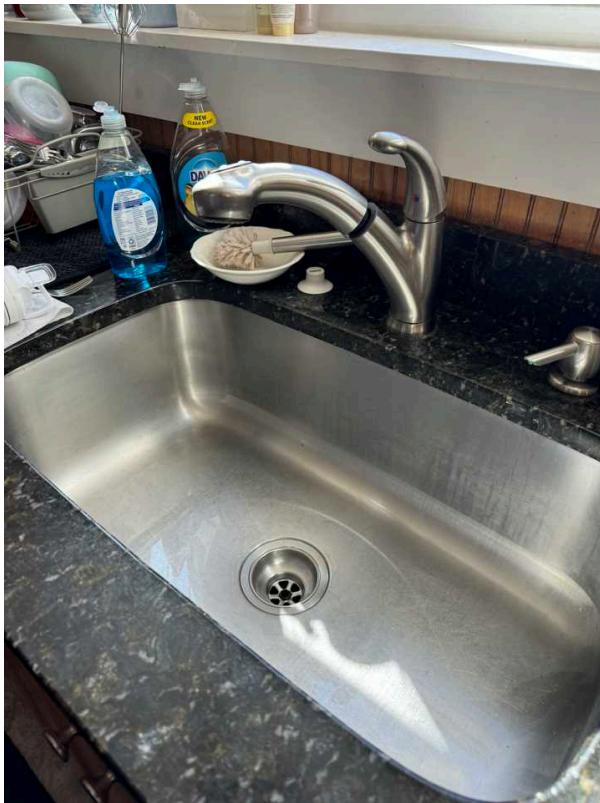
**Main Level/Kitchen - 118-
Insured Risk**

Floor, baseboard, wall, cabinets,
appliances and door damage

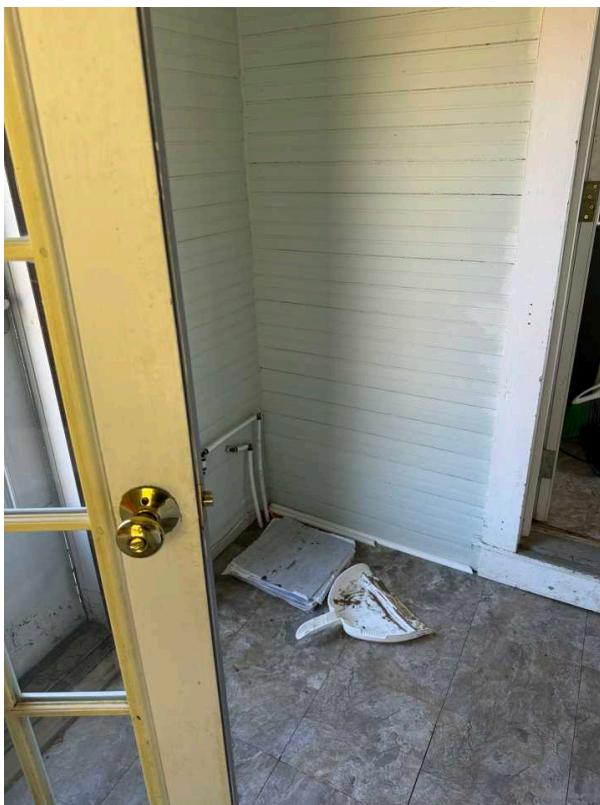
**Main Level/Laundry Room - 122-
Insured Risk**

Floor, wall and door damage

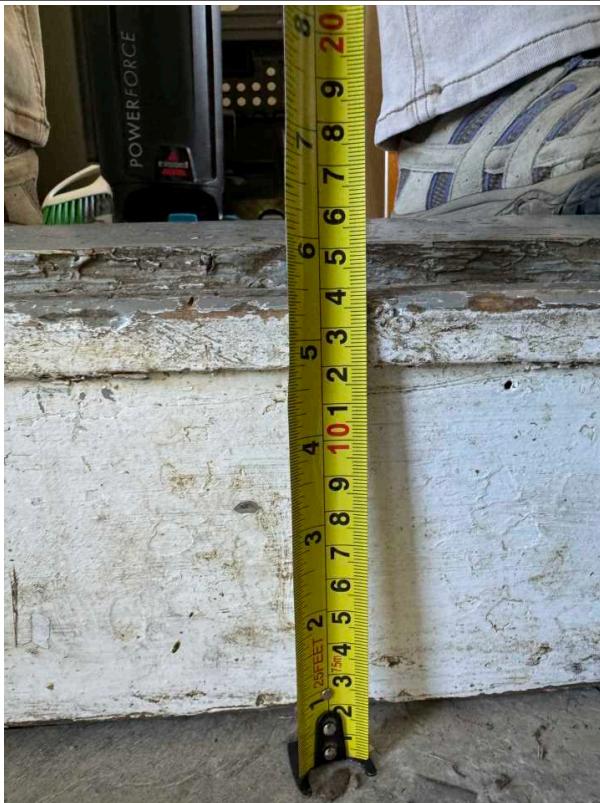
**Main Level/Laundry Room - 125-
Insured Risk**

The step up into the kitchen from laundry room is 6 inches

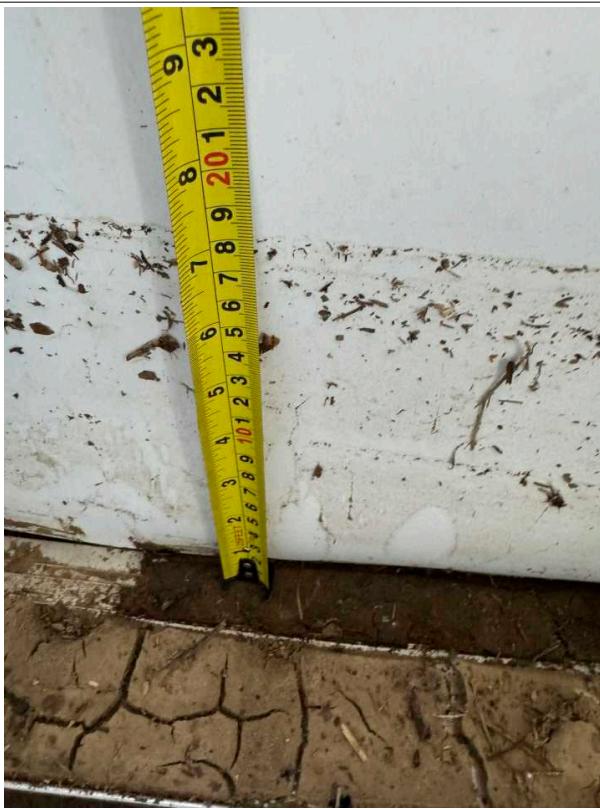
**Main Level/Laundry Room - 127-
Insured Risk**

Date Taken: 10/24/2024
Taken By: Dina Bullard
Flood line in the laundry room - 7 inches

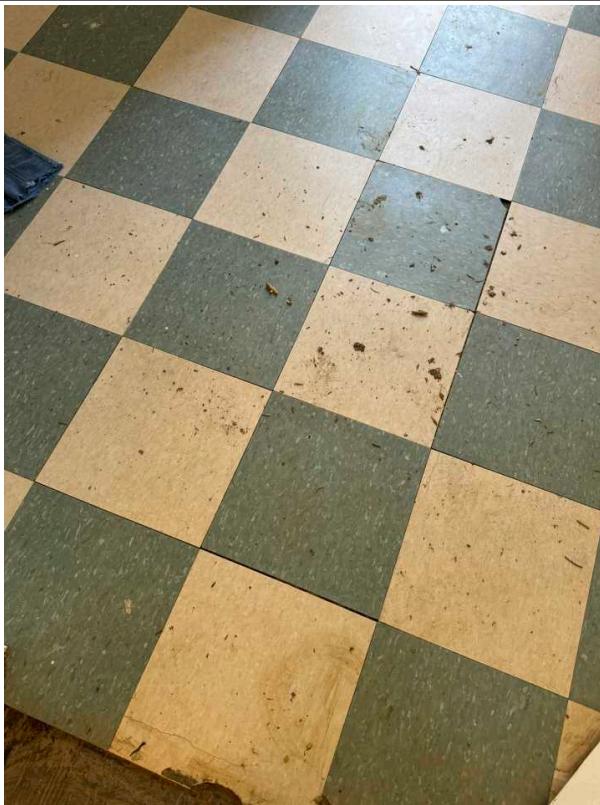
**Main Level/Bathroom - 129-
Insured Risk**

Date Taken: 10/24/2024
Taken By: Dina Bullard
Floor damage

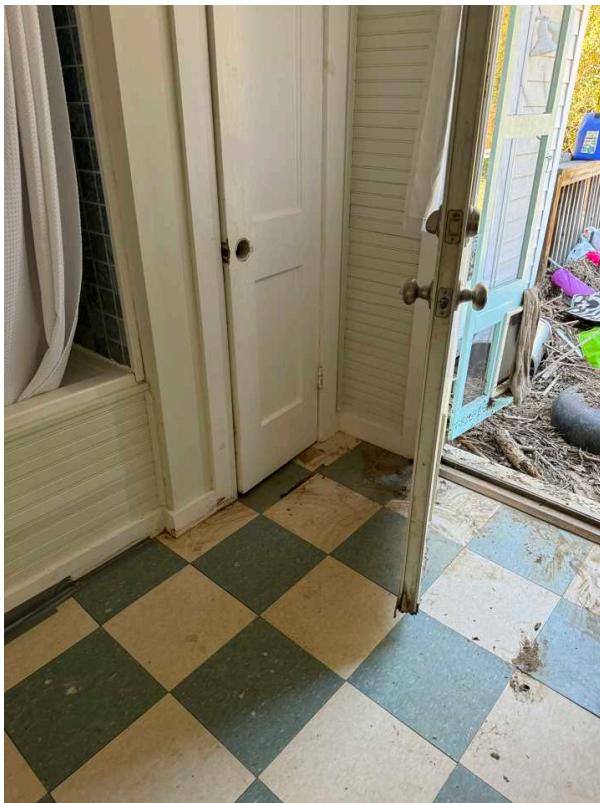
**Main Level/Bathroom - 130-
Insured Risk**

Date Taken: 10/24/2024
Taken By: Dina Bullard
Floor, wall, baseboard, door damage

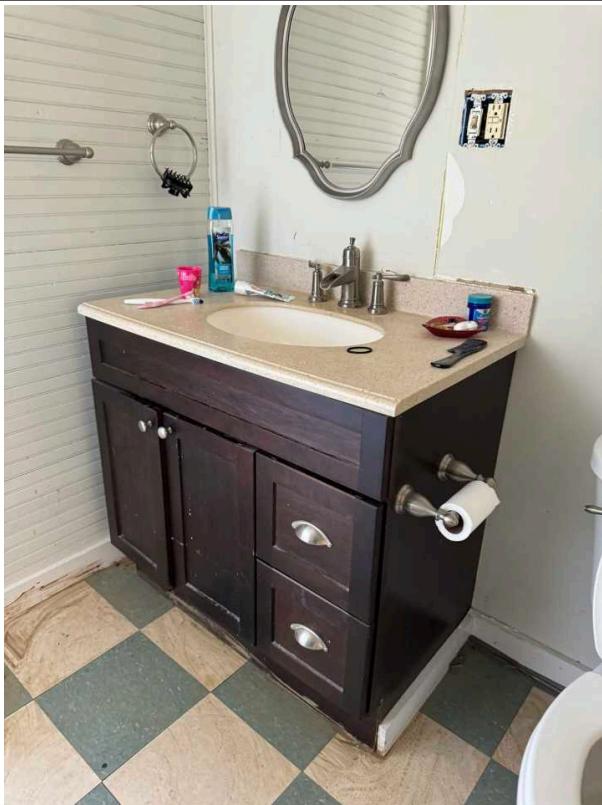
**Main Level/Bathroom - 131-
Insured Risk**

Date Taken: 10/24/2024
Taken By: Dina Bullard
Vanity damage

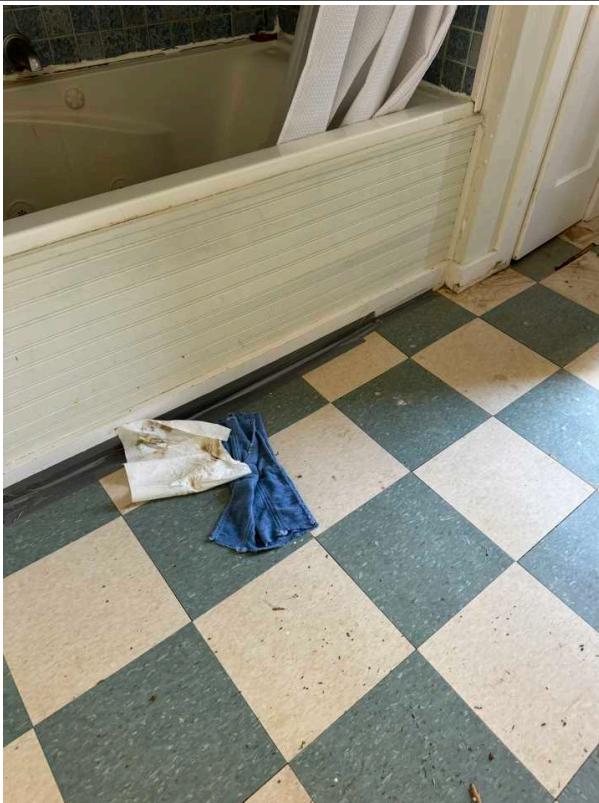
**Main Level/Bathroom - 133-
Insured Risk**

Date Taken: 10/24/2024
Taken By: Dina Bullard
Tub, floor damage

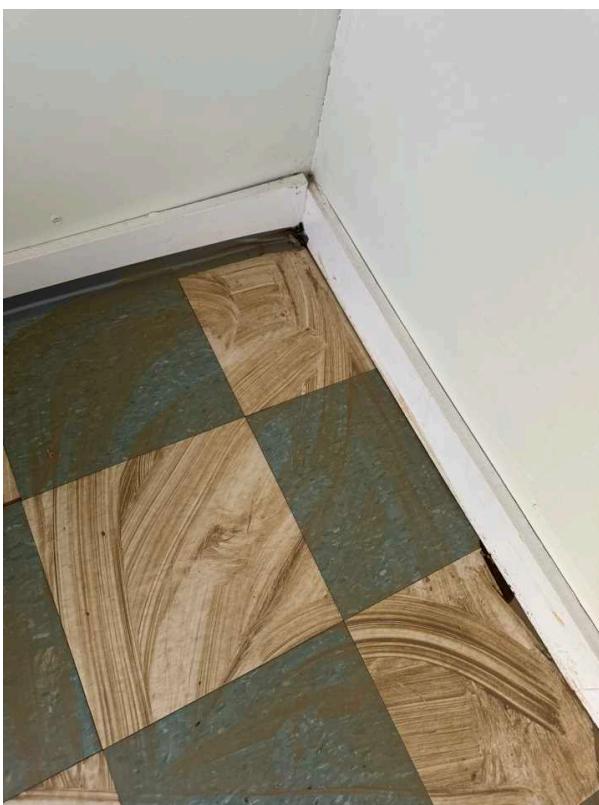
**Main Level/Bathroom - 134-
Insured Risk**

Date Taken: 10/24/2024
Taken By: Dina Bullard
Restroom in rear of home showing
evidence of flooring sinking, floor, wall,
and baseboard damage

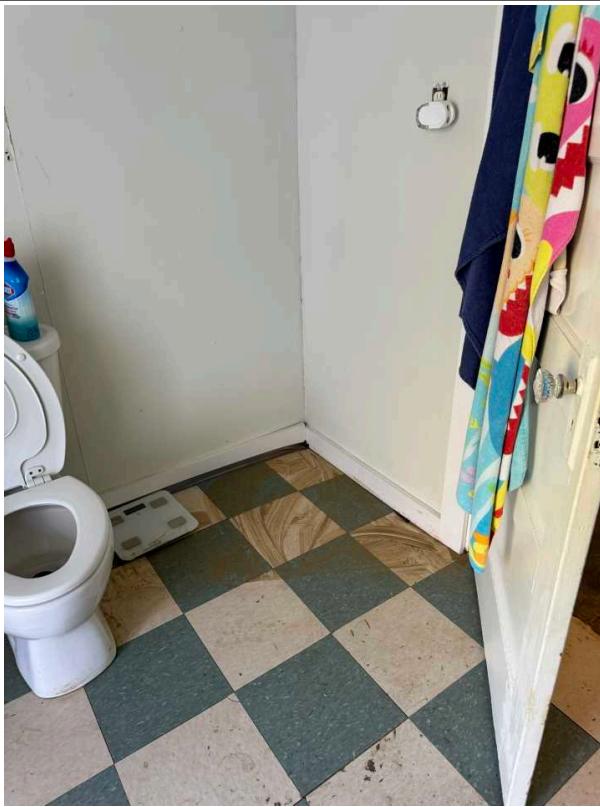
**Main Level/Bathroom - 135-
Insured Risk**

Restroom in rear of home showing evidence of flooring sinking. floor, wall, door and baseboard damage

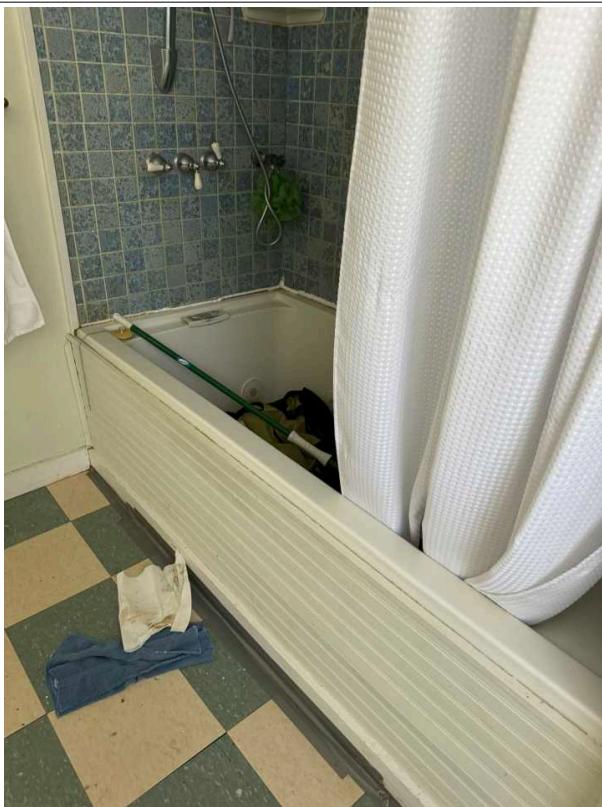
**Main Level/Shower - 137-
Insured Risk**

Tub/shower damage to floor and wall

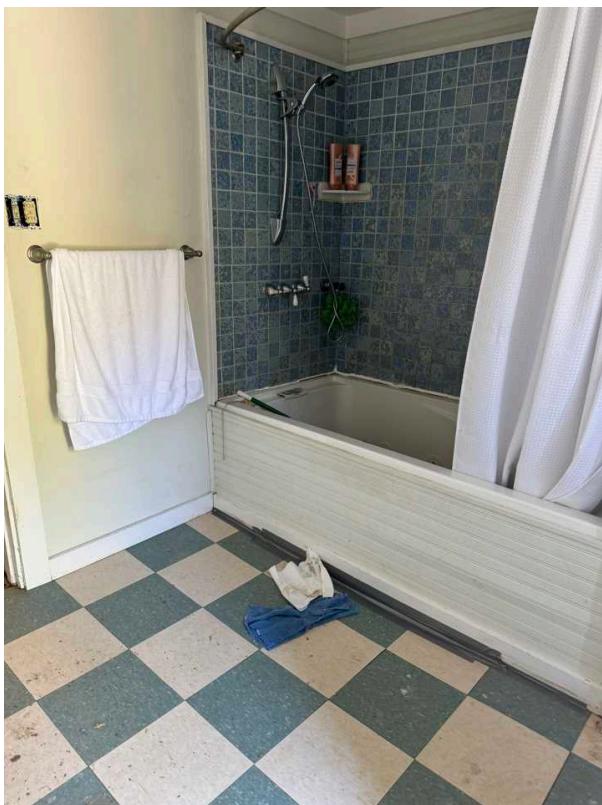
**Main Level/Shower - 138-
Insured Risk**

Tub/shower damage to floor and wall

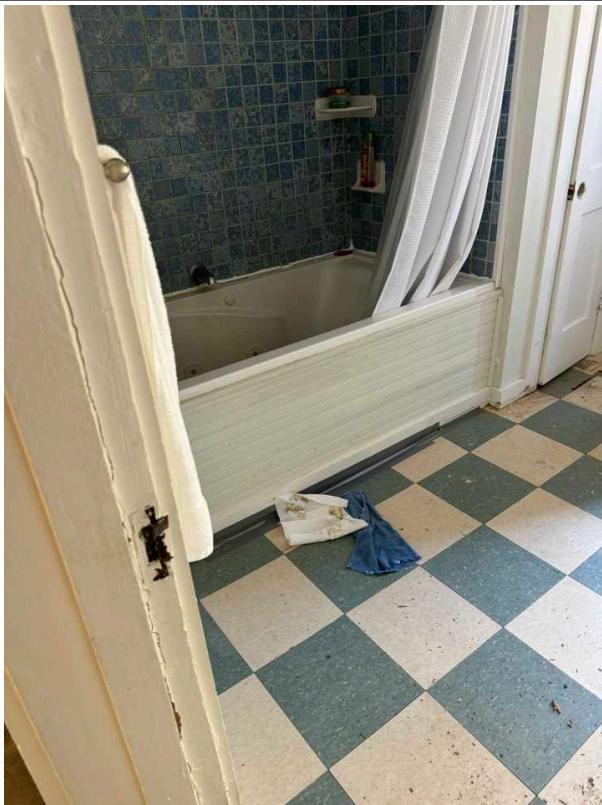
**Main Level/Shower - 139-
Insured Risk**

Tub/shower damage to floor and wall

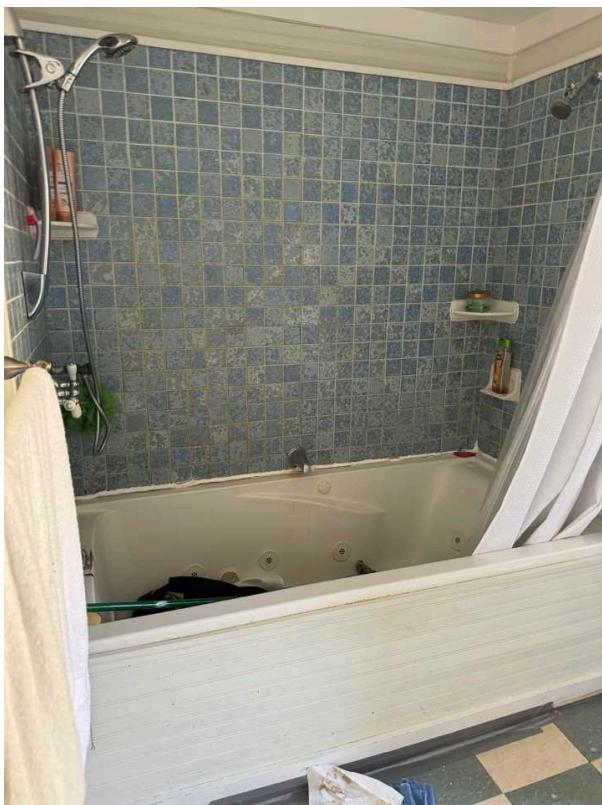
**Main Level/Shower - 140-
Insured Risk**

Tub/shower damage to floor and wall

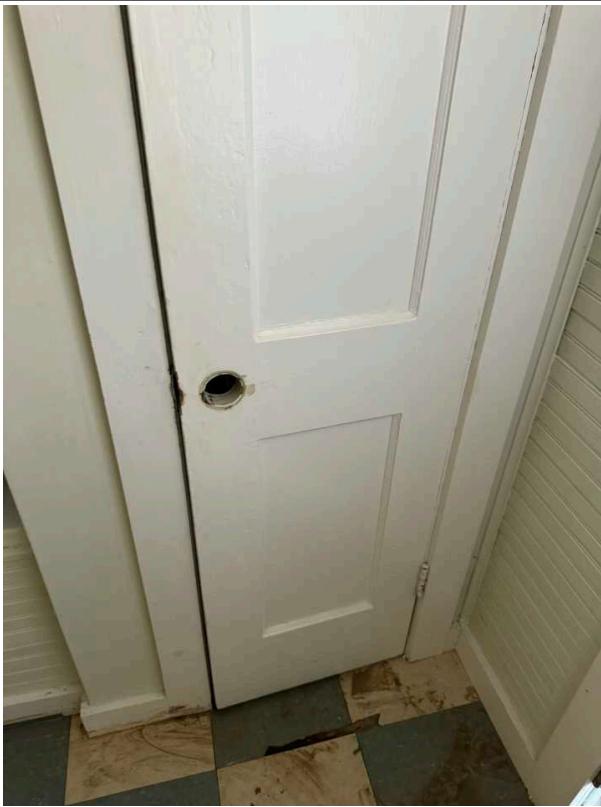
**Main Level/Linen Closet1 - 141-
Insured Risk**

Restroom in rear of home showing evidence of flooring sinking, Linen closet - wall, door damage

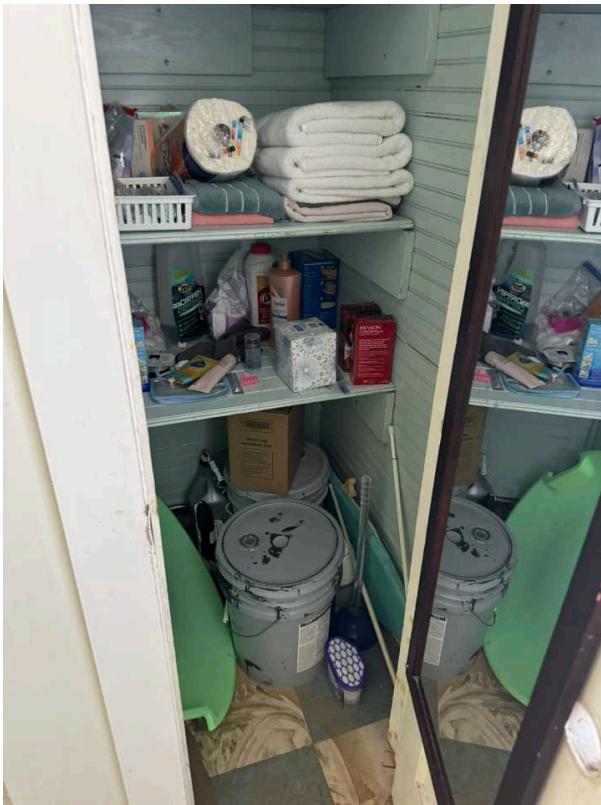
**Main Level/Linen Closet1 - 142-
Insured Risk**

Linen closet - wall, door damage
