## NARRATIVE REPORT

### General Property

| <b>Insured:</b> | SHELTAIR ST. PETERSBURG, LLC | <b>Assigned:</b> | 10/1/2024 |
| <b>Loss Address:</b> | 15733 FAIRCHILD DR BLDG 1<br>CLEARWATER FL 33762-3530 | <b>Mailing Address:</b> | 5302 NW 21ST TERRACE FORT<br>LAUDERDALE FL 33309 |

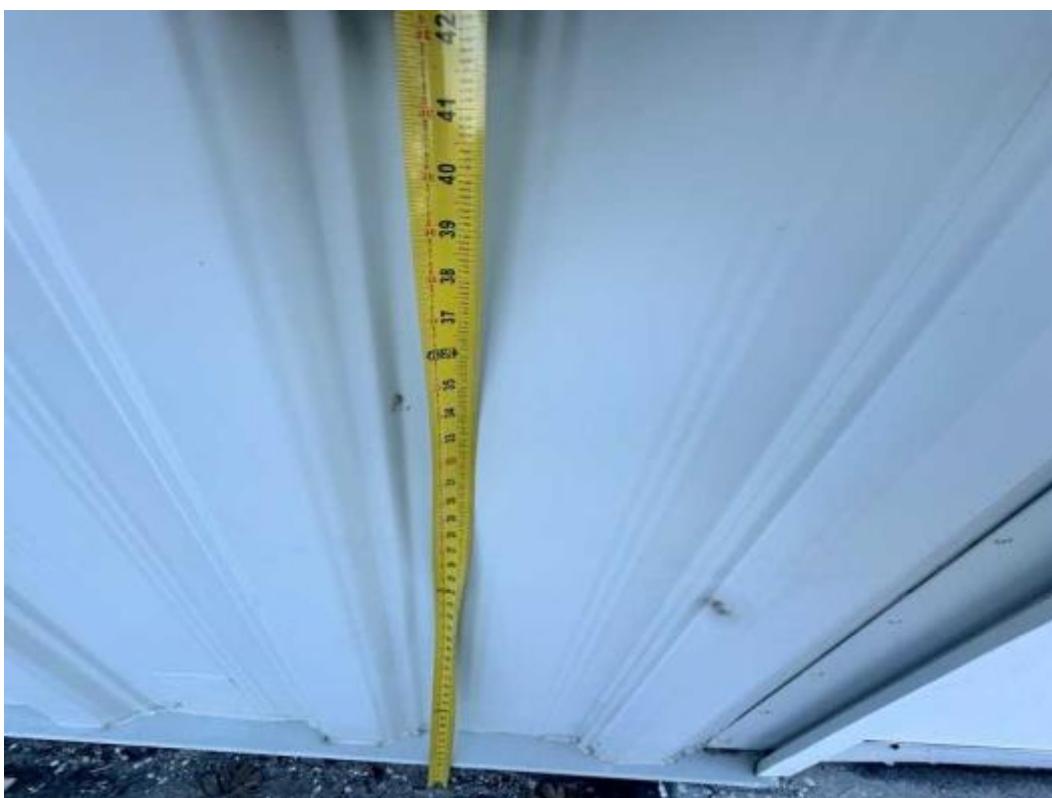
**Exterior/Ext\_Surfaces - 6-Exterior water line 35 inches**

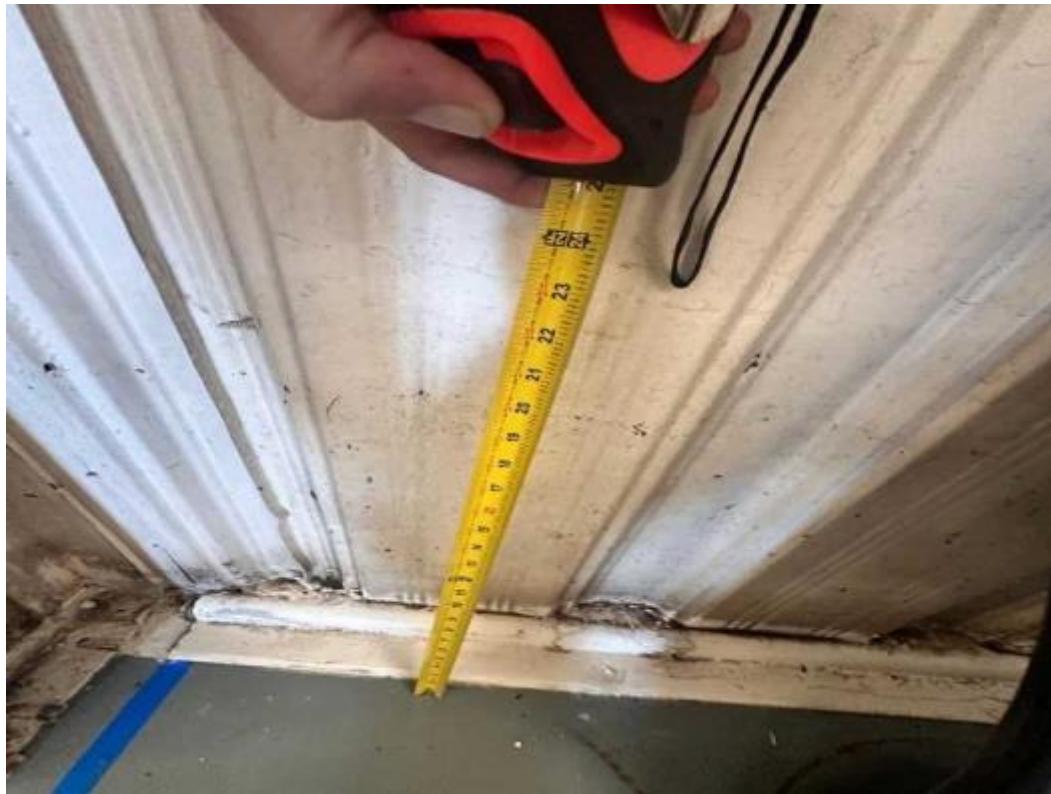
**Exterior/Ext\_Surfaces - 7-  
Interior water line 20 inches**

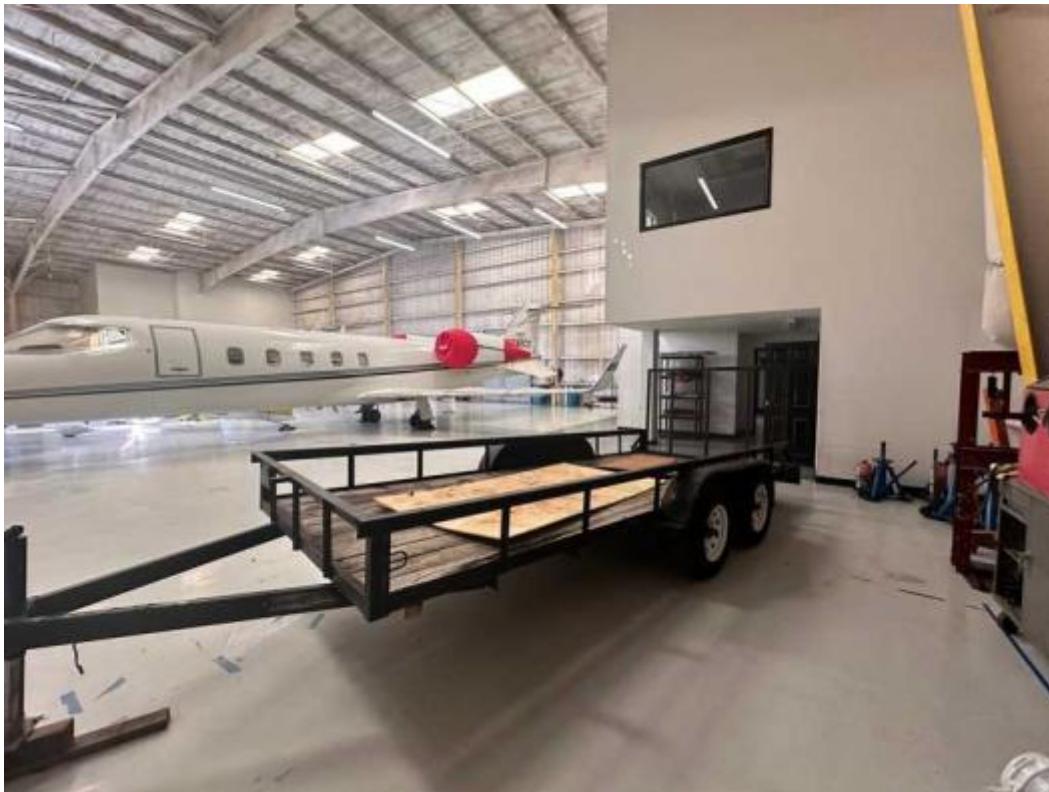
**Main Level/Hanger - 9-Hanger to storage rooms**

Rear wall includes 2 roll up doors and 4 exterior doors.

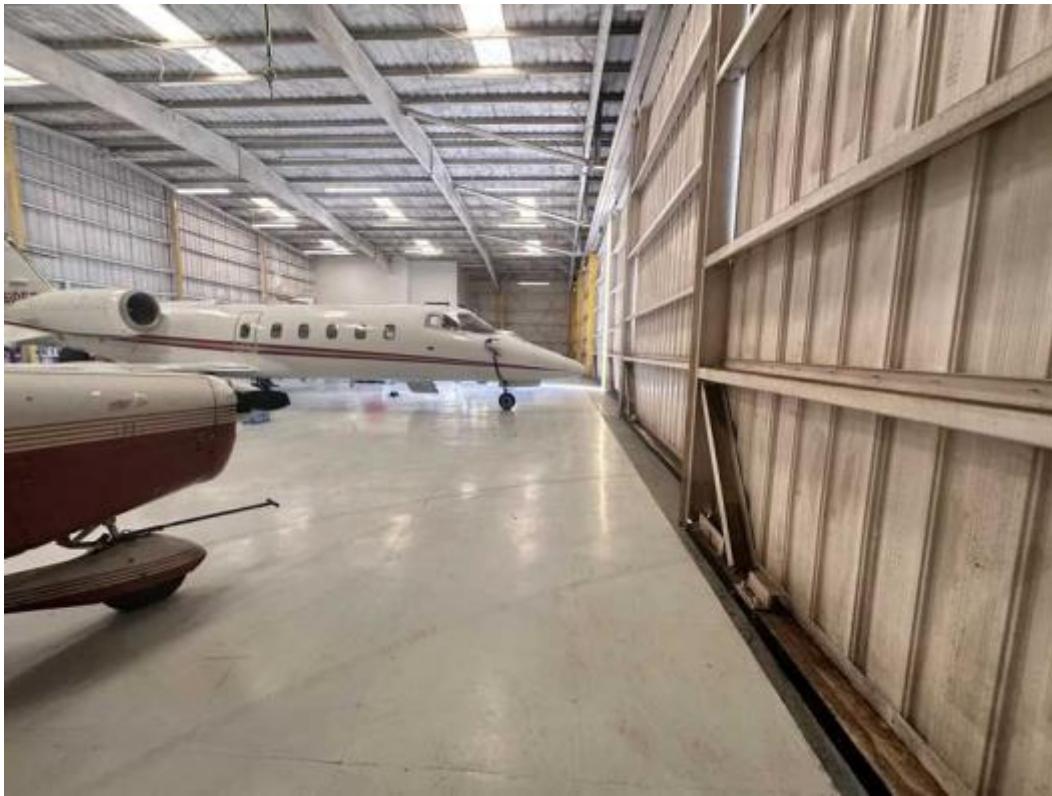
**Main Level/Hanger - 11-Hanger doors from left**

Front wall has 6 rolling hanger doors.  
Damage noted to 12" hanger wheels.  
Farthest area is storage room, bathroom  
2, and stairway 2.

- Each hanger door has 2 - 12-inch metal wheels and caster assemblies. They have become difficult to operate due to the damaged wheels. We have recommended cleaning and treat the hanger doors and to replace the 12 hanger door wheels.

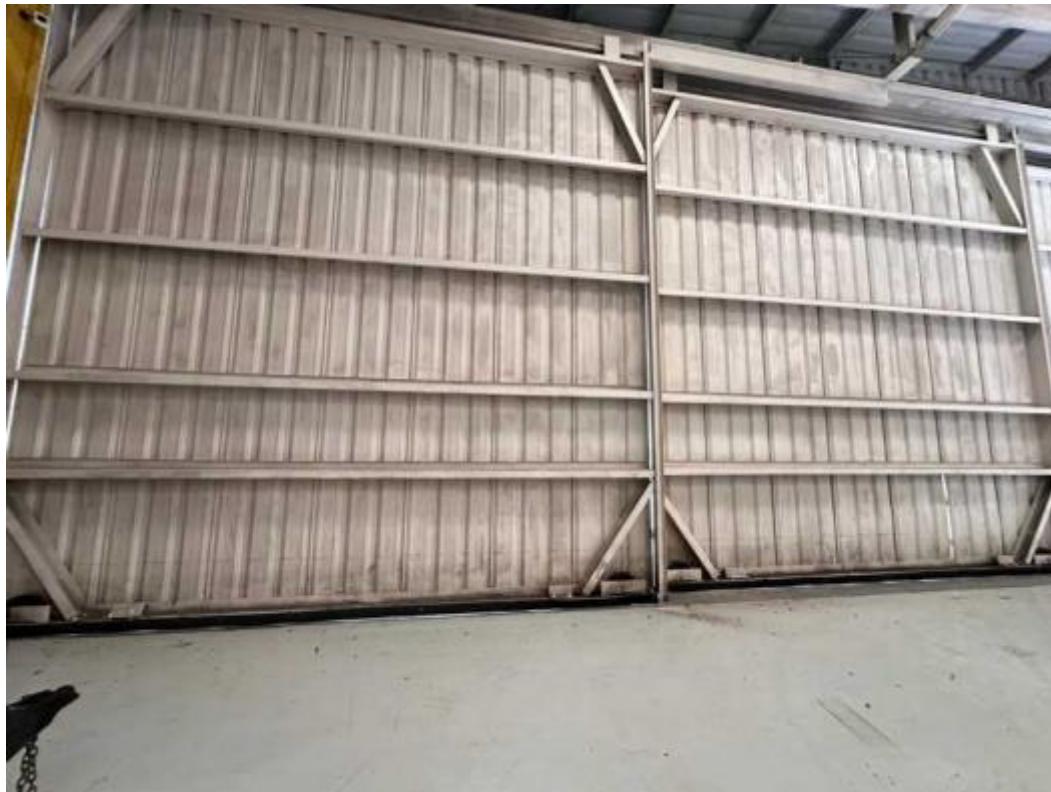
**Main Level/Hanger - 14-Hanger doors 1 and 2**

Front wall has 6 rolling hanger doors.  
Damage noted to 12" hanger wheels.

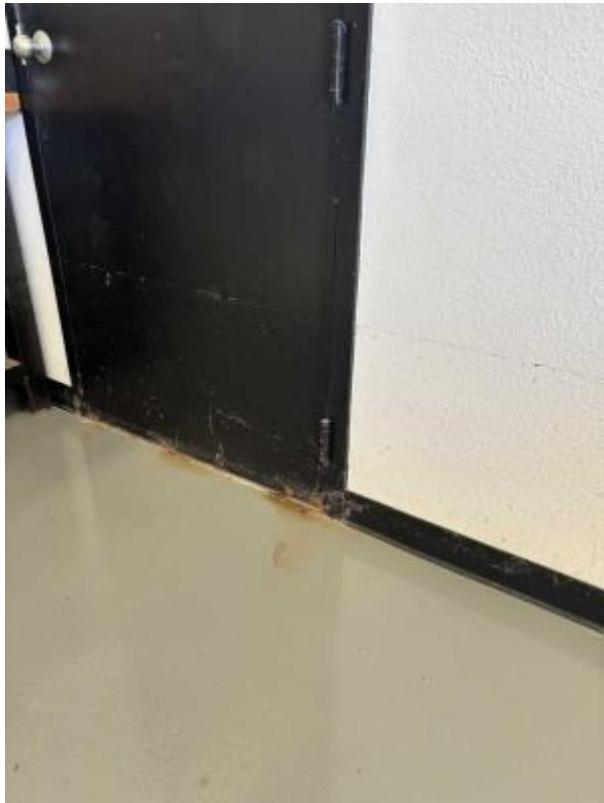
**Main Level/Hanger - 19-Interior water line and door damage**

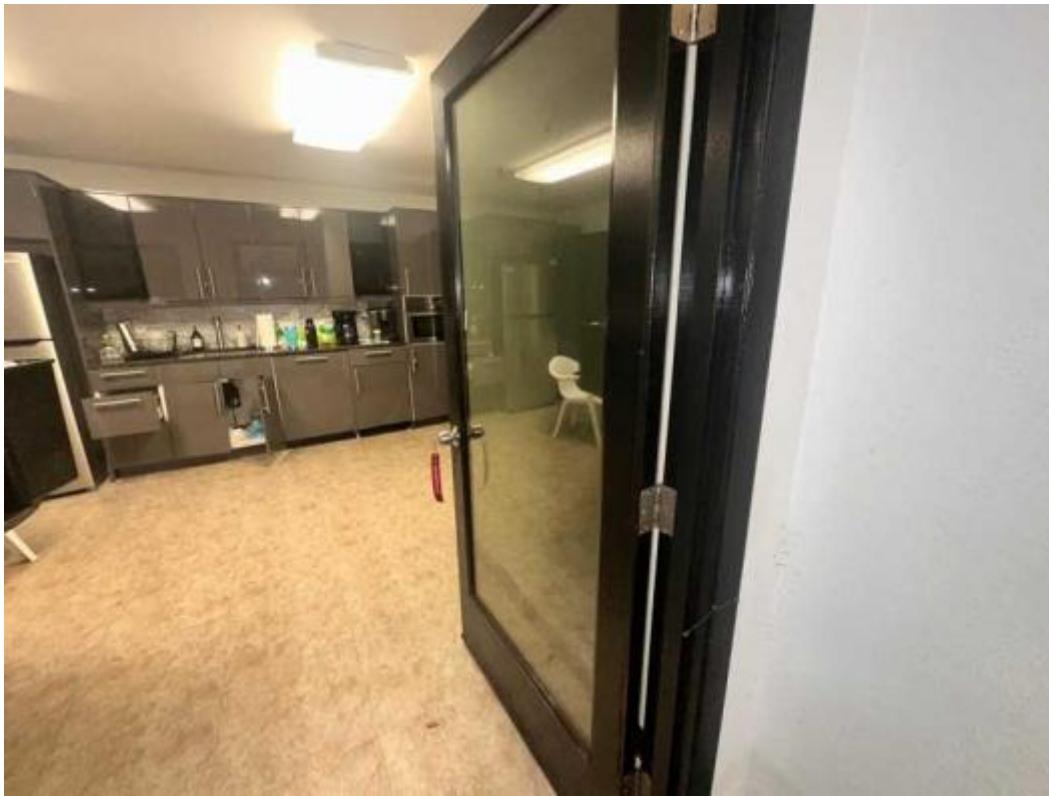
**Main Level/Break Room - 21-  
Break Room door with full lite**

Damage to vinyl tile flooring, trim, cabinets, full height cabinets, walls, and doors.

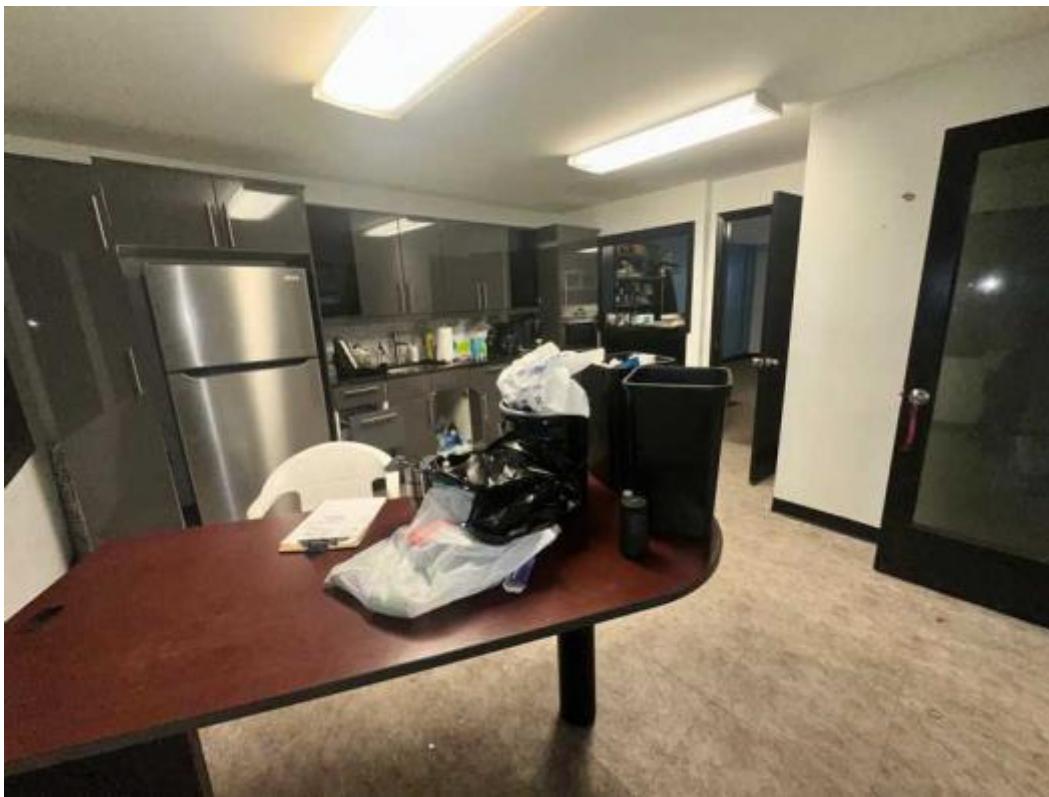
**Main Level/Break Room - 22-  
Break Room cabinets**

Built in oven in right full height cabinet must detach and reset to replace cabinets and repair damaged wall behind.

- Cabinetry – There are 2 full height cabinets in the breakroom along with 5 ft of lower cabinets that are damaged, and replacement is included in the estimate.

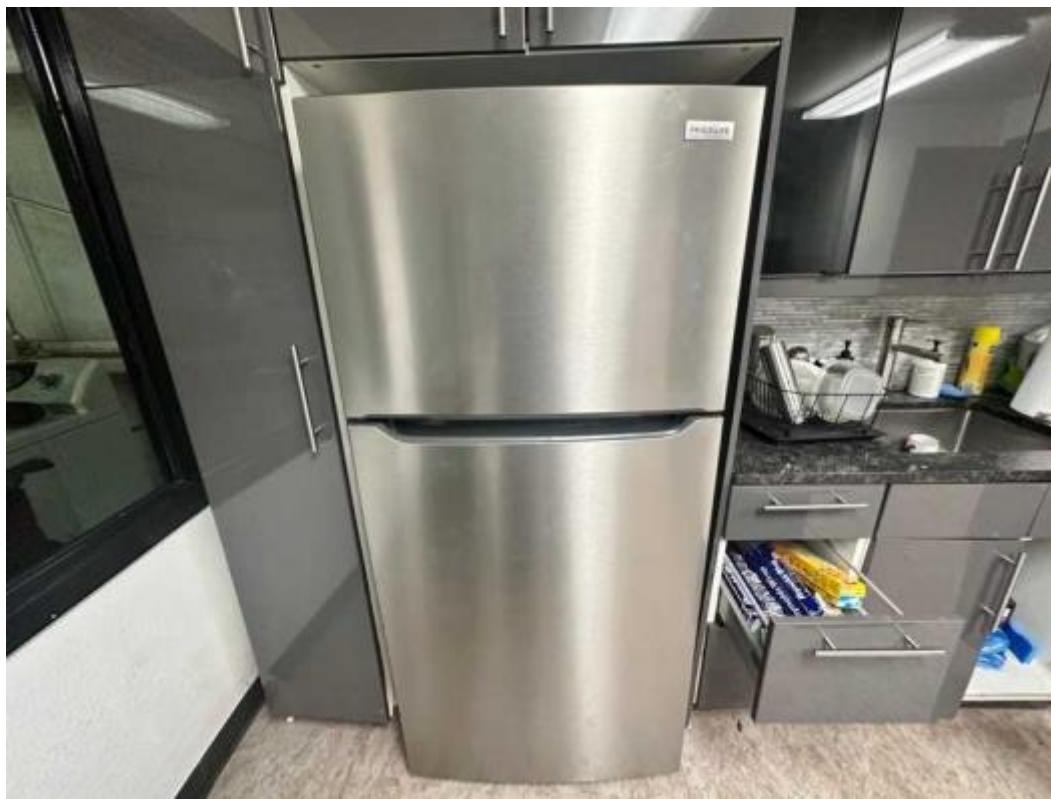
**Main Level/Break Room - 23-  
Break Room refrigerator**

Frigidaire 18.3 Cu. Ft. Top Freezer Refrigerator Model: LFTR1835VFB  
Serial: BA43721583 Man. Date: 09-24  
*Please note:* Glass tile back splash.

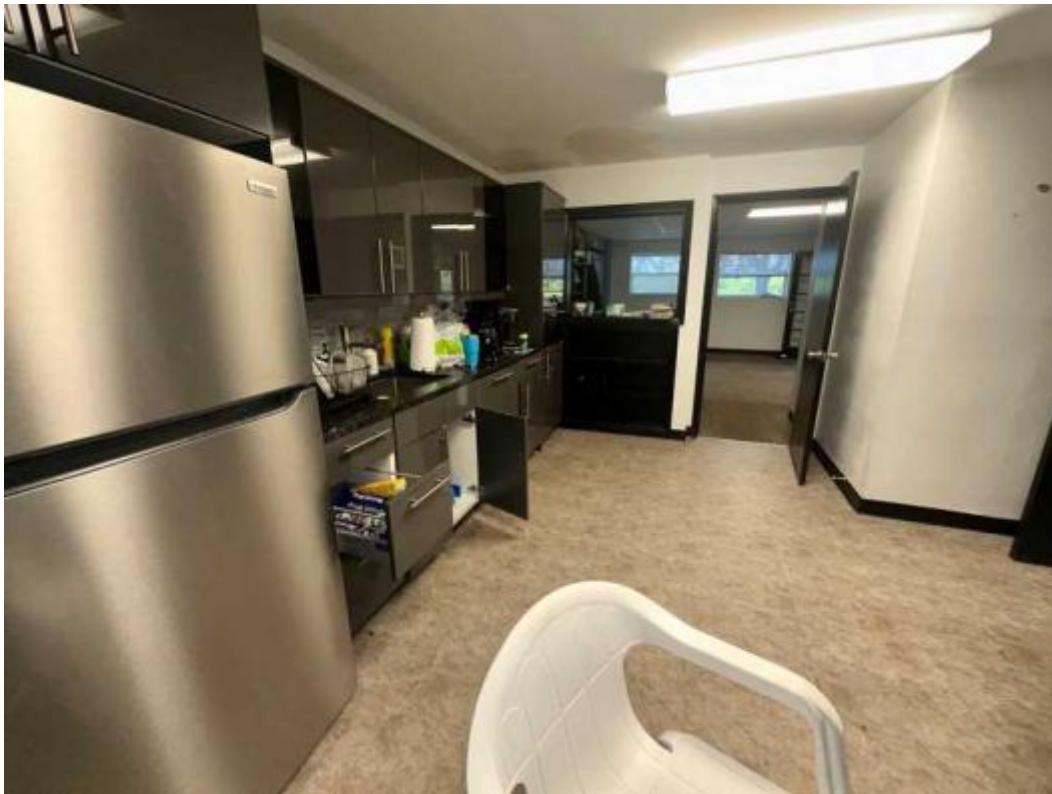
**Main Level/Break Room - 25-Break Room Cabinets**

Damage to vinyl tile flooring, trim, cabinets, walls, and doors.

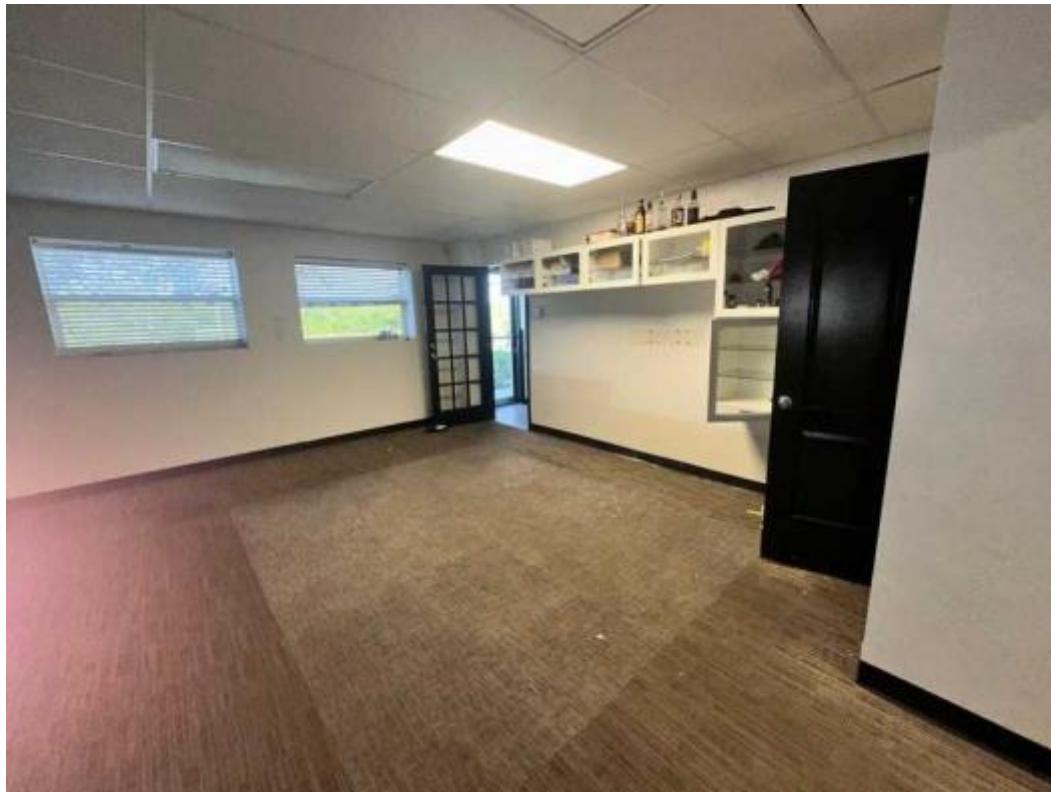
**Main Level/Storage Room 1 - 28-Storage Room 1**

Damage to carpet and padding, trim, walls, and 1 solid wood door and 1 french door.

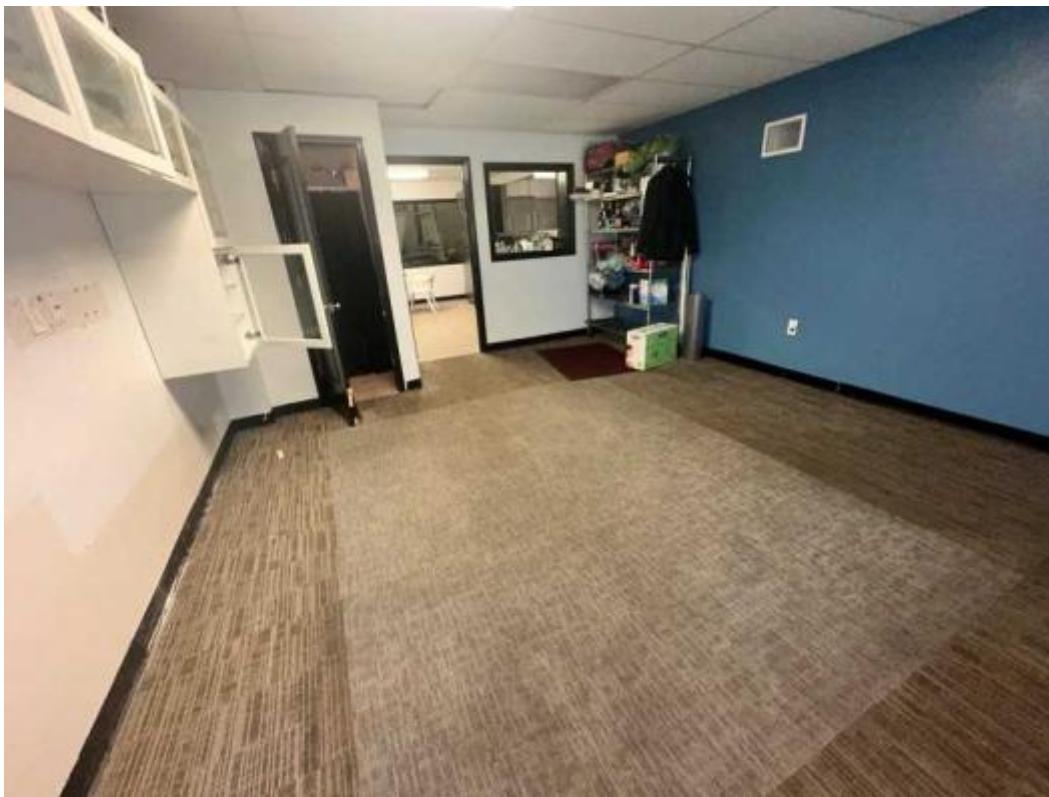
**Main Level/Storage Room 1 - 30-  
Storage Room 1 carpet flooring**

Detach and reset tall cabinet to repair drywall behind. Damage to outlets.

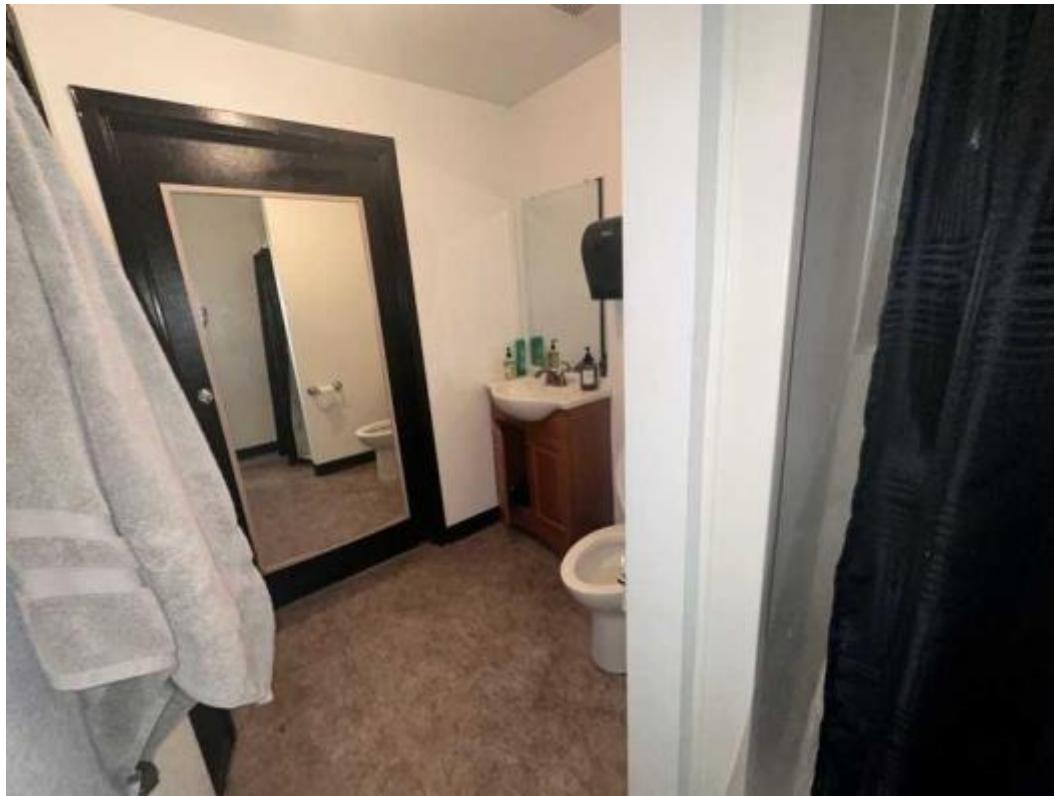
**Main Level/Bathroom 1 - 33-Bathroom 1**

Damage to vinyl tile flooring, trim, vanity, fiberglass shower, and 2 solid wood doors.

- Bathrooms – replace cabinetry, remove and reinstall toilet and sink. Toilet partitions are separating. Toilets need detached and reset to access the wall. The fiberglass showers will need to be replaced as they are glued in and require replacement when removed.

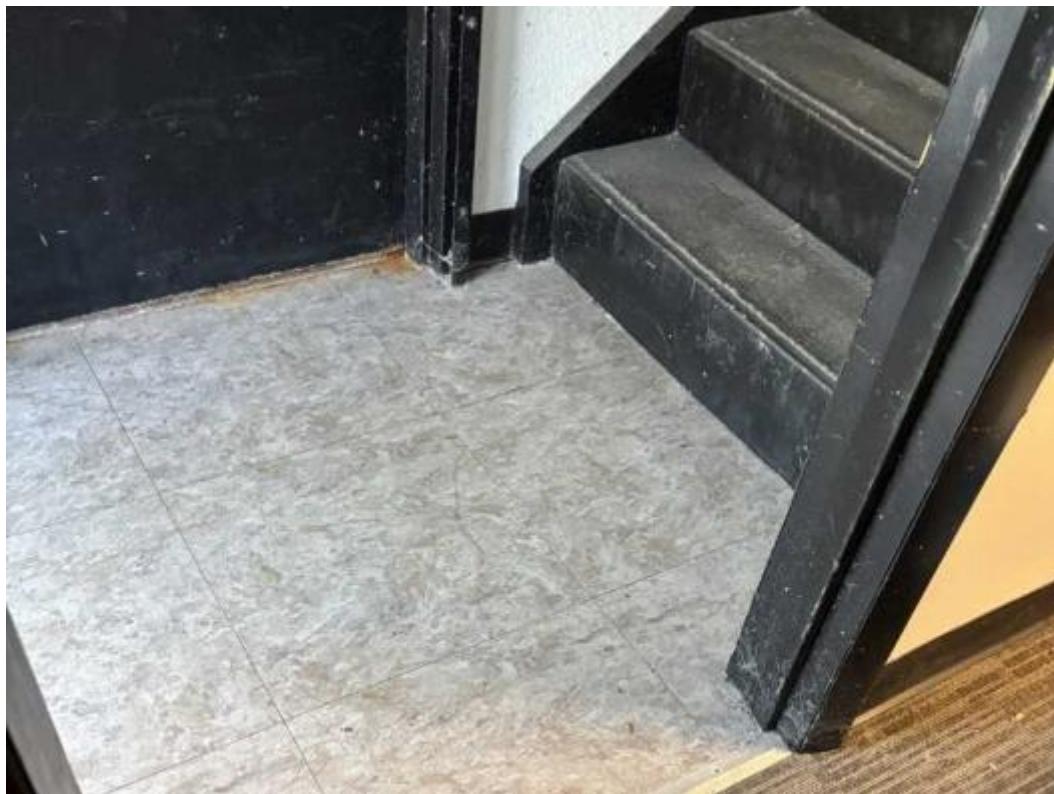
**Main Level/Entry 1 - 40-Entry 1 stairs and door to hanger**

Stairway from exterior. Damaged walls, trim, doors, and stairs.

- Stairs – The bottom 3 stairs, risers, stringers, and skirts are allowed in the estimate to be detached, cleaned and treated, and reinstalled. This will also allow drying and repair of the damaged walls below the stairs.

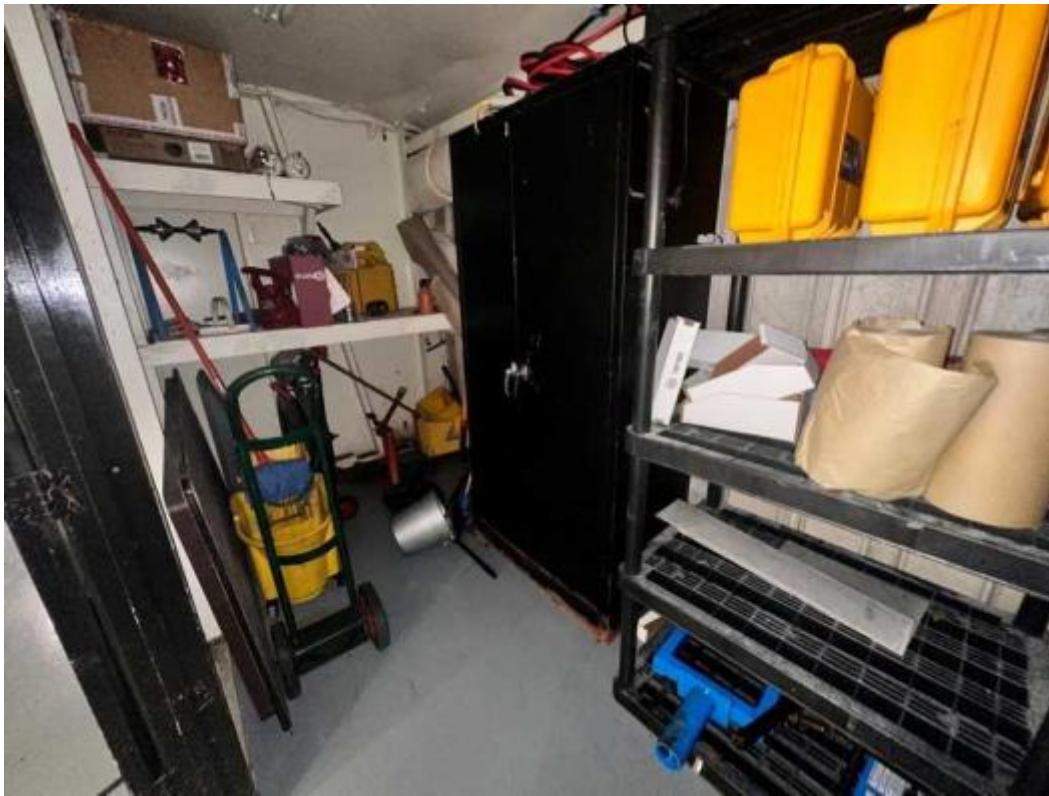
**Main Level/Storage Room 2 - 43-  
Storage Room 2**

Back wall is exterior wall, metal sheathing, no drywall.

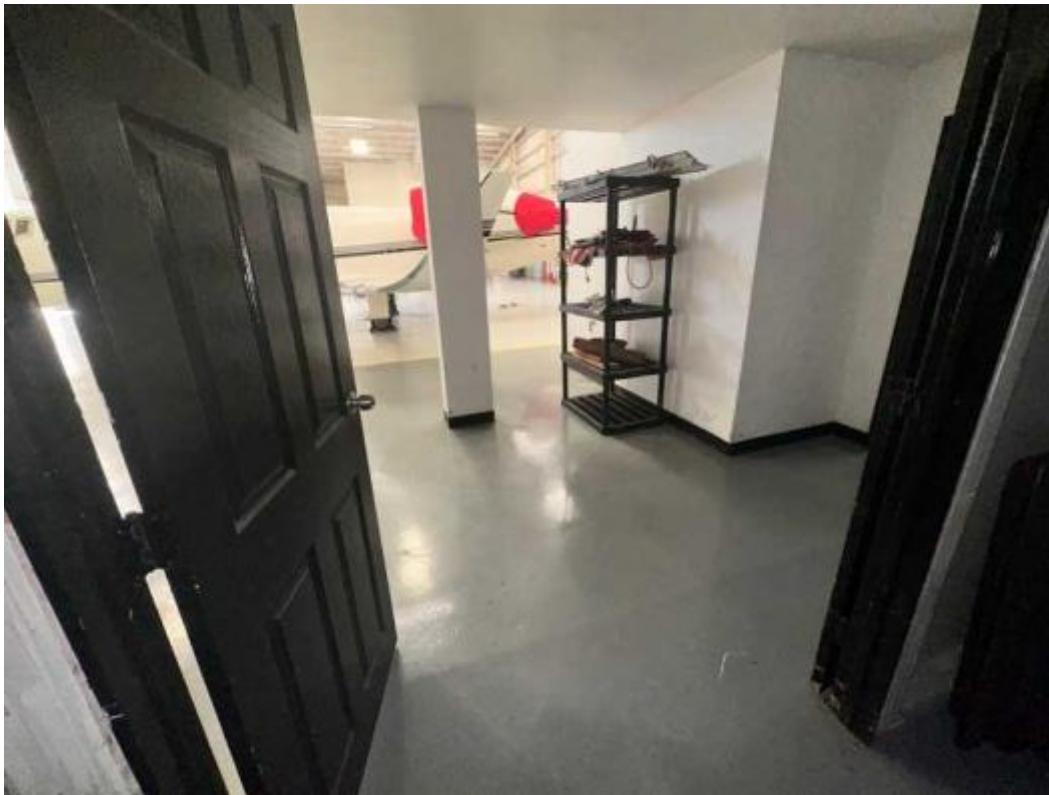
**Main Level/Storage Room 2 - 46-  
Storage Room 2**

Damage to trim, walls, and double  
French doors.

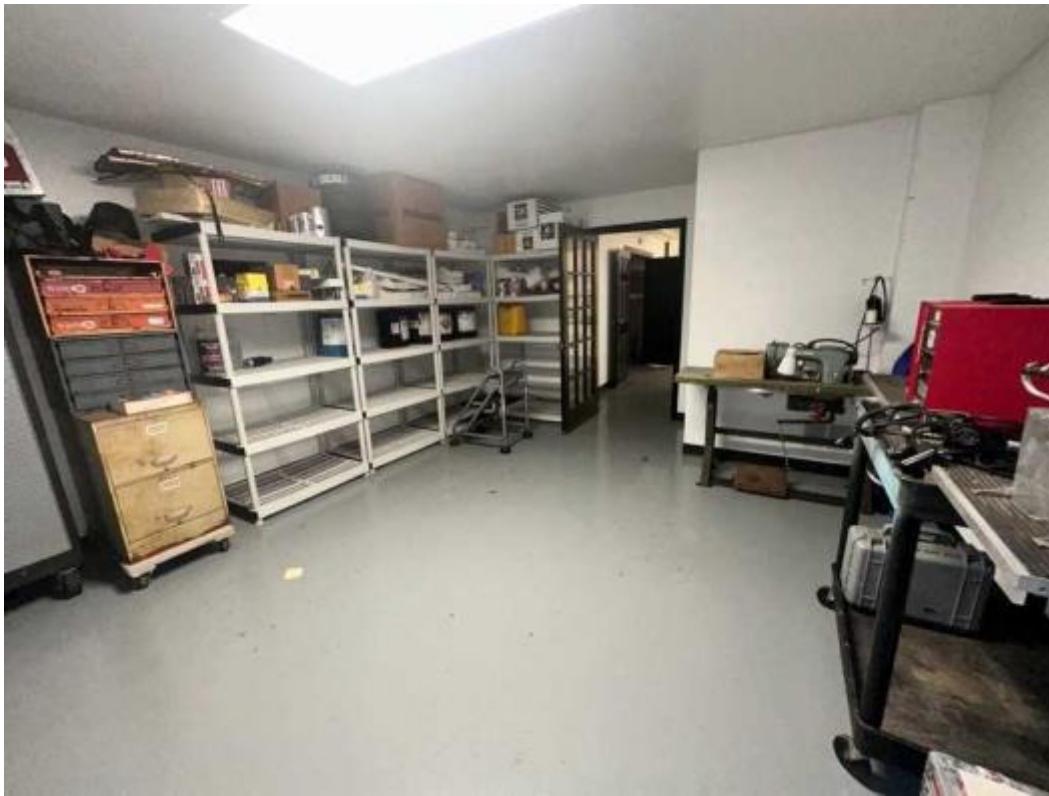
**Main Level/Storage Room 3 - 51-  
Storage Room 3**

Damage to trim, walls, and French door.  
Clean and treat floor.

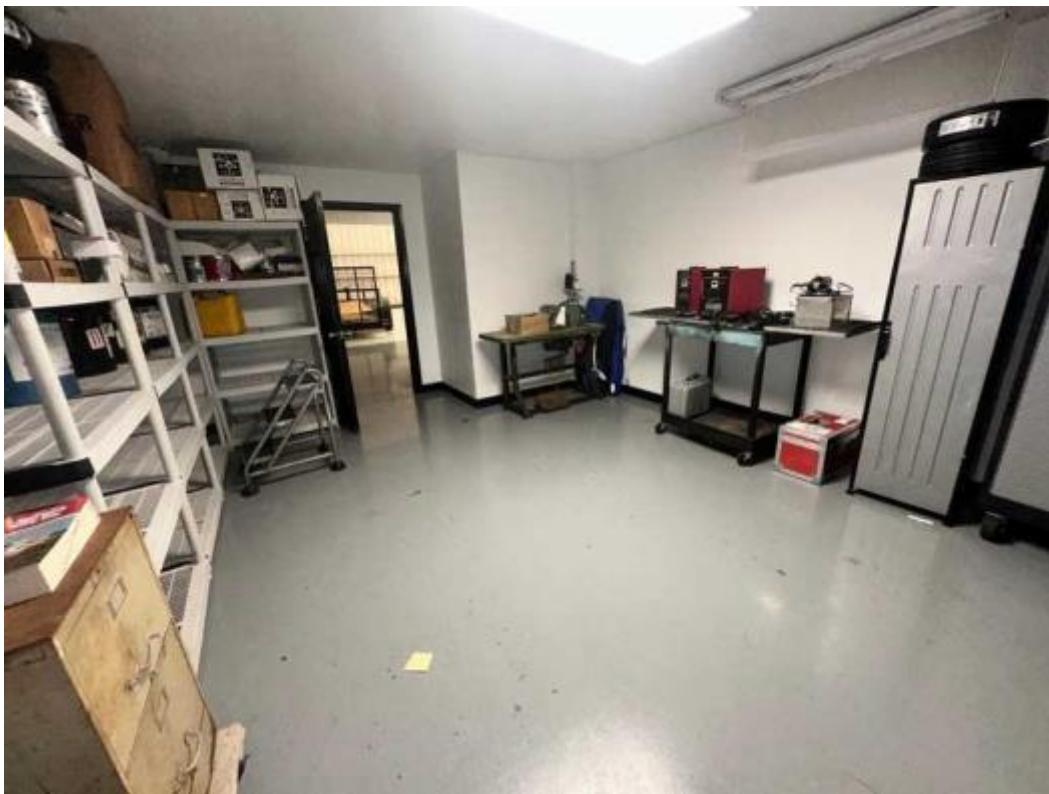
**Main Level/Storage Room 3 - 52-  
Storage Room 3**

Damage to trim, walls, and French door.  
Clean and treat floor.

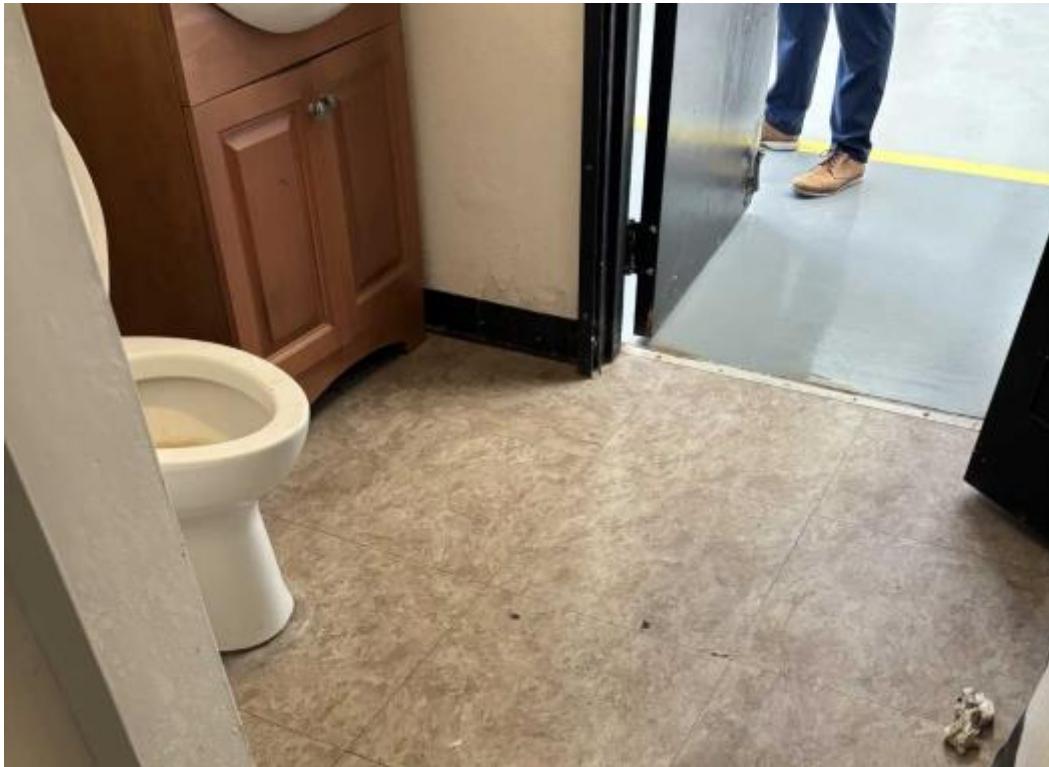
**Main Level/Bathroom 2 - 55-Bathroom 2 vanity and trim damage**

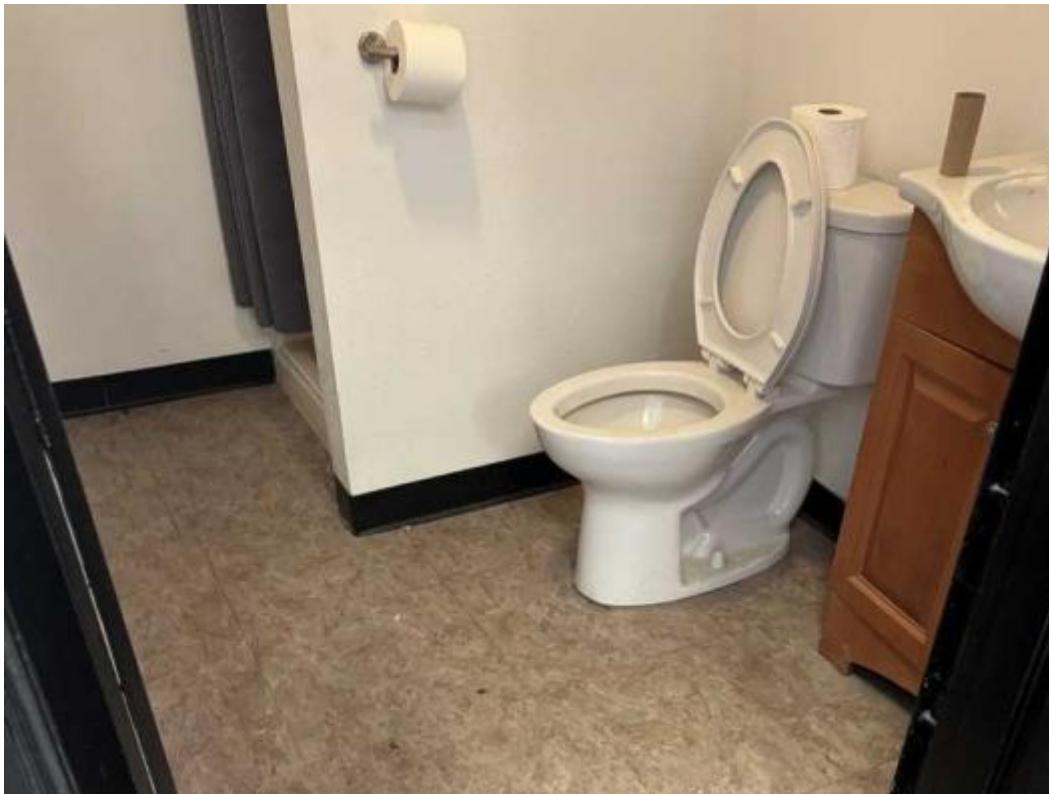
**Main Level/Bathroom 2 - 57-Bathroom 2**

Damage to vinyl tile flooring, trim, vanity, fiberglass shower, and 2 solid wood doors.

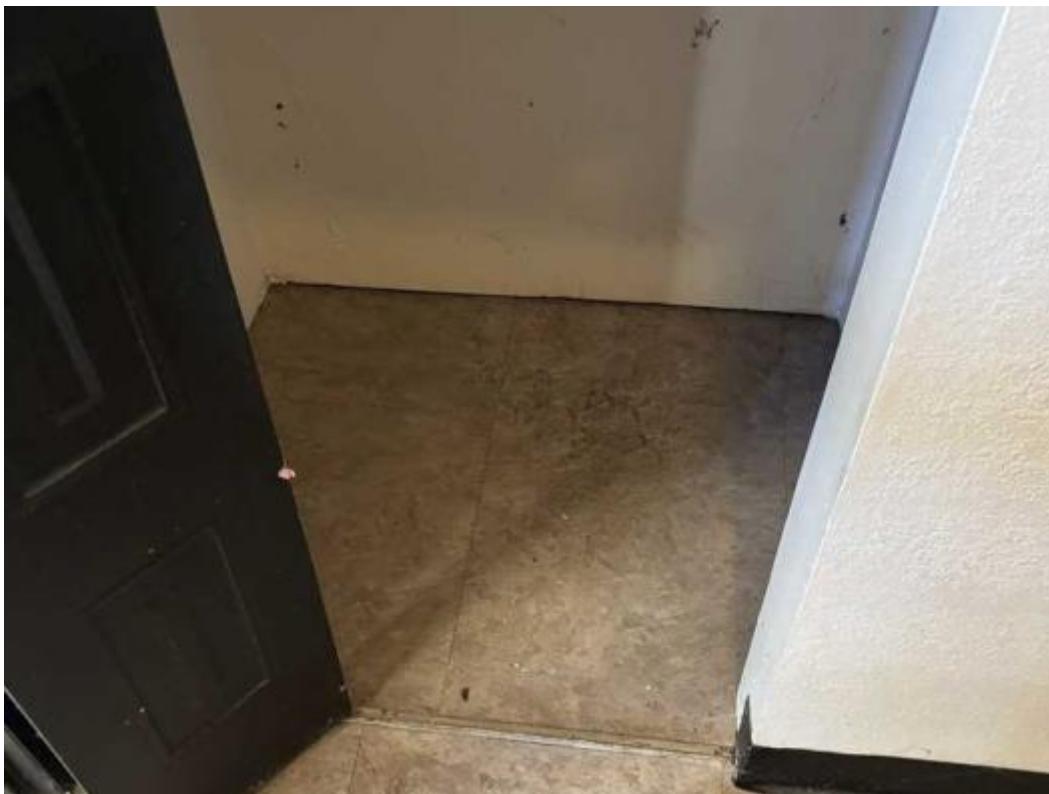
**Main Level/Closet 2 - 58-Closet 2 door, trim, and vinyl tile flooring**

Bifold door, flooring, and wall damage.
