NARRATIVE REPORT

DWELLING

Carrier:	Assurant Flood Insurance Program	Date of Loss:	9/27/2024
Insured:	NICOLE & HAROLD SATTERWHITE	Assigned:	10/15/2024
CID:	243558	Contacted:	10/15/2024
Claim Number:	8704948589-09272024	Inspected:	10/25/2024
Policy Number:	8704948589	Inspected With:	none
Loss Address:	2860 JOE LITTLE RD CRUMPLER NC 28617	Mailing Address:	2860 JOE LITTLE RD CRUMPLER NC 28617
Coverage A:	\$ 250,000.00	Mortgage:	FIRST NATIONAL BANK OF PA
Coverage B:	\$ 0.00	Verified with:	POLICYHOLDER
Policy Term:	3/24/2024 to 3/24/2025

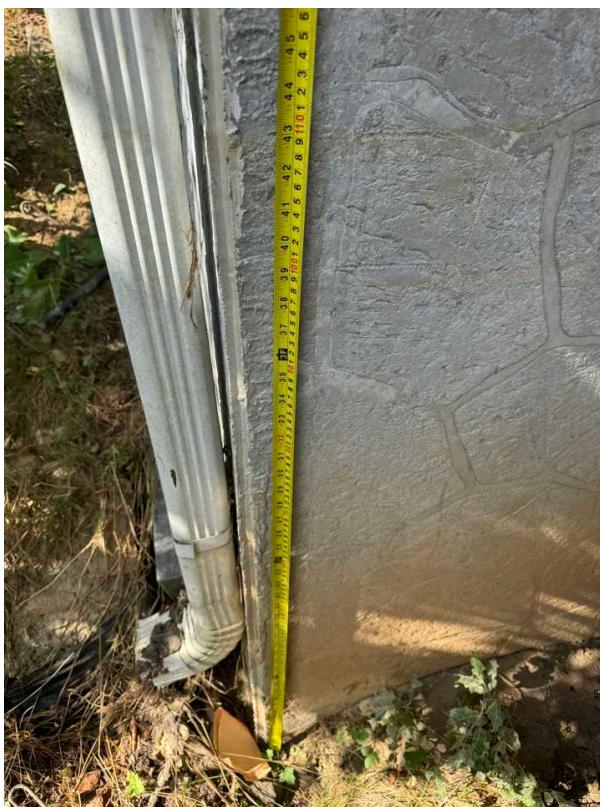
2-Insured Risk

Exterior flood line - 43 in

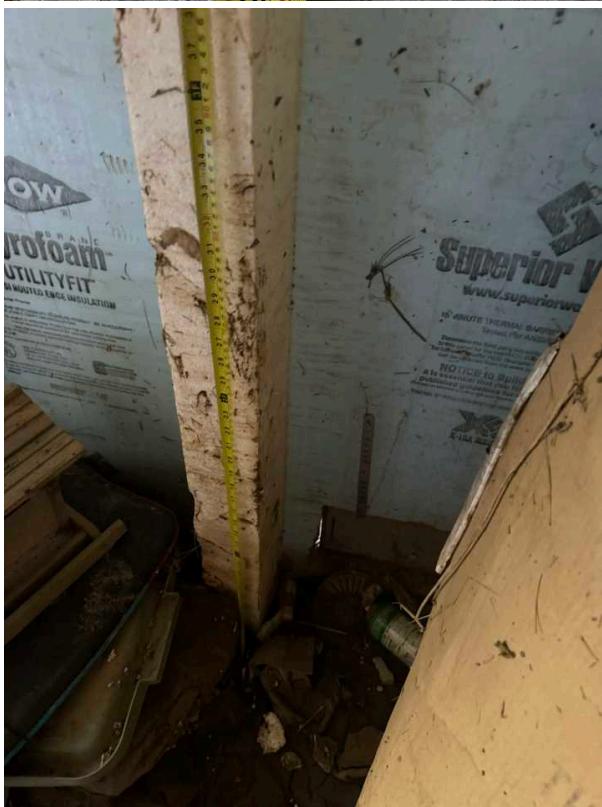
4-Insured Risk

Enclosure flood line - 47 in

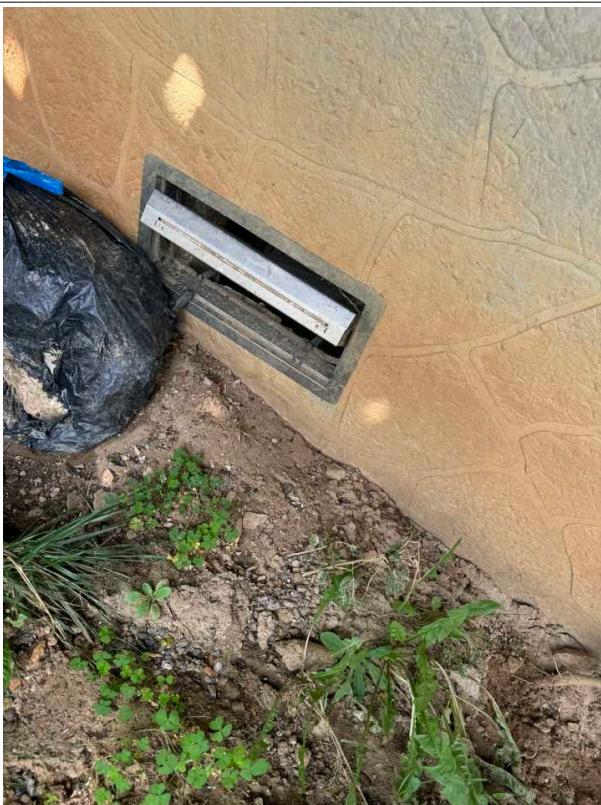
17-Insured Risk

Enclosure vents

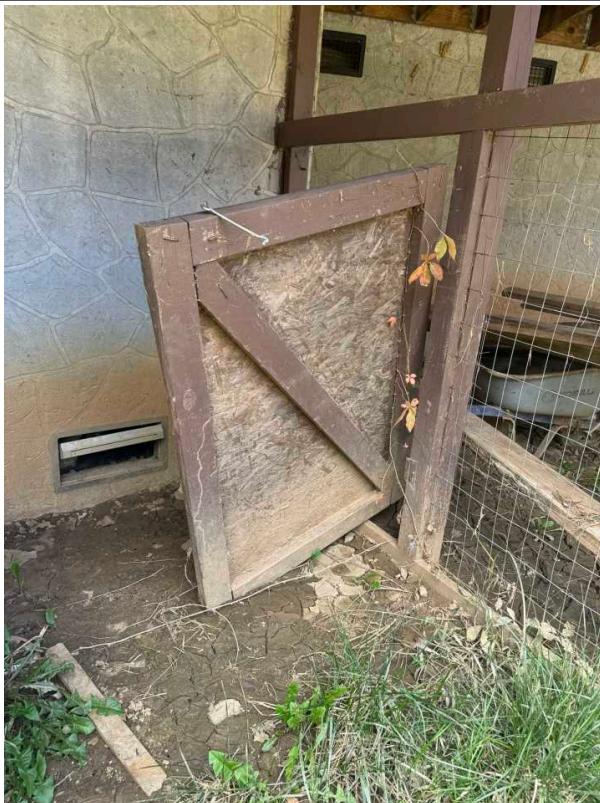
21-Insured Risk

Damage to exterior

- Clean with pressure washer exterior wall surfaces to 1' above the flood line on the rear, right, and left elevations

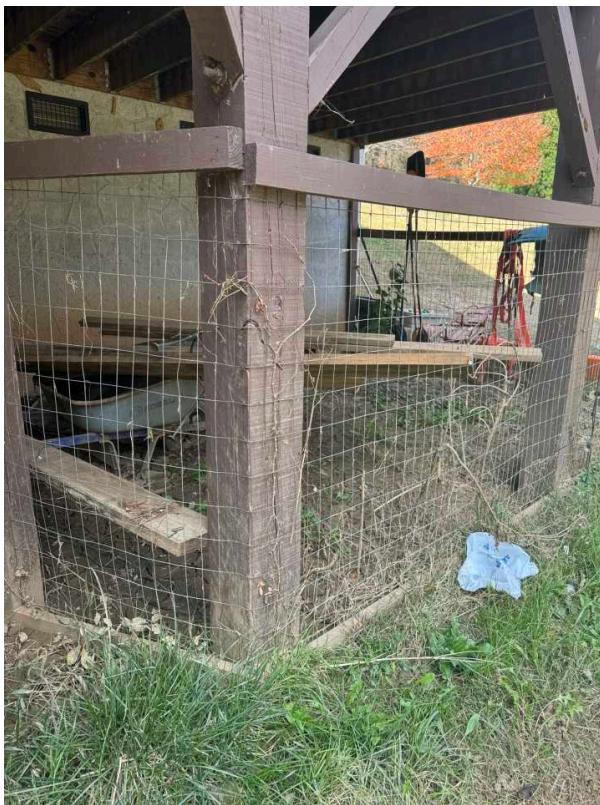
22-Insured Risk

Damage to exterior

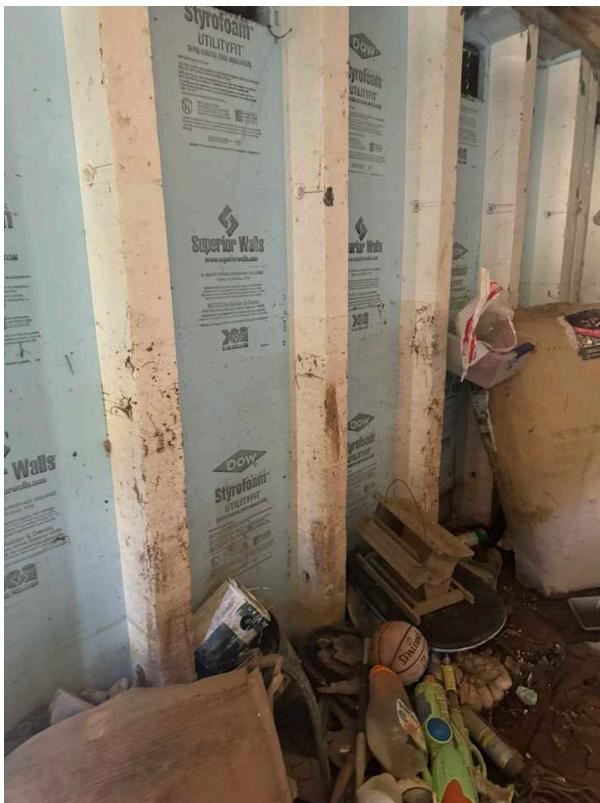
24-Insured Risk

Flood damage to lower enclosure.

- Flood loss cleanup of the lower enclosure, treat with anti-microbial and dry out.
- Clean, sanitize the interior surface masonry walls.

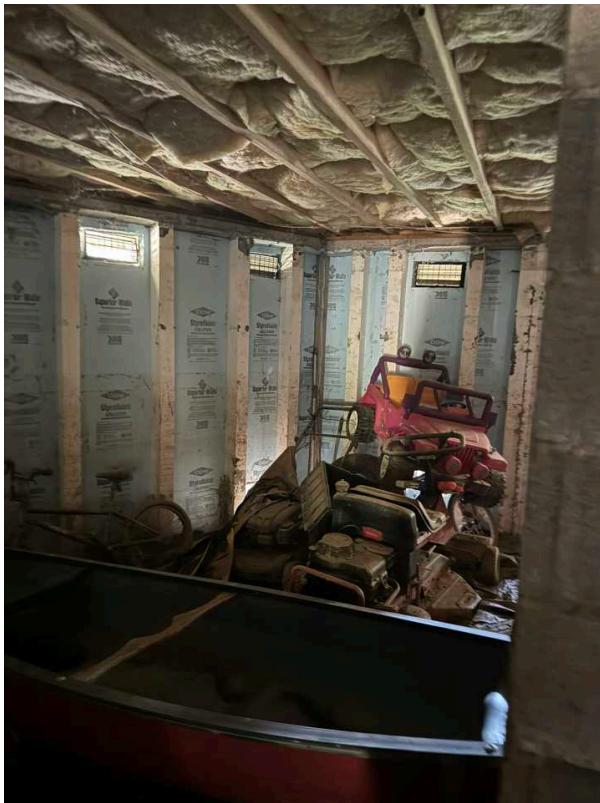
26-Insured Risk

Flood damage to lower enclosure.

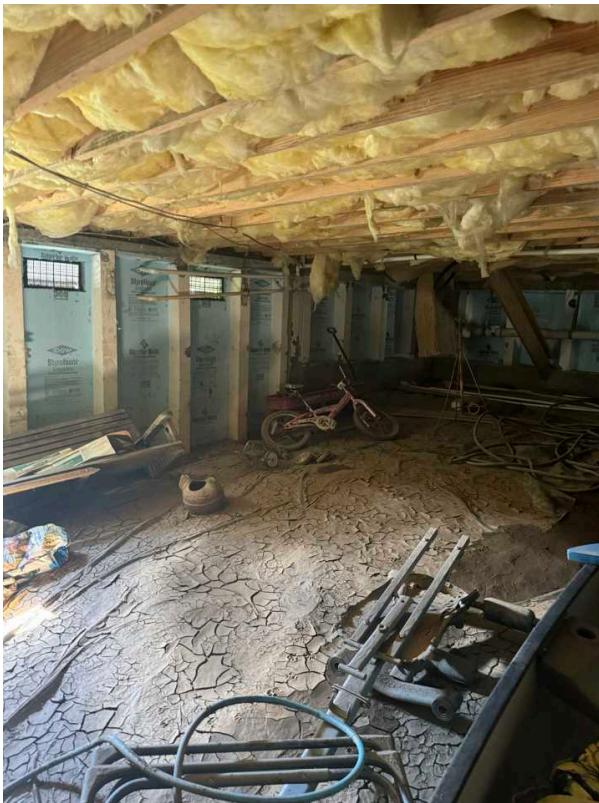
28-Insured Risk

Flood damage to lower enclosure.

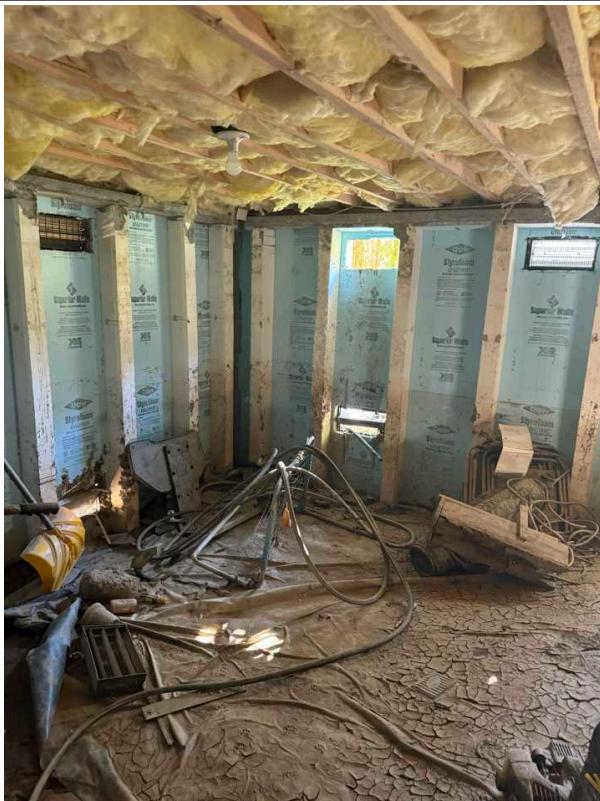
29-Insured Risk

Flood damage to lower enclosure.

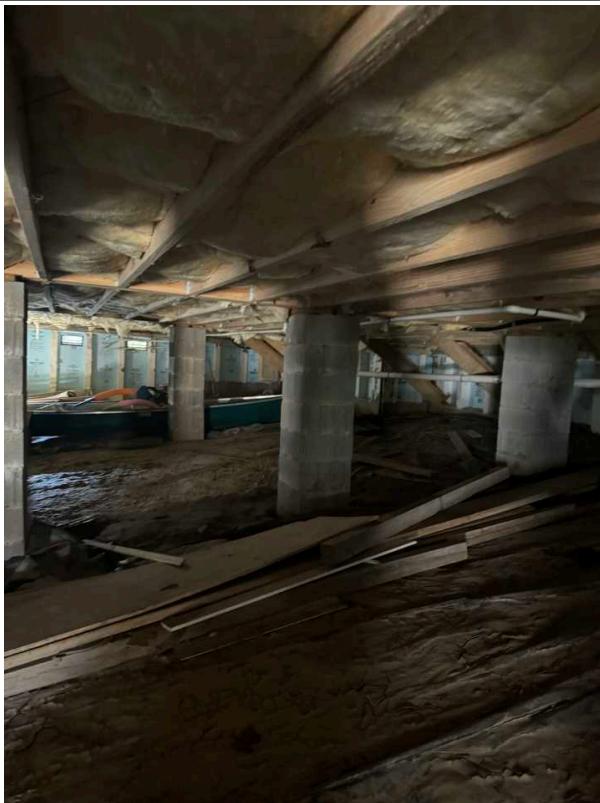
31-Insured Risk

Flood damage to lower enclosure.

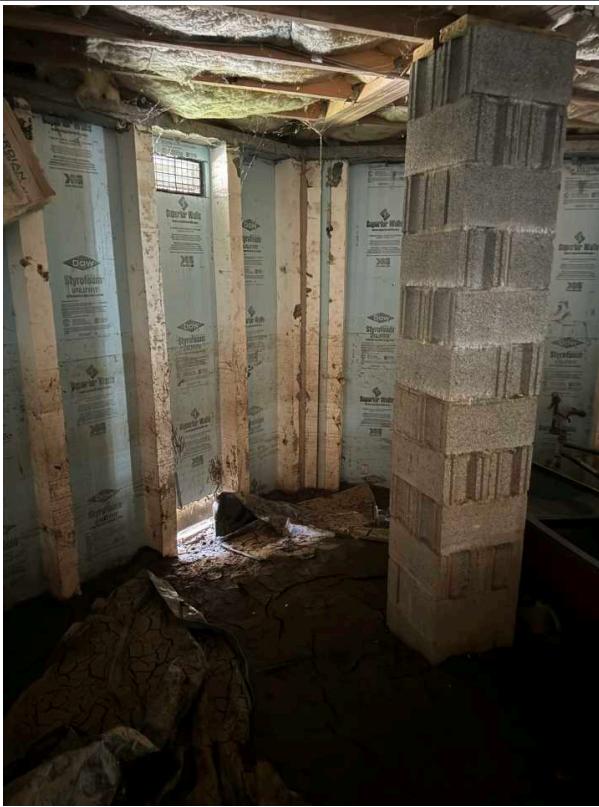
33-Insured Risk

Flood damage to lower enclosure.

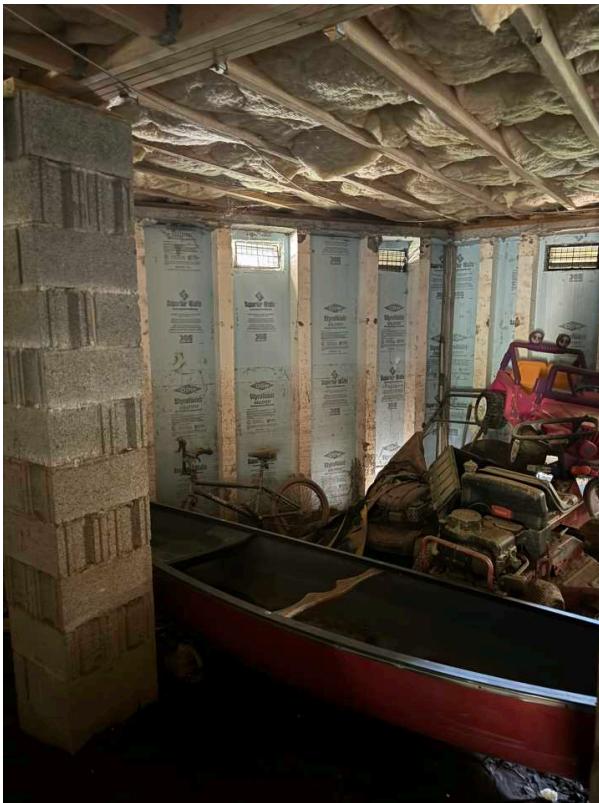
34-Insured Risk

Flood damage to lower enclosure.

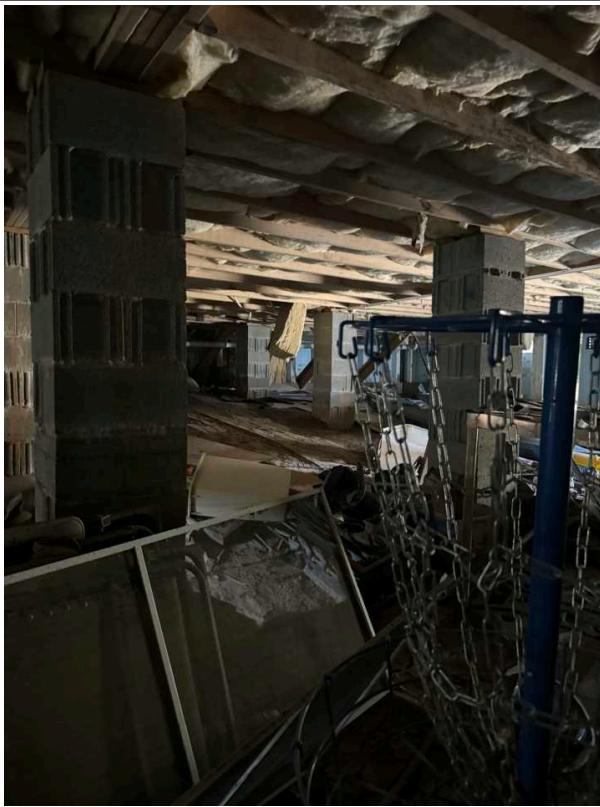
37-Insured Risk

Flood damage to lower enclosure.

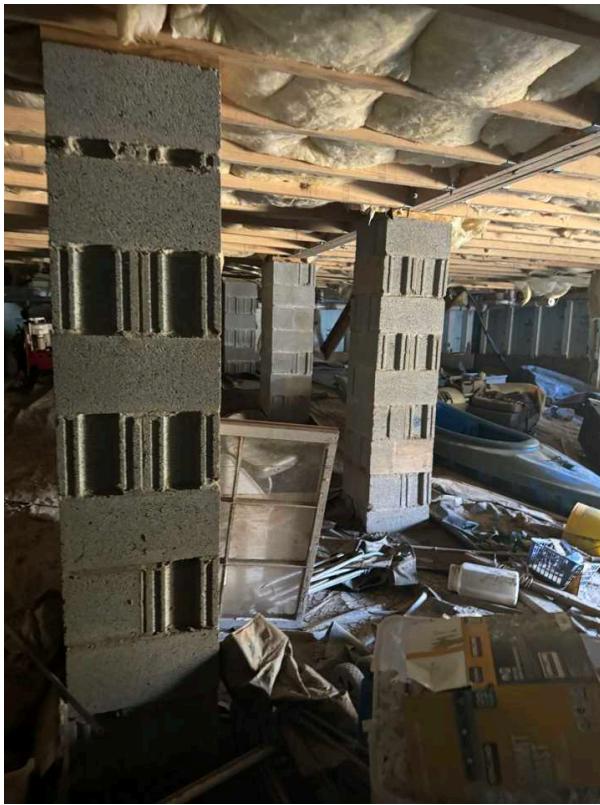
38-Insured Risk

Flood damage to lower enclosure.

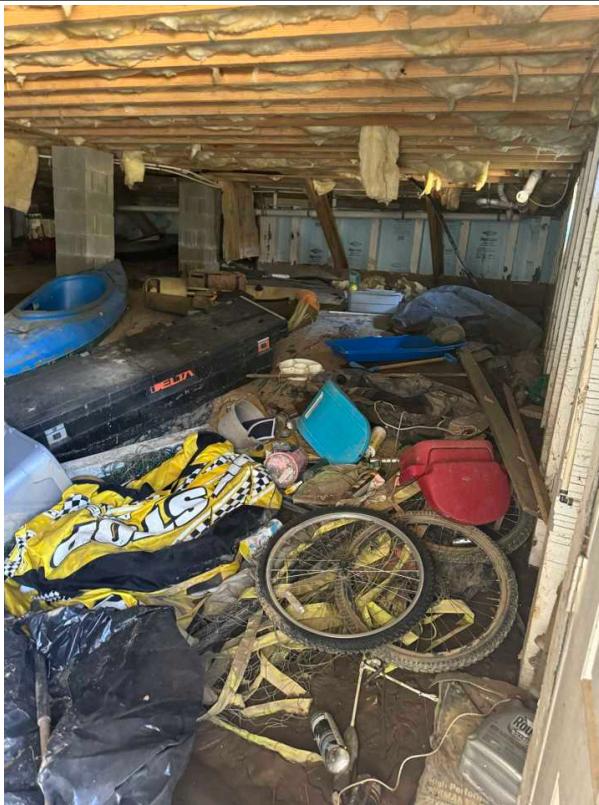
39-Insured Risk

Flood damage to lower enclosure.

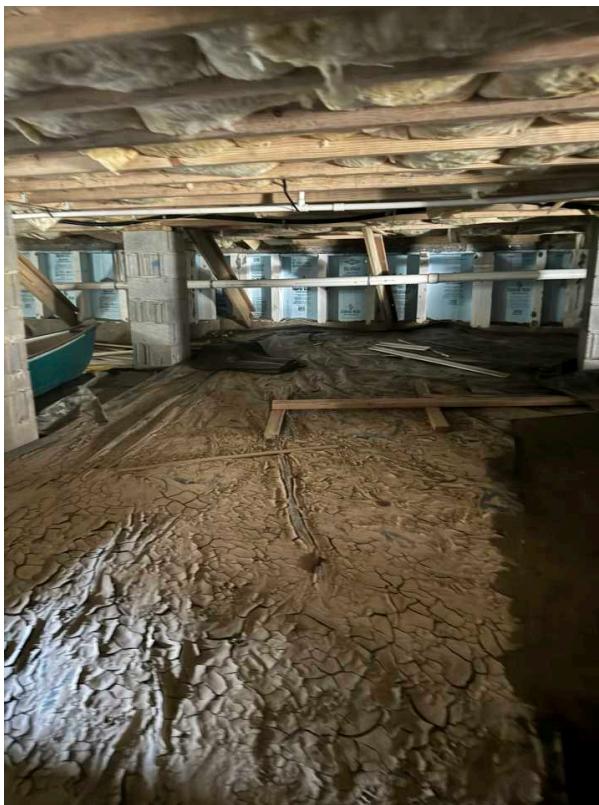
Date Taken: 10/25/2024
Taken By: Dina Bullard
Flood damage to lower enclosure.

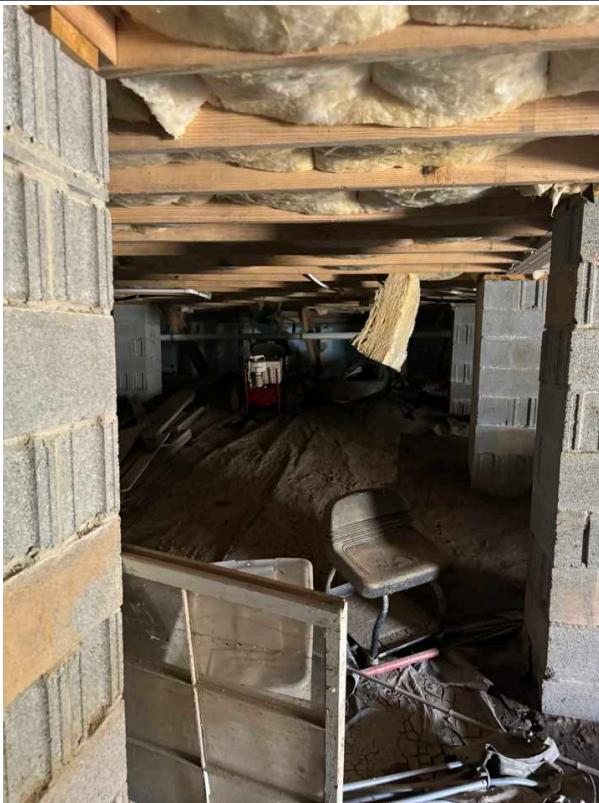
41-Insured Risk

Flood damage to lower enclosure.

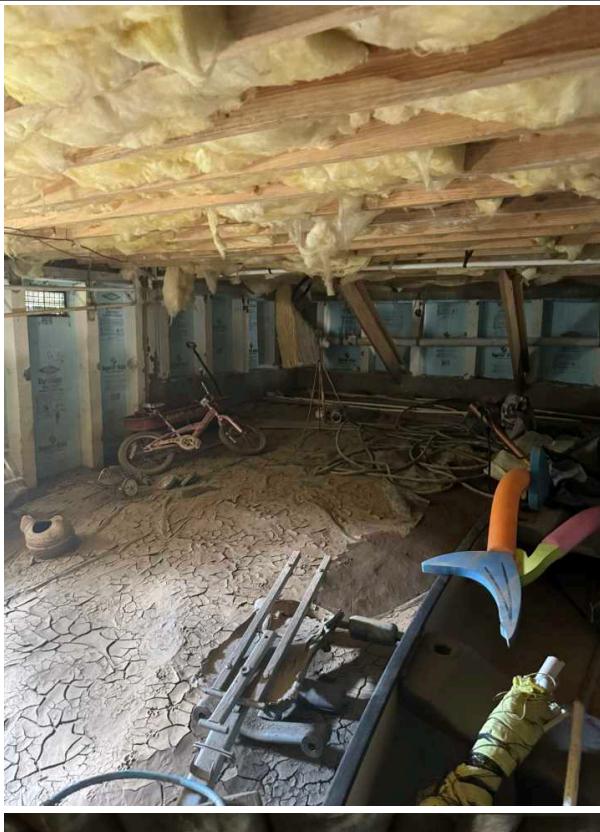
43-Insured Risk

Flood damage to lower enclosure.

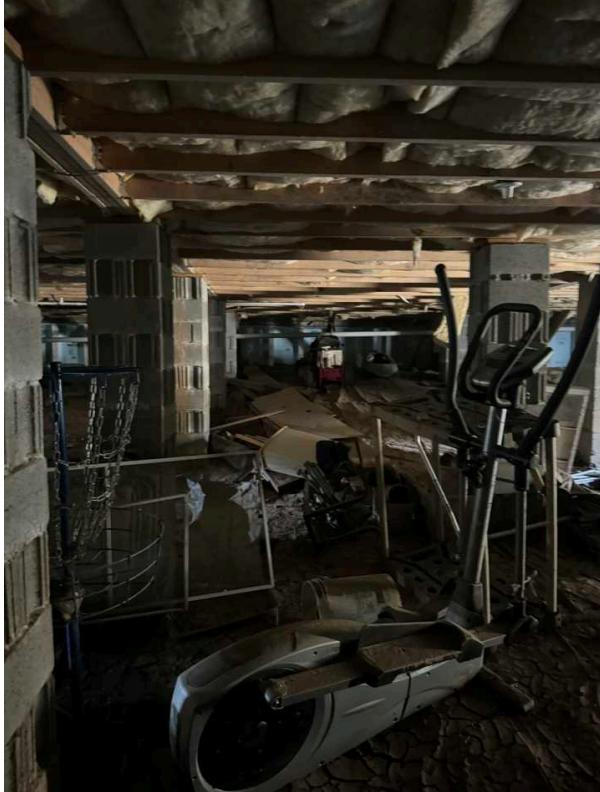
44-Insured Risk

Flood damage to lower enclosure.
