NARRATIVE REPORT

Request for Additional Payment

Carrier:	National General	Date of Loss:	7/17/2024
Insured:	. SENSIBLE CHOICE CONTRACTING, LLC	Assigned:	7/18/2024
CID:	233986	Contacted:	7/23/2024
Claim Number:	542109		
Policy Number:	0002903783		
Loss Address:	2 SHERMAN PL OSSINING NY 10562-3610	Mailing Address:	2 SHERMAN PL OSSINING NY 10562-3610

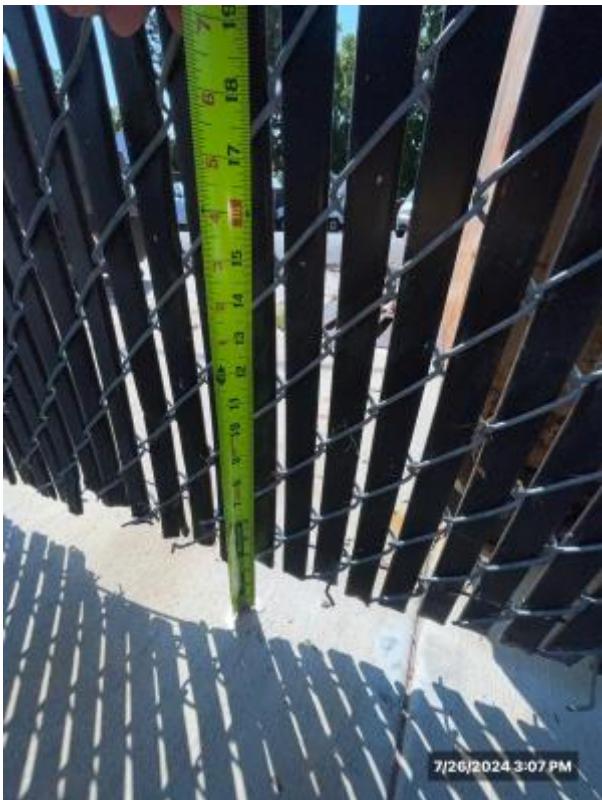
11-Fencing Water Line

approx 7 inches

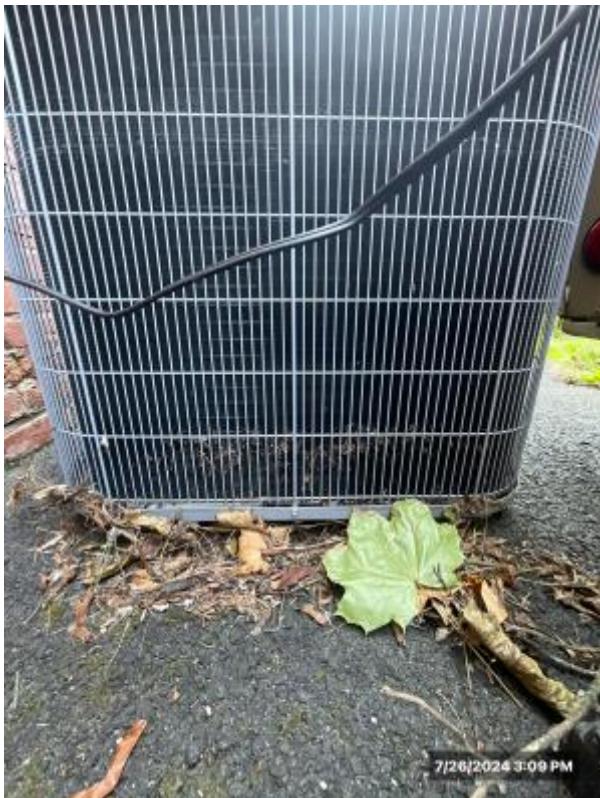
19-AC Unit 1

Water line visible

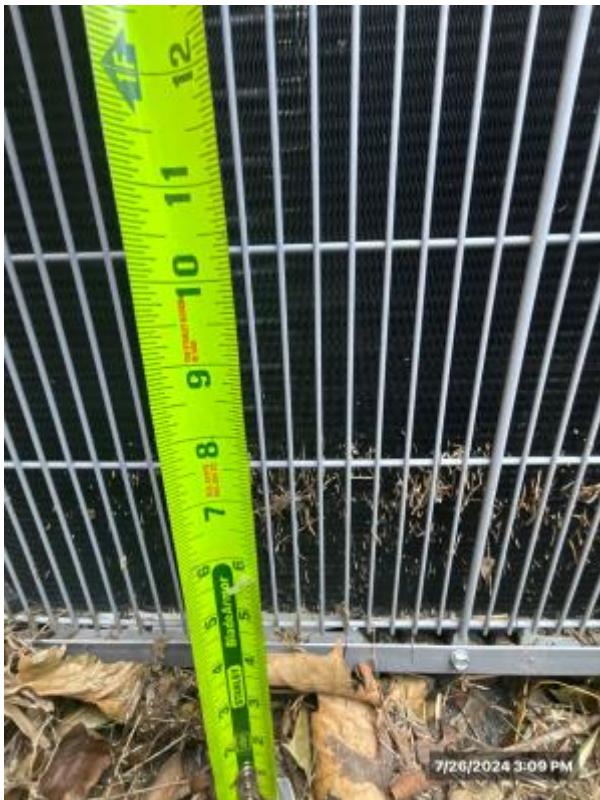
21-AC Unit 1

Water line approx 6 inches, unit is functioning normally

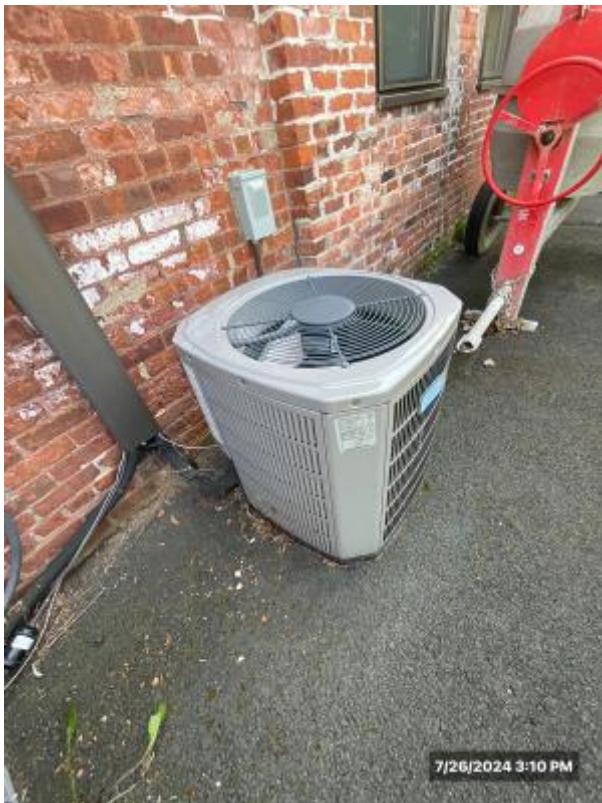
23-AC Unit 2

unit functioning normally

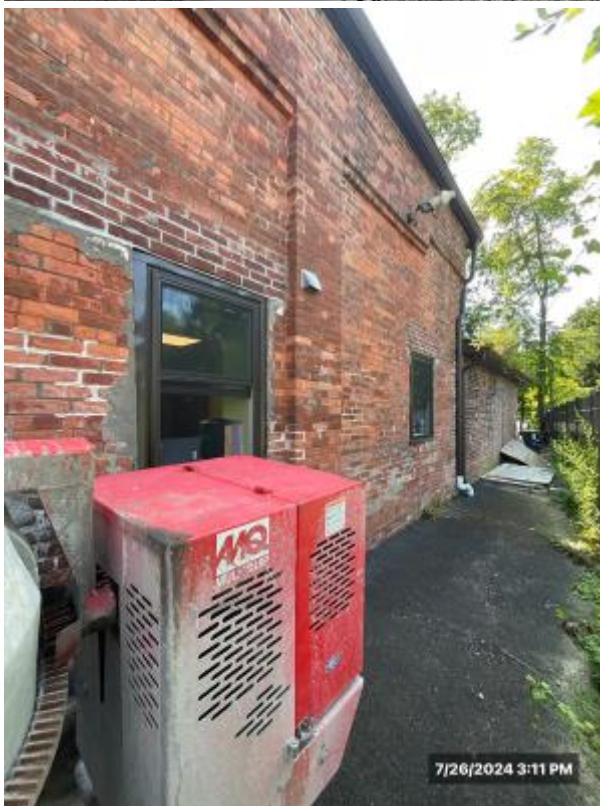
26-Right Elevation

walking the elevation towards the rear - no flood damages this area

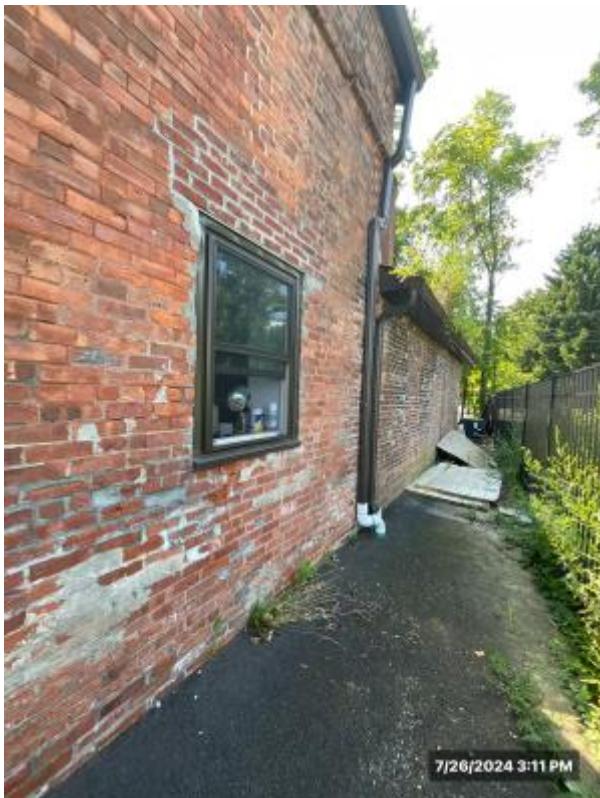
27-Right Elevation

walking the elevation towards the rear -
no flood damages this area

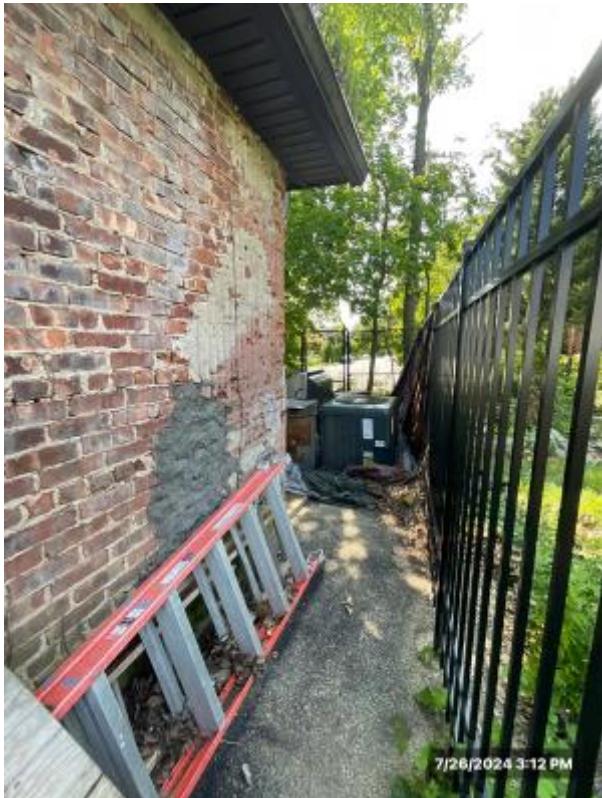
29-Right Elevation

walking the elevation towards the rear -
no flood damages this area

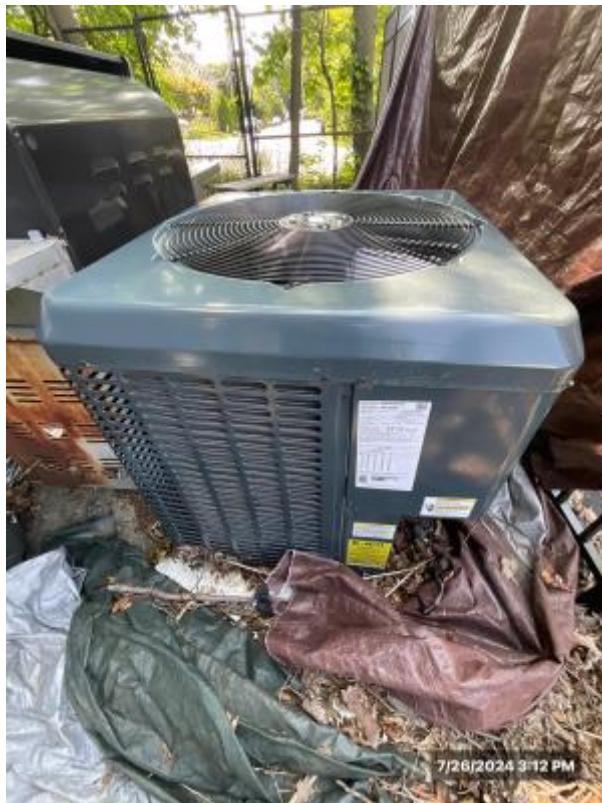
31-AC Unit 3

unit disconnected pre-loss

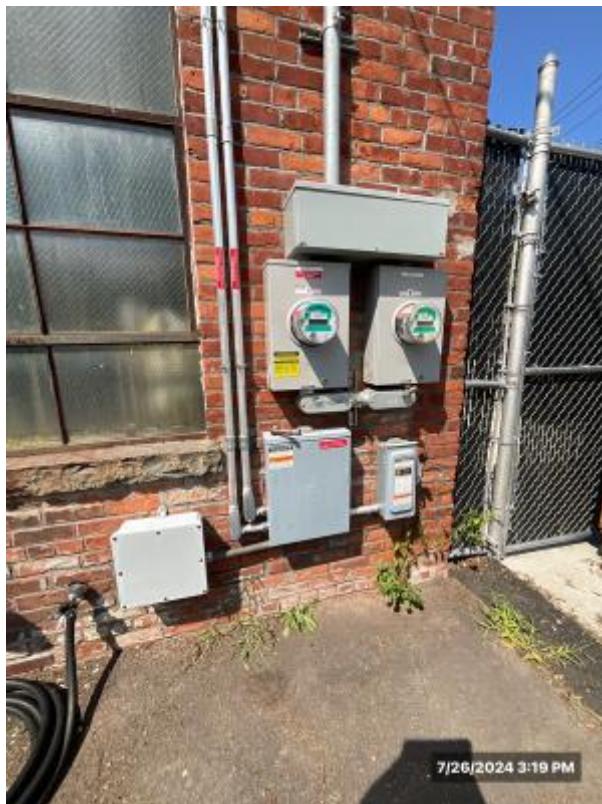
36-Left Elevation Meters

no visible/reported damages

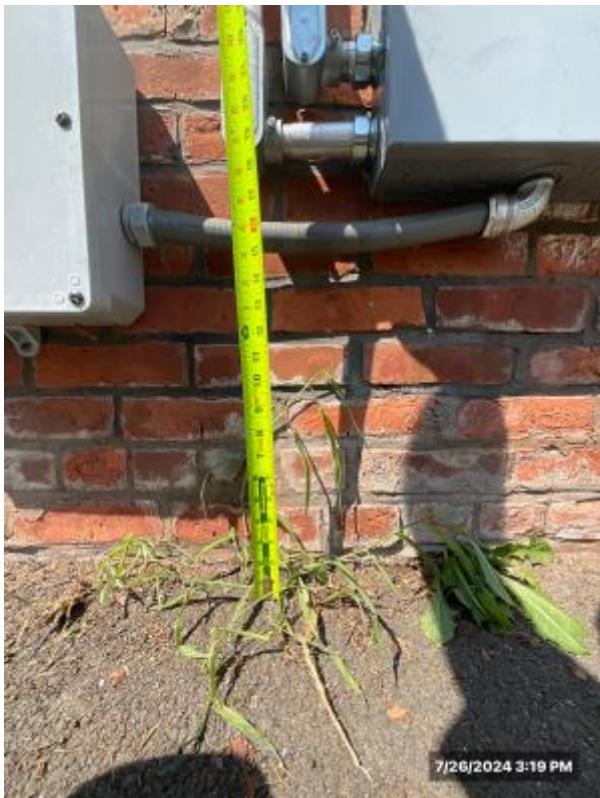
37-Left Elevation Meters

no visible/reported damages

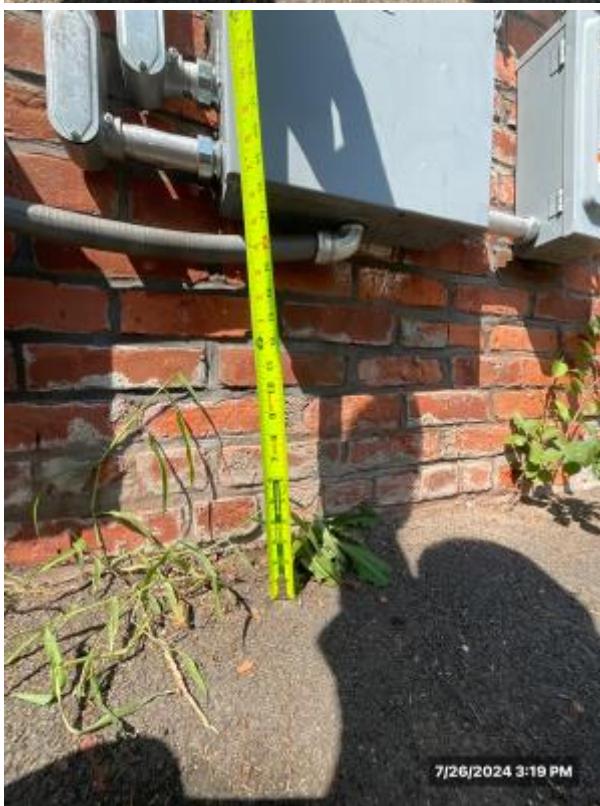
38-Left Elevation Meters

no visible/reported damages

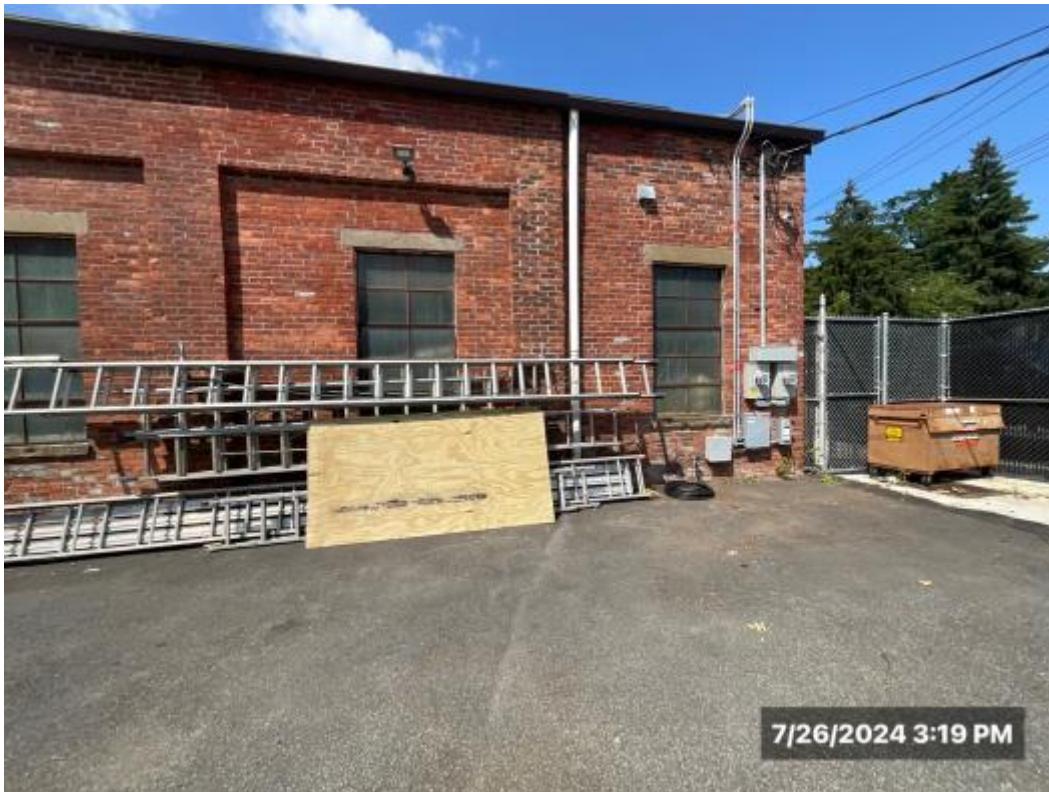
39-Left Elevation

no visible/reported flood damages this elevation

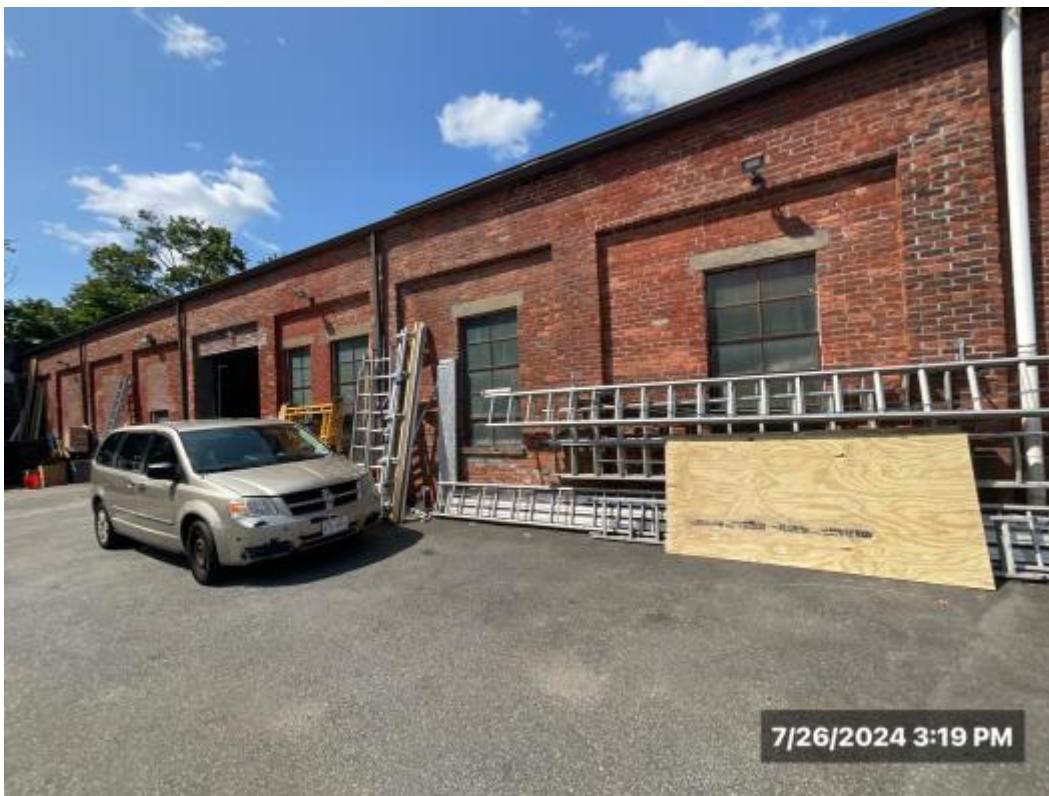
40-Left Elevation

no visible/reported flood damages this elevation

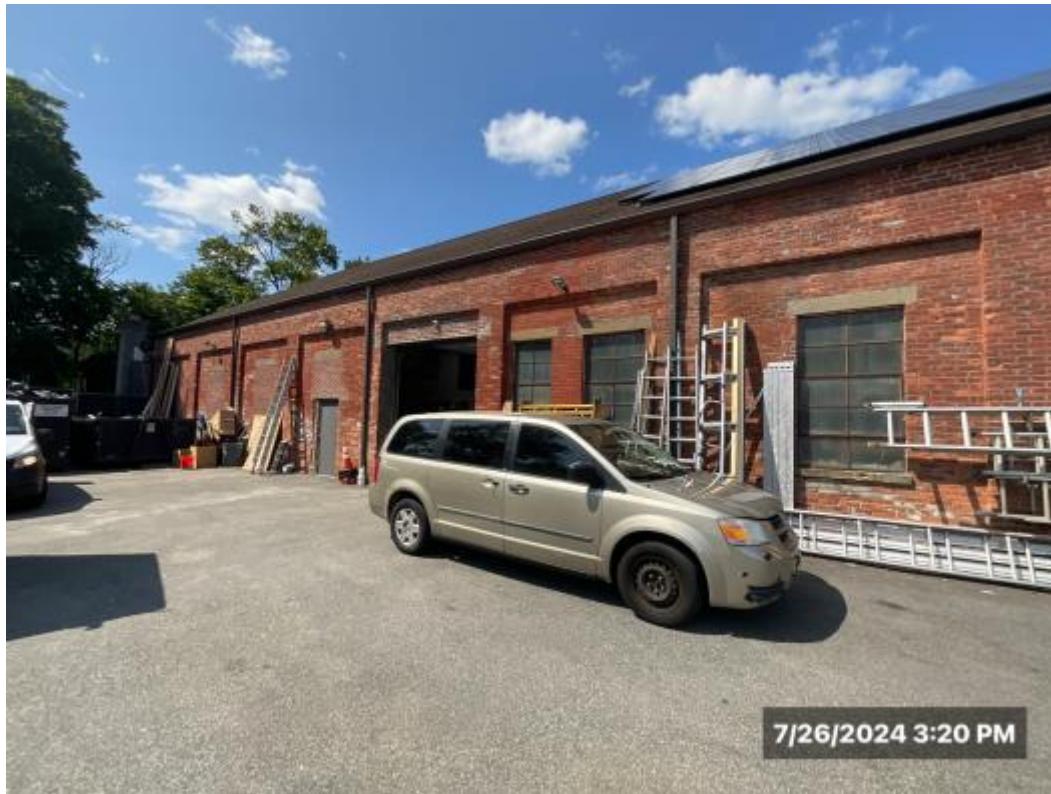
41-Left Elevation

no visible/reported flood damages this elevation

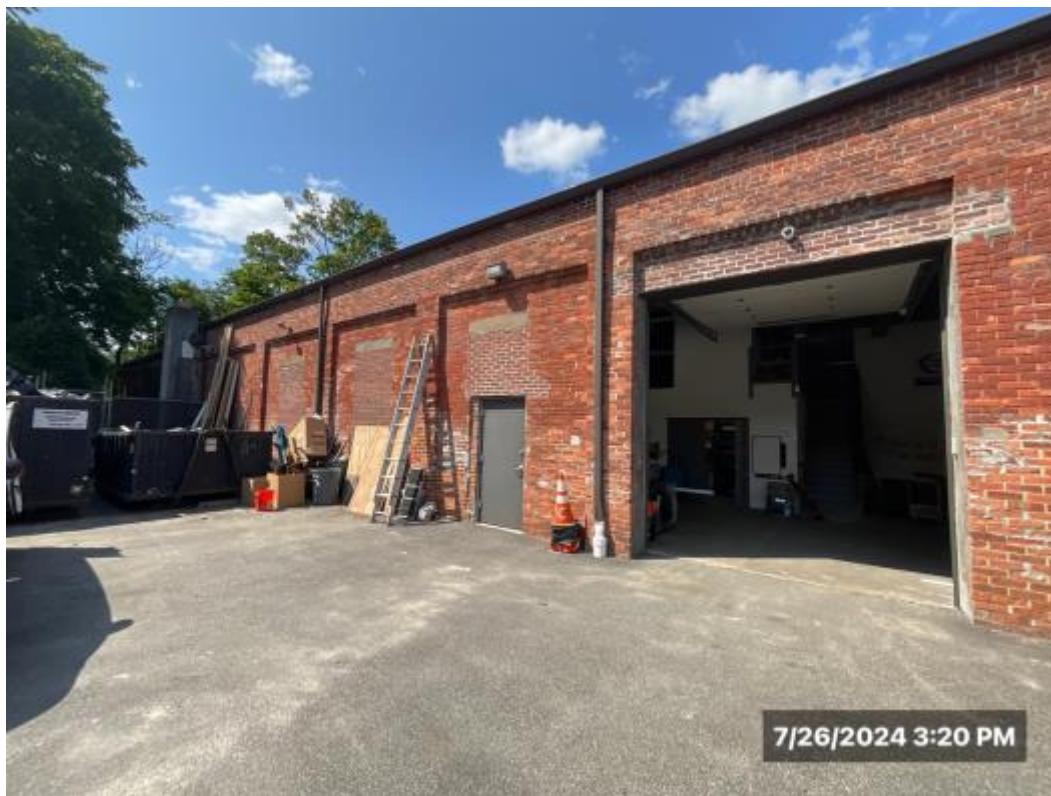
42-Left Elevation

no visible/reported flood damages this elevation

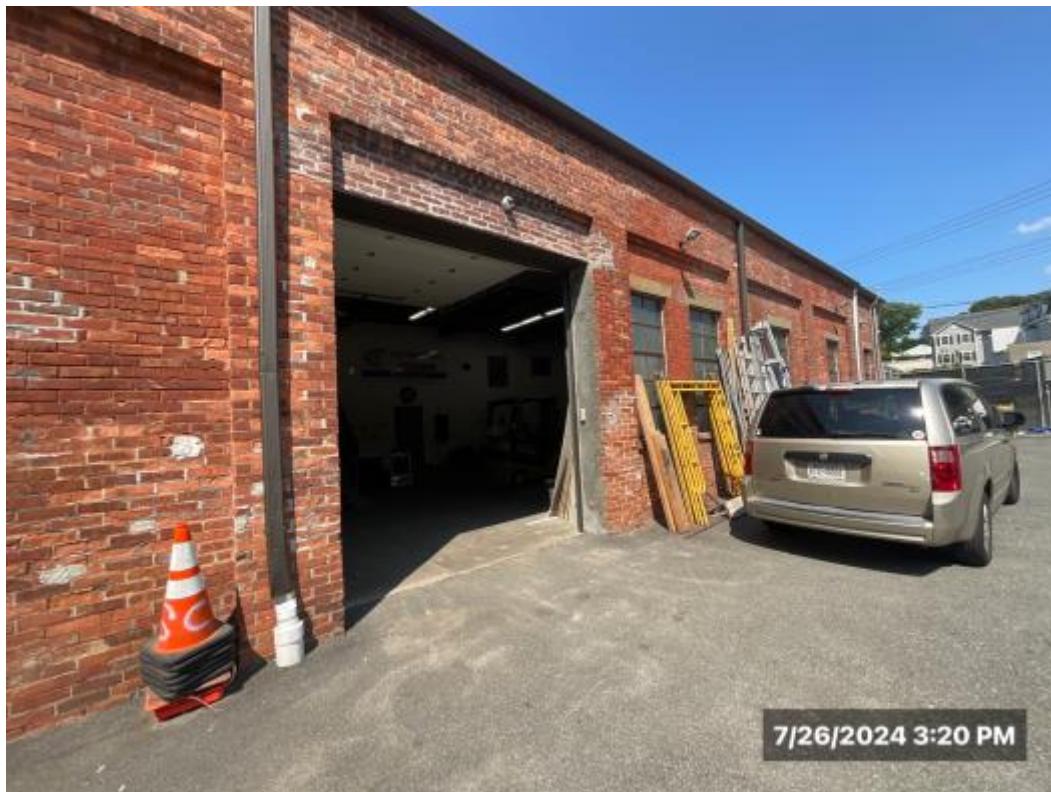
43-Left Elevation

no visible/reported flood damages this elevation

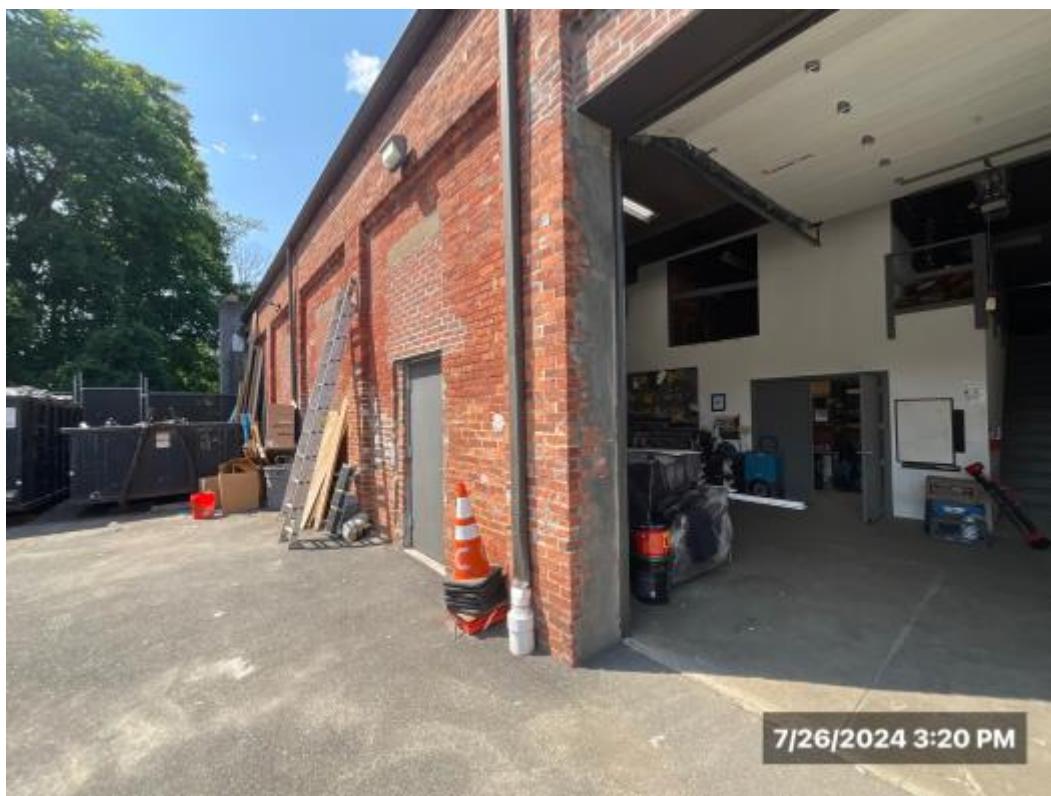
44-Left Elevation

no visible/reported flood damages this elevation

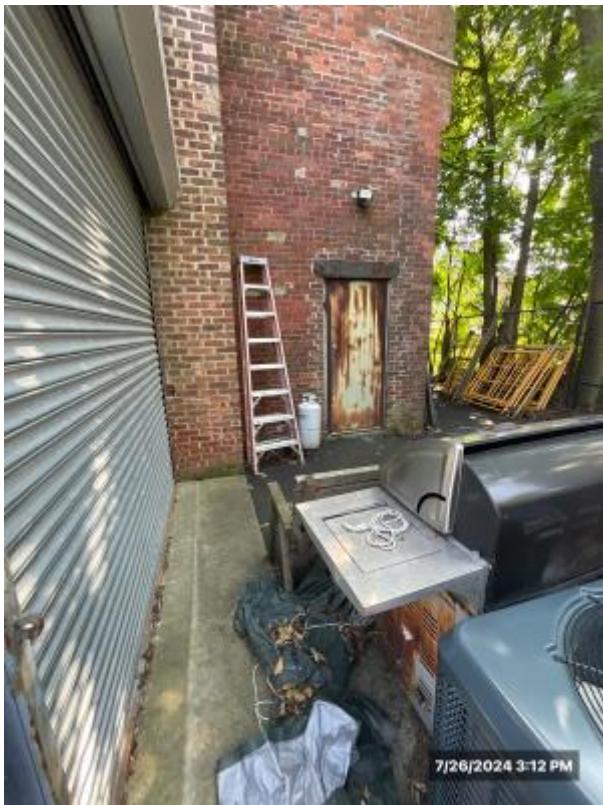
45-Rear Elevation

no visible/reported flood damages

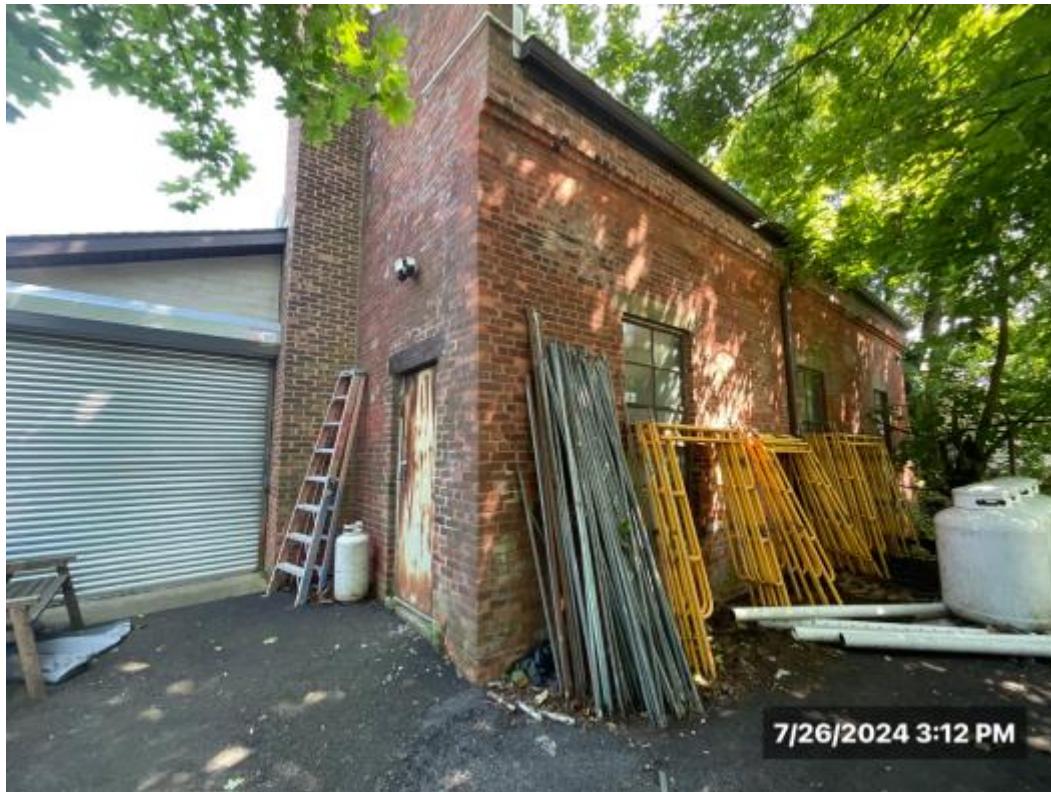
47-Rear Elevation

no visible/reported flood damages

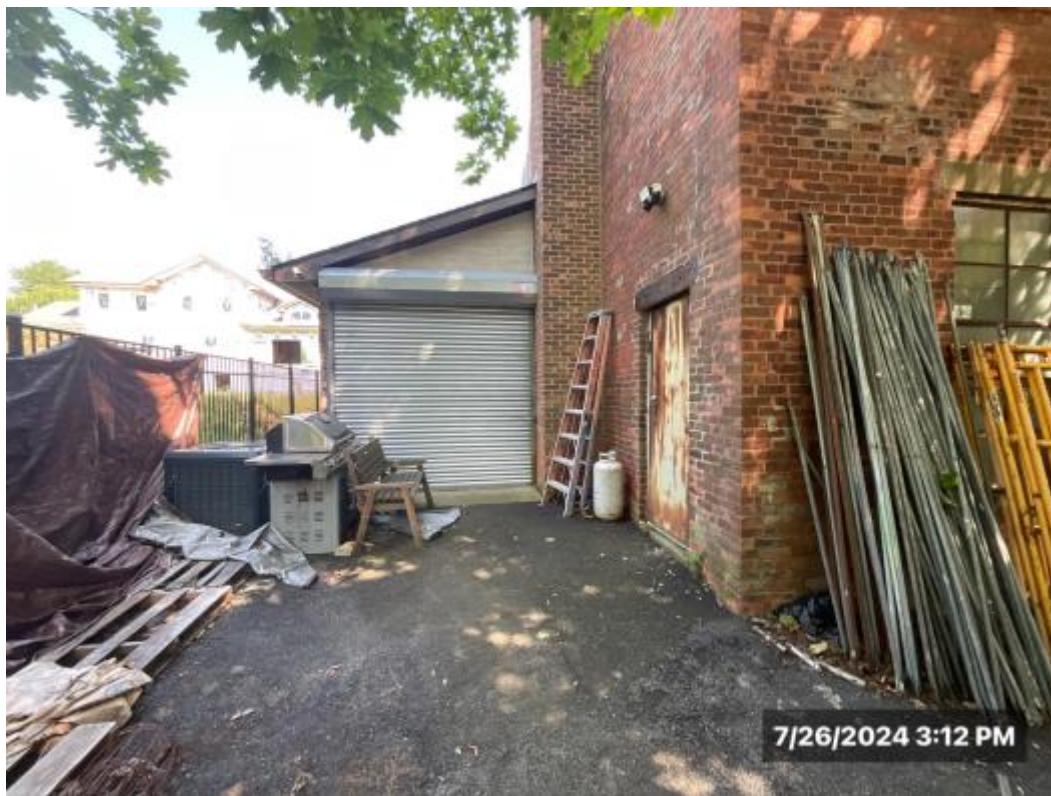
48-Rear Elevation

no visible/reported flood damages

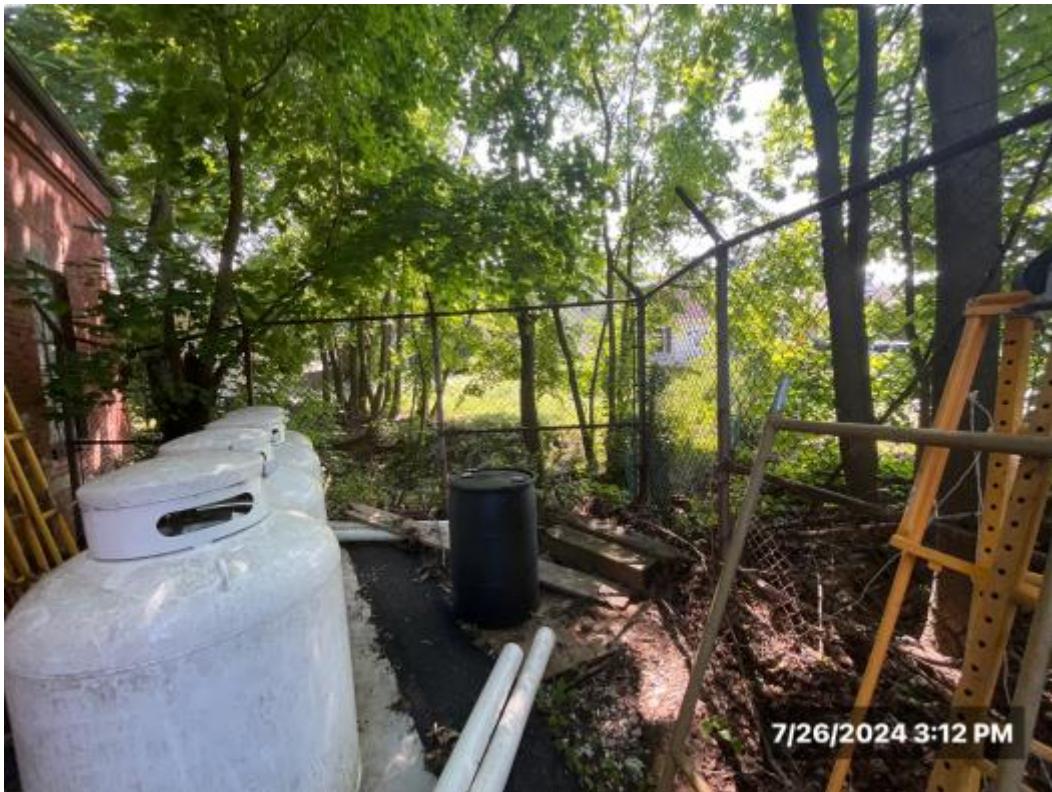
49-Rear Elevation

no visible/reported flood damages

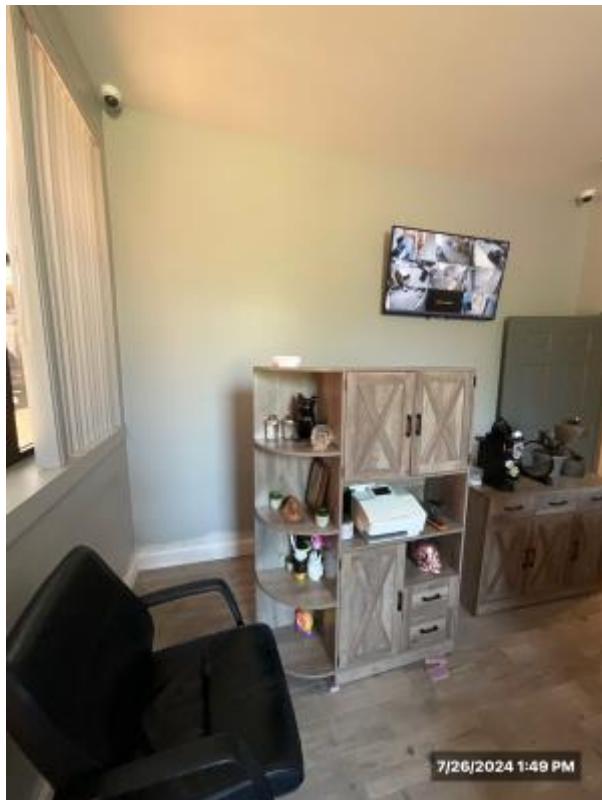
51-Reception

overviews upon entry to the building -
flood cuts and baseboard repairs already
made

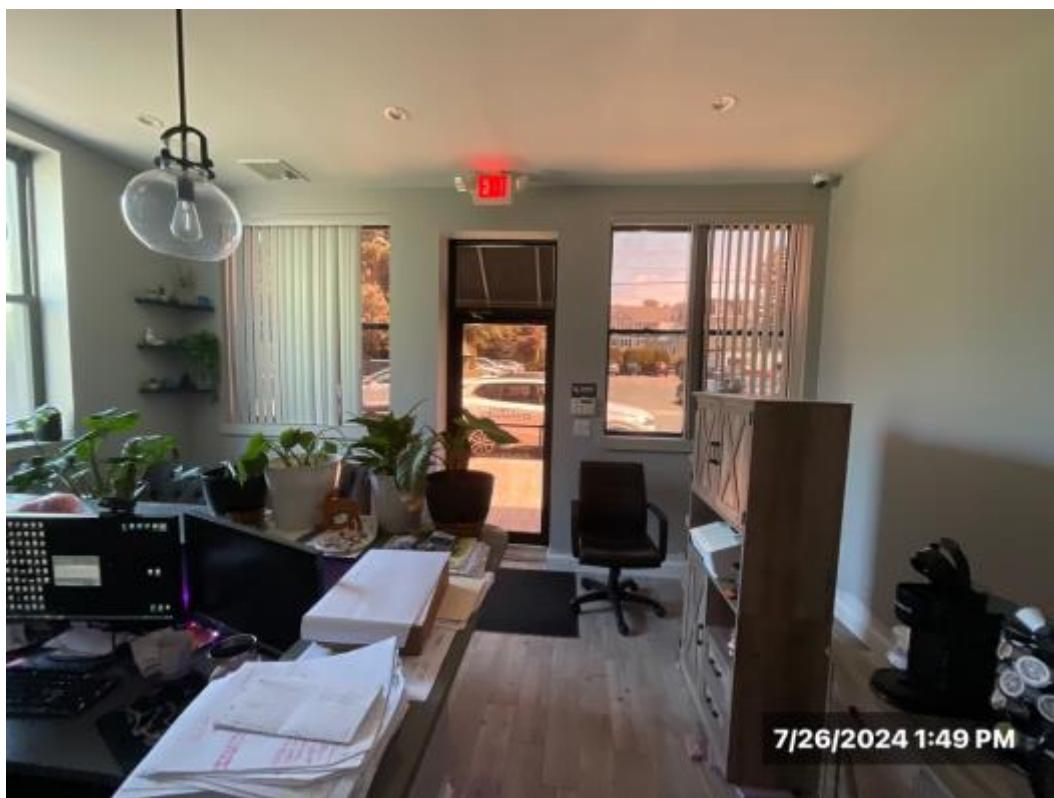
54-Reception

overviews upon entry to the building -
flood cuts and baseboard repairs already
made

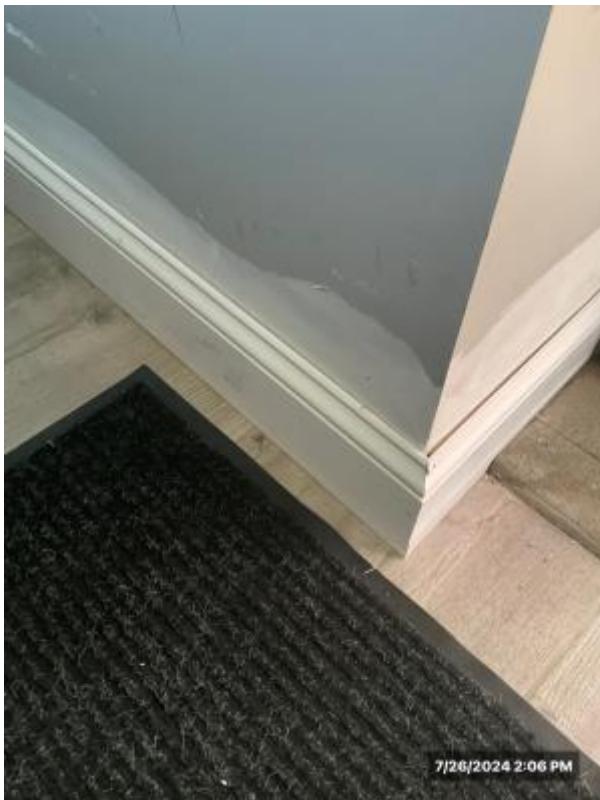
55-Reception

overviews upon entry to the building -
flood cuts and baseboard repairs already
made

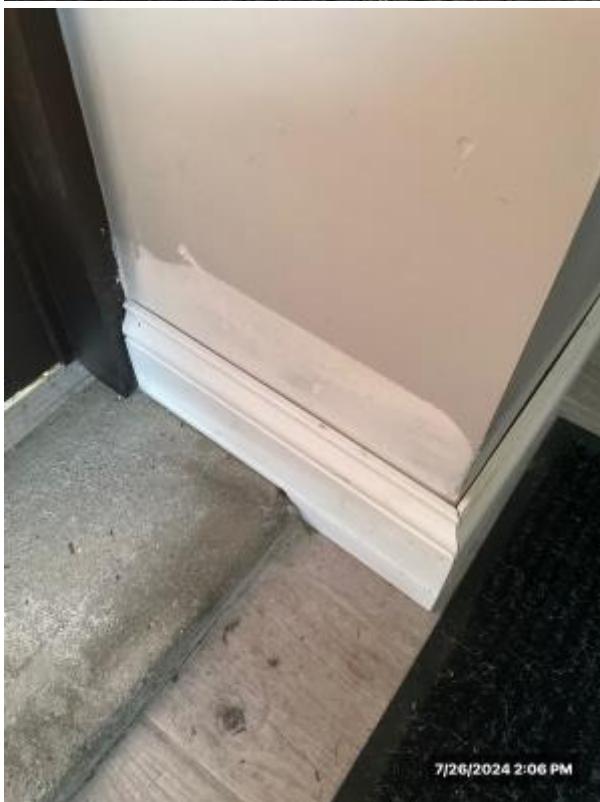
56-Reception

overviews upon entry to the building -
flood cuts and baseboard repairs already
made

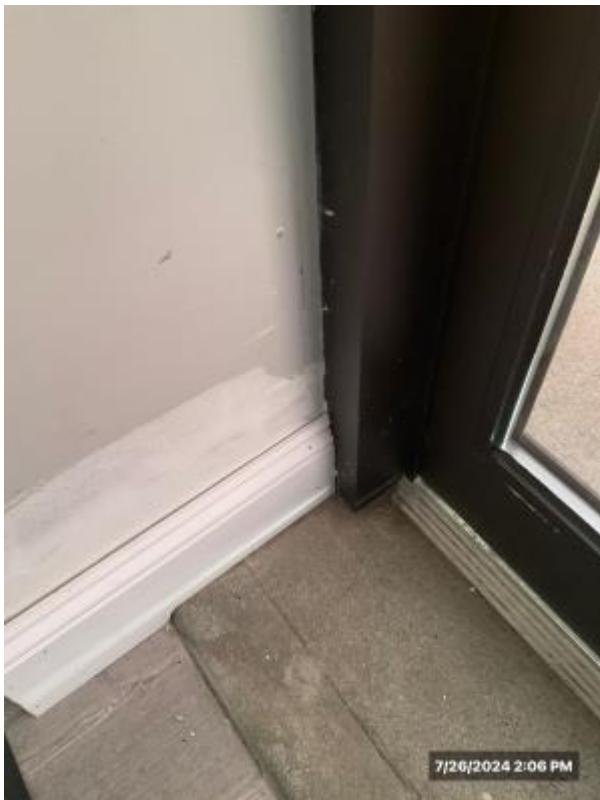
57-Reception

overviews upon entry to the building -
flood cuts and baseboard repairs already
made

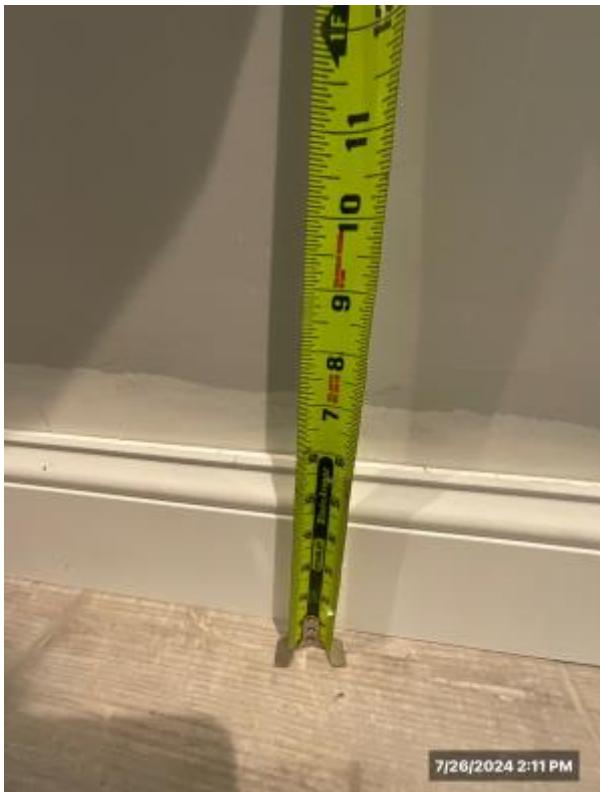
61-Reception

6" Baseboard throughout

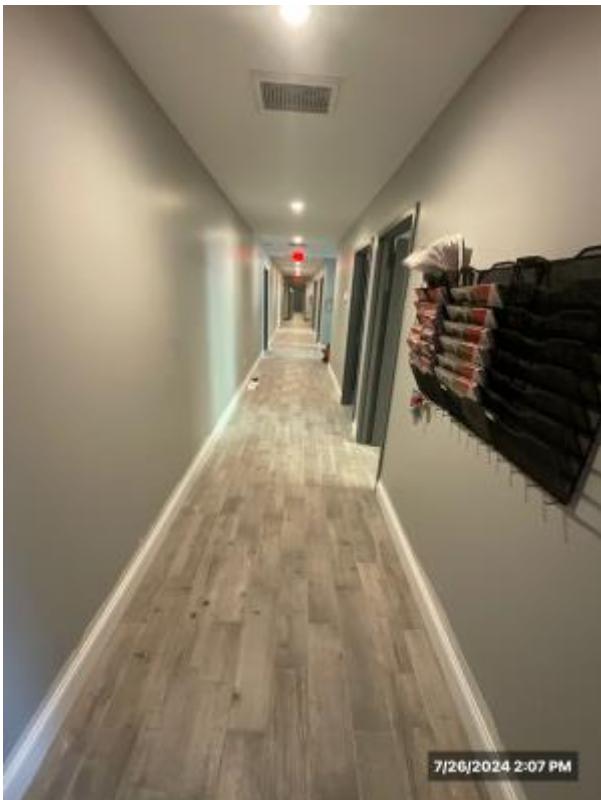
63-Hallway

overviews throughout the facility
hallway - floodcuts and baseboard
remove/replace already made

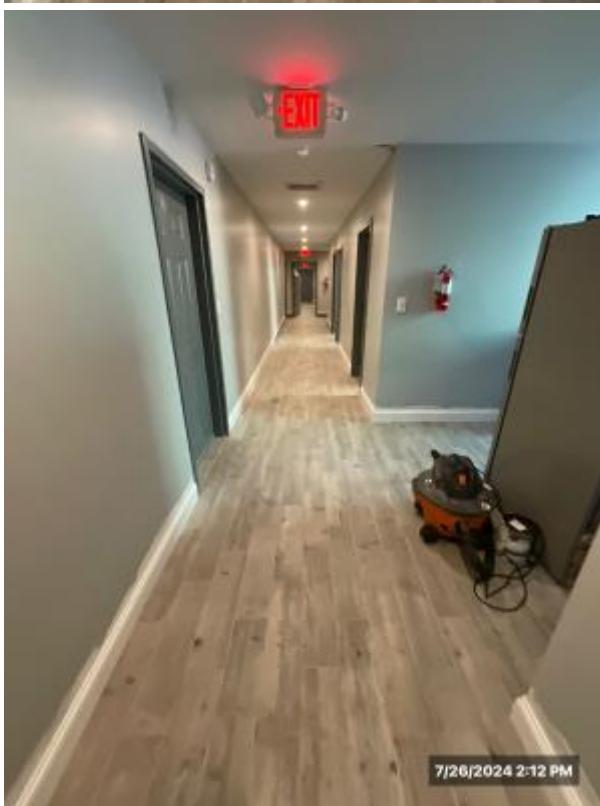
66-Hallway

overviews throughout the facility
hallway - floodcuts and baseboard
remove/replace already made

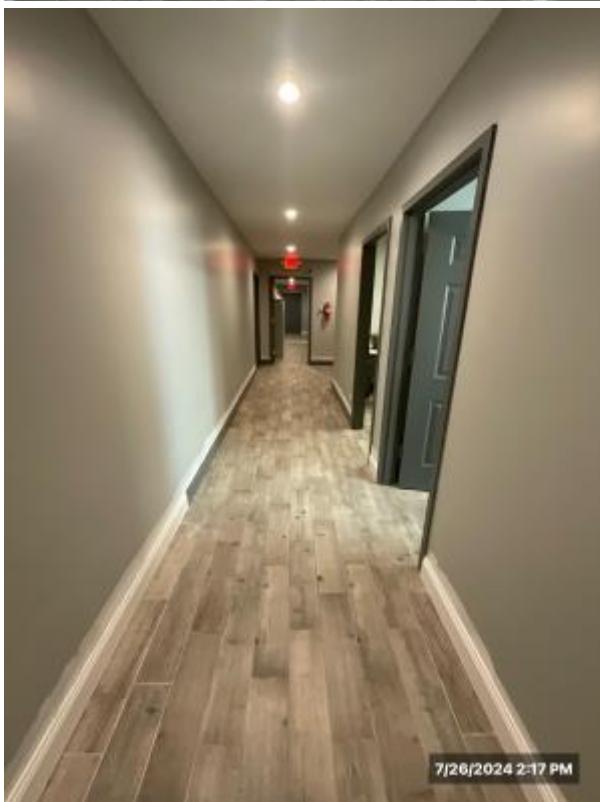
68-Hallway

overviews throughout the facility
hallway - floodcuts and baseboard
remove/replace already made

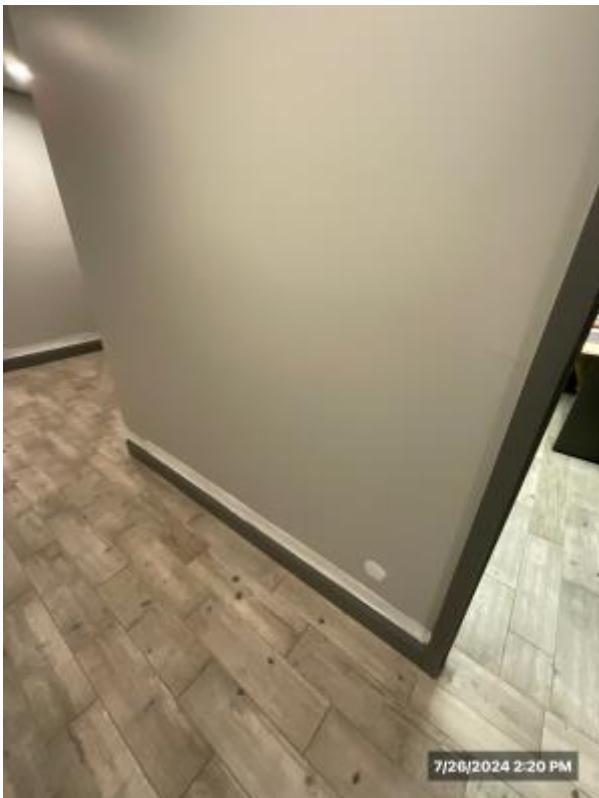
69-Hallway

overviews throughout the facility
hallway - floodcuts and baseboard
remove/replace already made

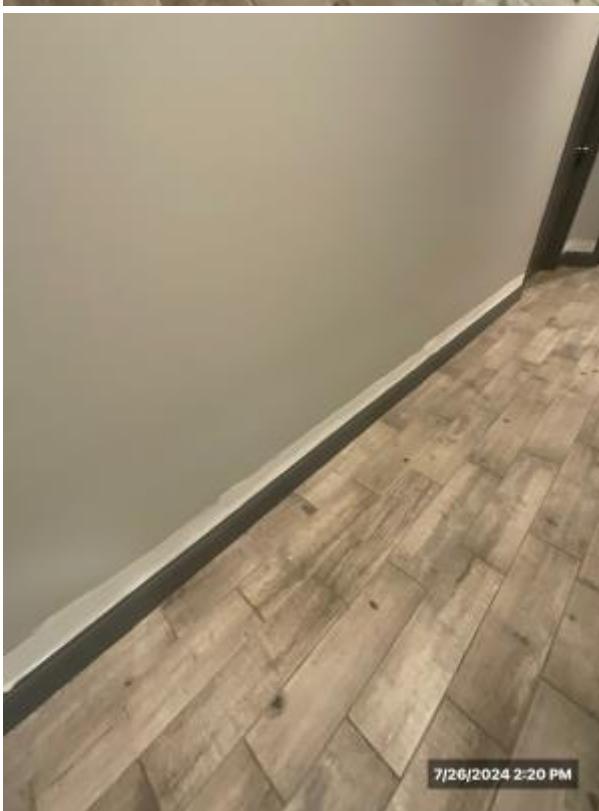
70-Hallway

overviews throughout the facility
hallway - floodcuts and baseboard
remove/replace already made

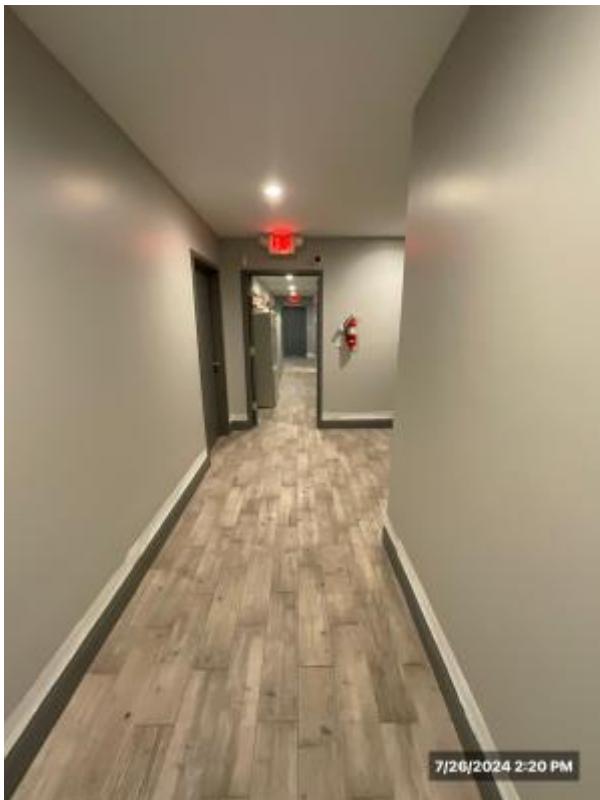
71-Hallway

overviews throughout the facility
hallway - floodcuts and baseboard
remove/replace already made

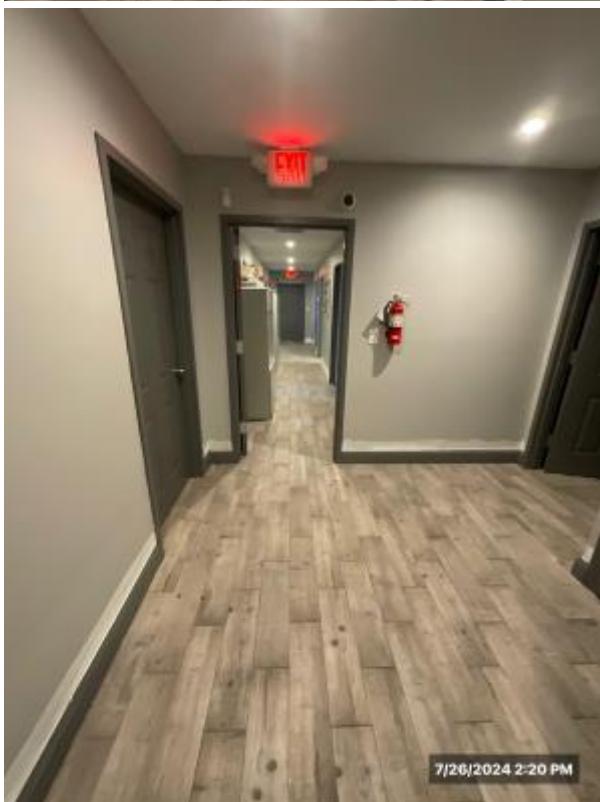
72-Hallway

overviews throughout the facility
hallway - floodcuts and baseboard
remove/replace already made

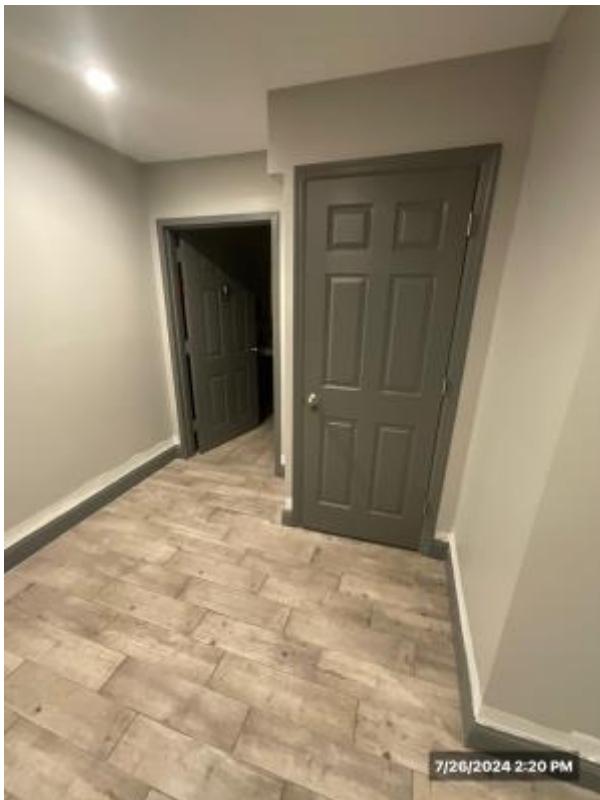
73-Hallway

overviews throughout the facility
hallway - floodcuts and baseboard
remove/replace already made

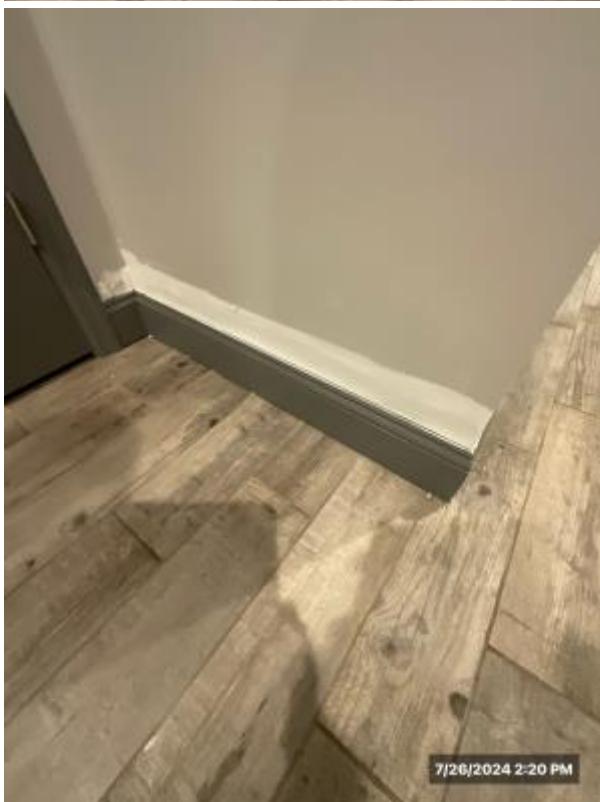
74-Hallway

overviews throughout the facility
hallway - floodcuts and baseboard
remove/replace already made

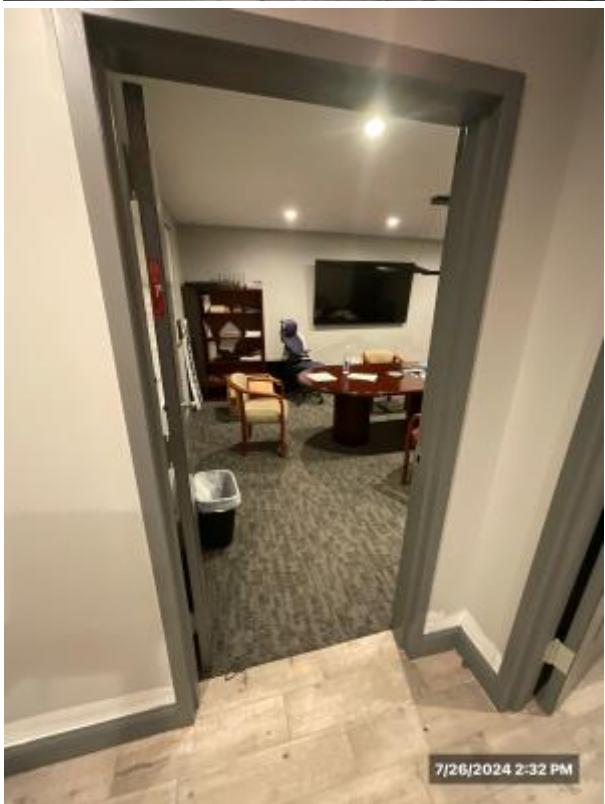
166-Conference Room

this room sustained catastrophic damage to the carpeting which has since been replaced - additional flood cut and baseboard remove/replace performed

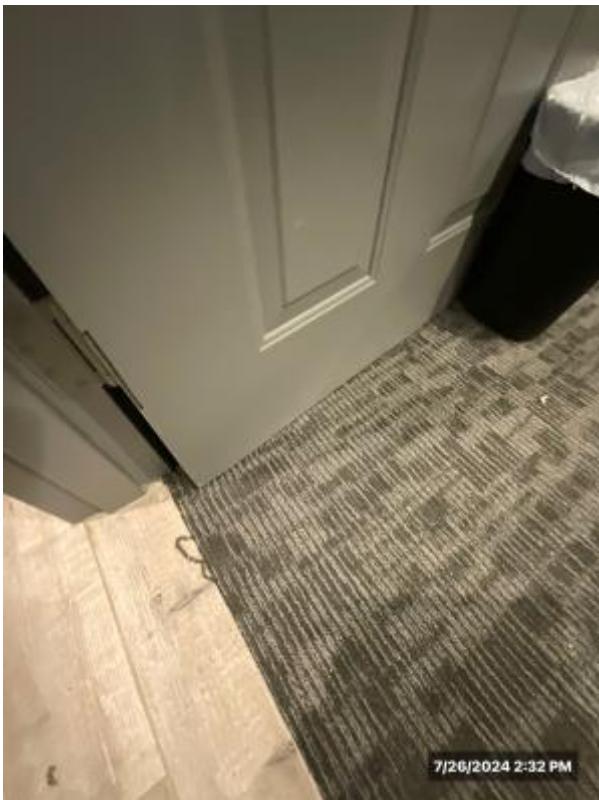
167-Conference Room

this room sustained catastrophic damage to the carpeting which has since been replaced - additional flood cut and baseboard remove/replace performed

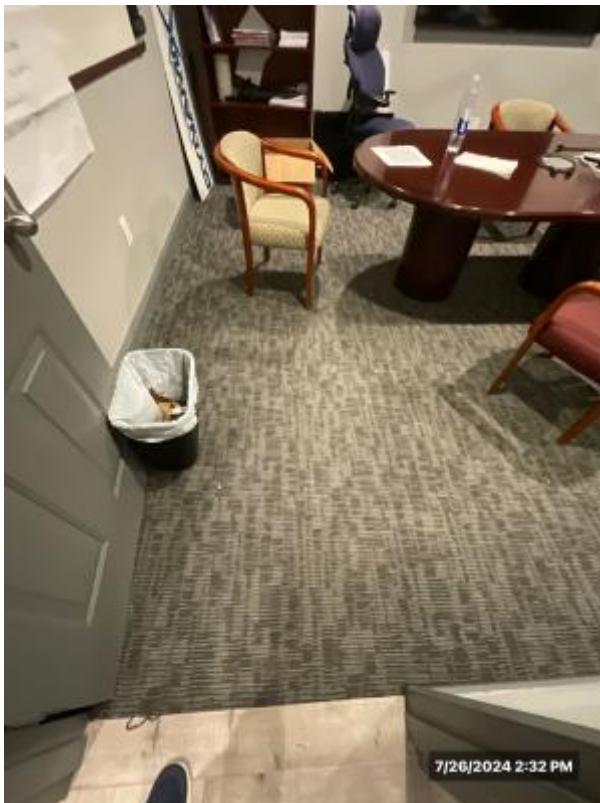
169-Conference Room

this room sustained catastrophic damage to the carpeting which has since been replaced - additional flood cut and baseboard remove/replace performed
