NARRATIVE REPORT

Request for Additional Payment

Carrier:	National General	Date of Loss:	7/17/2024
Insured:	. SENSIBLE CHOICE CONTRACTING, LLC	Assigned:	7/18/2024
CID:	233986	Contacted:	7/23/2024
Claim Number:	542109		
Policy Number:	0002903783		
Loss Address:	2 SHERMAN PL OSSINING NY 10562-3610	Mailing Address:	2 SHERMAN PL OSSINING NY 10562-3610

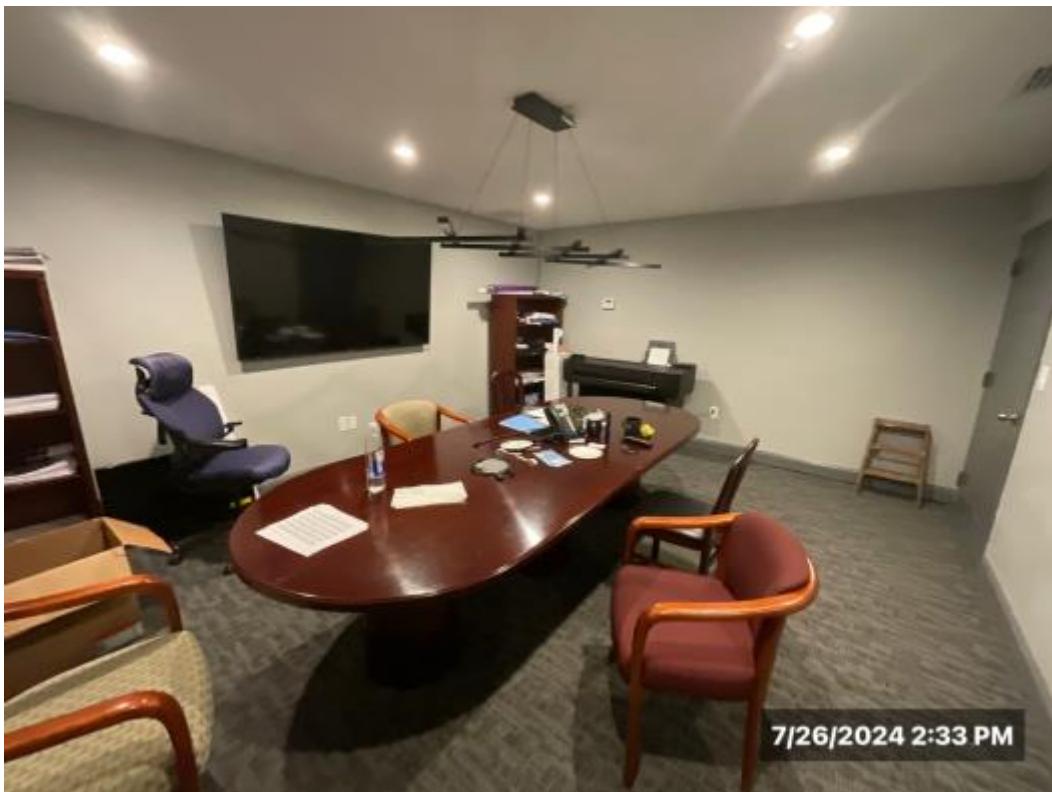
171-Conference Room

this room sustained catastrophic damage to the carpeting which has since been replaced - additional flood cut and baseboard remove/replace performed

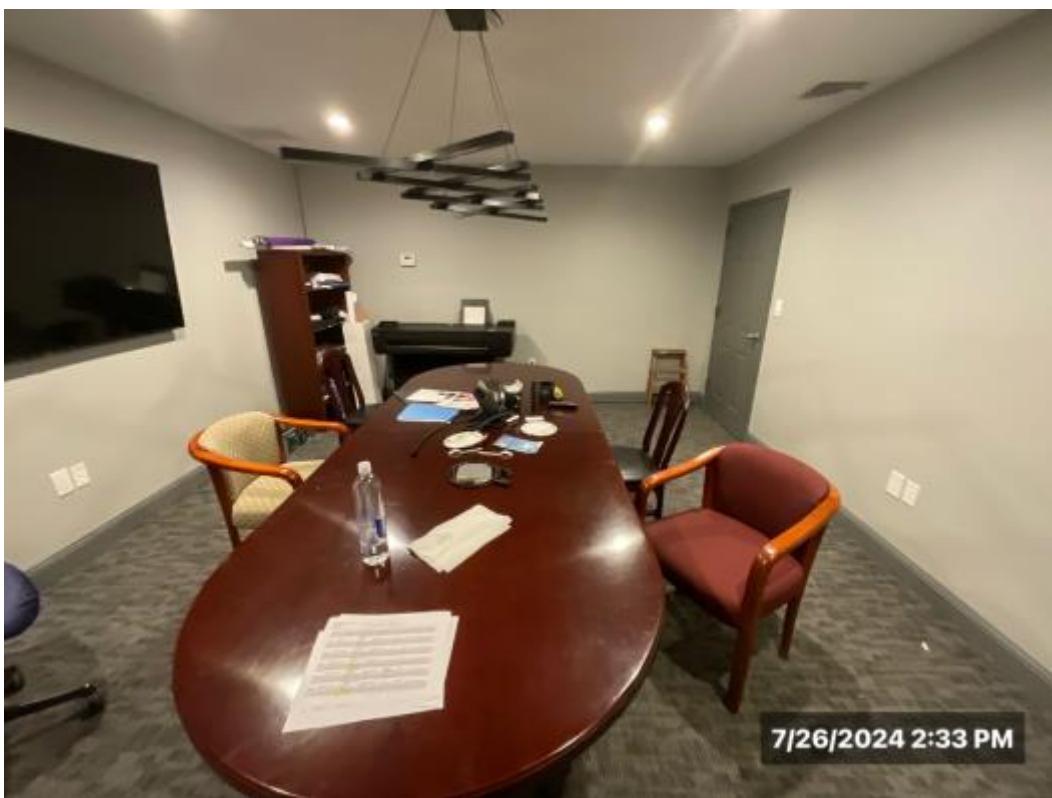
172-Conference Room

this room sustained catastrophic damage to the carpeting which has since been replaced - additional flood cut and baseboard remove/replace performed

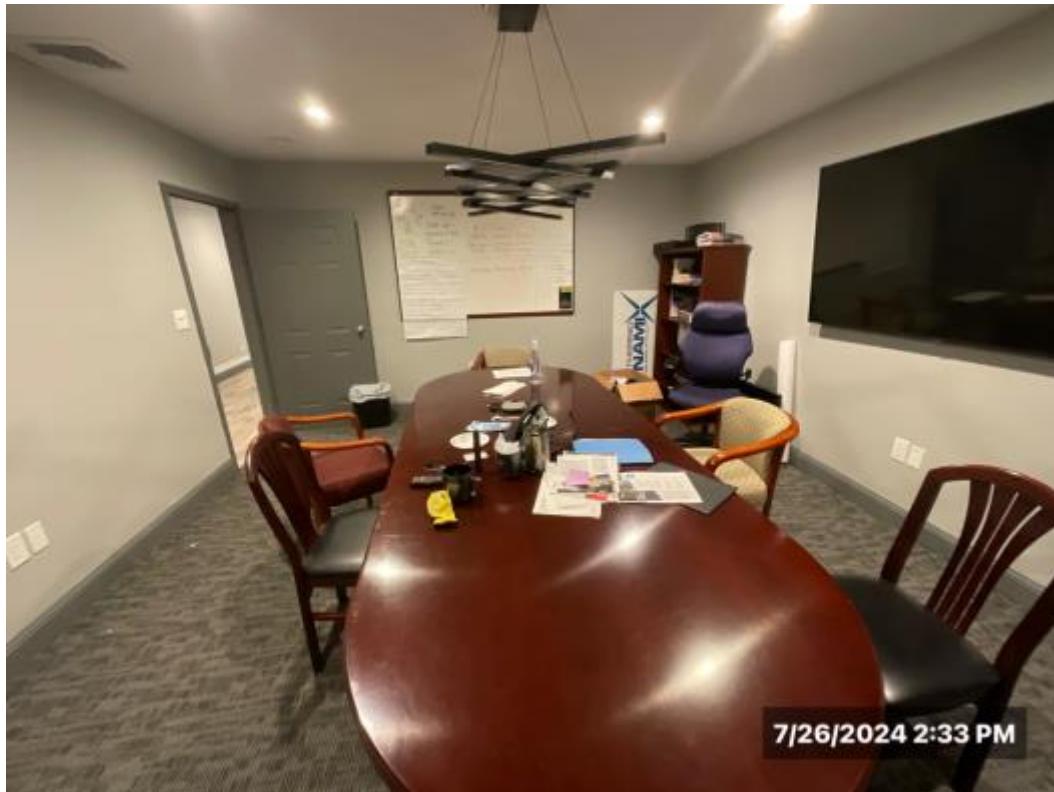
175-Conference Room

this room sustained catastrophic damage to the carpeting which has since been replaced - additional flood cut and baseboard remove/replace performed

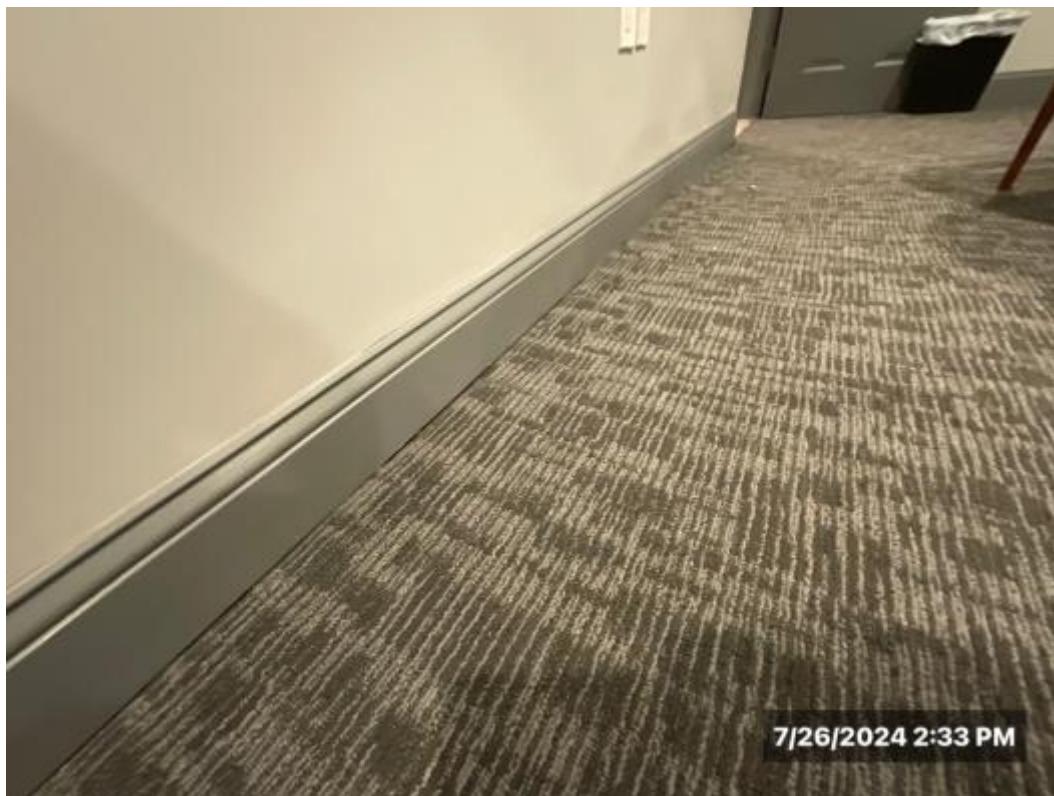
176-Conference Room

this room sustained catastrophic damage to the carpeting which has since been replaced - additional flood cut and baseboard remove/replace performed

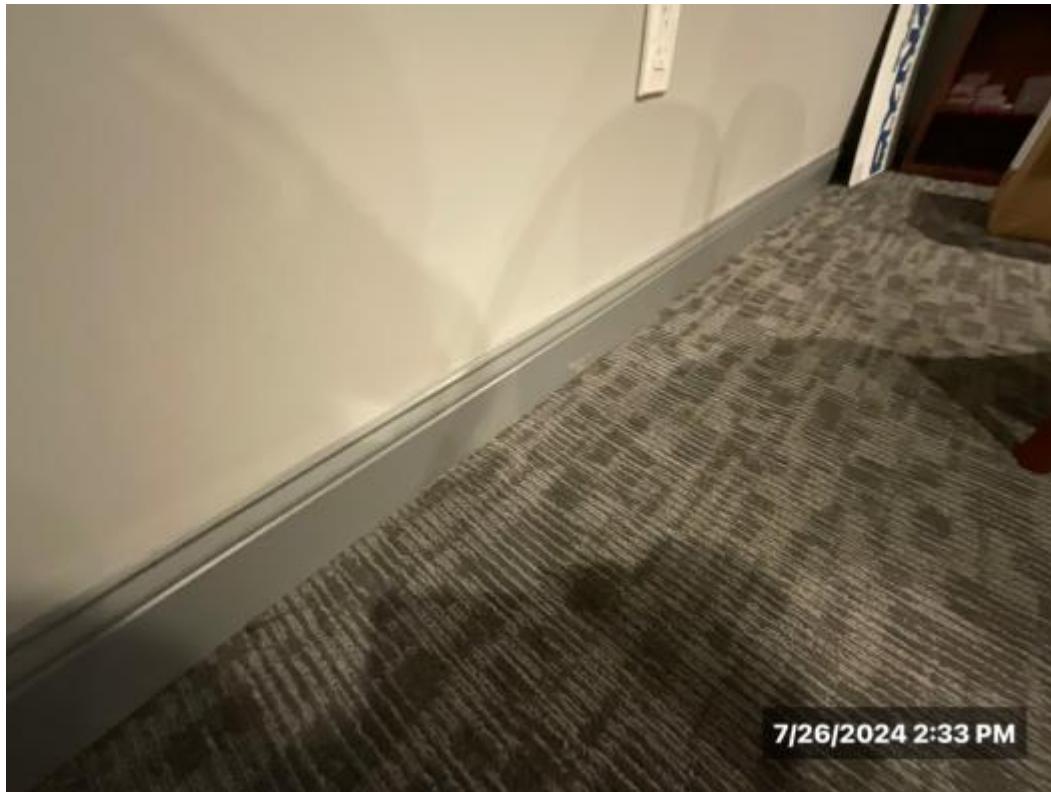
177-Conference Room

this room sustained catastrophic damage to the carpeting which has since been replaced - additional flood cut and baseboard remove/replace performed

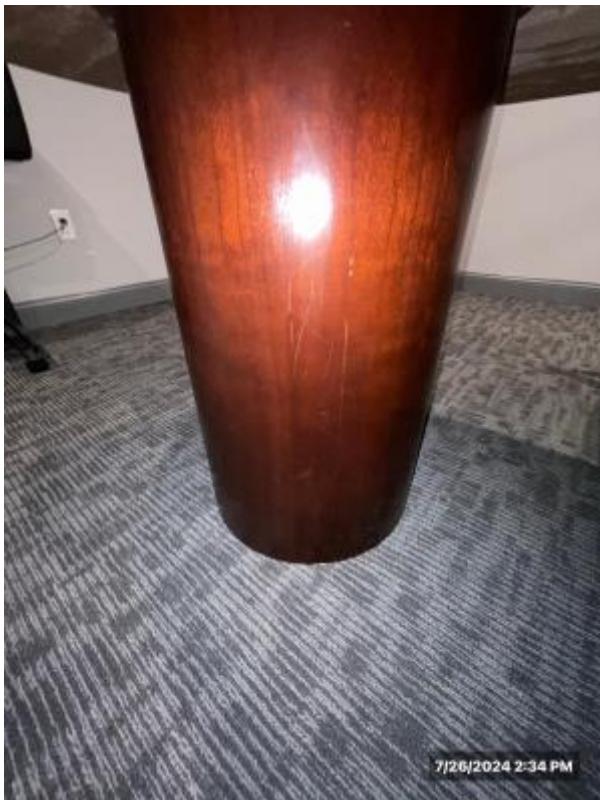
181-Conference Room

this room sustained catastrophic damage to the carpeting which has since been replaced - additional flood cut and baseboard remove/replace performed

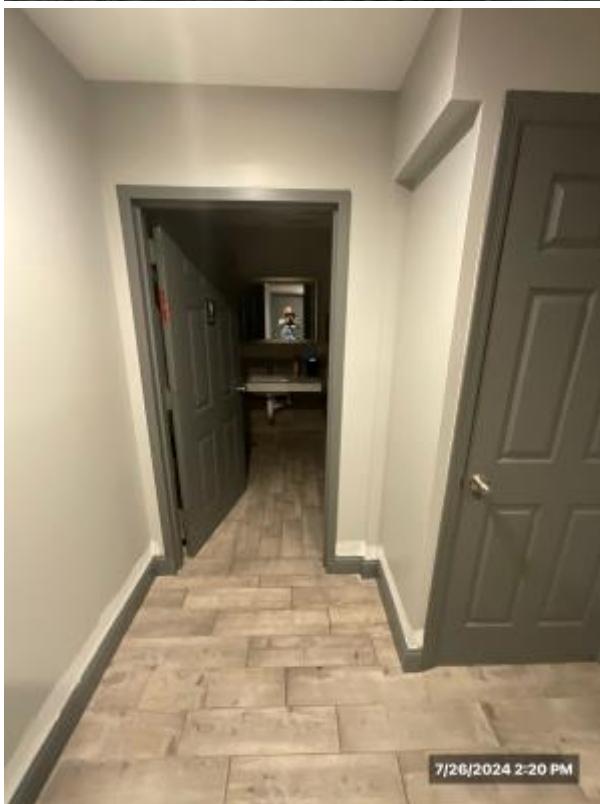
184-Bathroom

no catastrophic damages noted this area

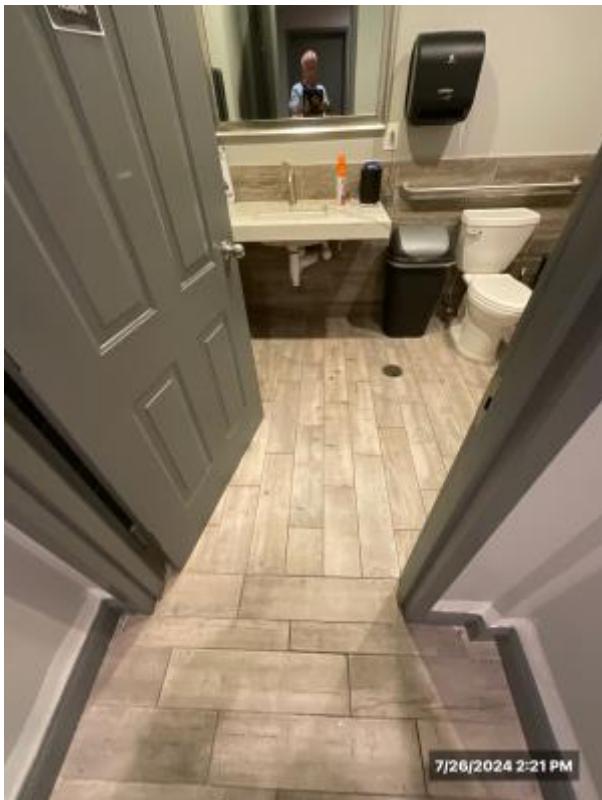
185-Bathroom

no catastrophic damages noted this area

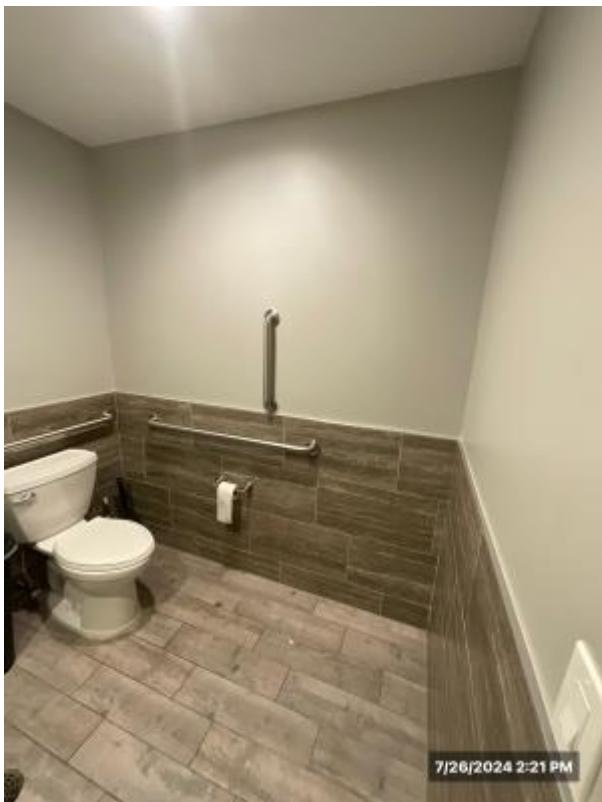
186-Bathroom

no catastrophic damages noted this area

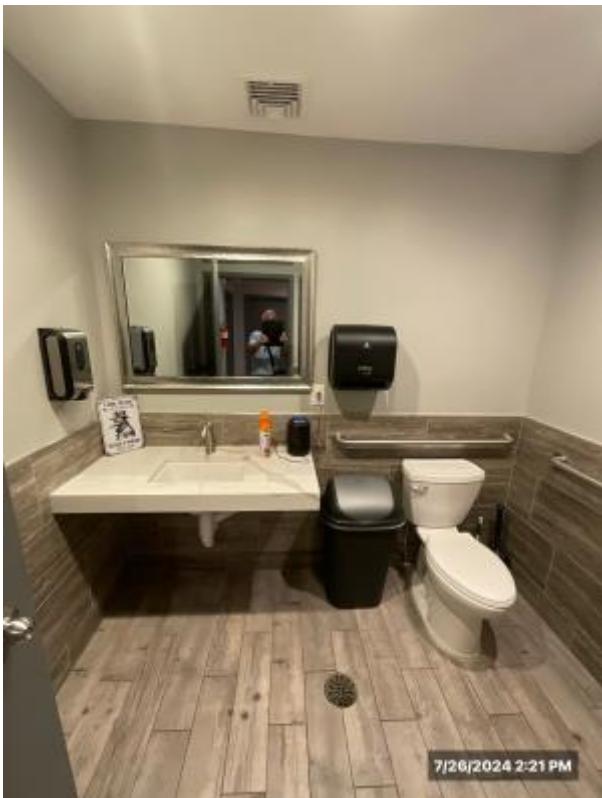
187-Bathroom

no catastrophic damages noted this area

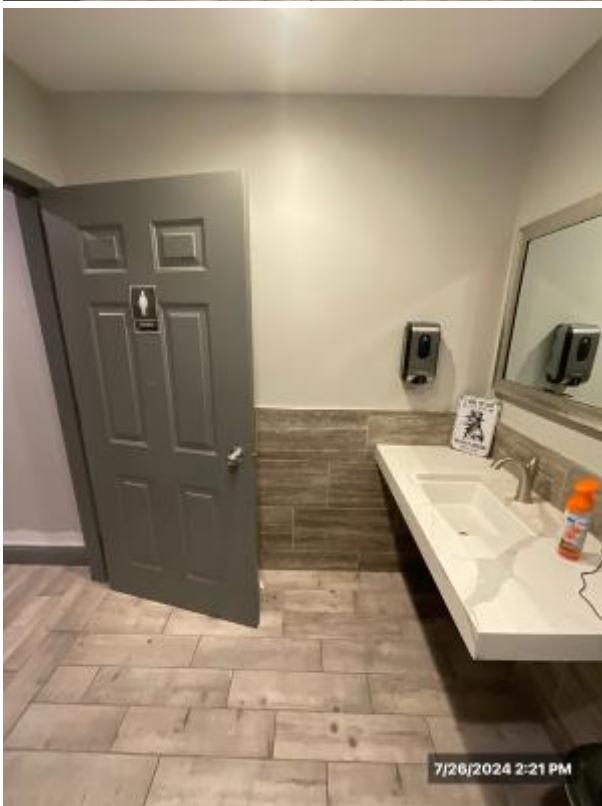
188-Bathroom

no catastrophic damages noted this area

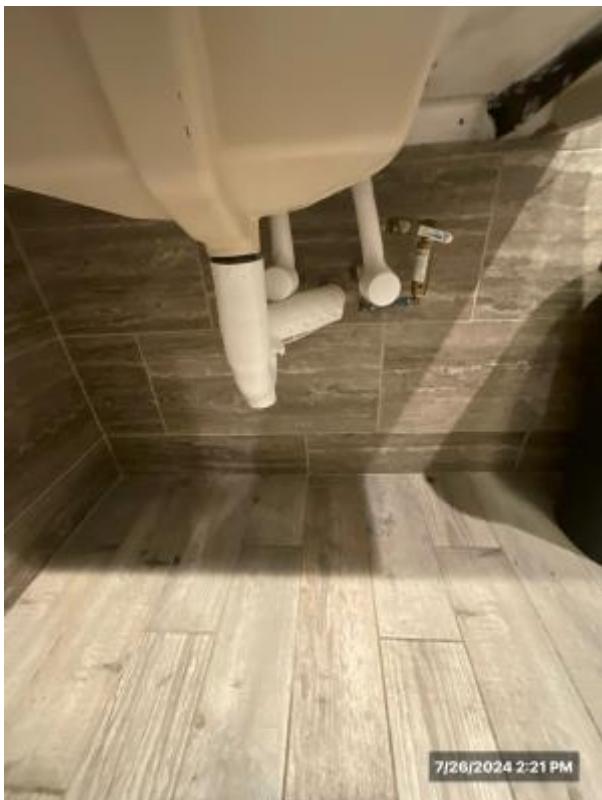
190-Bathroom

no catastrophic damages noted this area

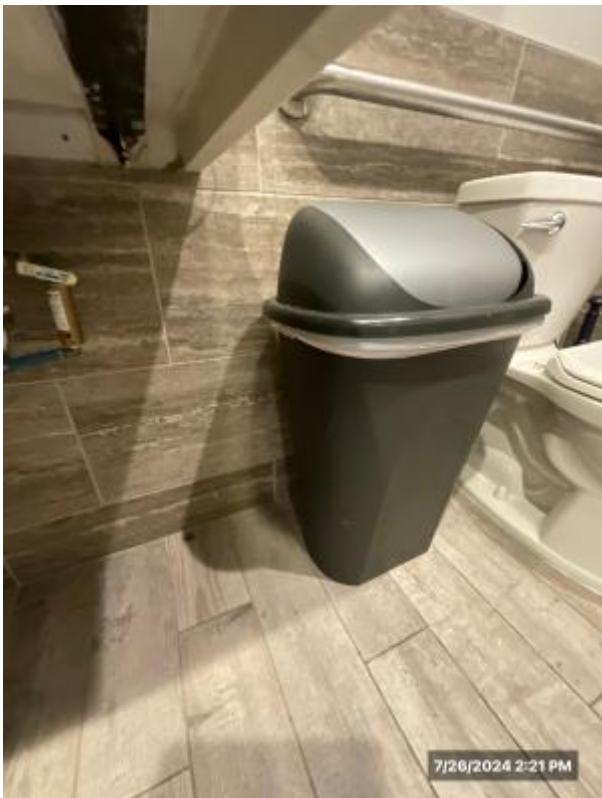
191-Bathroom

no catastrophic damages noted this area

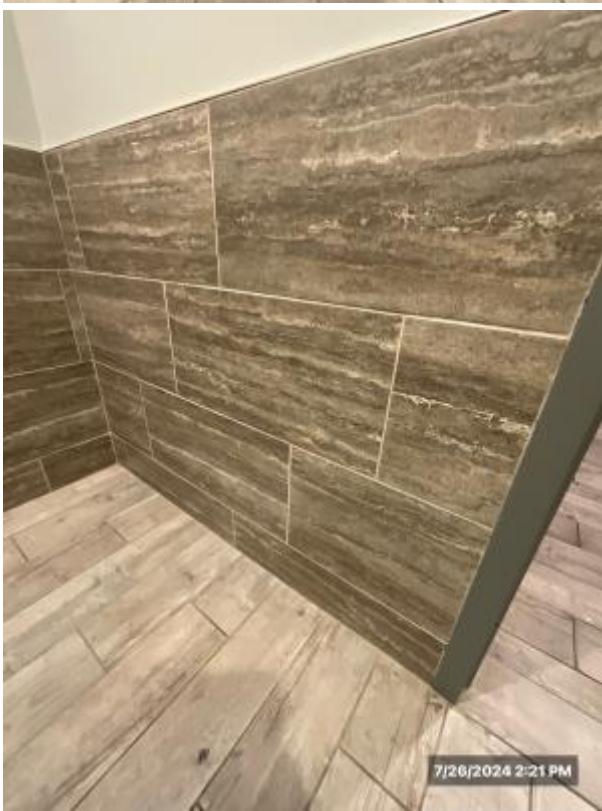
192-Bathroom

no catastrophic damages noted this area

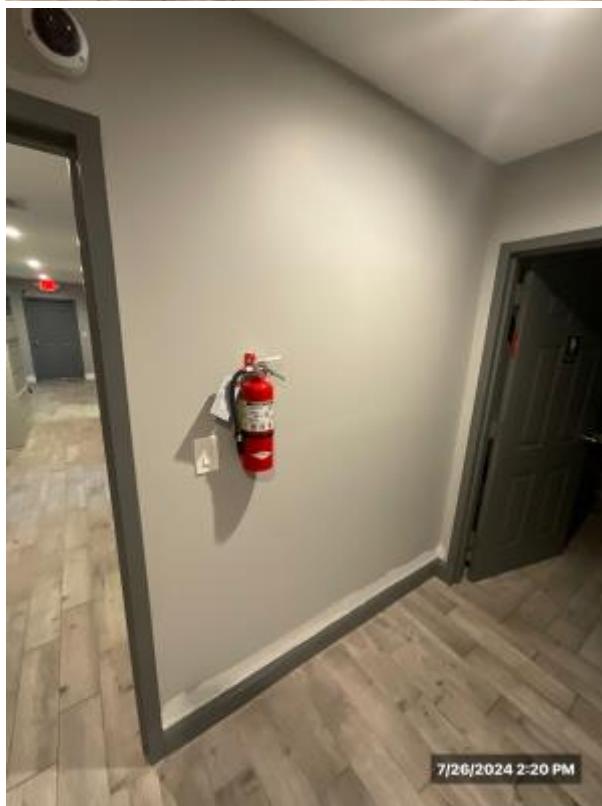
194-Rear Hallway

overviews throughout the facility
hallway - floodcuts and baseboard
remove/replace already made

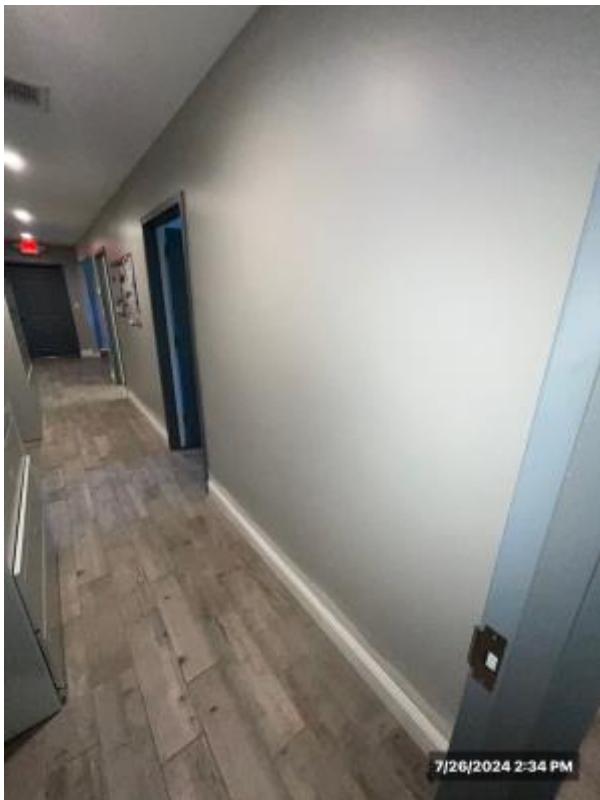
195-Rear Hallway

overviews throughout the facility
hallway - floodcuts and baseboard
remove/replace already made

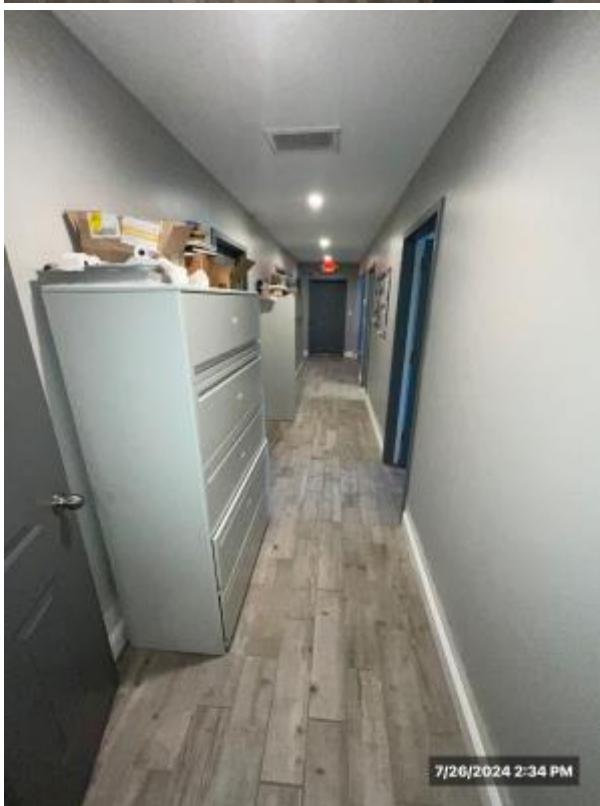
196-Rear Hallway

overviews throughout the facility
hallway - floodcuts and baseboard
remove/replace already made

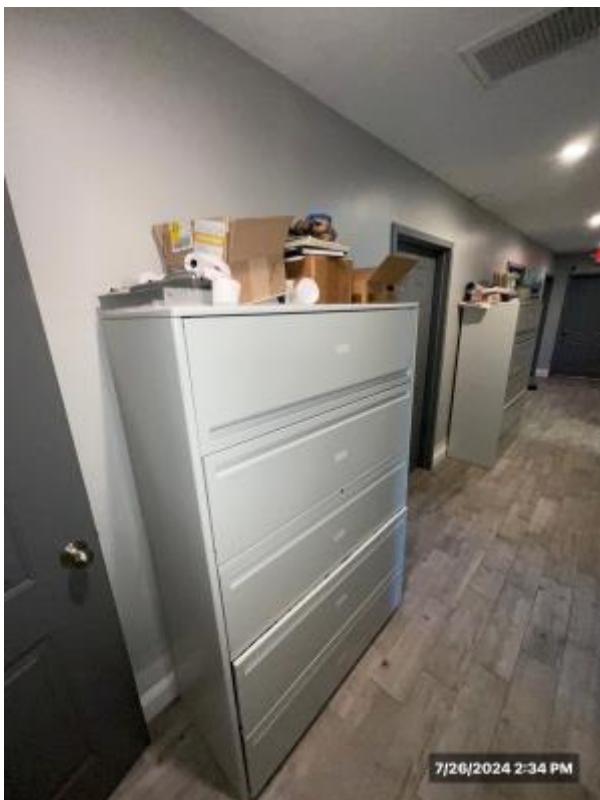
197-Rear Hallway

overviews throughout the facility
hallway - floodcuts and baseboard
remove/replace already made

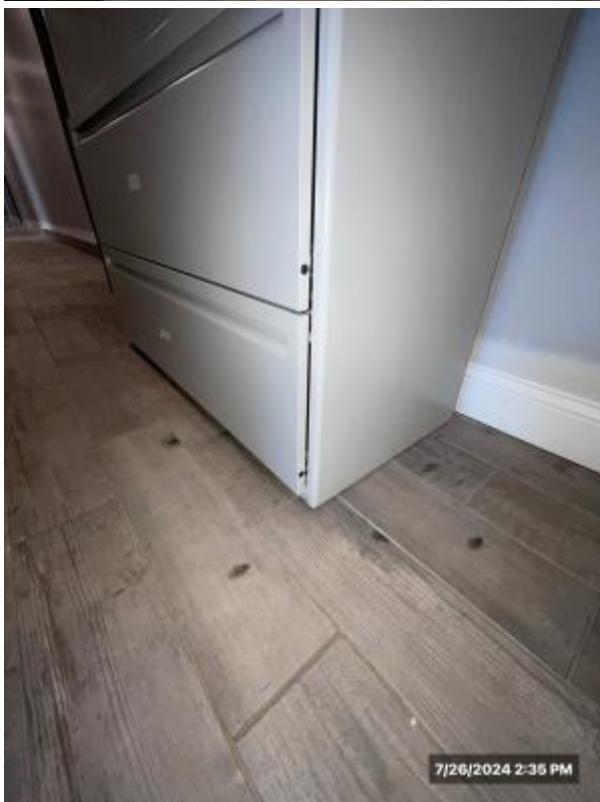
198-Rear Hallway

overviews throughout the facility
hallway - floodcuts and baseboard
remove/replace already made

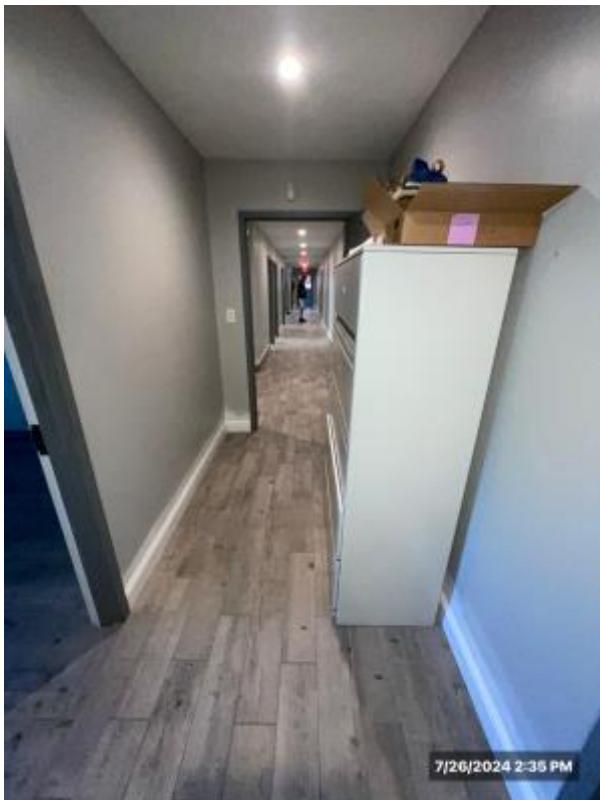
199-Rear Hallway

overviews throughout the facility
hallway - floodcuts and baseboard
remove/replace already made

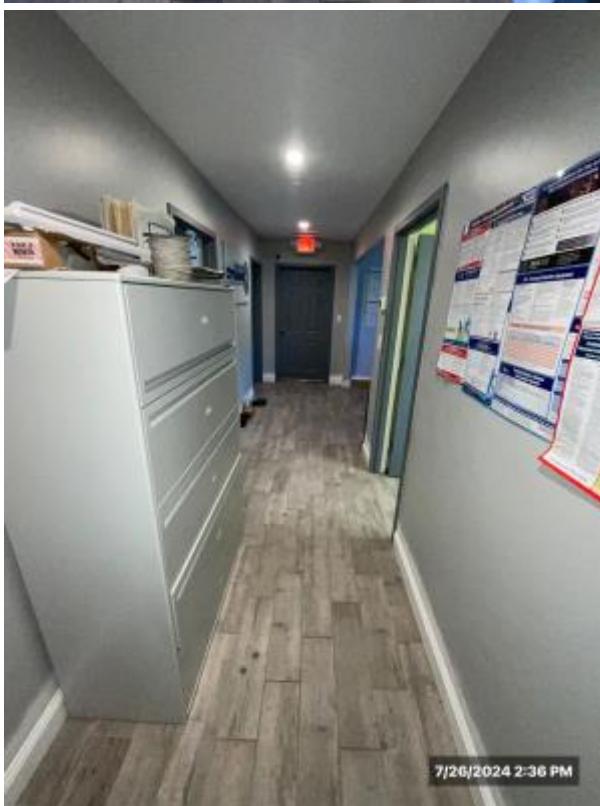
200-Rear Hallway

overviews throughout the facility
hallway - floodcuts and baseboard
remove/replace already made

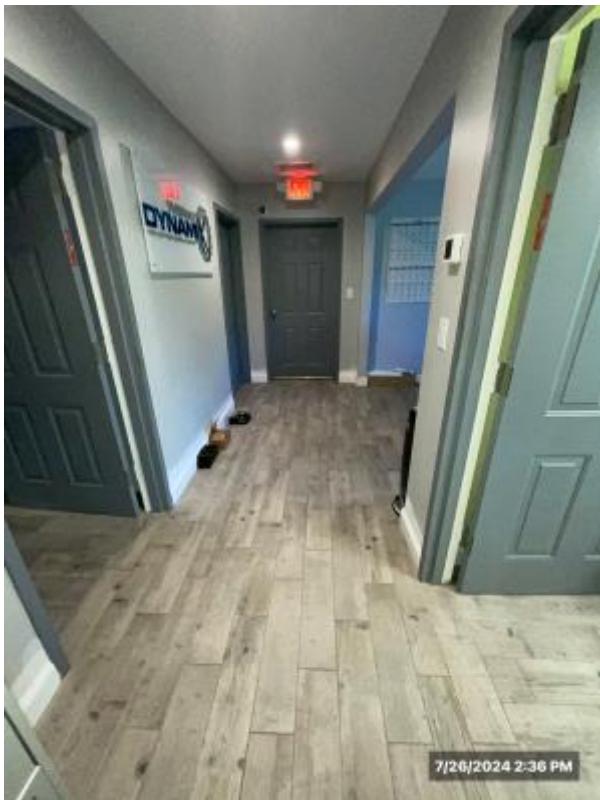
201-Rear Hallway

overviews throughout the facility
hallway - floodcuts and baseboard
remove/replace already made

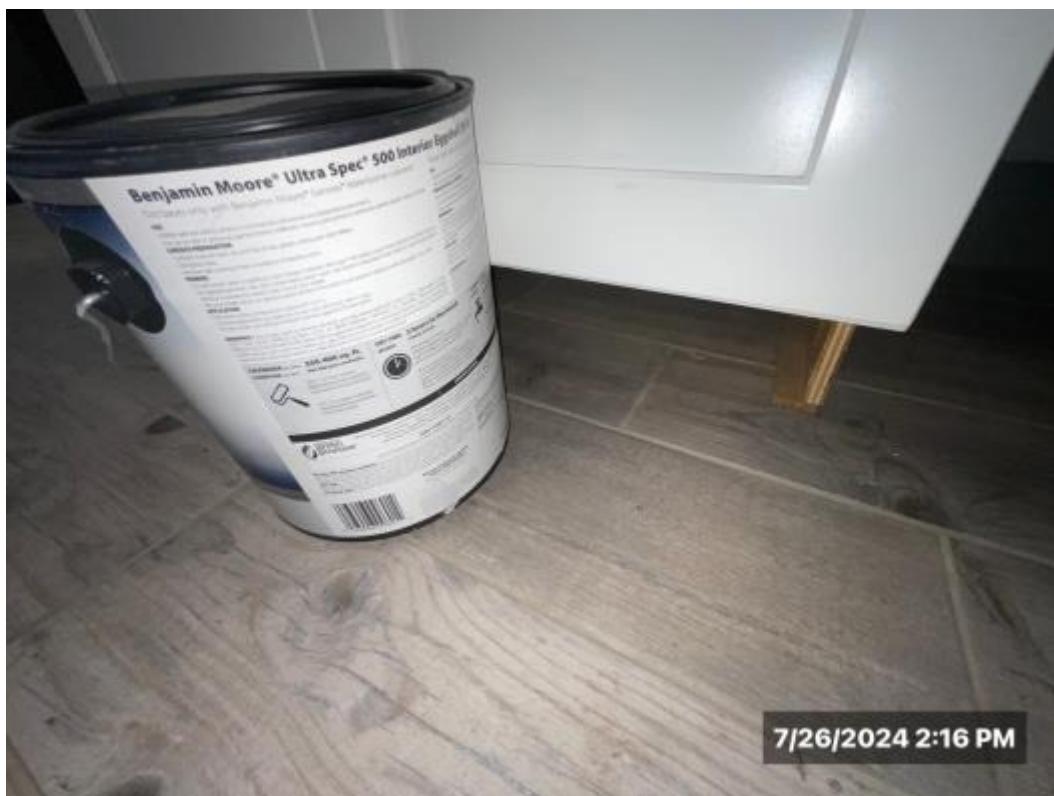
202-Mechanical

flood cut performed/baseboard
replacement - Insured states the water
heater is functioning normally

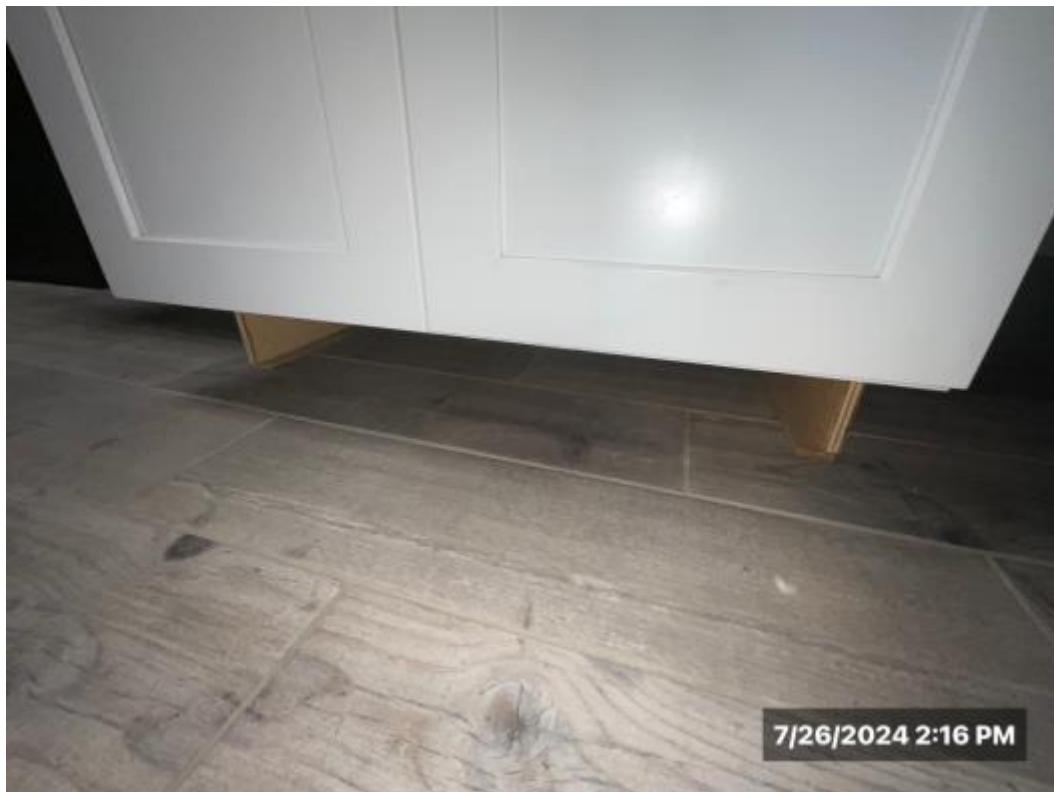
203-Mechanical

flood cut performed/baseboard replacement - Insured states the water heater is functioning normally

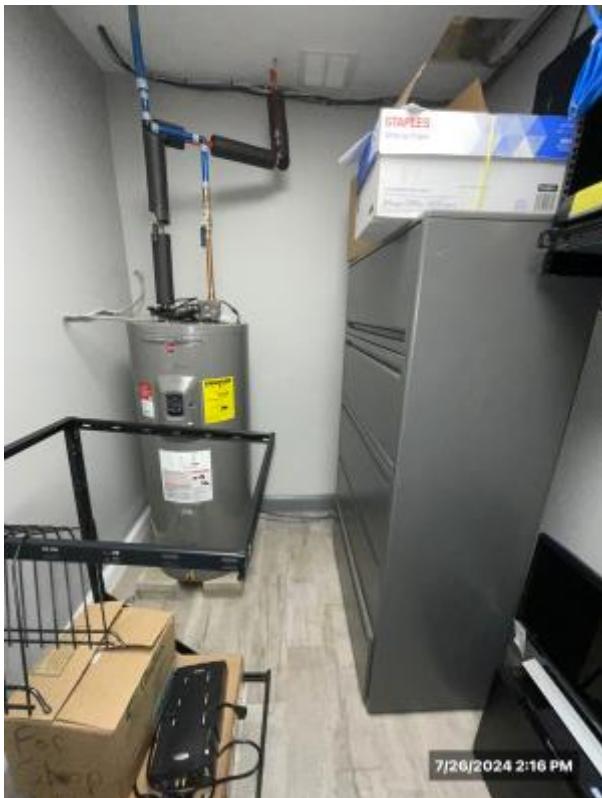
207-Mechanical

flood cut performed/baseboard replacement - Insured states the water heater is functioning normally

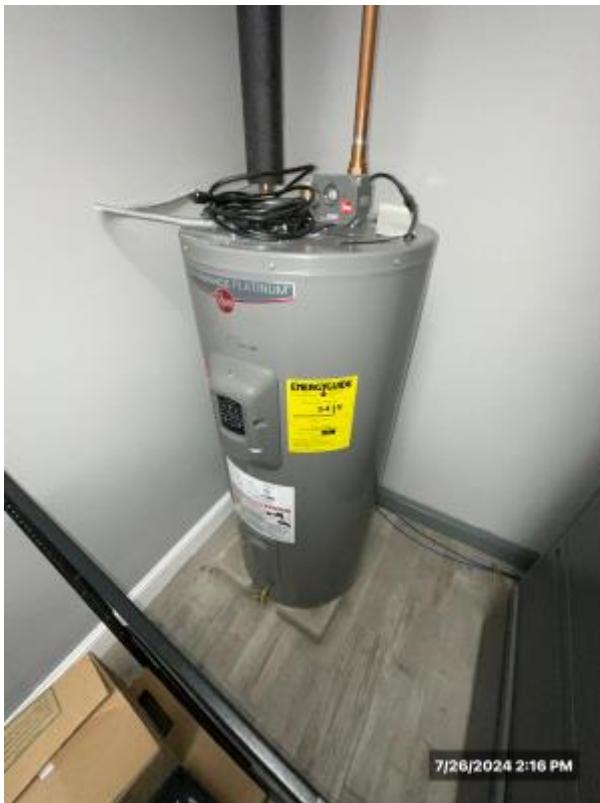
209-Mechanical

flood cut performed/baseboard replacement - Insured states the water heater is functioning normally

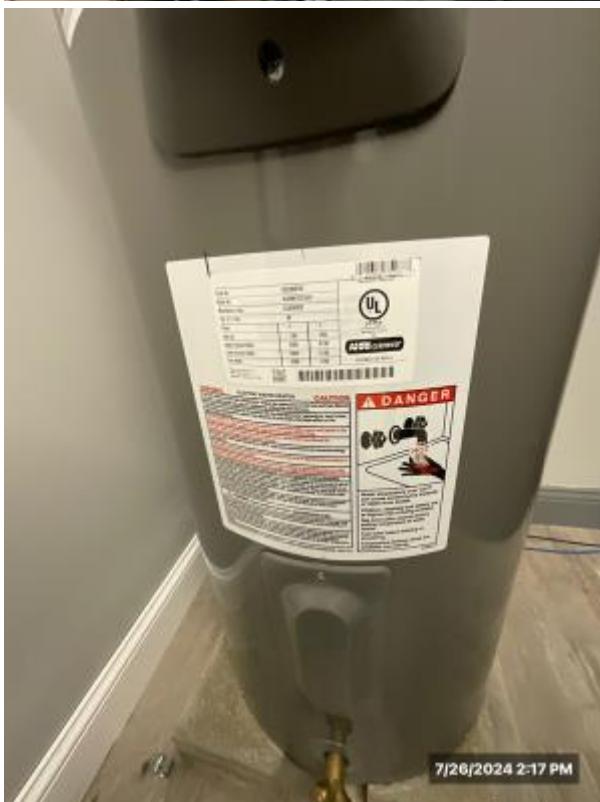
210-Mechanical

flood cut performed/baseboard replacement - Insured states the water heater is functioning normally - allowance made for service call

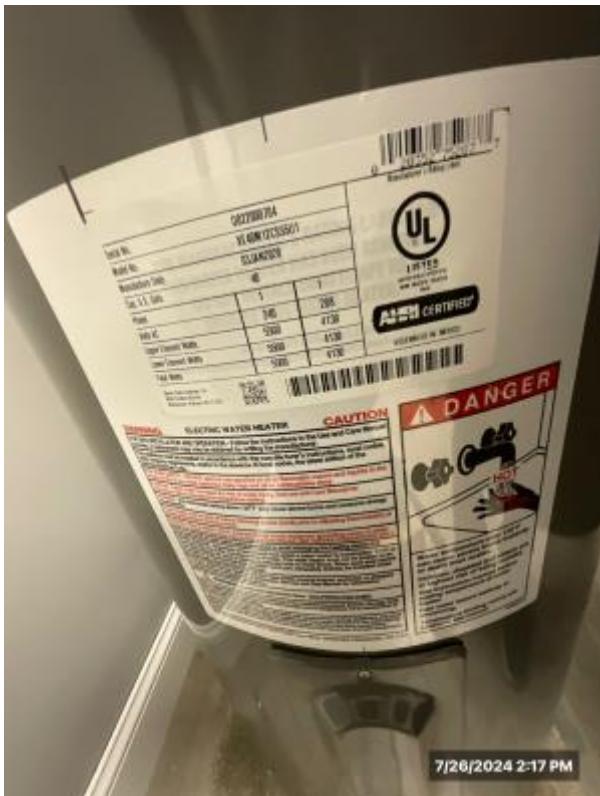
211-Mechanical

flood cut performed/baseboard replacement - Insured states the water heater is functioning normally

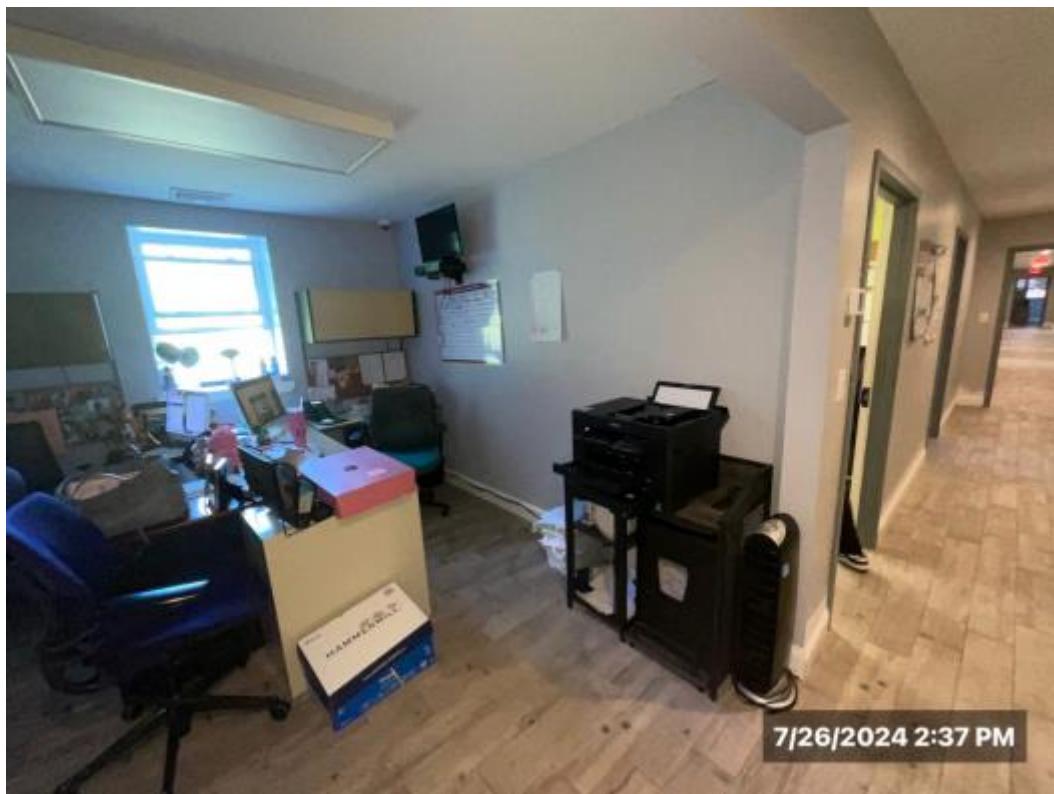
214-Rear Reception

overviews throughout the facility hallway - floodcuts and baseboard remove/replace already made

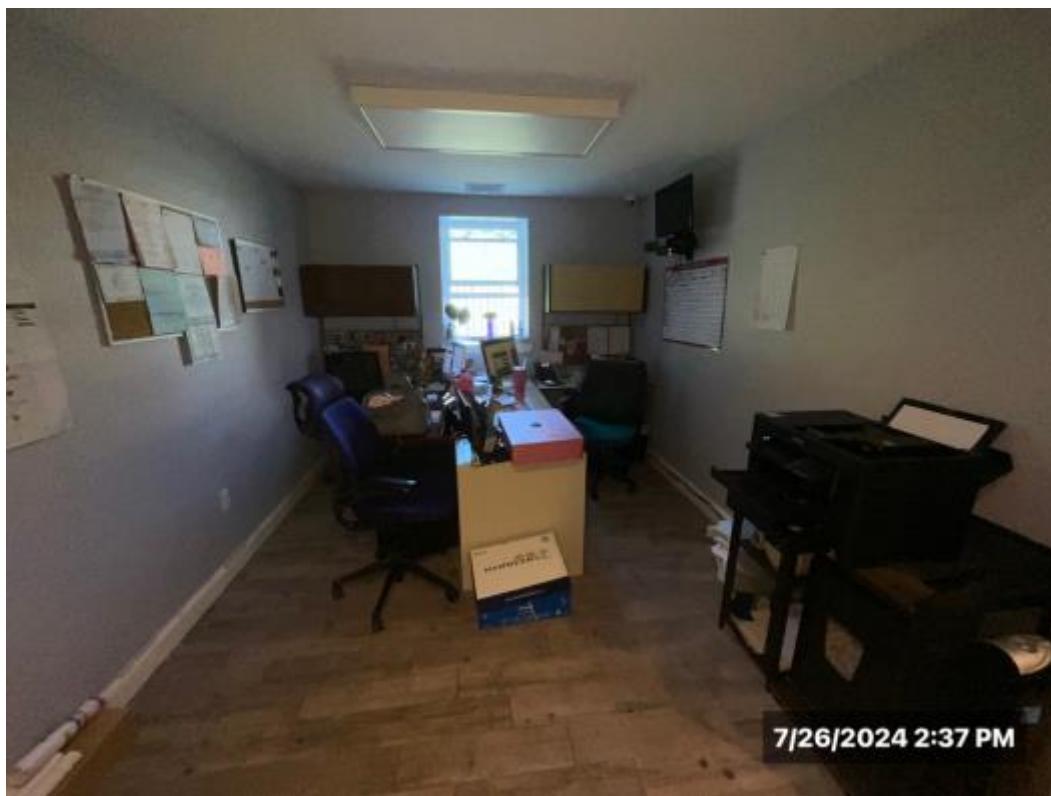
215-Rear Reception

overviews throughout the facility
hallway - floodcuts and baseboard
remove/replace already made

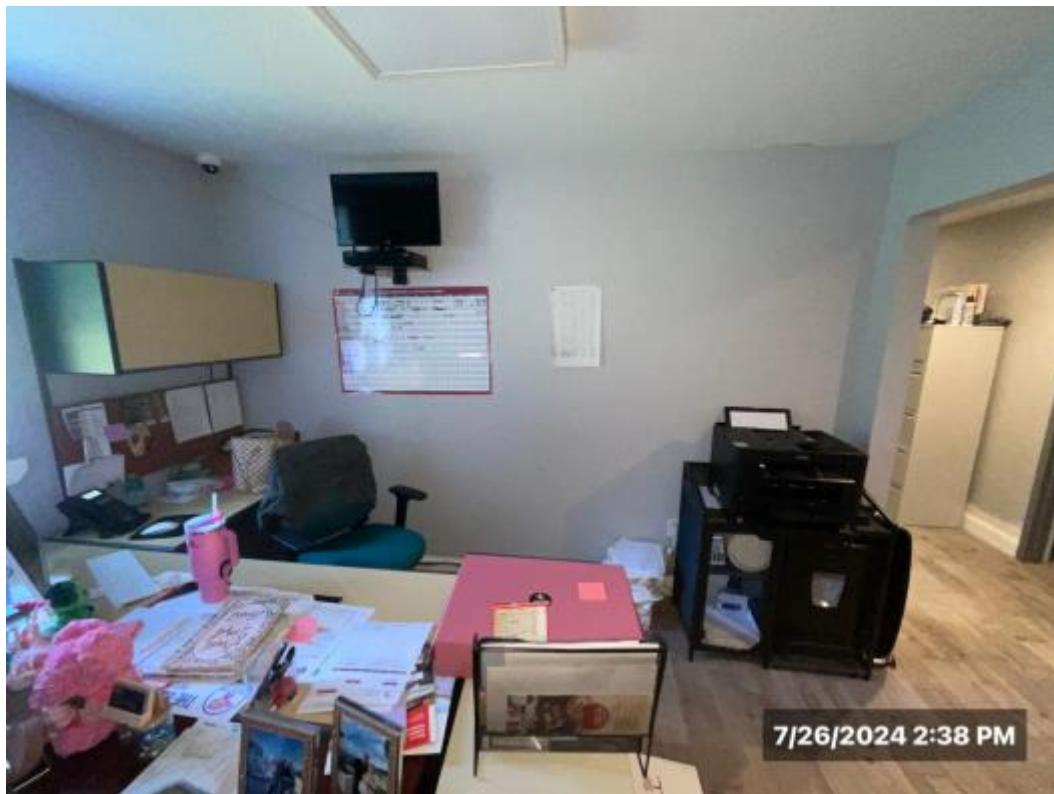
217-Rear Reception

overviews throughout the facility
hallway - floodcuts and baseboard
remove/replace already made

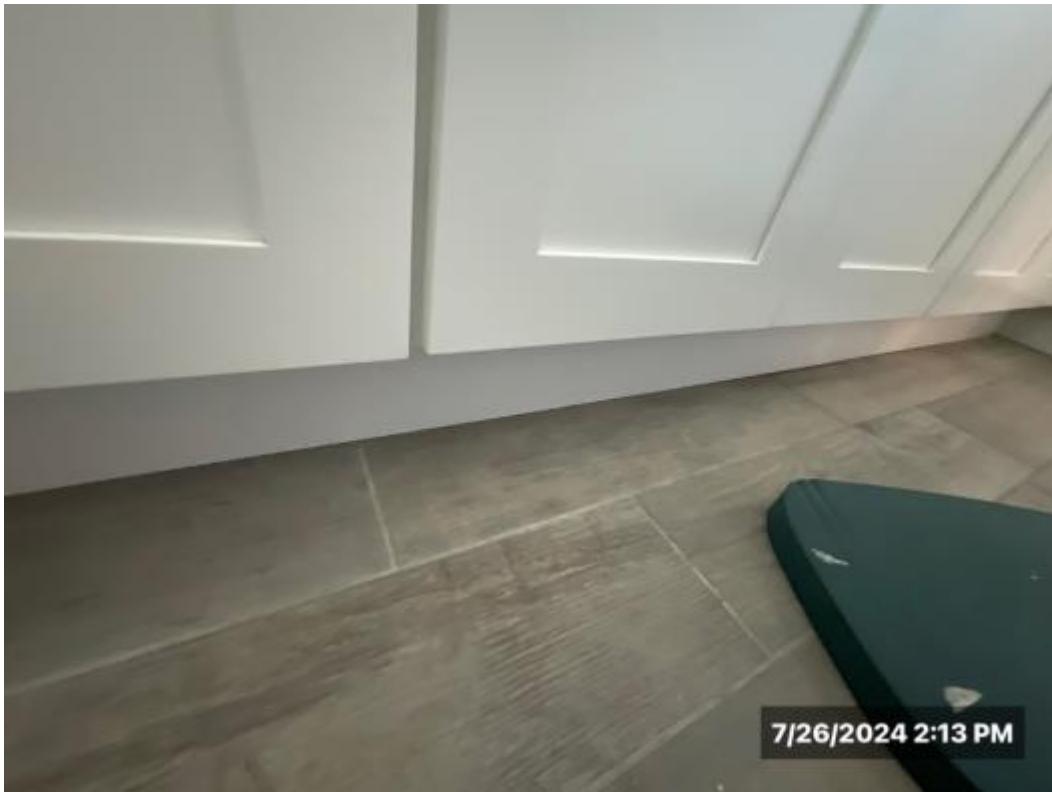
225-Kitchenette

repaired toe kick

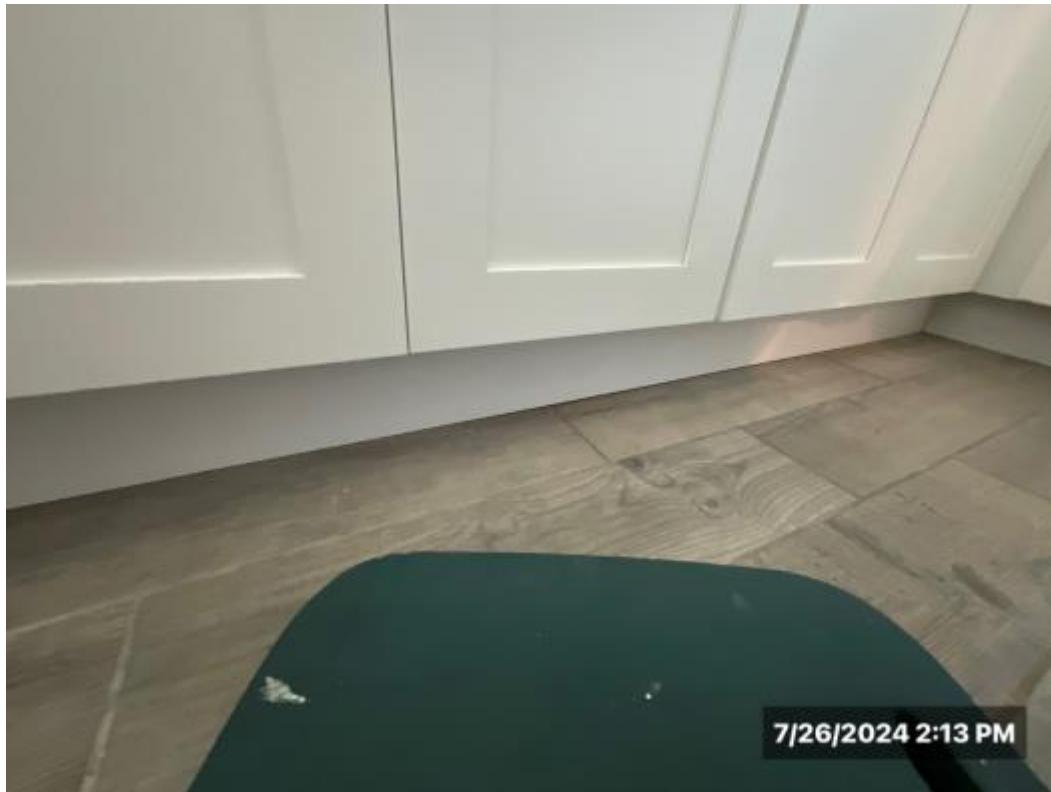
227-Kitchenette

view along run of repaired toe kick

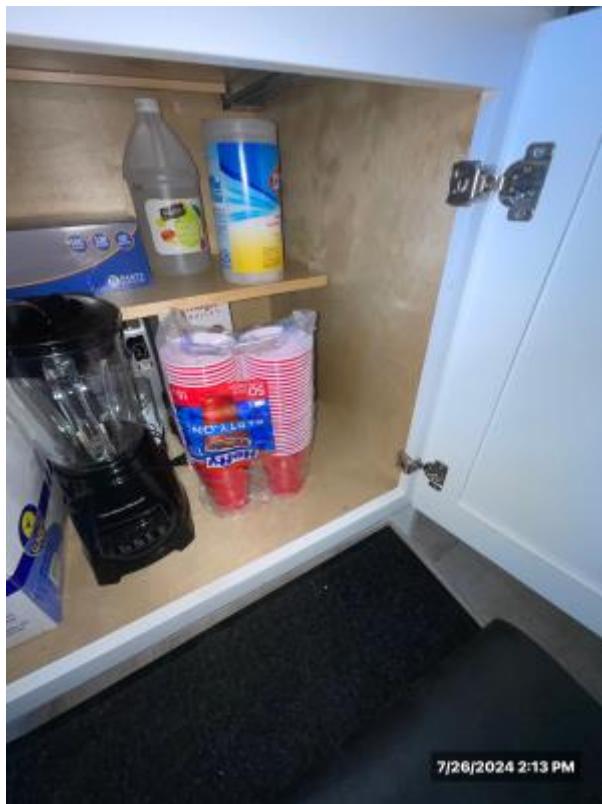
232-Kitchenette

interior of cabinetry, no visible damage

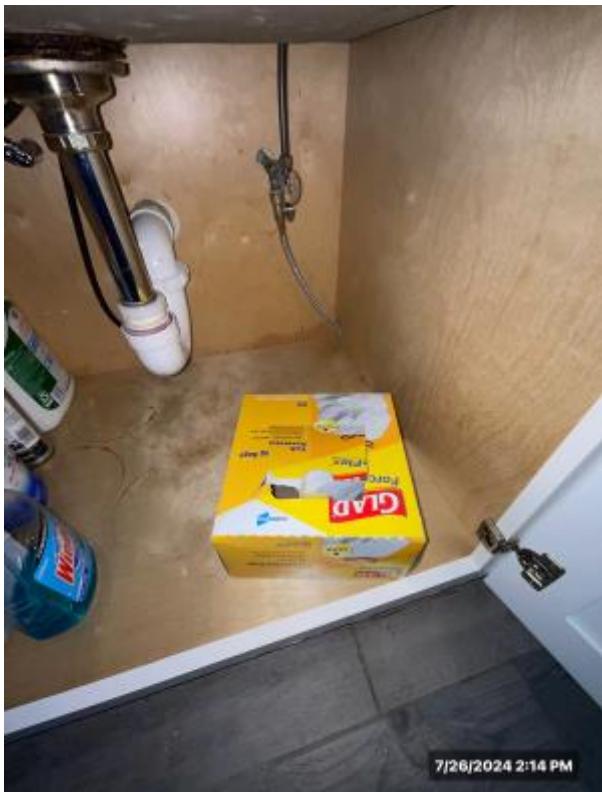
241-Kitchenette

sink base cabinet, no flood intrusion

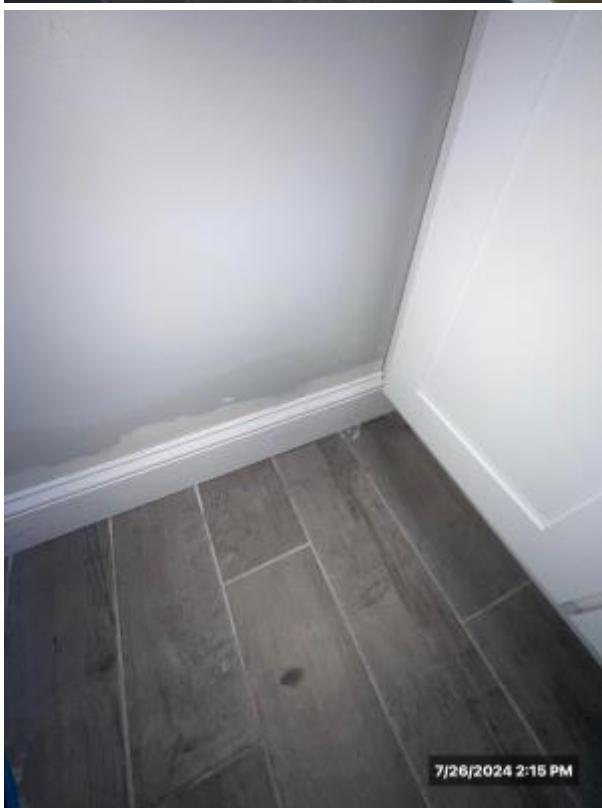
244-Kitchenette

4" flood cut and baseboard repairs made

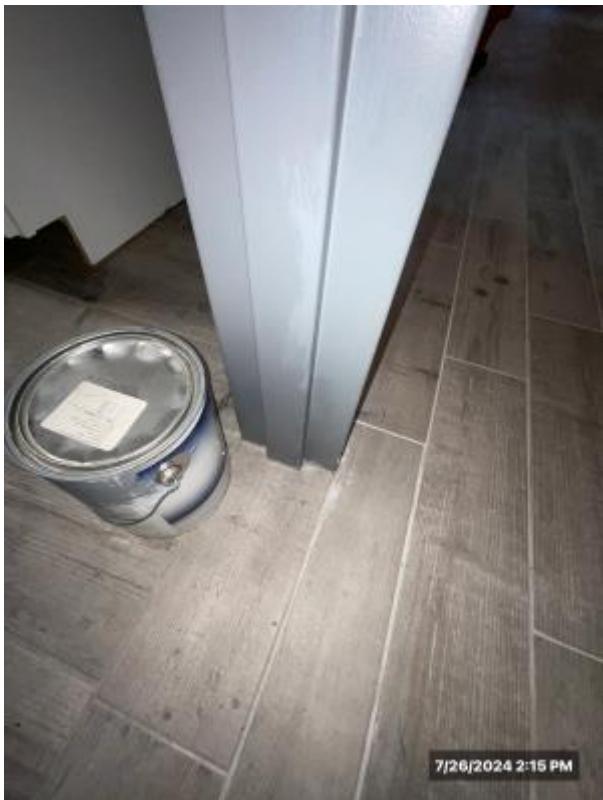
247-Kitchenette

paint touch up made to doorway framing
