NARRATIVE REPORT

Request for Additional Payment

Carrier:	National General	Date of Loss:	7/17/2024
Insured:	. SENSIBLE CHOICE CONTRACTING, LLC	Assigned:	7/18/2024
CID:	233986	Contacted:	7/23/2024
Claim Number:	542109		
Policy Number:	0002903783		
Loss Address:	2 SHERMAN PL OSSINING NY 10562-3610	Mailing Address:	2 SHERMAN PL OSSINING NY 10562-3610

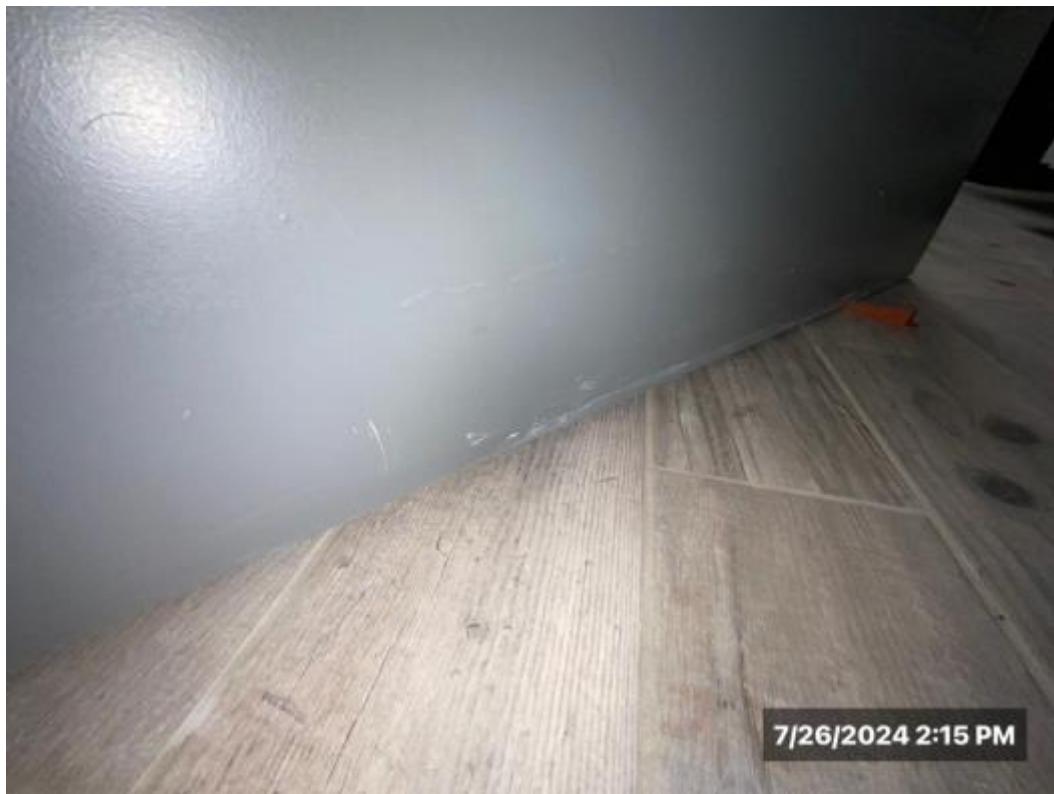
249-Kitchenette

water intrusion to base cabinet

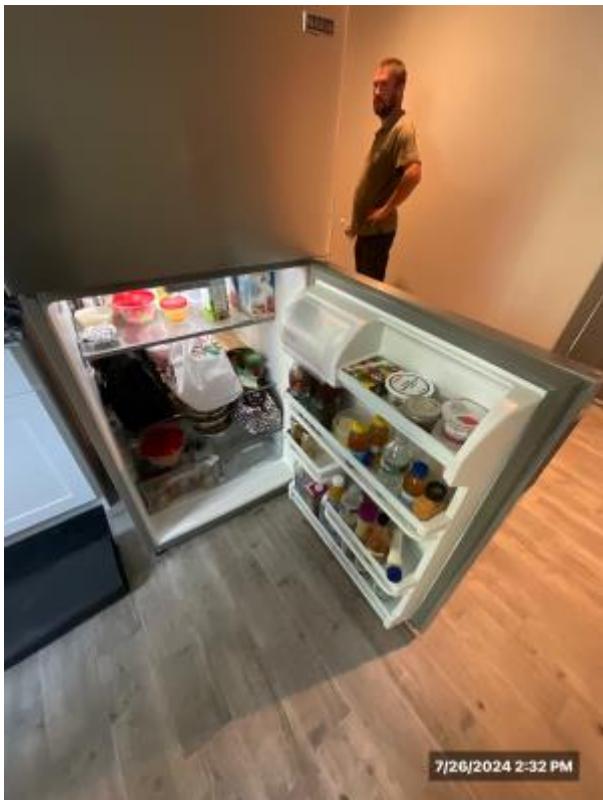
253-Kitchenette

interior of refrigerator

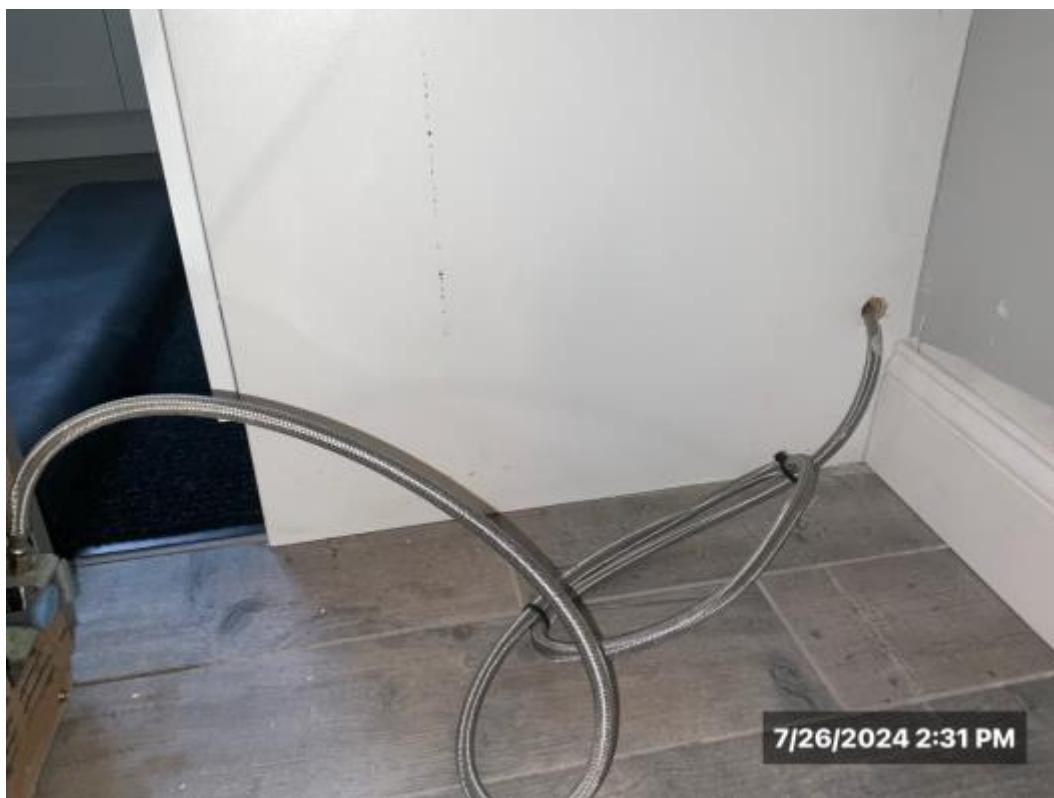
254-Kitchenette

water damage to cabinet

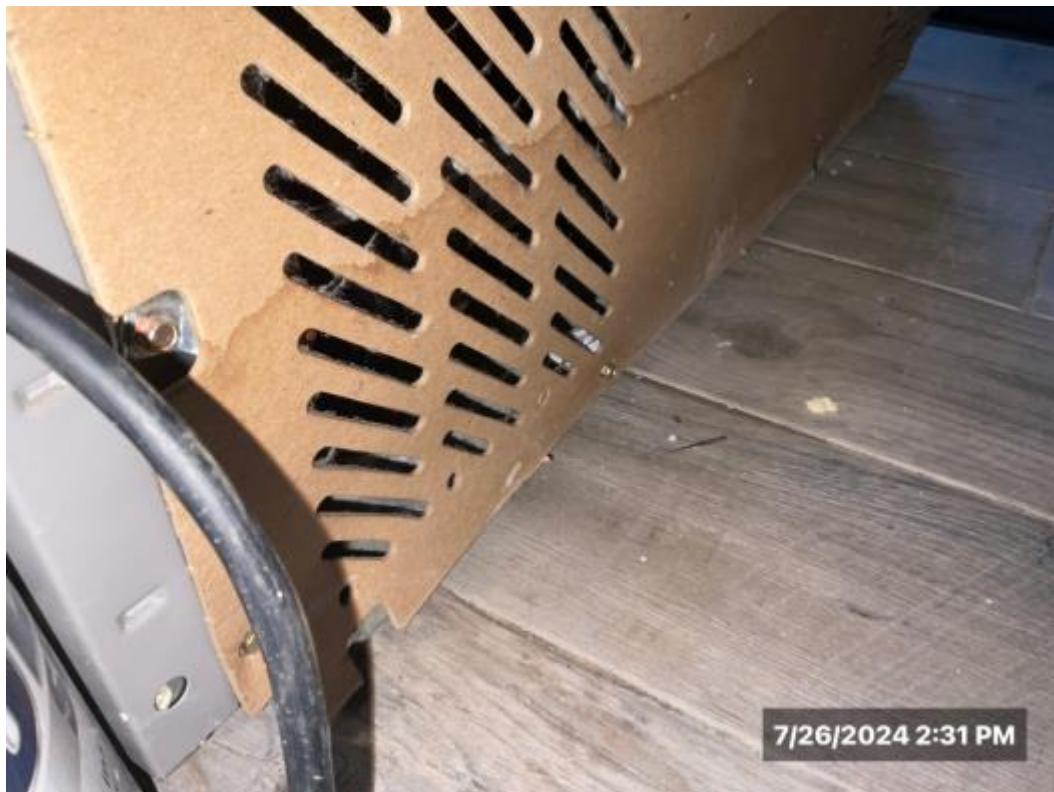
255-Kitchenette

flood line to refrigerator

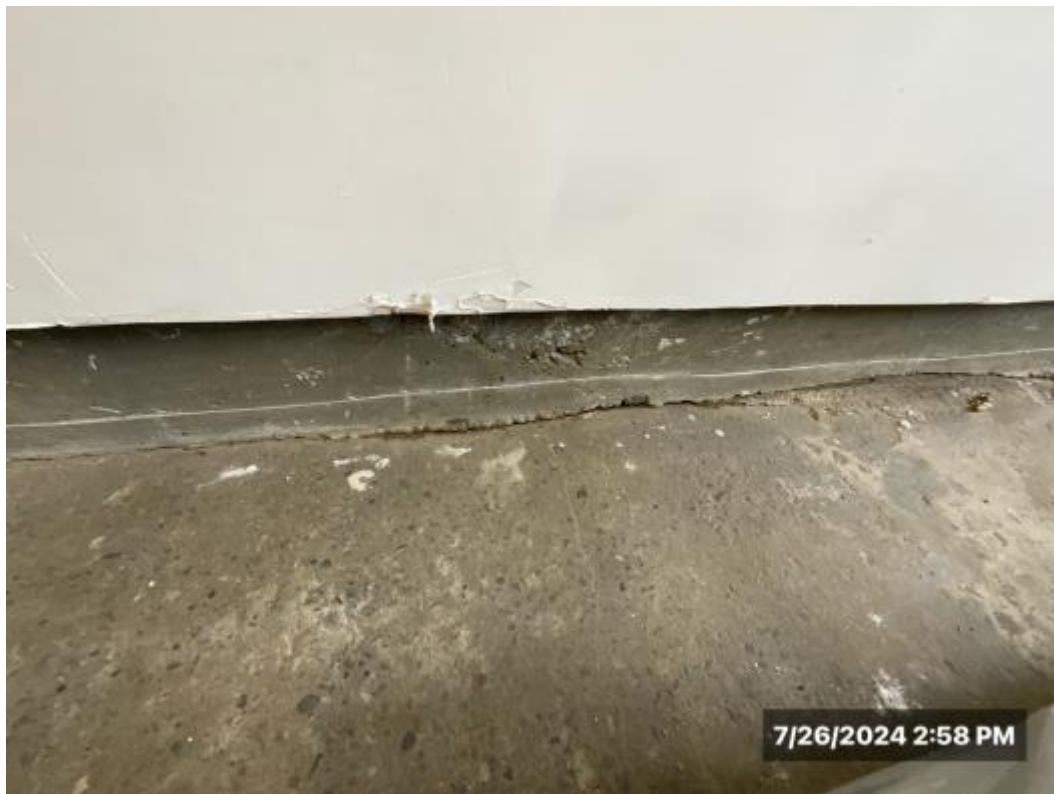
263-Front Storage

flood cut

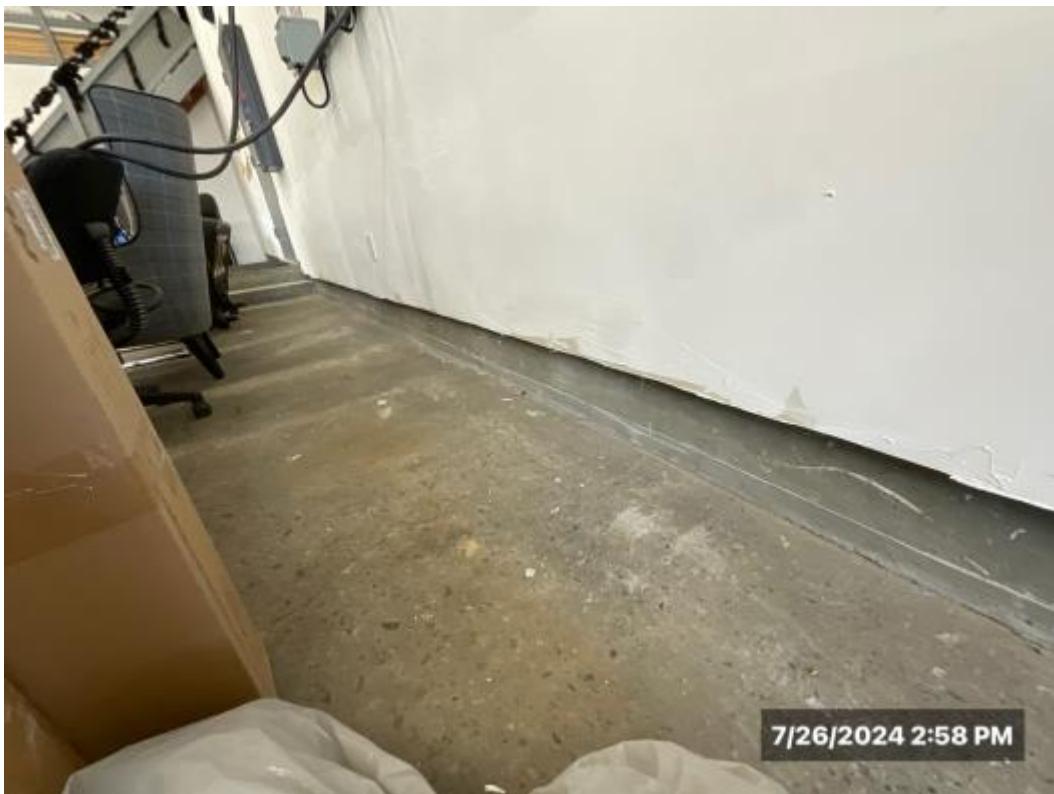
265-Front Storage

wide angle of run of flood cut

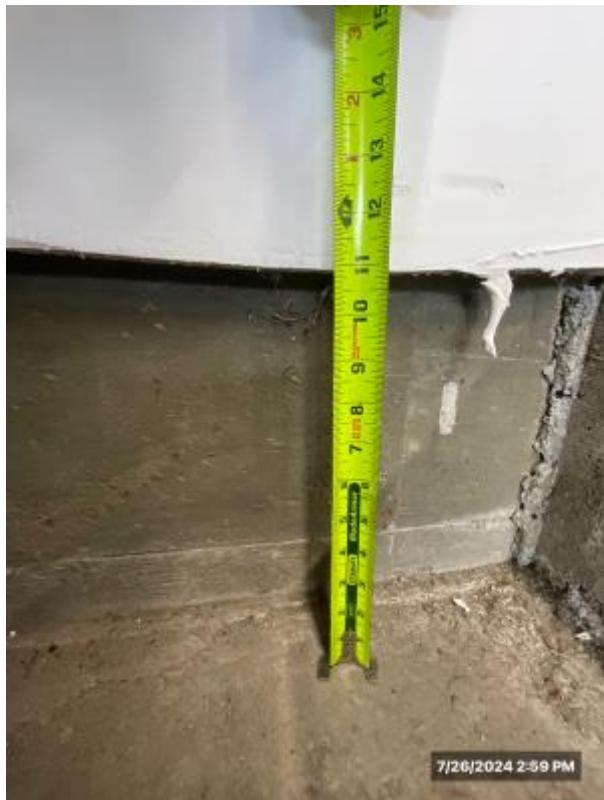
269-Front Storage

flood cut next to stairs

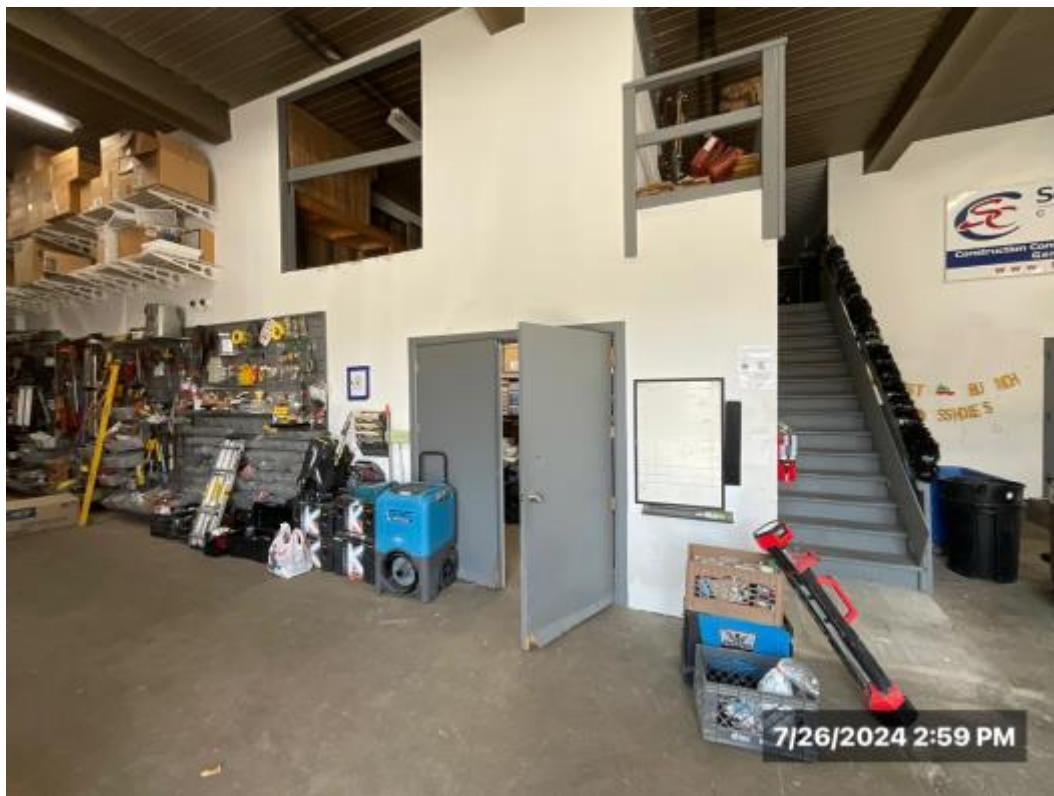
274-Front Storage

these solid doors water damaged

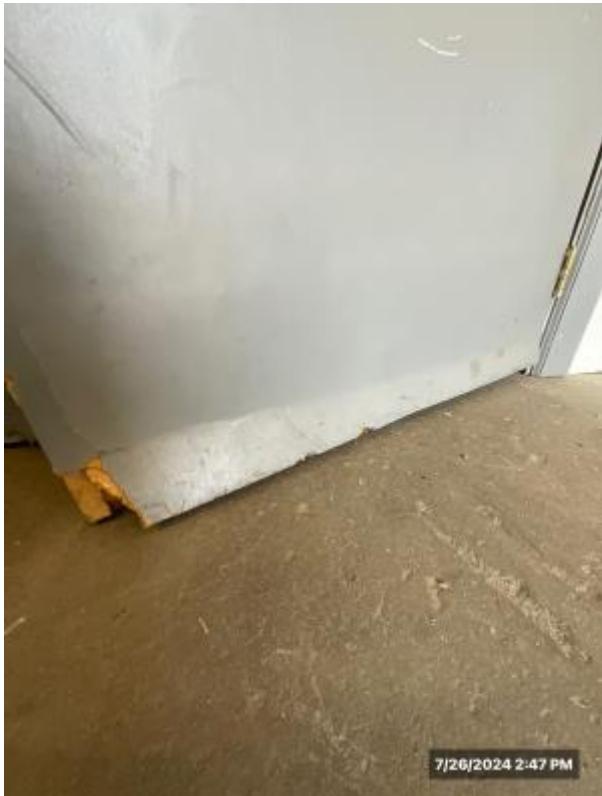
281-Equipment Room

water damage to doors

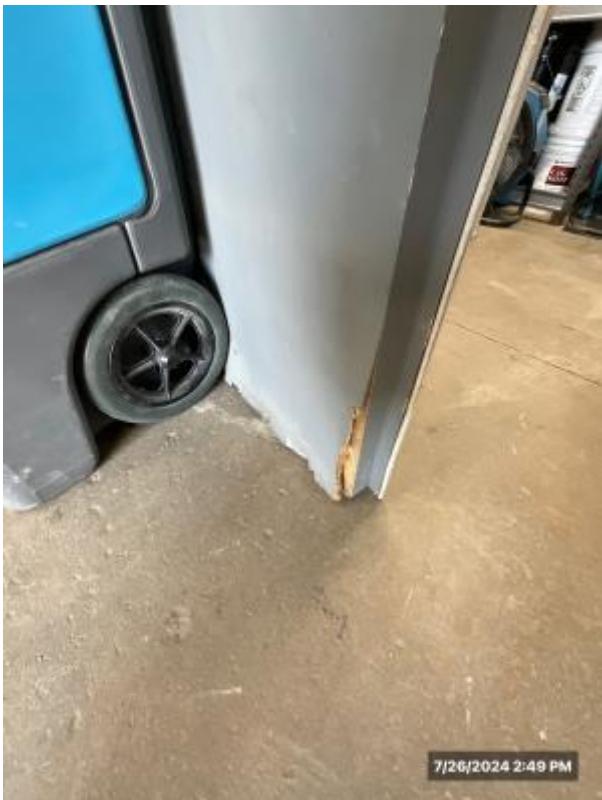
285-Equipment Room

closeup damaged door

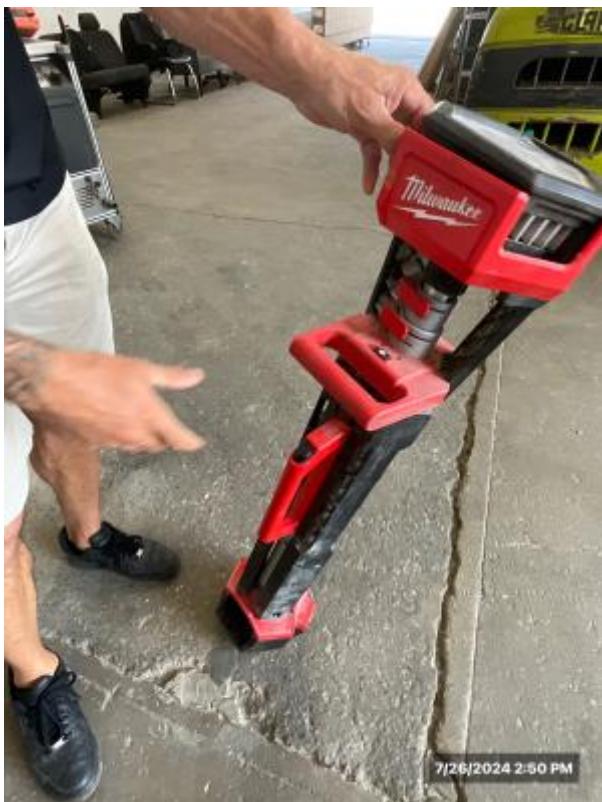
289-Milwaukee Rocket battery light

flood damaged, requires replacement - estimate line item 311

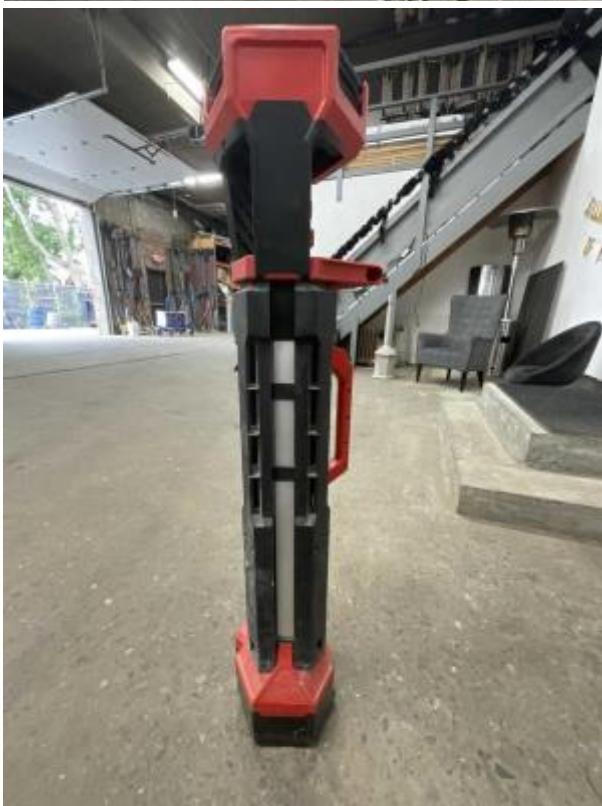
290-Milwaukee Rocket Battery Light (2)

DESCRIPTION	QUANTITY	UNIT PRICE	AGE	TAX	RCV	DEPREC.	ACV
311. Milwaukee Rocket Battery light <i>damage photos 288-289</i>	1.00 EA	179.00	0 yr	15.89	194.89	<26.85>	168.04

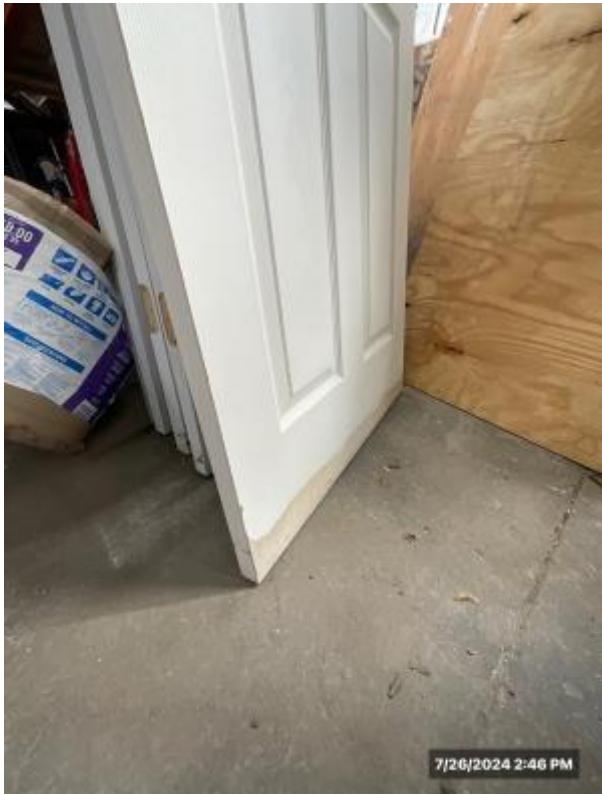
293-Hollow Core 6 Panel Door slabs

flood damaged hollow core doors, line items 312-313 in estimate

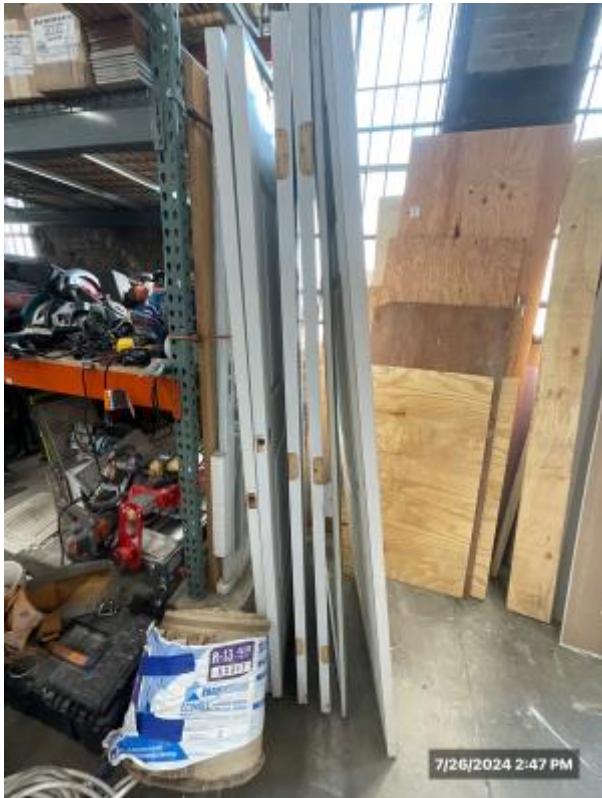
295-Hollow Core 6 Panel Door slabs

flood damaged hollow core doors, line items 312-313 in estimate

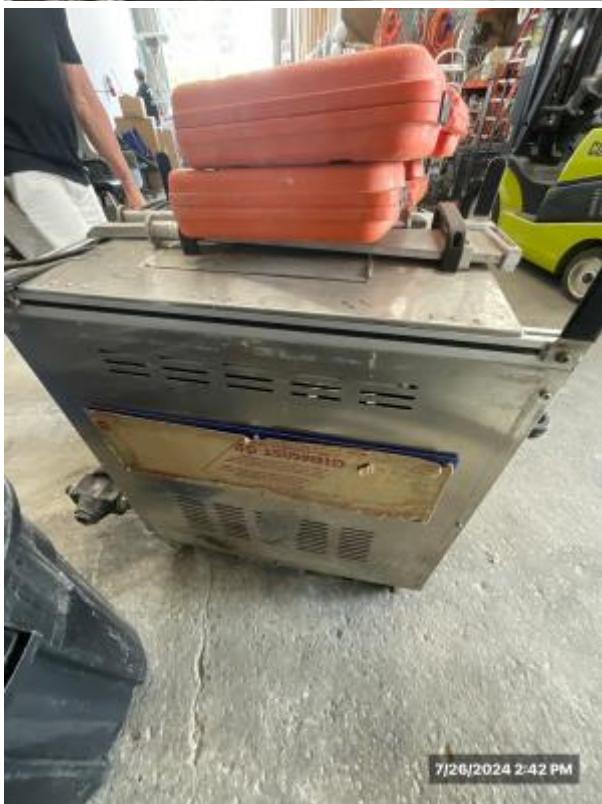
296-Cold Jet Ice Blasting Machine

314. Cold Jet Ice Blasting Machine <i>photos 296-301 - Manufacturer's pricing letter and Damage Assessment letter uploaded to file</i>	1.00 EA	45,700.00	17 yr	4,055.88	49,755.88	<6,855.00>	42,900.88

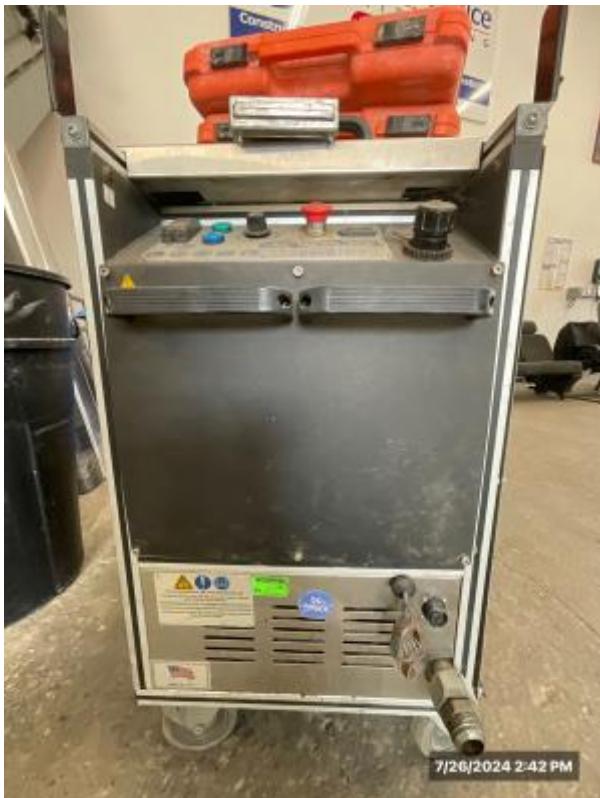
297-Cold Jet Ice Blasting Machine

this unit flood damaged, is not functioning, and requires replacement - Unit 80FP, manufacturer pricing letter uploaded to file - Line item 314 in estimate

Assembly # 2A0148-G2
Serial # 51H2-K-1237

Cold Jet has reviewed the photos of the unit and due to the unit being in 24 inches of water and the probability of the electronics being damaged the unit is not repairable.

Line item 314 in estimate

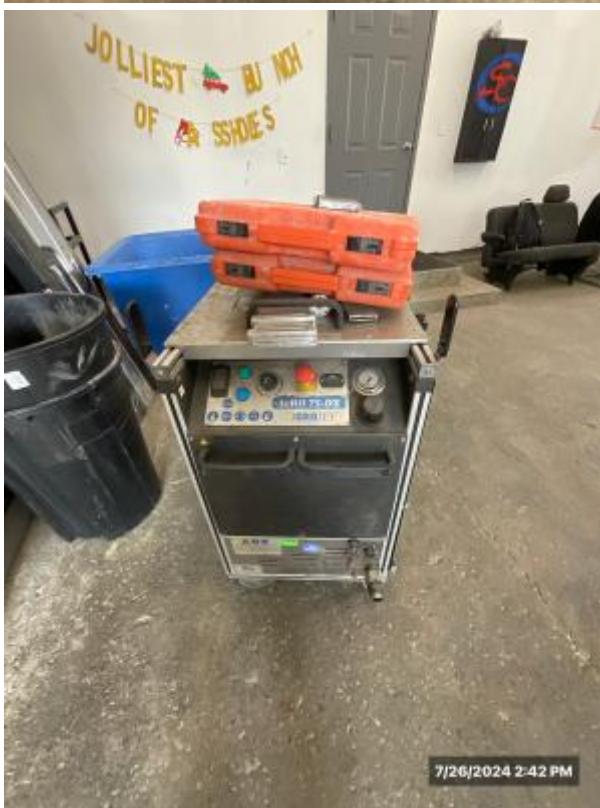
298-Cold Jet Ice Blasting Machine

this unit flood damaged, is not functioning, and requires replacement - Unit 80FP, manufacturer pricing letter uploaded to file - Line item 314 in estimate

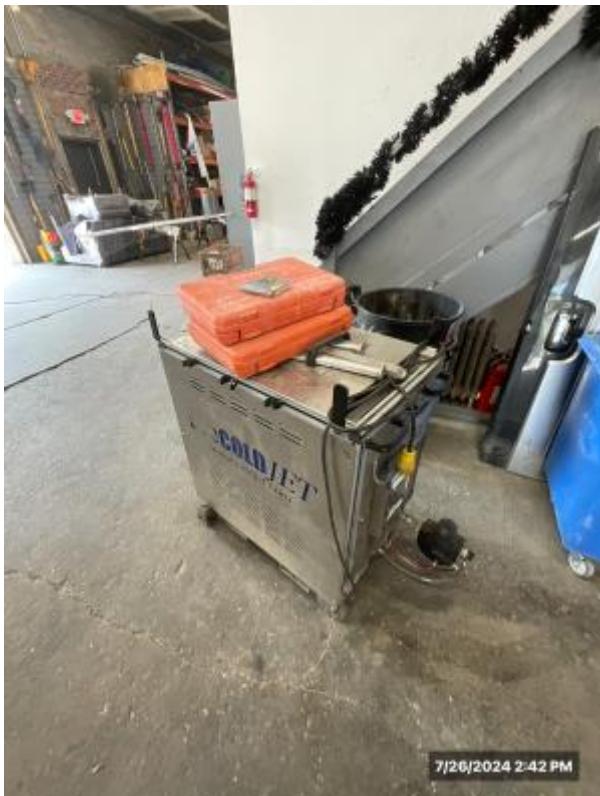
299-Cold Jet Ice Blasting Machine

this unit flood damaged, is not functioning, and requires replacement - Unit 80FP, manufacturer pricing letter uploaded to file - Line item 314 in estimate

Assembly # 2A0148-G2
Serial # 51H2-K-1237

Line item 314 in estimate

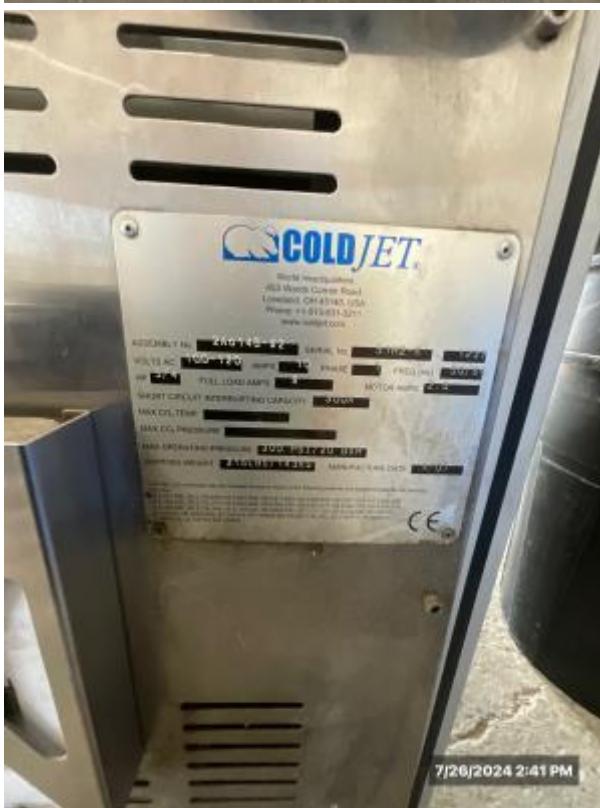
300-Cold Jet Ice Blasting Machine

this unit flood damaged, is not functioning, and requires replacement - Unit 80FP, manufacturer pricing letter uploaded to file - Line item 314 in estimate

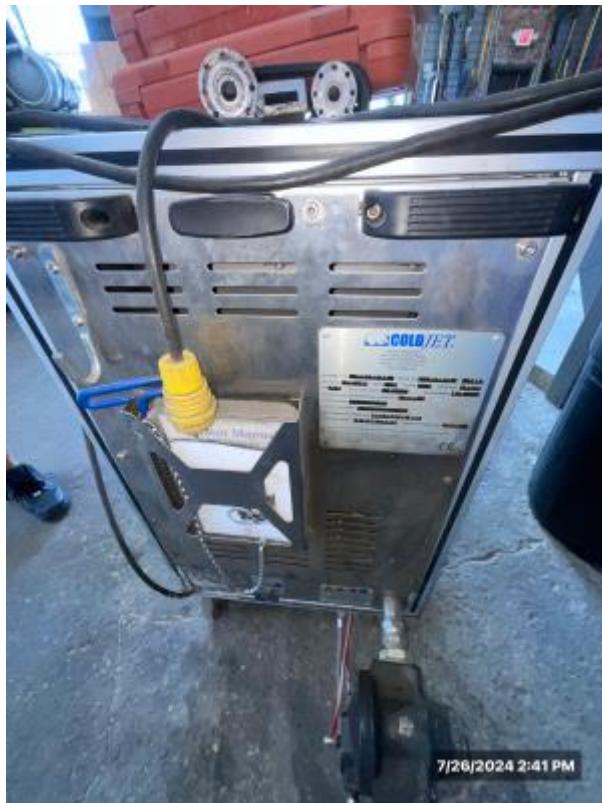
301-Cold Jet Ice Blasting Machine

this unit flood damaged, is not functioning, and requires replacement - Unit 80FP, manufacturer pricing letter uploaded to file - Line item 314 in estimate

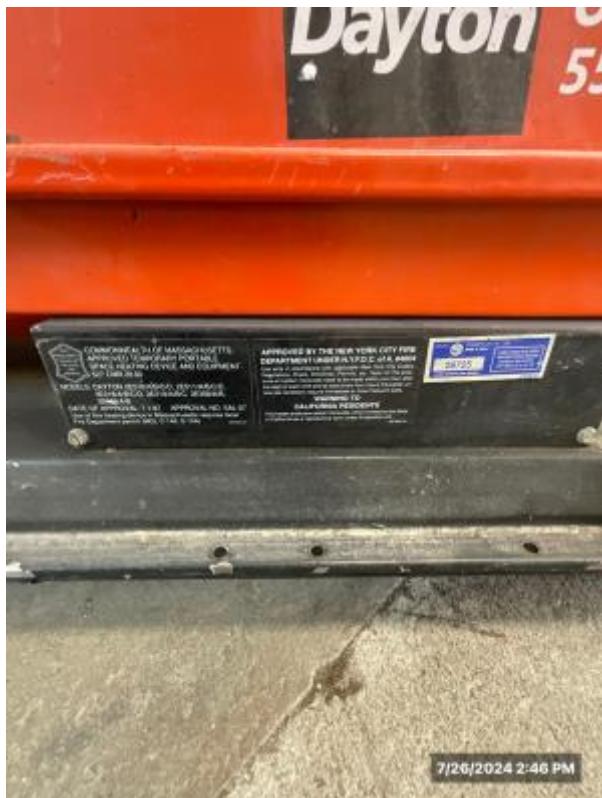
303-Dayton Oil Fired 55,000 BTU Diesel Heater

this unit flood damaged, replacement required
Model 2D511D
Line item #315

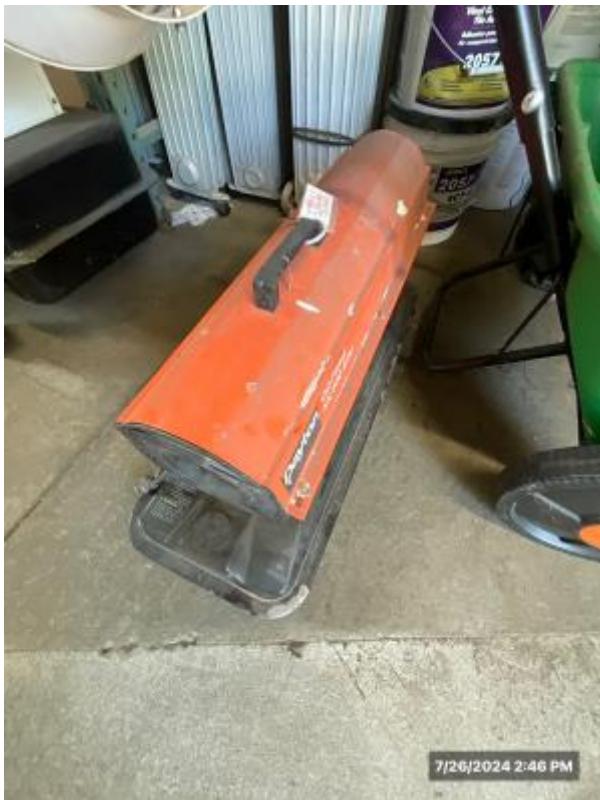
305-Dayton Oil Fired 55,000 BTU Diesel Heater

this unit flood damaged, replacement required
Model 2D511D
Line item #315

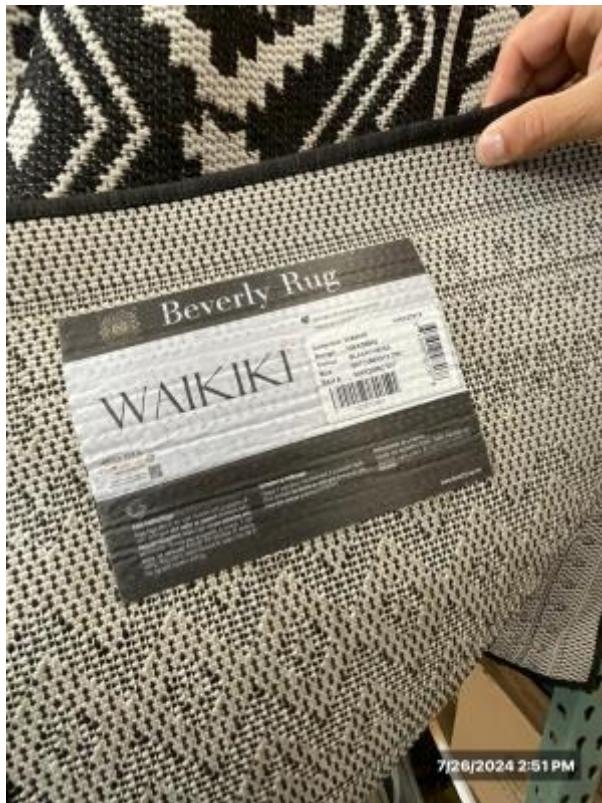
307-Office Area Rug

this rug exposed to CAT 3 water,
requires replacement
Line item 316

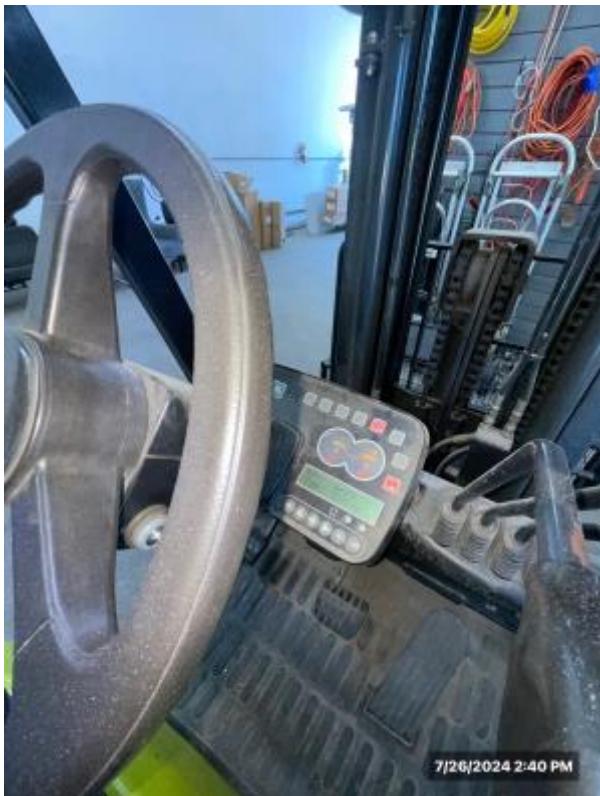
345-Forklift

check engine light on - insured will be testing further to determine the extent of the flood damages

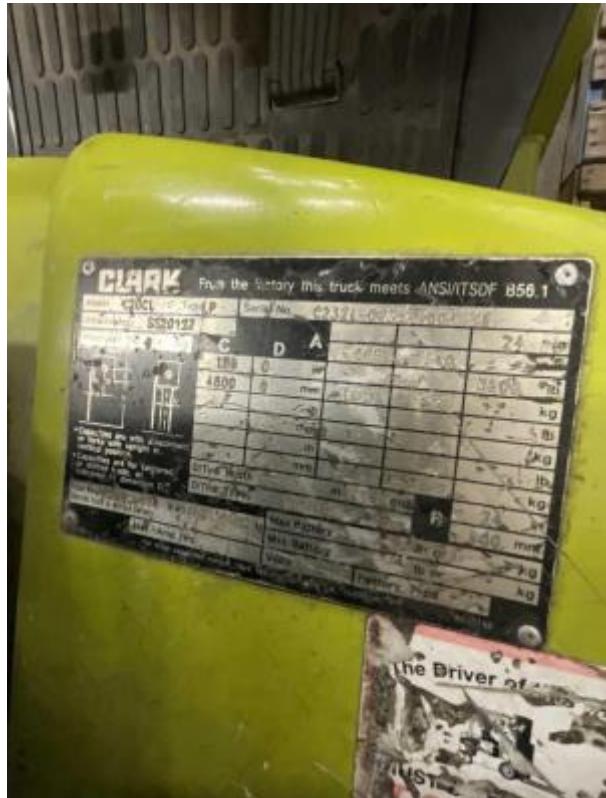
349-Forklift (4)

check engine light on - insured will be testing further to determine the extent of the flood damages
