NARRATIVE REPORT

DWELLING / UNIT OWNER

Carrier:	American Bankers Insurance Co	Date of Loss:	9/27/2024
Insured:	Donald and Shelby McGuire	Assigned:	10/2/2024
CID:	240045	Contacted:	10/2/2024
Claim Number:	8704207471	Inspected:	10/8/2024
Policy Number:	8704207471	Inspected With:	Deceased insured's son, Donald W., & daughter-in-law
Loss Address:	1811 Lake Drive Charlotte NC 28214	Mailing Address:	1811 Lake Drive Charlotte NC 28214
Coverage A:	\$ 190,000.00	Mortgage:	Wells Fargo Bank, N.A. #936
Coverage B:	\$ 63,000.00	Verified with:	Named Insured's son, Donald W. McGuire
Policy Term:	4/25/2024 to 4/25/2025

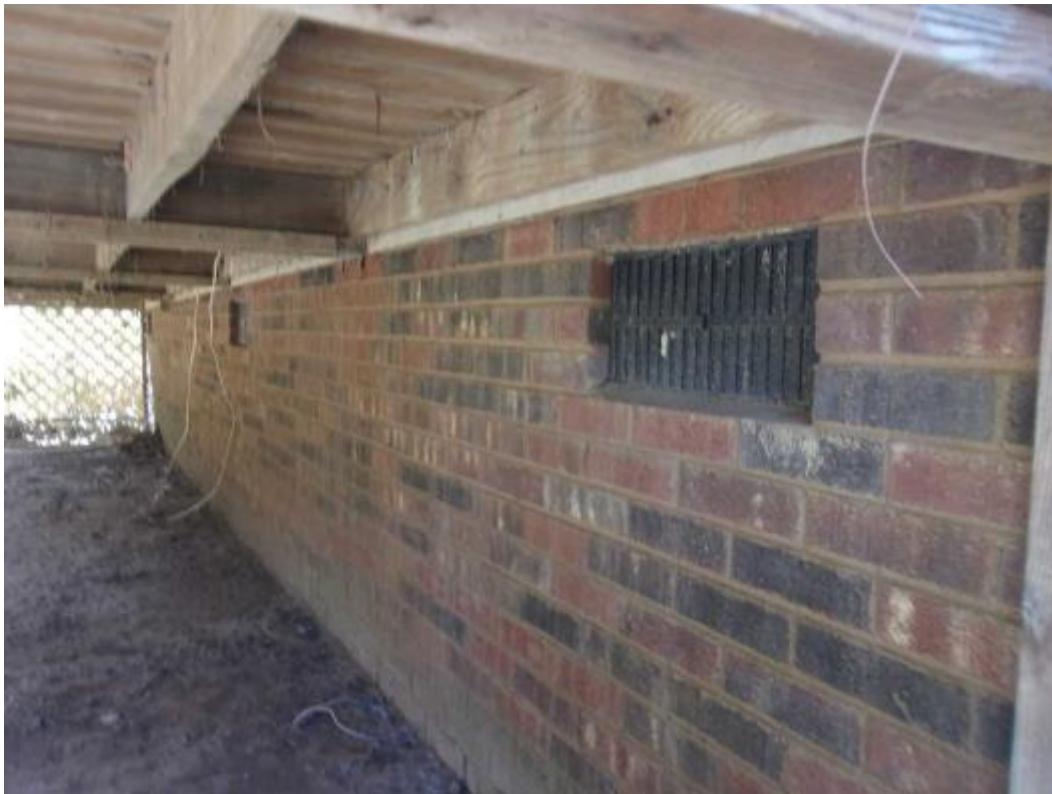
Exterior - 21-Front Elevation

Under Front Porch,
No vents within 1' of grade.

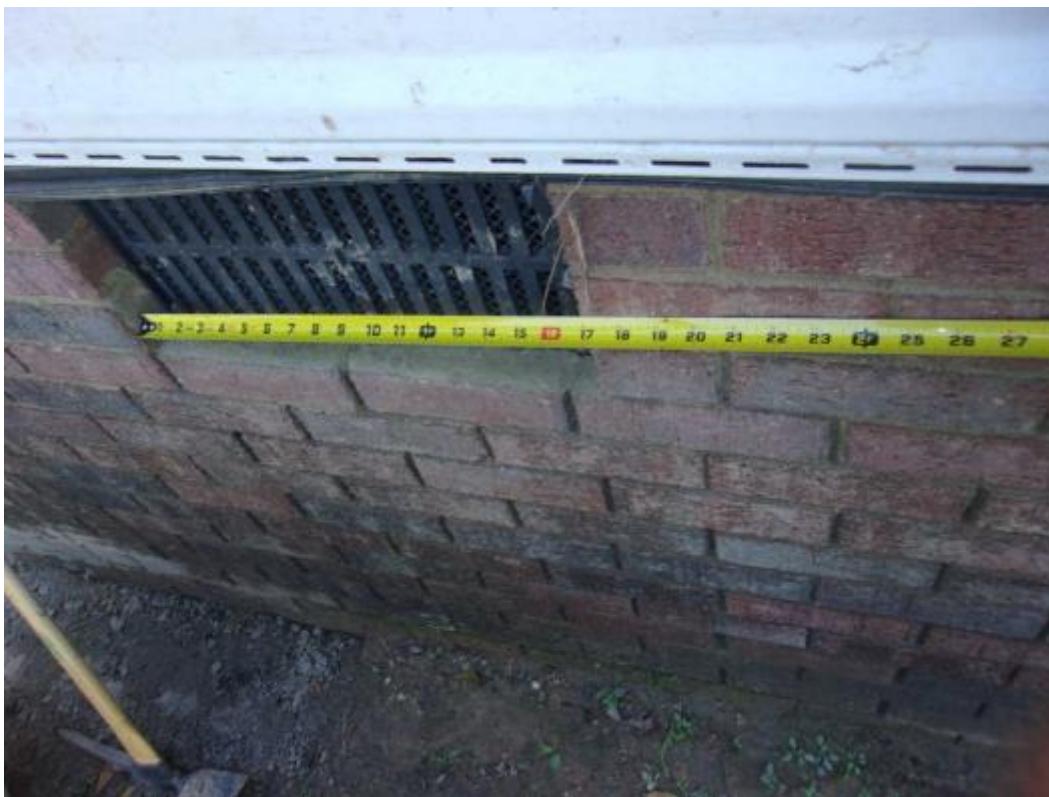
Exterior - 25-Right Elevation

No vents within 1' of ground

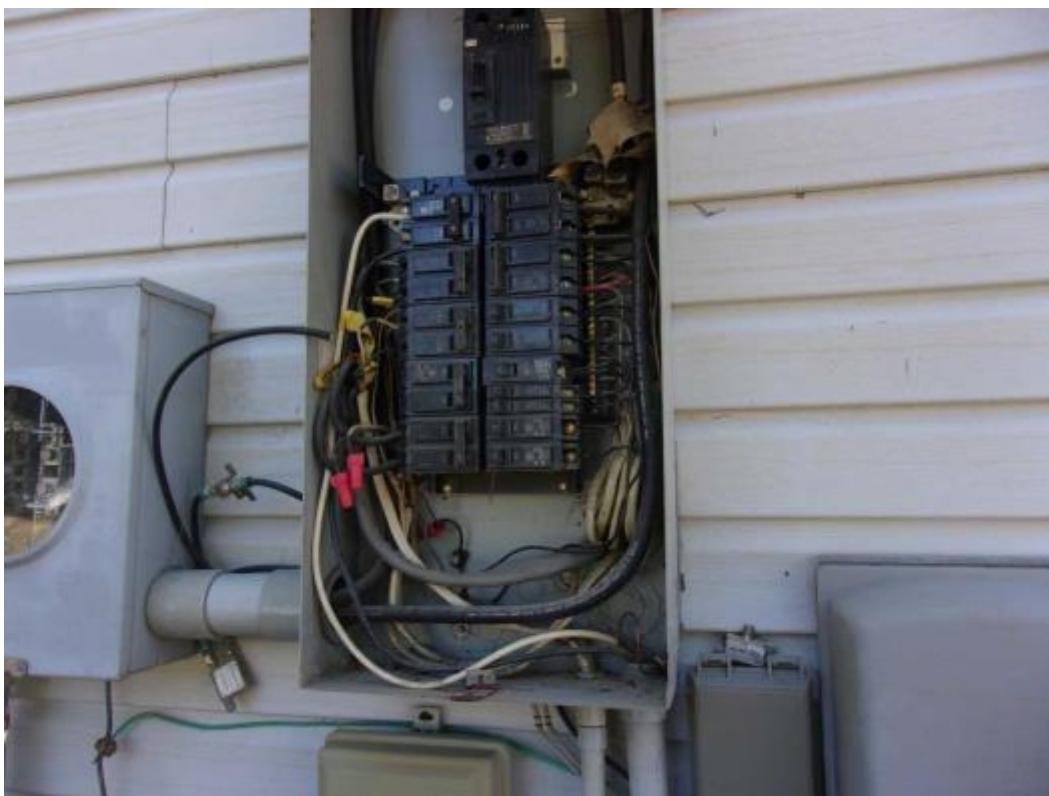
Exterior - 28-Right Elevation - Electrical

Service Panel and meter base were underwater, replacement recommended

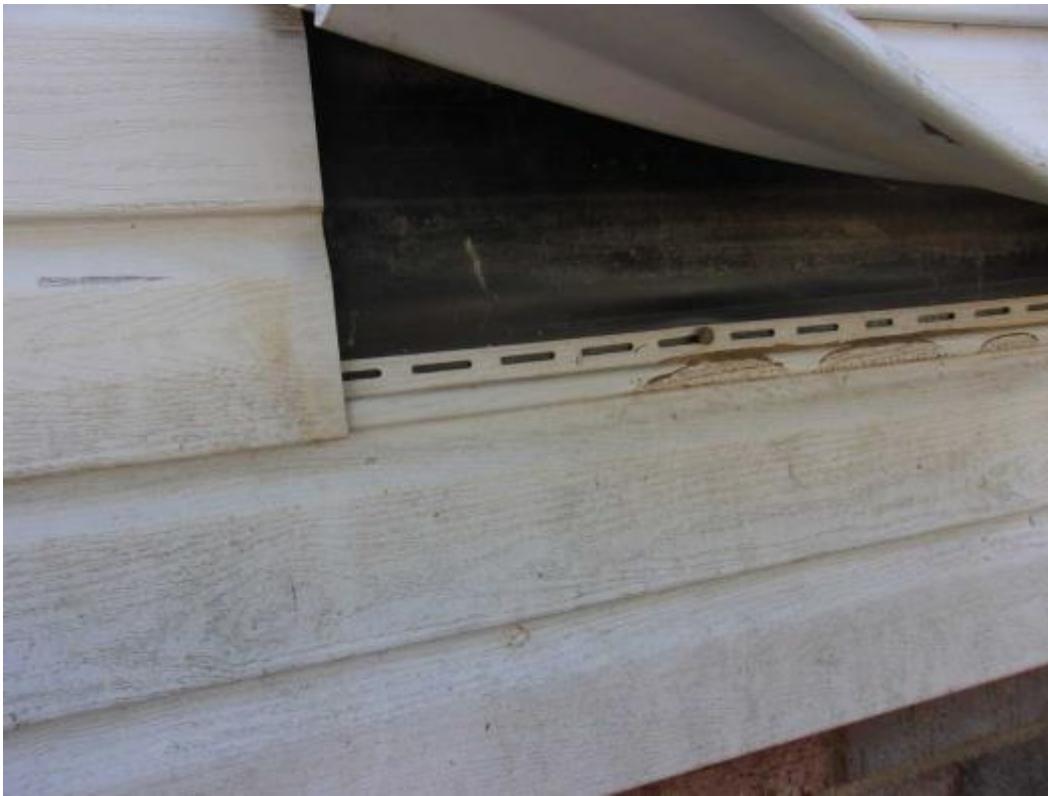
Exterior - 31-Rear Elevation

Siding not insulated

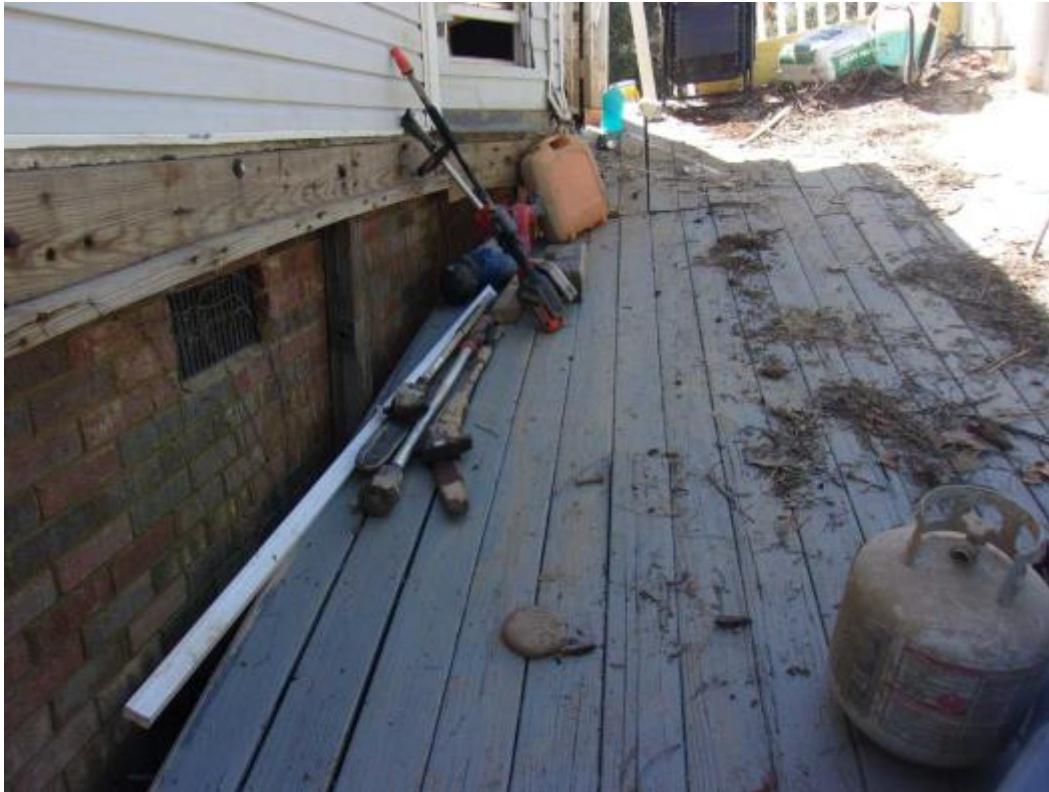
Exterior - 33-Rear Elevation

Attached structure pulled away by floodwater

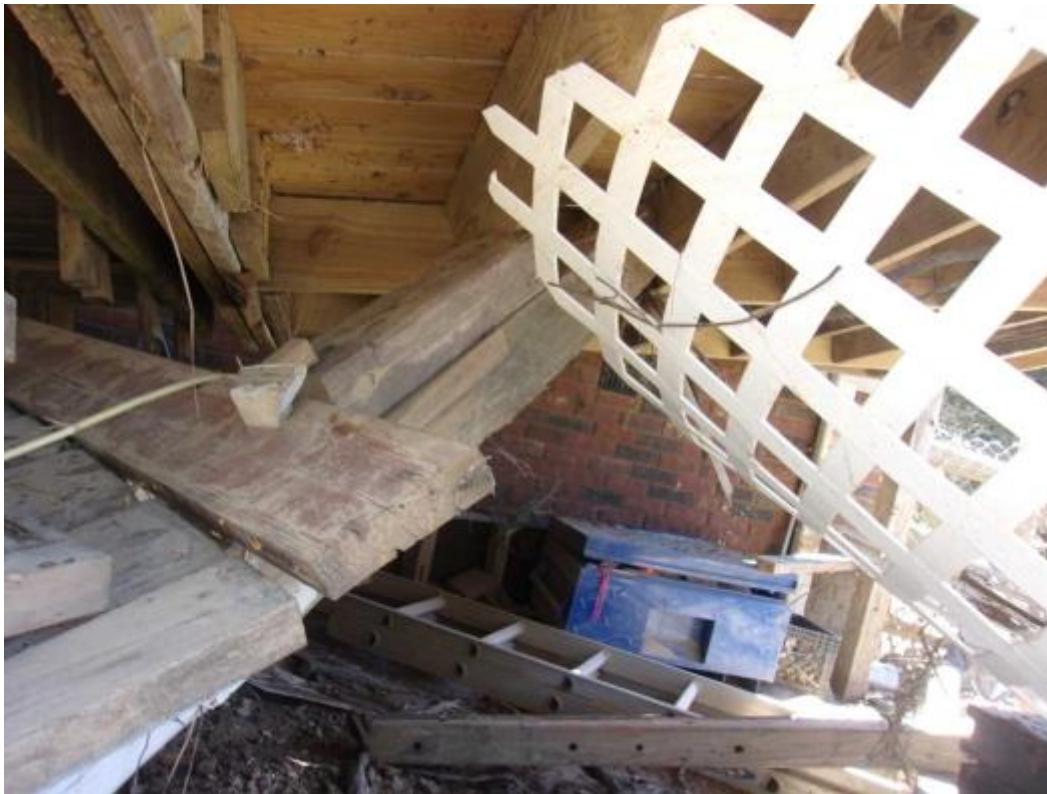
Exterior - 35-Rear Elevation

Under the now detached structure, more personal property

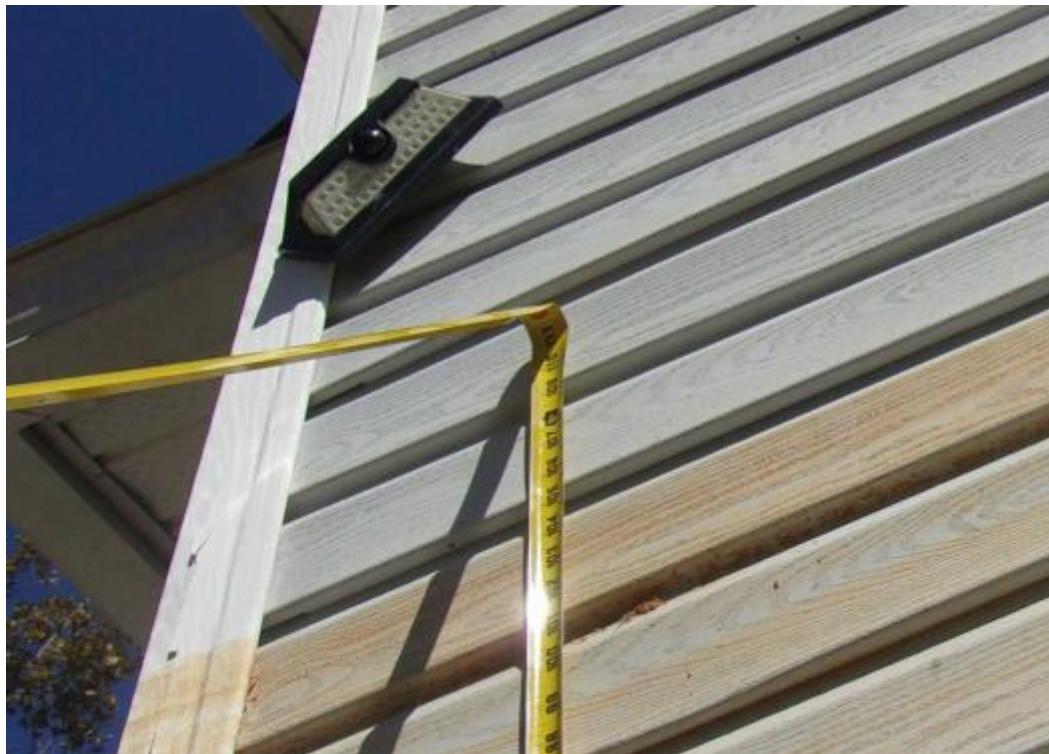
Exterior - 37-Left-Rear

Waterline: 8'8"

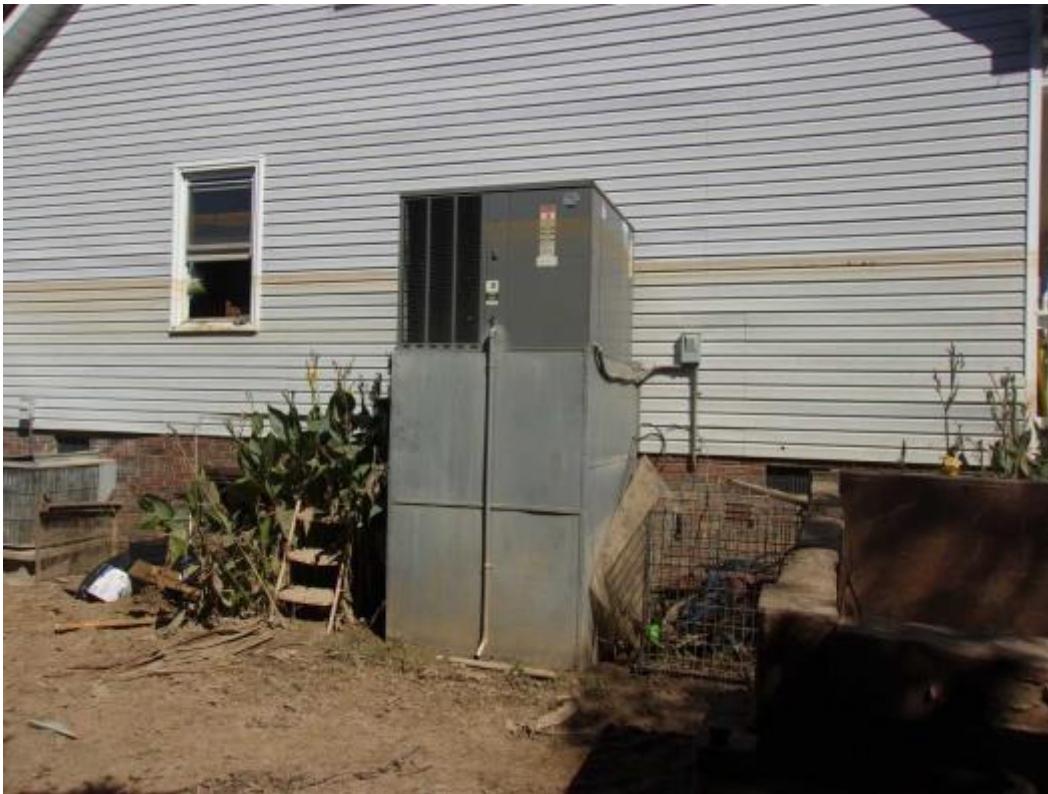
Exterior - 39-Left Elevation

Elevated Heat Pump and disconnect switch

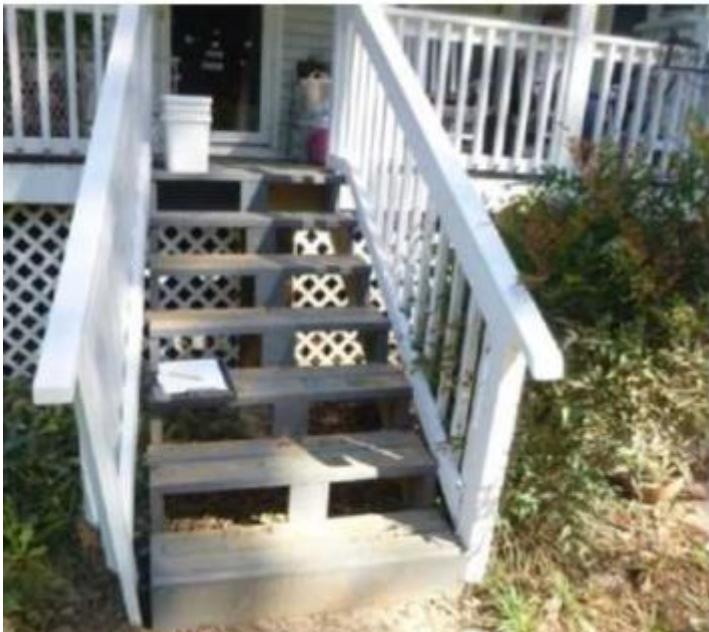
Photo ID :
A - Front Stairs

No indication stairs replaced after 2019 loss,

Cleaning allowance only, this estimate

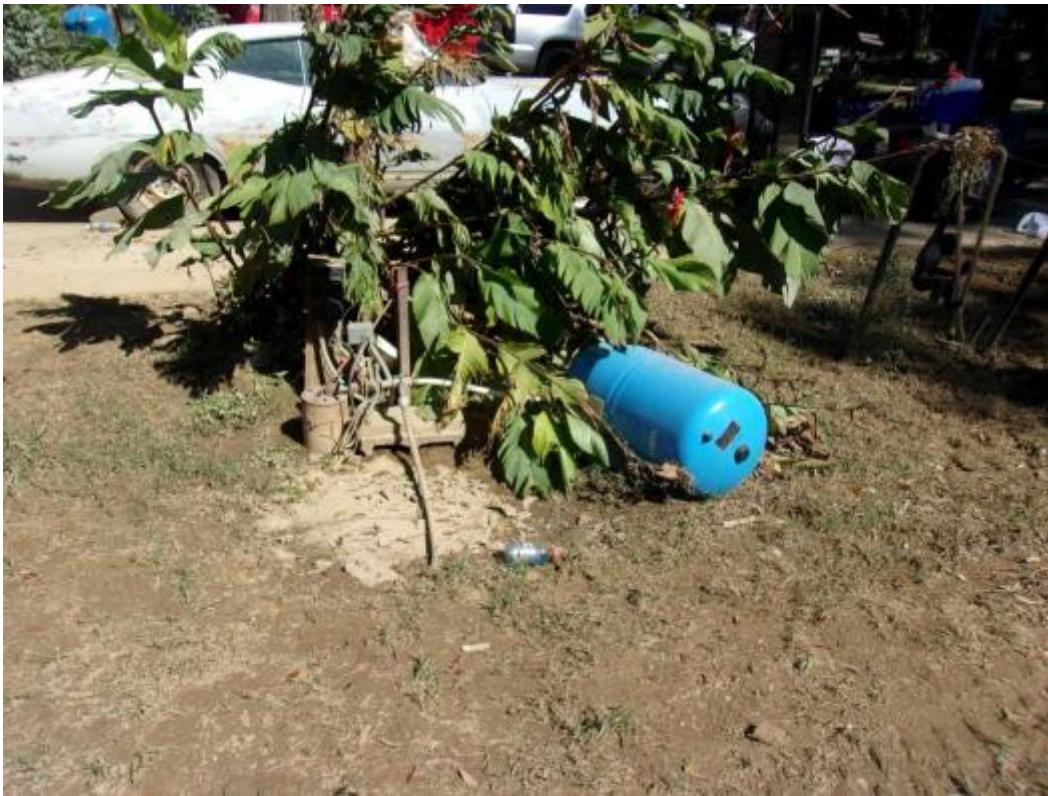
Exterior - 135-Well Pump no covered

Outside of perimeter wall

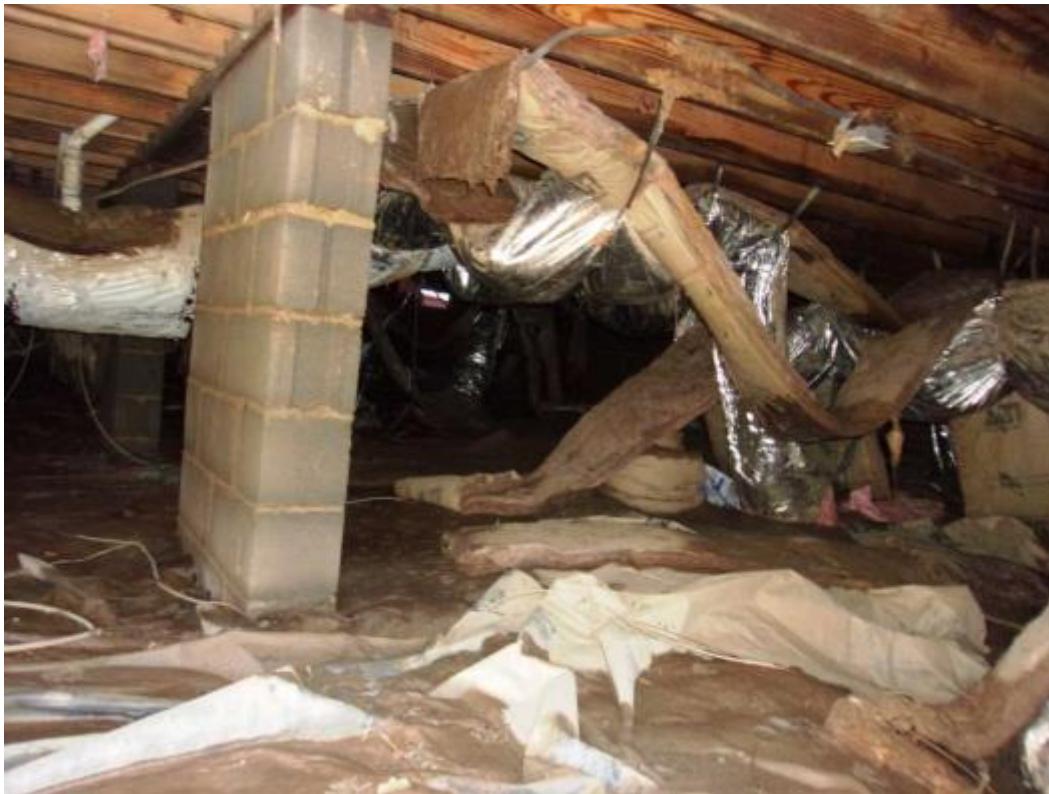
Ground Level/Crawlspace - 51-Crawlspace Overview

Insulation, ductwork, electrical, and (unattached)vapor barrier damage.

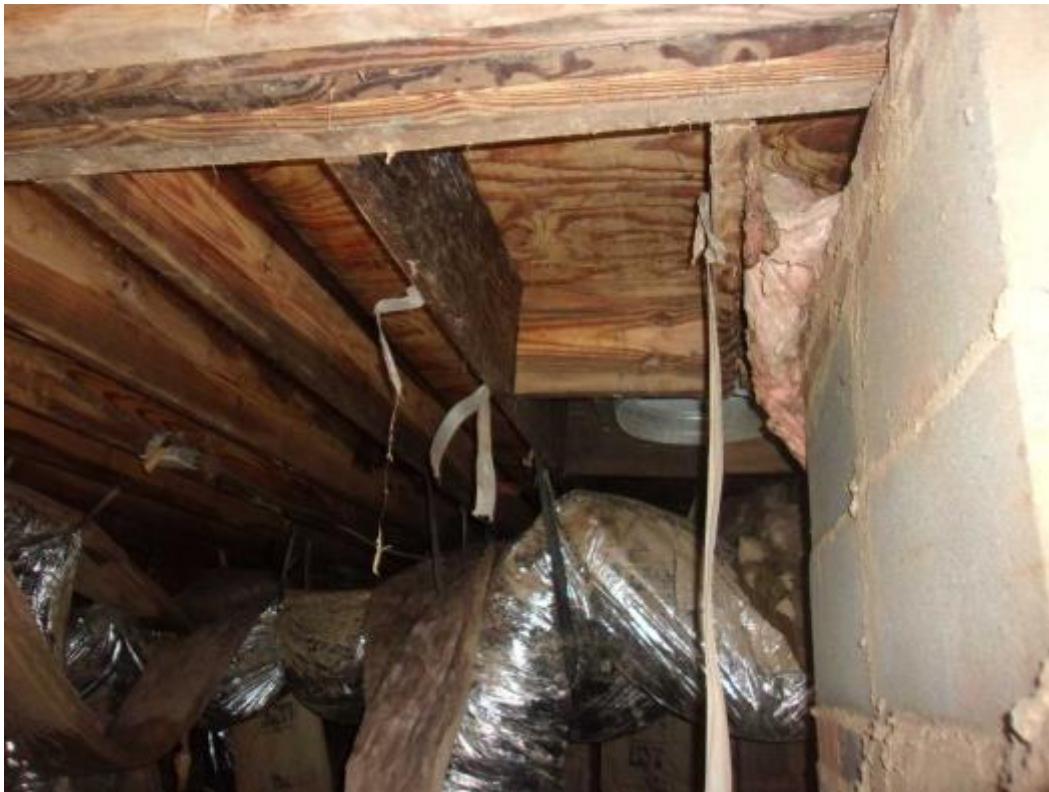
Ground Level/Crawlspace - 54-Crawlspace

Insulation and insulated flexible ducts damaged

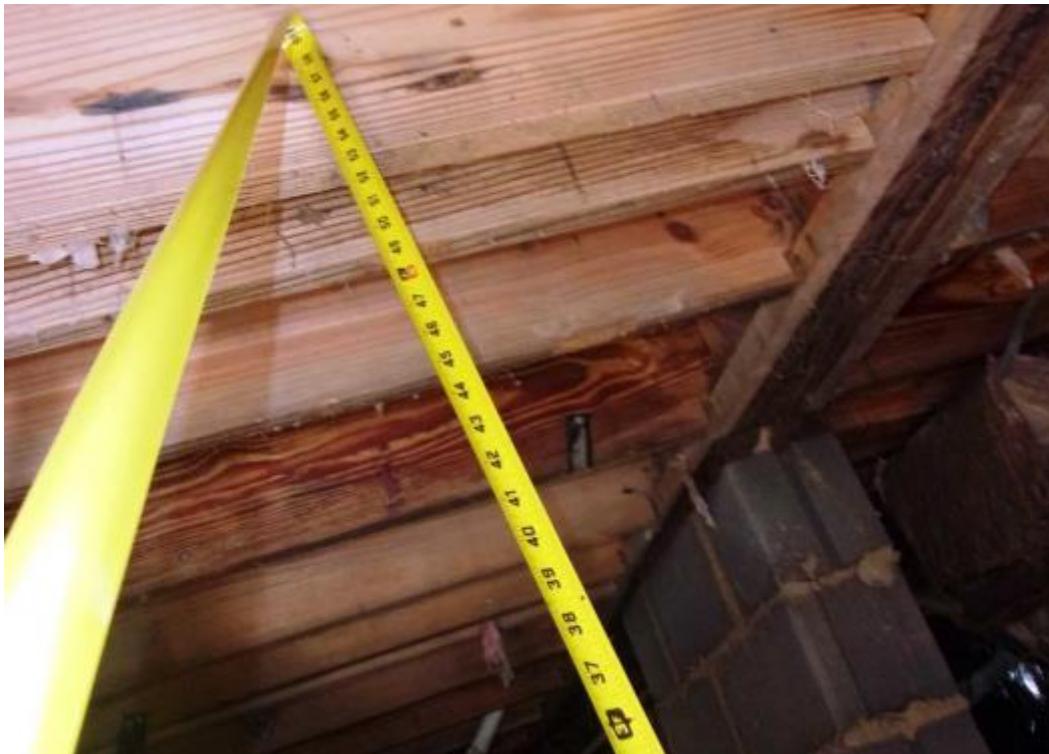
Ground Level/Crawlspace - 55-Crawlspace

Taken By: Dean Palmieri
approx 4'5"

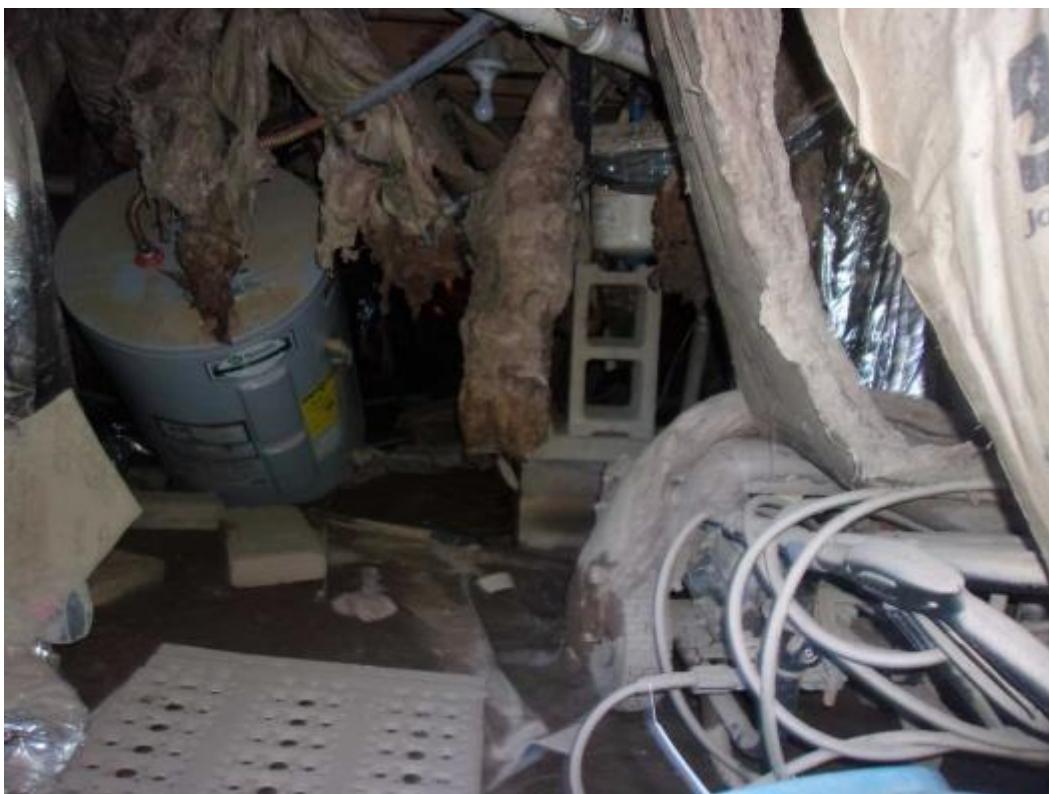
Ground Level/Crawlspace - 56-Crawlspace

Taken By: Dean Palmieri
Damage to water heater, electrical, insulation

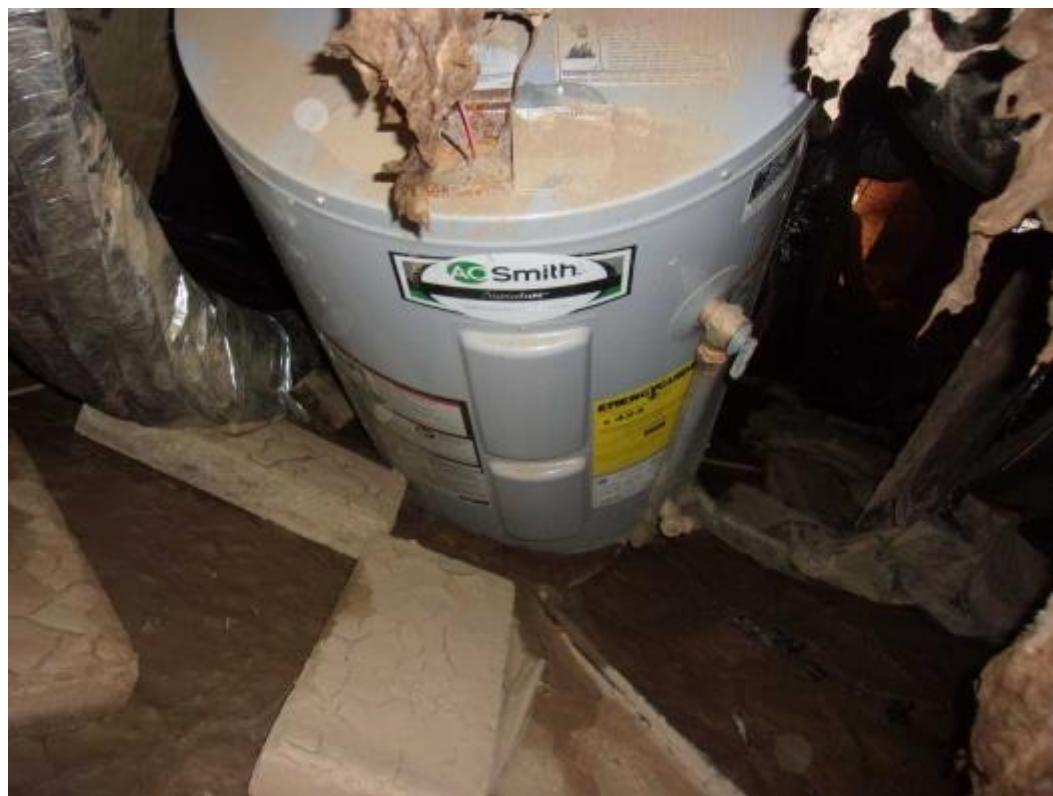
Ground Level/Crawlspace - 58-Crawlspace

Water heater similar in appearance to 2019 item

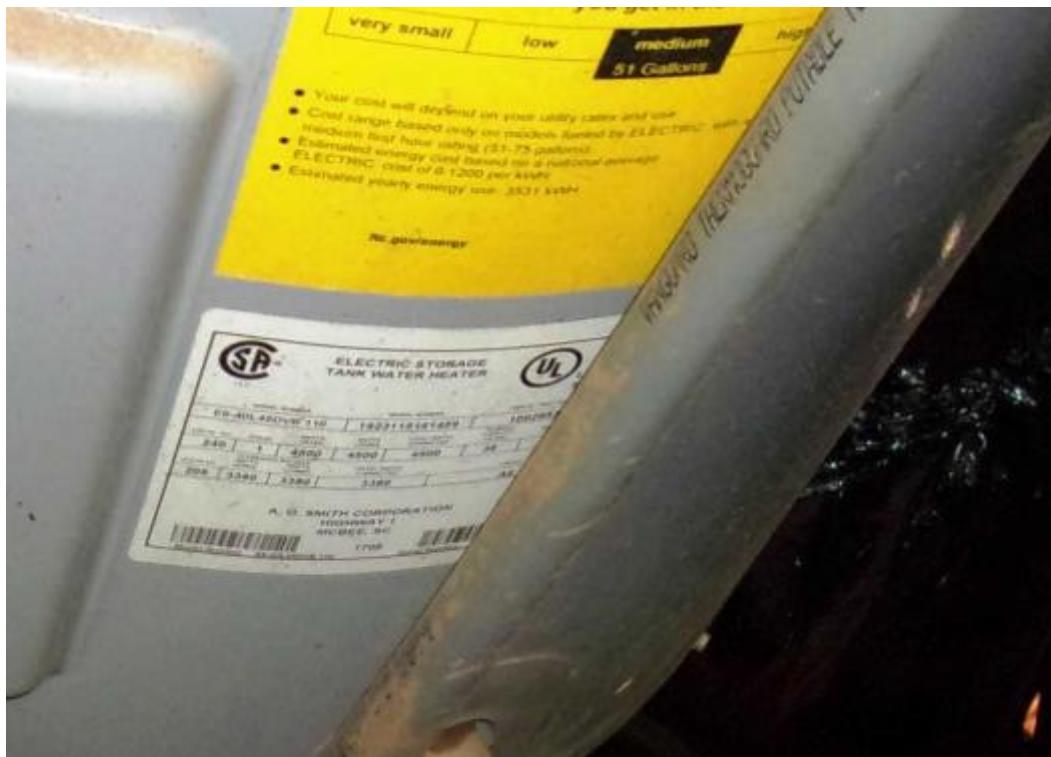
Ground Level/Crawlspace - 59-Water Heater

Comment :
Overview of crawlspace which was inches away from being fully submerged. Cleanup, dryout, application of mildewcide, and replacement of the floor insulation, ductwork, and water heater required.

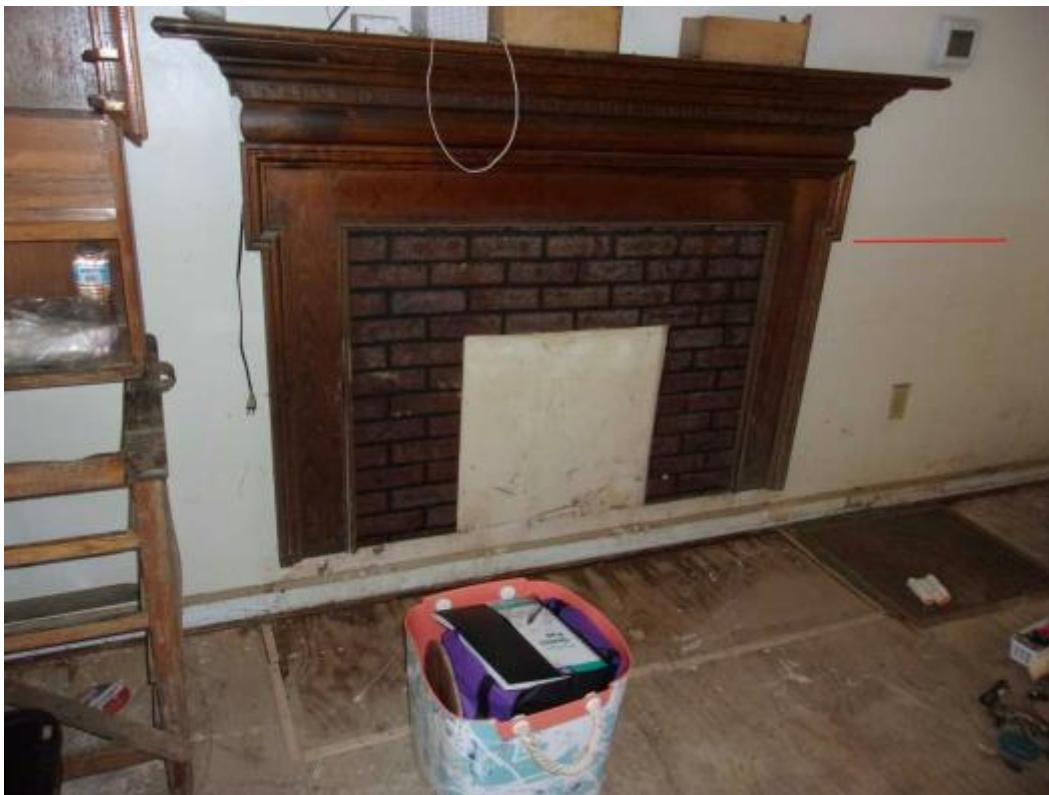
Main Level/Living Room - 66-Living Room

Simulated brick panel
Water level was below mantel, but wood trim around "fireplace" was wet and requires replacement

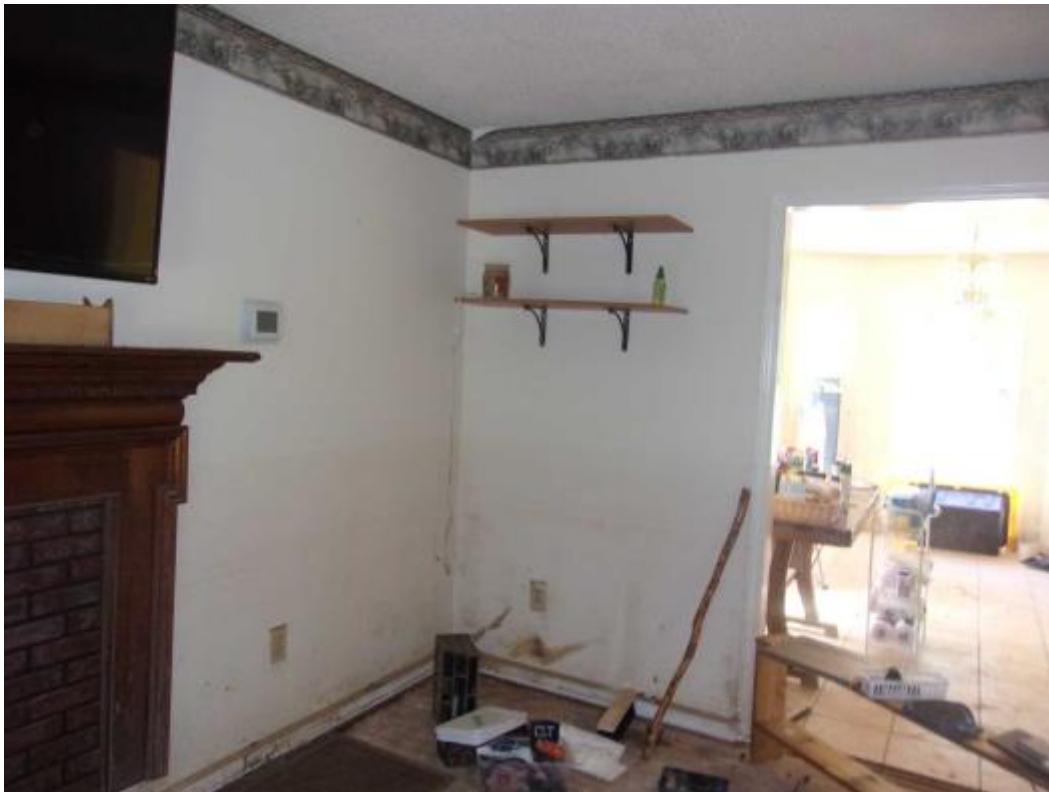
Main Level/Living Room - 67-Living Room

Overview- Wallpaper border, sprayed ceiling

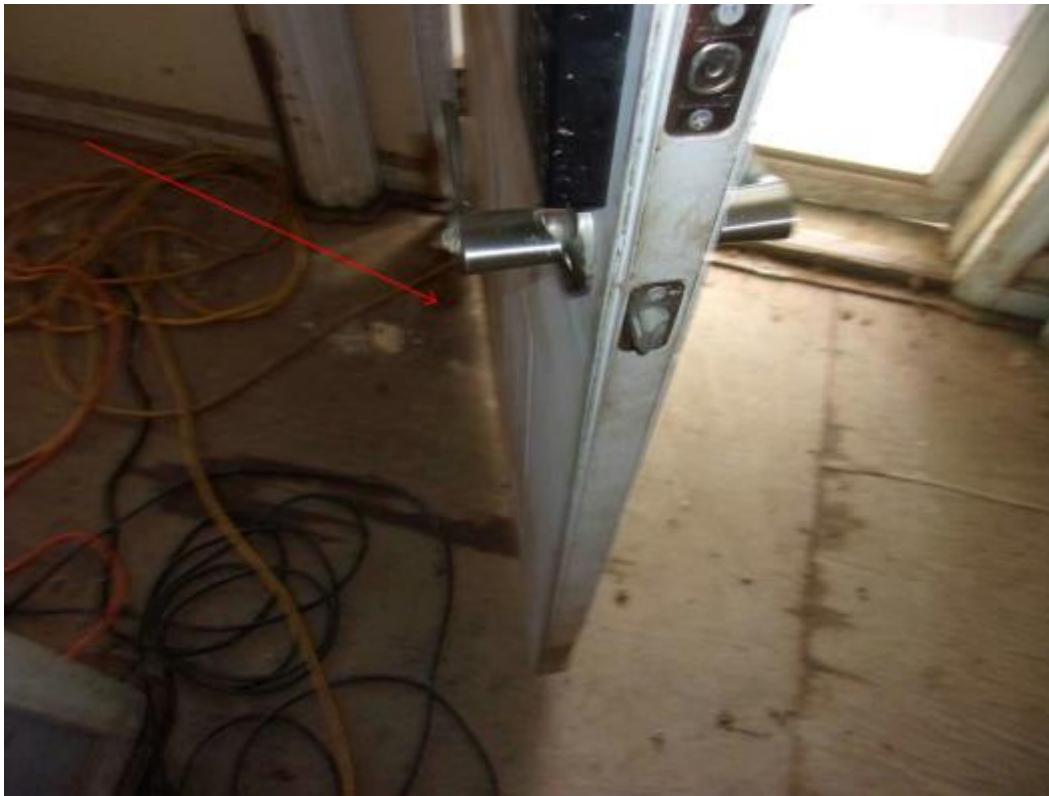
Main Level/Living Room - 72-Living Room

Front door swelling, water entered around seams, replacement recommended

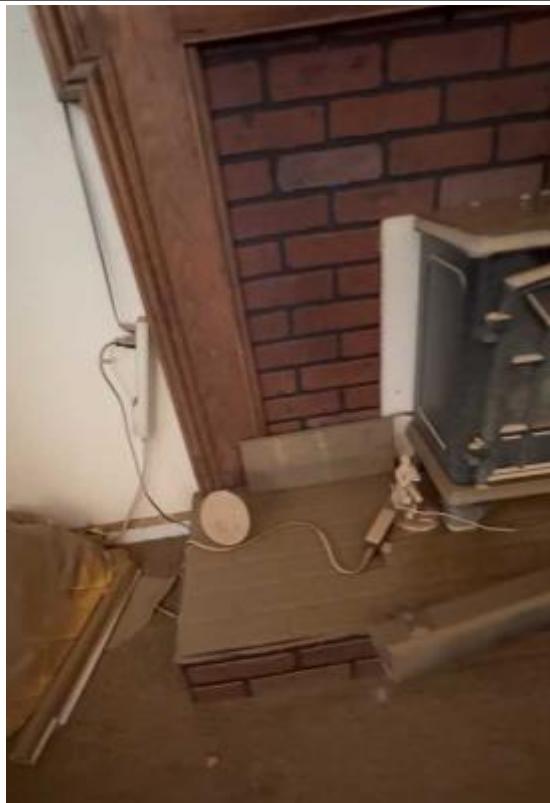
**Main Level/Living Room - 74-
Living Room**

Fireplace "Hearth", removed prior to inspection

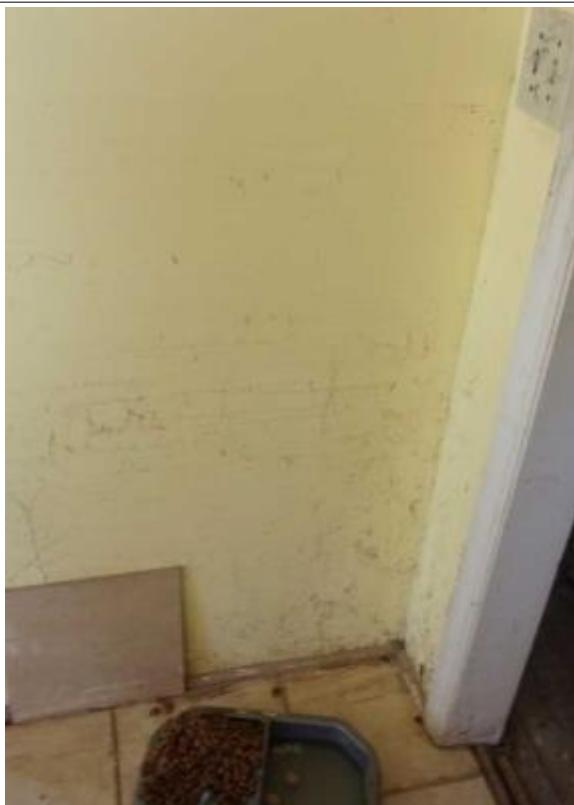
Main Level/Dining Room - 81-Dining Room

42" Waterline;
Drywall Replacement to 8'

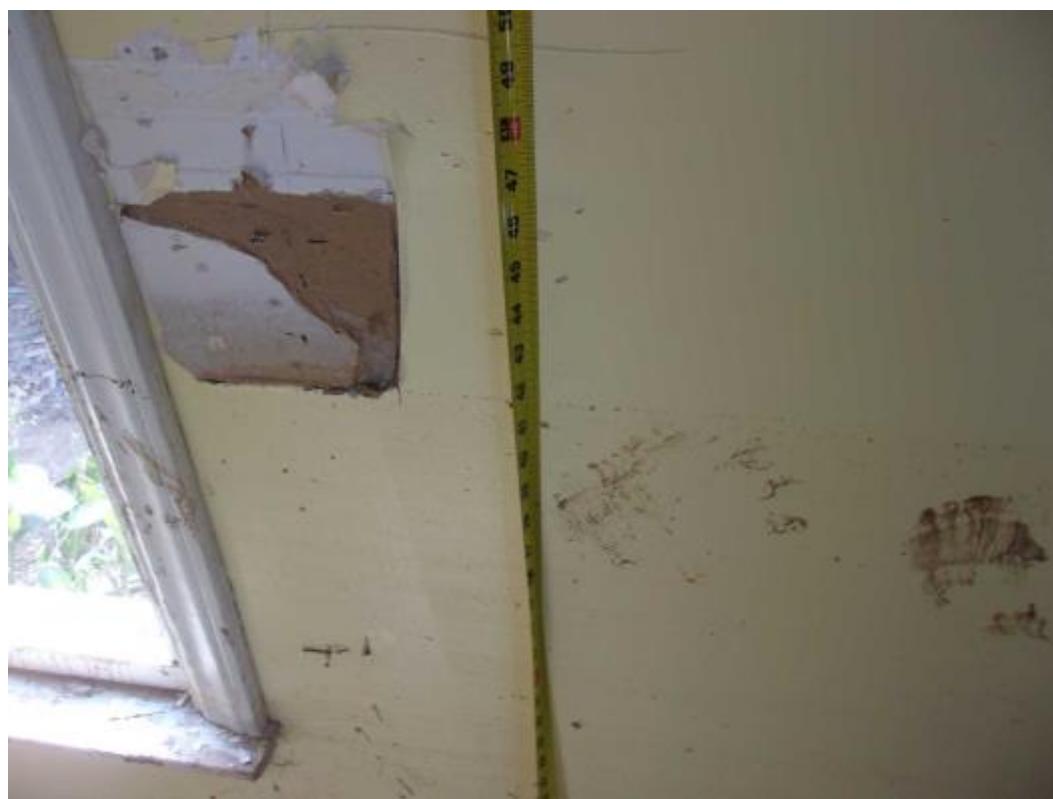
Main Level/Dining Room - 80-Dining Room

Baseboard not all walls

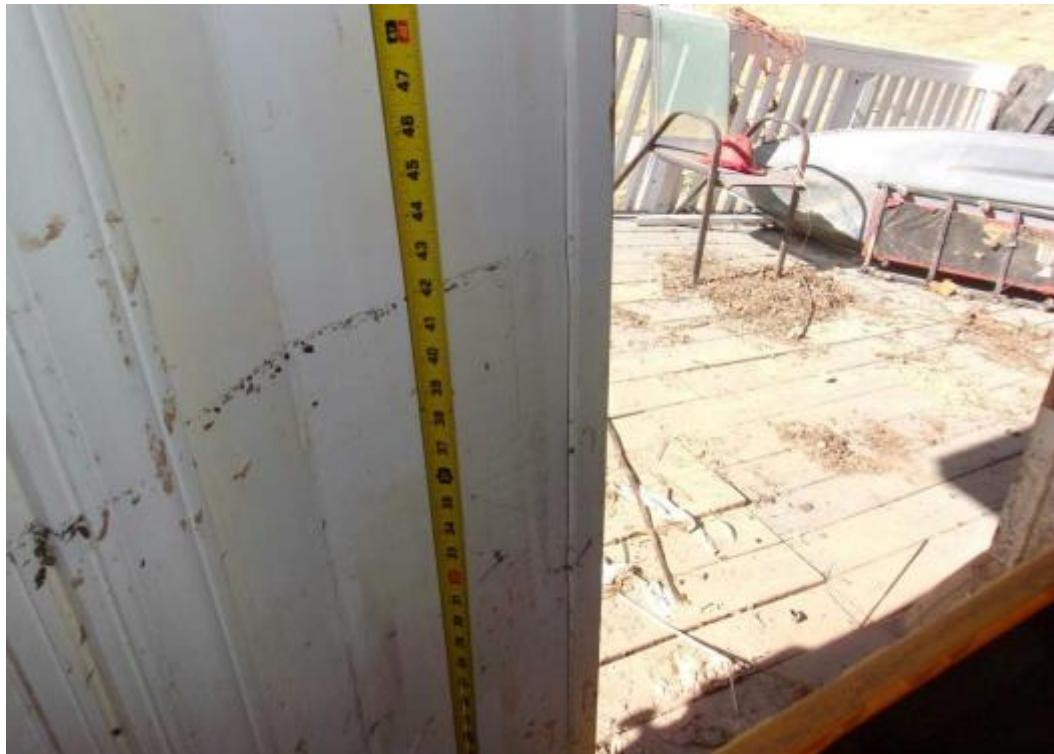
Main Level/Dining Room - 90-Interior - Dining Room

Waterline 3'6"

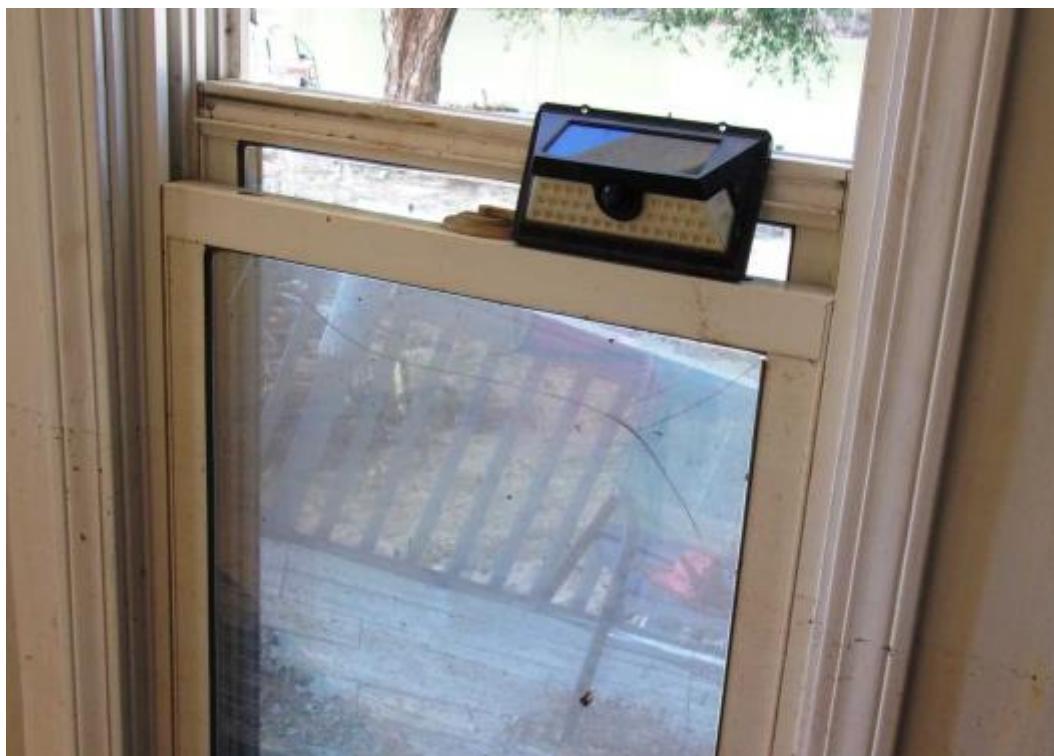
Main Level/Dining Room - 85-Dining Room

Cracked rear window

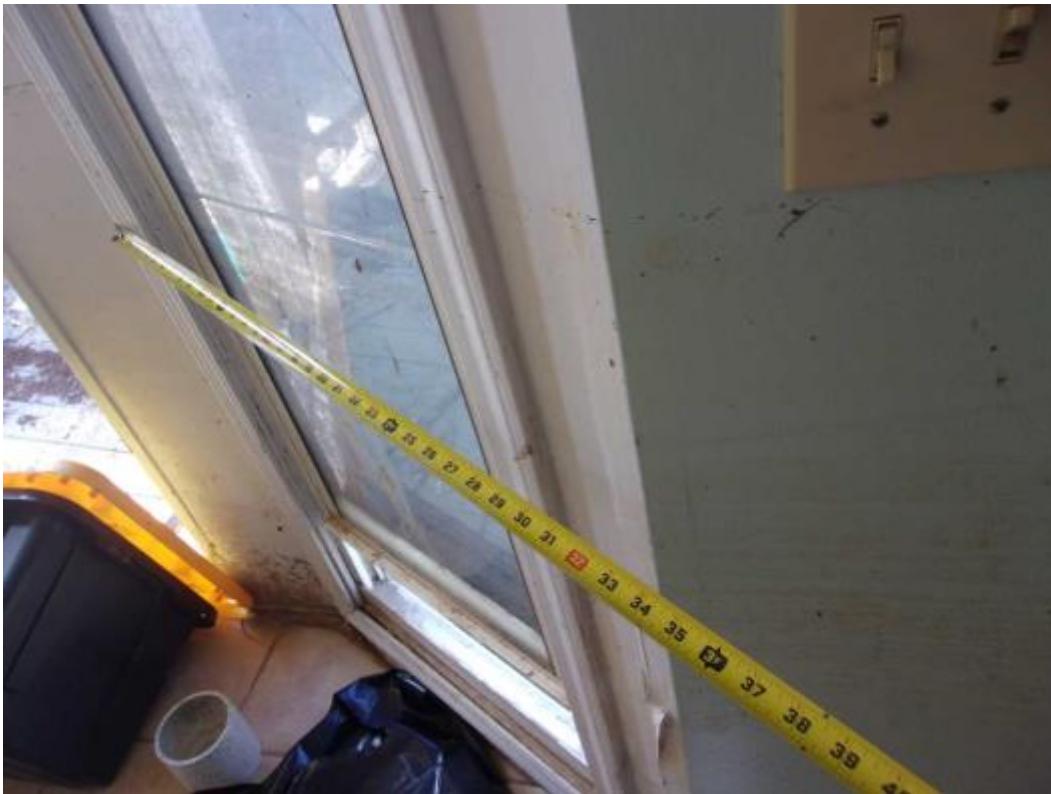
Main Level/Dining Room - 84-Dining Room

Broken window,
Water line below switches

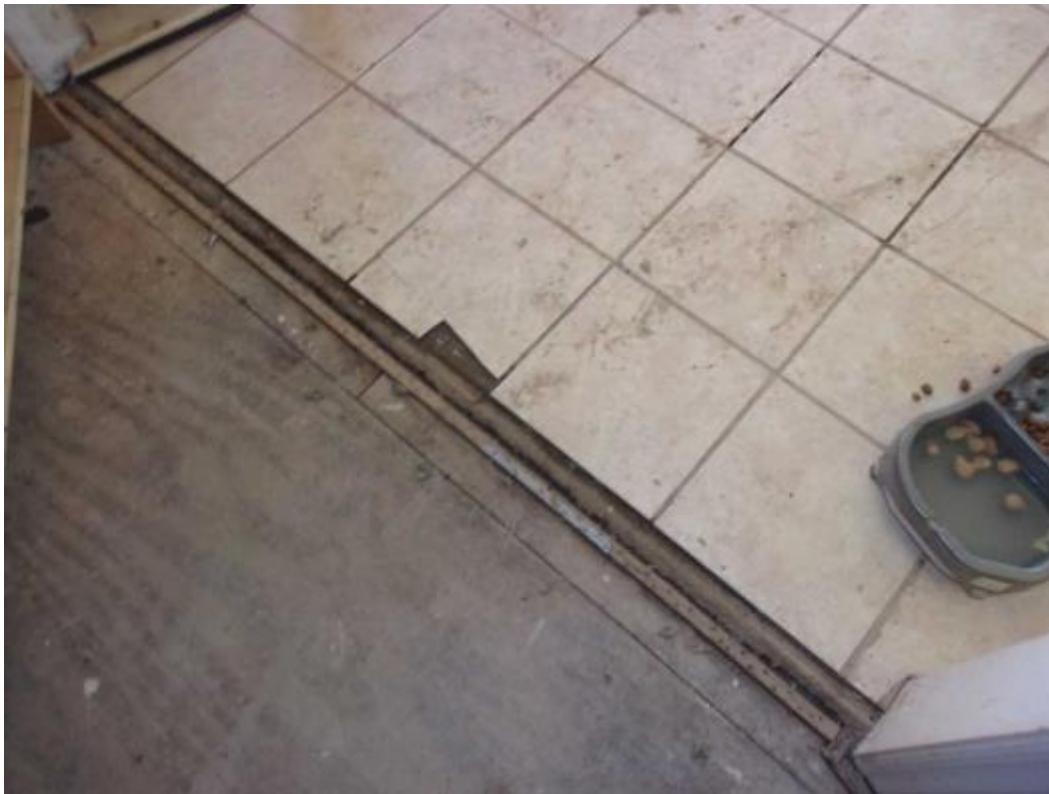
Main Level/Dining Room - 86-Dining Room

Tile replacement recommended

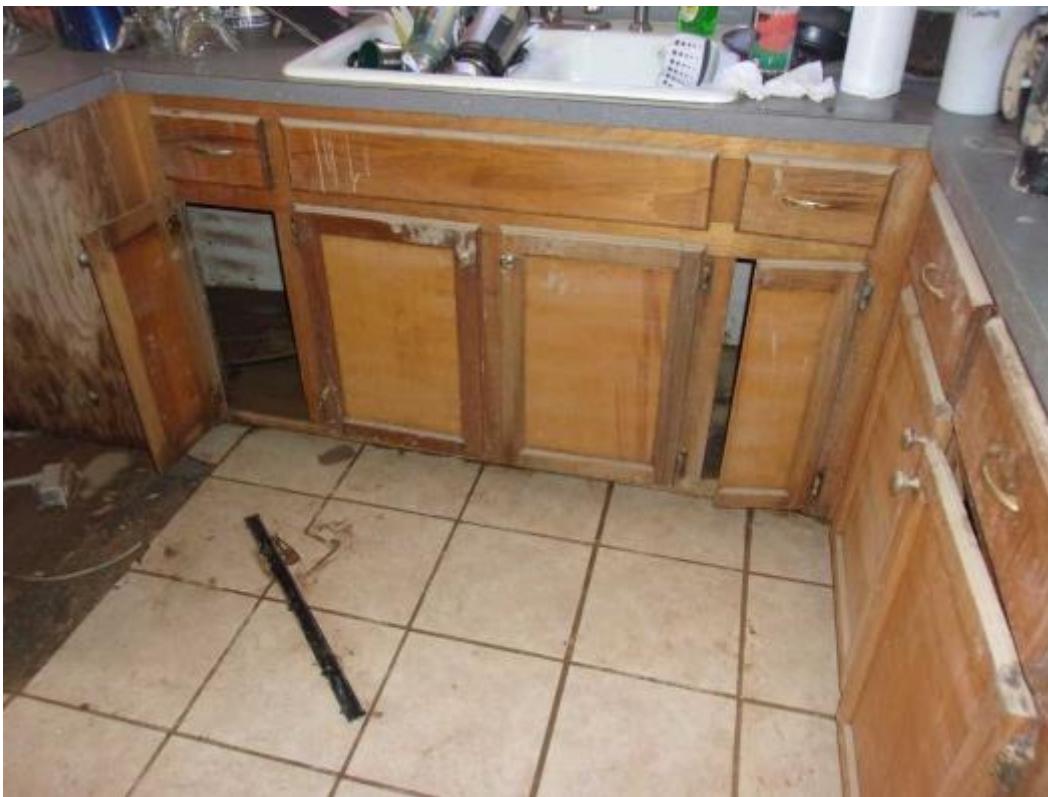
Main Level/Kitchen - 96-Kitchen

Damage to cabinets

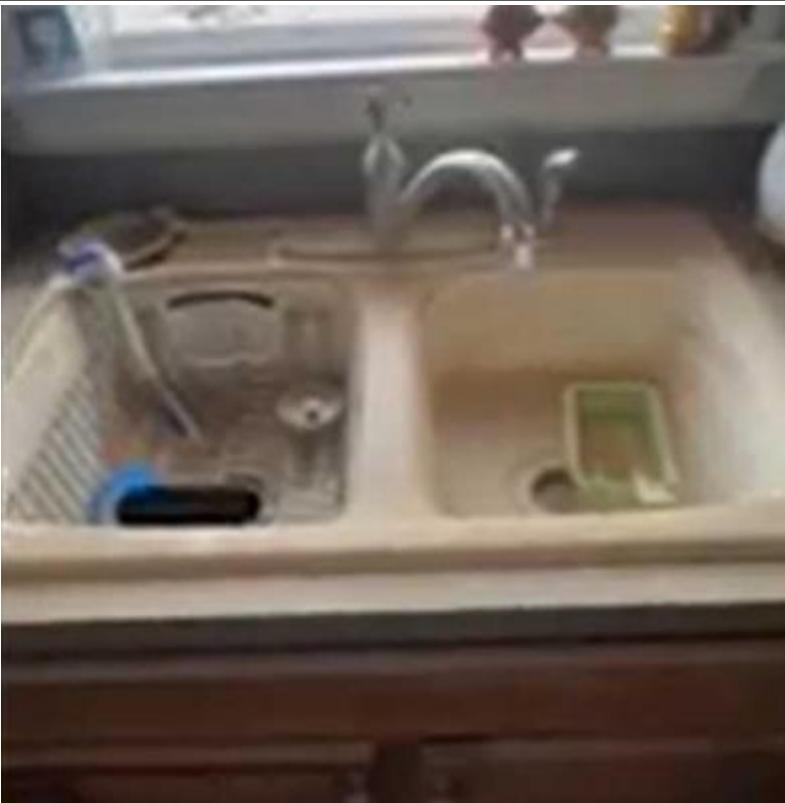
Main Level/Kitchen - 163-Kitchen

Sink undamaged
