NARRATIVE REPORT

DWELLING / UNIT OWNER

Carrier:	American Bankers Insurance Co	Date of Loss:	9/27/2024
Insured:	Donald and Shelby McGuire	Assigned:	10/2/2024
CID:	240045	Contacted:	10/2/2024
Claim Number:	8704207471	Inspected:	10/8/2024
Policy Number:	8704207471	Inspected With:	Deceased insured's son, Donald W., & daughter-in-law
Loss Address:	1811 Lake Drive Charlotte NC 28214	Mailing Address:	1811 Lake Drive Charlotte NC 28214
Coverage A:	\$ 190,000.00	Mortgage:	Wells Fargo Bank, N.A. #936
Coverage B:	\$ 63,000.00	Verified with:	Named Insured's son, Donald W. McGuire
Policy Term:	4/25/2024 to 4/25/2025

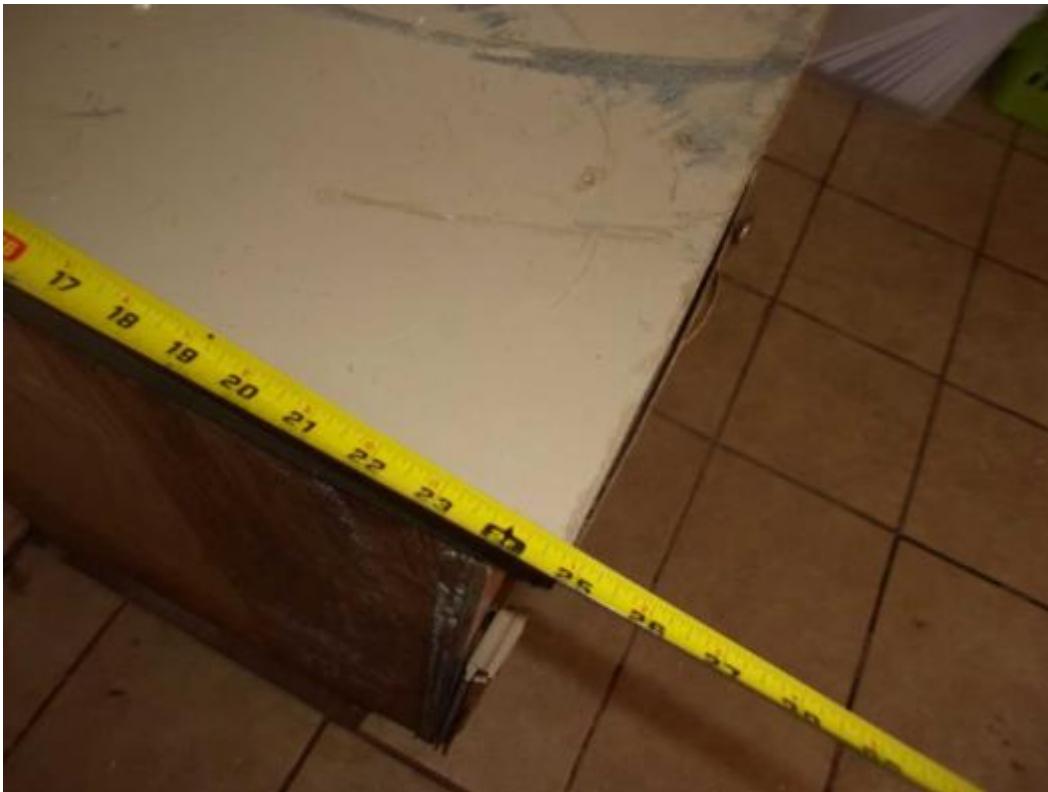
Main Level/Kitchen - 99-Kitchen

Damaged countertop

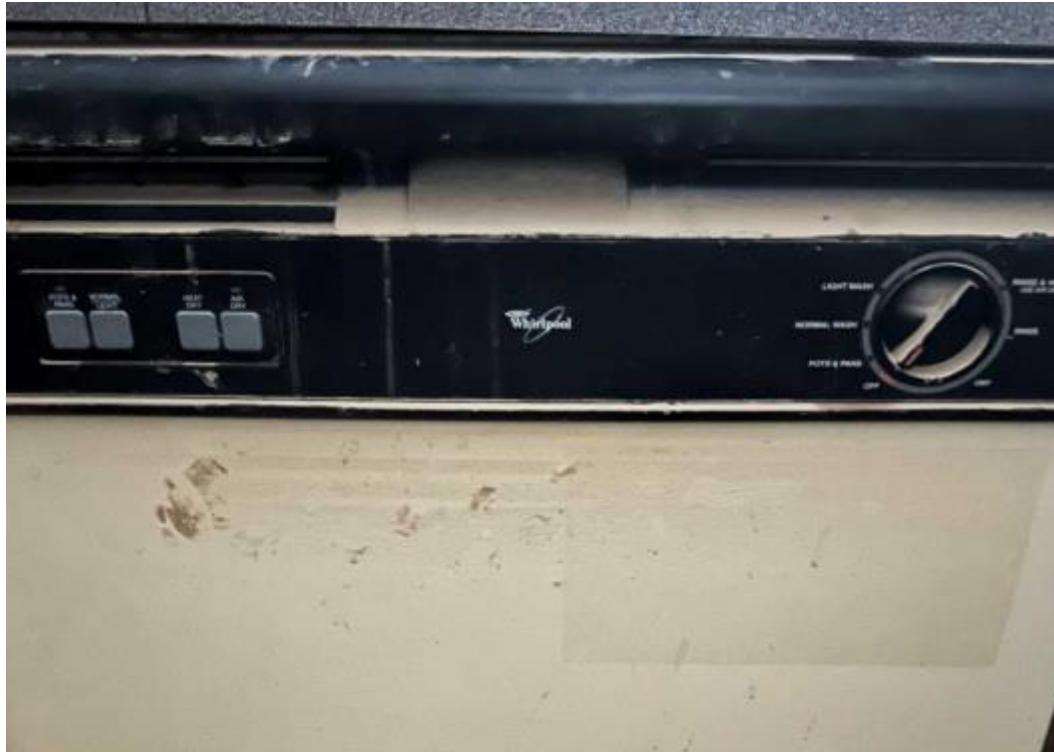
Main Level/Kitchen - 104-Kitchen

Removed prior to inspection
No label- estimated standard item

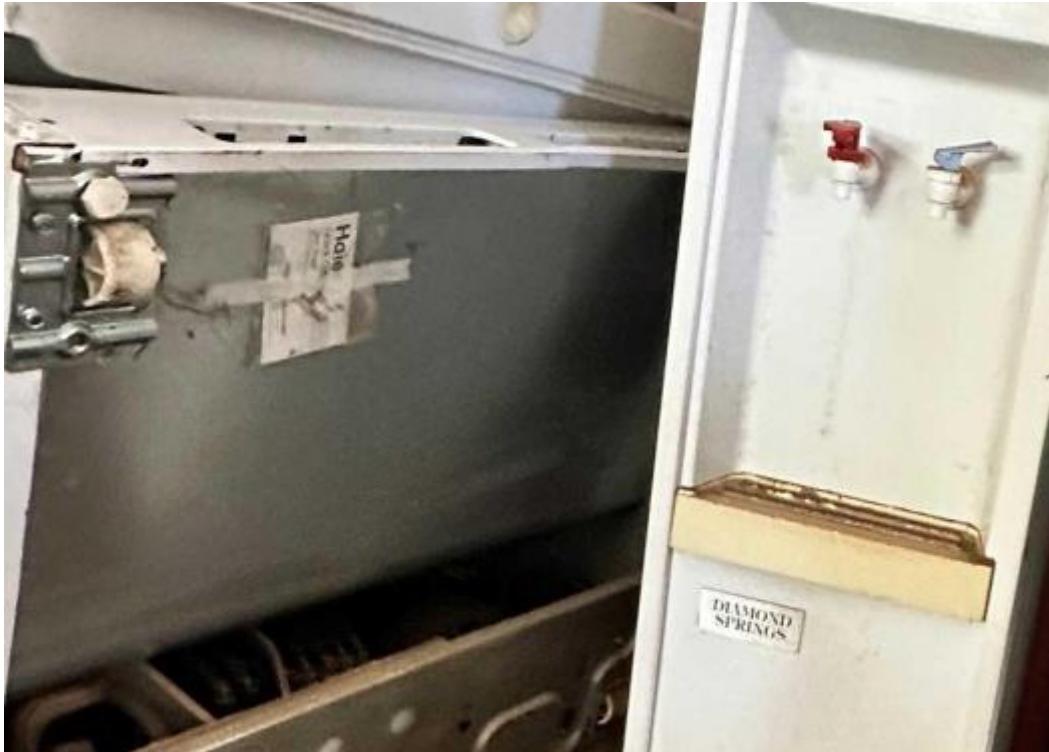
Main Level/Kitchen - 103-Kitchen

Diamond Springs Water cooler and Haier refrigerator

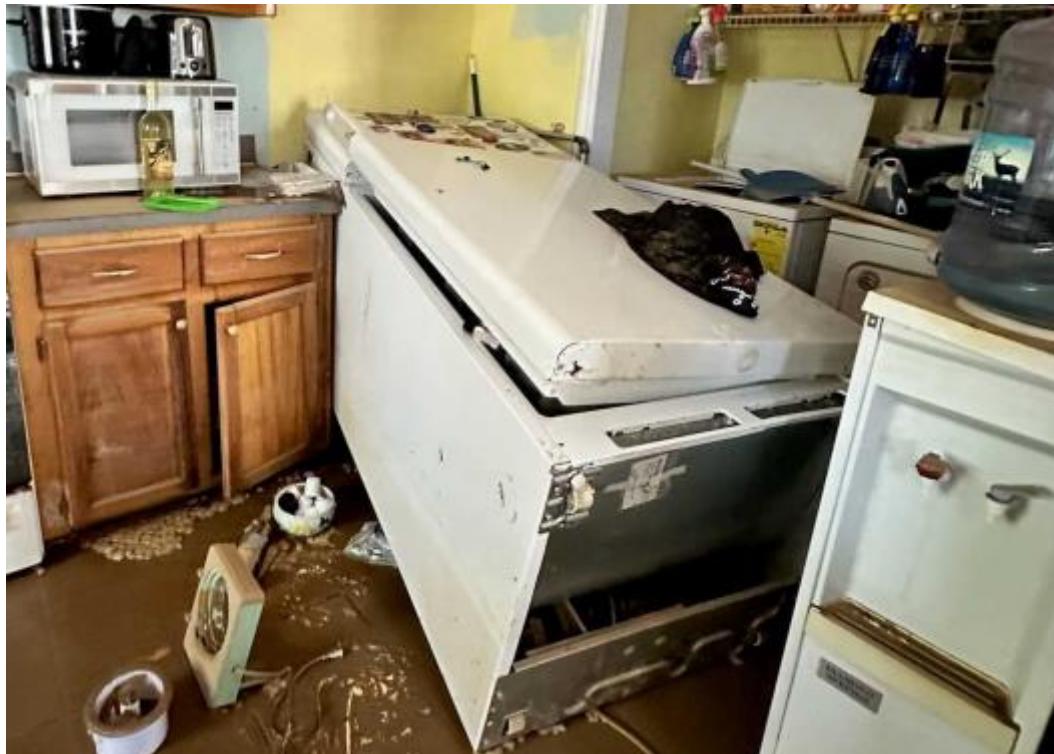
Main Level/Kitchen - 159-Kitchen

Top freezer refrigerator, GE washer and dryer behind

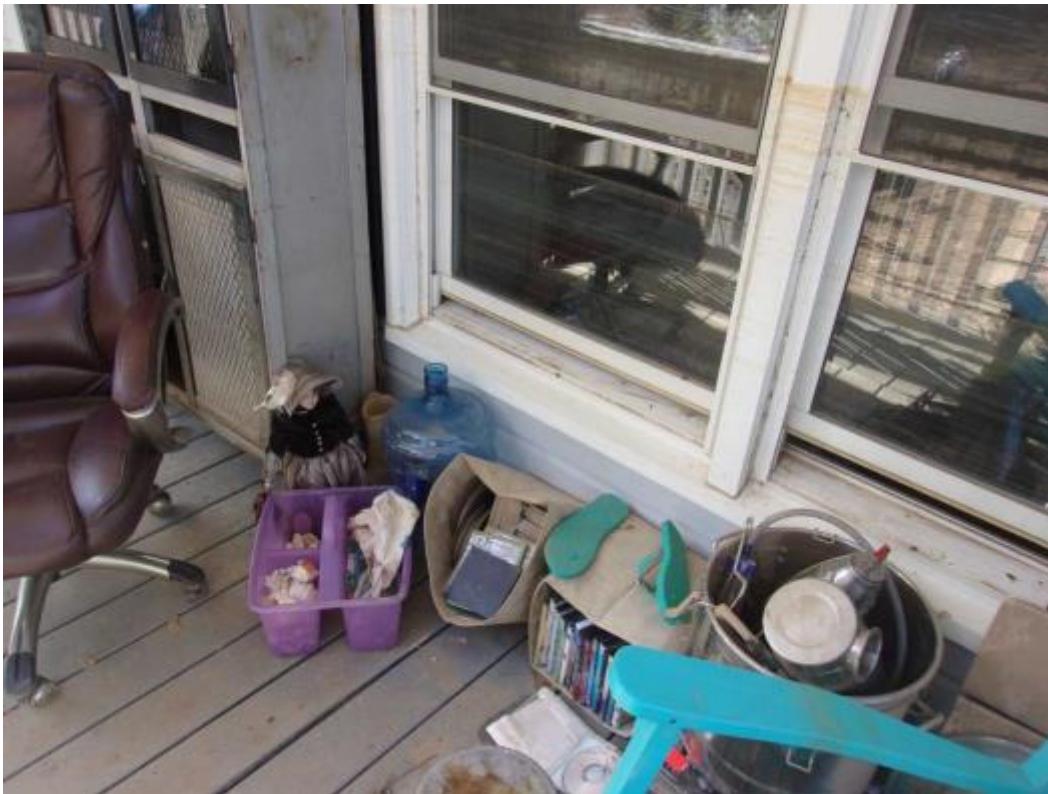
Main Level/Bedroom - 111-Bedroom

Taken By: Dean Palmieri
from exterior, no damage to windows

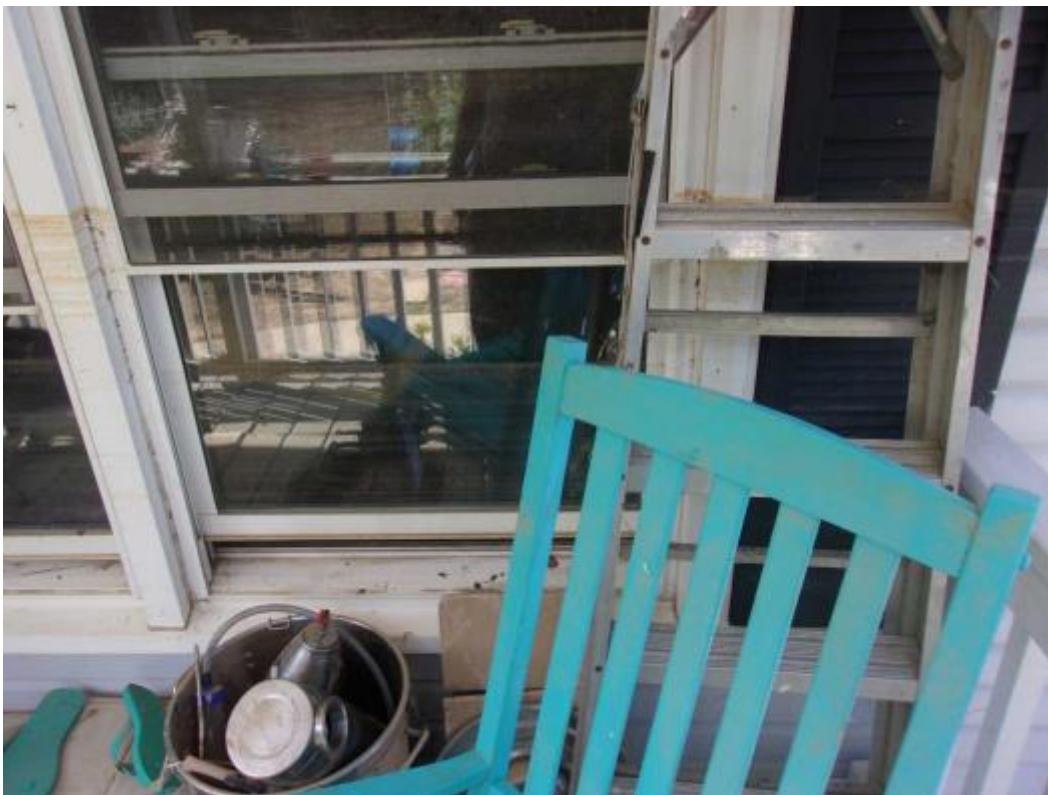
Main Level/Bedroom - 92-Bedroom

Taken By: Dean Palmieri
from exterior, no damage to windows

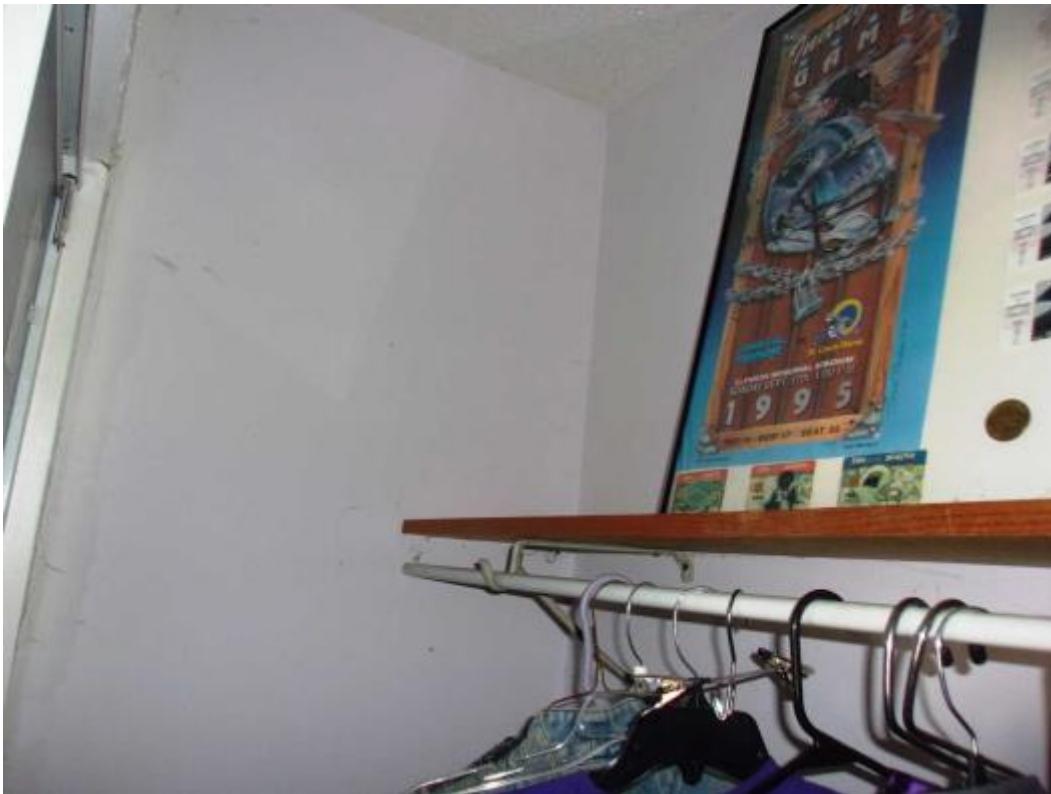
Main Level/BR Closet - 114-Bedroom Closet

Taken By: Dean Palmieri
popcorn ceiling

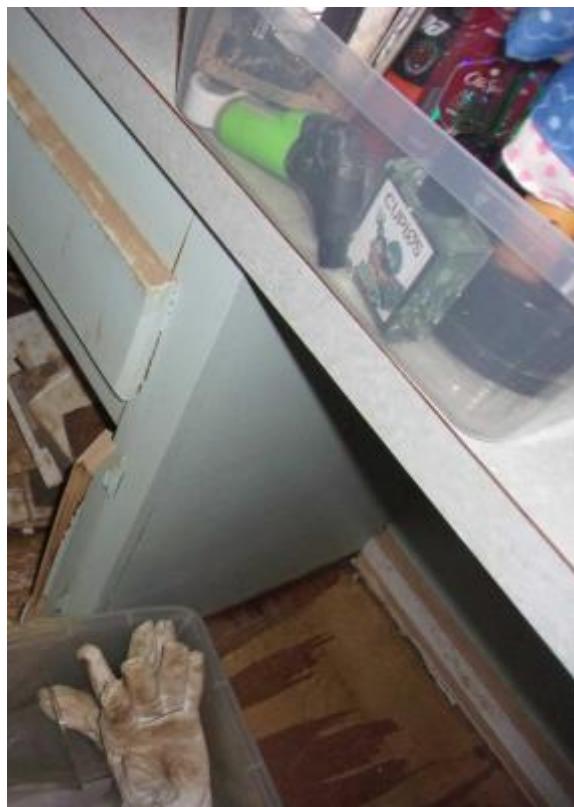
Main Level/Bathroom - 166-Bathroom

Damaged vanity and countertop

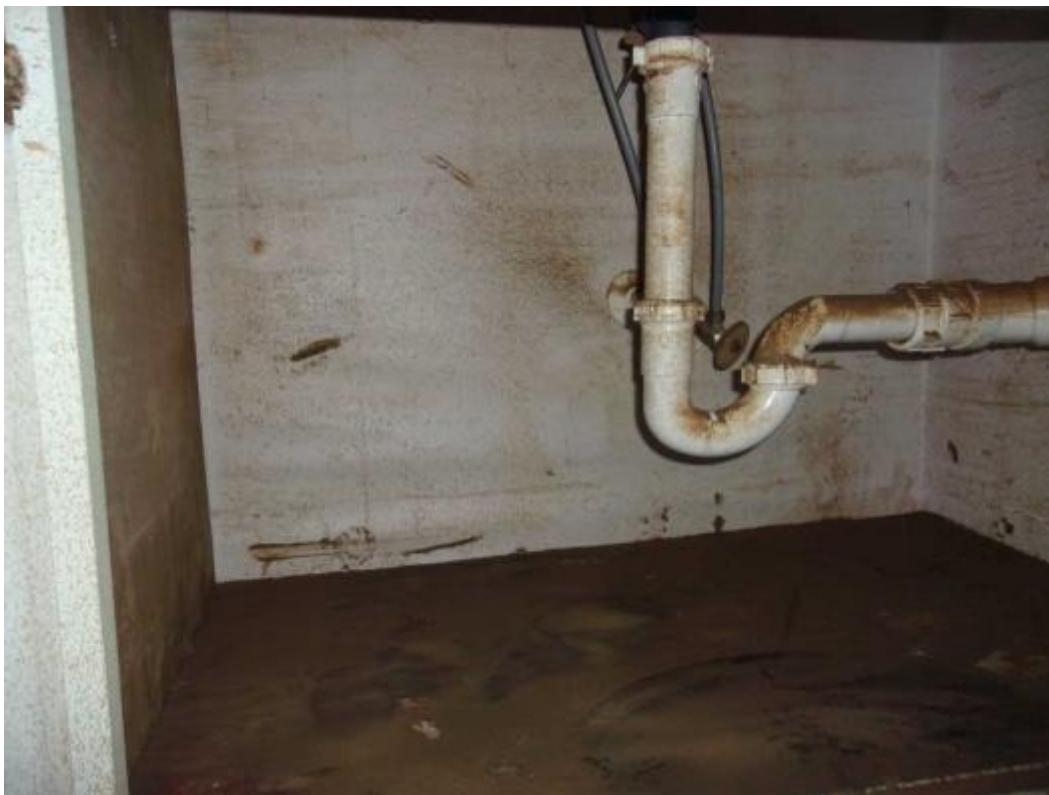
Main Level/Bathroom - 165-Bathroom

Cabinet swelling, replacement recommended

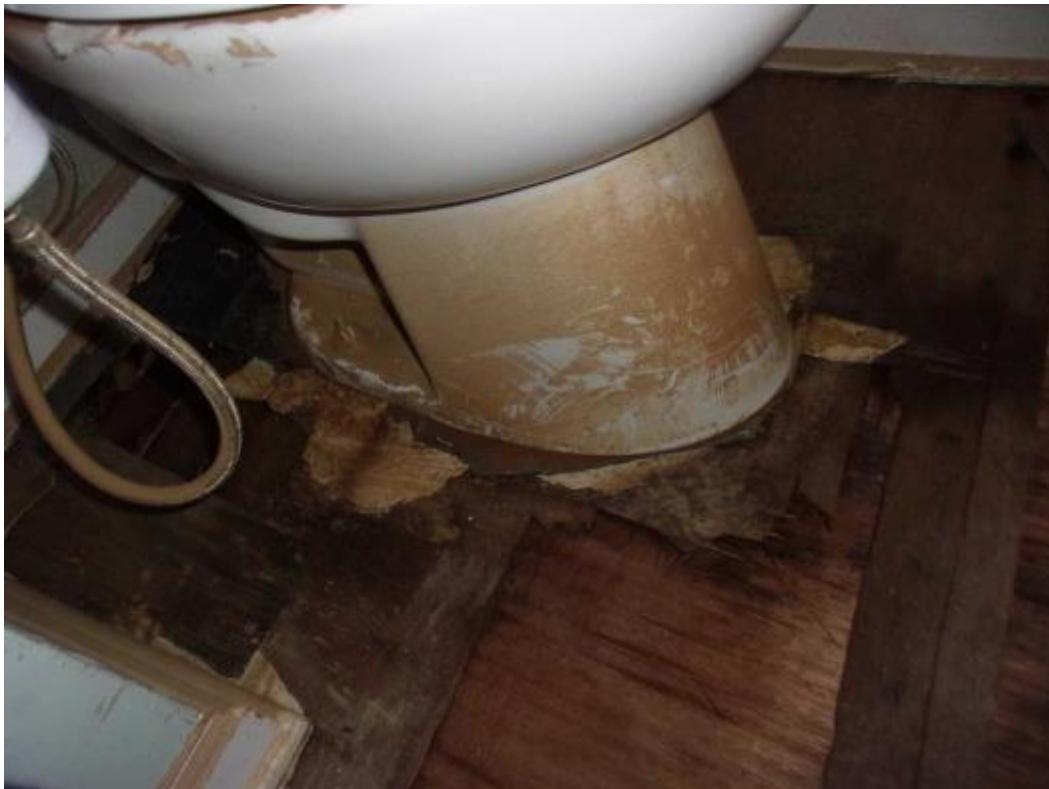
Main Level/Bathroom - 122-Toilet

Floor previously covered with luan over subfloor

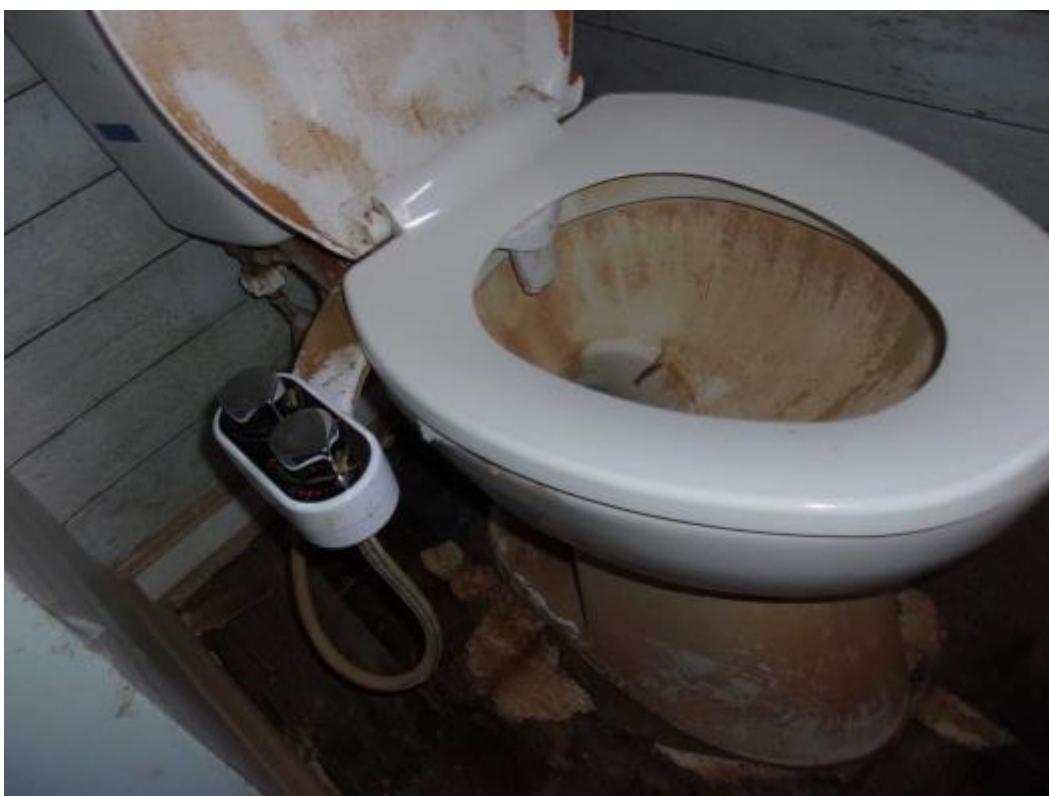
Main Level/Bathroom - 123-Bathroom

Water over top of toilet, replacement recommend, including bidet attachment

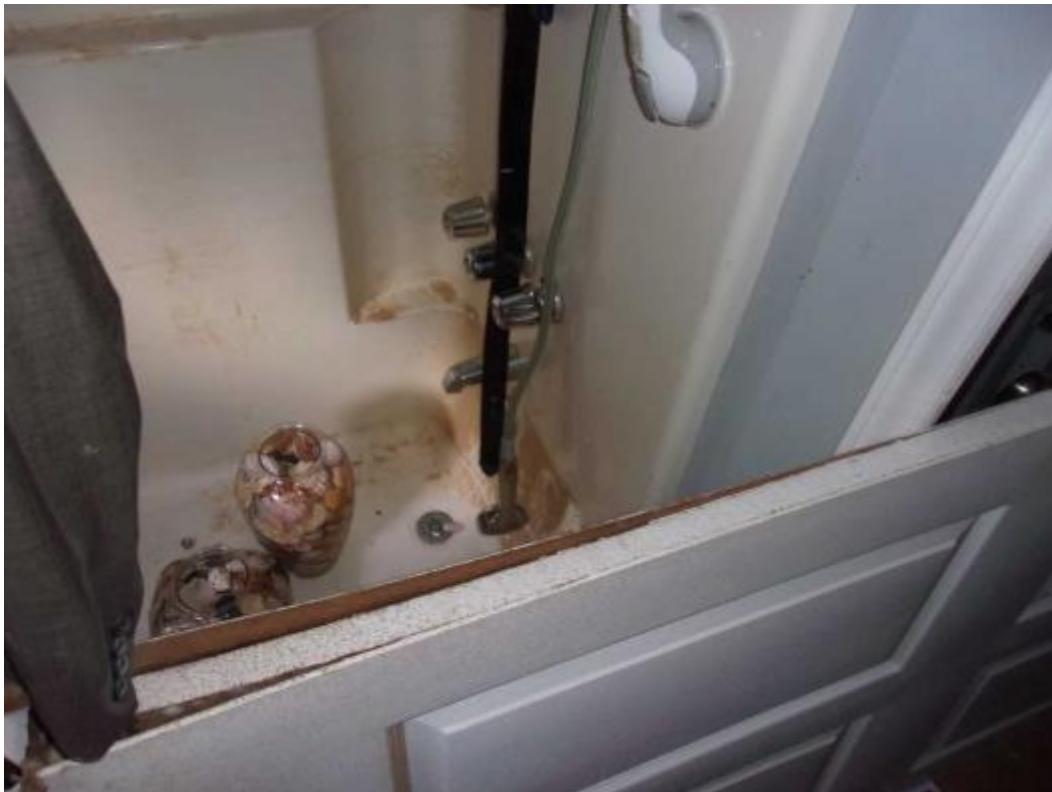
Main Level/Bathroom - 125-Bathroom

Damaged doors, tub salvageable

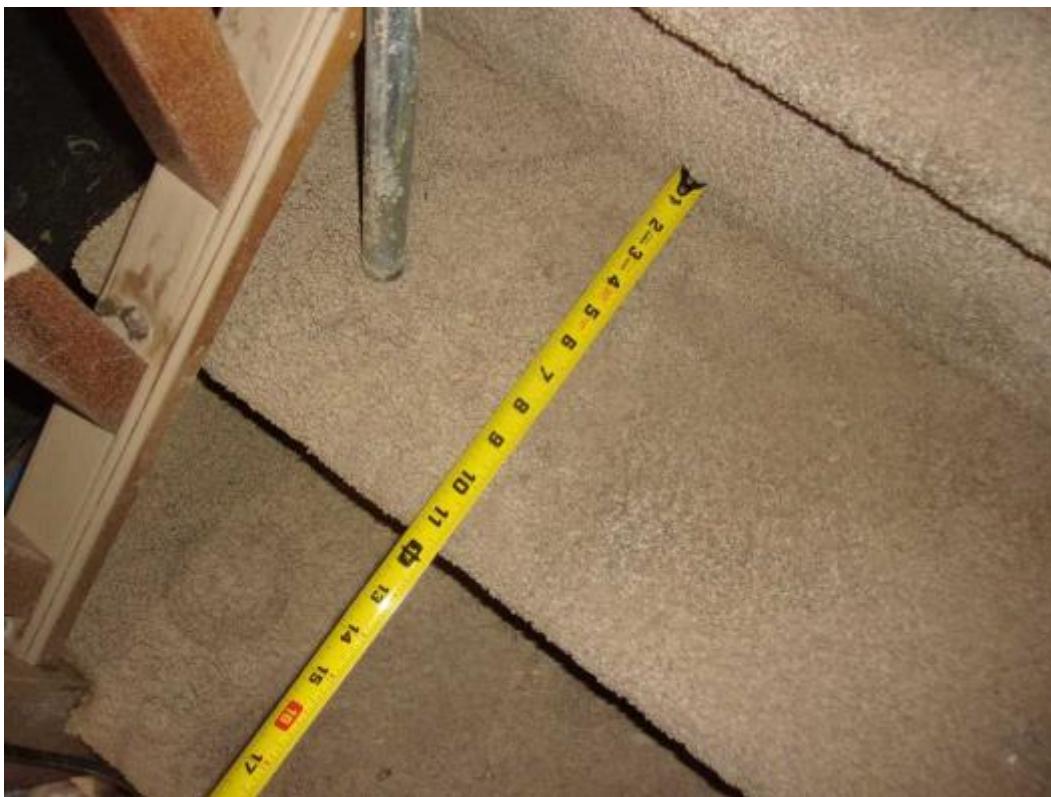
Main Level/Stairs - 128-Stairs

Damage to carpet

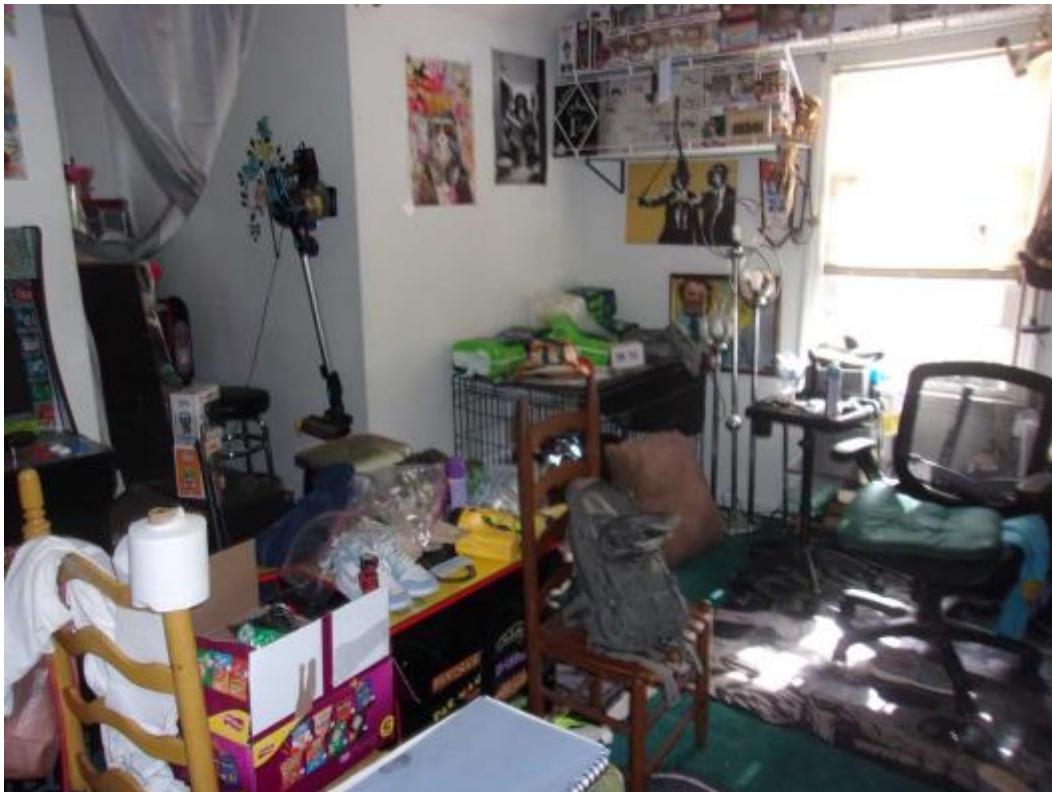
Miscellaneous - 167-Upstairs Office

Overview, no damage

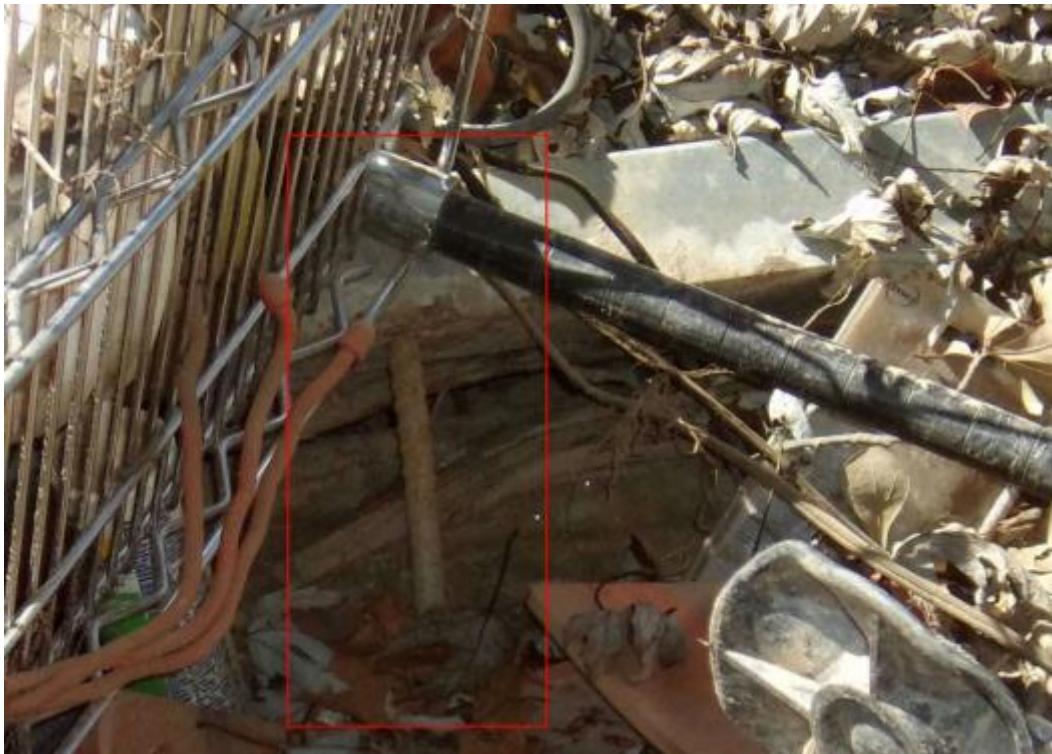
APS/Detached Garage - 6-Detached Garage

mechanically anchored to the ground

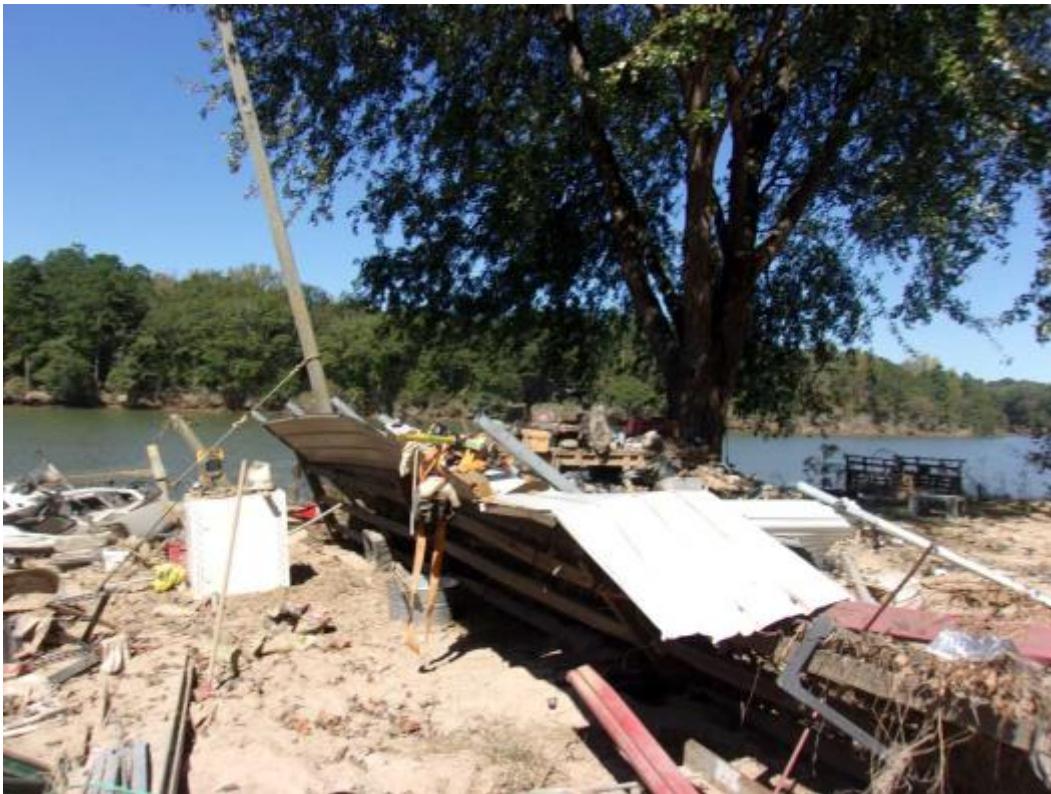
APS/Detached Garage - 8-Detached Garage

Left wall

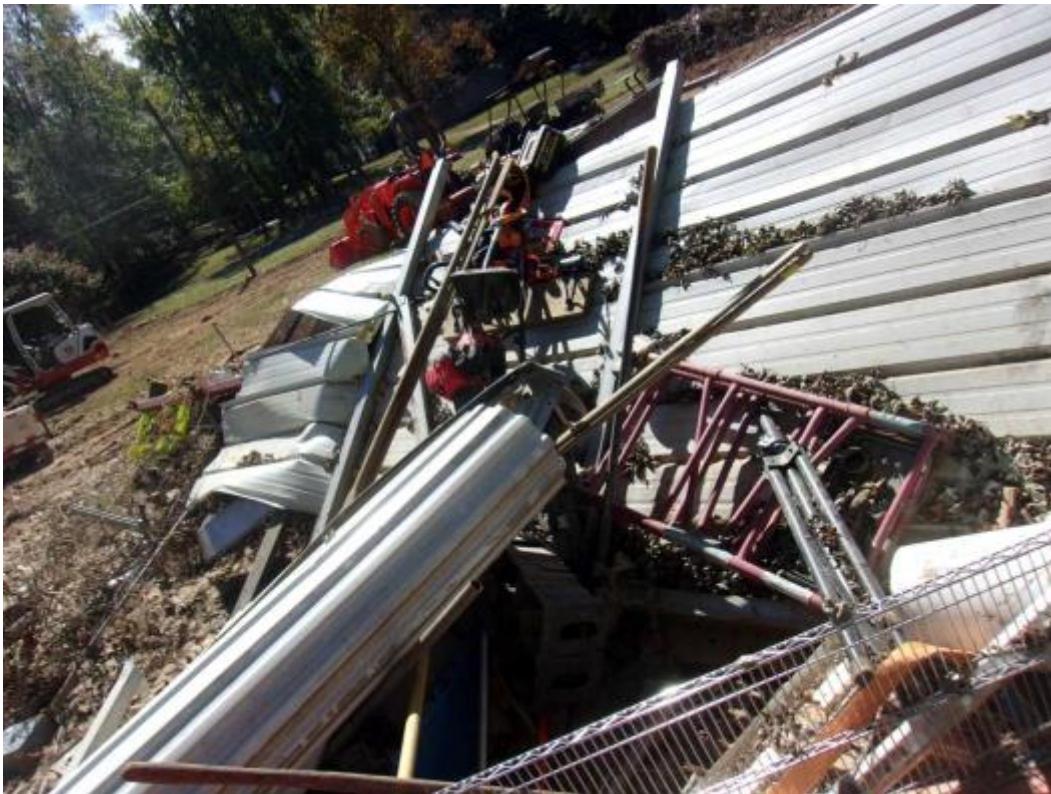
APS/Detached Garage - 10-Detached Garage

Garage door

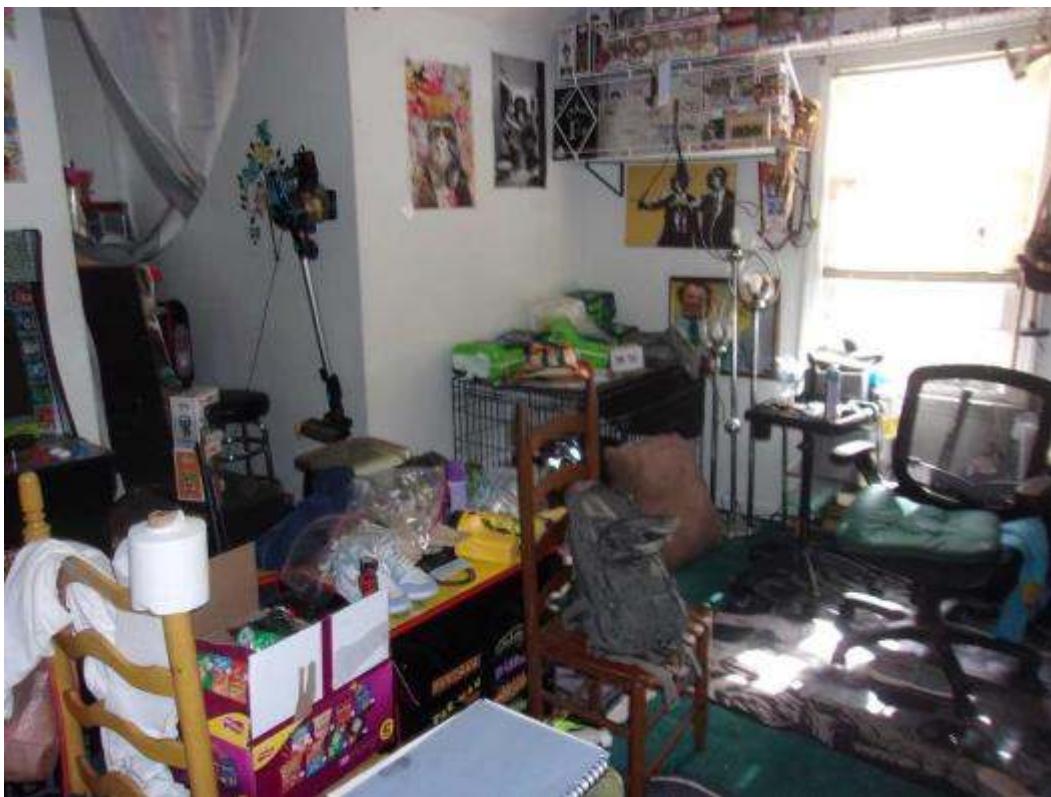
Miscellaneous - 167-Upstairs Office

Overview, no damage
