NARRATIVE REPORT

DWELLING / UNIT OWNER

Carrier:	American Bankers	Date of Loss:	9/26/2024
Insured:	BETTY ANNE ADAMS	Assigned:	10/2/2024
CID:	FL0124	Contacted:	10/2/2024
Claim Number:	6900165078	Inspected:	10/8/2024
Policy Number:	6900165078	Inspected With:	Click or tap here to enter text.
Loss Address:	12408 SUNSHINE LN TREASURE ISLAND FL 33706-5036	Mailing Address:	12408 SUNSHINE LN TREASURE ISLAND FL 33706-5036
Coverage A:	\$ 235,000.00	Mortgage:	None.
Coverage B:	\$ 21000.00	Verified with:	Insured.
Policy Term:	6/28/2024 to 6/28/2025

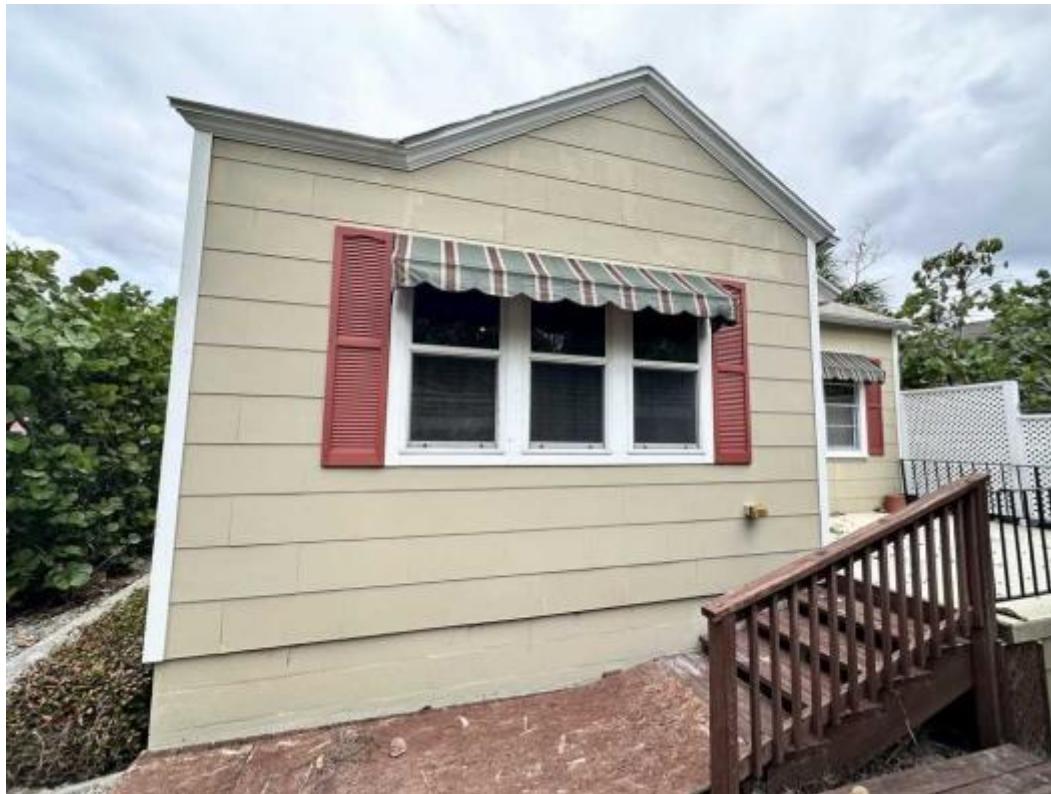
Exterior/Ext_Surfaces - 1-Front elevation

Risk is a single family dwelling built in 1938 and is Pre-Fire and elevated (garage is non-elevated). The risk is the insured's principle residence and is owner occupied. The risk had 12 inches of water on the interior and an exterior water line of 46 inches with a 26 inch interior water line on garage and laundry area. Advance request of \$15,000 for building and advance for contents was denied by insured.

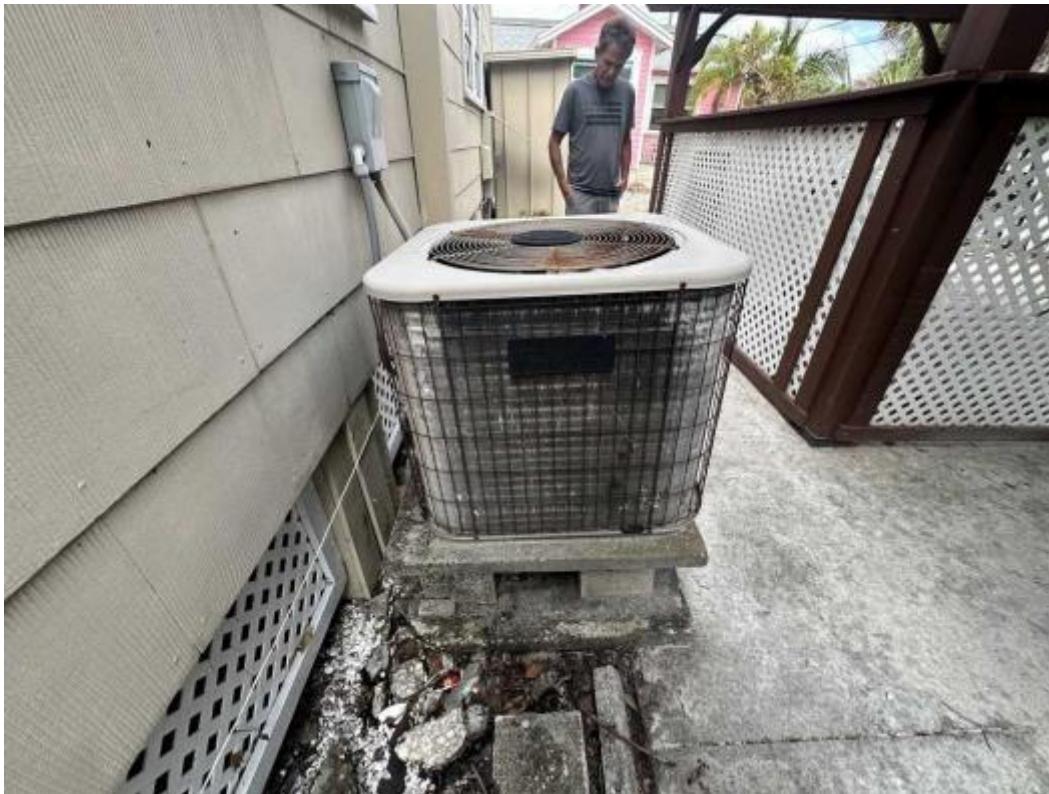
Exterior/Ext_Surfaces - 9-Air condenser

Goodman 2 Ton, 13 Seer Electric Heat Pump Model: RHA30B2D Serial: 0302147548 Age: Feb. 2003

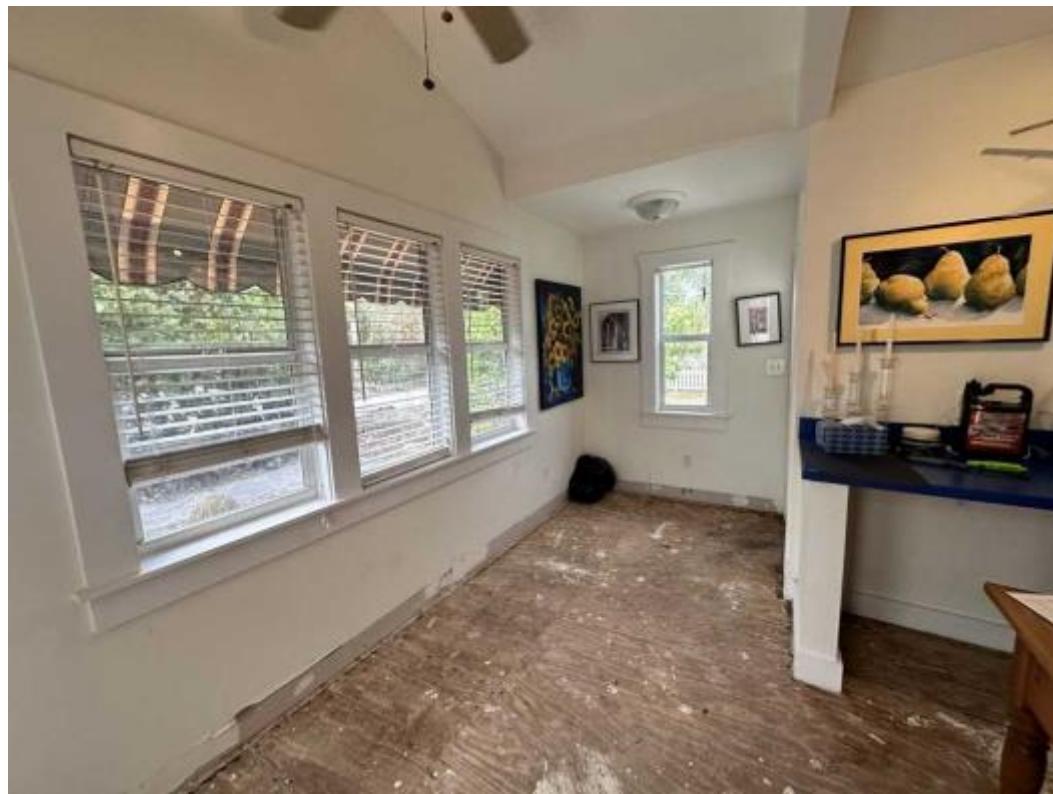
Main Level/Kitchen - 14-Kitchen

Damage to carpet, trim, cabinetry, walls, appliances, and doors.

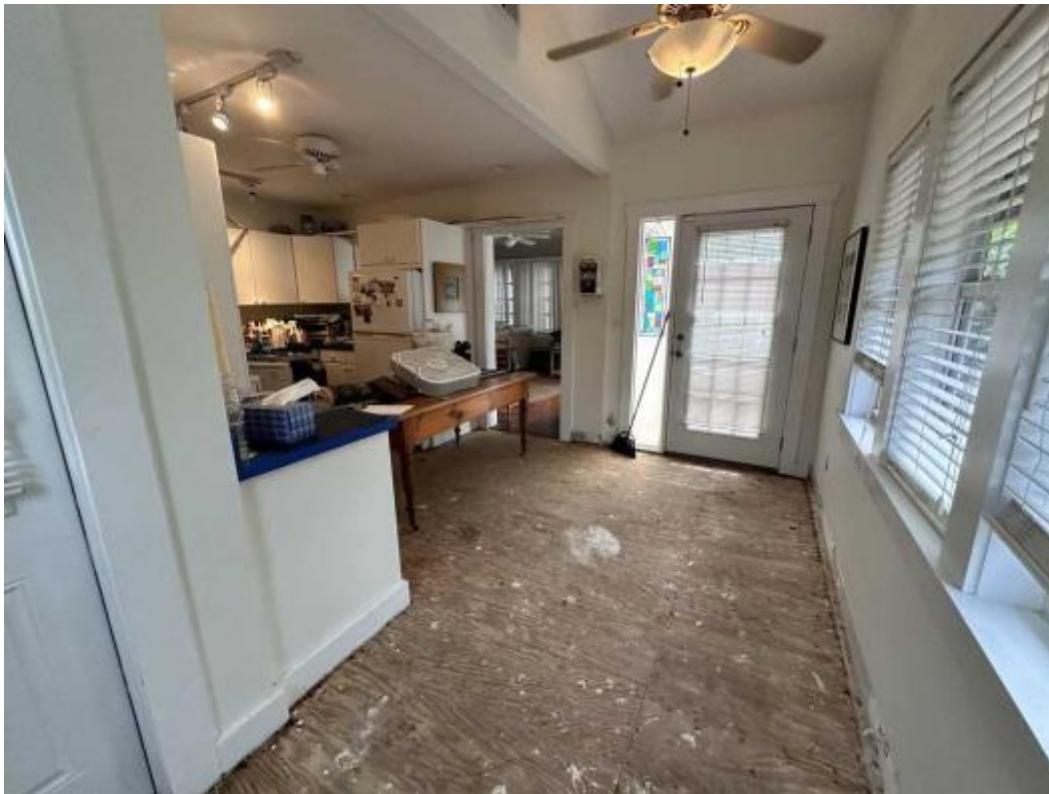
Main Level/Kitchen - 19-Kitchen

Damage to carpet, trim, cabinetry, walls, appliances, and doors.

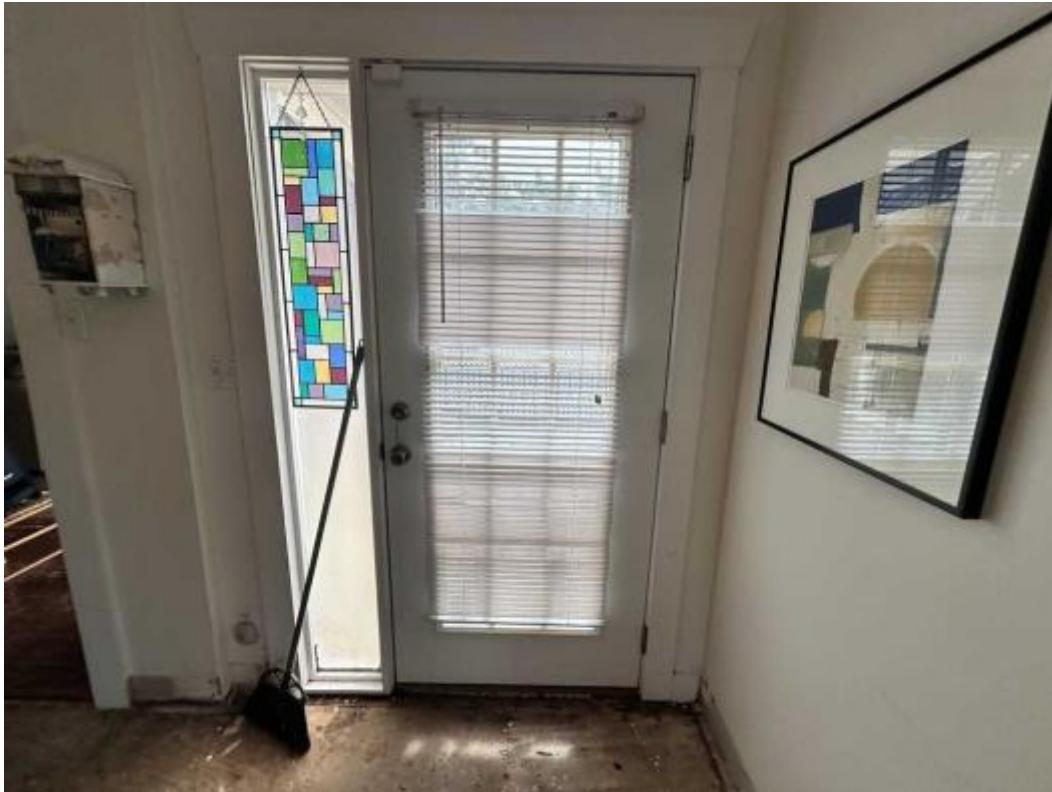
Main Level/Kitchen - 21-Entry door and side light

Damage to door and side lite.

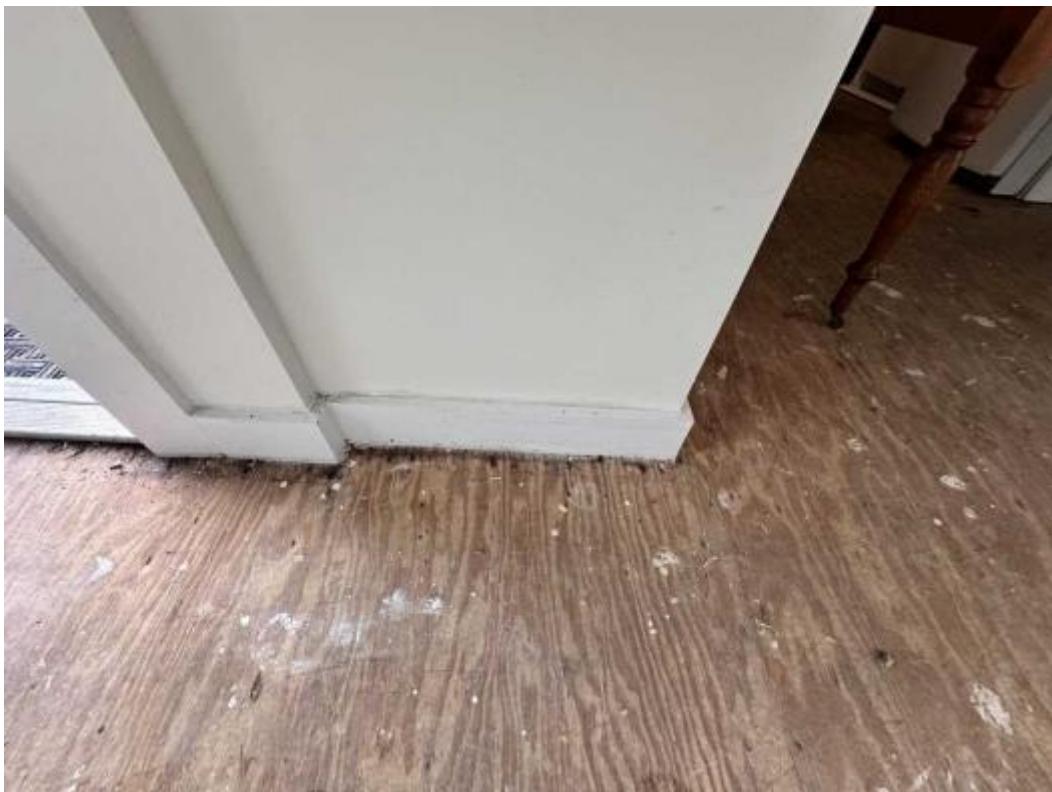
Main Level/Kitchen - 22-Damaged baseboards and carpet removed

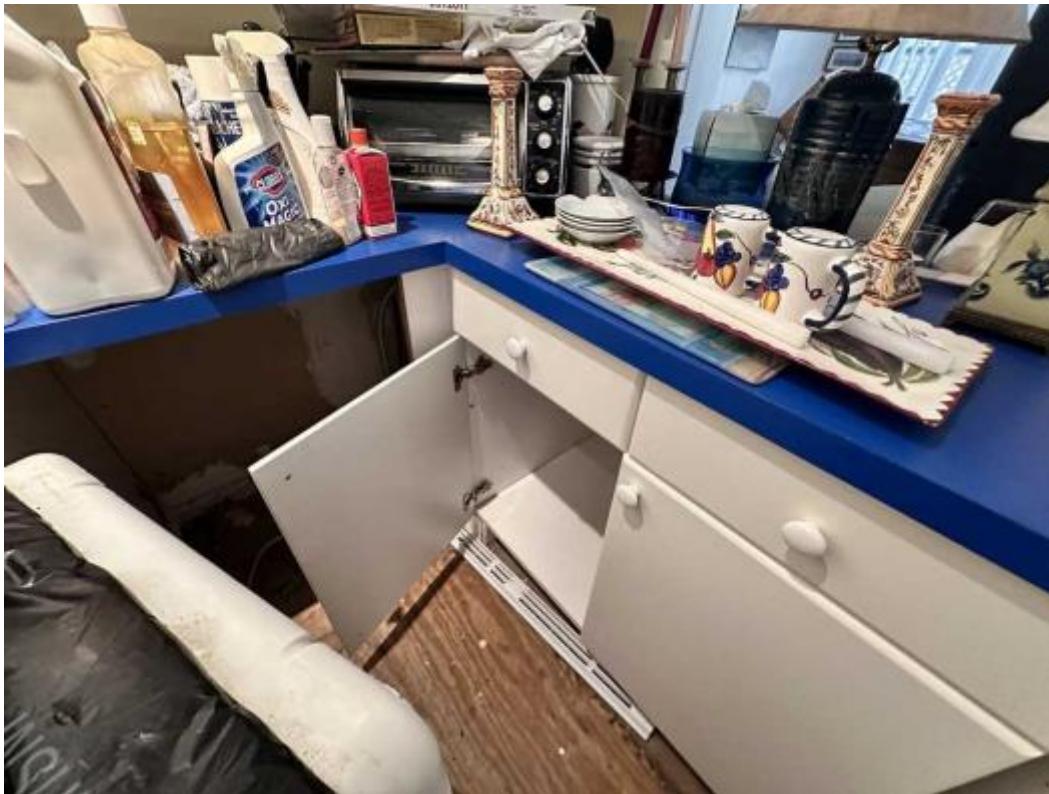
Main Level/Kitchen - 23-Kitchen cabinet damage

Water heater located under kitchen cabinet. Damaged cabinet and flooring. Laminate counter tops.

- Cabinets –base cabinets were splitting from flood waters and require replacement. Laminate countertops are glued down and will need to be replaced when removed to repair cabinets.
- Appliances – Damaged refrigerator, dishwasher, range, and water heater were all inundated with salt water and will require replacement.

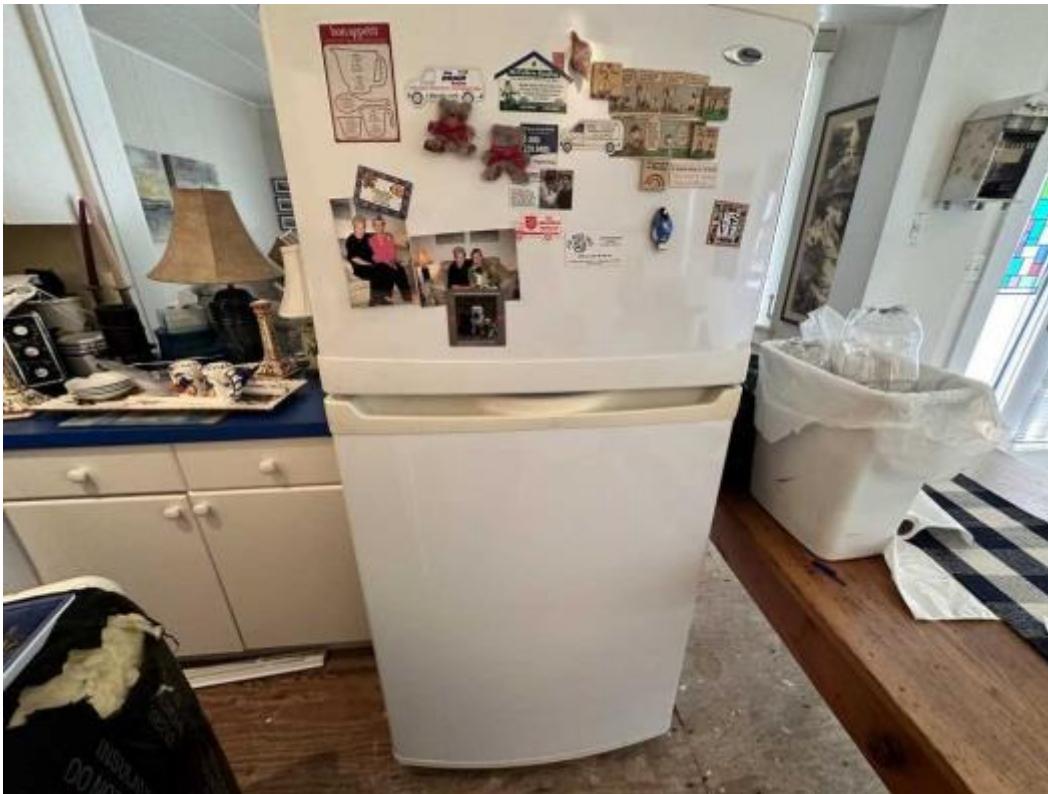
**Main Level/Kitchen - 25-
Refrigerator**

Amana 19 cu. ft. Freestanding
Top-freezer Refrigerator Model:
ATB1932MRW00 Serial: EW1605321
Date: Feb. 2016

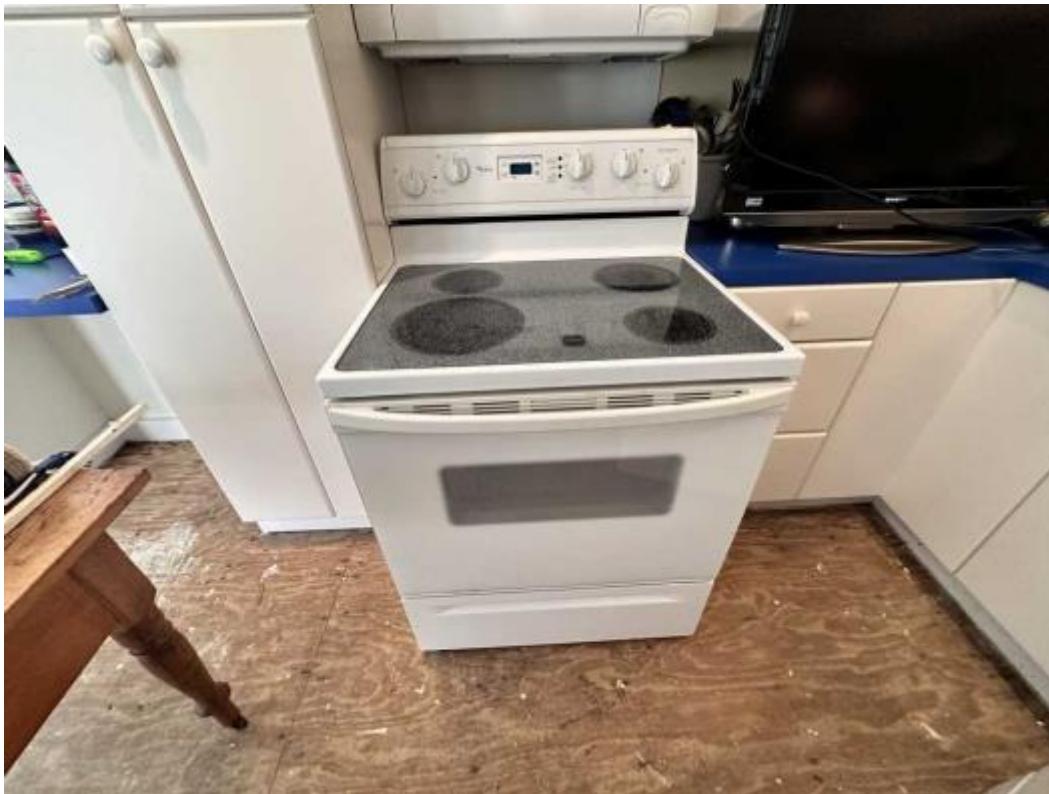
Main Level/Kitchen - 27-Range

Whirlpool 30" Freestanding Electric Range Model: RF366PXGQ Serial: RL0420874 Age: Feb 2001

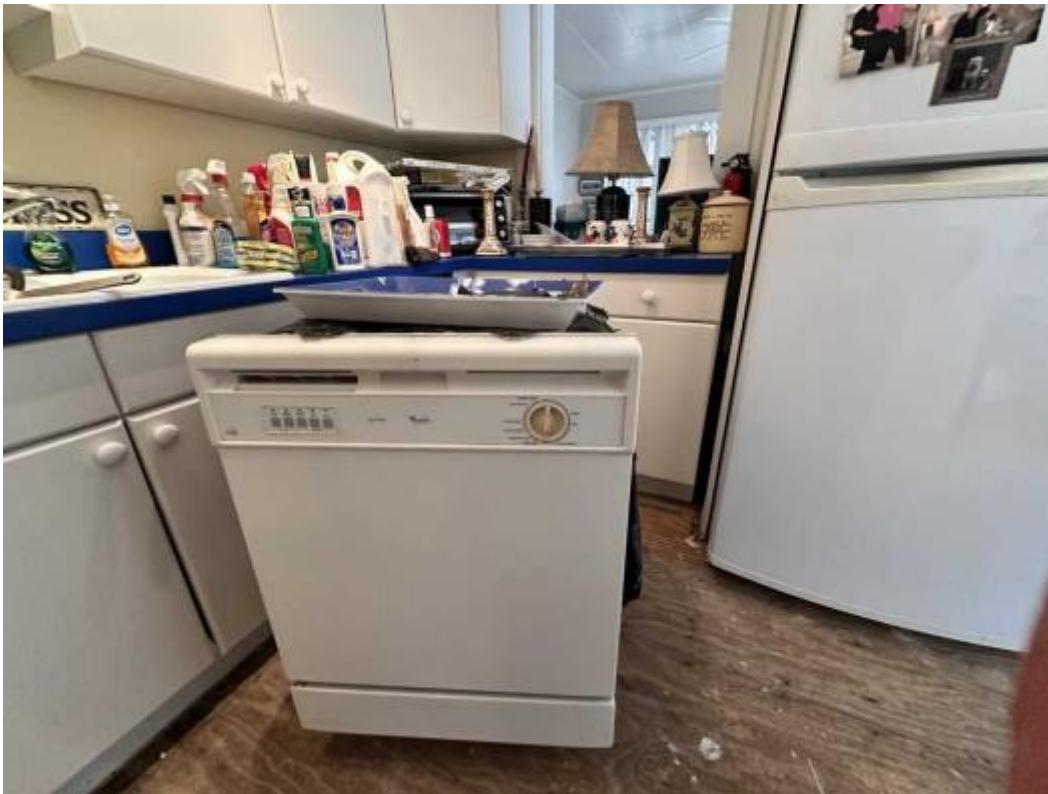
**Main Level/Kitchen - 29
Dishwasher**

Whirlpool 24" Under Counter
Dishwasher Model: DU912PFGQ2
Serial: FL1030309 Date: March 2001.

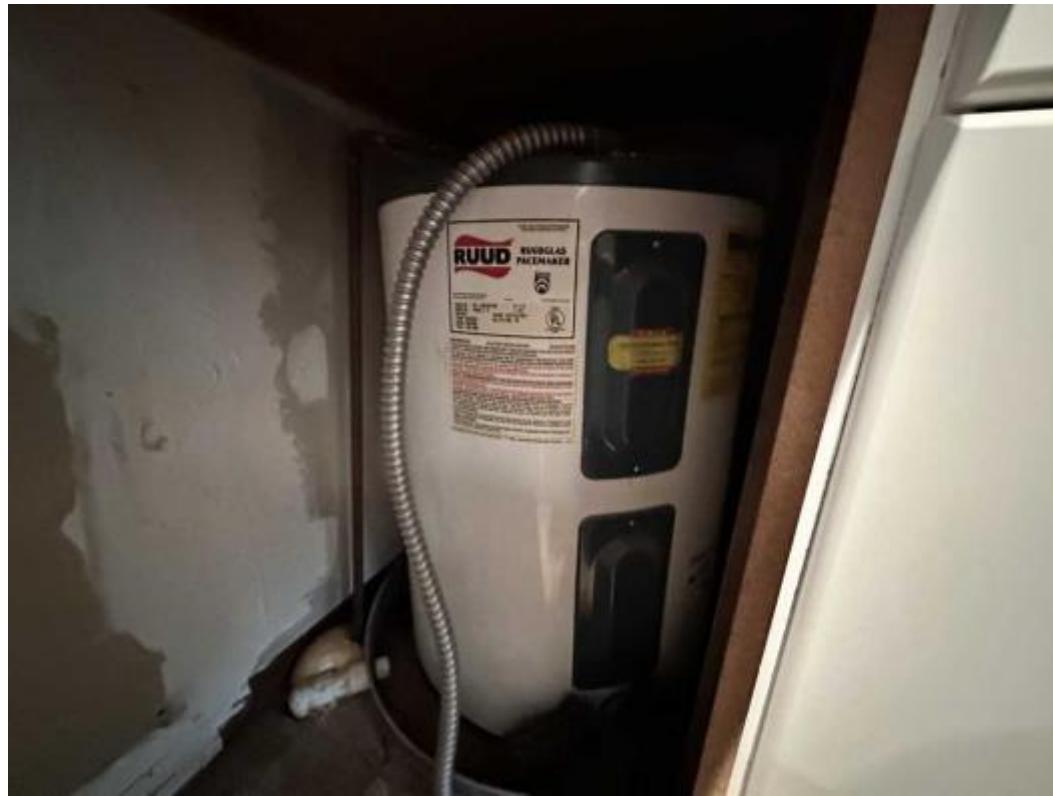
Main Level/Kitchen - 31-Water heater

Ruud Pacemaker 30 Gallon 4.5 kW
240V ac 1-Phase Short Electric Water Heater Model: PES30-2 Serial: RU 0201C01105

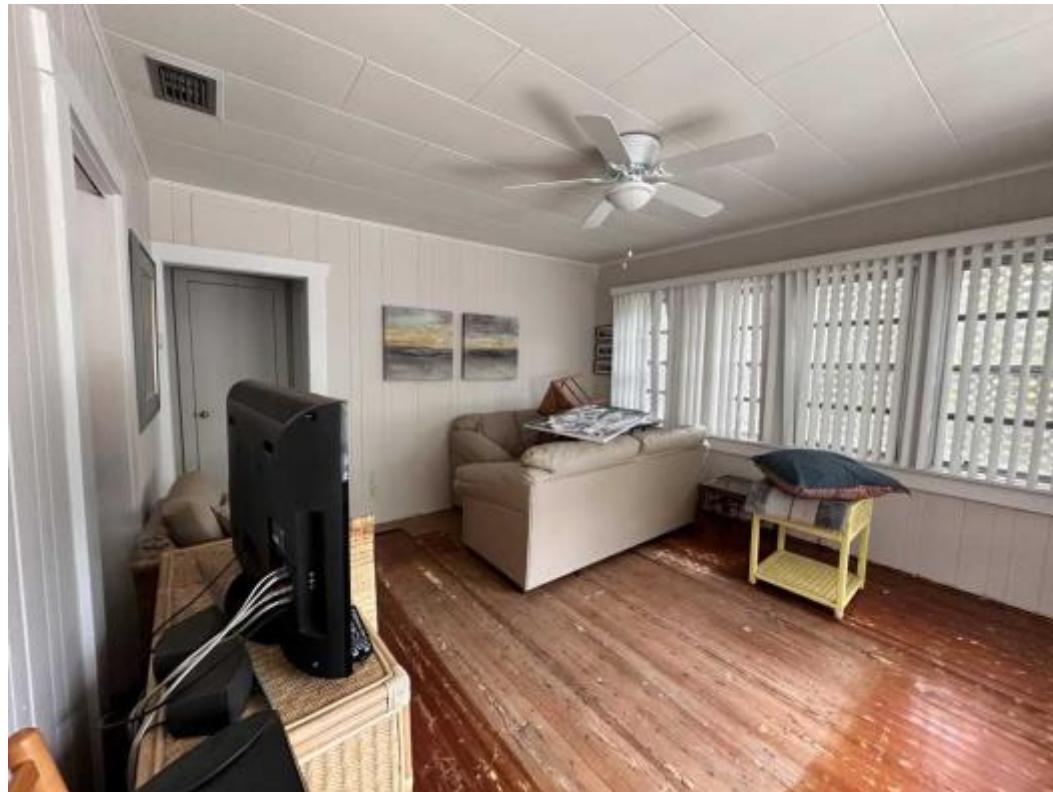
Main Level/Living Room - 33-Living room

Damage to hardwood flooring, trim, paneled walls, and door openings.

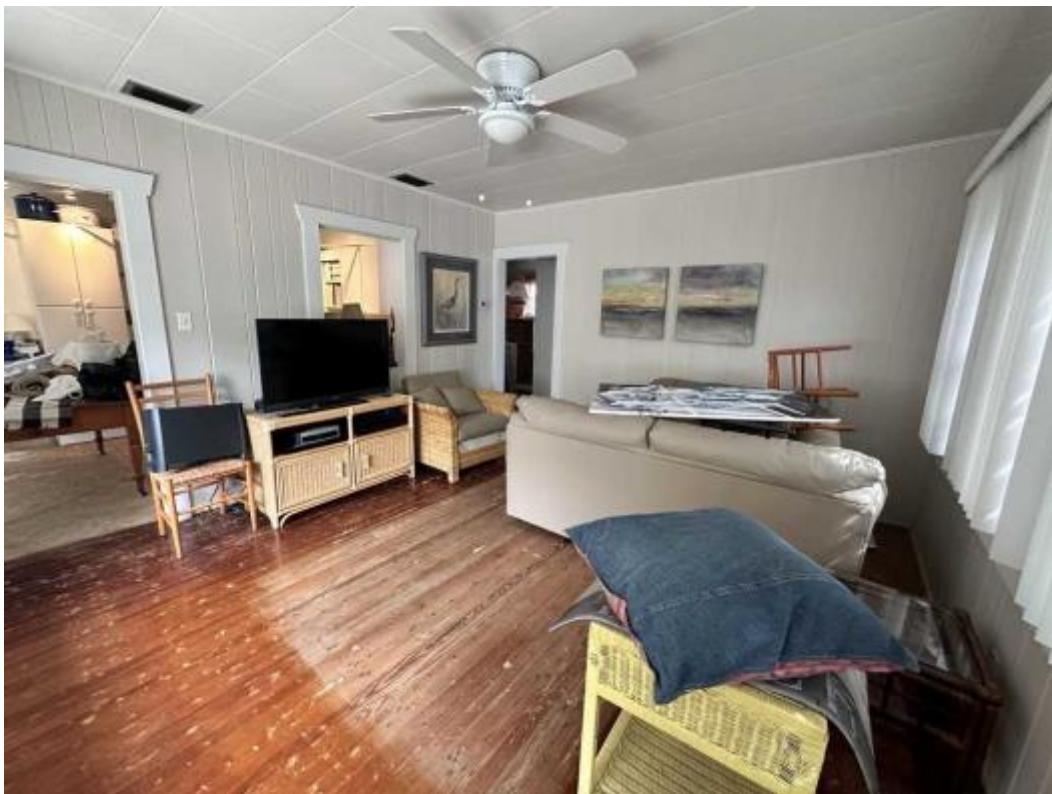
Main Level/Living Room - 36-Living room

Damaged hardwood flooring.

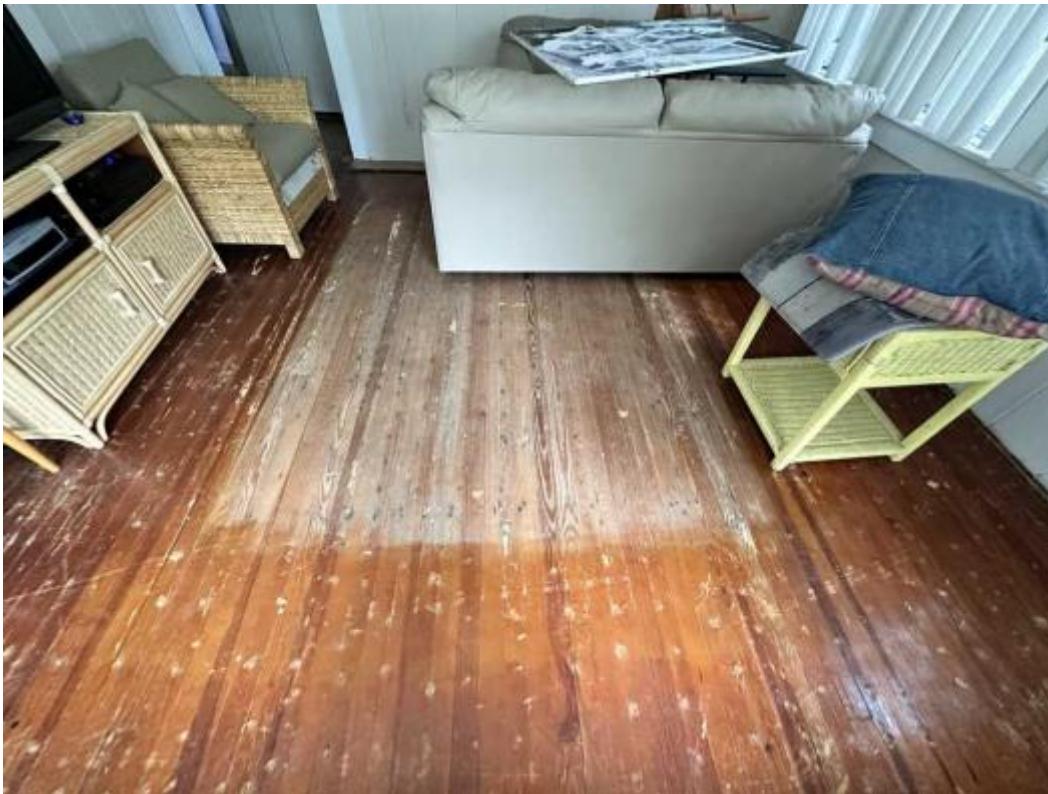
**Main Level/Living Room - 37-
Living room floor**

Hardwood flooring.

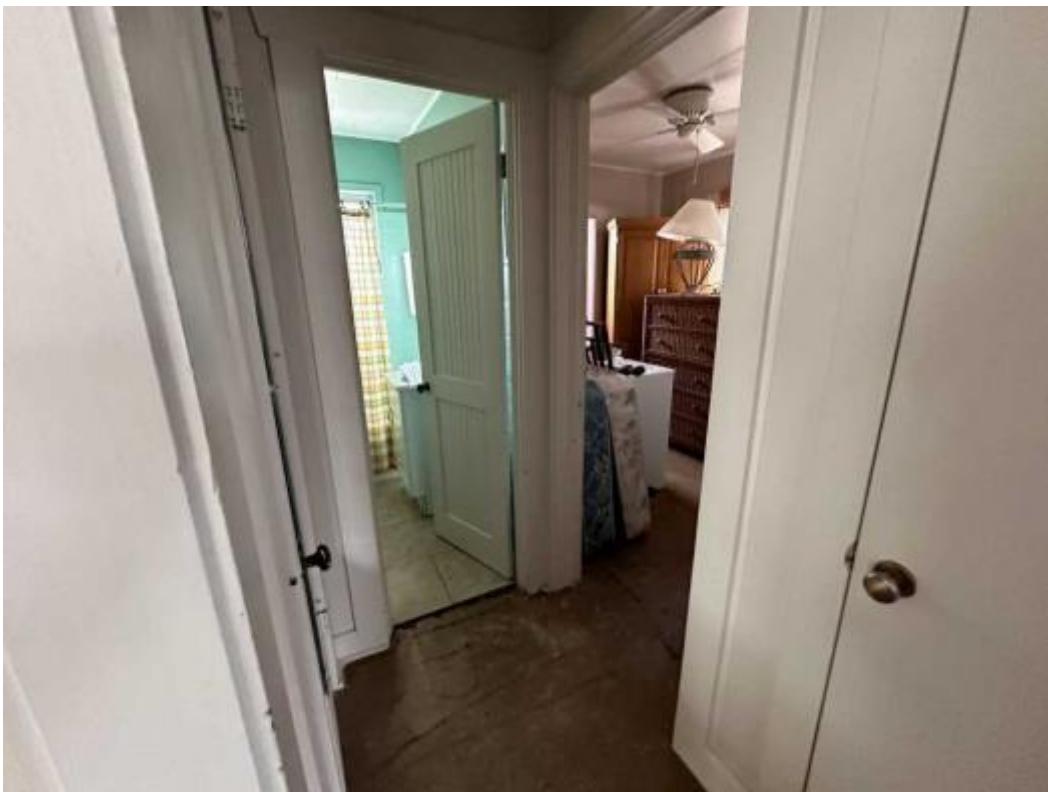
**Main Level/Hallway - 38-
Hallway**

Damage to hardwood flooring, carpet,
trim, paneled walls, and doors.

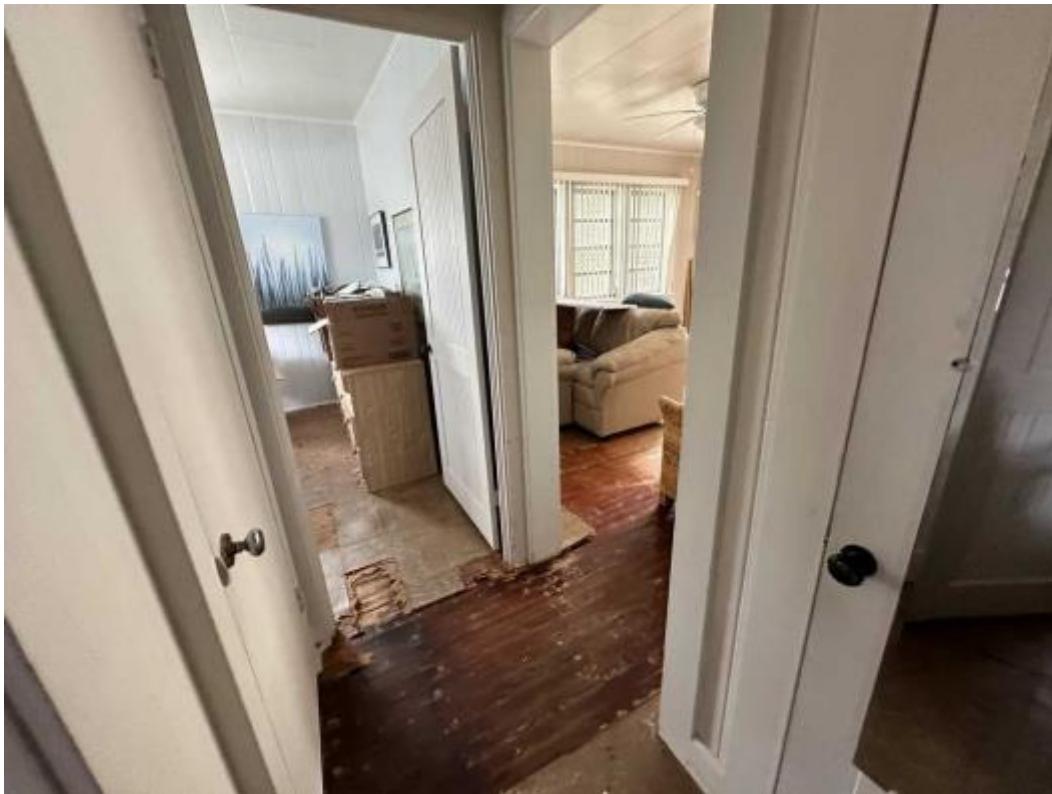
Main Level/Hallway - 39 Hallway

Damage to hardwood flooring, carpet, trim, paneled walls, and doors. Buckling and warping hardwood flooring.

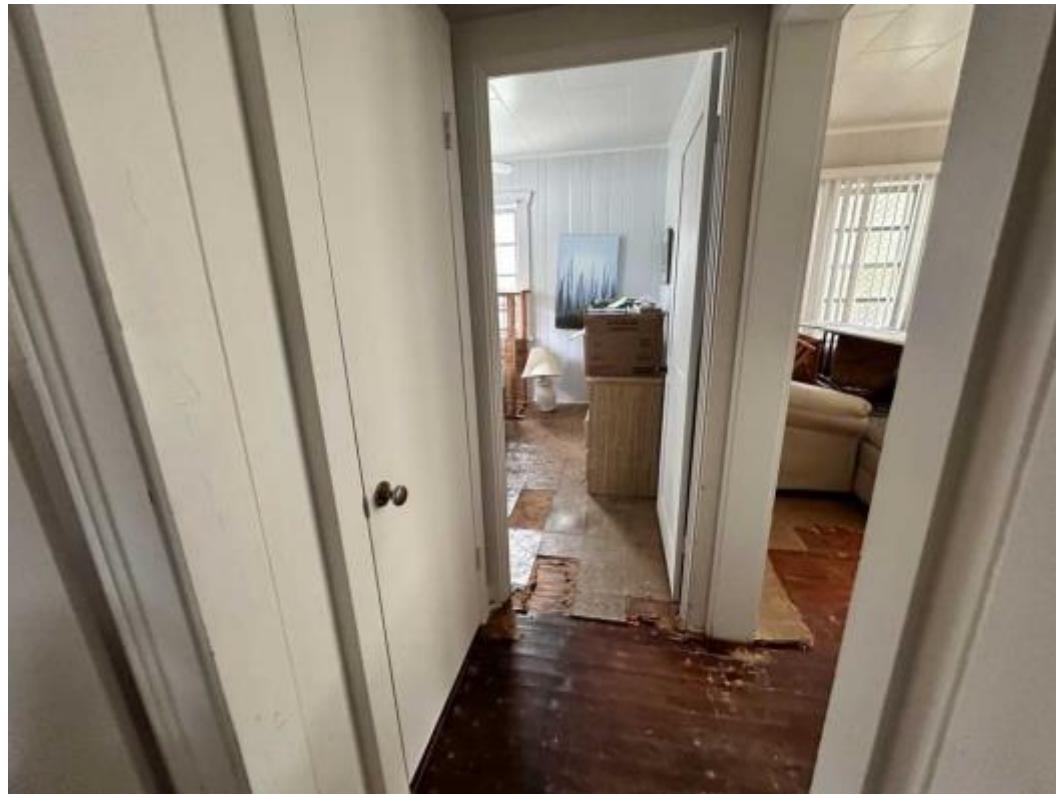
Main Level/Hallway - 41-Hallway

Damage to hardwood flooring, carpet, trim, paneled walls, and doors. Please note damaged engineered wood flooring in Bedroom and hardwood flooring in portion of hallway.

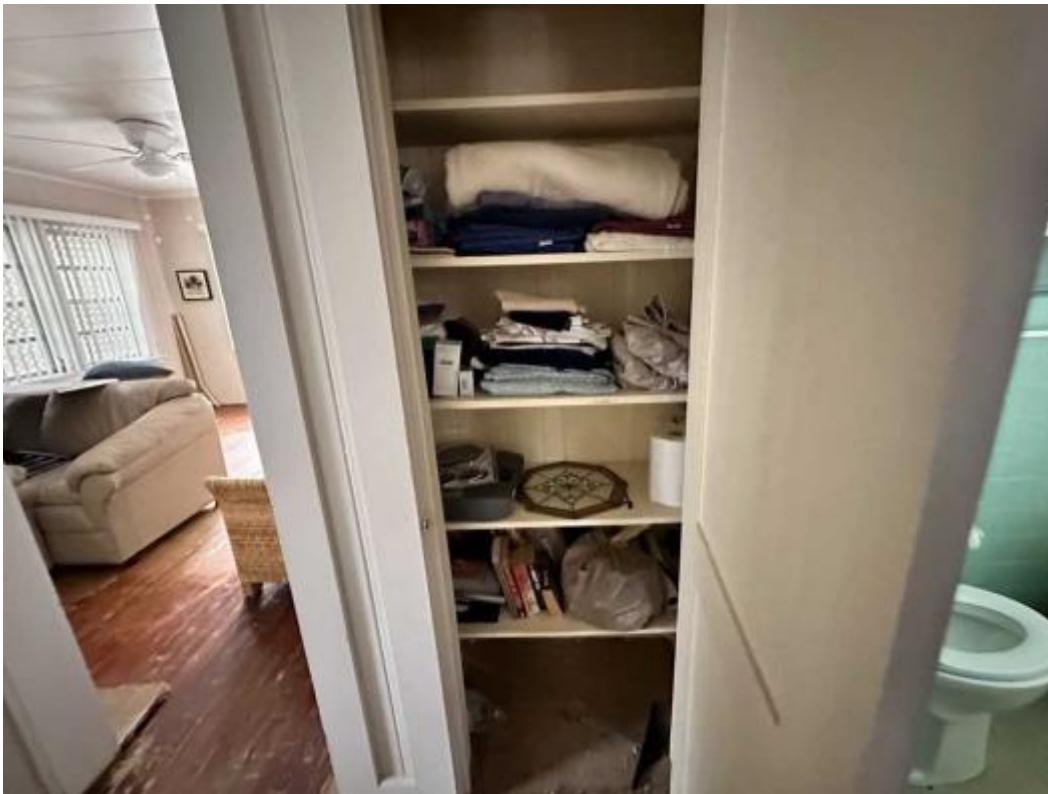
Main Level/Linen Closet - 43-Linen Closet

Damage to carpet, trim, paneled walls, and doors.

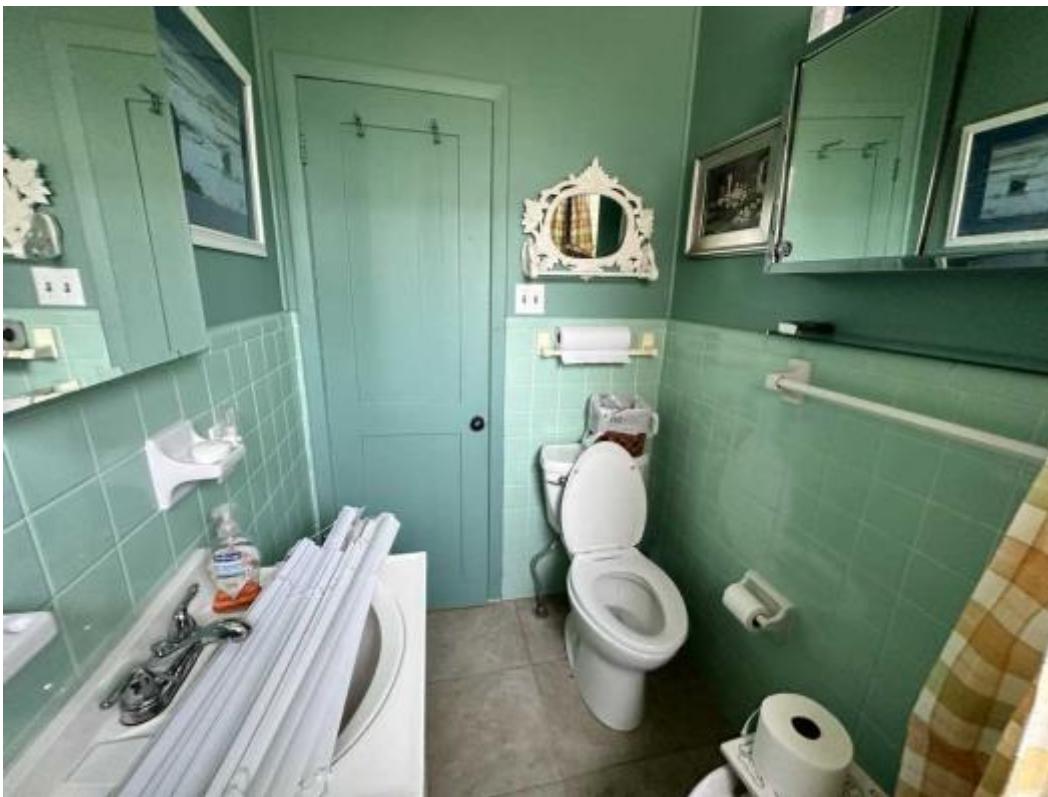
Main Level/Bathroom - 44-Bathroom

Tile walls with greenboard behind tile. damage to flooring, trim, vanity, walls, and doors.

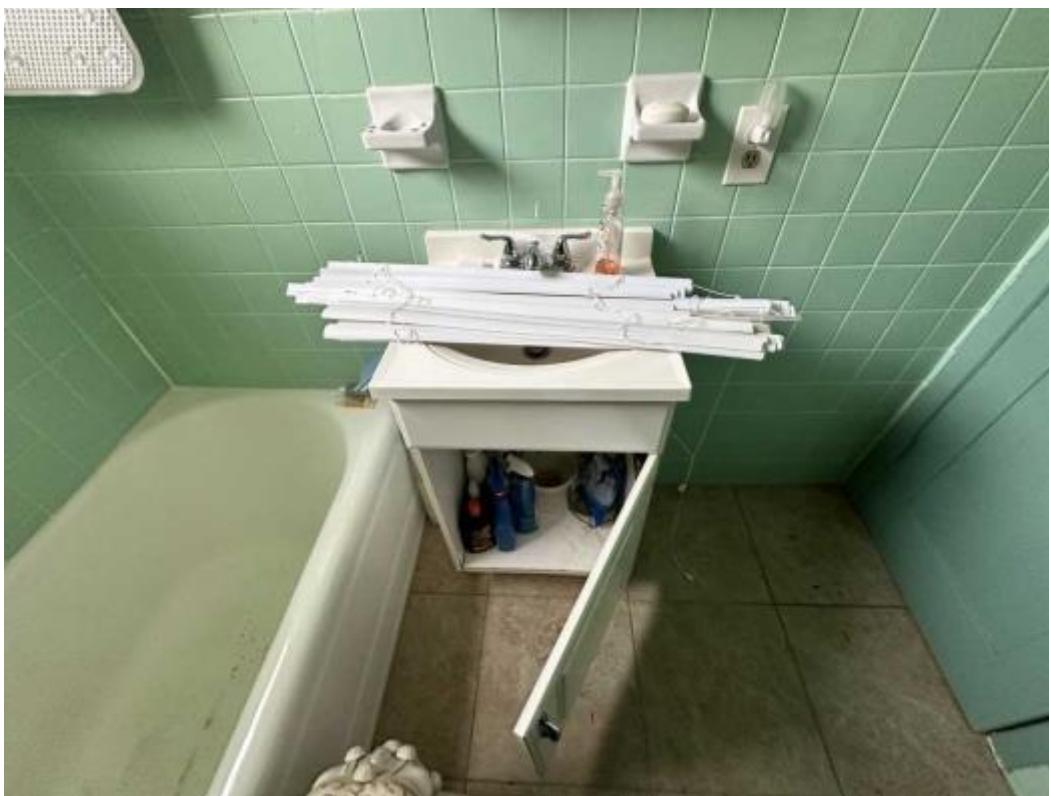
Main Level/Bathroom - 48-Bathroom vanity

Tile walls with greenboard behind tile.
damage to Damage to flooring, trim,
walls, and doors.

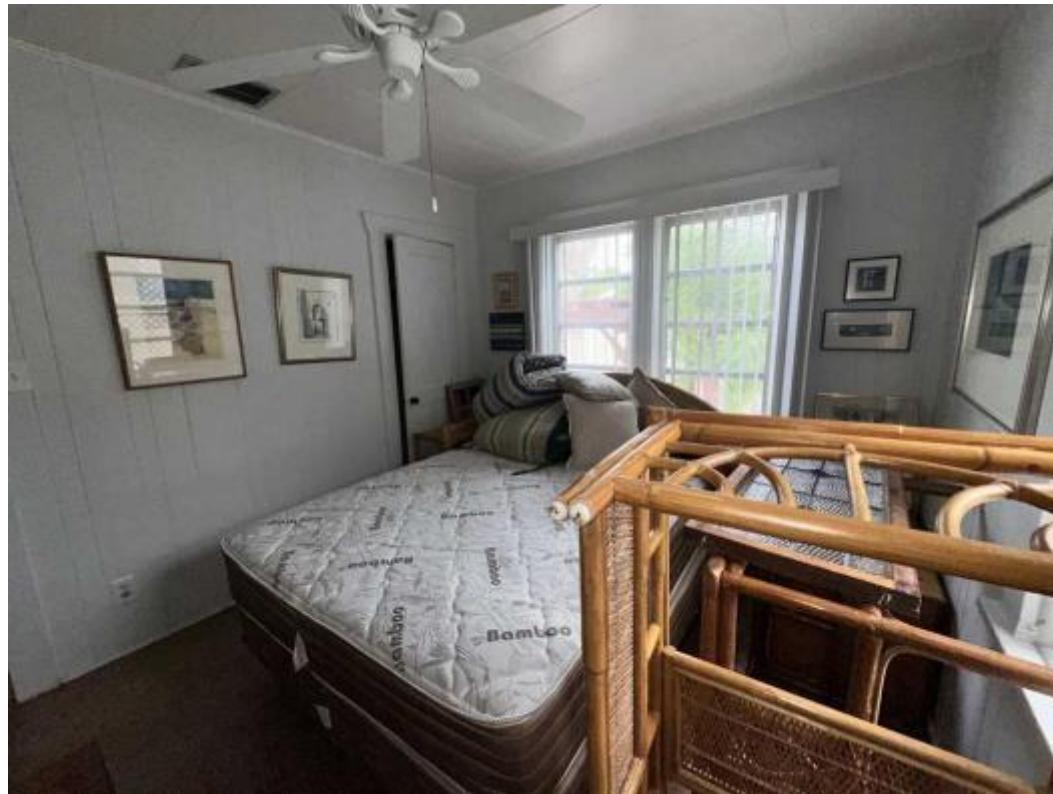
Main Level/Bedroom - 49-Bedroom

Damage to flooring, trim, doors, paneling, and doors. Carpet over engineered wood flooring is included as content item.

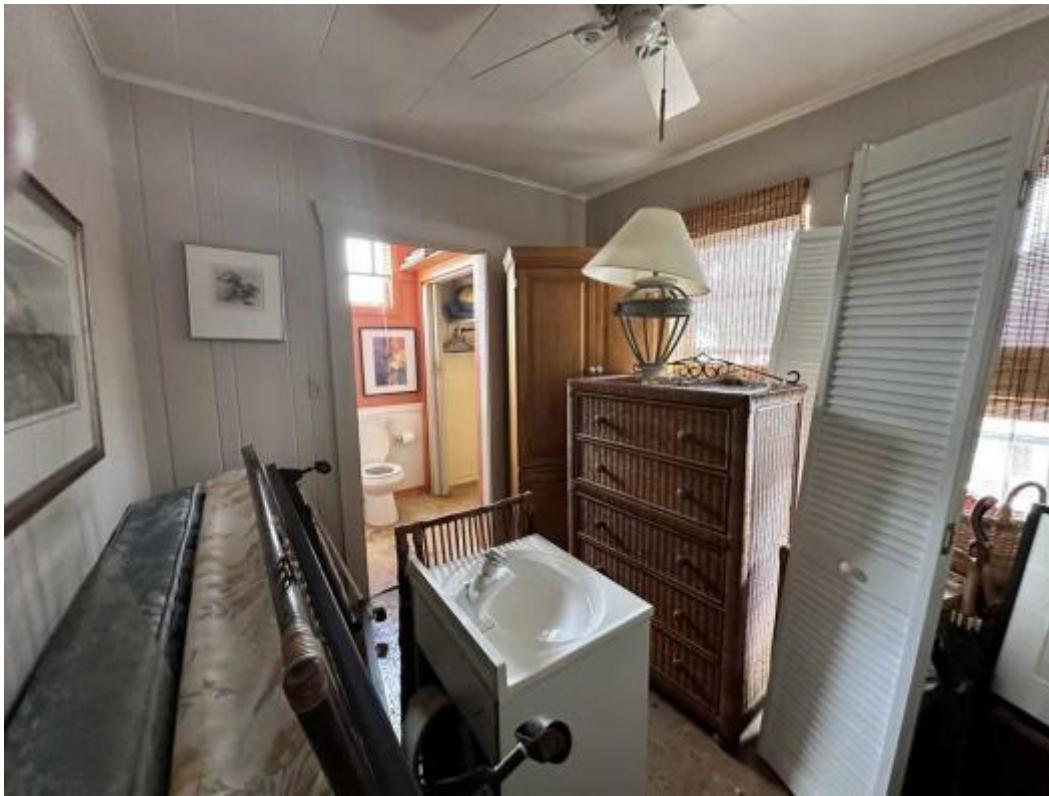
**Main Level/Master Bedroom -
53-Master bedroom**

Damage to flooring, trim, doors, paneling, and doors. Carpet over engineered wood flooring is included as content item.

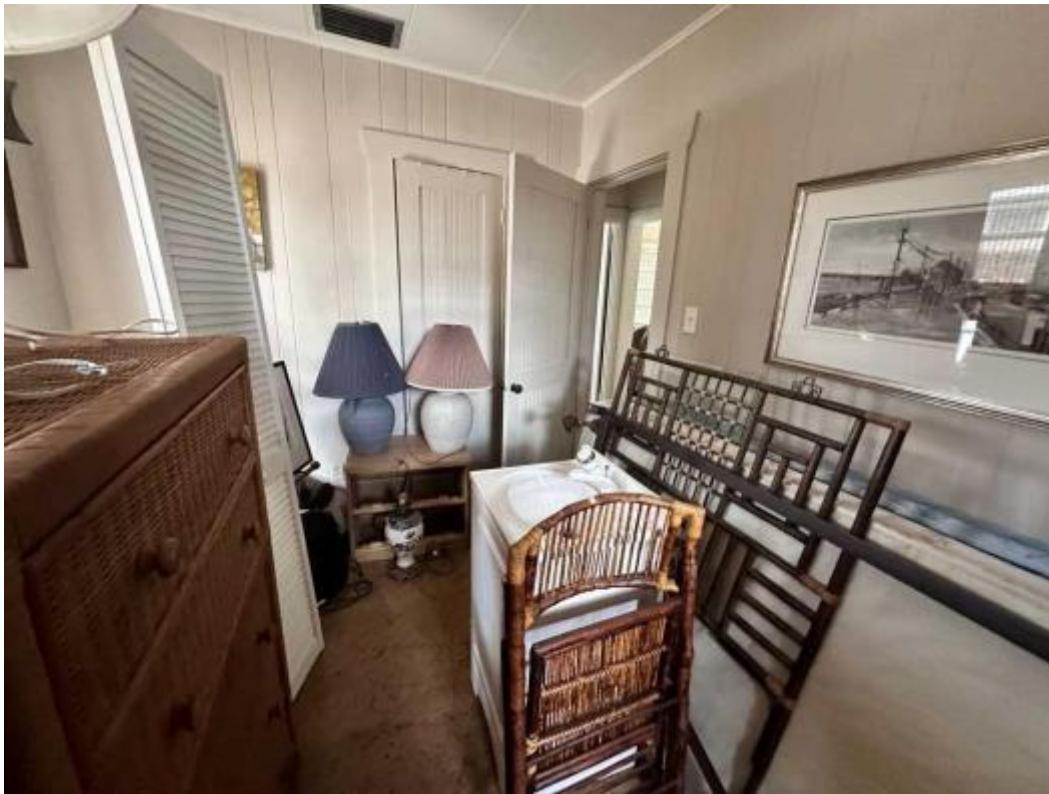
**Main Level/Master Bedroom -
55-Master bedroom**

Damage to flooring, trim, doors, paneling, and doors. Carpet over engineered wood flooring is included as content item.

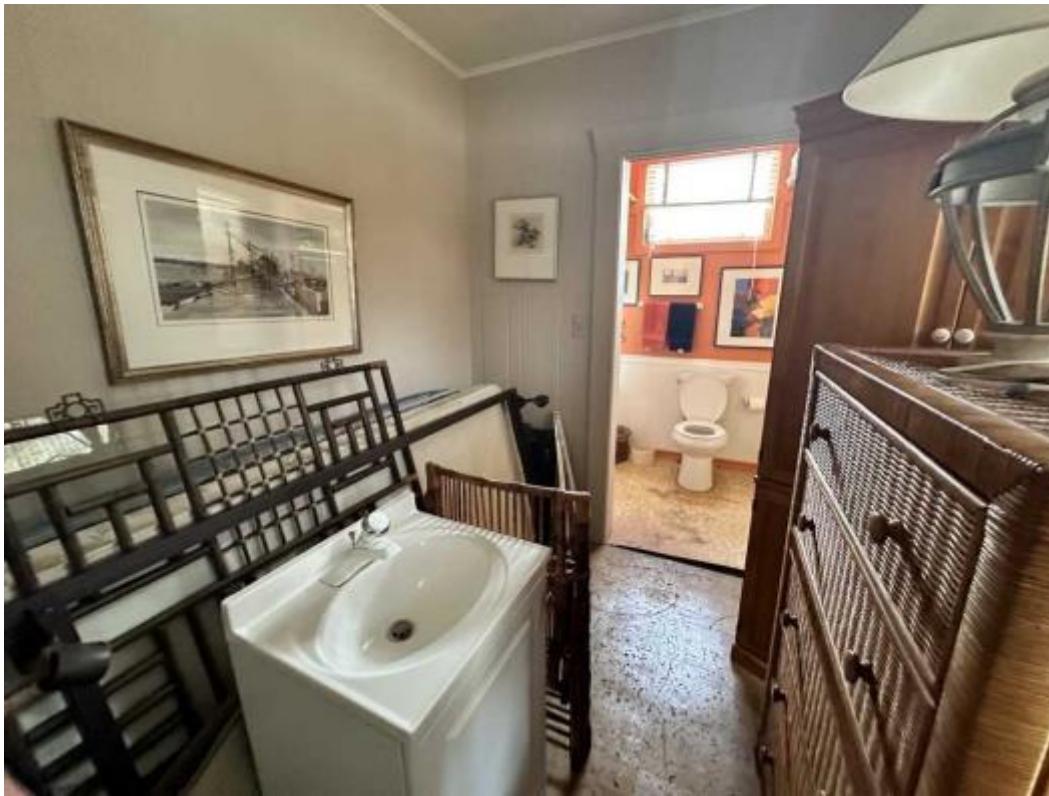
Main Level/Master Bedroom - 57-Master bedroom

Carpet over engineered wood flooring is included as content item. Entry to 1/2 Bath.

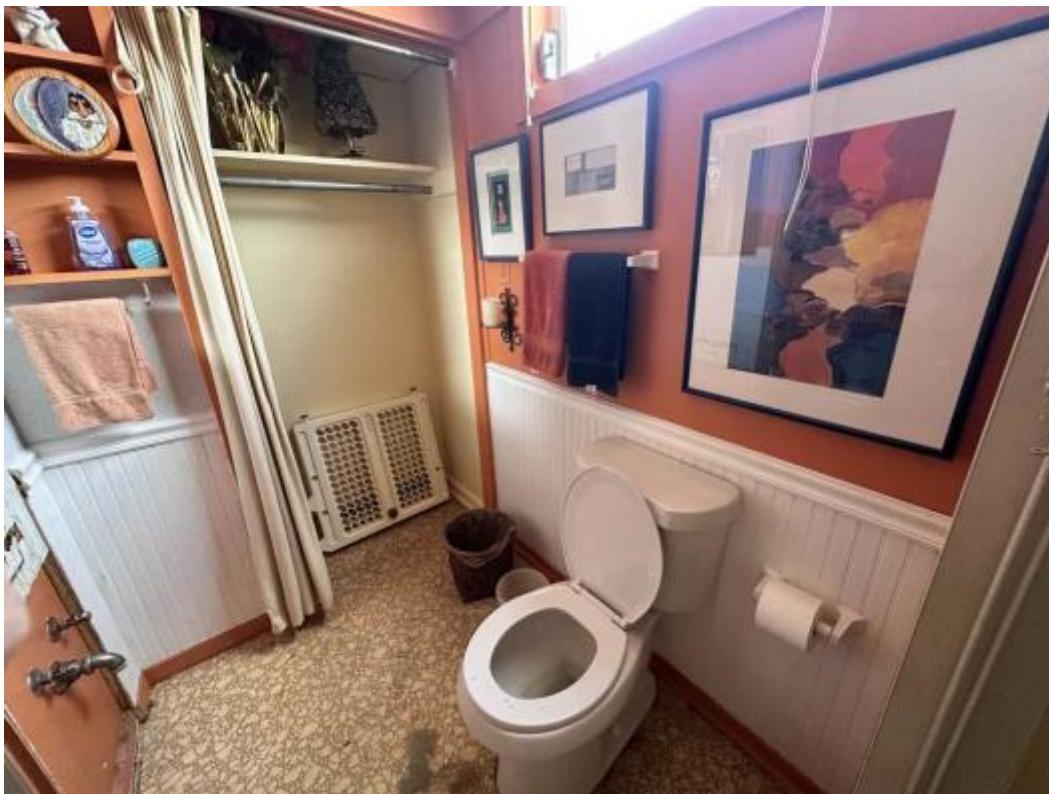
Main Level/1/2 Bath - 58-Master bath

Damage to vinyl flooring, trim, wainscotting, drywall, vanity, and doors.

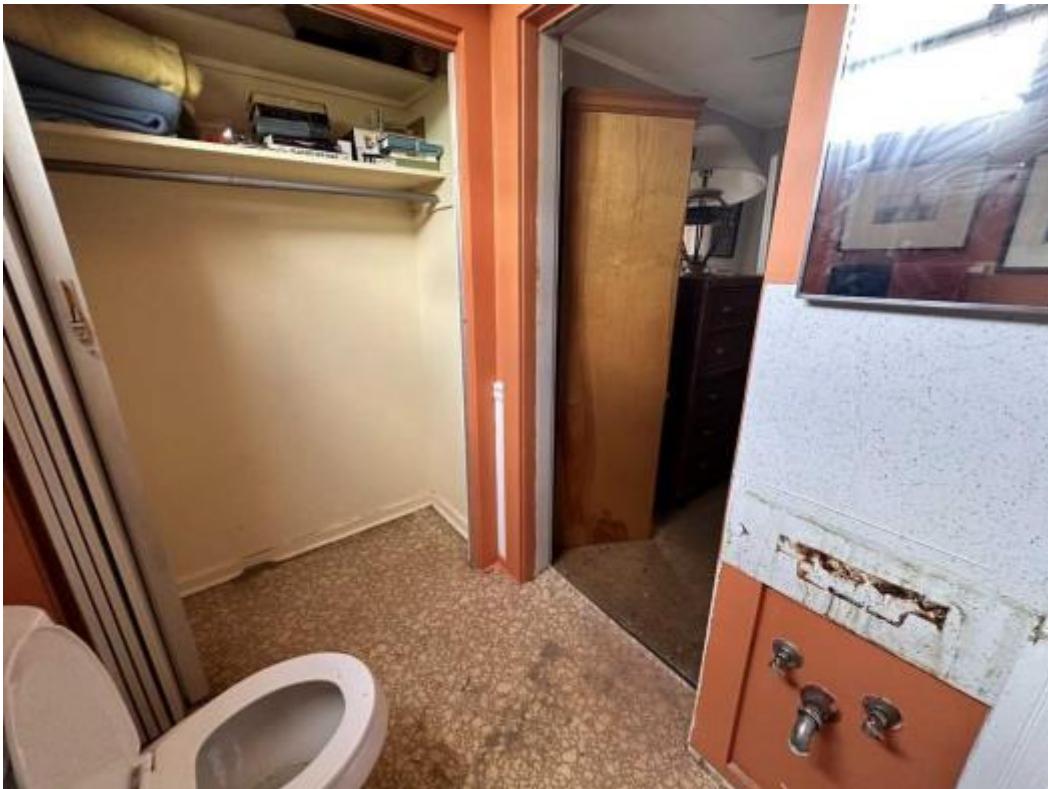
Main Level/1/2 Bath - 59-Master bath

Damage to vinyl flooring, trim, wainscoting, drywall, vanity, and doors.
