NARRATIVE REPORT

DWELLING / UNIT OWNER

Carrier:	American Bankers	Date of Loss:	9/26/2024
Insured:	BETTY ANNE ADAMS	Assigned:	10/2/2024
CID:	FL0124	Contacted:	10/2/2024
Claim Number:	6900165078	Inspected:	10/8/2024
Policy Number:	6900165078	Inspected With:	Click or tap here to enter text.
Loss Address:	12408 SUNSHINE LN TREASURE ISLAND FL 33706-5036	Mailing Address:	12408 SUNSHINE LN TREASURE ISLAND FL 33706-5036
Coverage A:	\$ 235,000.00	Mortgage:	None.
Coverage B:	\$ 21000.00	Verified with:	Insured.
Policy Term:	6/28/2024 to 6/28/2025

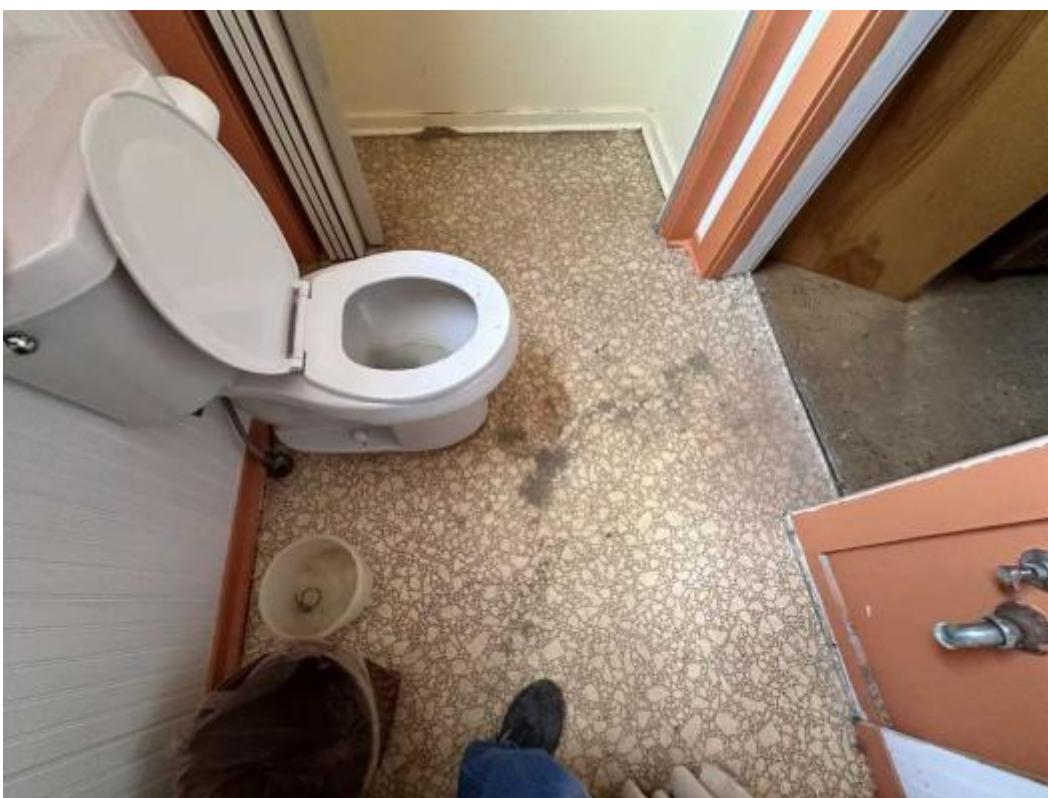
Main Level/1/2 Bath - 60-Master bath vinyl flooring

Damage to vinyl flooring, trim, wainscoting, drywall, vanity, and doors.

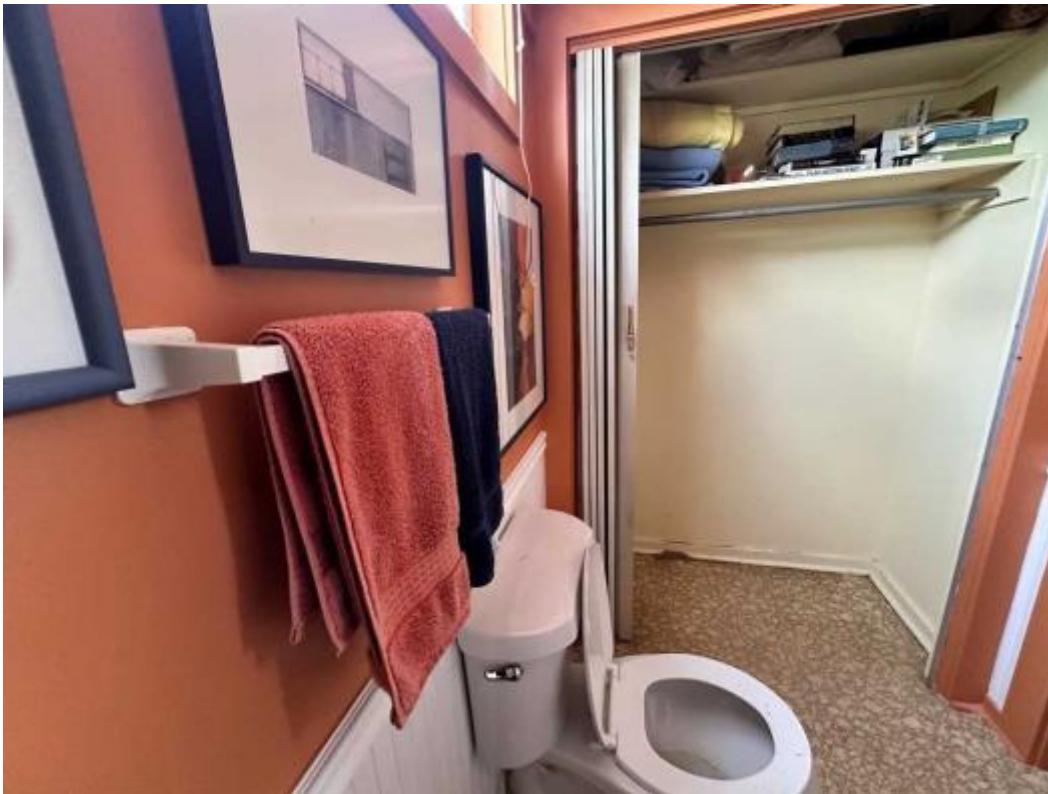
Main Level/MB Closet 2 - 61-MB Closet 1

Damage to vinyl flooring, trim, drywall, and door. Note, that trim is painted stain grade.

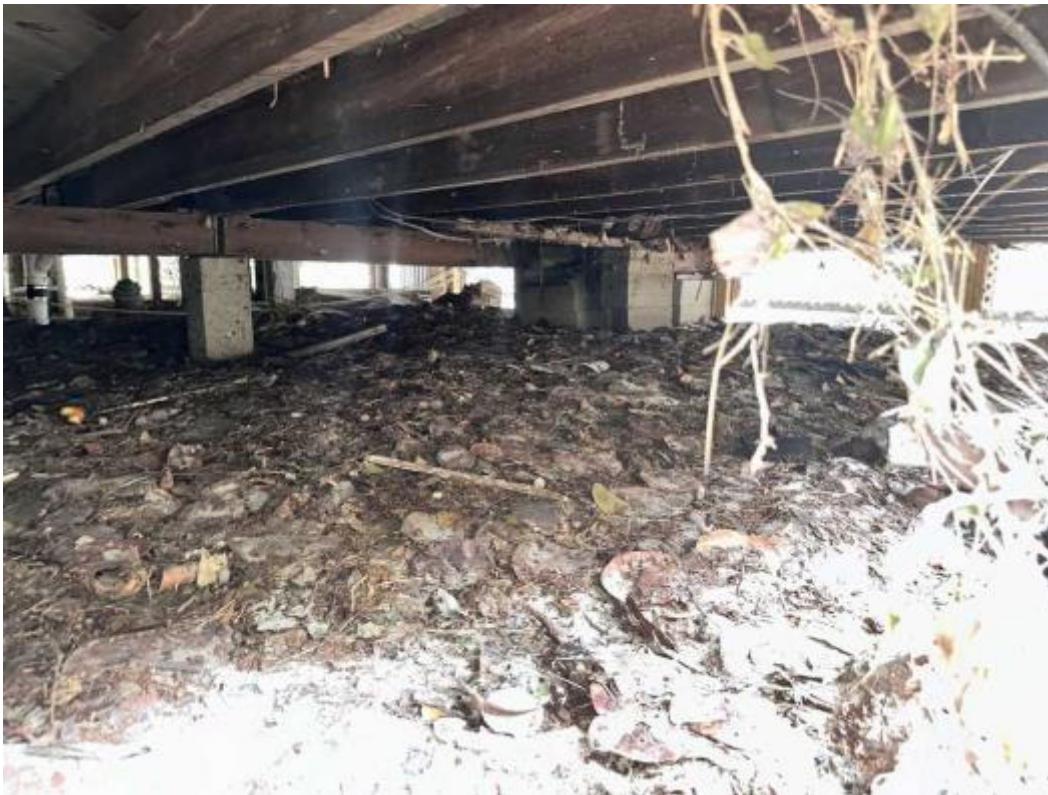
Crawlspace/Crawlspace - 64-Crawlspace

3 ft crawlspace, water inundated the floor framing and subfloor. Allow to clean and treat and muck out.

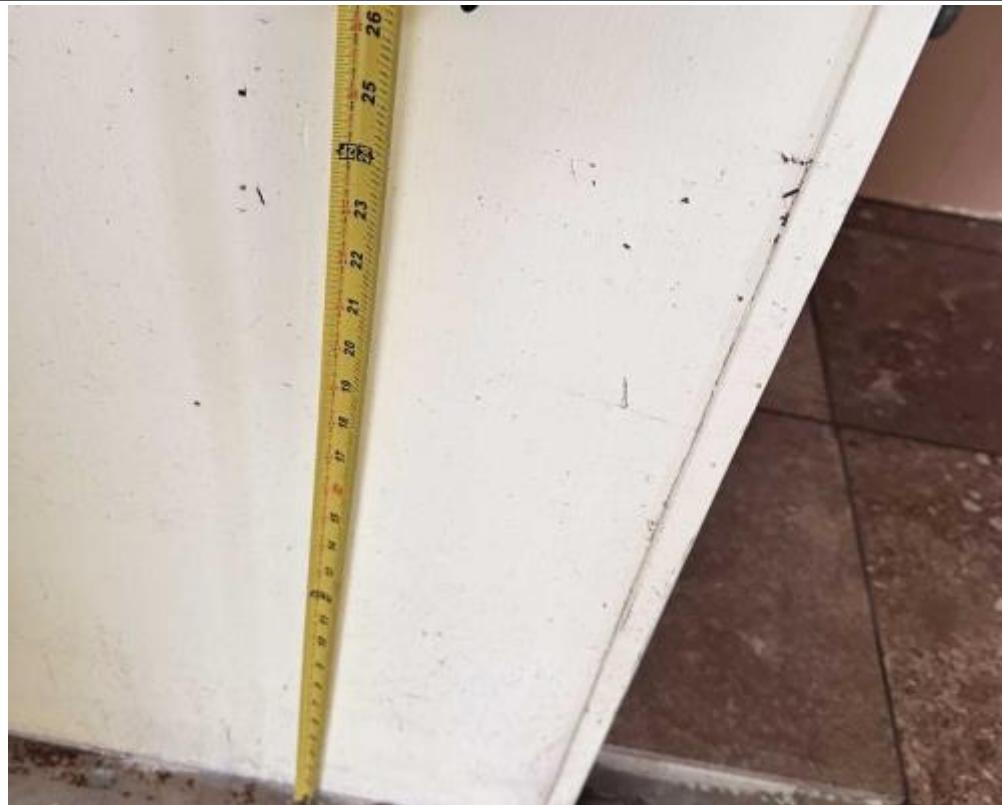
Detached Garage - 69-Garage interior water line 26 inches

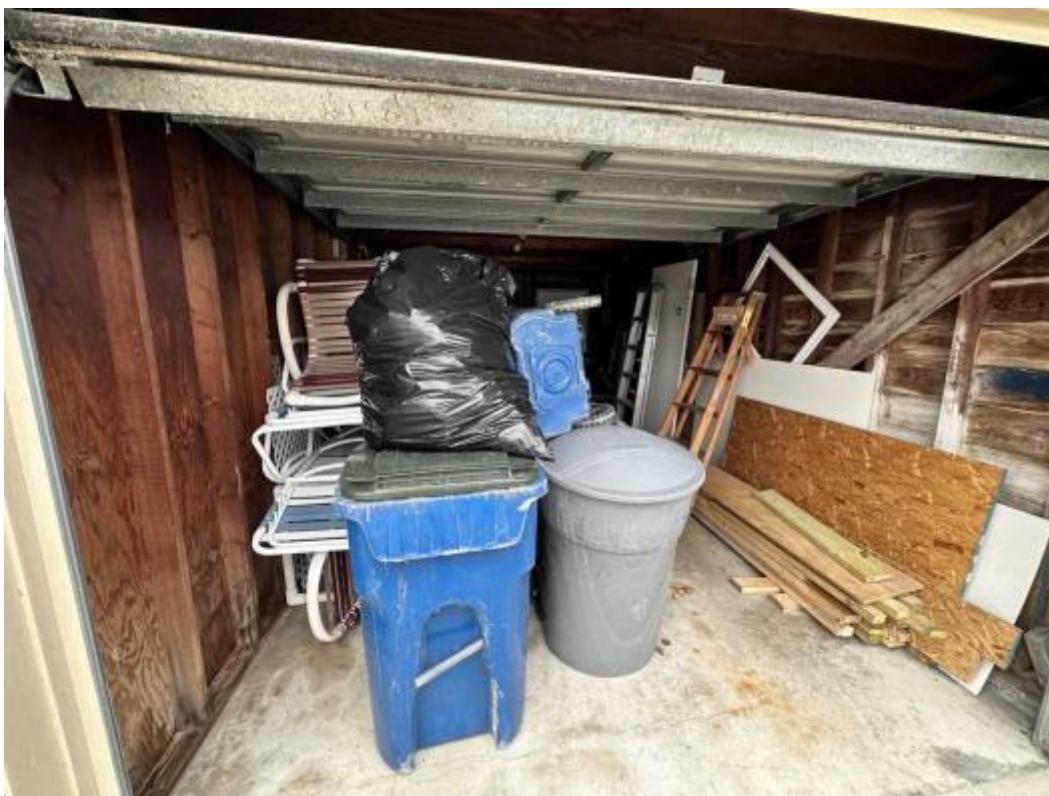
Detached Garage/Detached Garage - 72-Garage - damaged rollup garage door

- Doors – remove and replace doors, remove and reinstall hardware.
- Remove and replace damaged garage door. It is not an automatic door and will no longer move up and down.
- Bathrooms - replacement of bathroom vanity.
- Replacement of associated plumbing fixtures.
- Replacement of tile shower unit.

Clean and treat unfinished stud walls and clean floor.

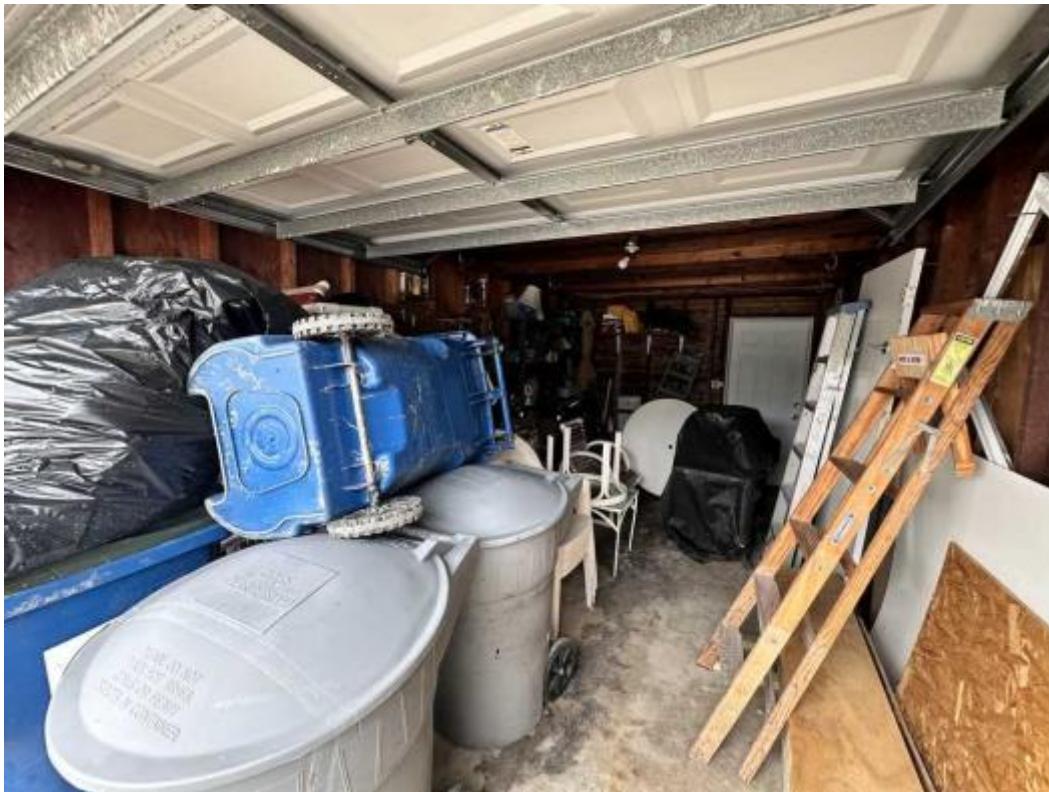
Detached Garage/Detached Garage - 73-Garage - interior 3

Rear door is damaged,

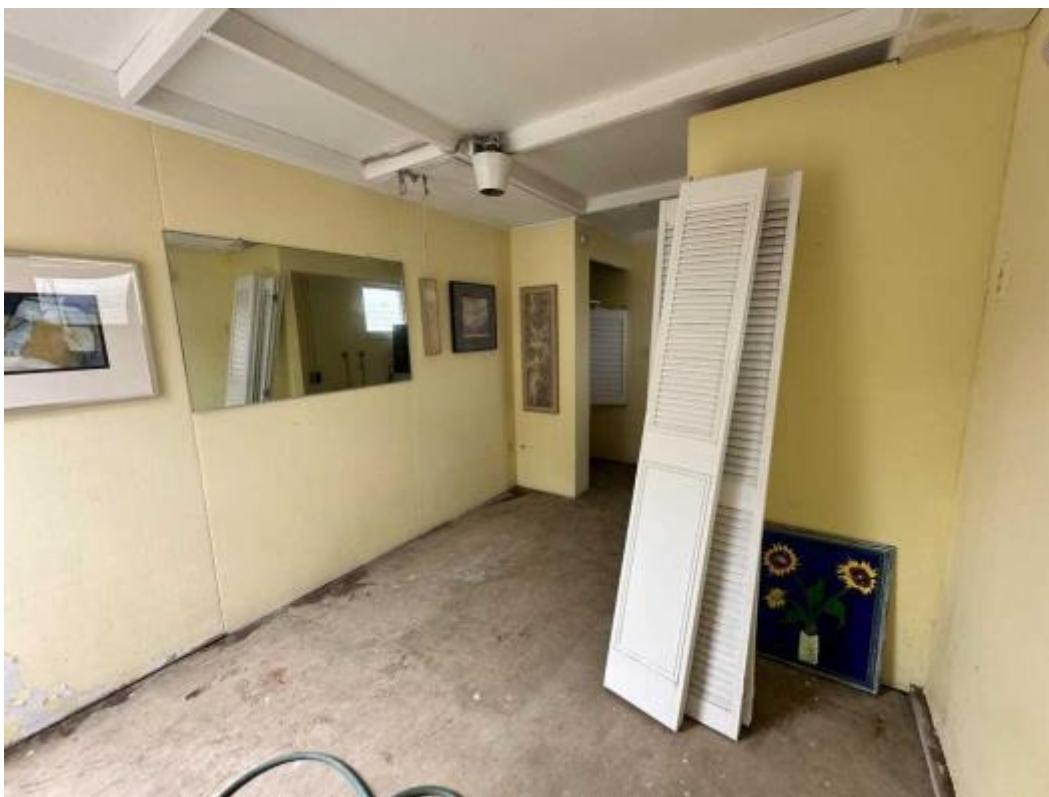
Detached Garage/Laundry - 74-Laundry

Damage to floor, trim, drywall, doors, appliances, and tile shower.

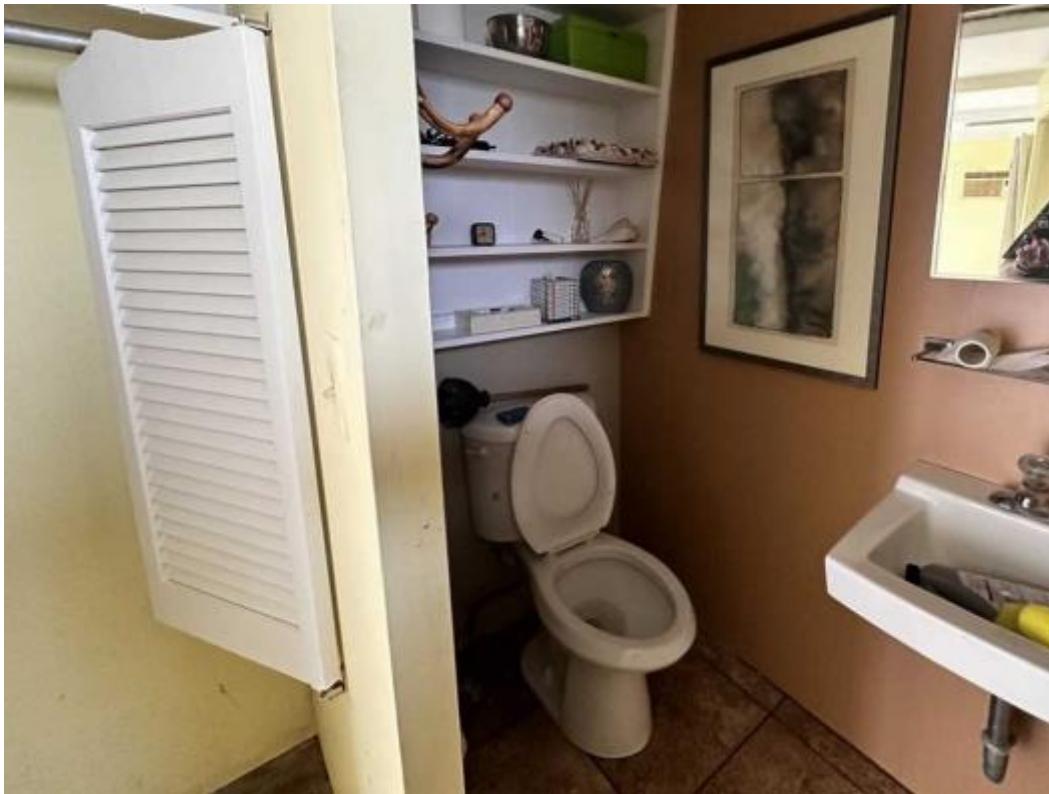
Detached Garage/Bathroom - 77-Garage - bathroom toilet and sink area

Damage to floor, trim, drywall, doors, appliances, and tile shower.

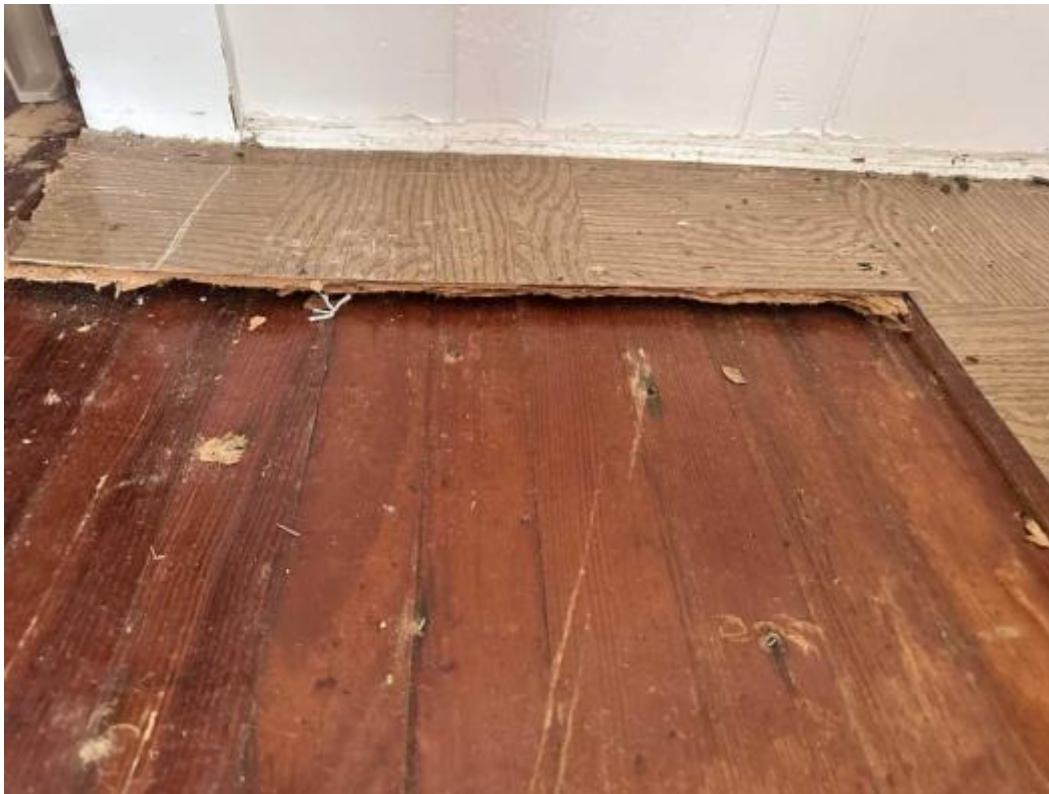
**BAContents list/Living - 79-
Contents**

Engineered wood flooring over
hardwood flooring. Engineered wood
flooring is contents item.

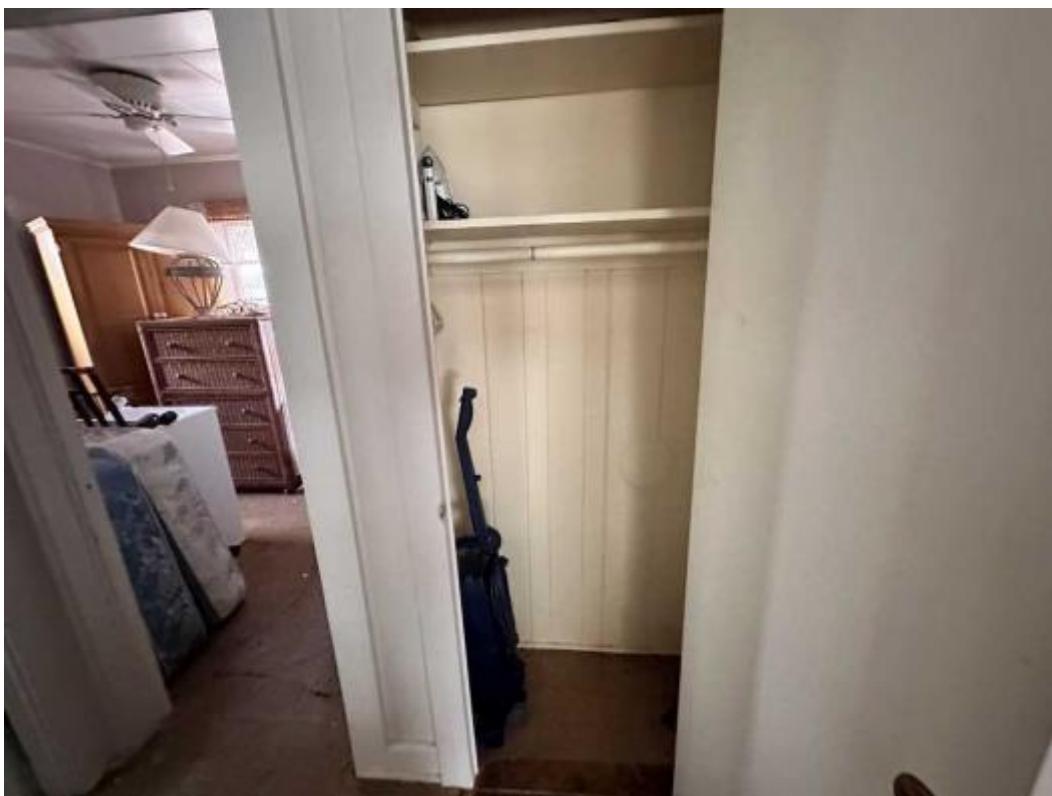
BAContents list/Hall Closet - 94-Contents

Carpet was laid over hardwood flooring on 1/2 of hallway flooring. Carpet over this portion of the floor is contents.

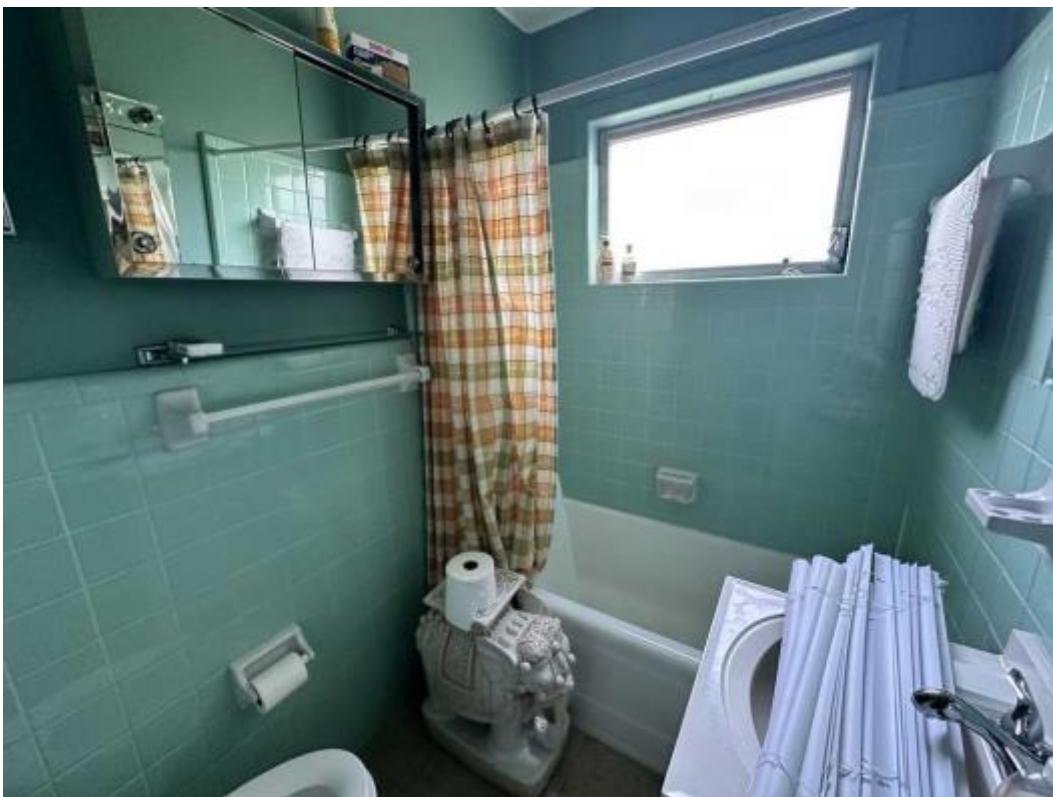
BAContents list/Bathroom - 95- Contents

Damaged elephant plant stand.

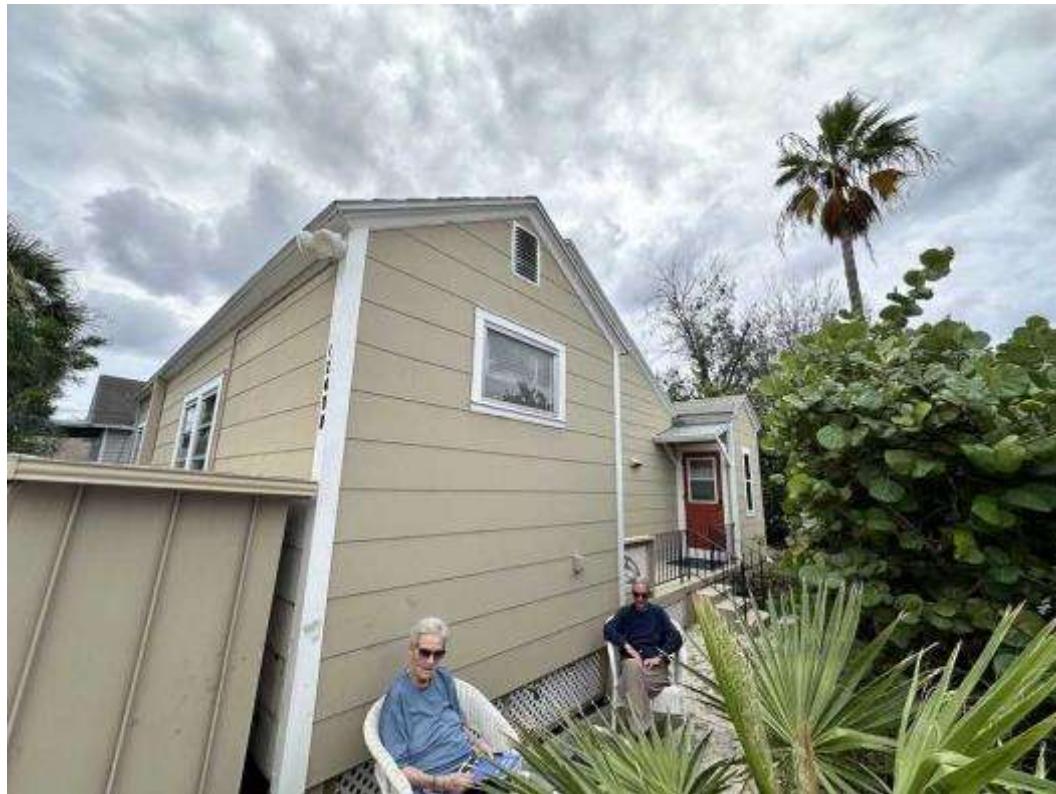
1-Front elevation, address verification

Risk is a single family dwelling built in 1938 and is Pre-Firm and elevated (garage is non-elevated). The risk is the insured's principle residence and is owner occupied. The risk had 12 inches of water on the interior and an exterior water line of 46 inches with a 26 inch interior water line on garage and laundry area. Advance request of \$15,000 for building and advance for contents was denied by insured.

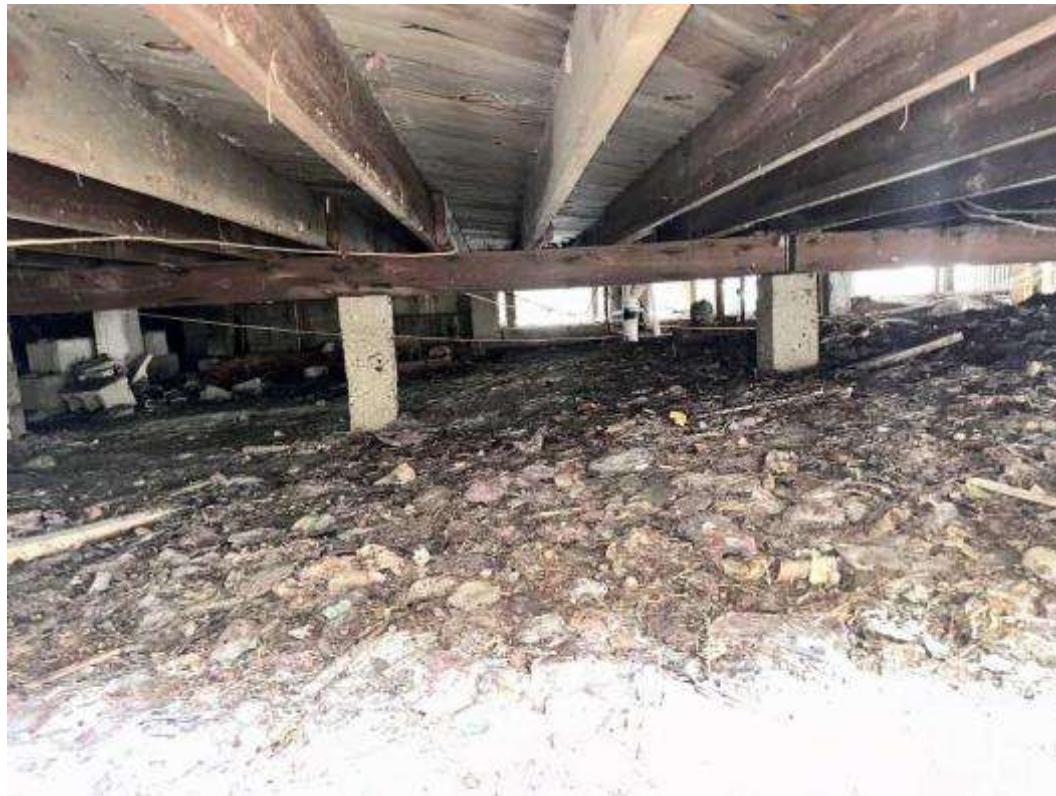
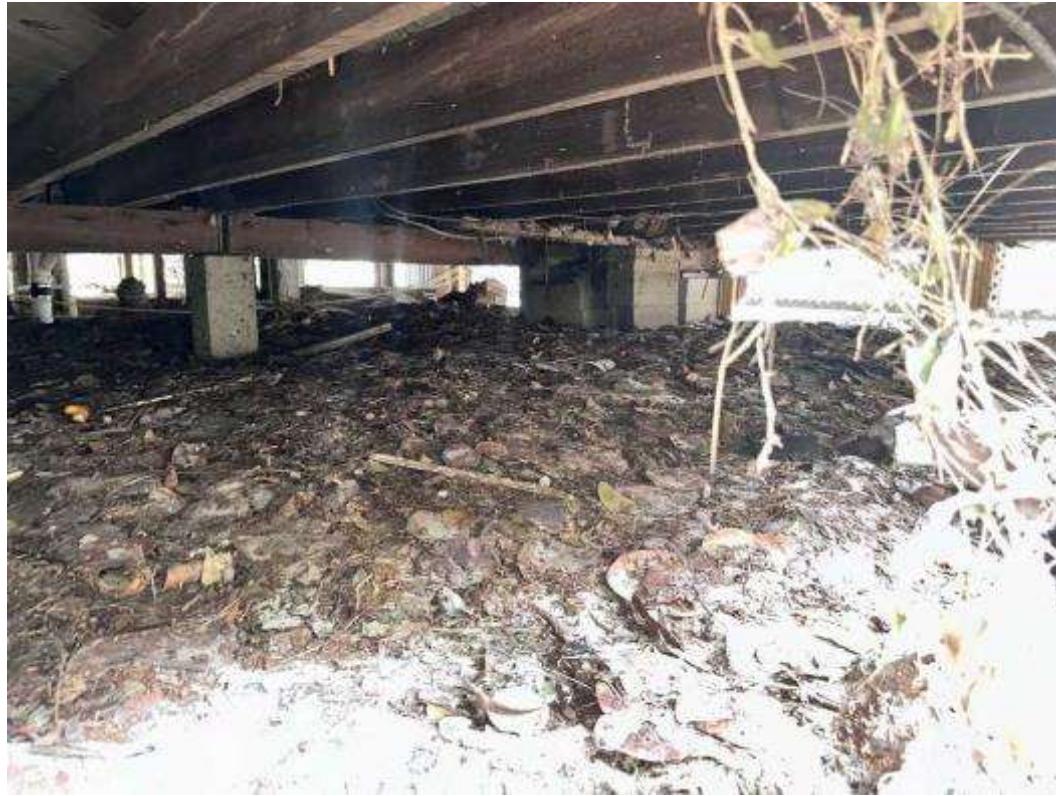
82-Crawlspace

- Underwriting discrepancy observed: *inspection photos confirm risk is elevated with crawl space.*
- Policy currently shows: *rated as non-elevated building - no basement.*
- Recommend changing policy to: *policy should be changed to elevated building with crawlspace.*
- Supporting documentation: *a photo report has been included in this underwriting referral to show elevated with crawlspace.*
