NARRATIVE REPORT

DWELLING / UNIT OWNER

Carrier:	American Bankers	Date of Loss:	10/10/2024
Insured:	PATRA BROWN	Assigned:	12/10/2024
CID:	243608	Contacted:	12/10/2024
Claim Number:	7406051373-10102024	Inspected:	11/2/2024
Policy Number:	7406051373	Inspected With:	Patra Brown
Loss Address:	701 W MADISON ST PLANT CITY FL 33563	Mailing Address:	701 W MADISON ST PLANT CITY FL 33563
Coverage A:	\$ 170,000.00	Mortgage:	M&T Bank
Coverage B:	\$ 40,000.00	Verified with:	Patra Brown
Policy Term:	11/30/2023 to 11/30/2024

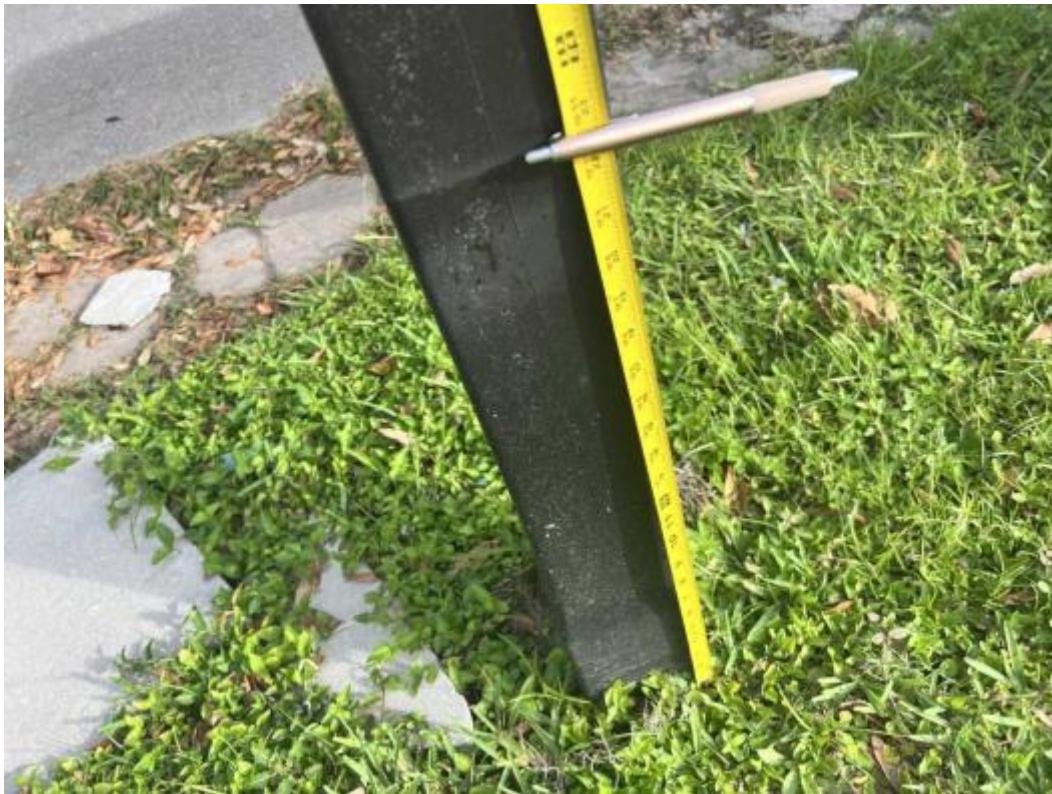
**Exterior/Footprint - 3-exterior
flood line - 22"**

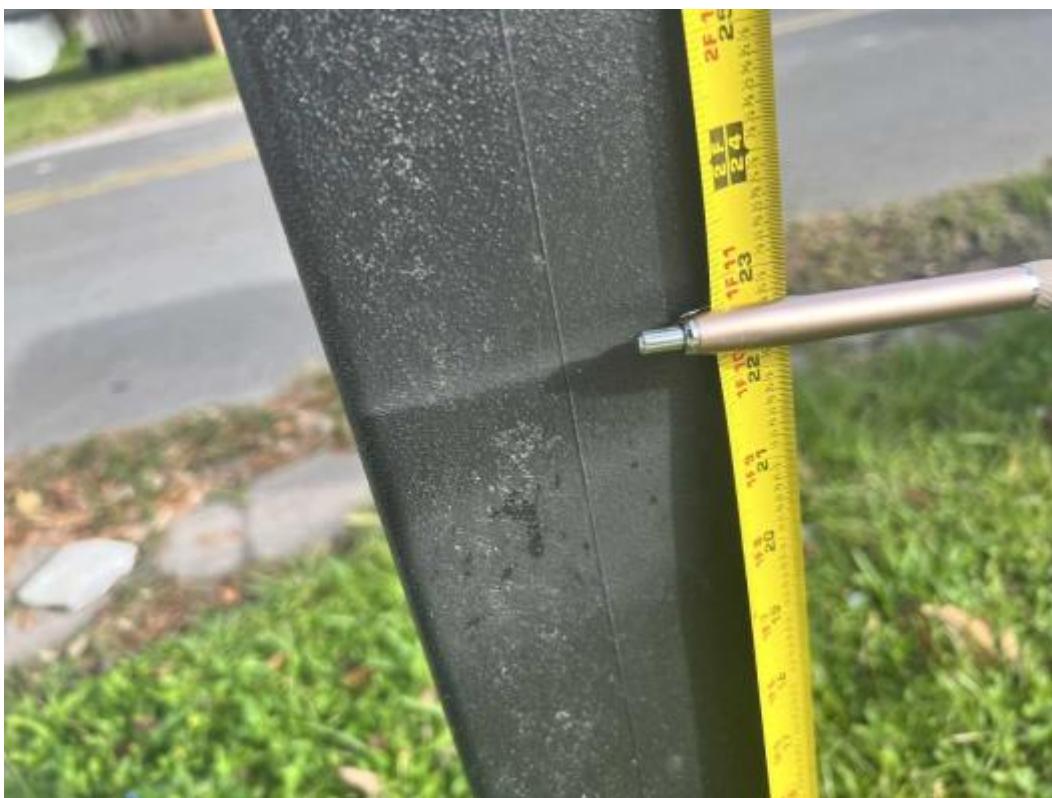
**Exterior/Footprint - 4-exterior
flood line - 22"**

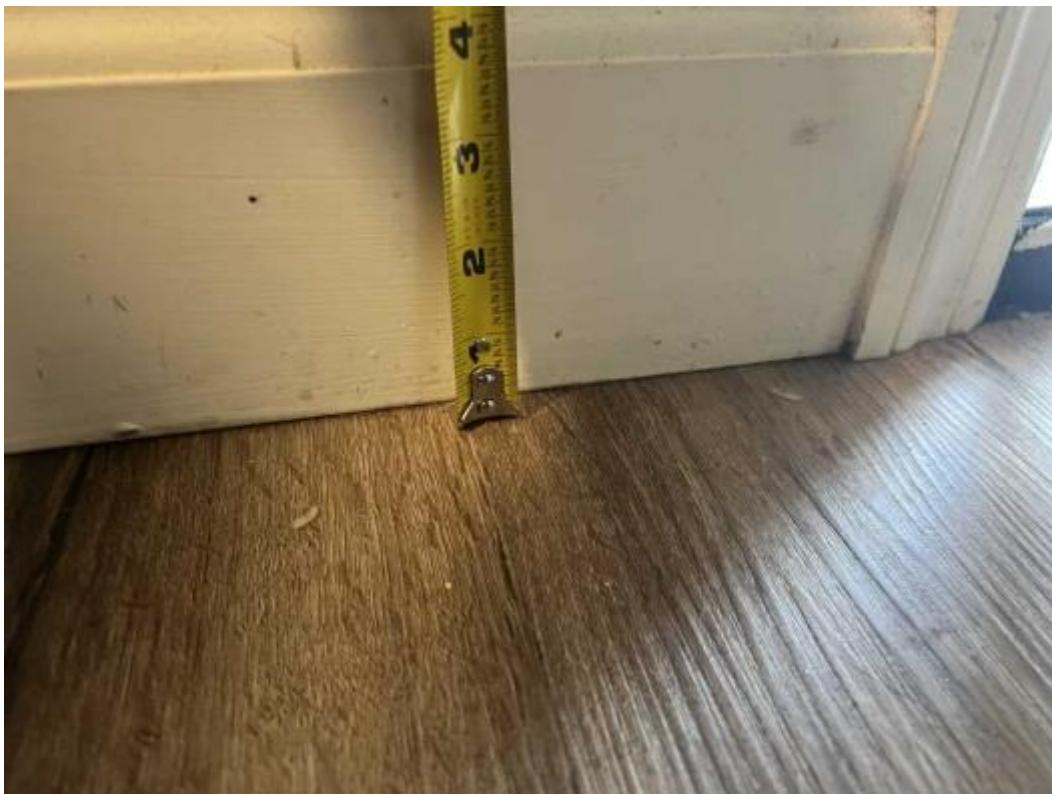
Exterior/Footprint - 5-interior flood line - 1"

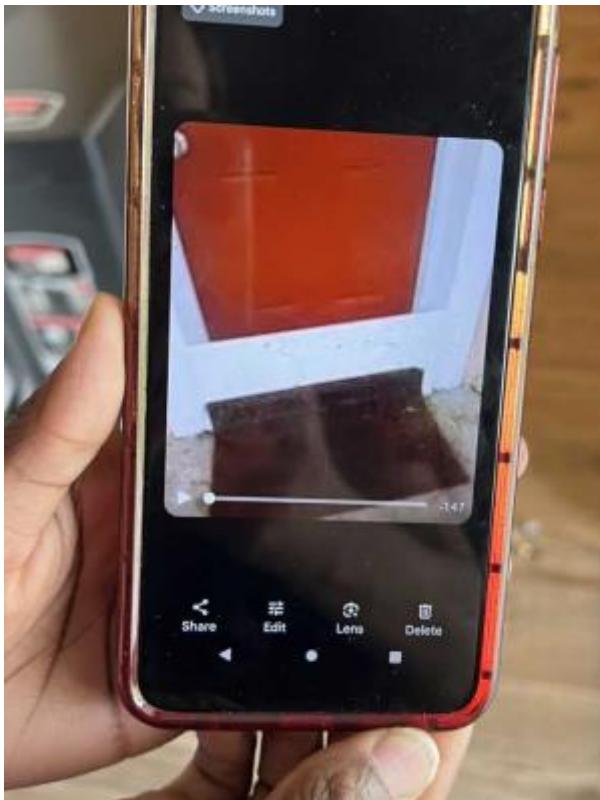
Exterior/Footprint - 7-front door

screen shot of insured's phone showing flood line on board that was placed and sealed at the front door

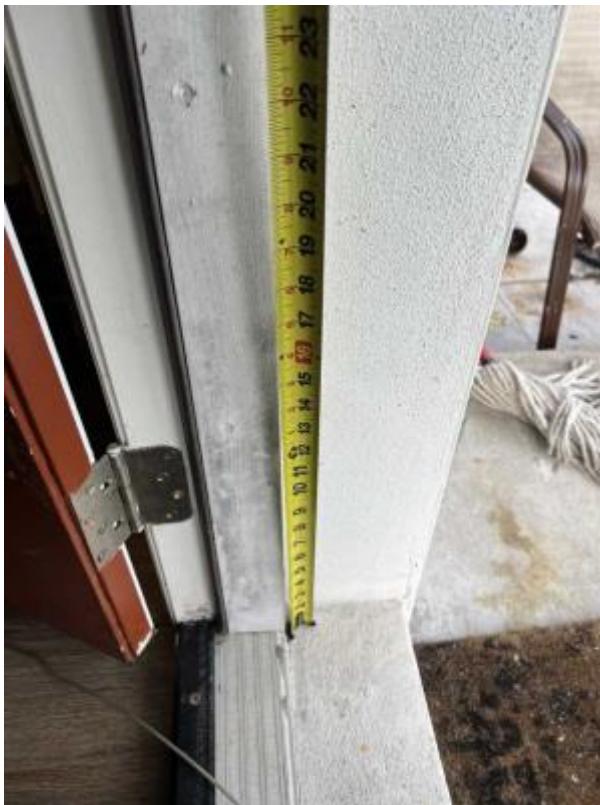
Exterior/Footprint - 9-front door

approximate height of flood line seen on board in insured photo.

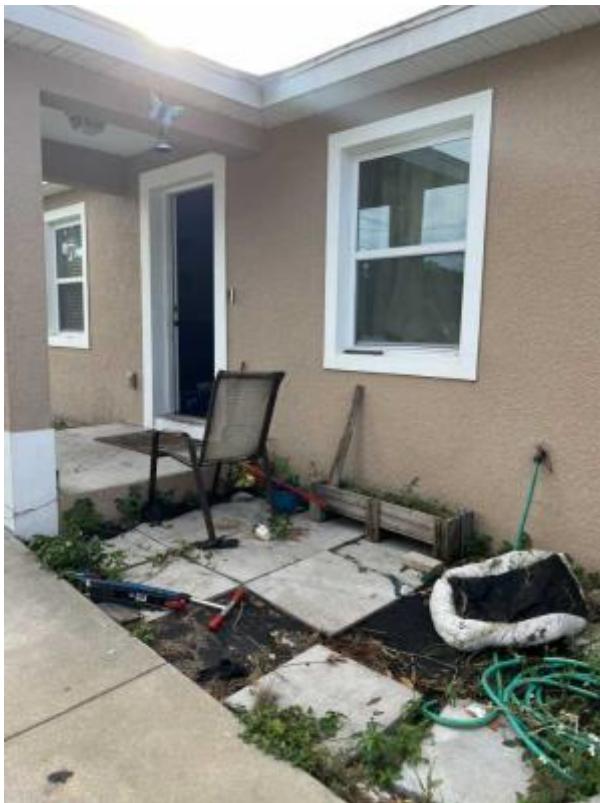
**Exterior/Front Elevation - 11-
front elevation**

Taken By: Crystal Bryant
overview of front elevation

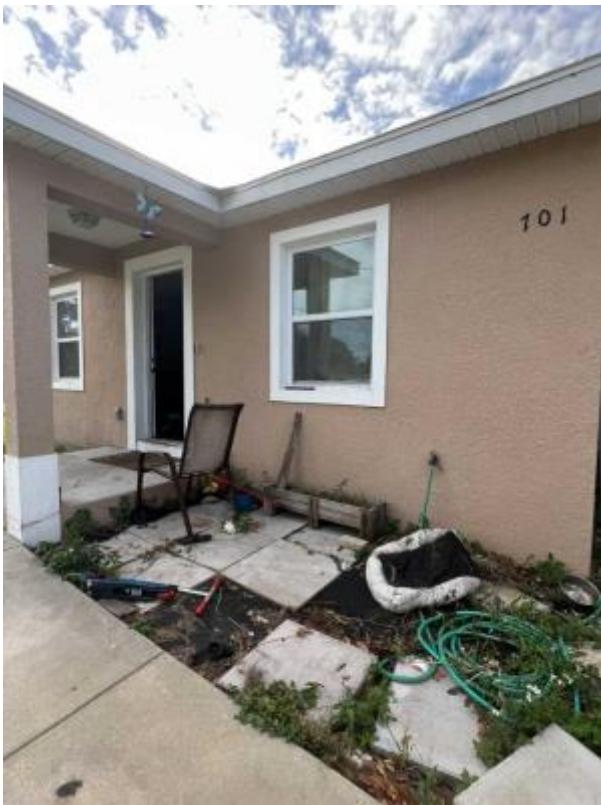
Exterior/Front Elevation - 13-front elevation

overview of front elevation

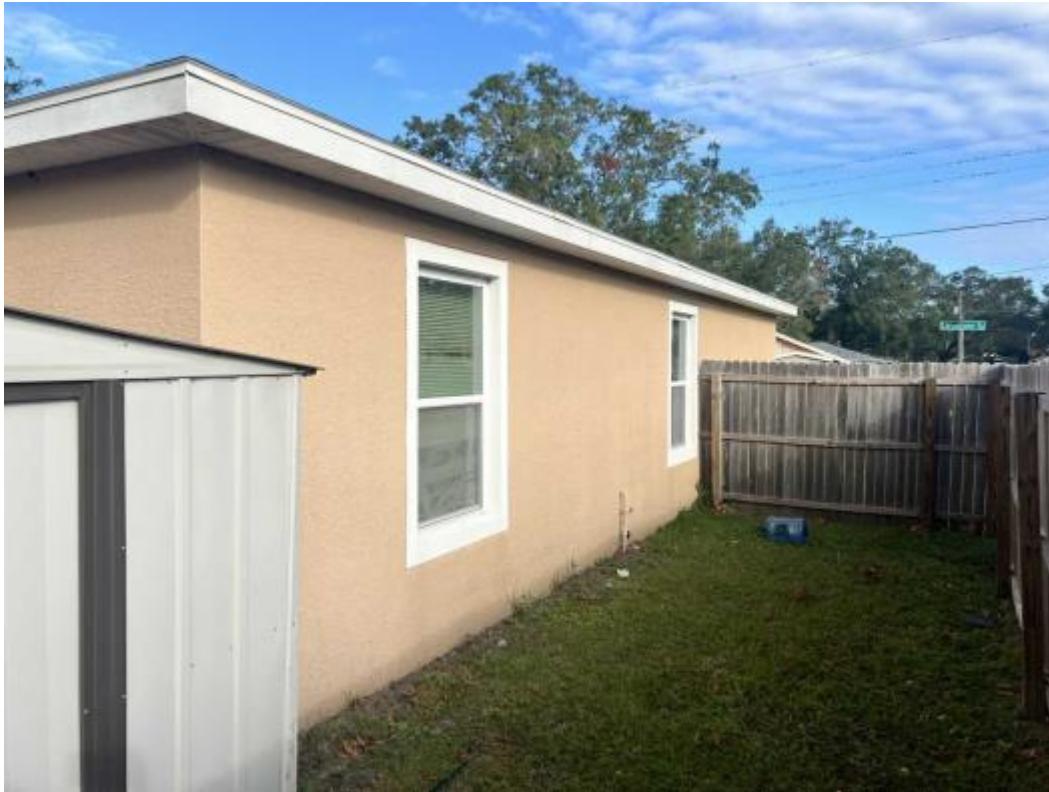
Exterior/Left Elevation - 15-left elevation

Taken By: Crystal Bryant
overview of left elevation

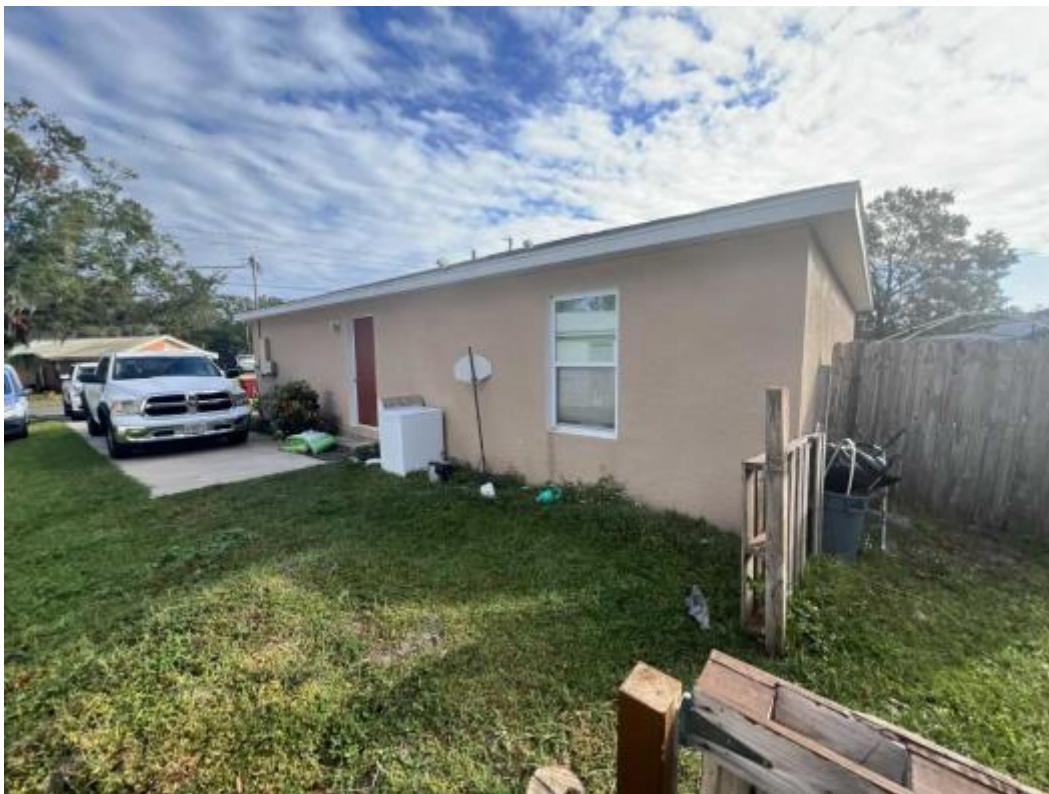
Exterior/Right Elevation - 19-right elevation

Taken By: Crystal Bryant
overview of right elevation

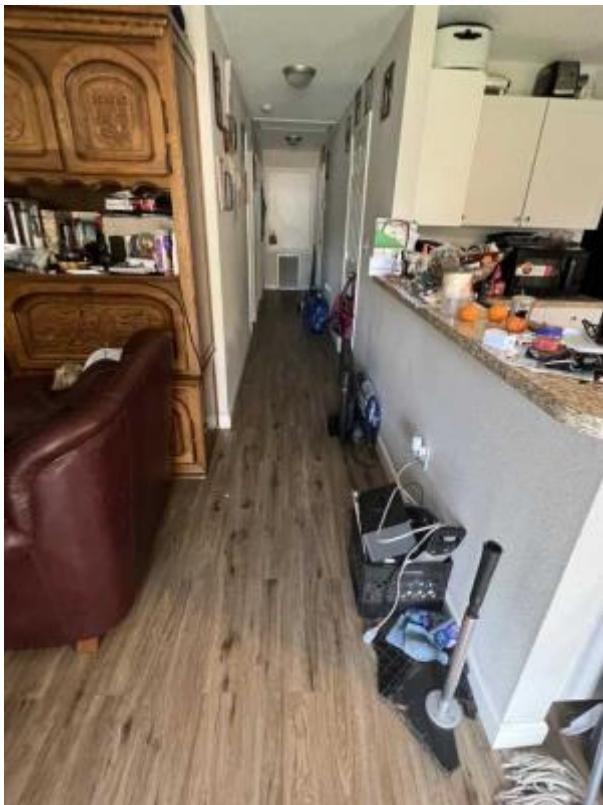
Main Level/Living Room - 21-living room

Taken By: Crystal Bryant
overview of living room

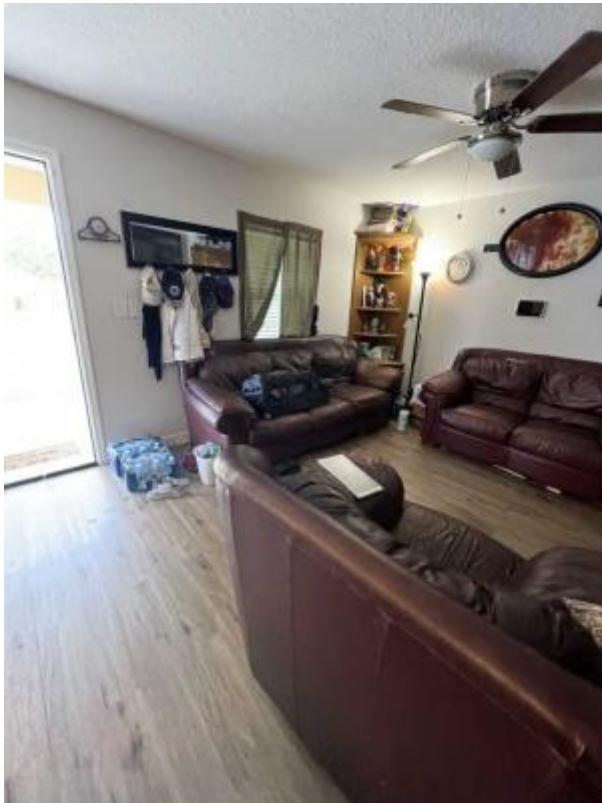
Main Level/Living Room - 23-living room

Taken By: Crystal Bryant
overview of living room

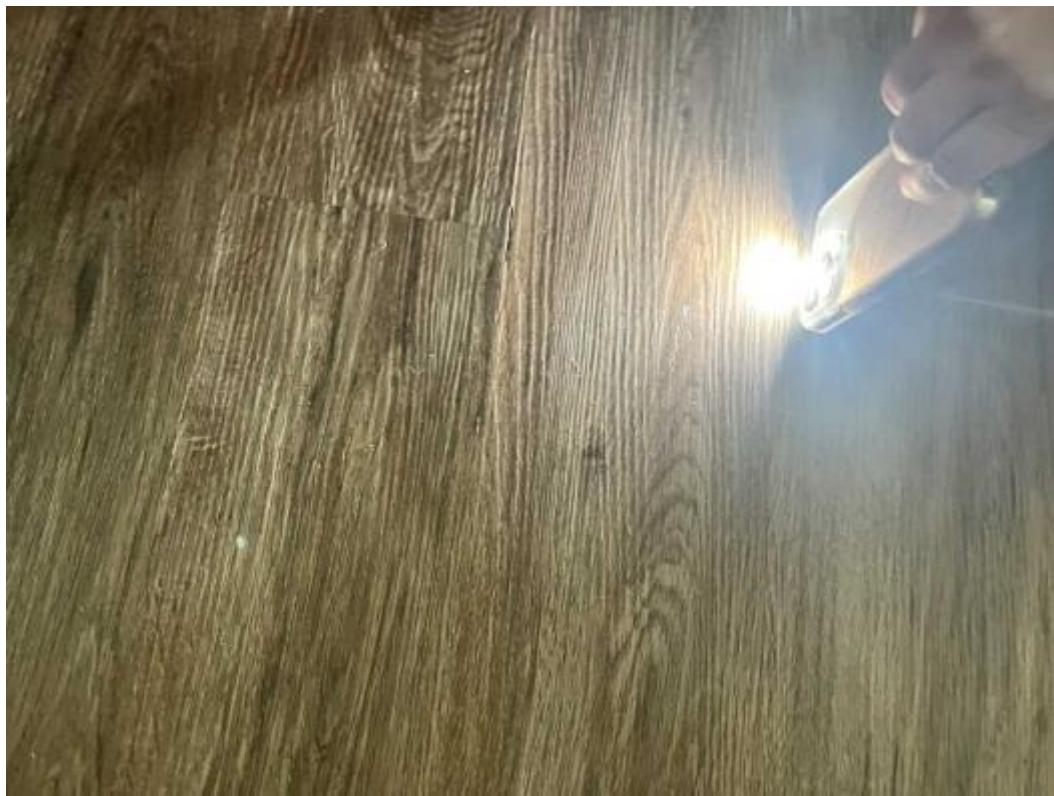
Main Level/Living Room - 25-living room

Taken By: Crystal Bryant
flood damage to living room floor

- Structural drying
- Flood loss clean up
- Replace laminate flooring in living room, kitchen, hallway, hall bath, and bedroom 2
- Replace baseboards in affected rooms
- Replace front door
- Paint wall covering
- Detach & Reset kitchen lower cabinets as flooring continues beneath them

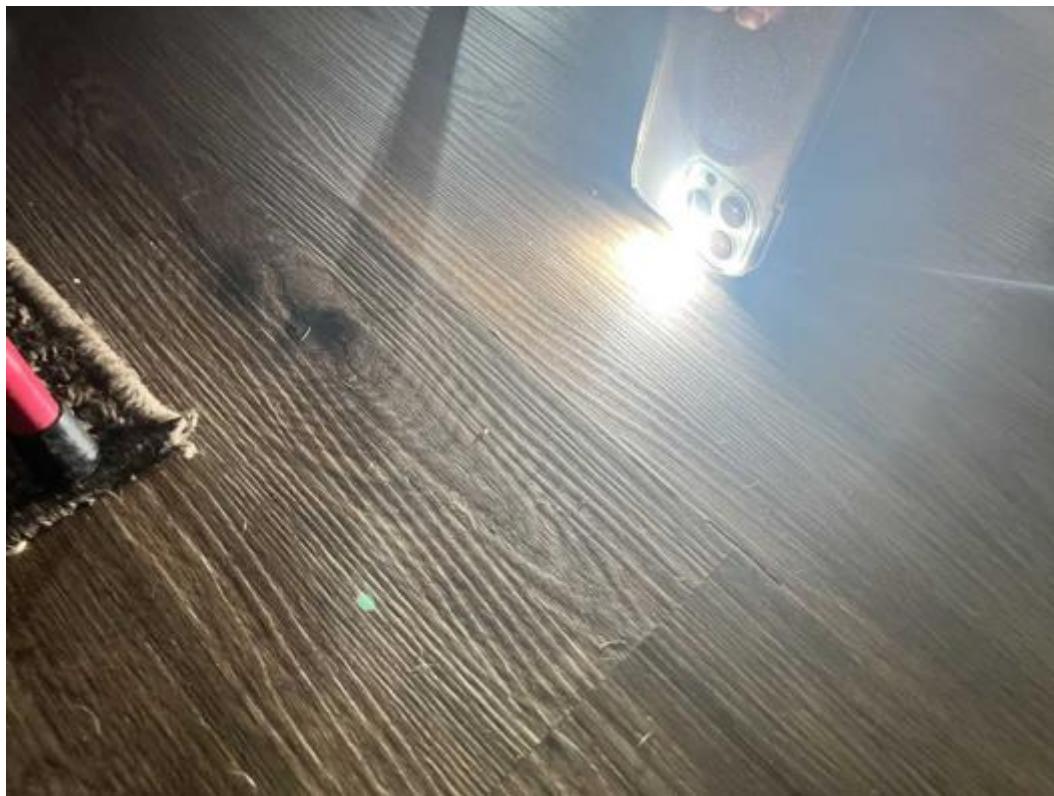
Main Level/Living Room - 26-living room

Taken By: Crystal Bryant
flood damage to living room floor

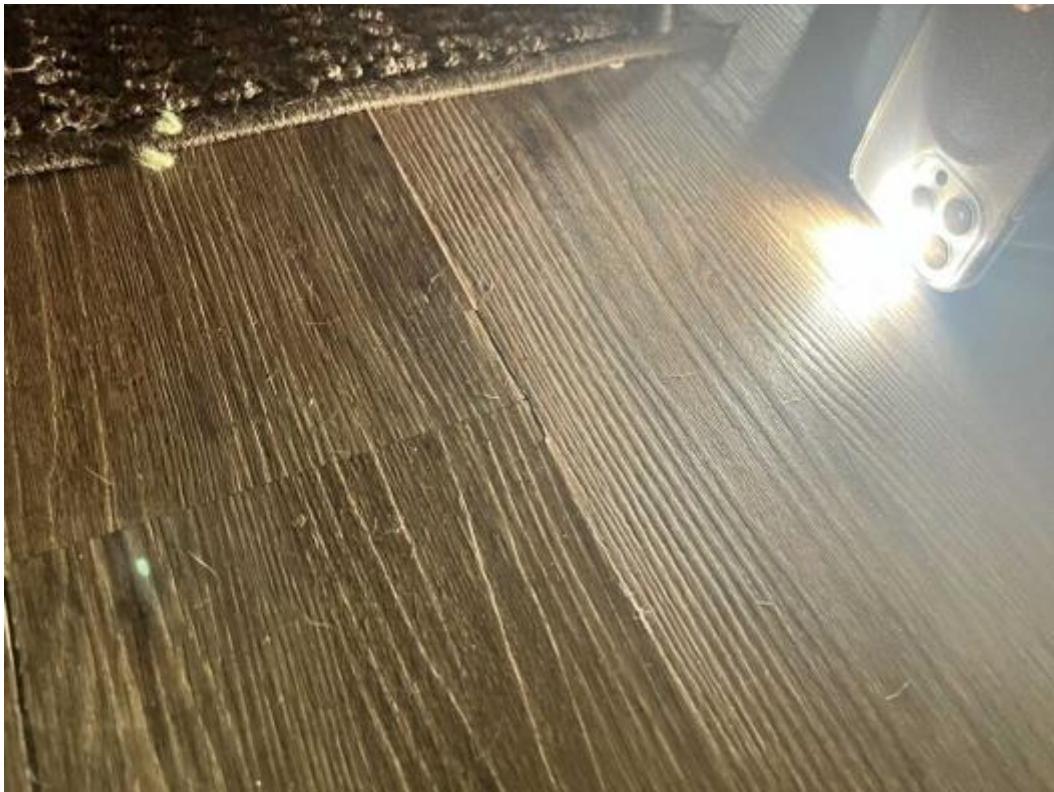
Main Level/Living Room - 27-living room

flood damage to living room floor

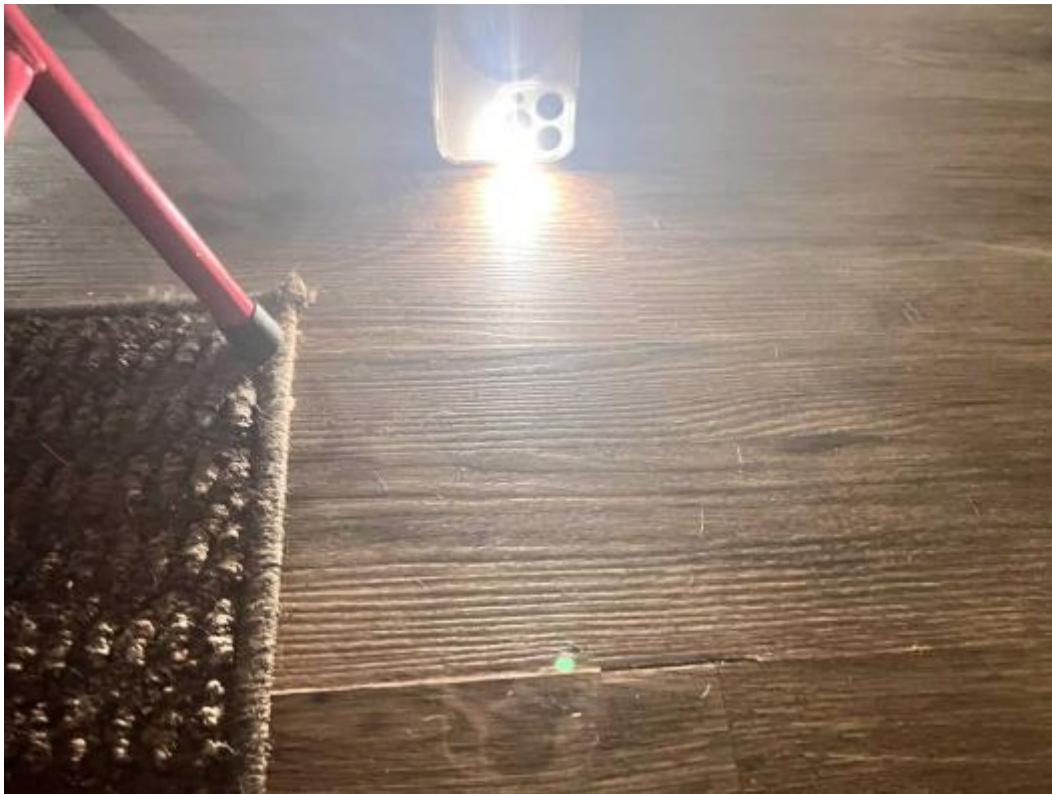
Main Level/Living Room - 29-living room

flood damage to living room floor

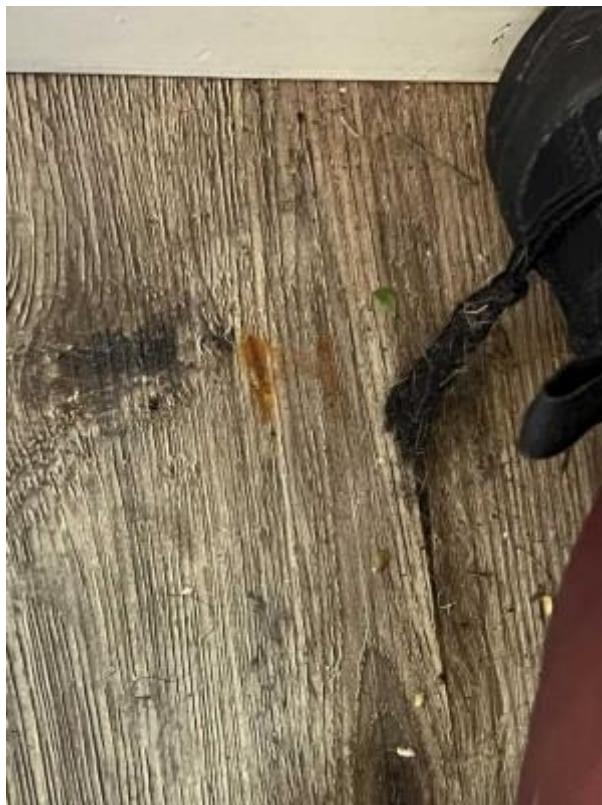
Main Level/Living Room - 30-living room

flood damage to living room floor

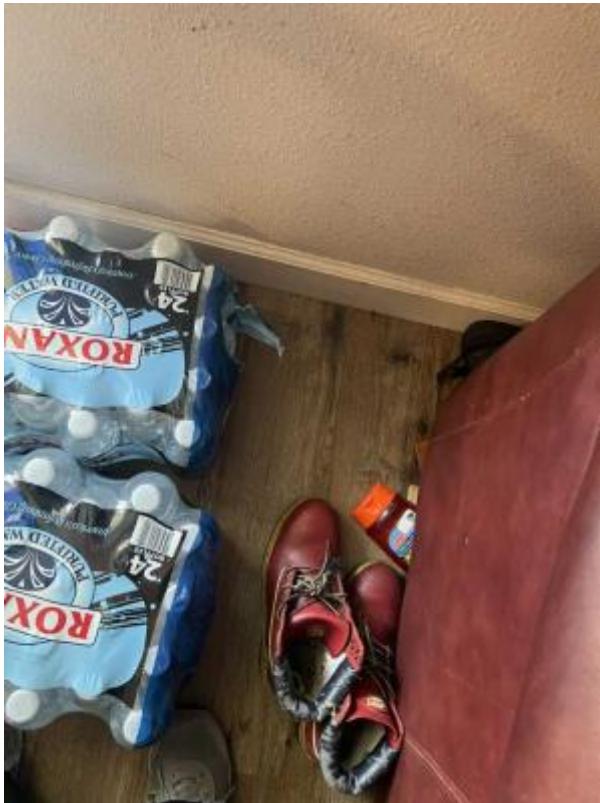
Main Level/Living Room - 31-living room

Taken By: Crystal Bryant
flood damage to living room floor

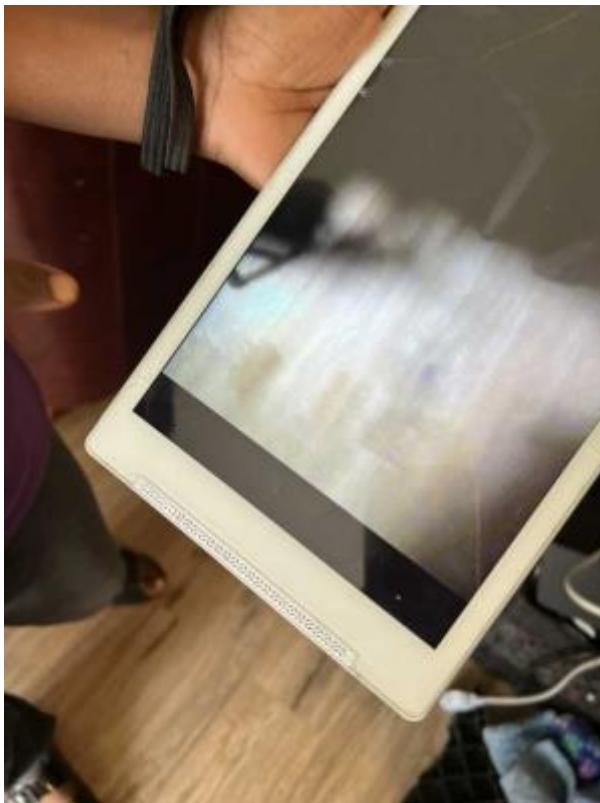
**Main Level/Living Room - 33-
living room**

screen shot of insured's tablet showing
flood water on living room floor

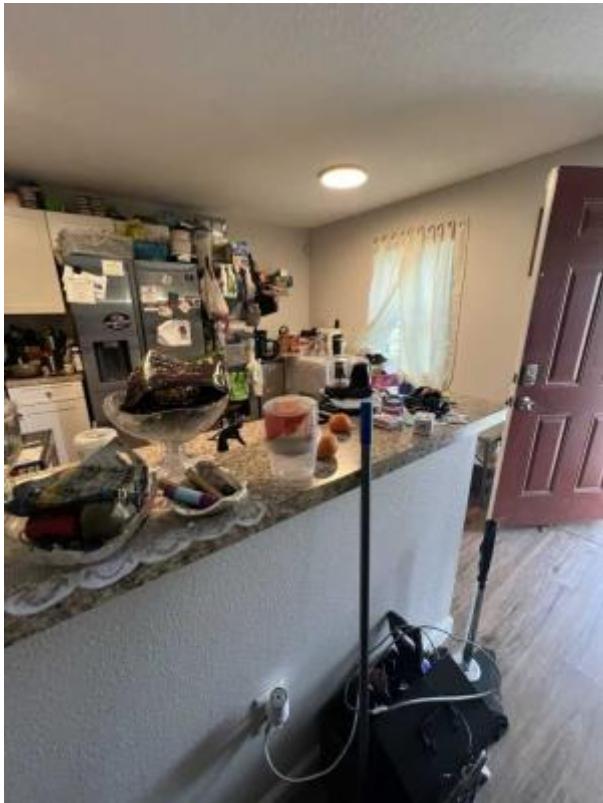
Main Level/Kitchen - 37-kitchen

overview of kitchen

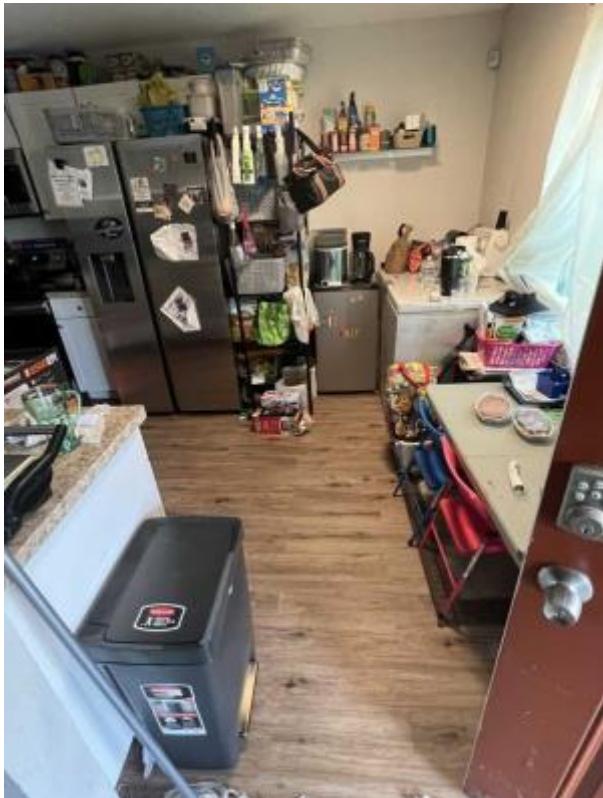
Main Level/Kitchen - 39-kitchen

overview of kitchen

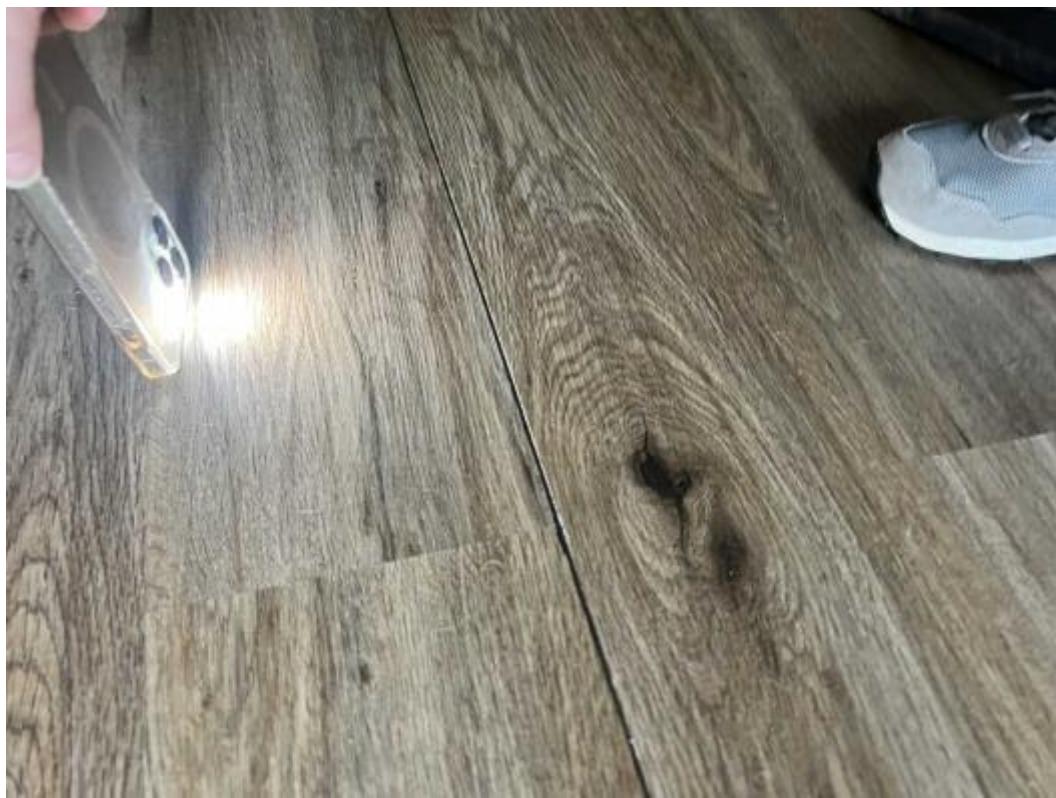
Main Level/Kitchen - 42-kitchen

flood damage to kitchen flooring

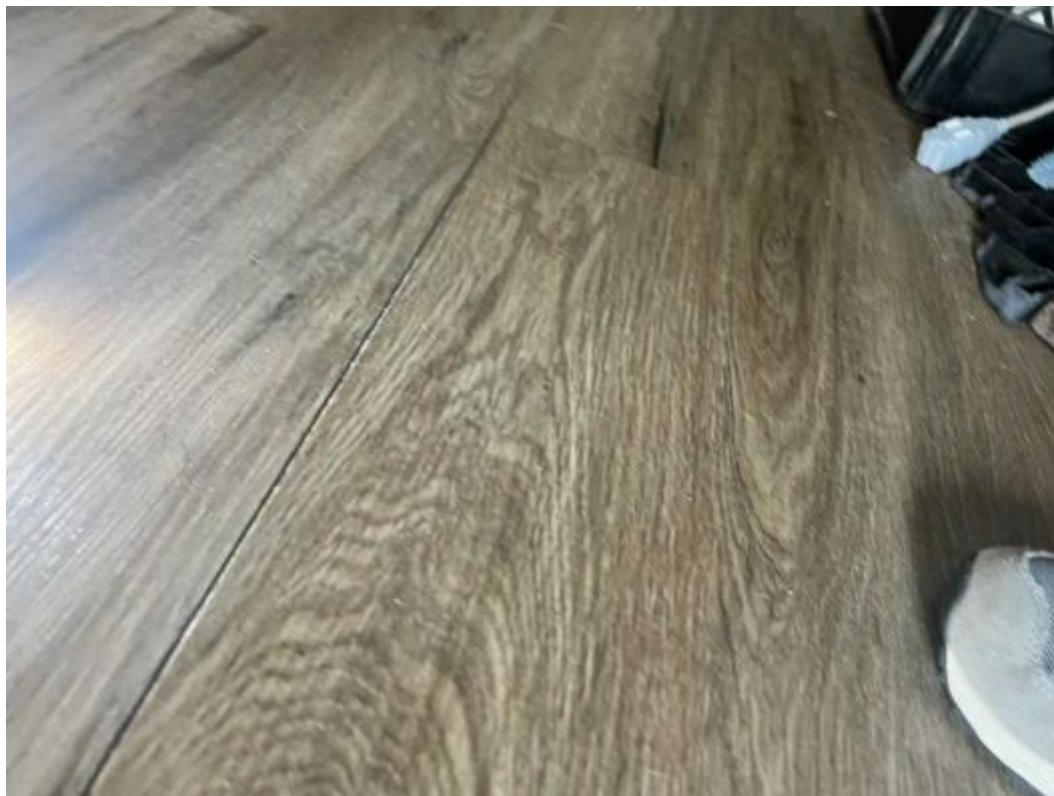
Main Level/Kitchen - 43-kitchen

flood damage to kitchen flooring

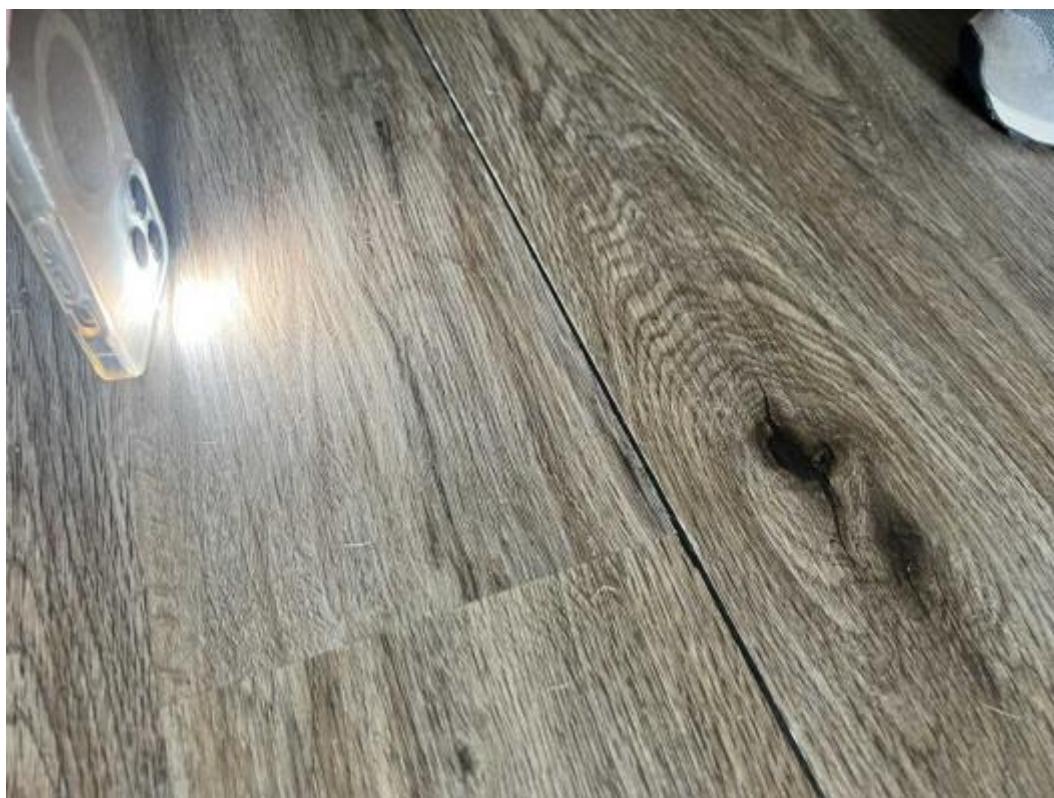
Main Level/Kitchen - 44-kitchen

flood damage to kitchen flooring

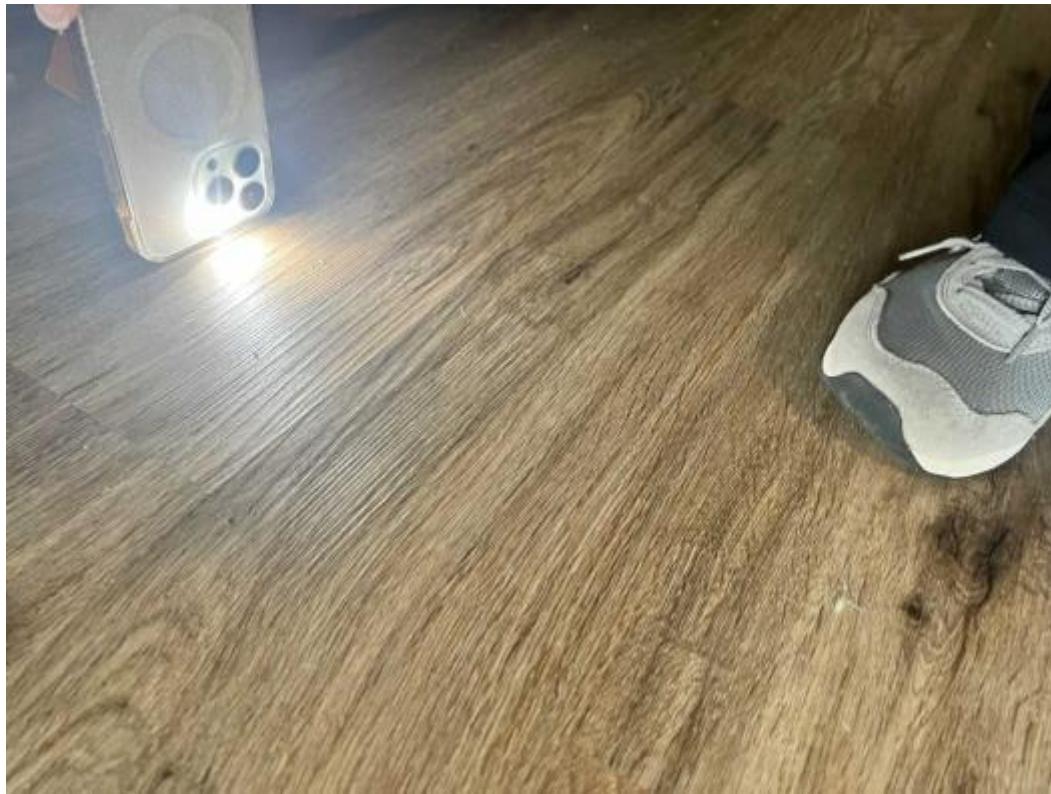
Main Level/Kitchen - 45-kitchen

flood damage to kitchen flooring

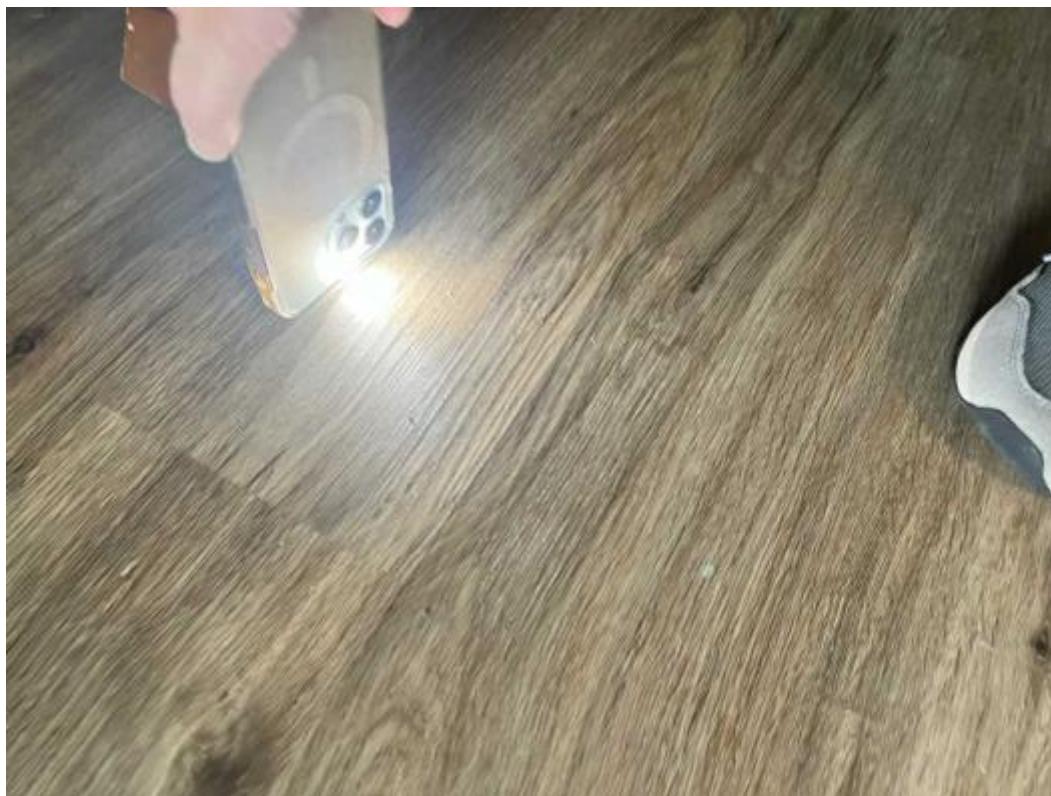
Main Level/Kitchen - 46-kitchen

flood damage to kitchen flooring

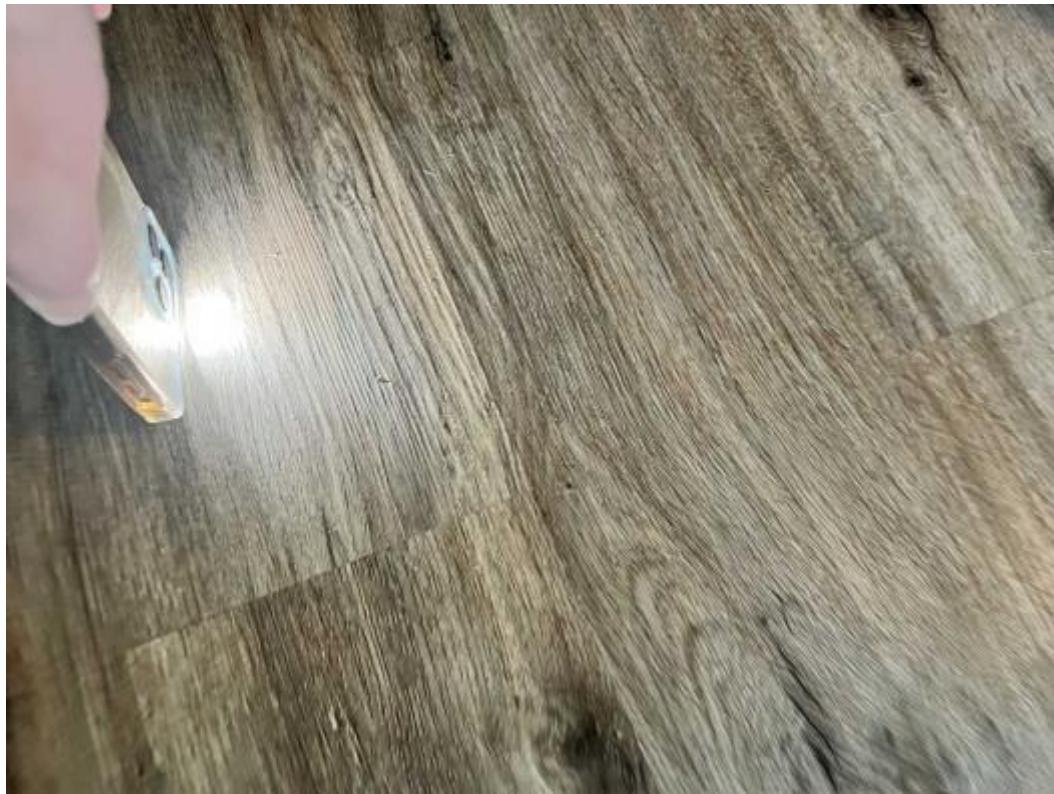
Main Level/Kitchen - 47-kitchen

flood damage to kitchen flooring

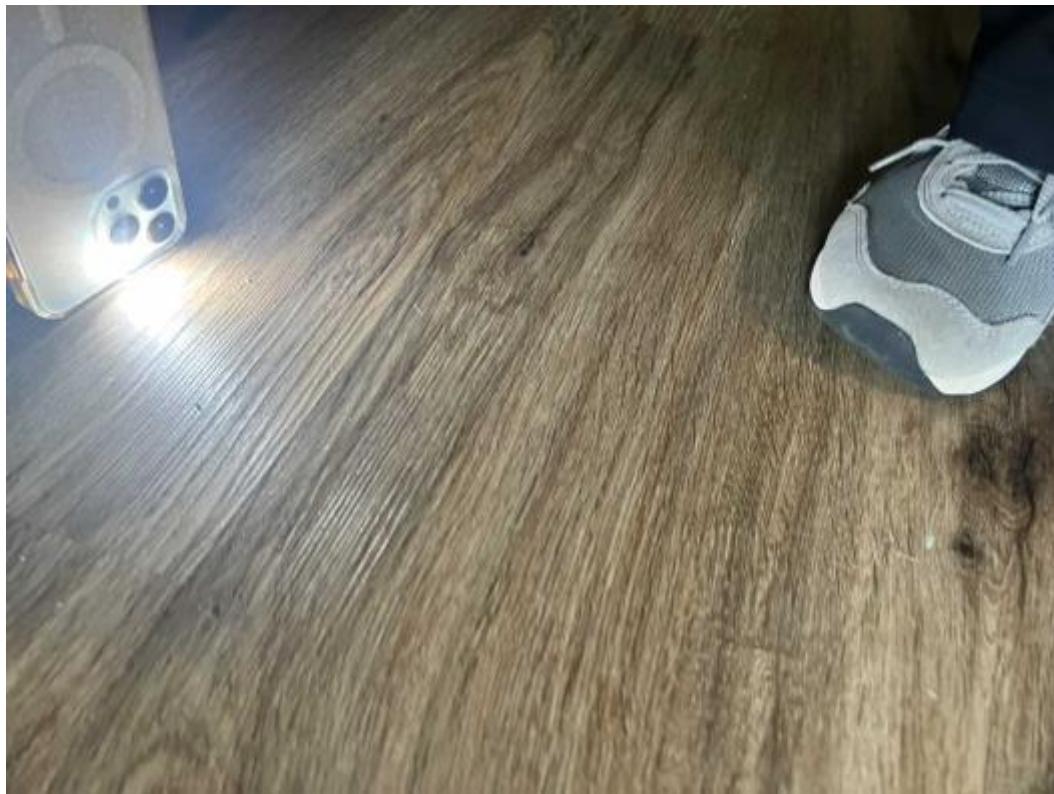
Main Level/Kitchen - 48-kitchen

flood damage to kitchen flooring

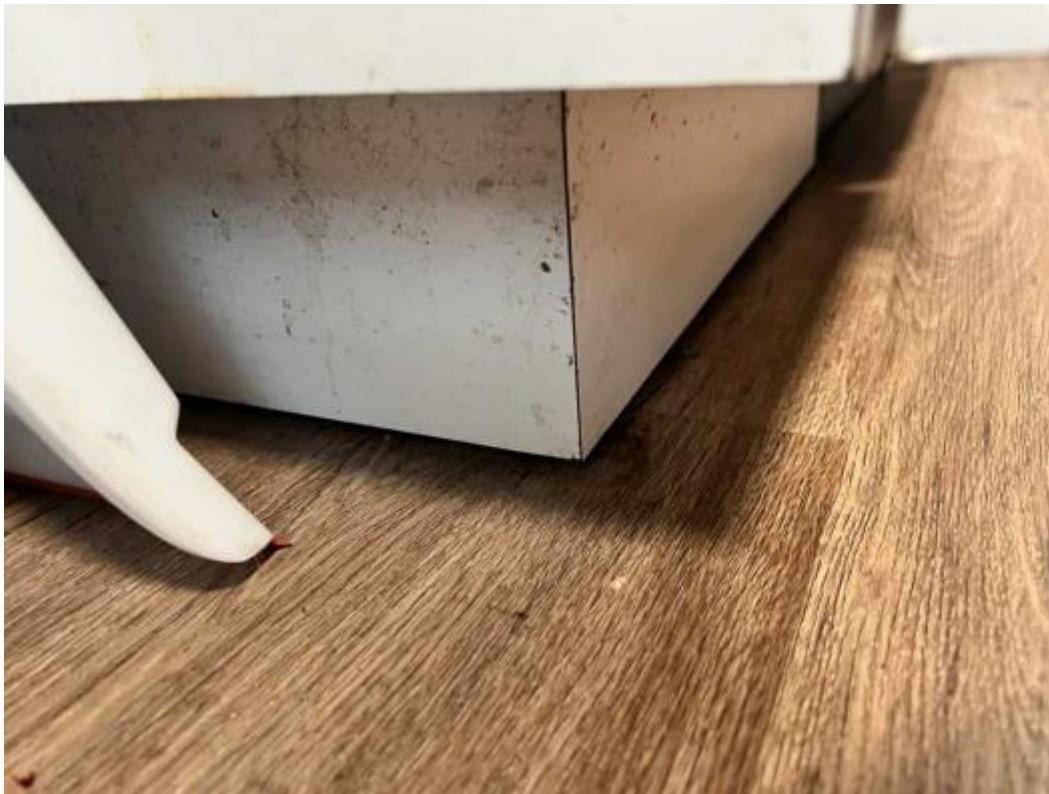
Main Level/Kitchen - 49-kitchen

flooring continues under kitchen cabinets

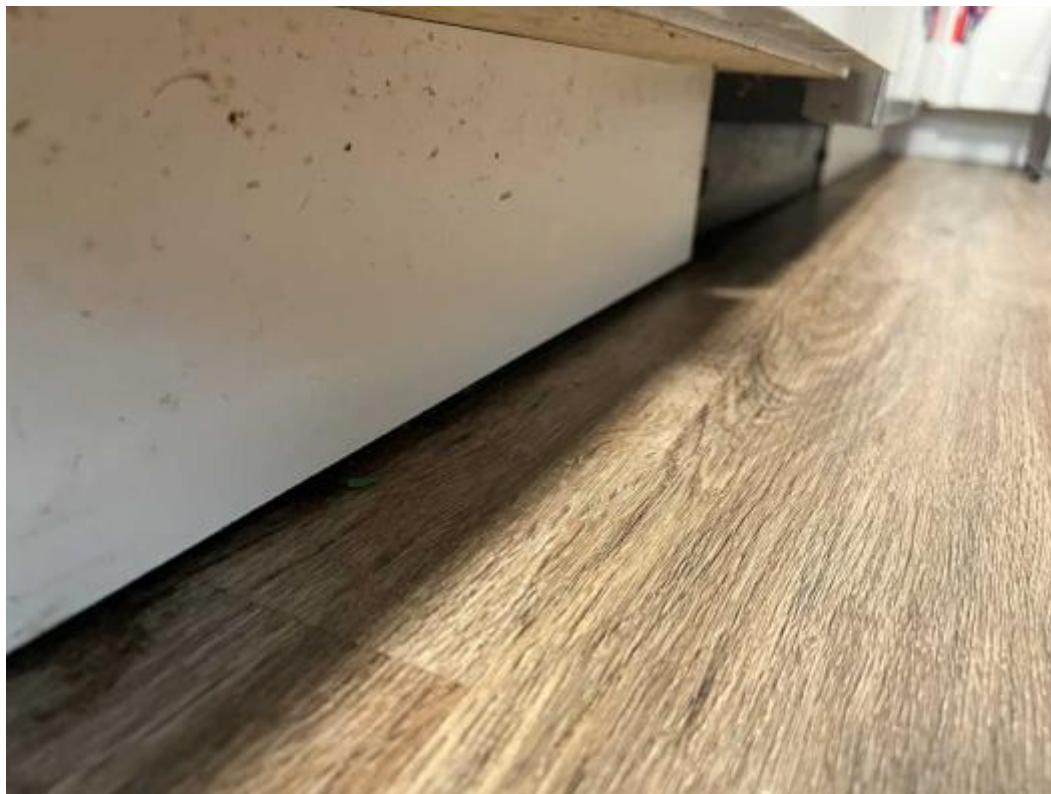
Main Level/Kitchen - 51-kitchen

flooring continues under kitchen cabinets

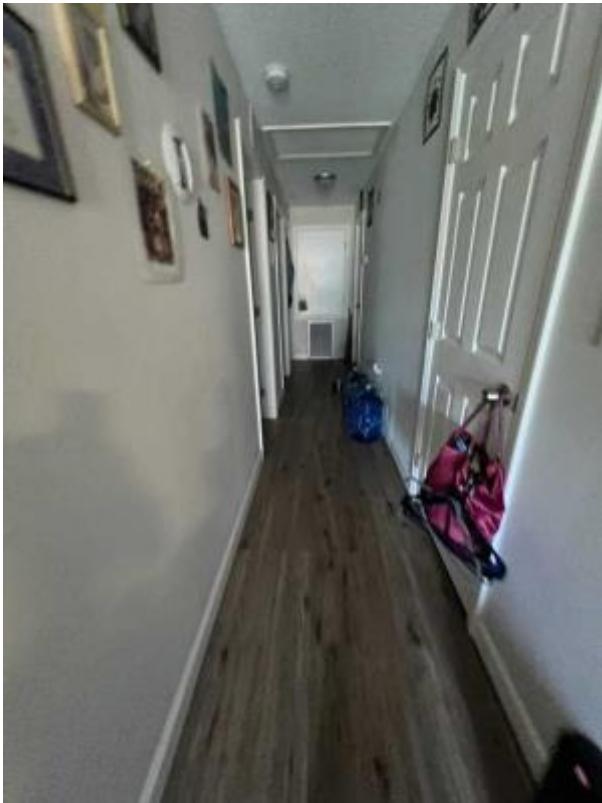
Main Level/Hallway - 53-hallway

overview of hallway

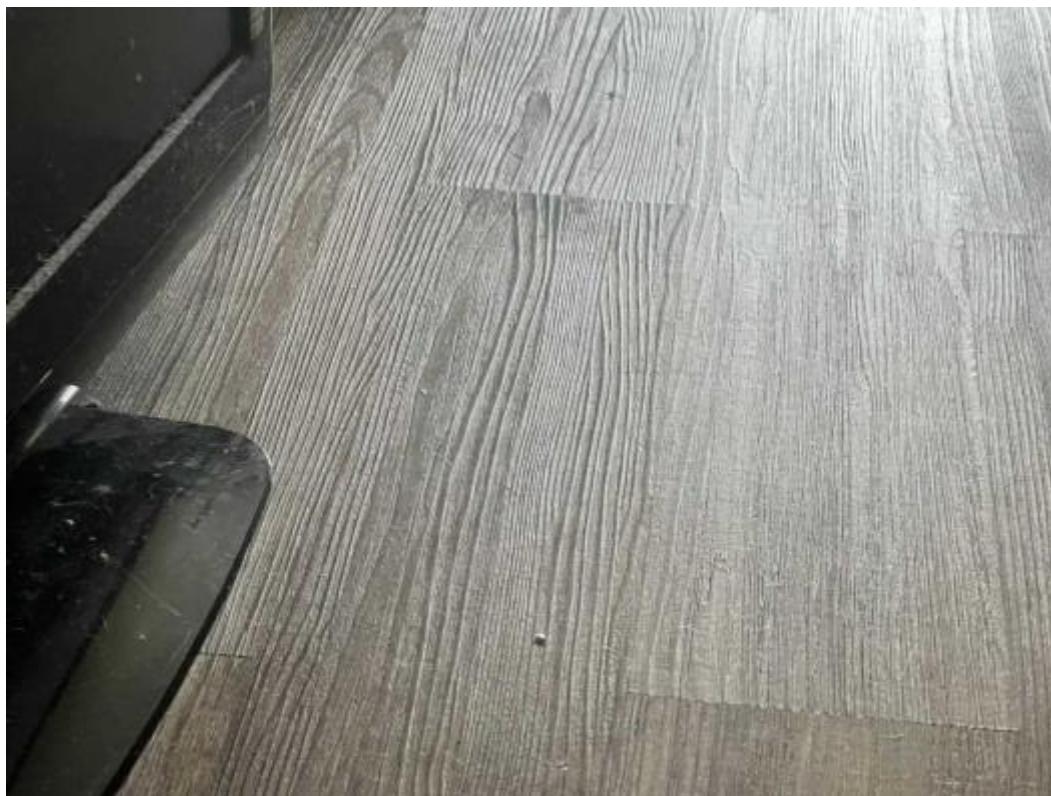
Main Level/Hallway - 56-hallway

flood damage to hallway flooring
