NARRATIVE REPORT

DWELLING / UNIT OWNER

Carrier:	American Bankers	Date of Loss:	10/10/2024
Insured:	PATRA BROWN	Assigned:	12/10/2024
CID:	243608	Contacted:	12/10/2024
Claim Number:	7406051373-10102024	Inspected:	11/2/2024
Policy Number:	7406051373	Inspected With:	Patra Brown
Loss Address:	701 W MADISON ST PLANT CITY FL 33563	Mailing Address:	701 W MADISON ST PLANT CITY FL 33563
Coverage A:	\$ 170,000.00	Mortgage:	M&T Bank
Coverage B:	\$ 40,000.00	Verified with:	Patra Brown
Policy Term:	11/30/2023 to 11/30/2024

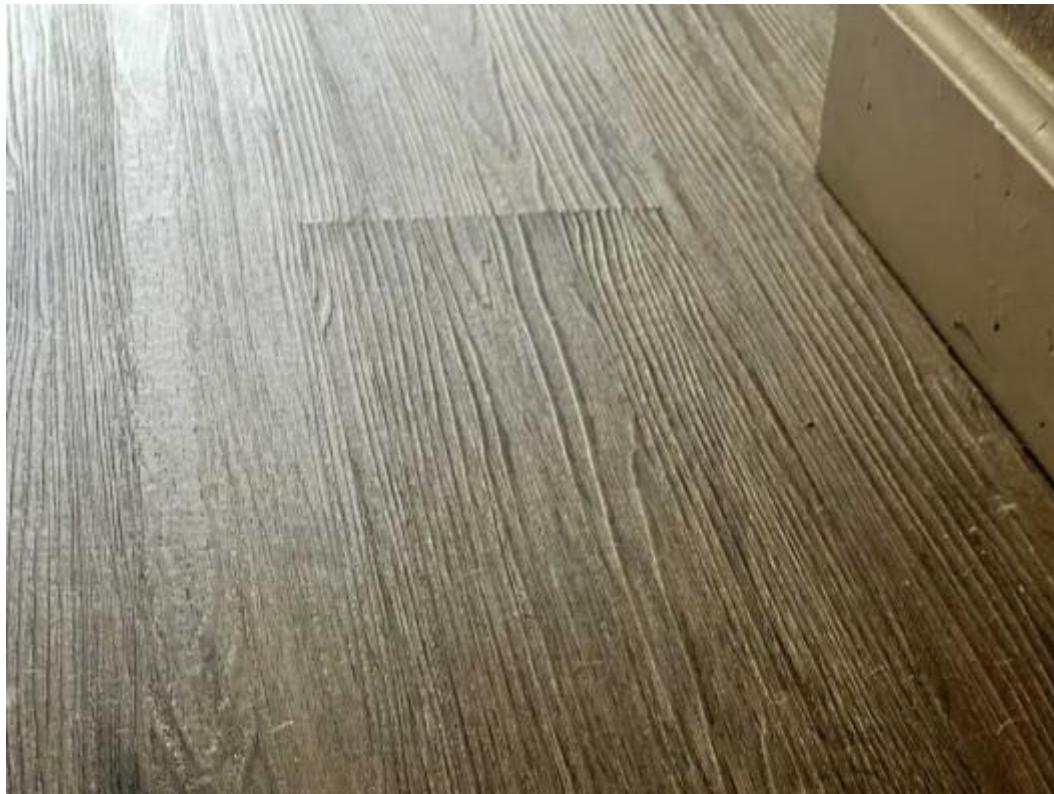
Main Level/Hallway - 57-hallway

flood damage to hallway flooring

- Structural drying
- Flood loss clean up
- Replace laminate flooring in living room, kitchen, hallway, hall bath, and bedroom 2
- Replace baseboards in affected rooms
- Replace front door
- Paint wall covering
- Detach & Reset kitchen lower cabinets as flooring continues beneath them

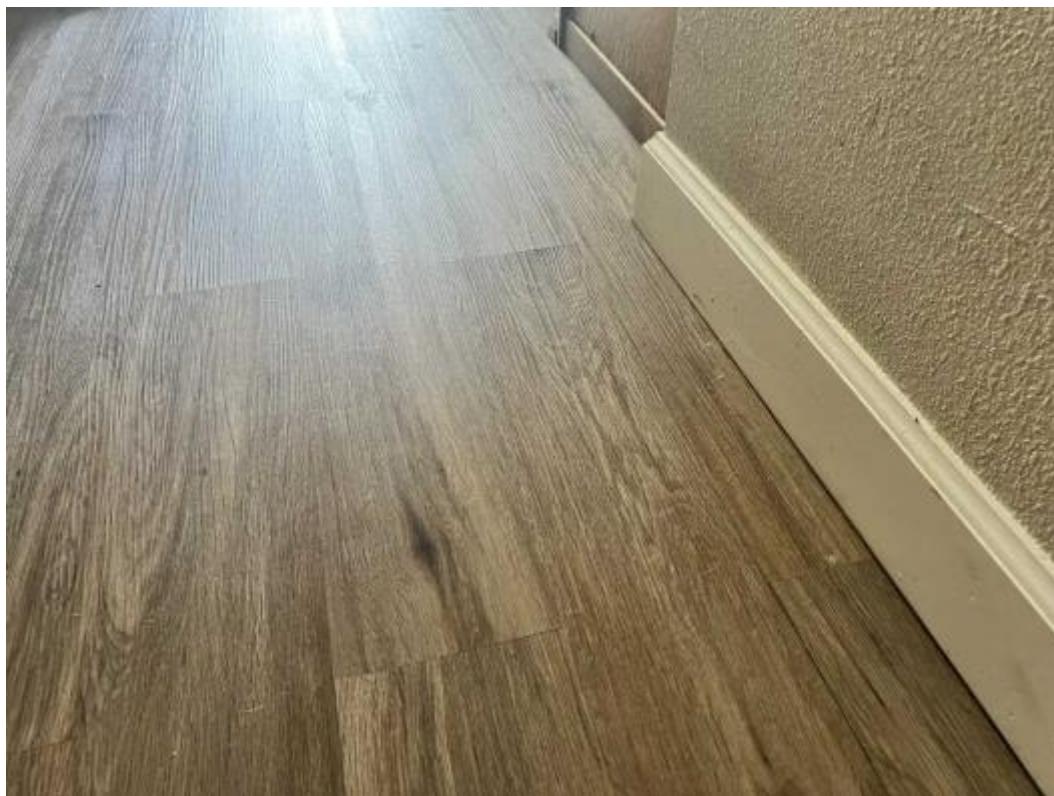
Main Level/Hallway - 58-hallway

flood damage to hallway flooring

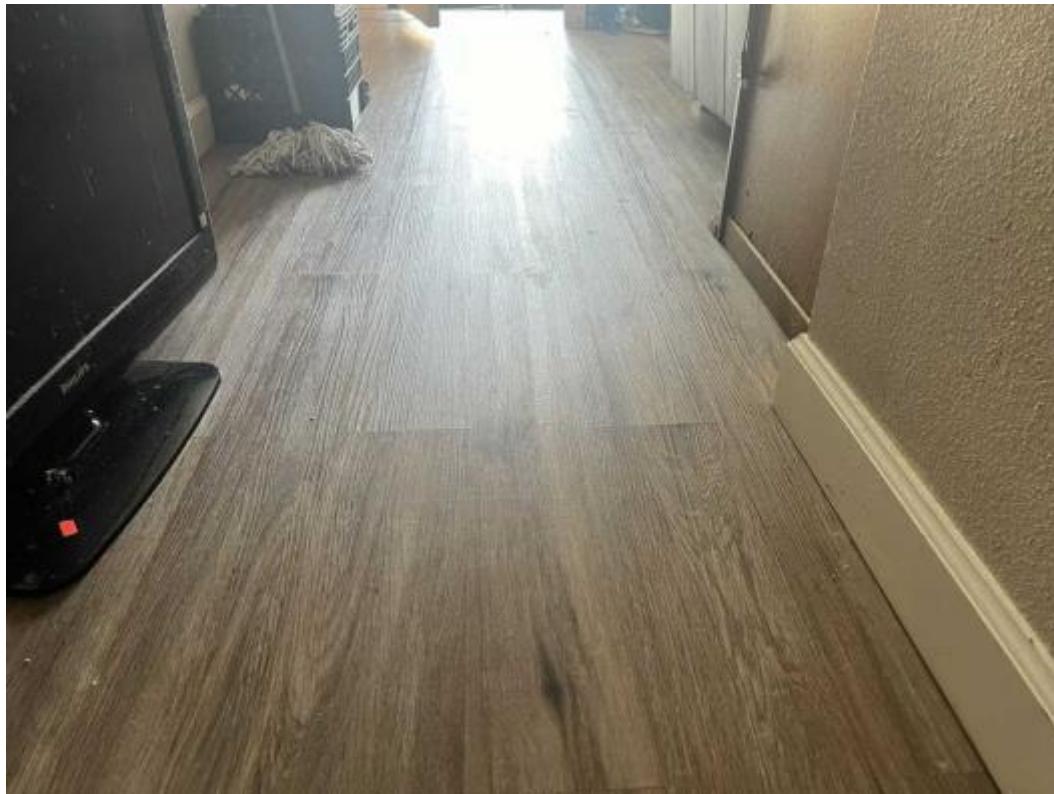
Main Level/Hallway - 59-hallway

flood damage to hallway flooring

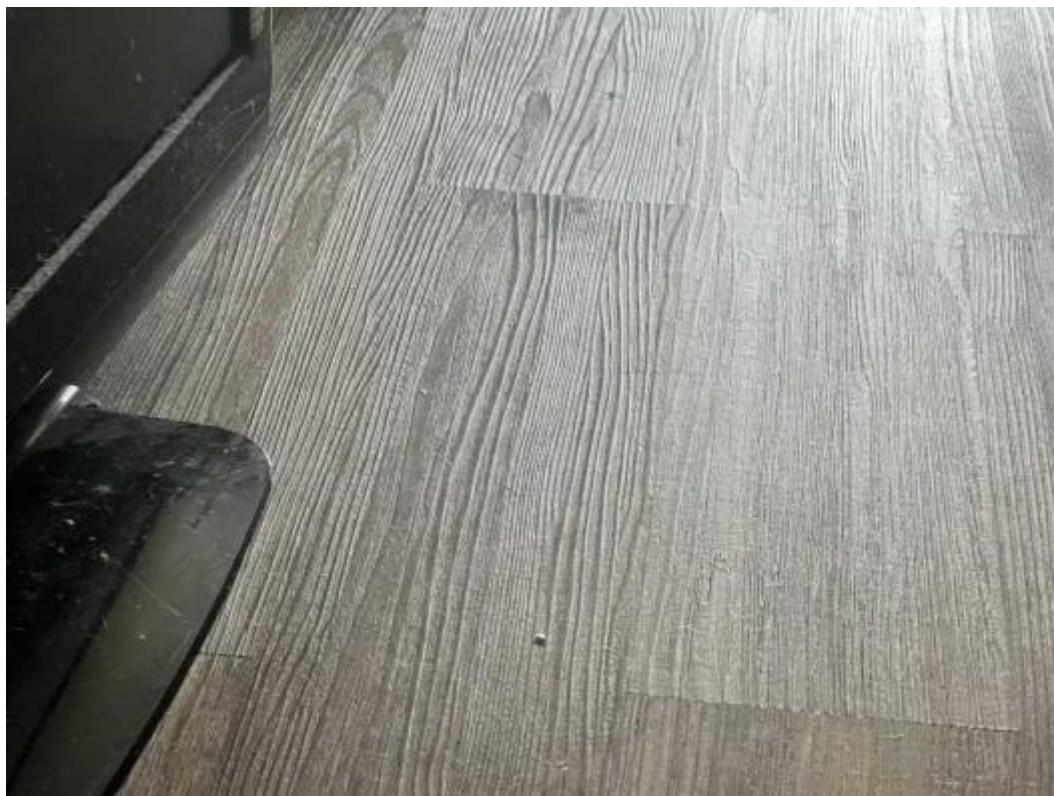
Main Level/Hallway - 60-hallway

flood damage to hallway flooring

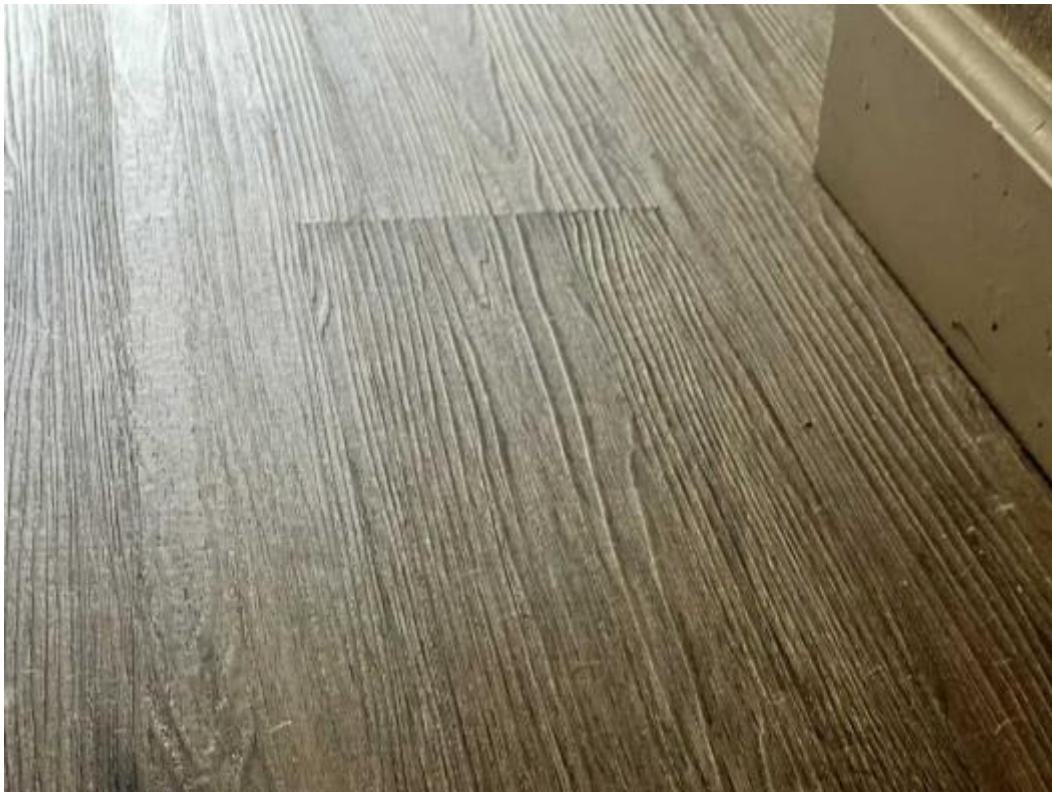
Main Level/Hallway - 61-hallway

flood damage to hallway flooring

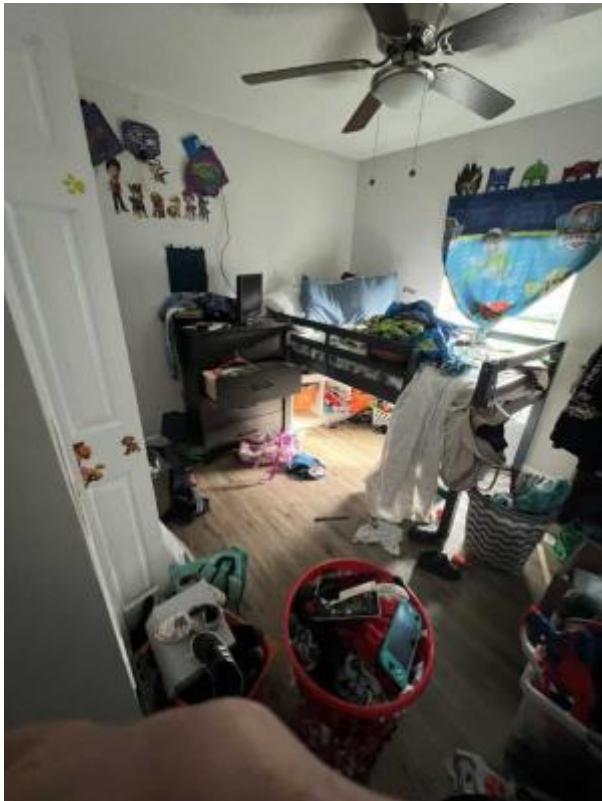
Main Level/Bedroom 2 - 65-bedroom 2

hallway flooring is continuous into the bedroom

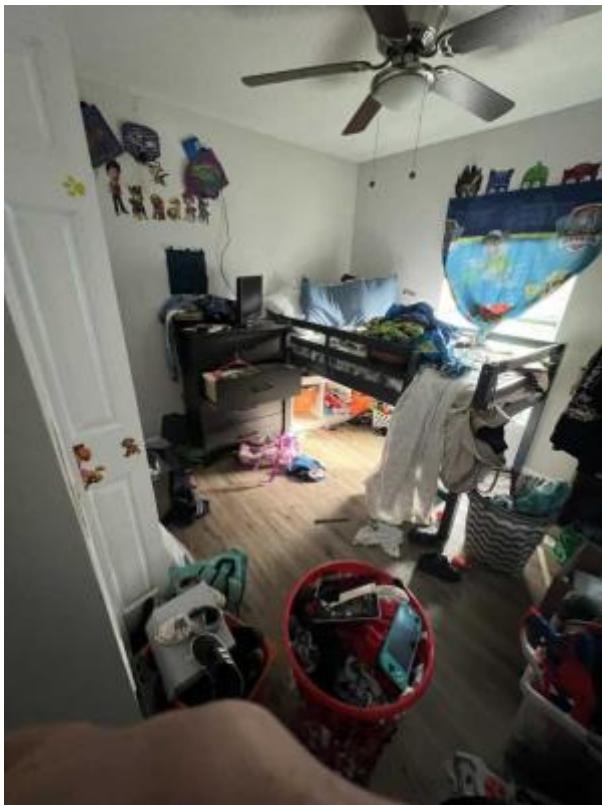
Main Level/Bedroom 2 - 67-bedroom 2

hallway flooring is continuous into the bedroom

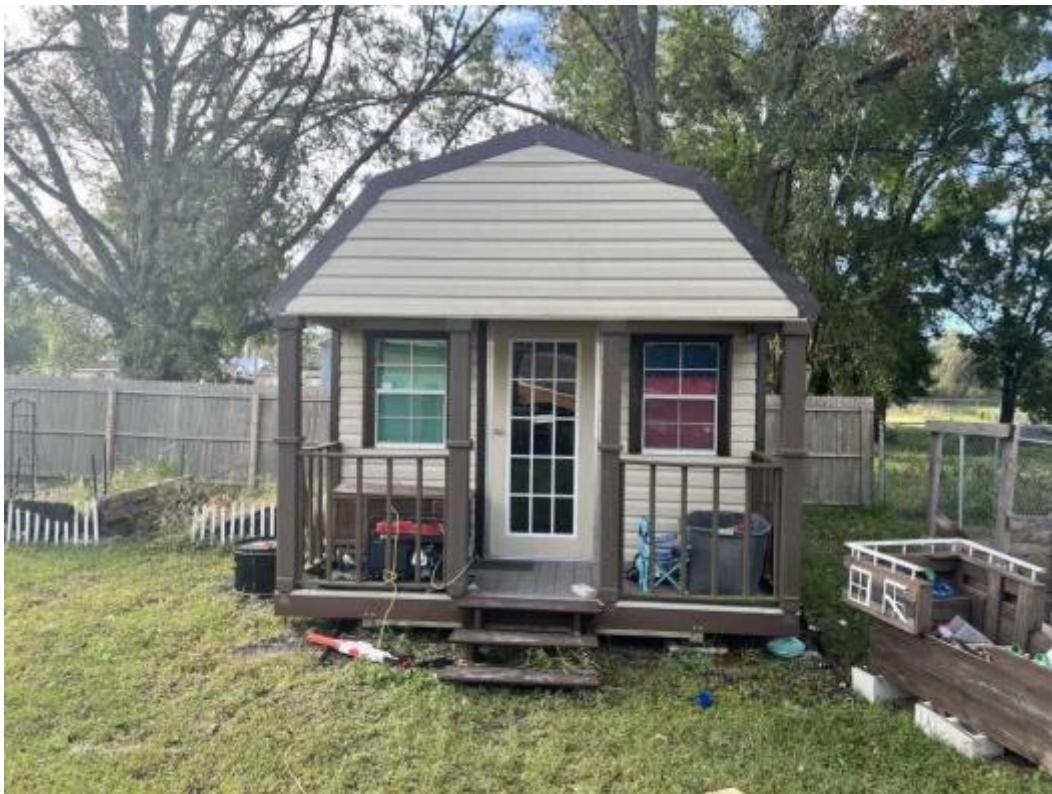
Shed - 68-shed

overview of shed, no damage reported to contents within shed

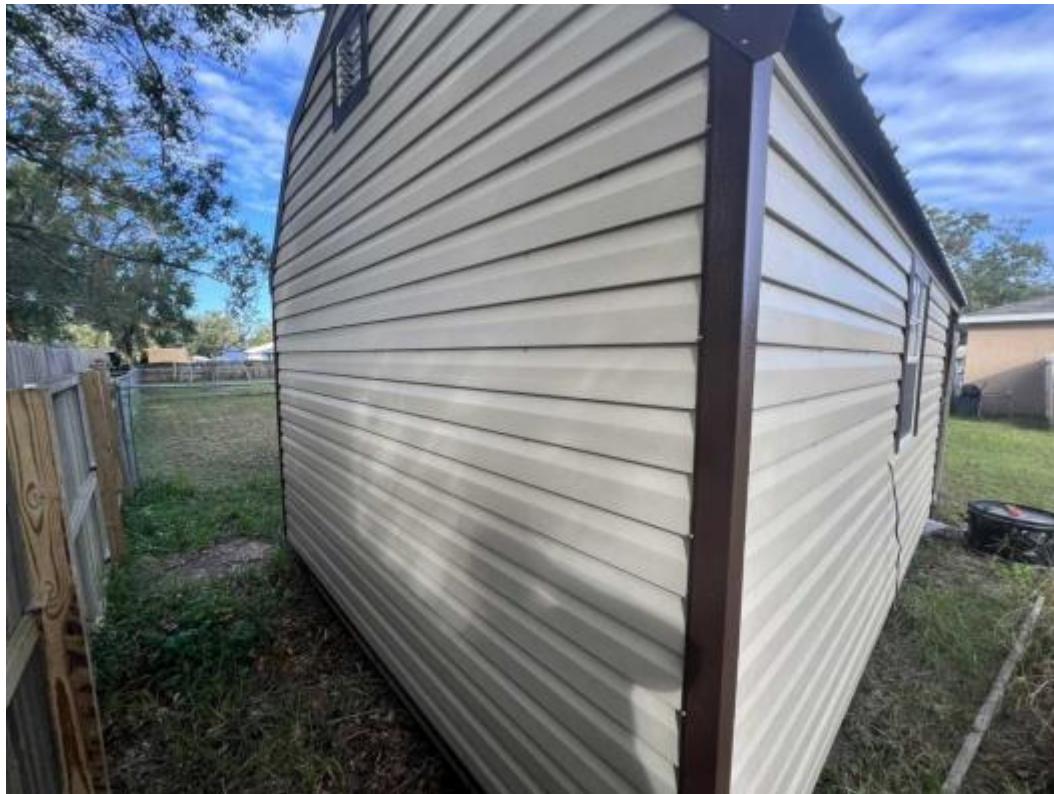
Shed - 69-shed

overview of shed, no damage reported to contents within shed

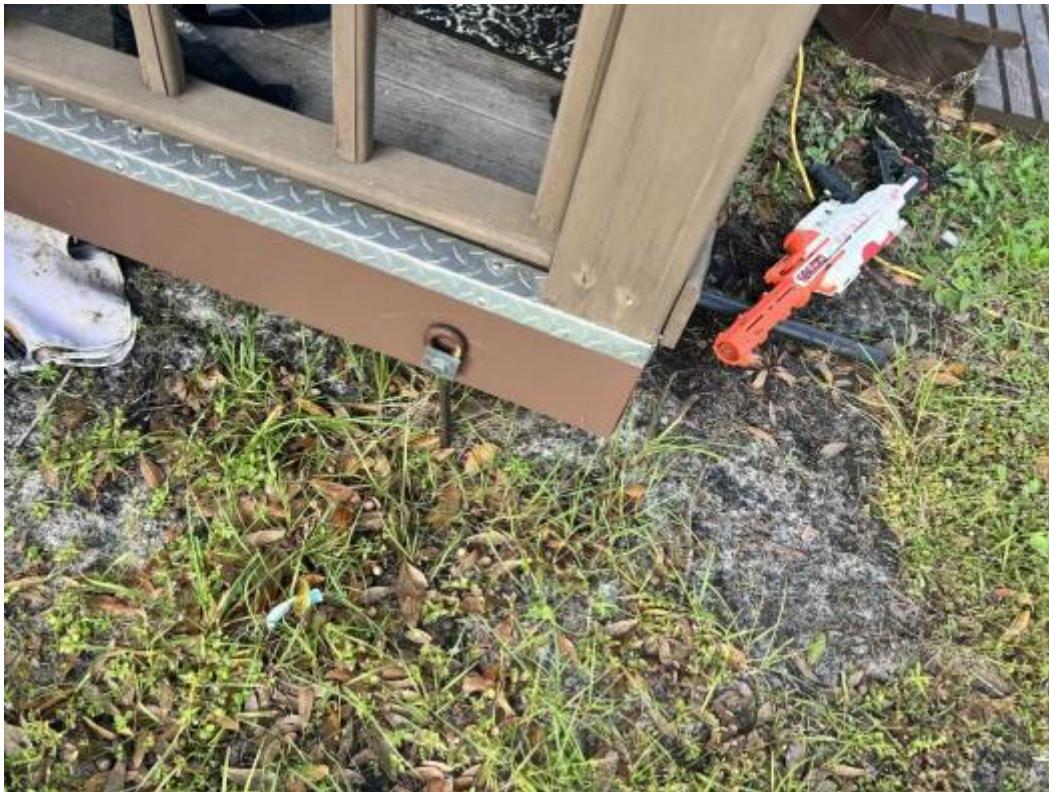
Shed - 71-shed

overview of shed ground anchors
