NARRATIVE REPORT

DWELLING / UNIT OWNER

Carrier:	Hartford Fire Insurance Company	Date of Loss:	9/26/2024
Insured:	GUY/CHERYL CARPENTER	Assigned:	9/27/2024
CID:	237149	Contacted:	9/29/2024
Claim Number:	547762	Inspected:	10/1/2024
Policy Number:	6500357167	Inspected With:	Mr. and. Ms. Carpenter
Loss Address:	2808 SHANNON DR PUNTA GORDA FL 33950-2319	Mailing Address:	2808 SHANNON DR PUNTA GORDA FL 33950-2319
Coverage A:	\$ 217,000.00	Mortgage:	FIRST FLORIDA CREDIT UNION
Coverage B:	\$ 100,000.00	Verified with:	POLICYHOLDERS
Policy Term:	7/6/2024 to 7/6/2025

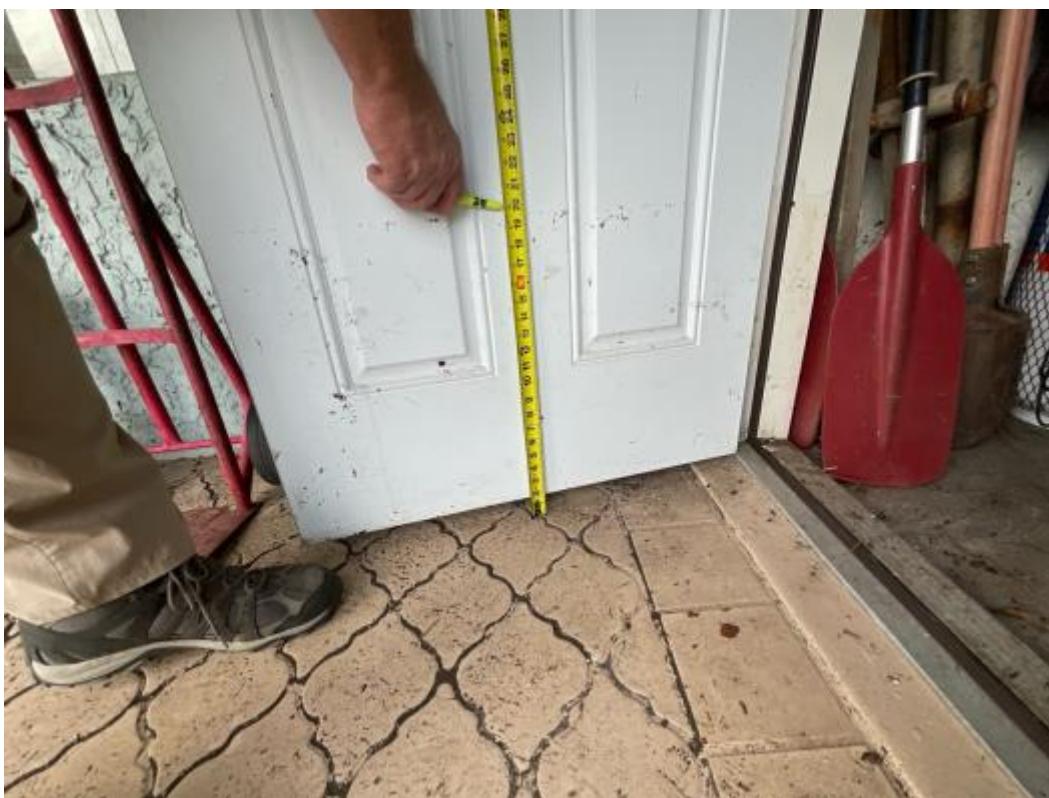
375-Exterior Water Line 20"

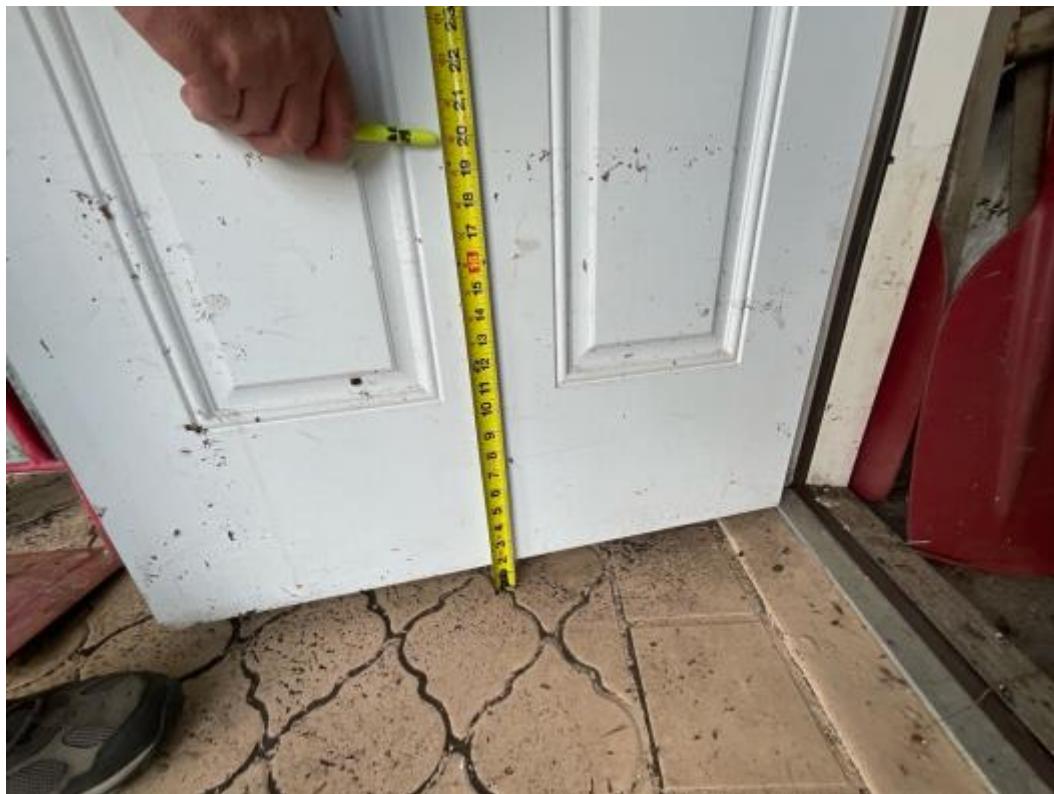
376-Exterior Water Line 20"

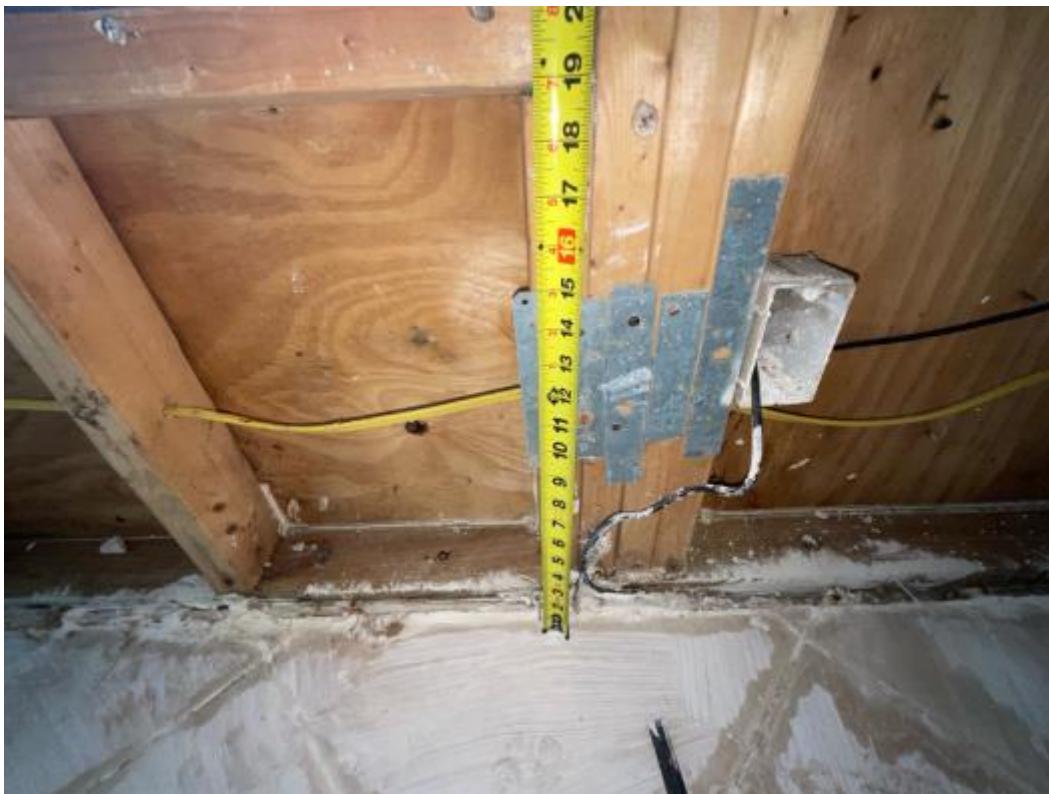
380-Interior Water Line 10"

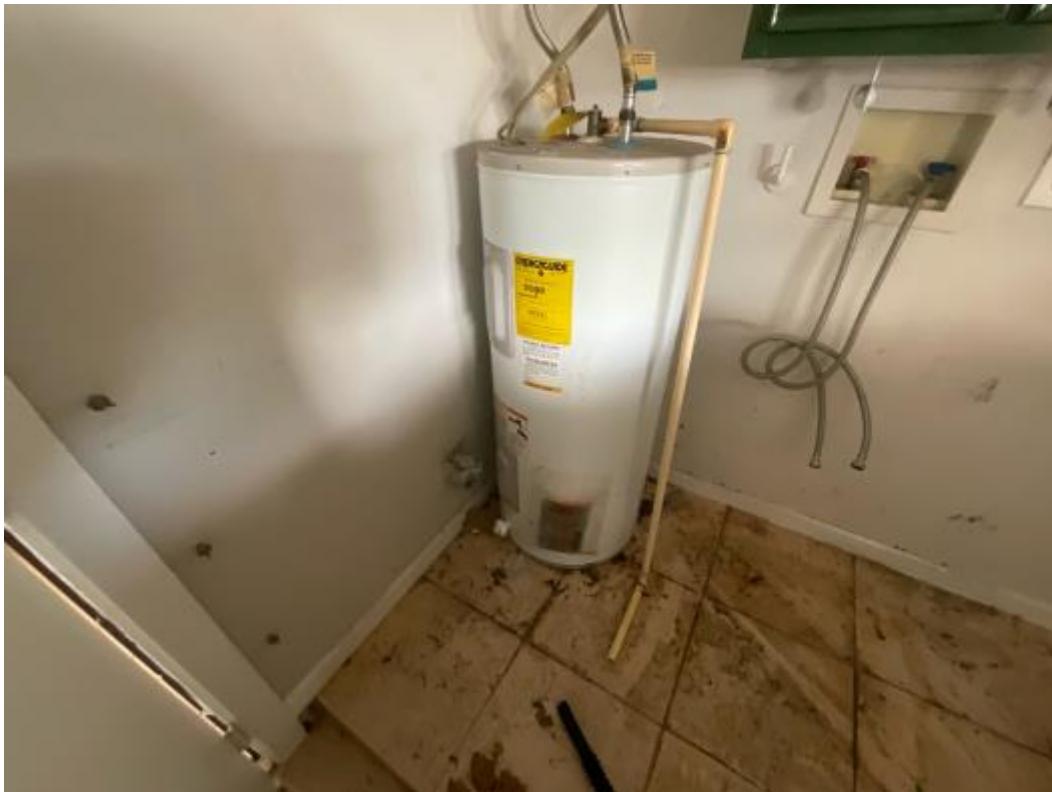
404-Garage

Hot water tank
