NARRATIVE REPORT

DWELLING / UNIT OWNER

Carrier:	Hartford Fire Insurance Company	Date of Loss:	9/26/2024
Insured:	ANNA CABANA I LLC	Assigned:	10/1/2024
CID:	239582	Contacted:	10/10/2024
Claim Number:	556903	Inspected:	10/16/2024
Policy Number:	6500384948	Inspected With:	Garrett Yankee
Loss Address:	3711 4TH AVE HOLMES BEACH FL 34217-1995	Mailing Address:	17092 SMOKEY HOLLOW RD TRAVERSE CITY MI 49686
Coverage A:	\$ 250,000.00	Mortgage:	None
Coverage B:	\$ 30,000.00	Verified with:	Barbara Yankee
Policy Term:	9/21/2024 to 9/21/2025

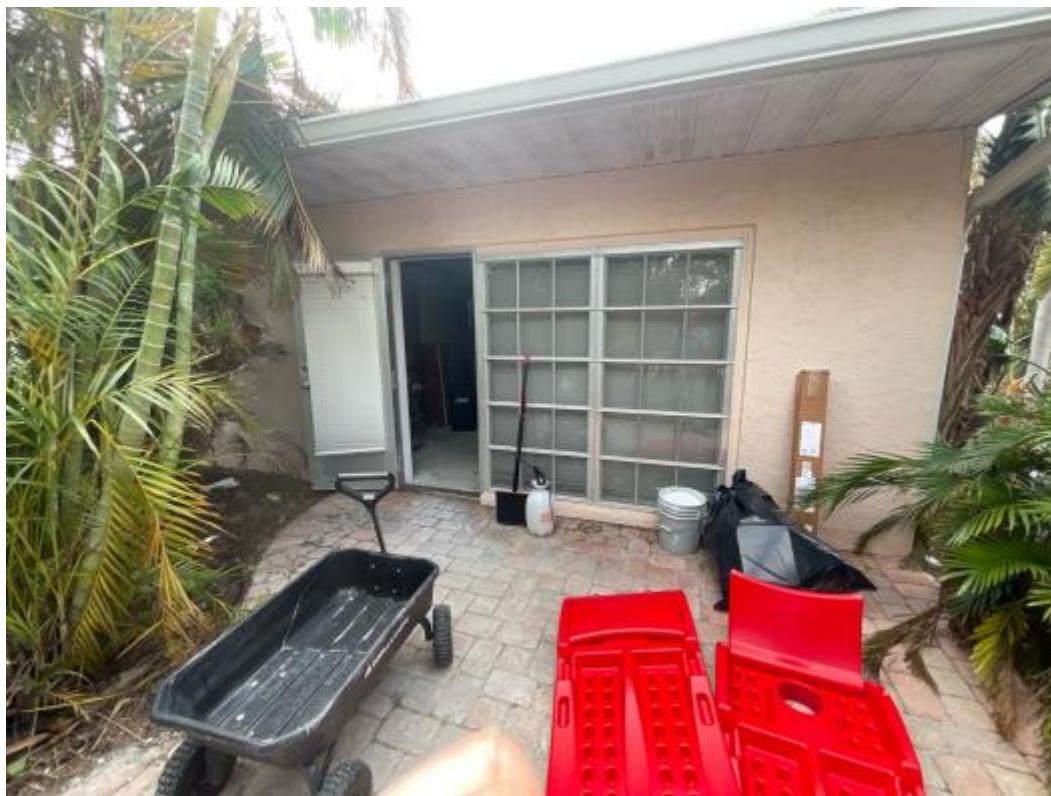
SKETCH1/Exterior/Ext_Surfaces - 4-

Front

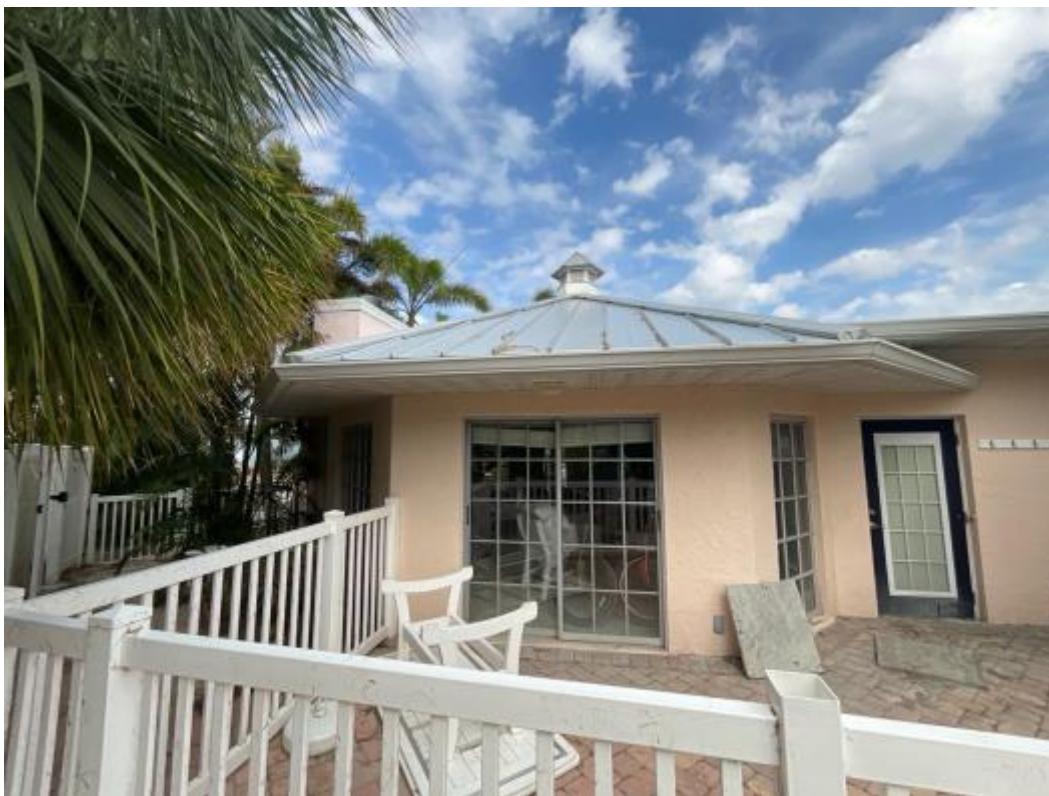
SKETCH1/Exterior/Ext_Surfaces - 8-

Rear Overview

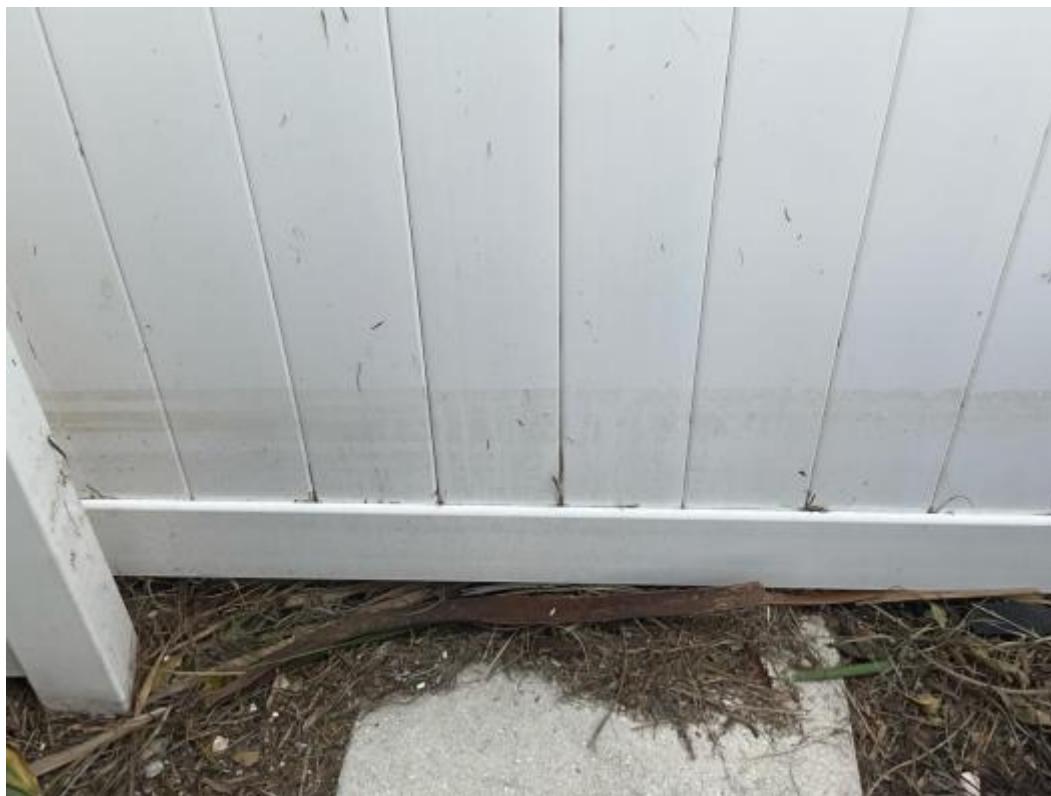
SKETCH1/Exterior/Ext_Surfaces - 12-

External Water Line 14"

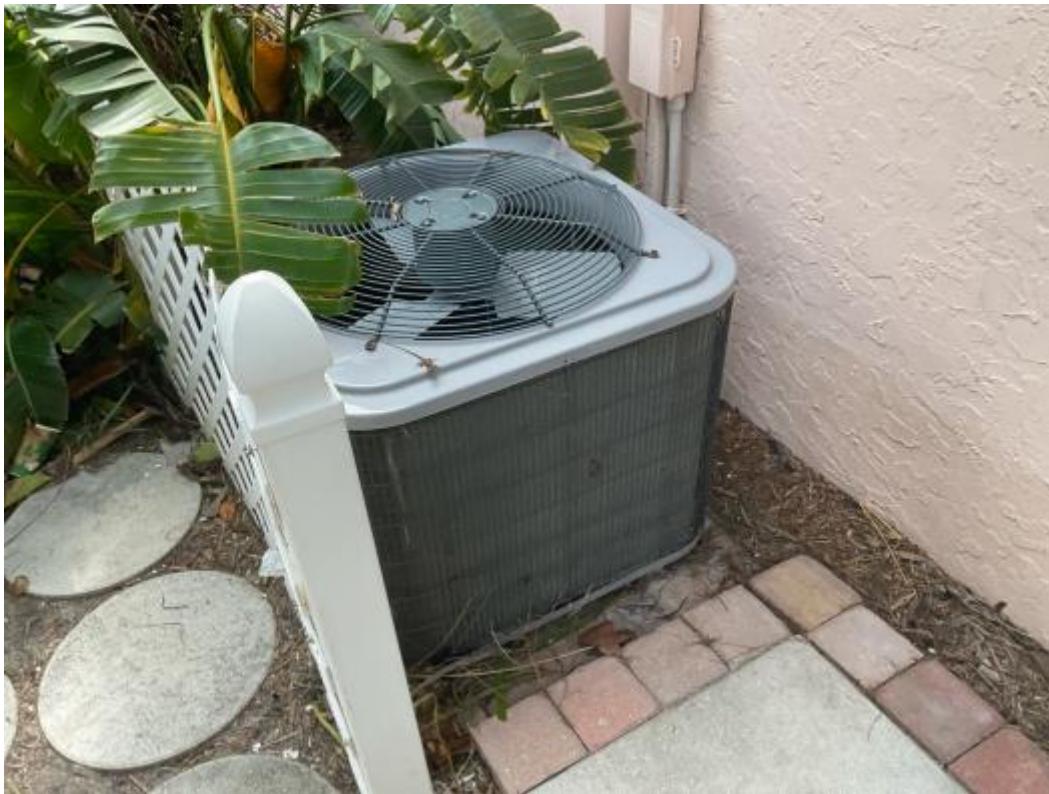
SKETCH1/Exterior/Ext_Surfaces - 13-

Taken By: David Bumpers
HVAC 1

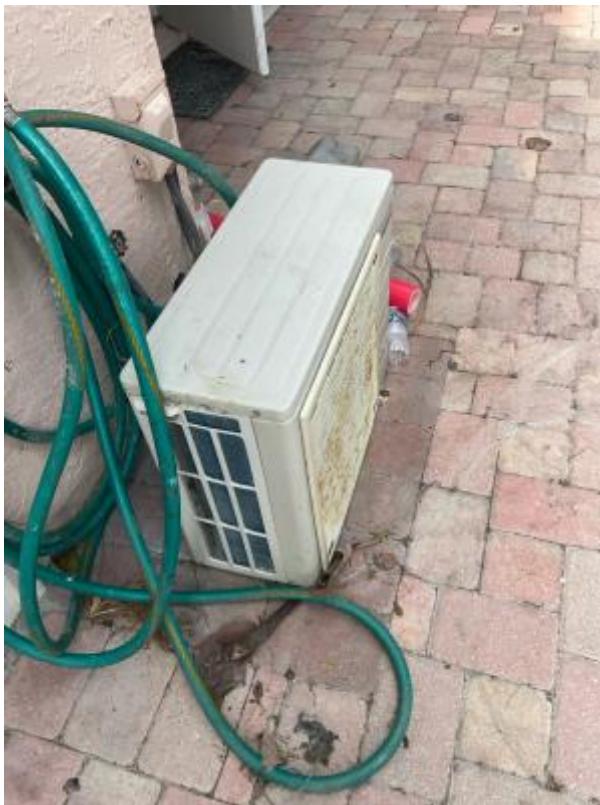
SKETCH1/Exterior/Ext_Surfaces - 15-

Taken By: David Bumpers
HVAC 2

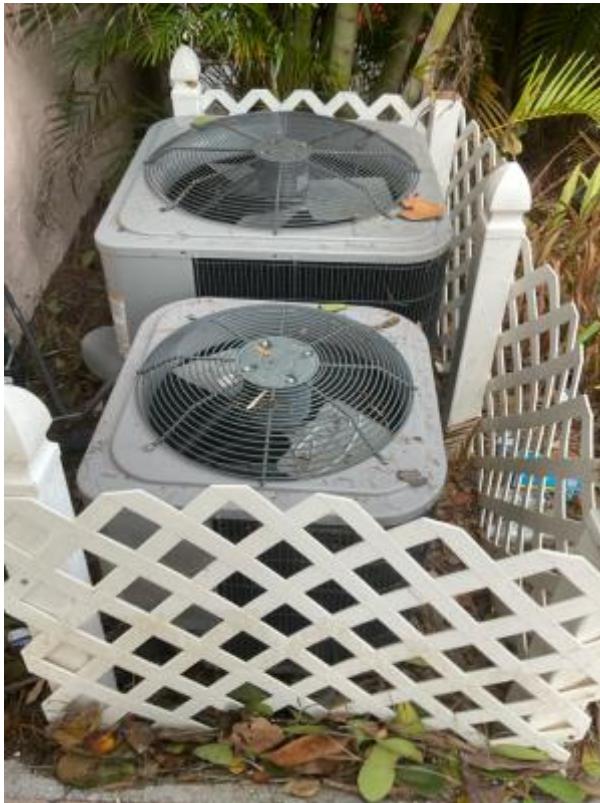
SKETCH1/Exterior/Ext_Surfaces - 17-

Taken By: David Bumpers
HVAC 3&4

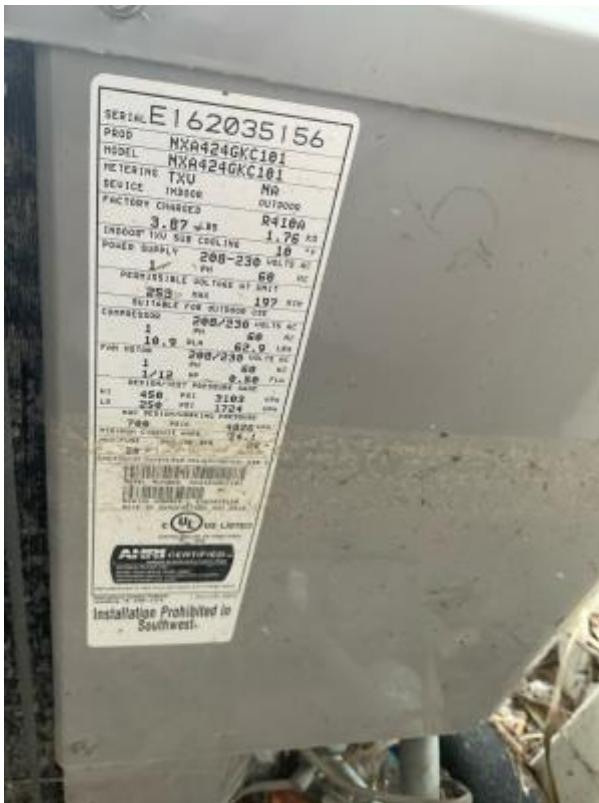
SKETCH1/Exterior/Ext_Surfaces - 19-

Model NXA424GKC101
Serial E162035156

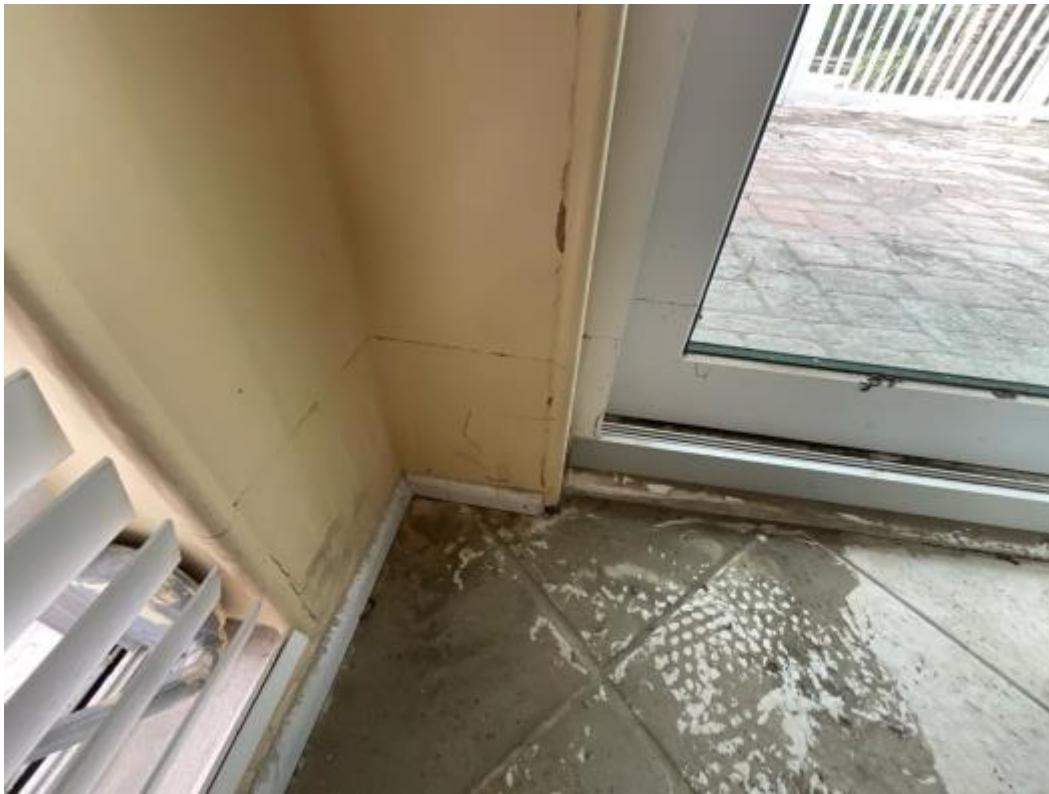
**SKETCH1/Main Level/Sunroom
one - 29-**

Window Crank Below Waterline

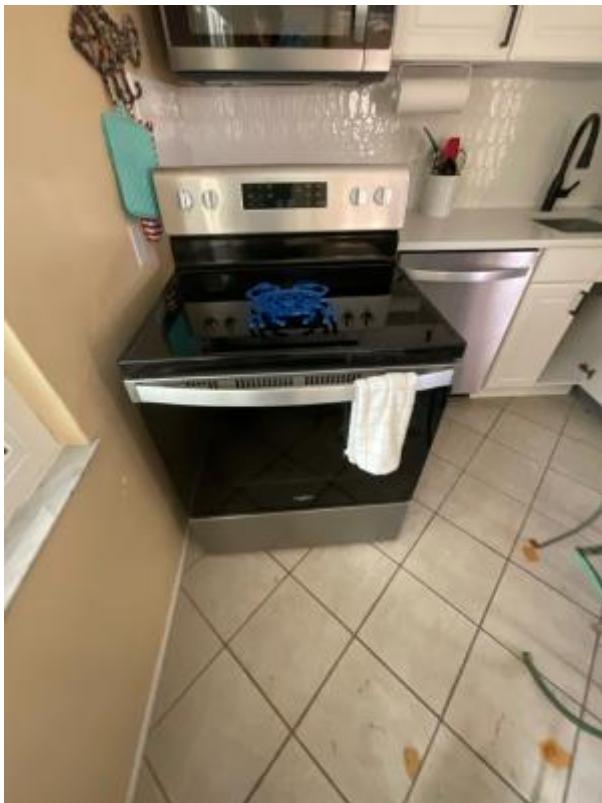
SKETCH1/Main Level/Kitchen One - 37-

Taken By: David Bumpers
Range

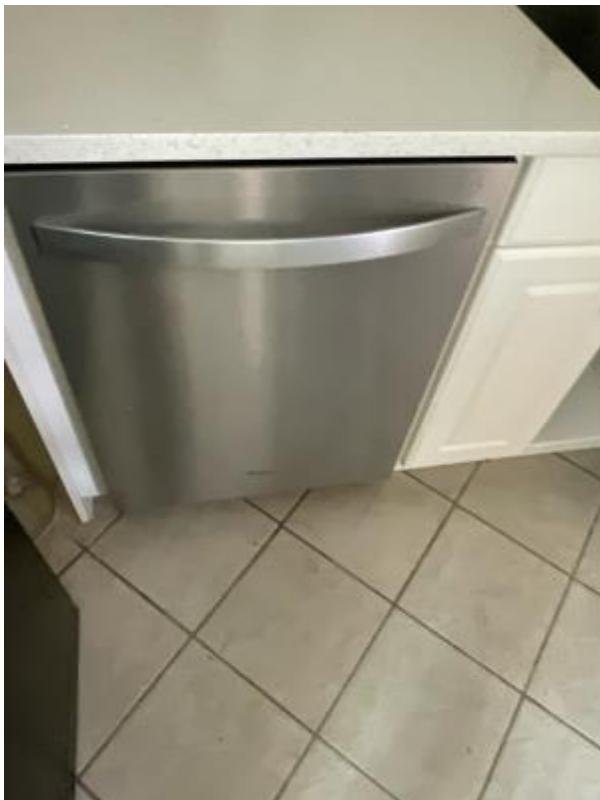
SKETCH1/Main Level/Kitchen One - 39-

Dishwasher

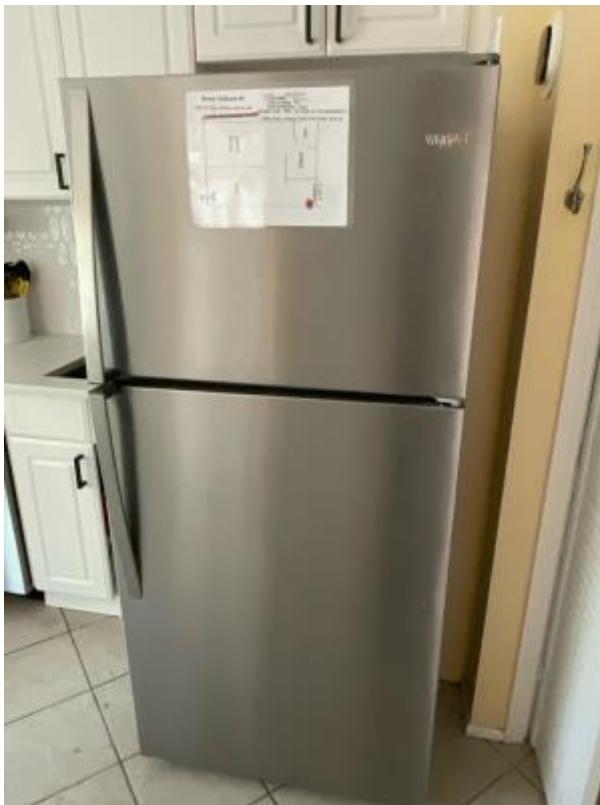
**SKETCH1/Main Level/Kitchen
One - 41-**

Refrigerator

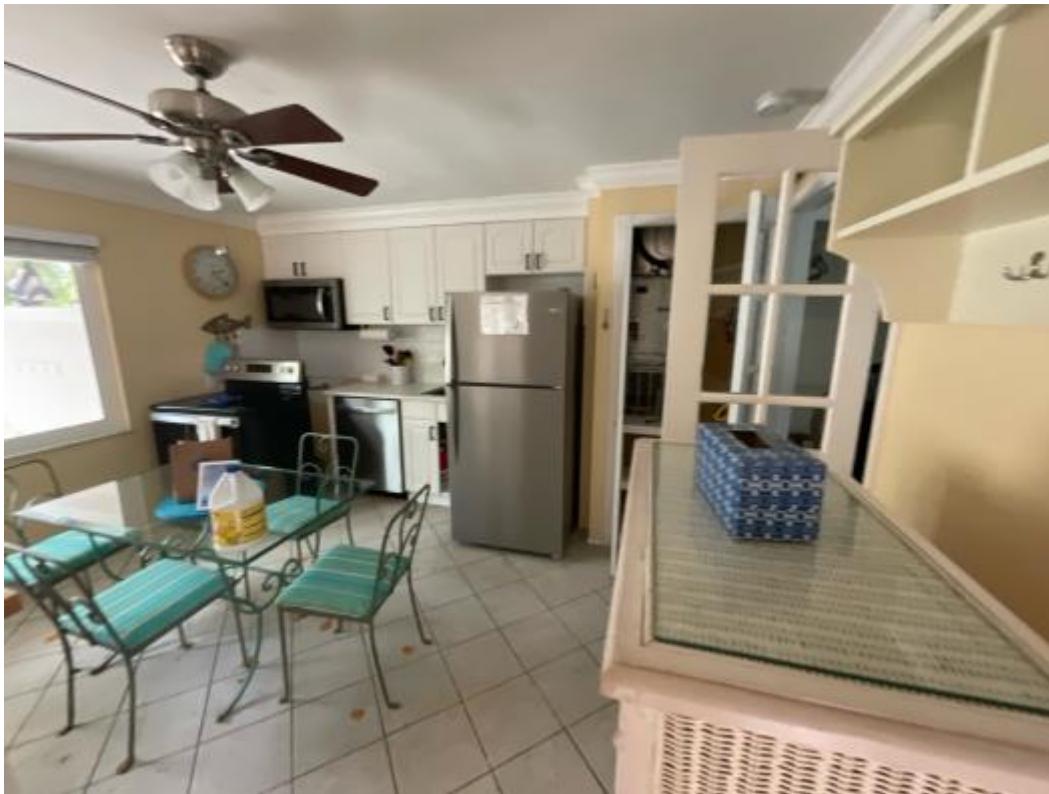
SKETCH1/Main Level/Kitchen One HVAC - 43-

Kitchen One HVAC Overview

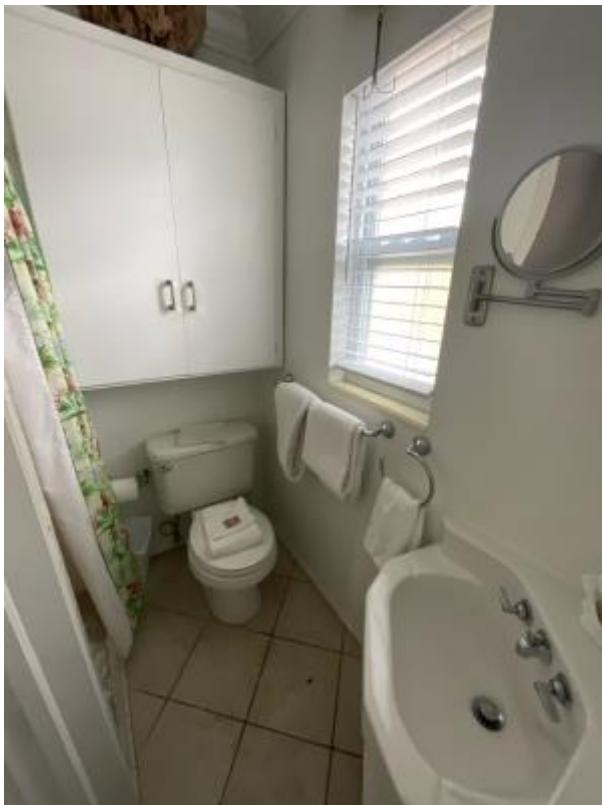
SKETCH1/Main Level/Bathroom One - 49-

Bathroom One

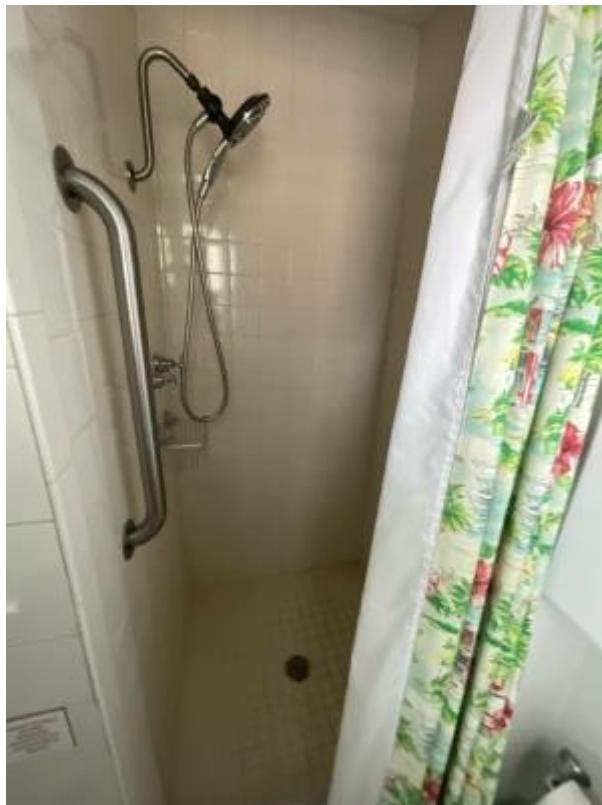
SKETCH1/Main Level/Bathroom One - 51-

Bathroom One

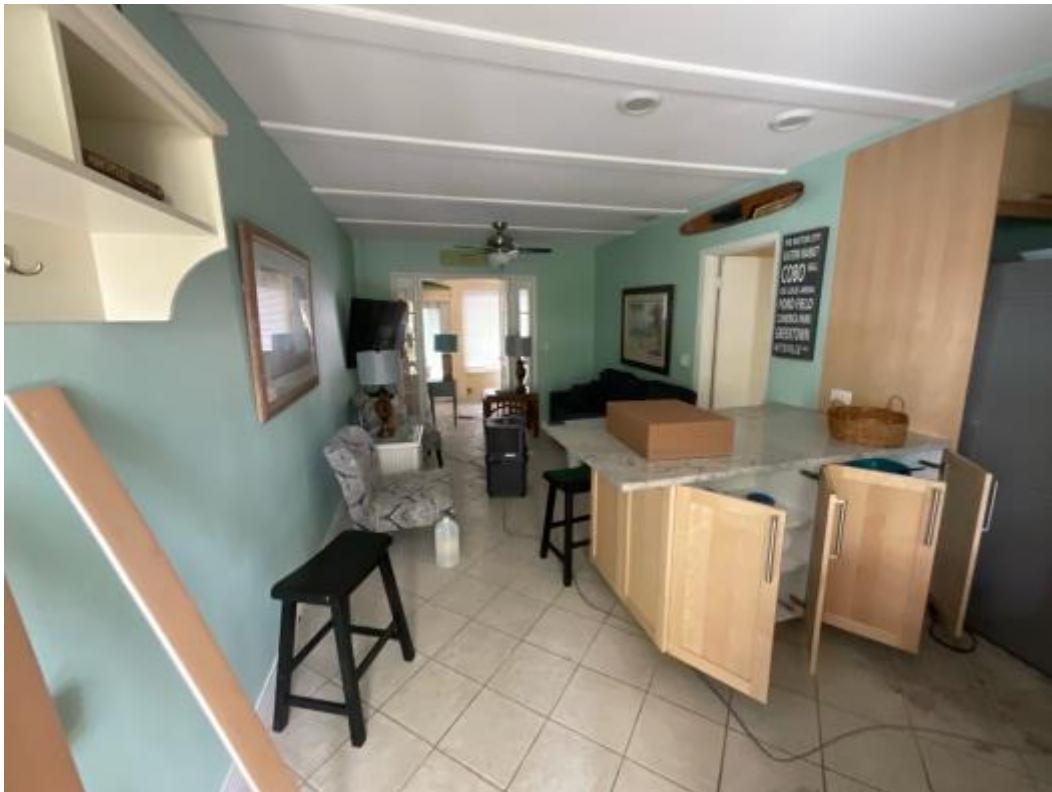
SKETCH1/Main Level/Main room two - 53-

Main Room Two Overview

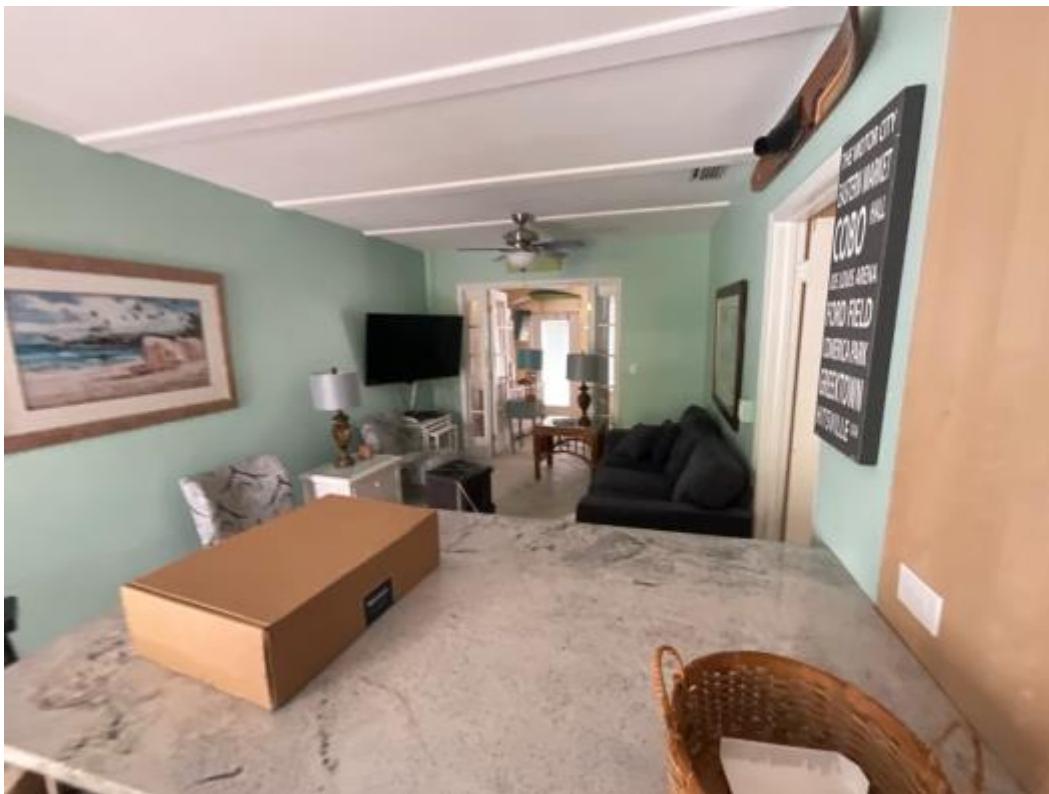
SKETCH1/Main Level/Main room two - 55-

Main Room Two Overview

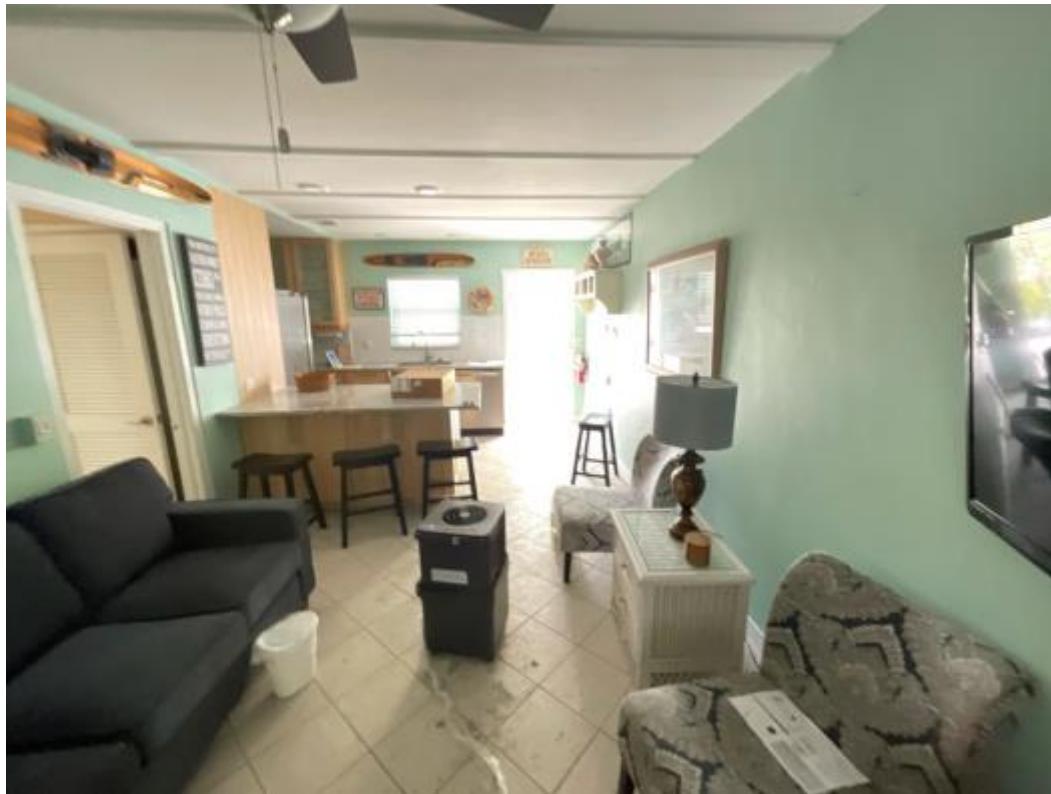
SKETCH1/Main Level/Main room two - 57-

Main Room Two Overview

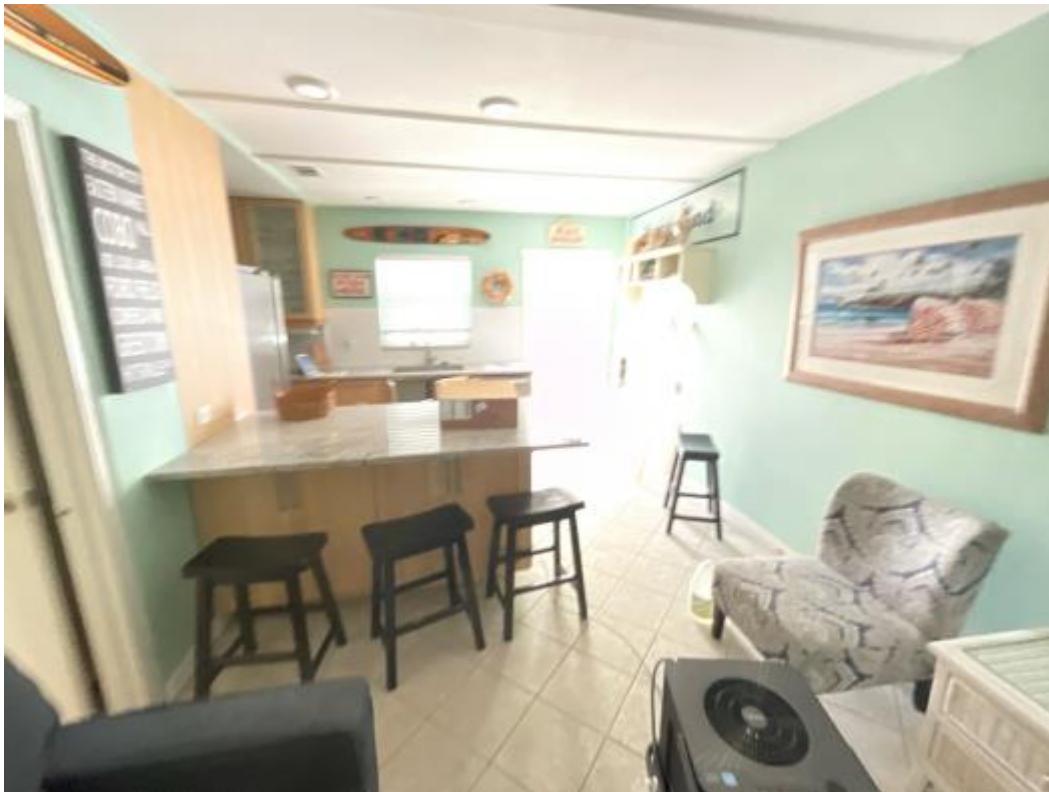
SKETCH1/Main Level/Main room two - 59-

Main Room Two Overview

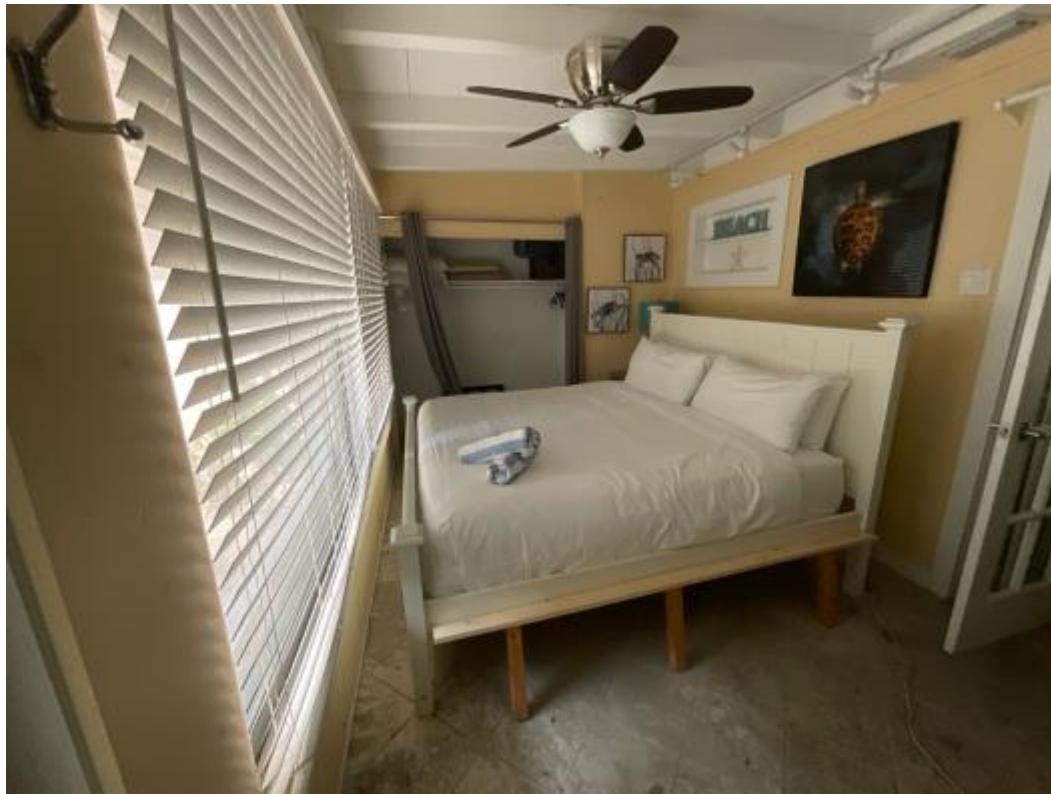
SKETCH1/Main Level/Bedroom two - 67-

Bedroom Two

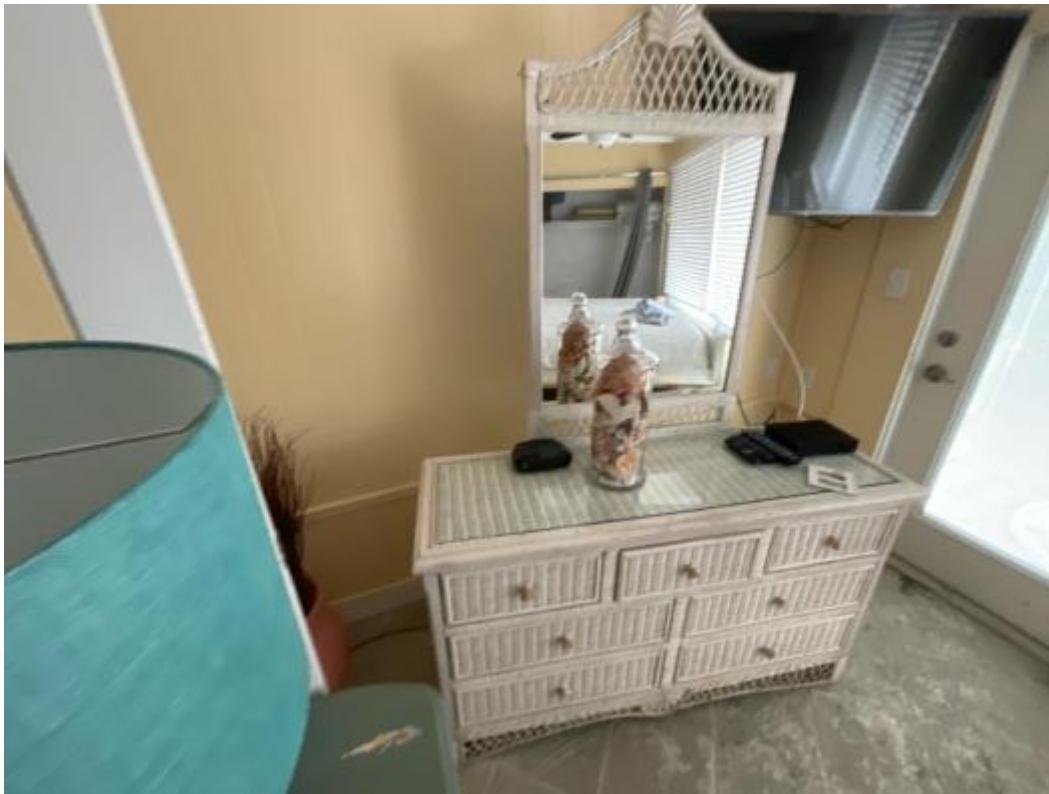
SKETCH1/Main Level/Bedroom two - 69-

Bedroom Two

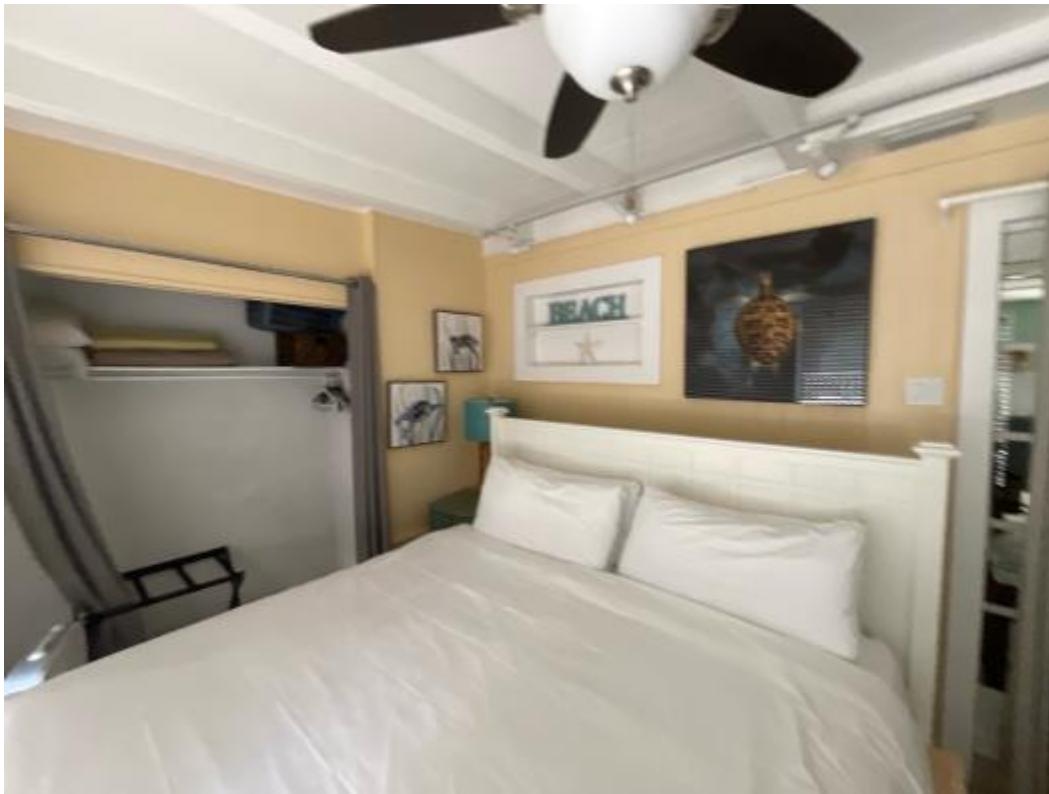
SKETCH1/Main Level/Bedroom two - 73-

Bedroom Two

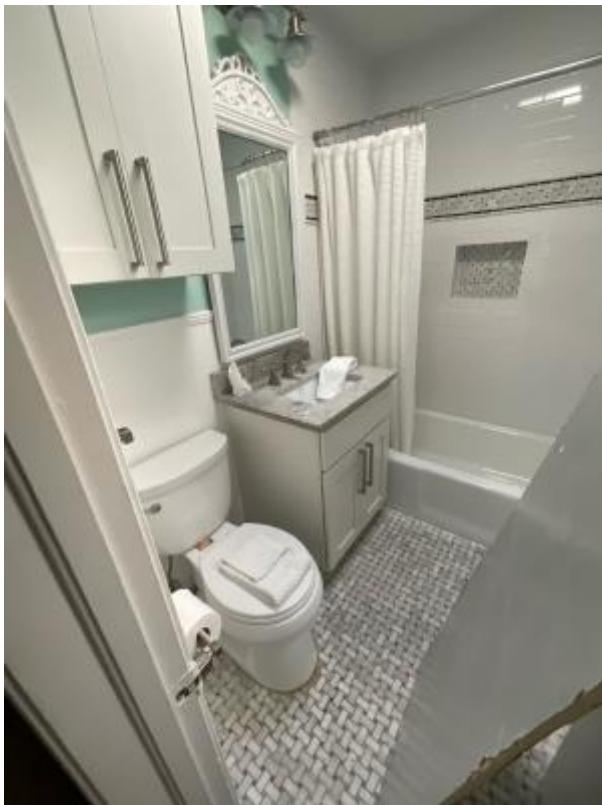
SKETCH1/Main Level/Bathroom two - 77-

Bathroom Two Overview

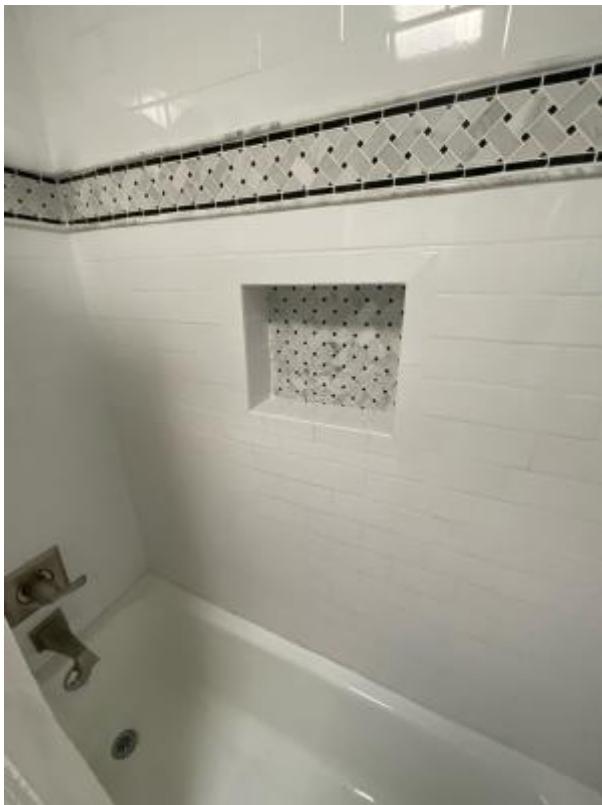
SKETCH1/Main Level/Bathroom two - 79-

Bathroom Two Shower Niche and custom detail

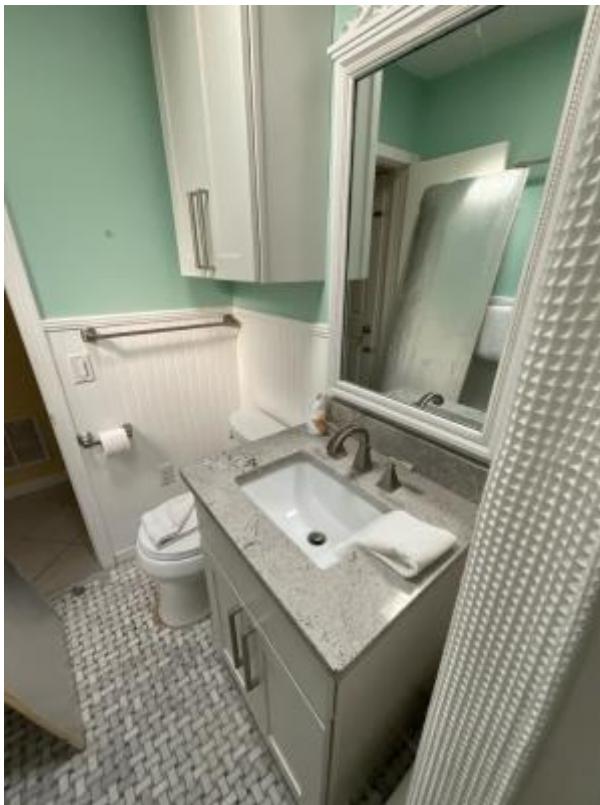
**SKETCH1/Main Level/Bathroom
two - 81-**

Vanity Damage

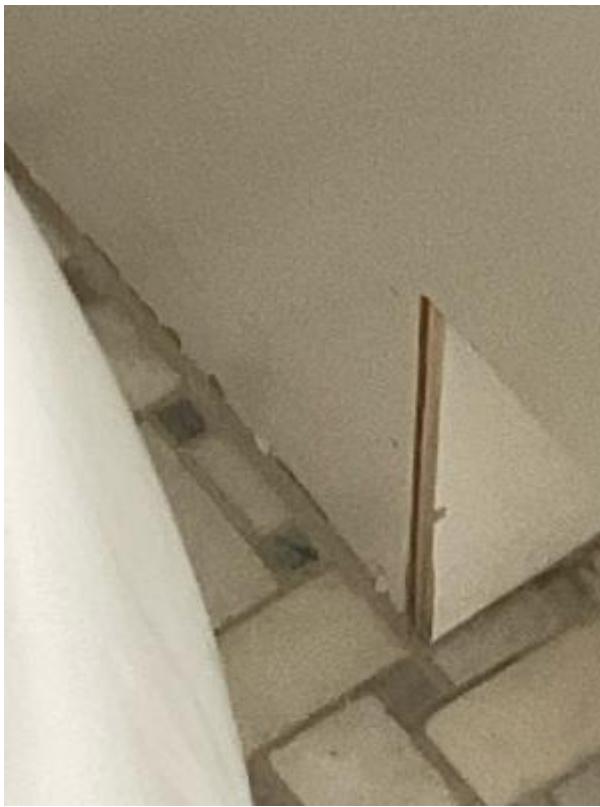
**SKETCH1/Main Level/Bathroom
two - 83-**

Vanity Damage

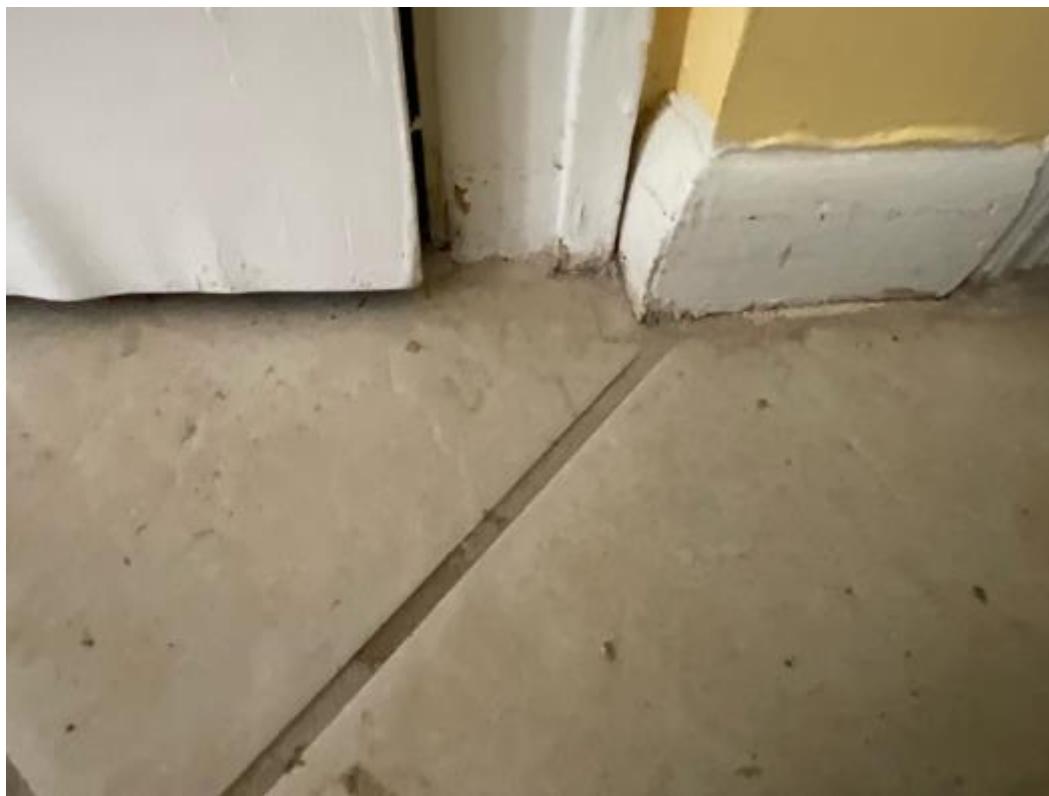
SKETCH1/Main Level/Bedroom three - 94-

Door Damage

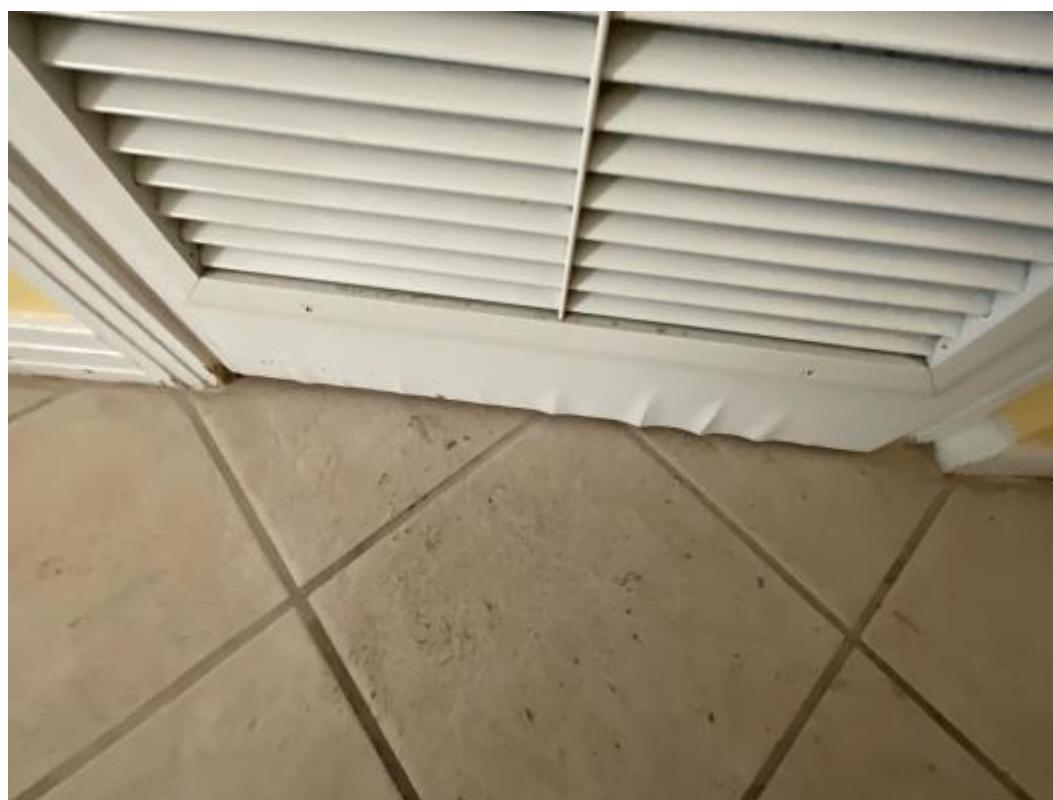
**SKETCH1/Main Level/HVAC
Three - 96-**

HVAC three door damage

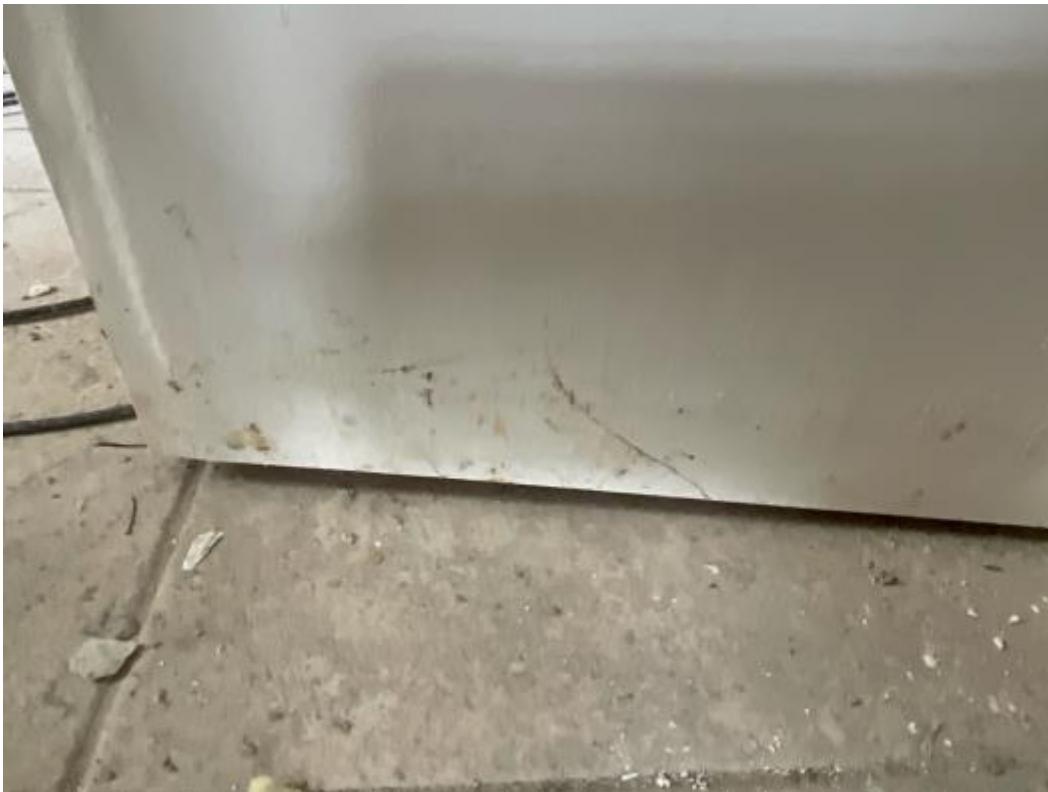
SKETCH1/Main Level/Front Room Four - 119-

Door Damage

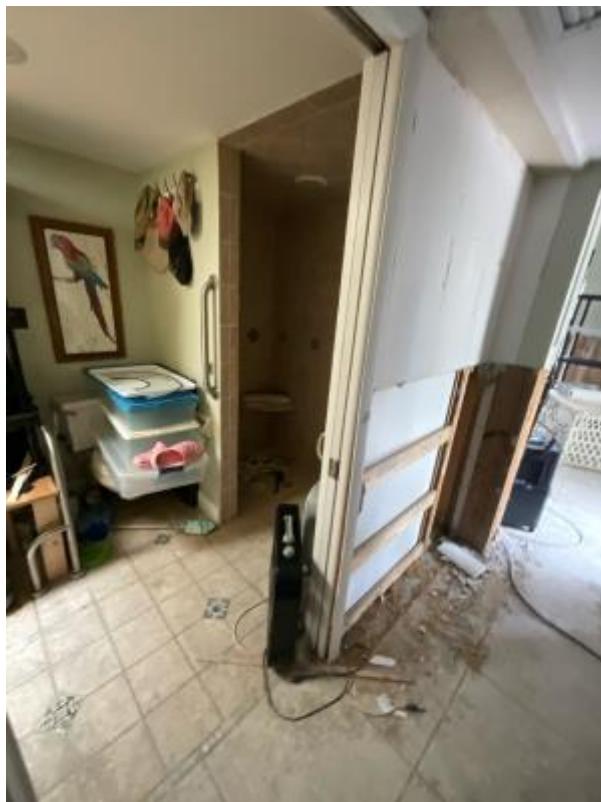
SKETCH1/Main Level/Front Bath Four - 124-

Front Bath Four

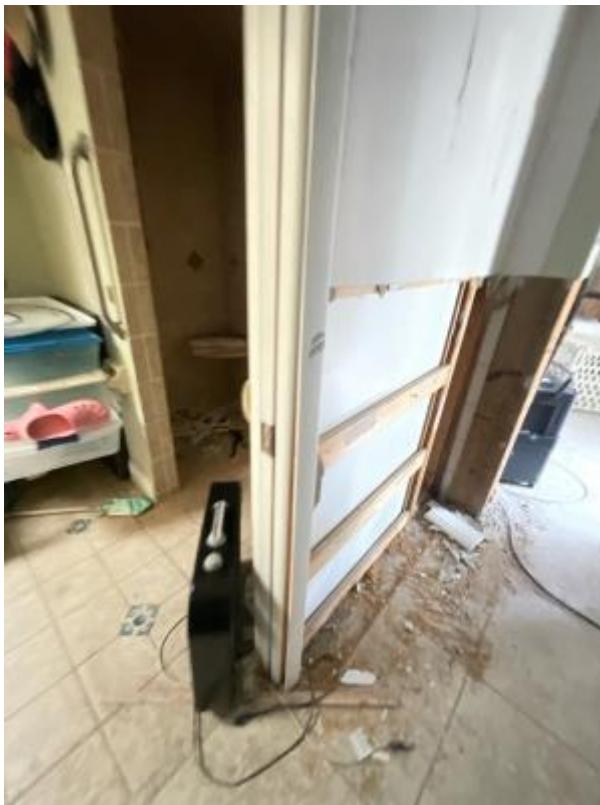
SKETCH1/Main Level/Front Bath Four - 125-

Front Bath Four

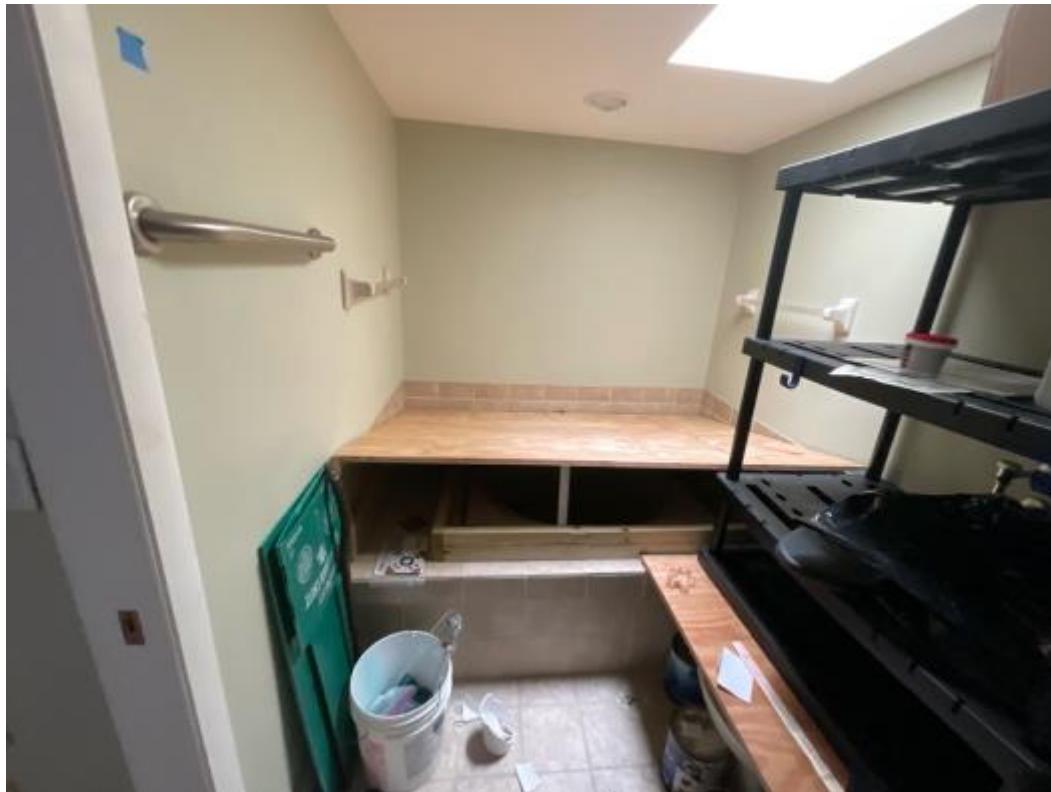
SKETCH1/Main Level/Shower Four - 131-

Built in Jacuzzi Tub

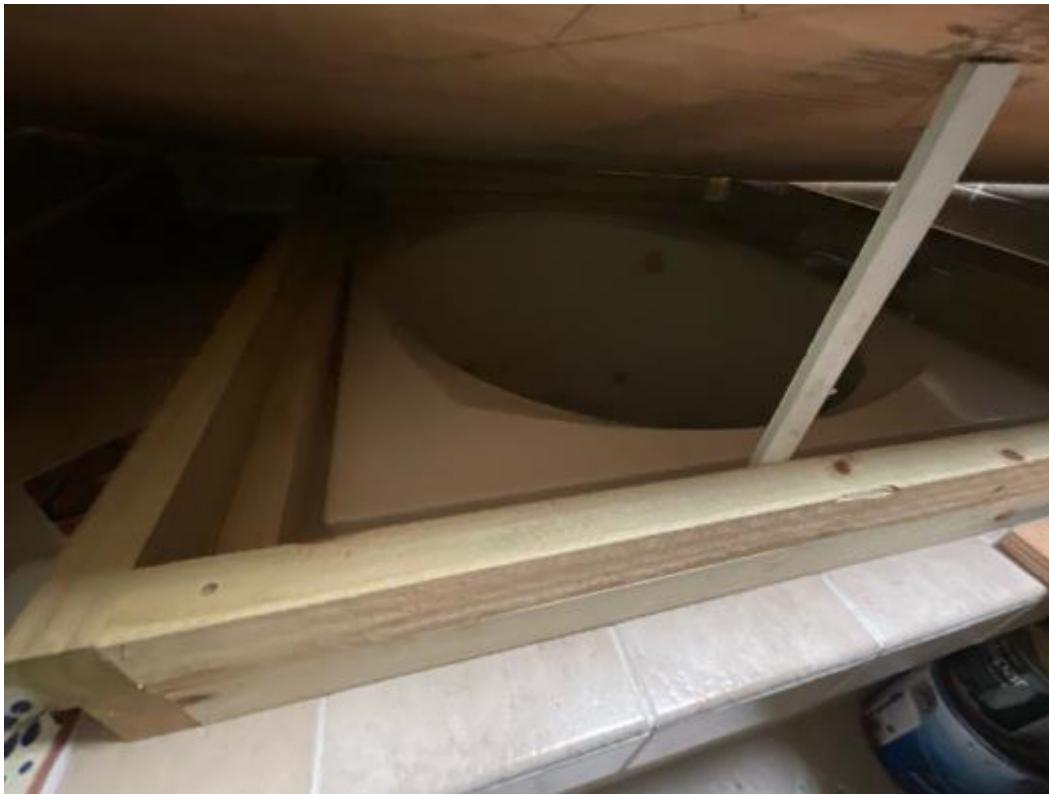
SKETCH1/Main Level/Shower Four - 133-

Built in Jacuzzi Tub

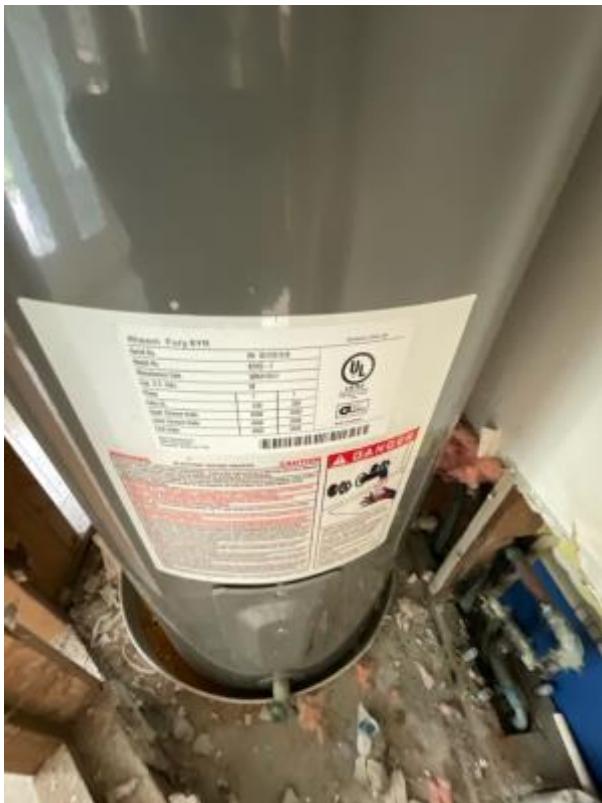
**SKETCH1/Main Level/Hall
Closet 5 - 141-**

Mod R2V52-2
Ser # RH 0512267618
