NARRATIVE REPORT

DWELLING / UNIT OWNER

Carrier:	Hartford Fire Insurance Company	Date of Loss:	9/26/2024
Insured:	ANNA CABANA I LLC	Assigned:	10/1/2024
CID:	239582	Contacted:	10/10/2024
Claim Number:	556903	Inspected:	10/16/2024
Policy Number:	6500384948	Inspected With:	Garrett Yankee
Loss Address:	3711 4TH AVE HOLMES BEACH FL 34217-1995	Mailing Address:	17092 SMOKEY HOLLOW RD TRAVERSE CITY MI 49686
Coverage A:	\$ 250,000.00	Mortgage:	None
Coverage B:	\$ 30,000.00	Verified with:	Barbara Yankee
Policy Term:	9/21/2024 to 9/21/2025

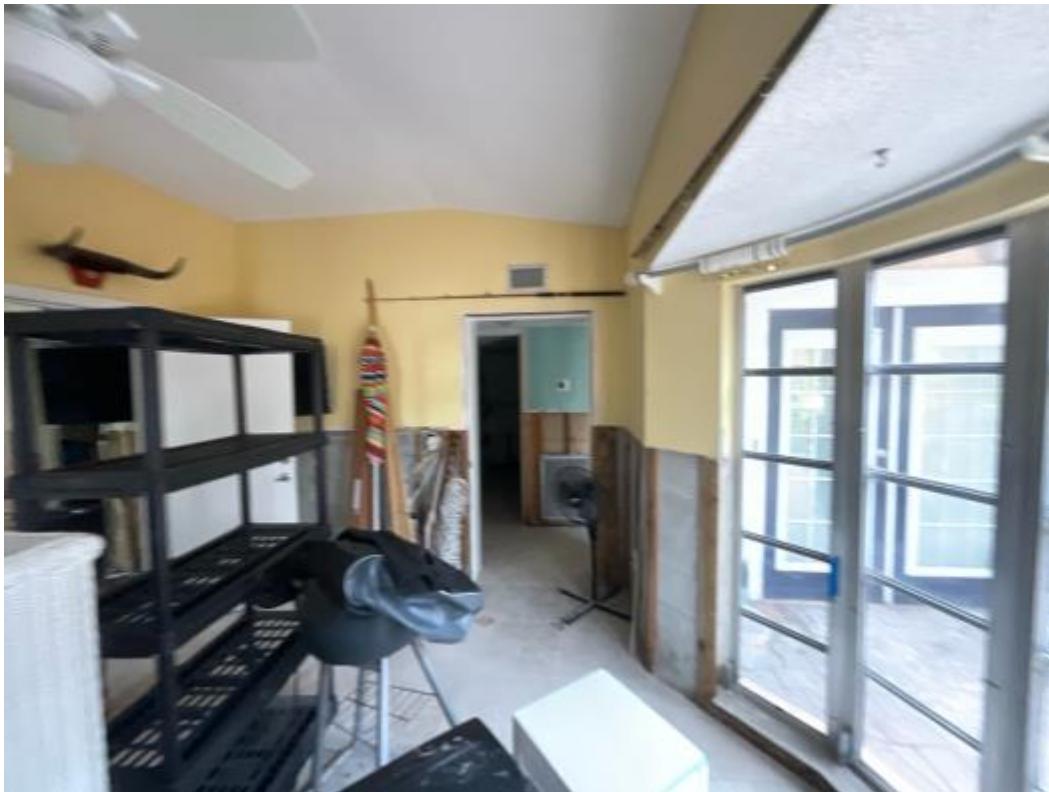
SKETCH1/Main Level/Dining Room Five - 153-

Jalousie Windows

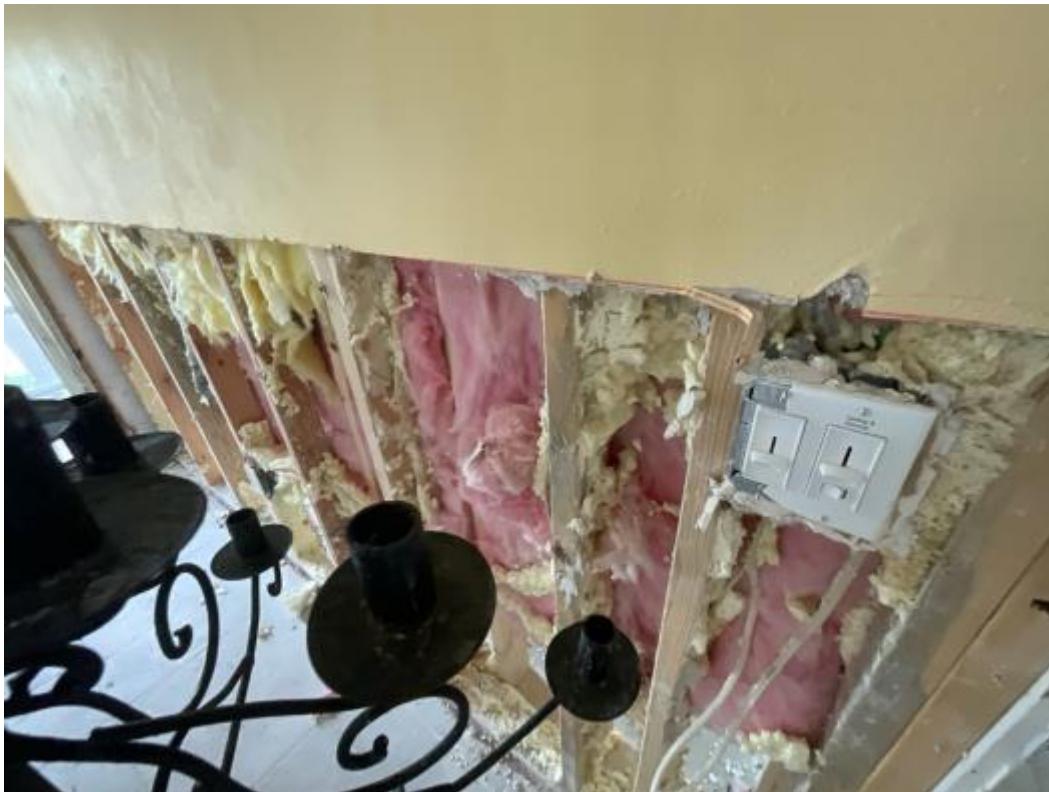
SKETCH1/Main Level/Dining Room Five - 155-

Interior Insulation

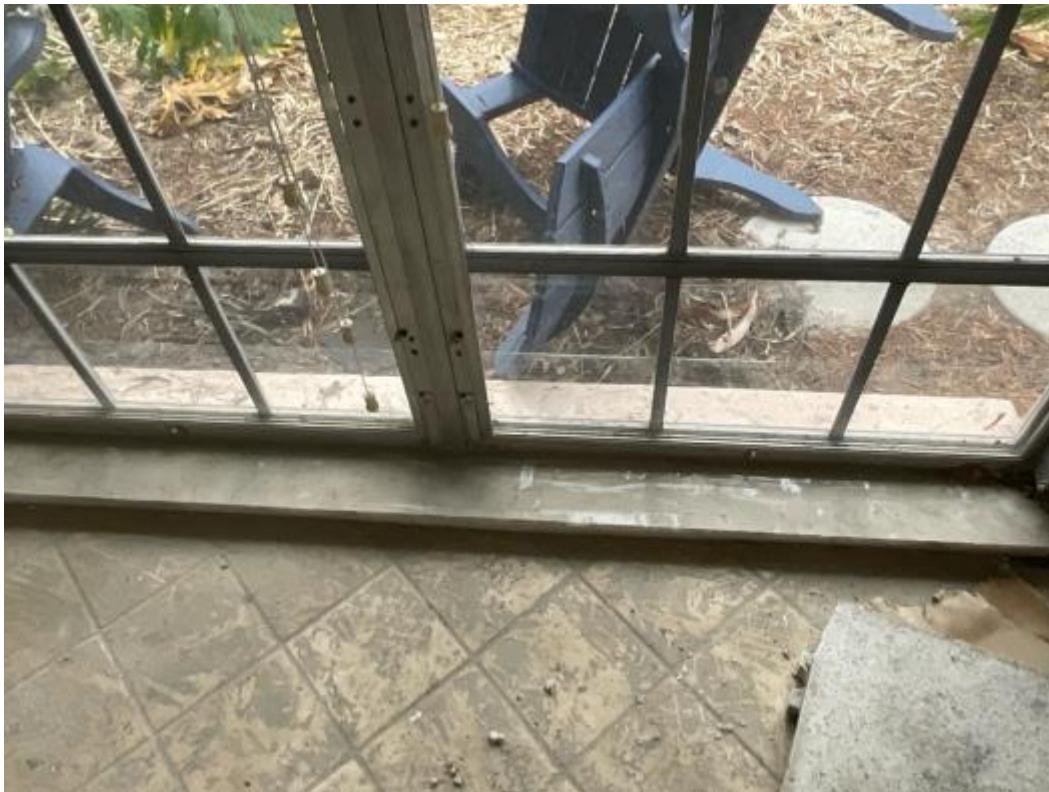
SKETCH1/Main Level/Living Room Five - 189-

Jalousie Windows
