Policyholder:	SUSAN COTTLE, STEVE COTTLE	Loss Address:	960 182ND AVE E, REDINGTON SHORES,
Policy Number:	9904123014		FL,
Claim Number:	9904123014-09262024		33708-1039,
Date of Loss:	9/26/2024	Adjuster:	David Quenelle
Carrier:	American Bankers

CARRIER CONCERNS **REVISED FINAL REPORT**

NARRATIVE REPORT **DWELLING / UNIT OWNER**

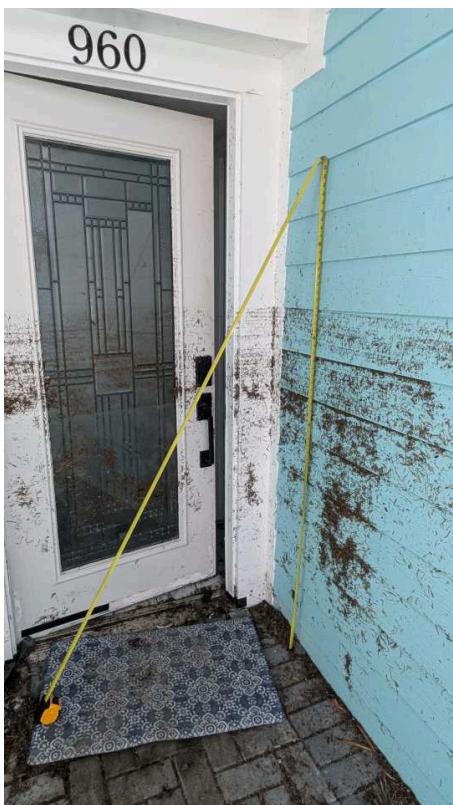
18-Exterior Waterline 52"

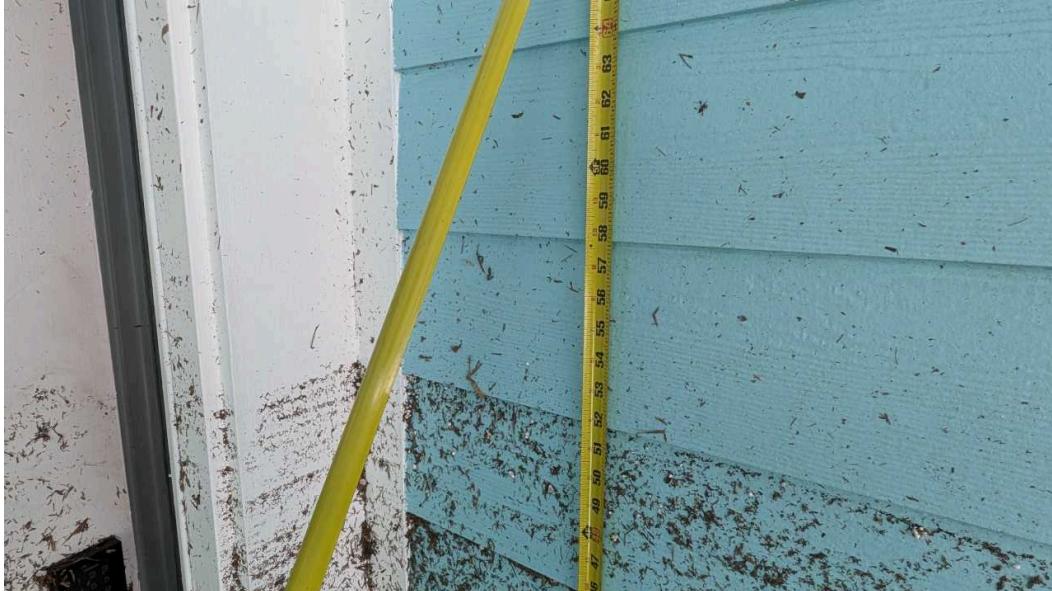
19-Exterior Waterline 52"

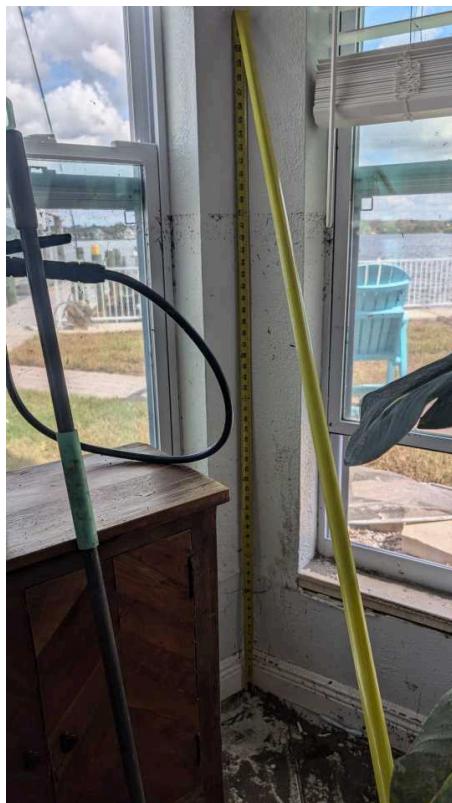
20-Interior Waterline 48"

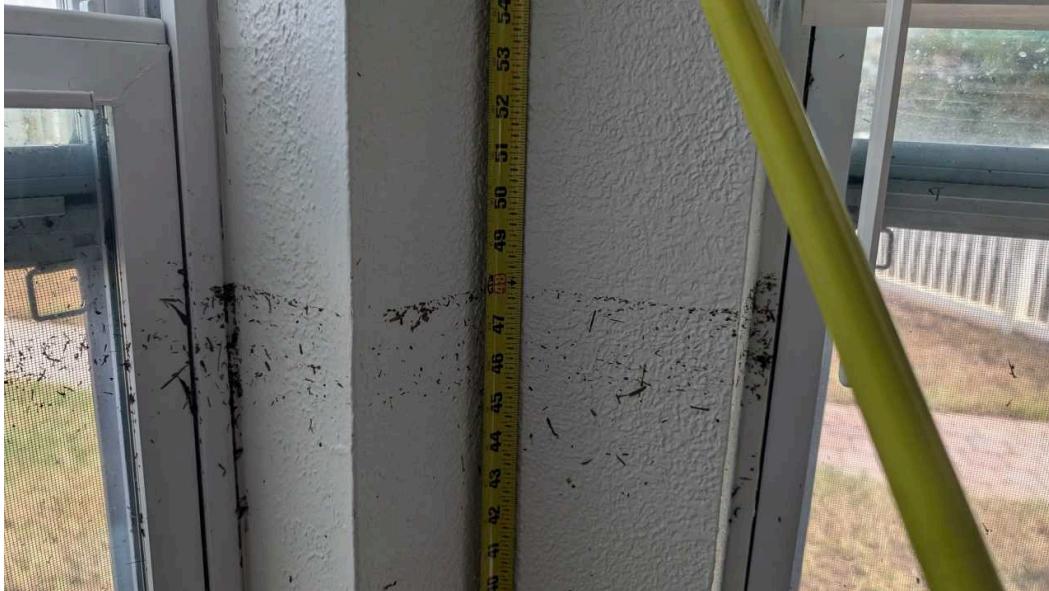
21-Interior Waterline 48"

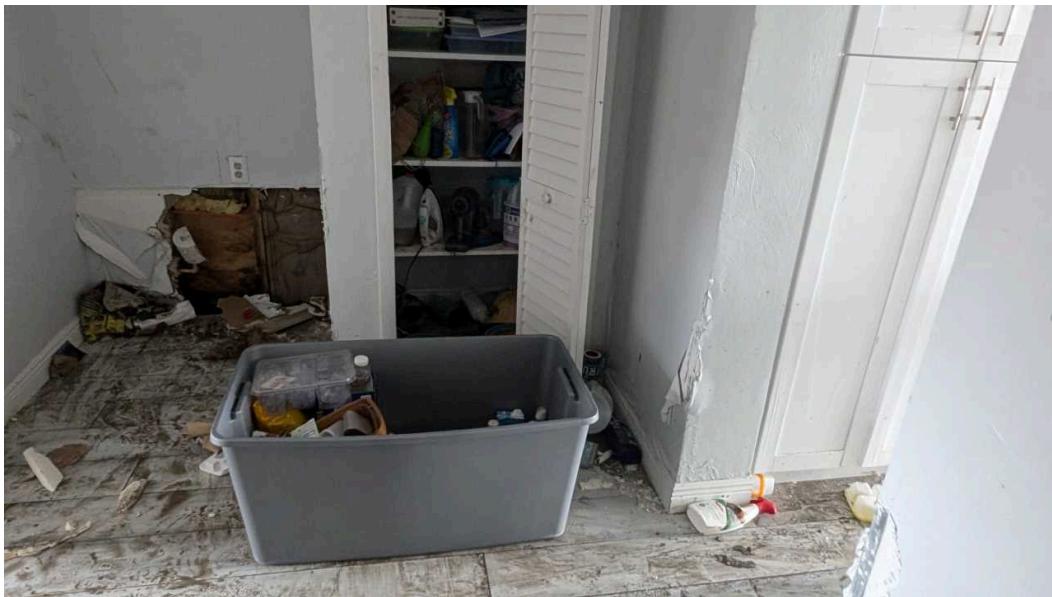
78-Laundry Room

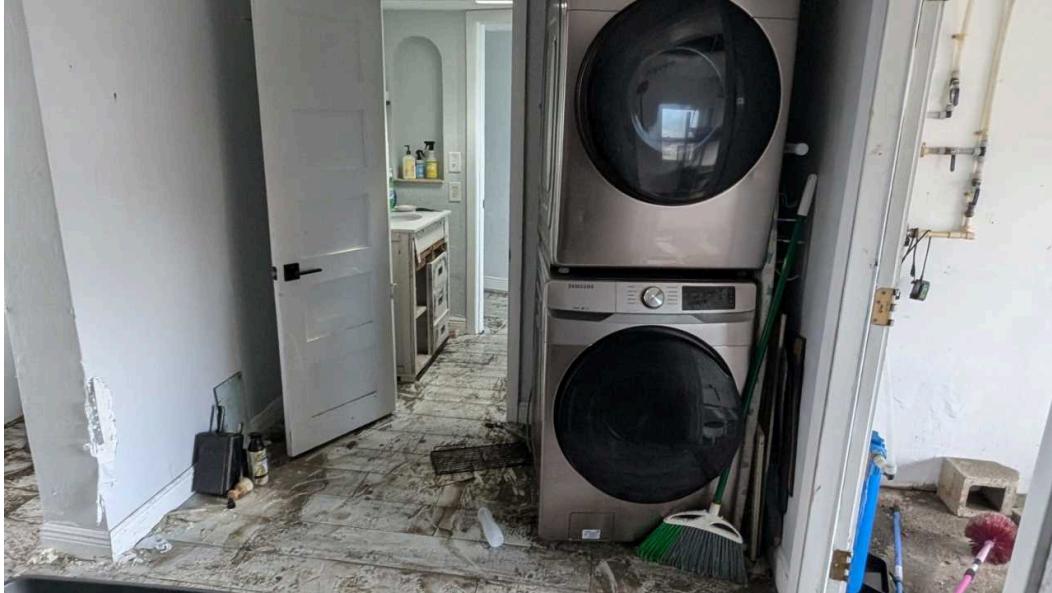
79-Laundry Room

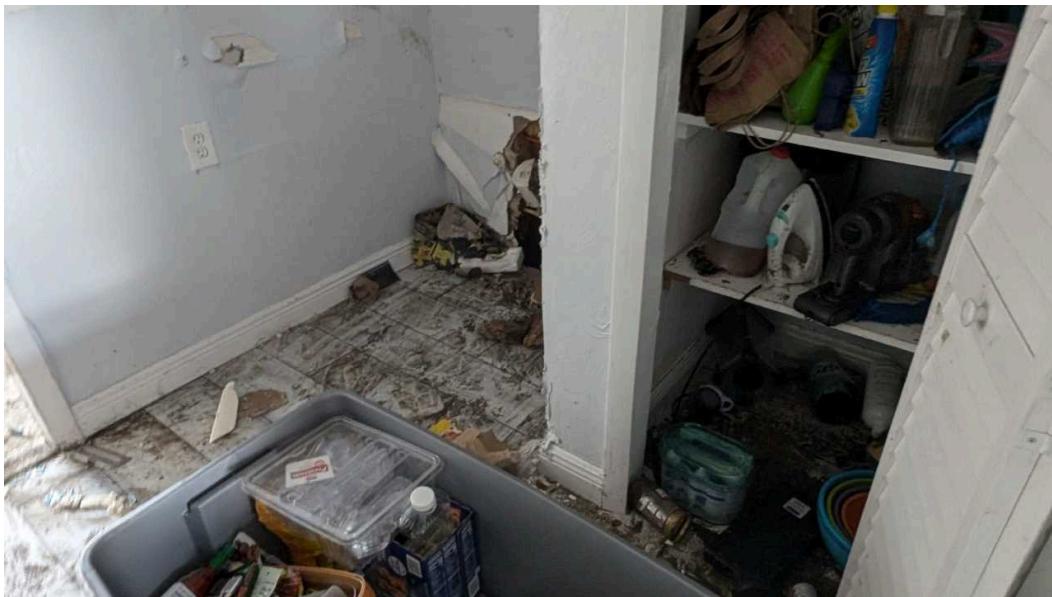
80-Laundry Room Closet

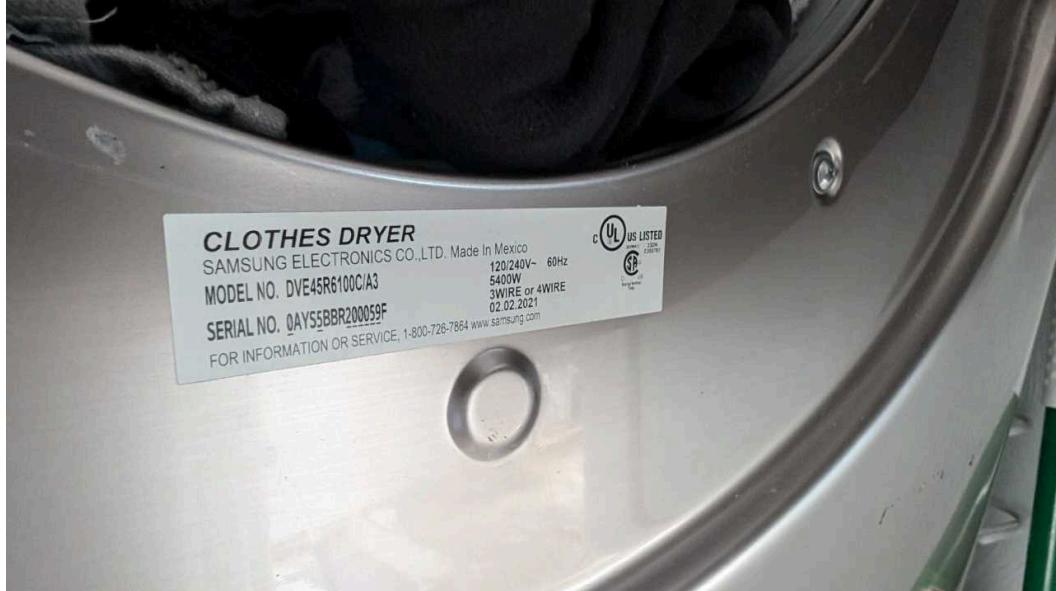
81-Laundry Room

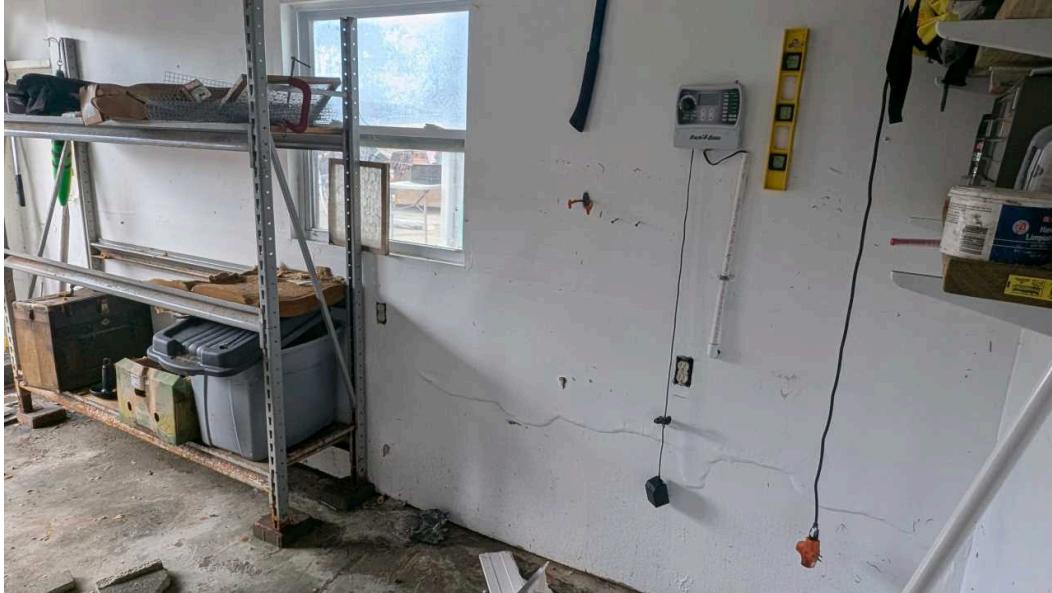
83-Garage

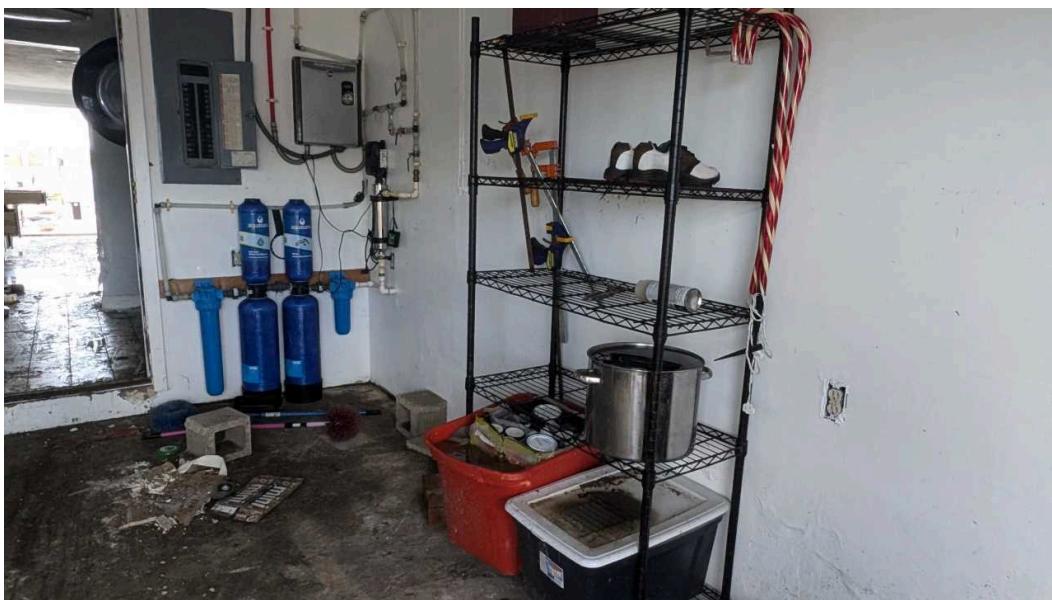
84-Garage

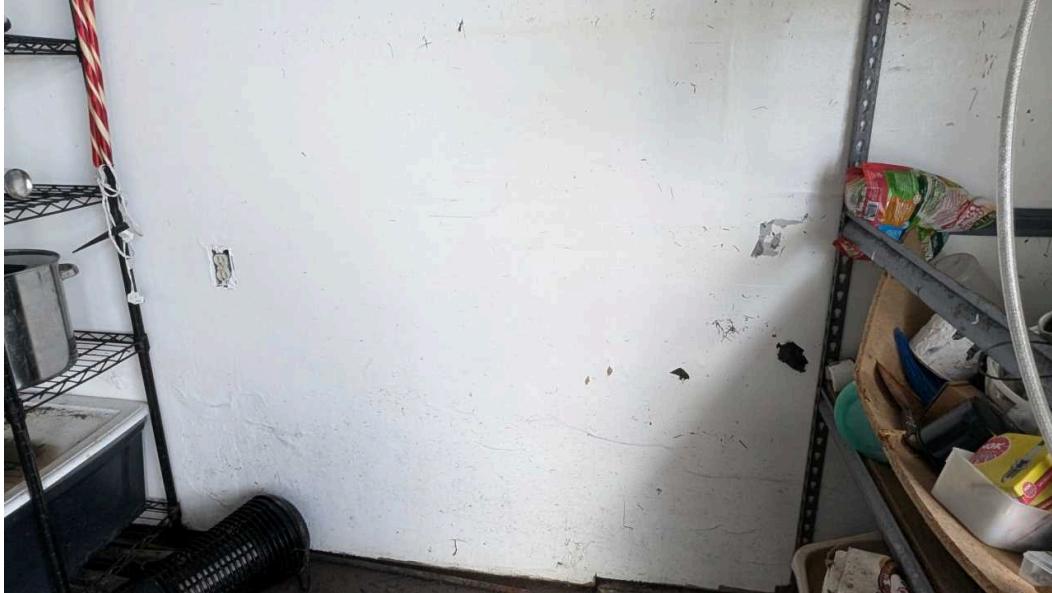
85-Garage

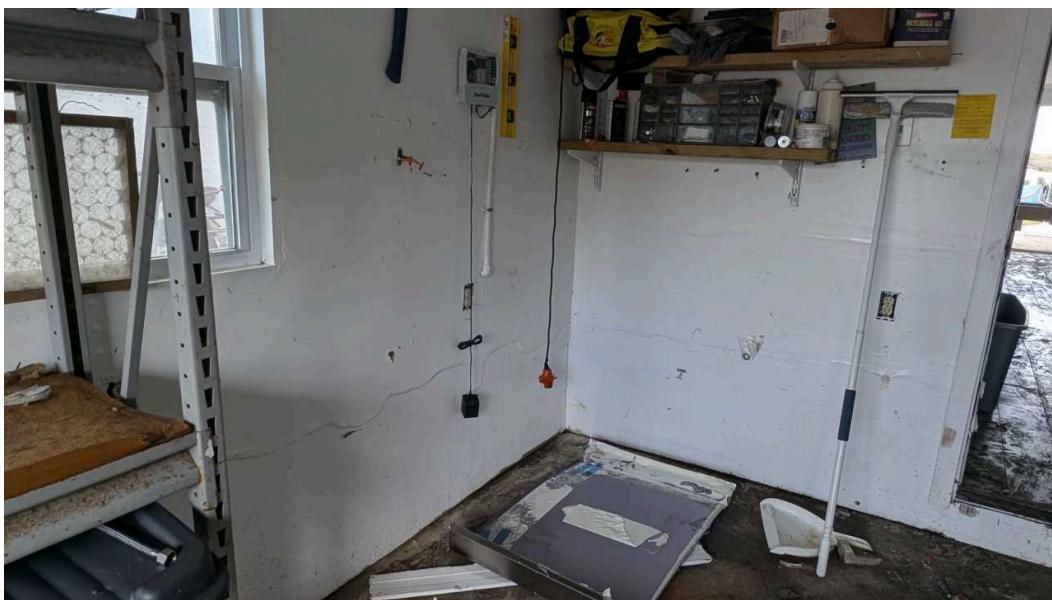
86-Garage

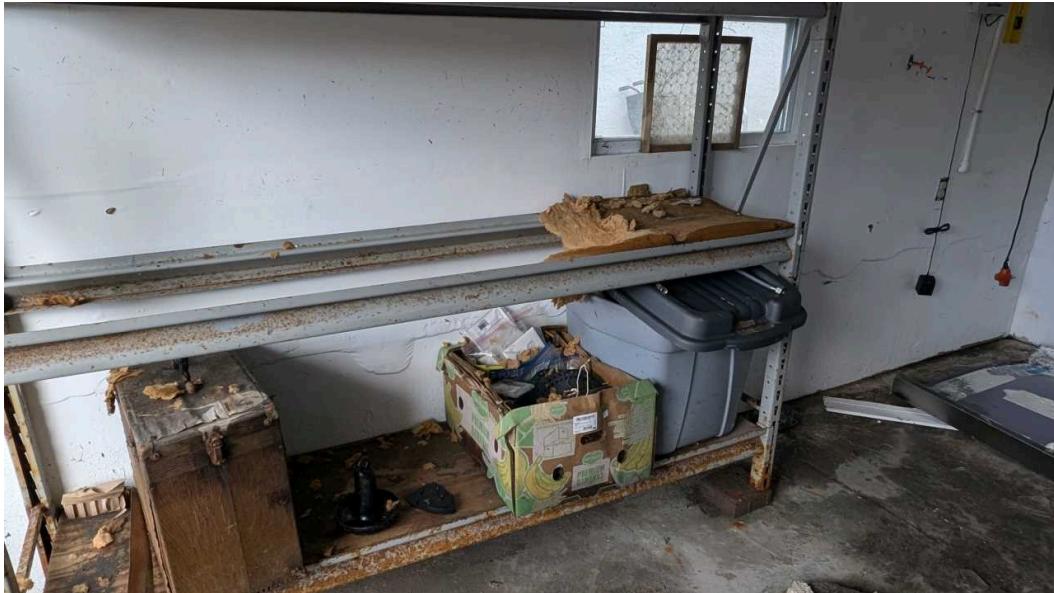
87-Garage

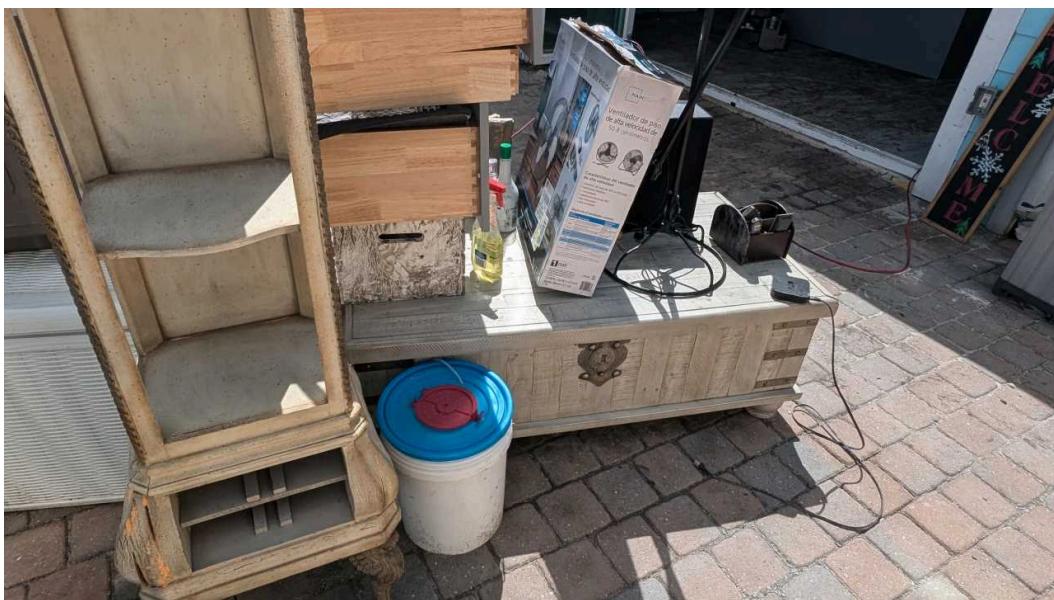
88-Damaged Contents

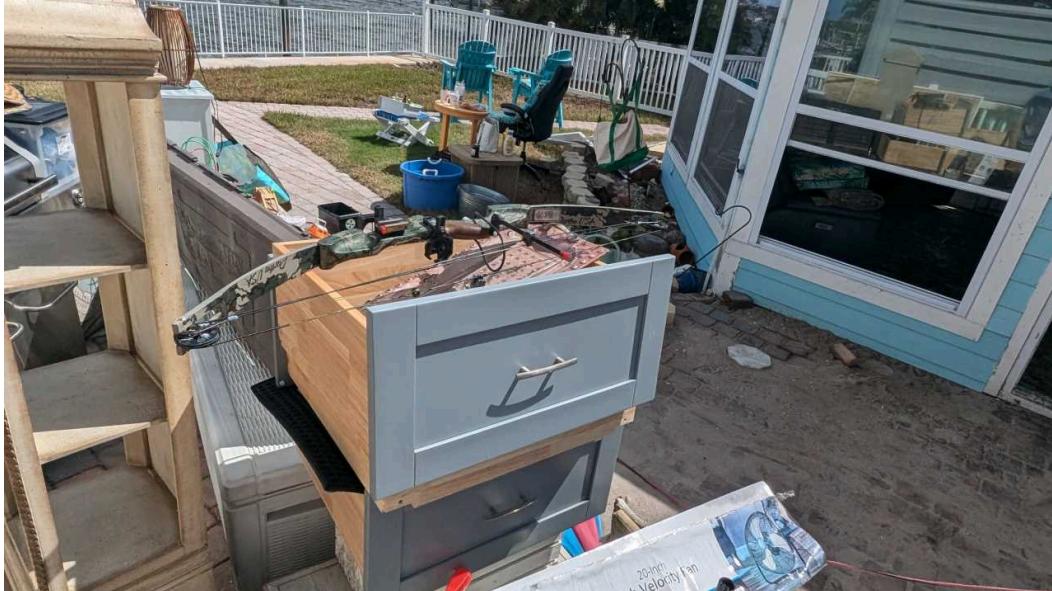
89-Damaged Contents

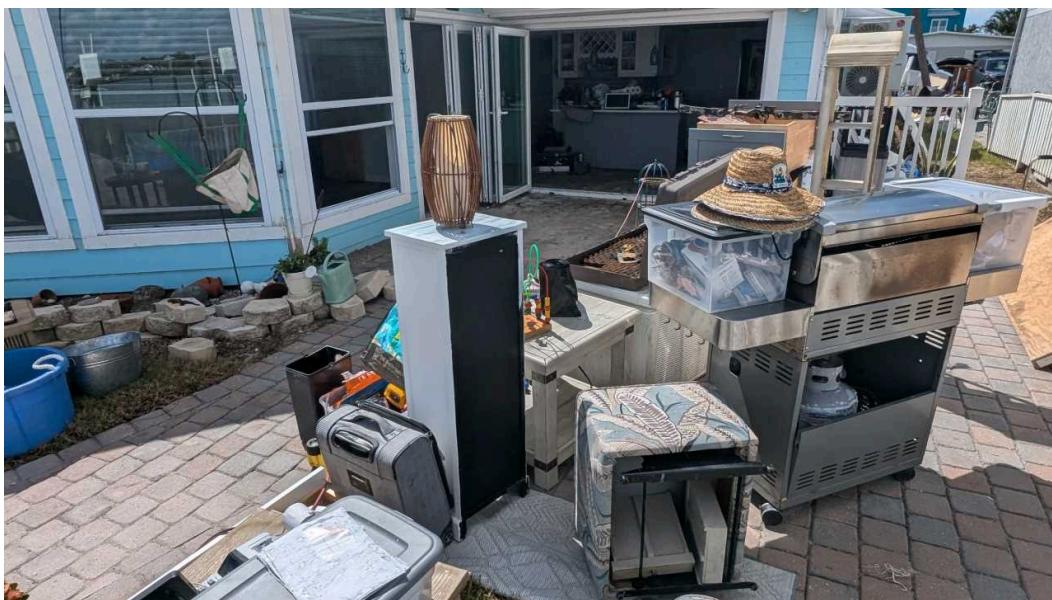
90-Damaged Contents

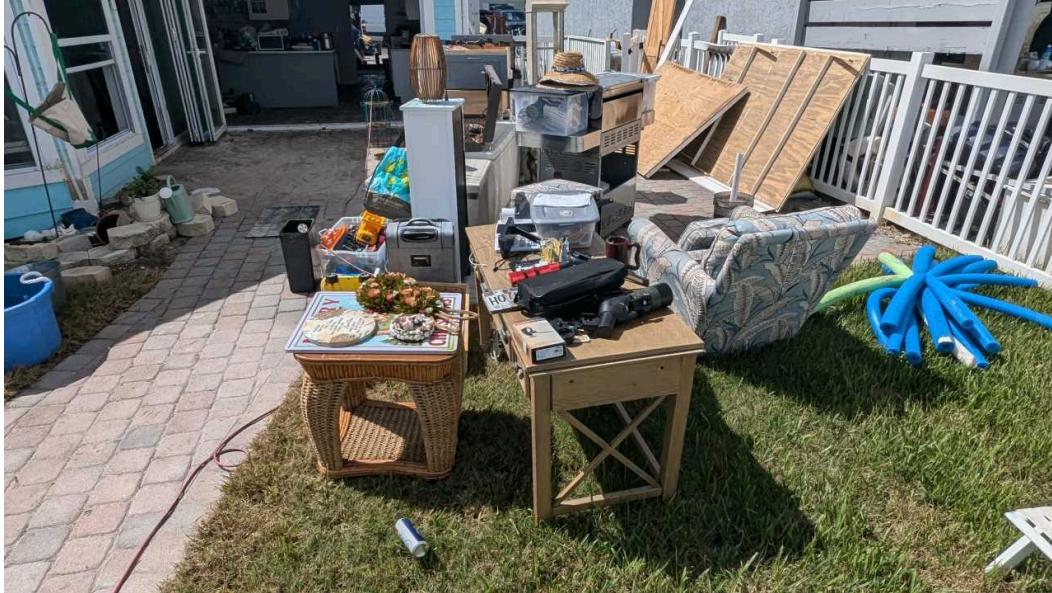
91-Damaged Contents

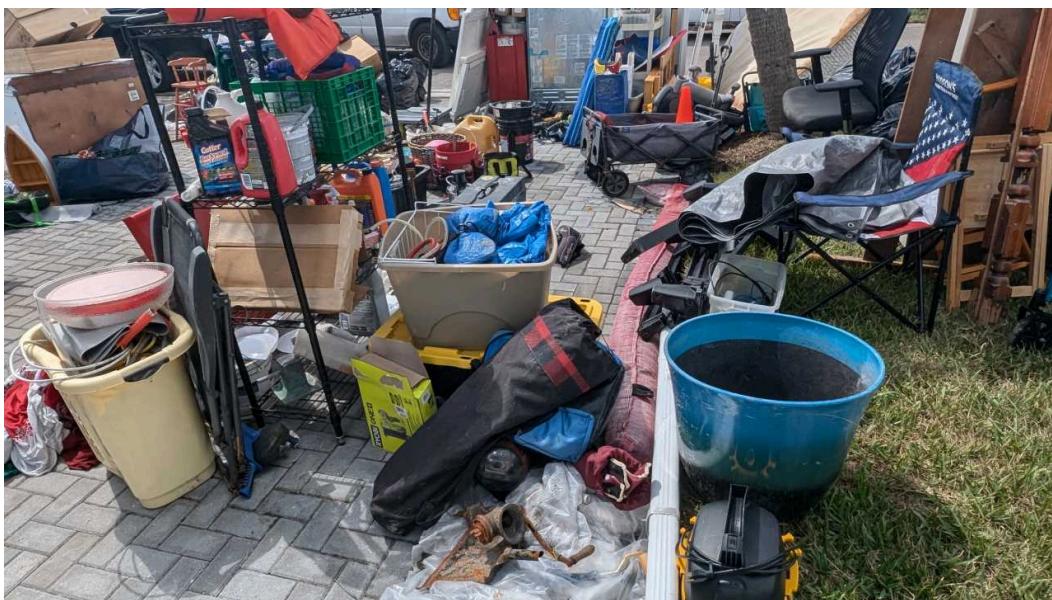
92-Damaged Contents

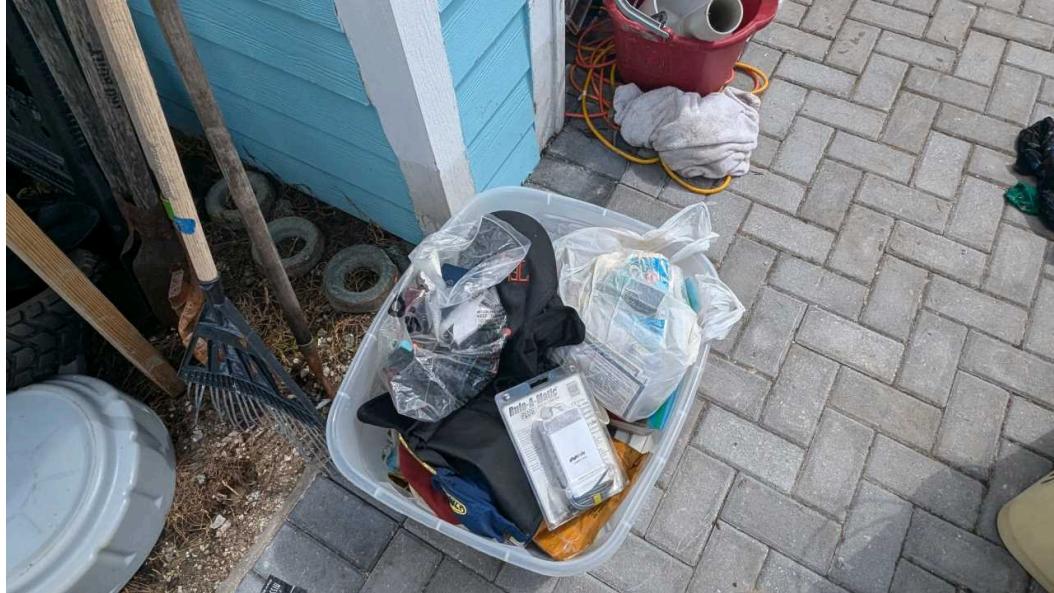
93-Damaged Contents

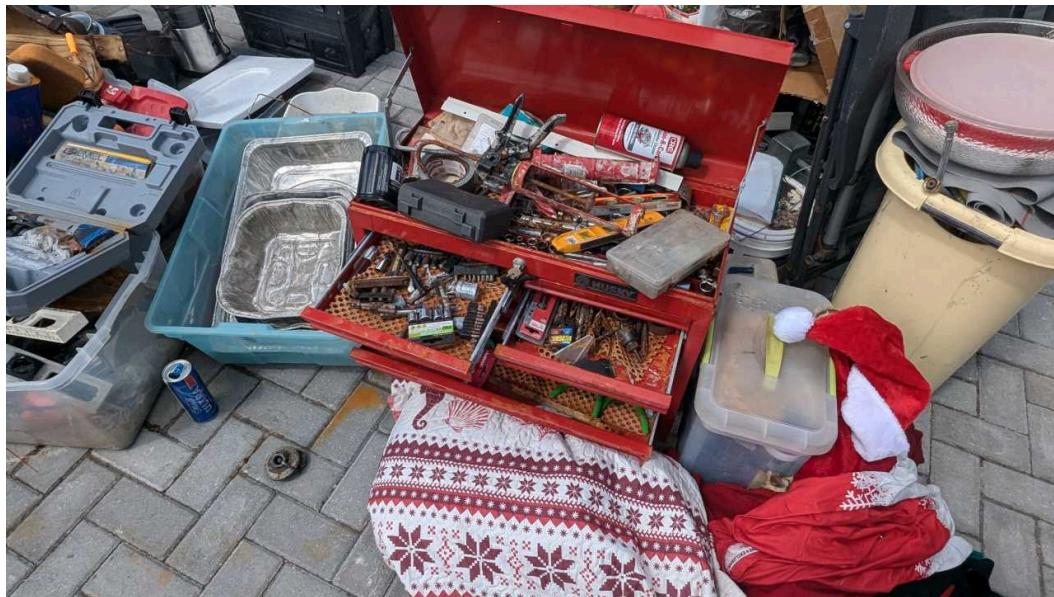
94-Damaged Contents

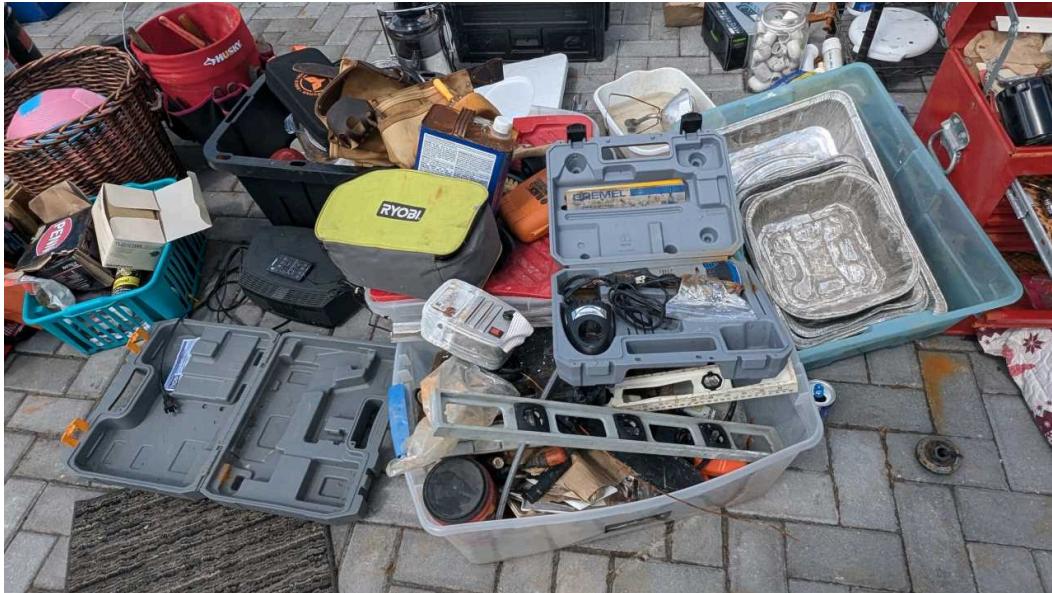
95-Damaged Contents

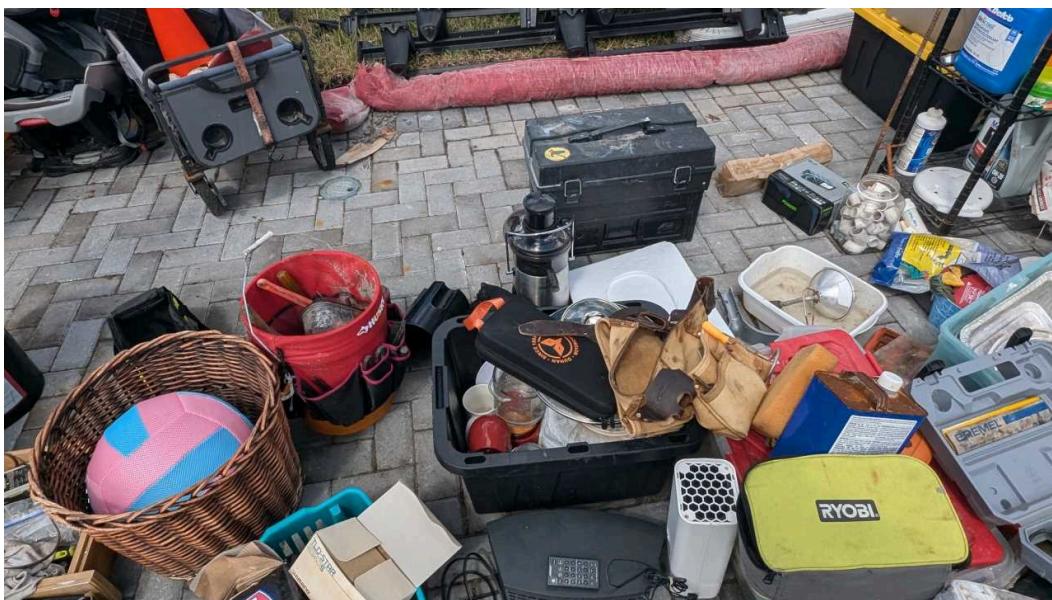
96-Damaged Contents

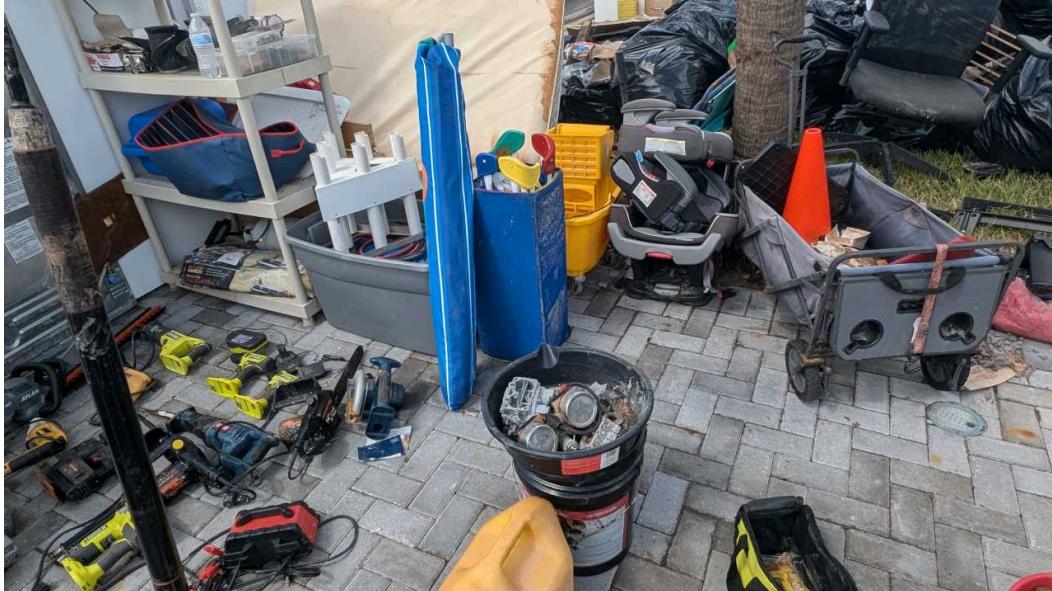
97-Damaged Contents

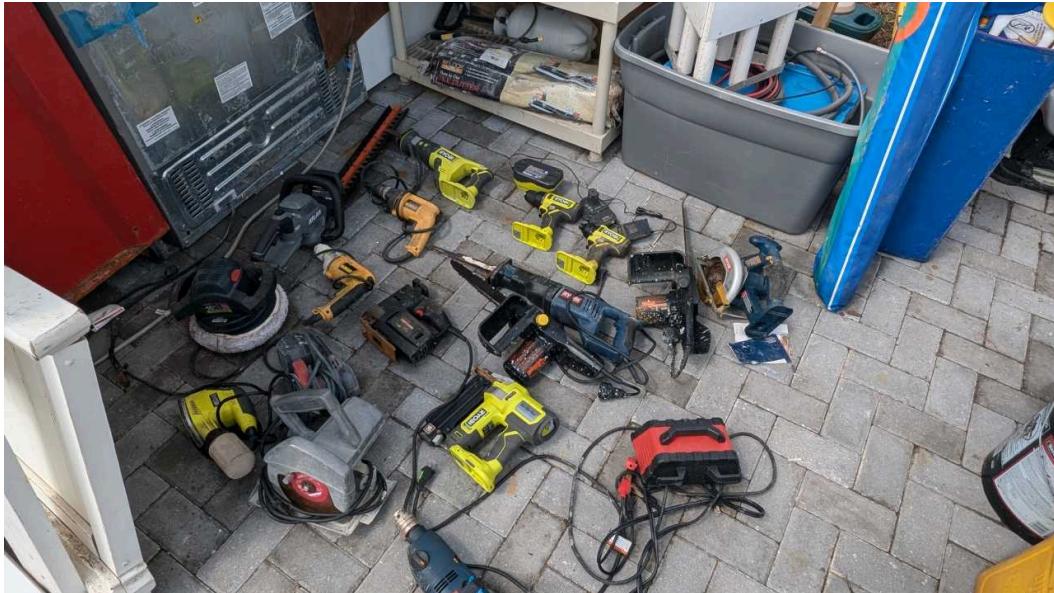
99-Damaged Contents

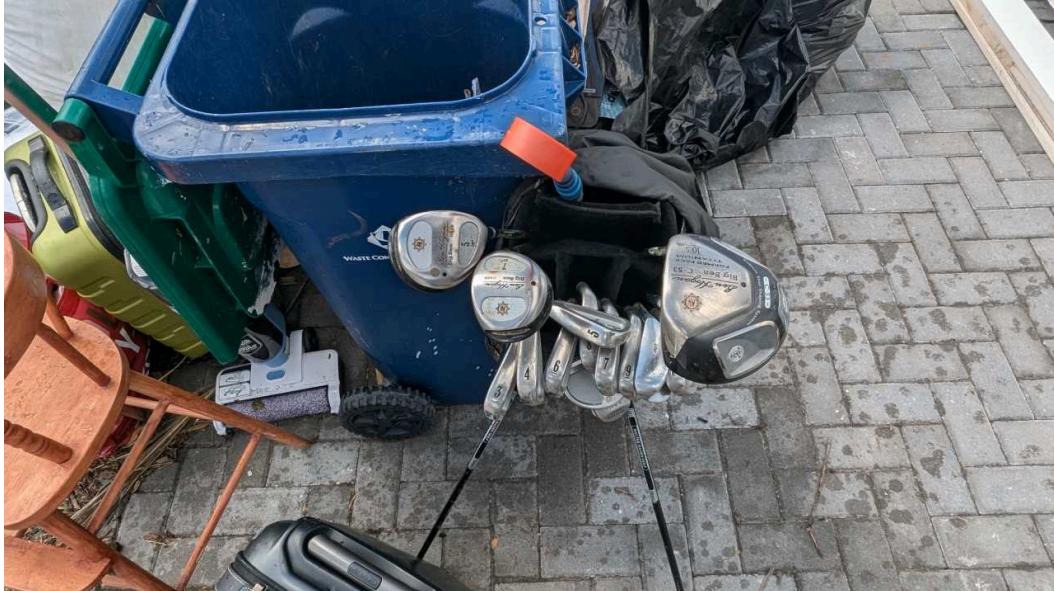
101-Damaged Contents

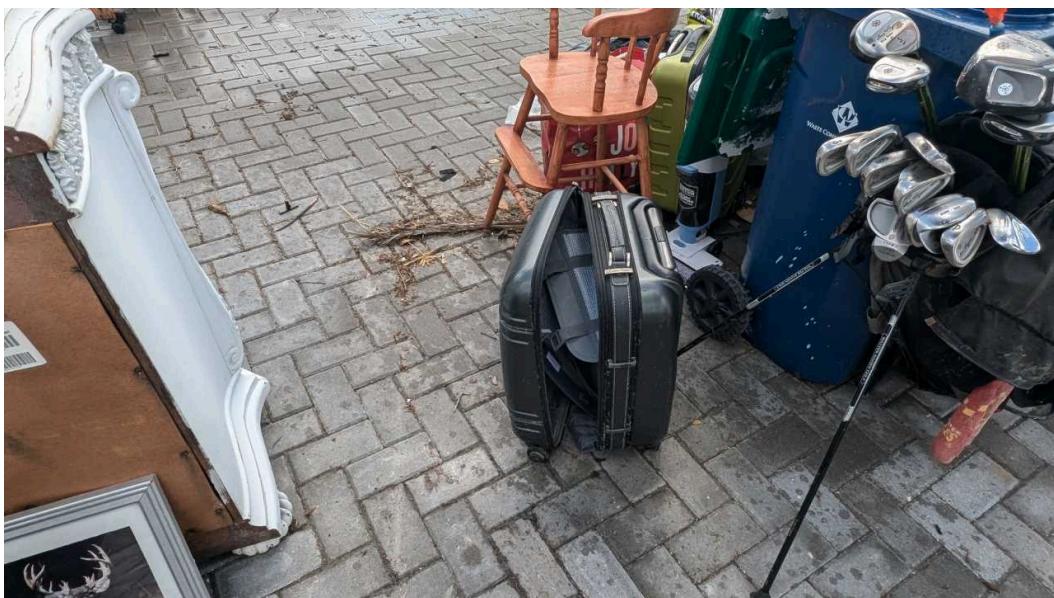
102-Damaged Contents

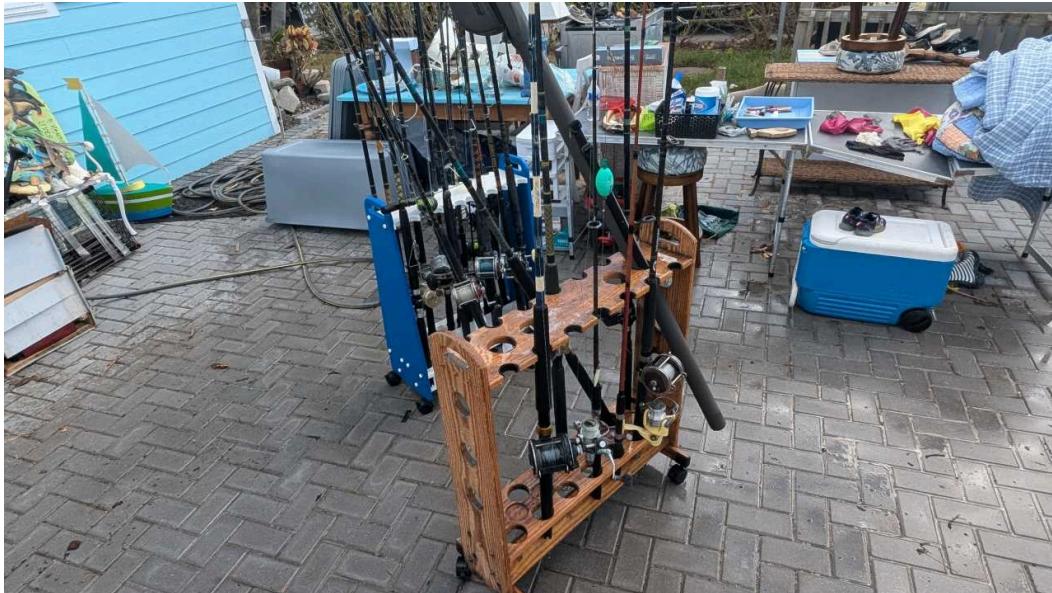
103-Damaged Contents

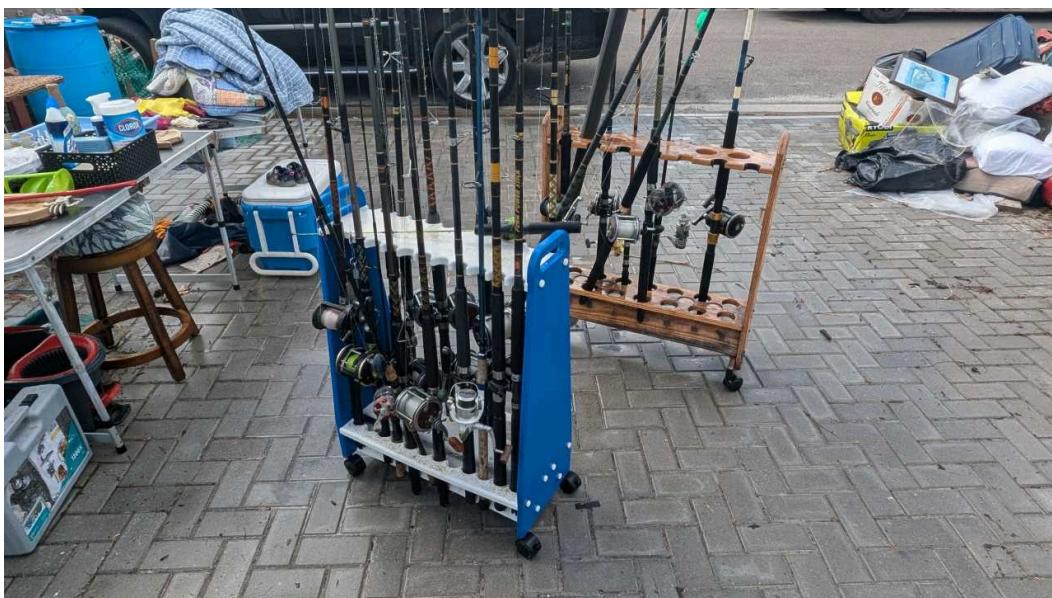
104-Damaged Contents

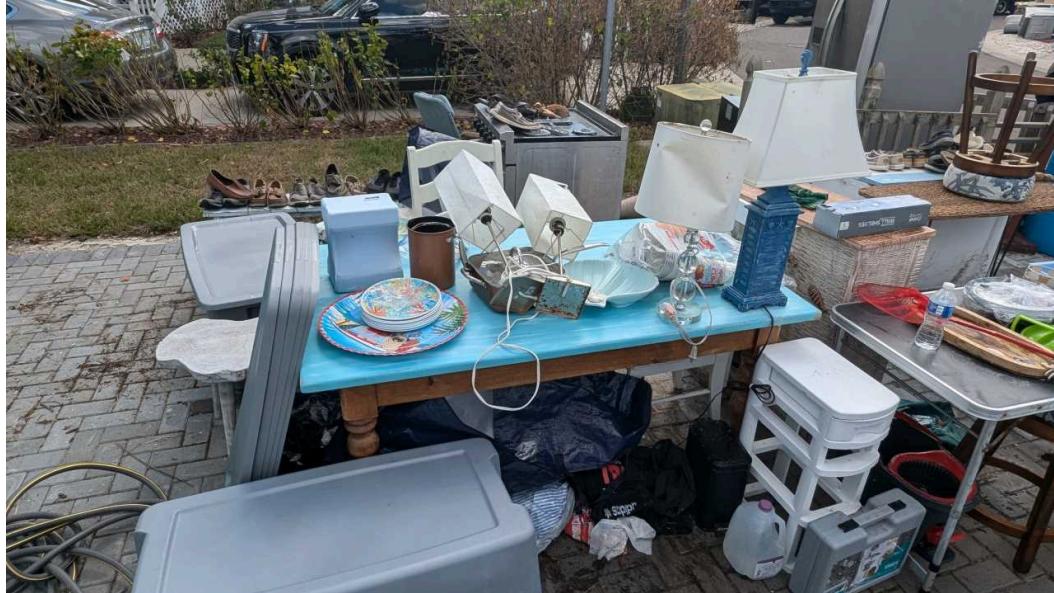
105-Damaged Contents

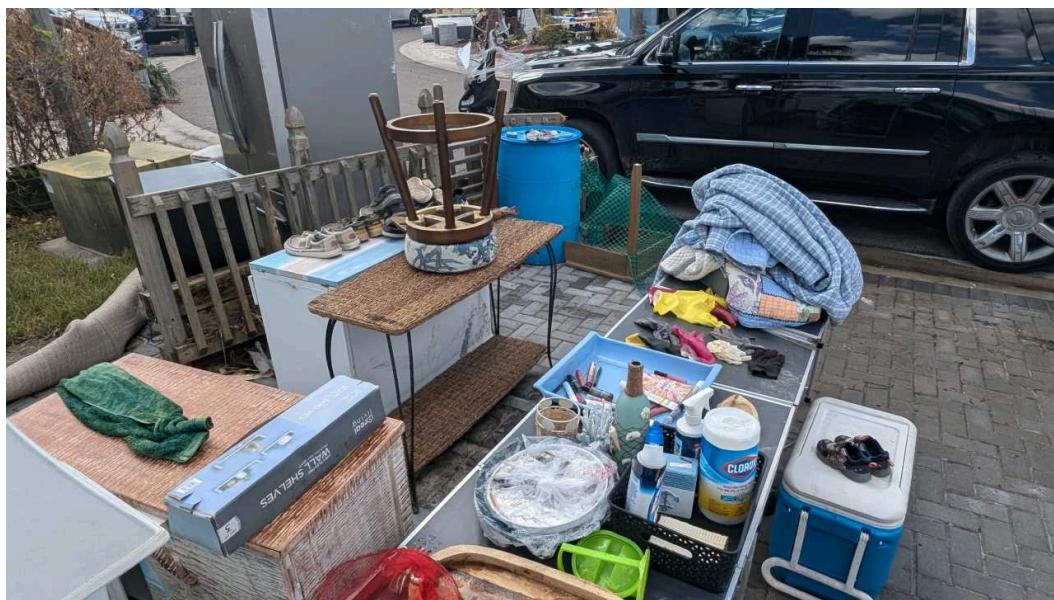
106-Damaged Contents

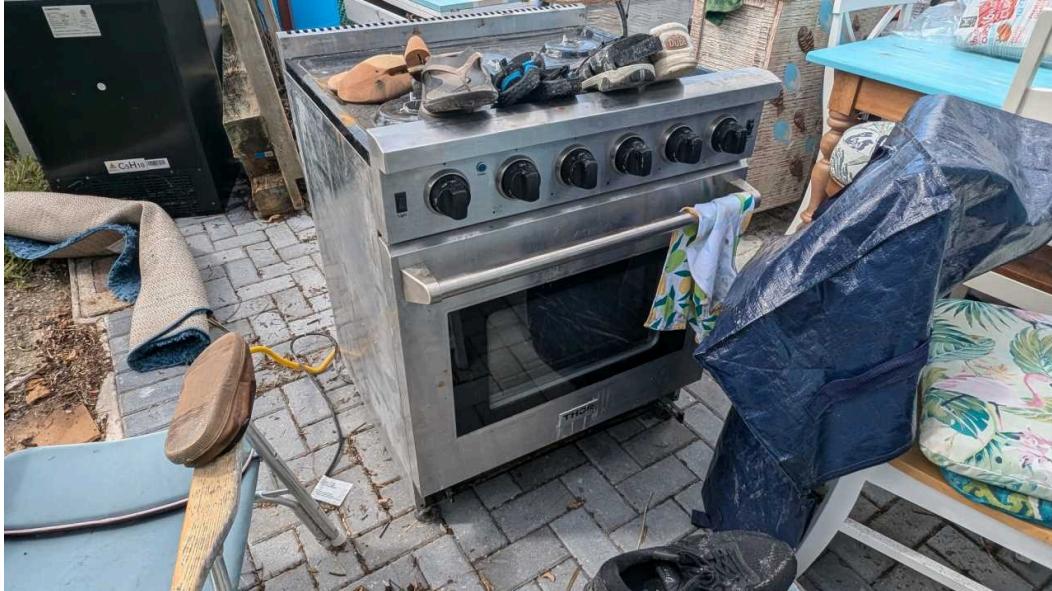
107-Damaged Contents

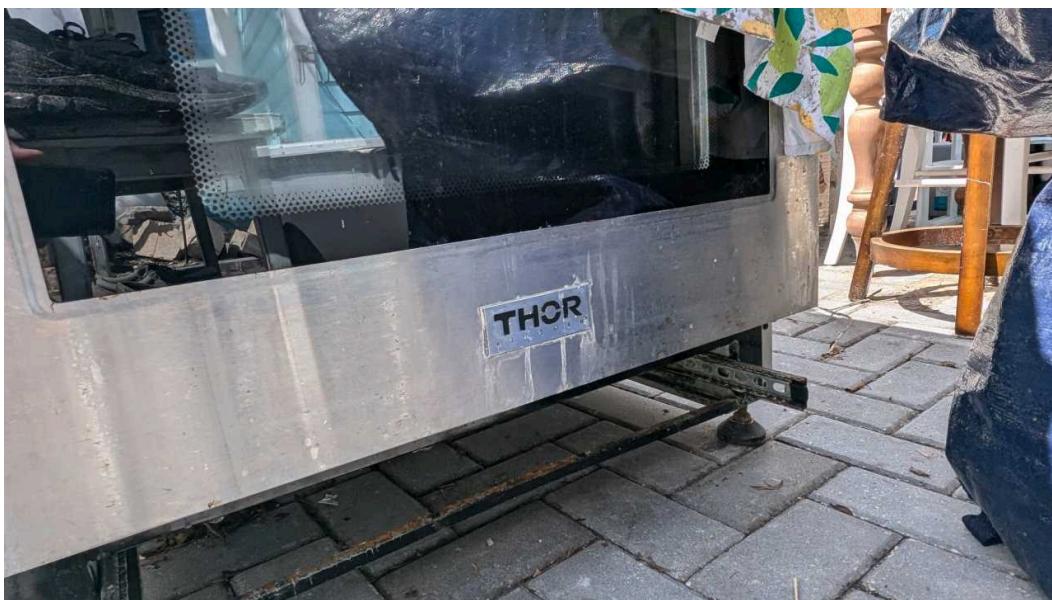
108-Damaged Contents

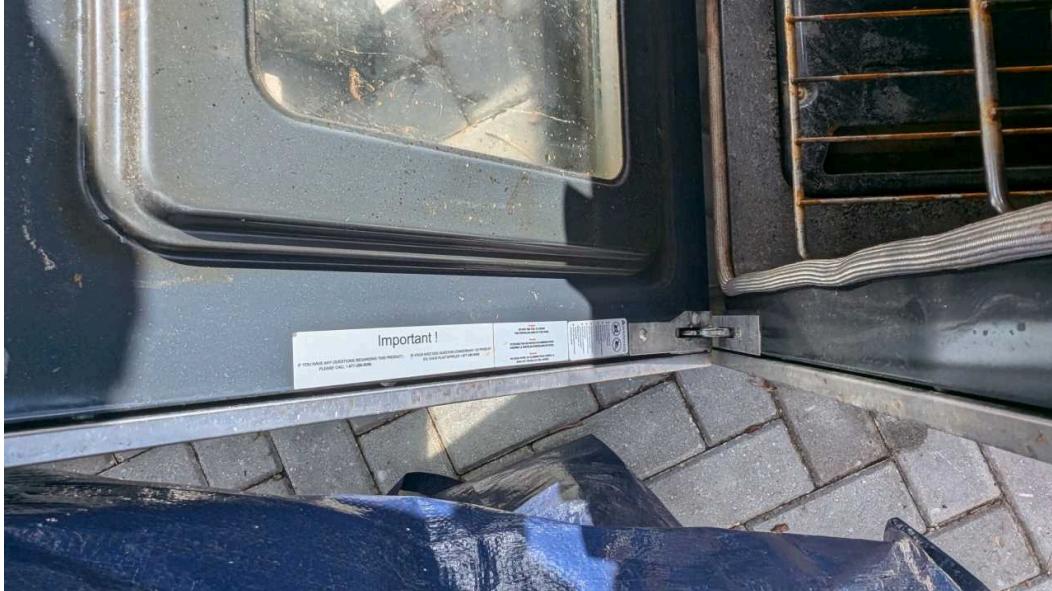
109-Damaged Contents

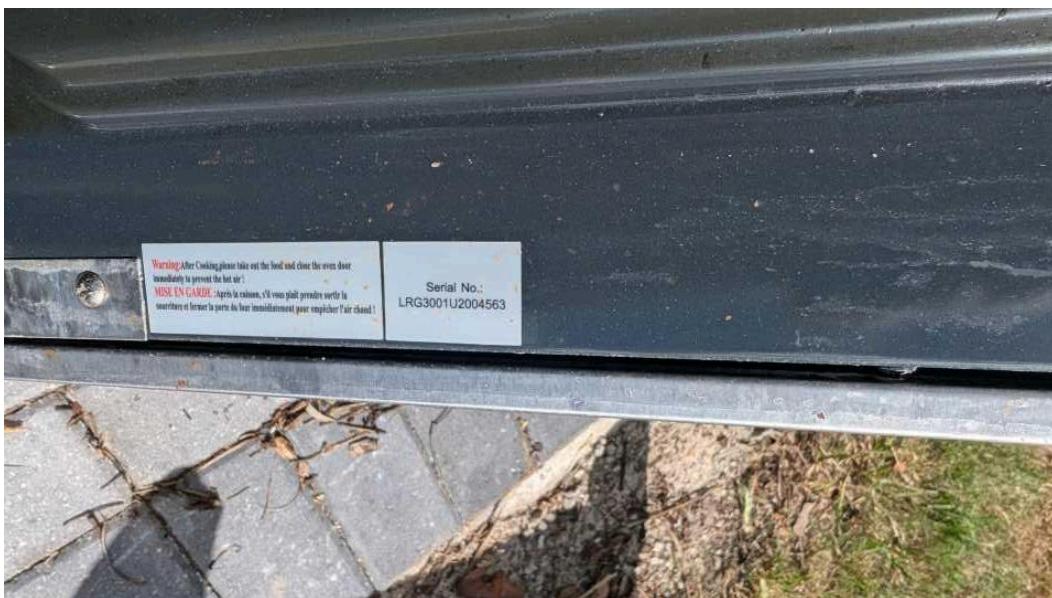
110-Damaged Contents

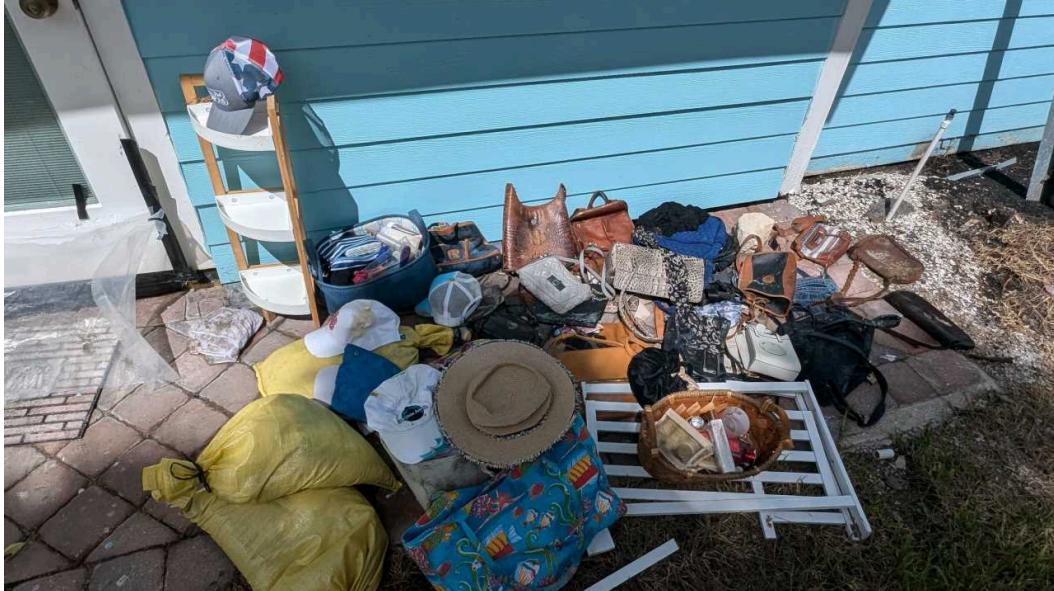
111-Damaged Contents

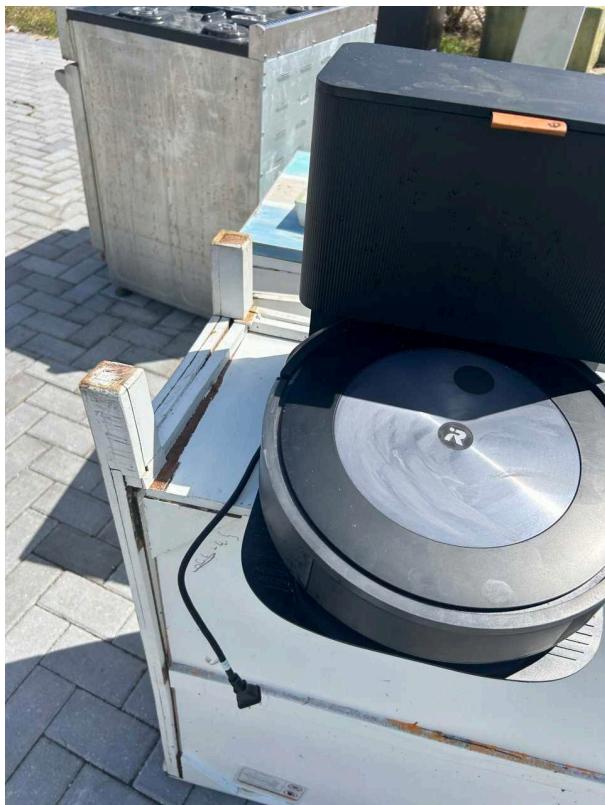
112-Damaged Contents

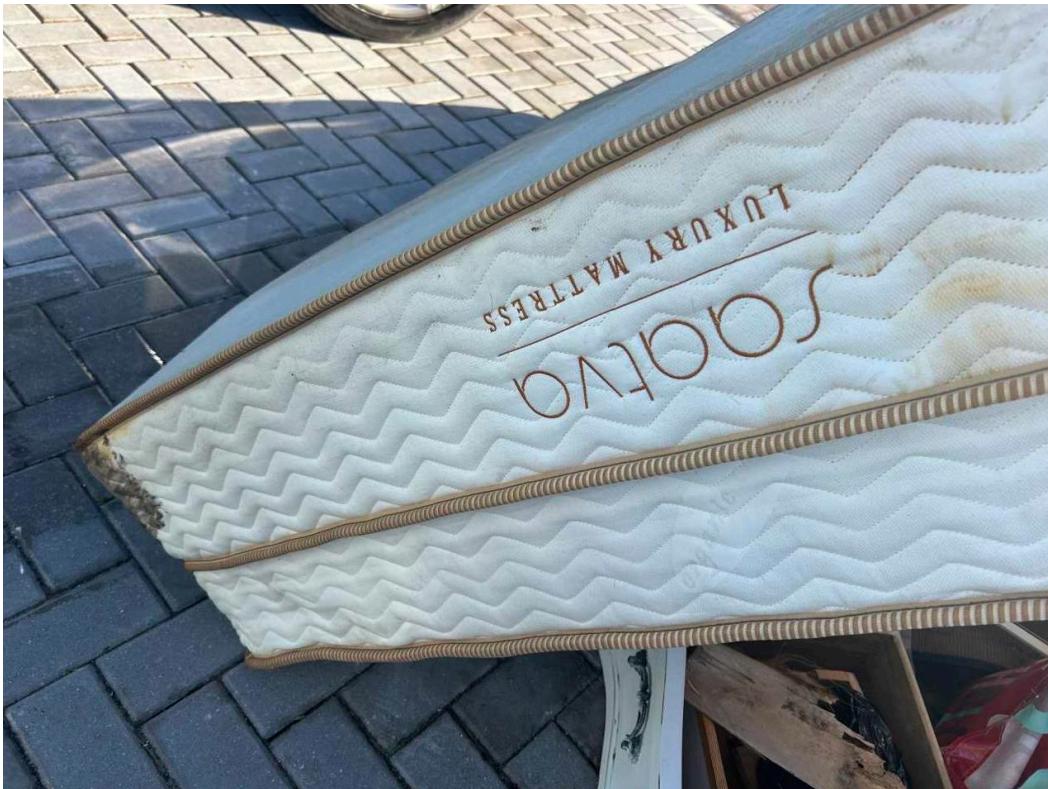
113-Damaged Contents
