Policyholder:	SUSAN COTTLE, STEVE COTTLE	Loss Address:	960 182ND AVE E, REDINGTON SHORES,
Policy Number:	9904123014		FL,
Claim Number:	9904123014-09262024		33708-1039,
Date of Loss:	9/26/2024	Adjuster:	David Quenelle
Carrier:	American Bankers

CARRIER CONCERNS **REVISED FINAL REPORT**

NARRATIVE REPORT **DWELLING / UNIT OWNER**

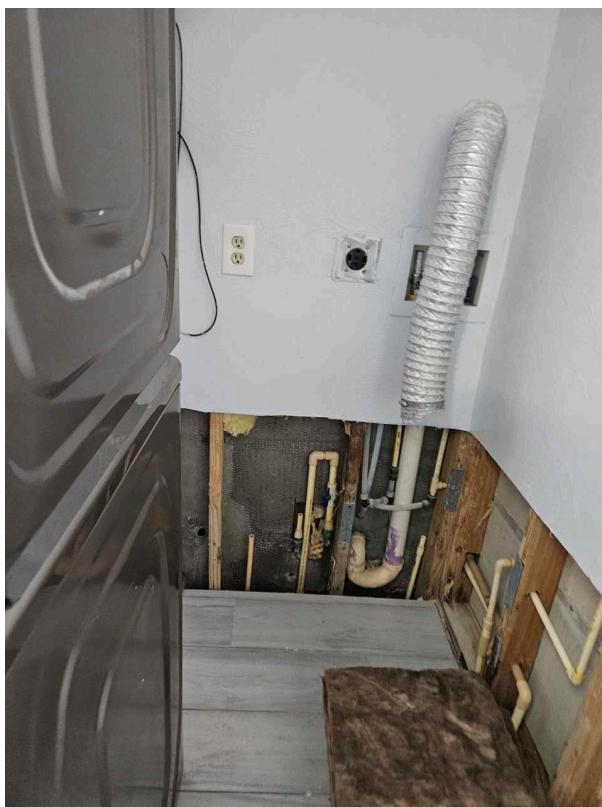
114-Prior Repairs

repairs following the prior loss of
12/17/2023

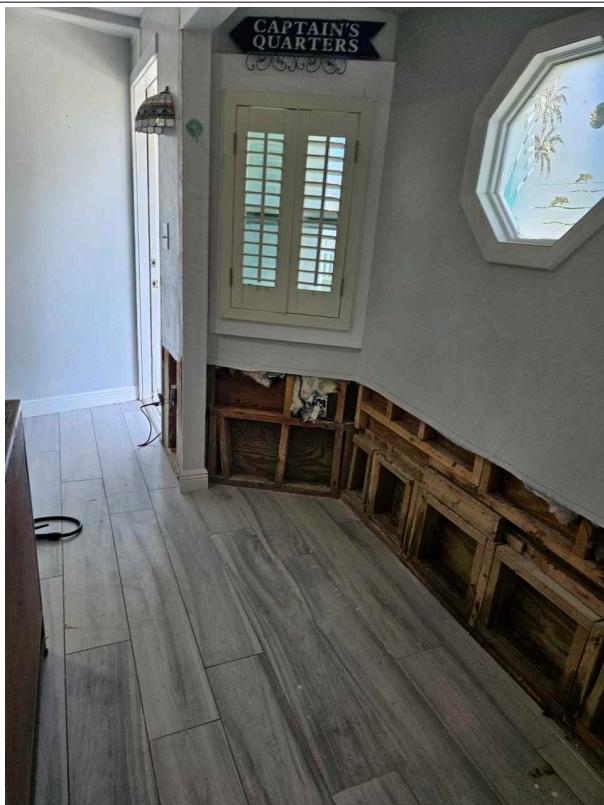
Mr Cottle has provided photos of repairs in progress following the most recent prior loss on 12/17/2023. The photos demonstrate that the drywall and baseboards had been removed.

115-Prior Repairs

repairs following the prior loss of
12/17/2023

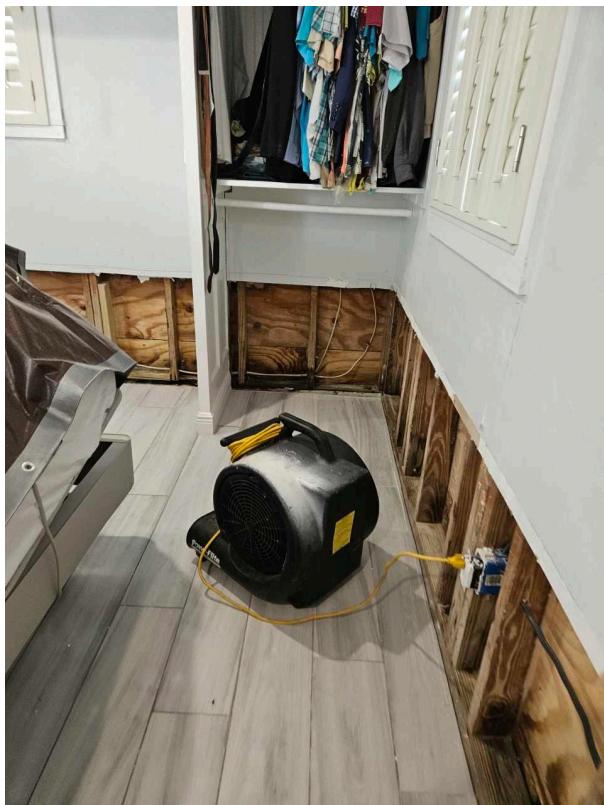
116-Prior Repairs

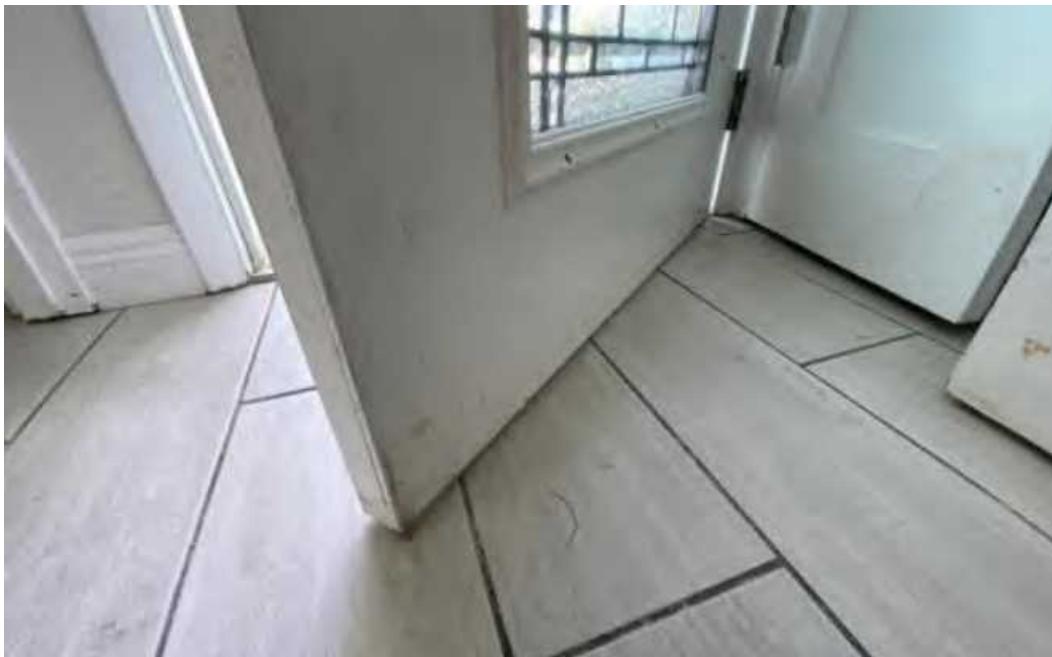
118-Prior Loss Photo

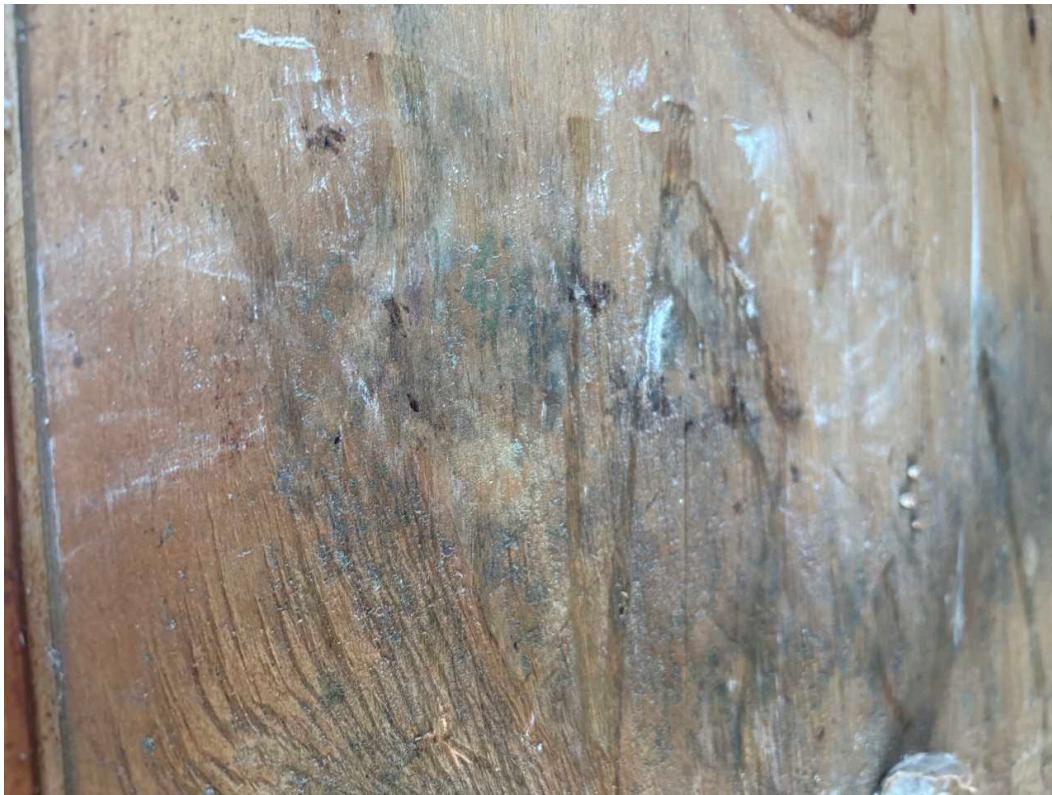
120-Damaged Exterior Wall Sheathing

- Remove and replace sheathing to waterline +1'
- Remove and replace fiber cement siding
- Paint Siding

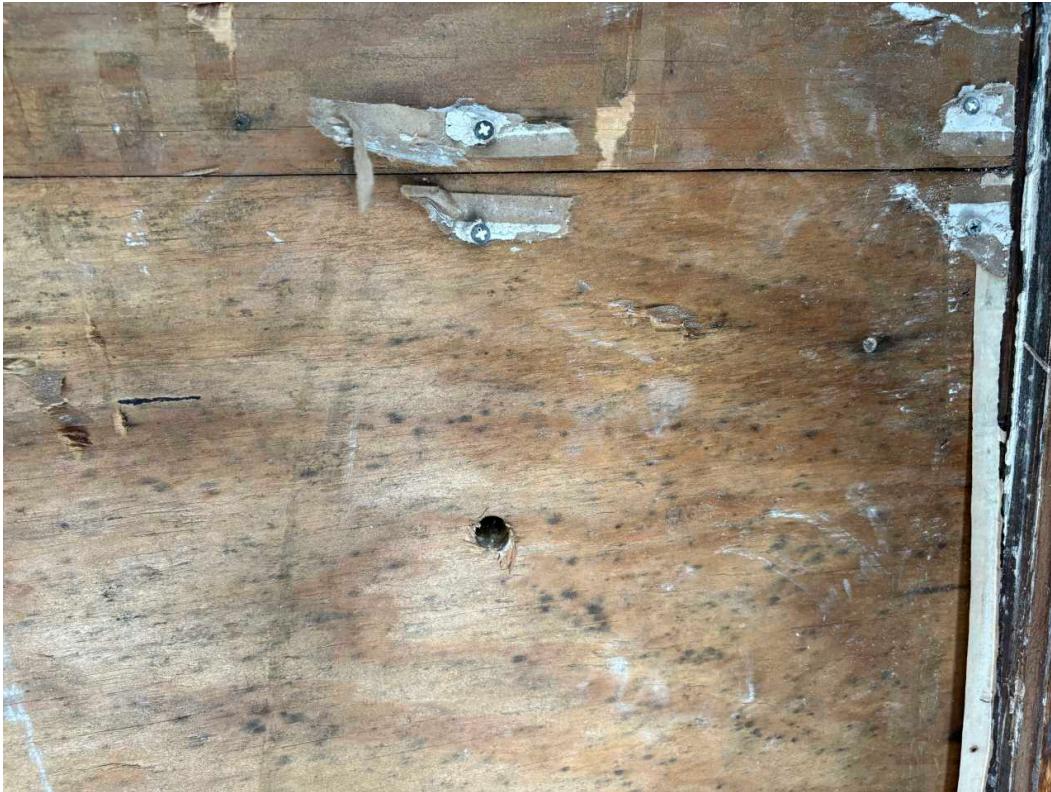
121-Damaged Exterior Wall Sheathing

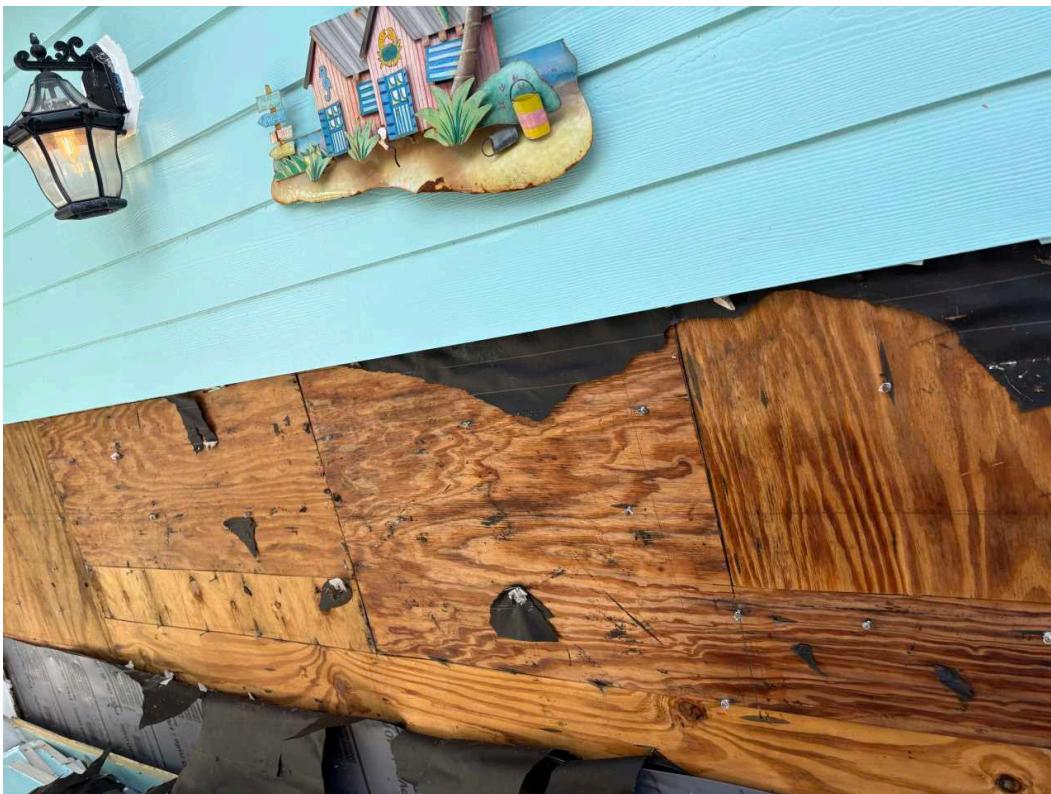
122-Damaged Exterior Wall Sheathing

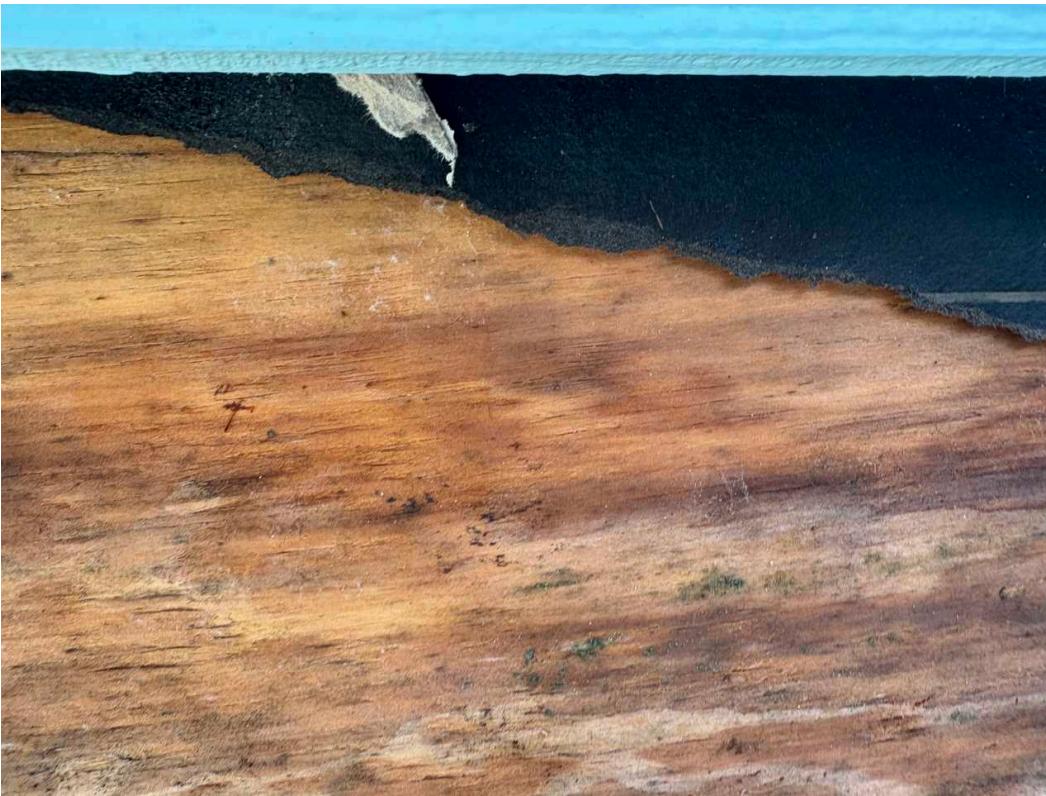
123-Damaged Exterior Wall Sheathing

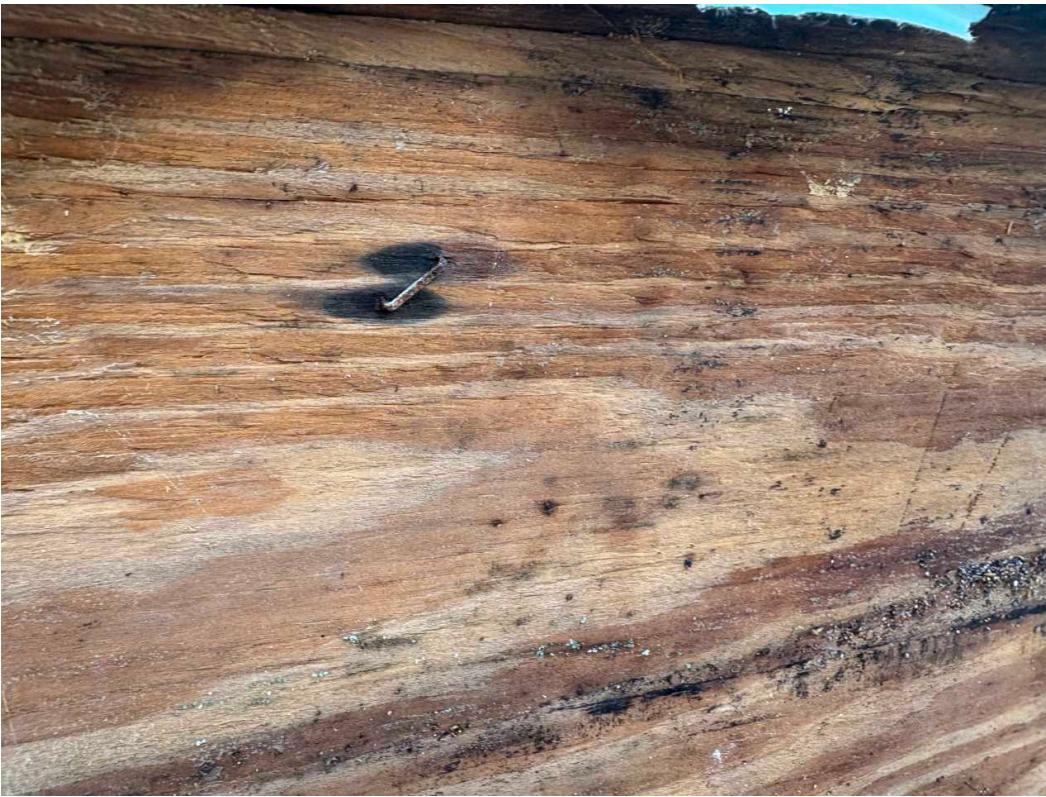
124-Damaged Exterior Wall Sheathing

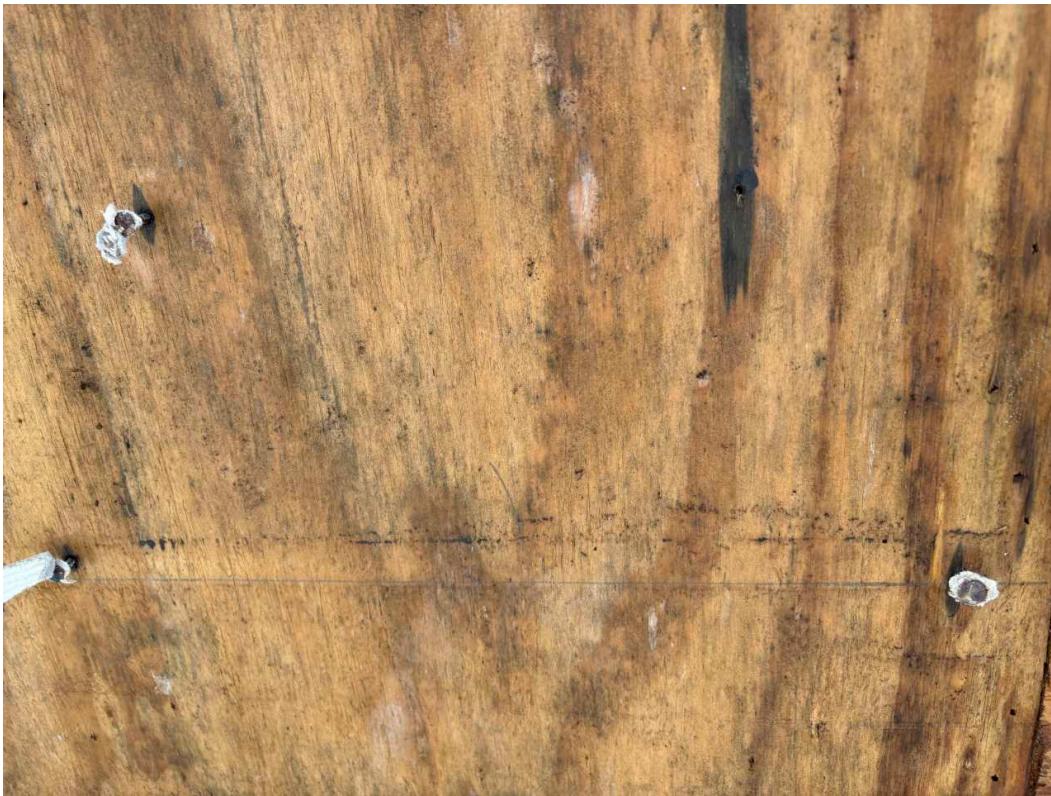
125-Damaged Exterior Wall Sheathing

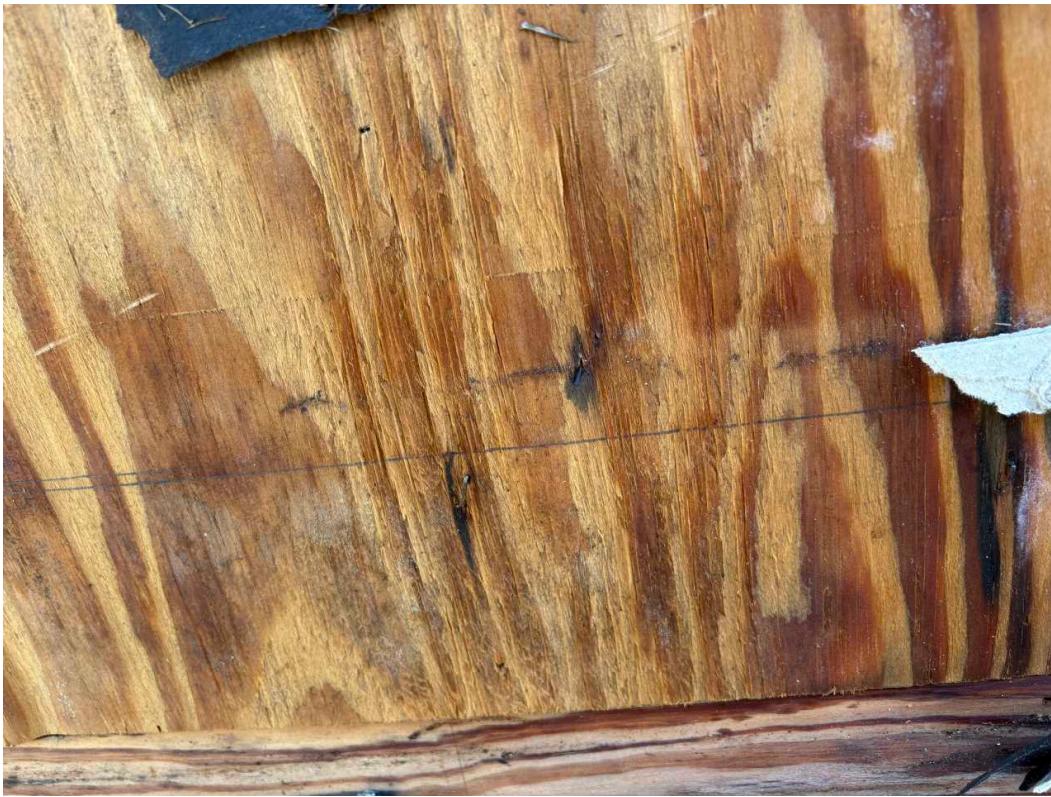
126-Damaged Exterior Wall Sheathing

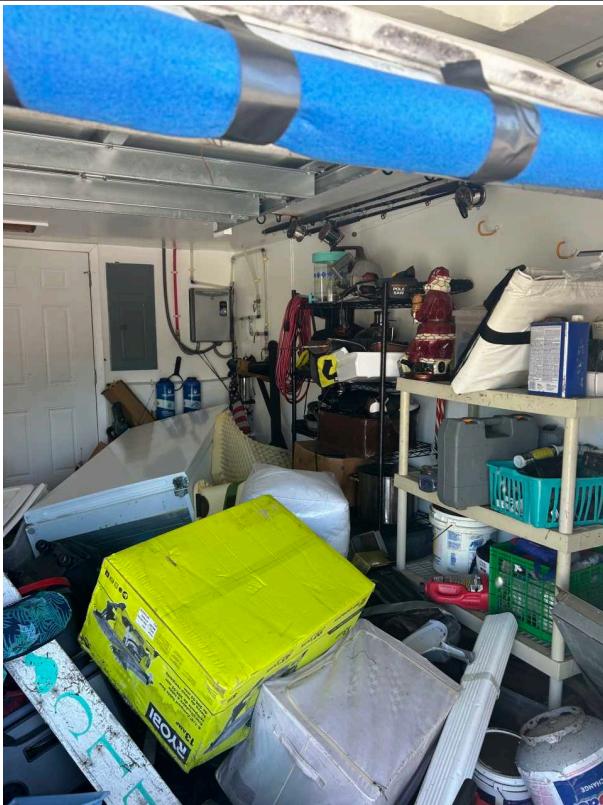
127-Damaged Contents

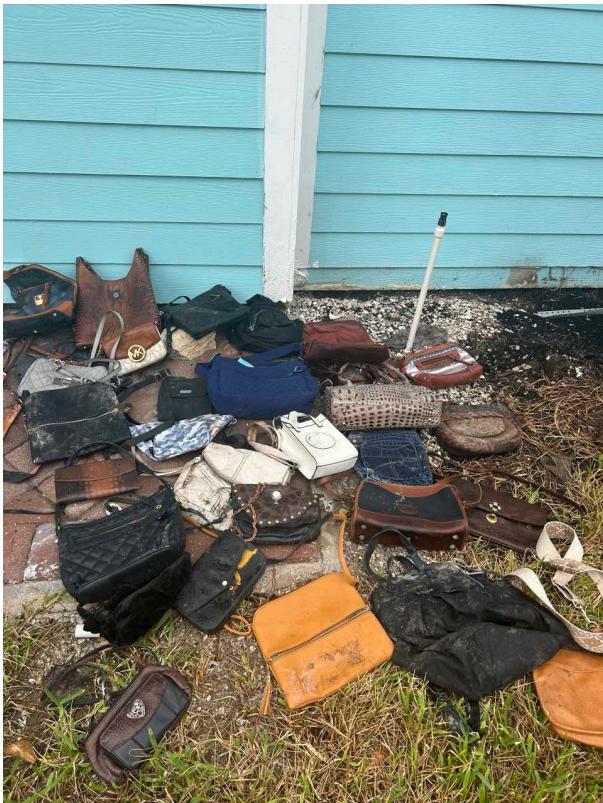
128-Damaged Contents

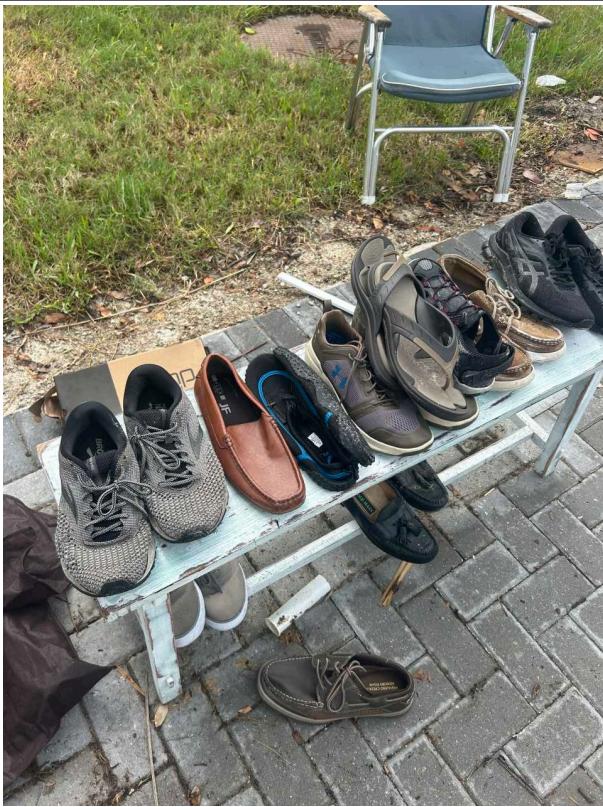
130-Damaged Contents

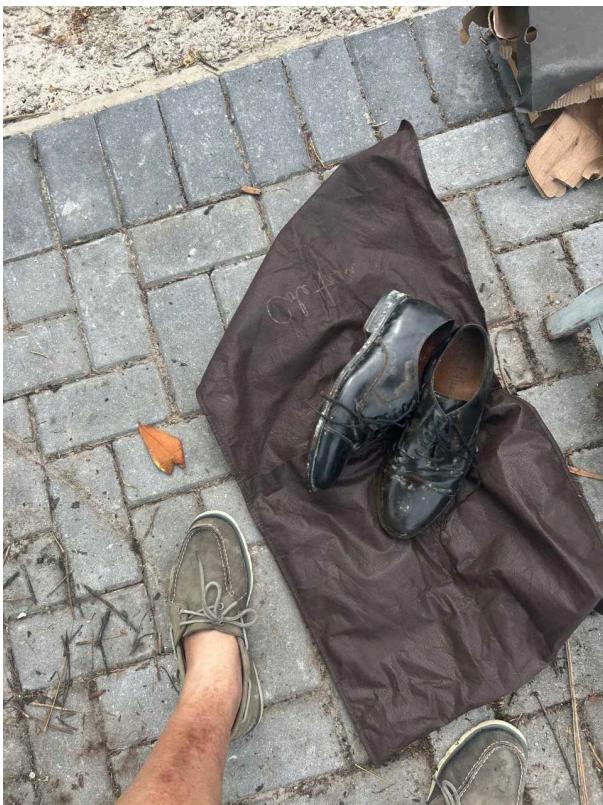
131-Damaged Contents

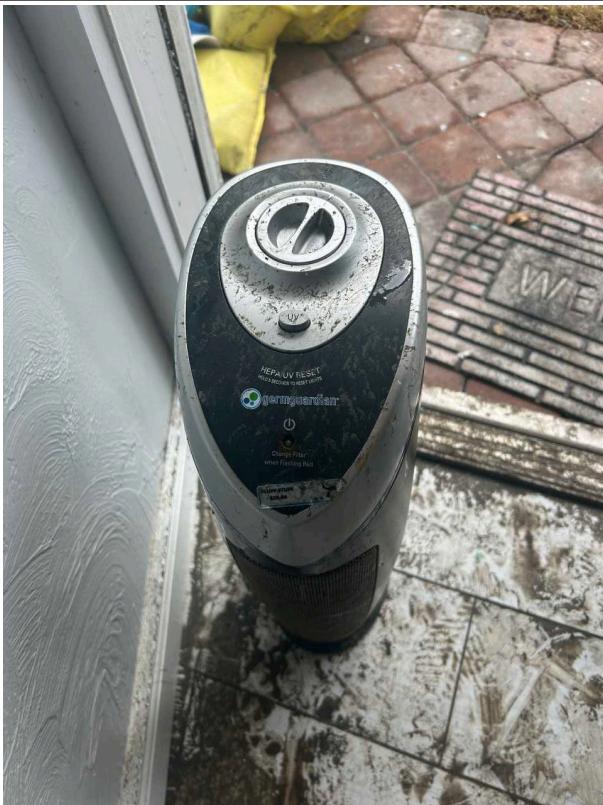
132-Damaged Contents

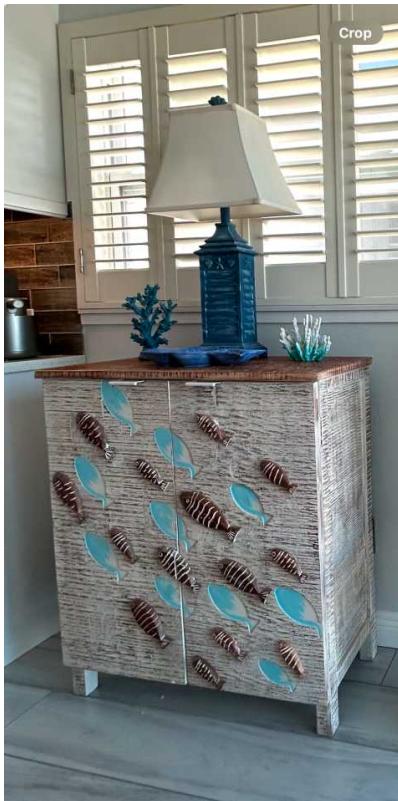
133-Damaged Contents

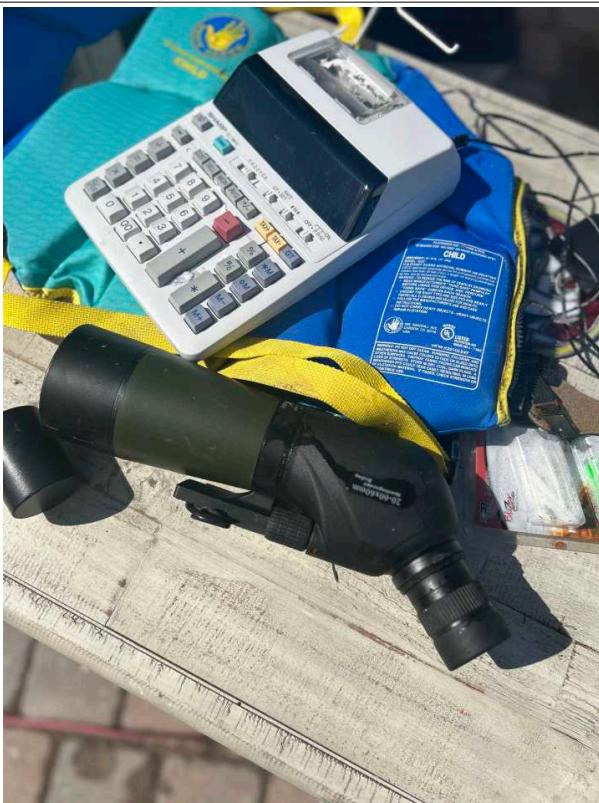
134-Damaged Contents

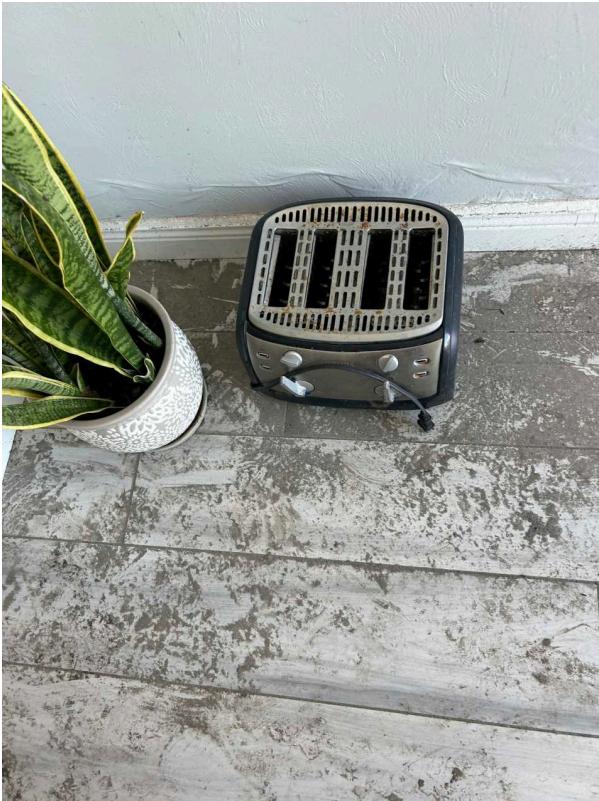
135-Damaged Contents

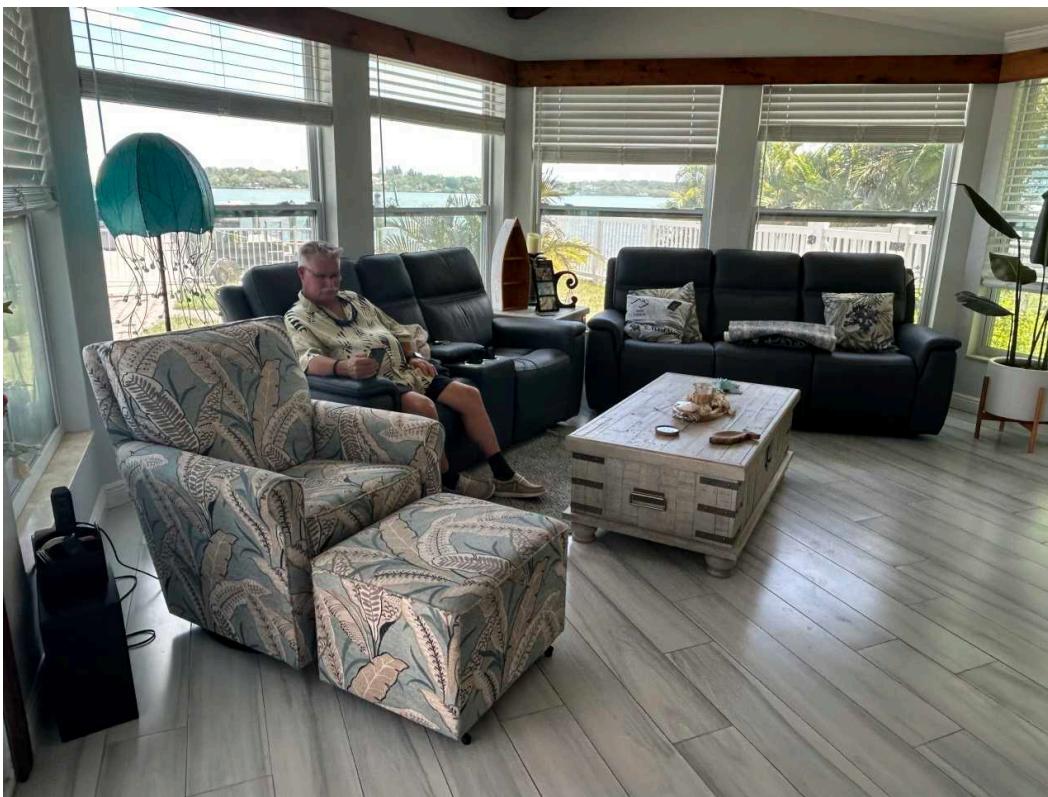
136-Damaged Contents

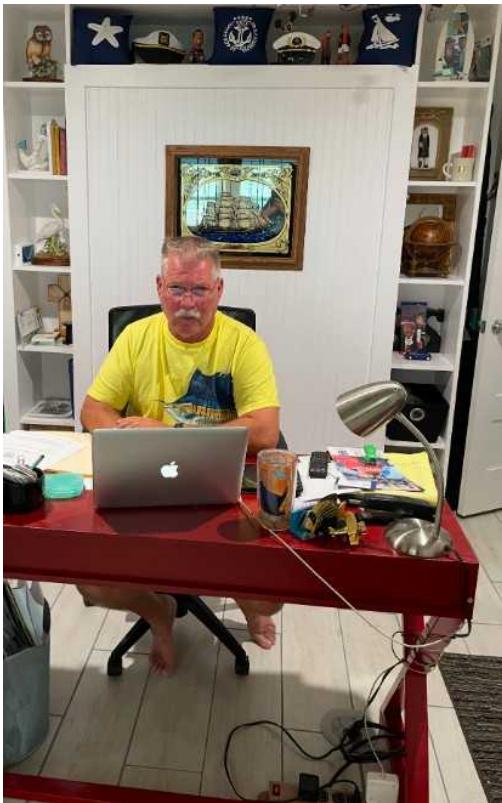
137-Damaged Contents

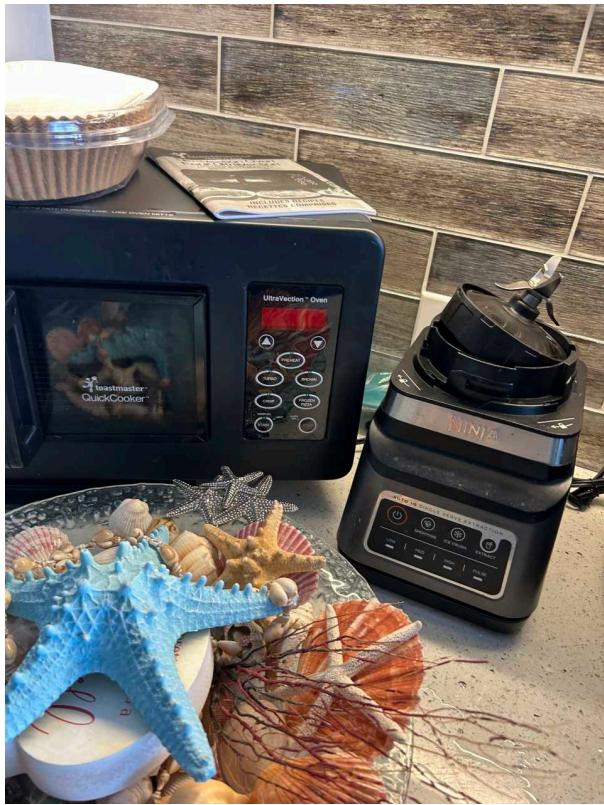
139-Damaged Contents

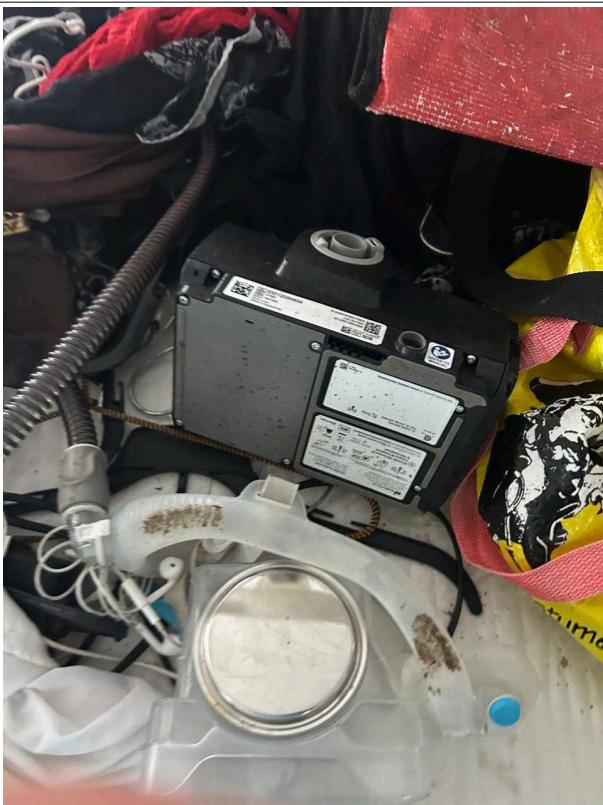
140-Damaged Contents

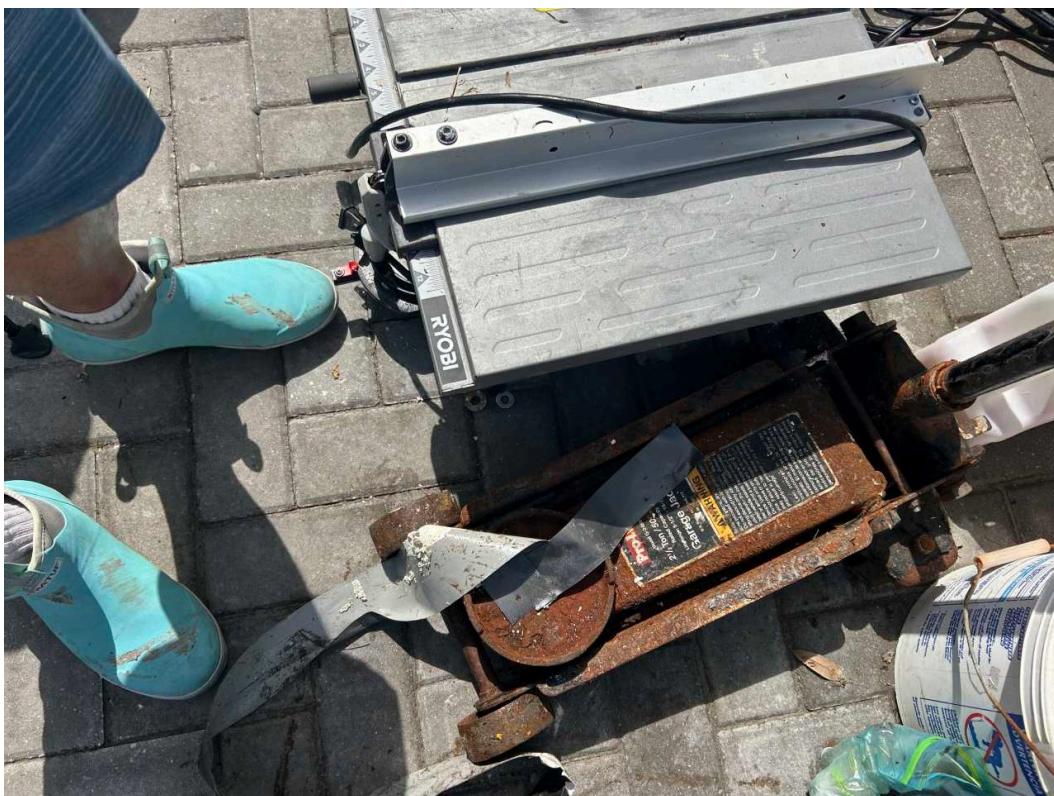
141-Damaged Contents

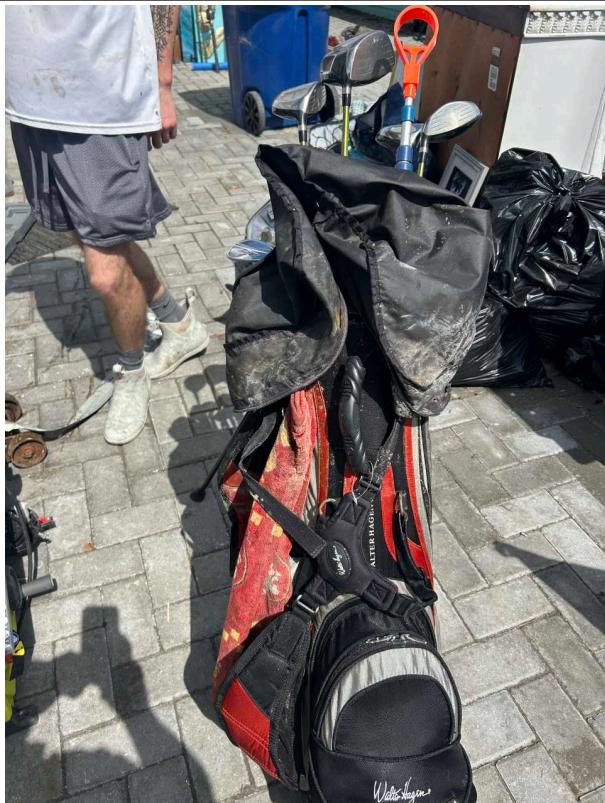
142-Damaged Contents

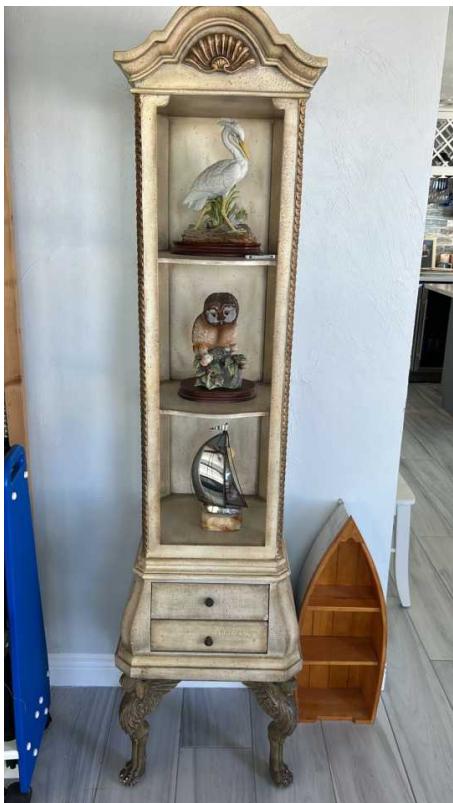
143-Damaged Contents

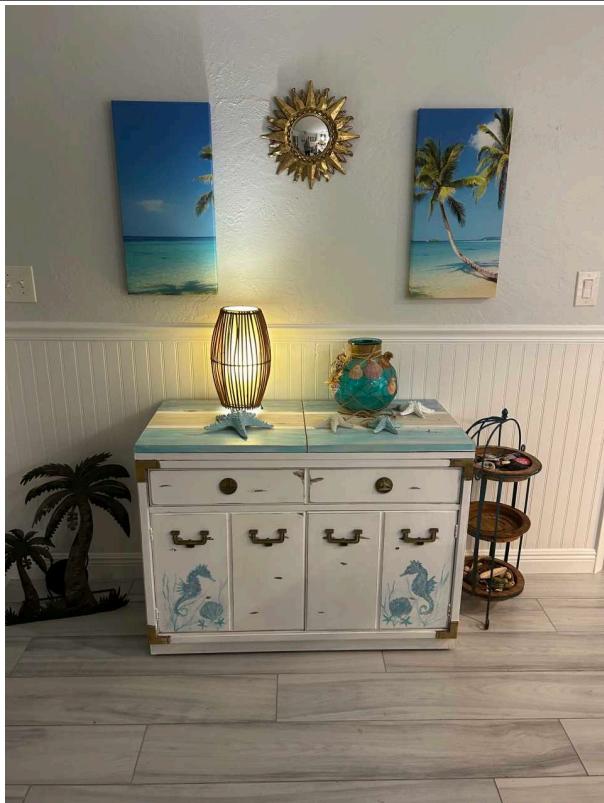
144-Damaged Contents

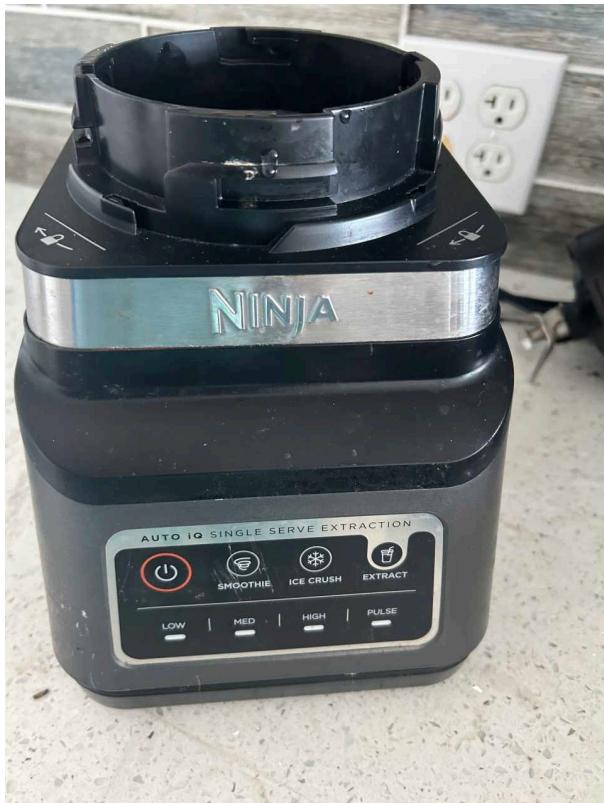
145-Damaged Contents

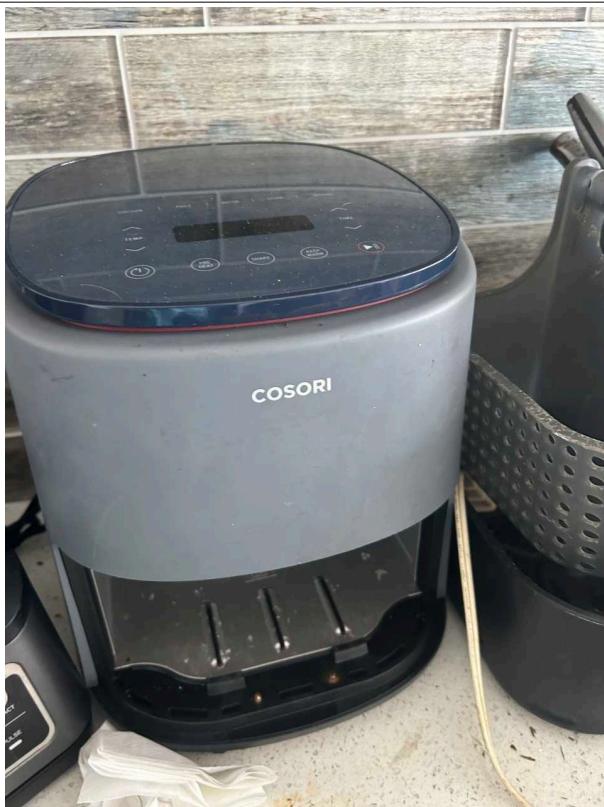
146-Damaged Contents

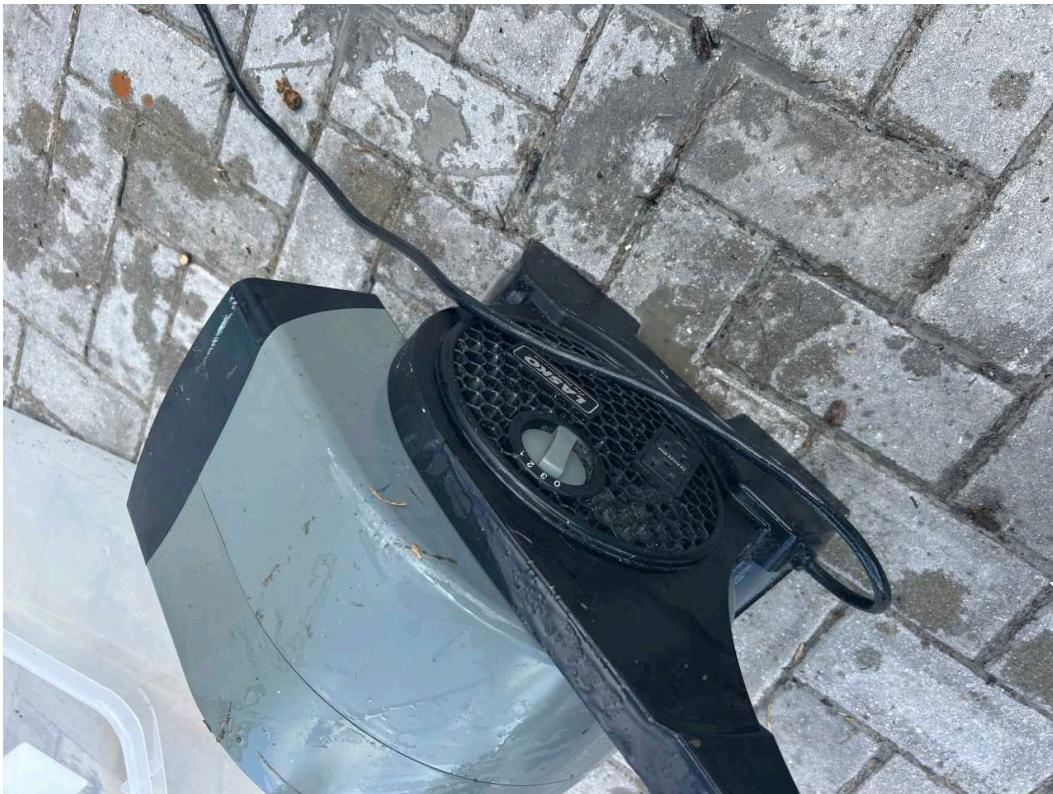
148-Damaged Contents

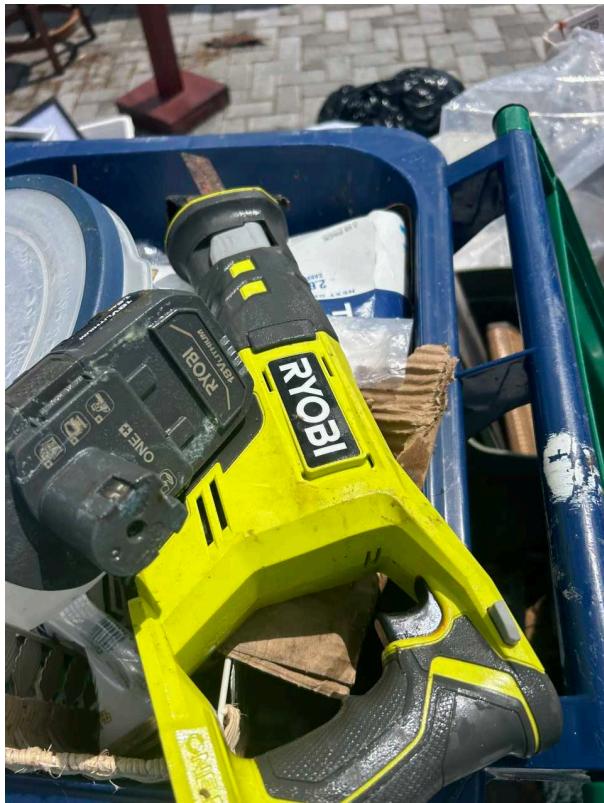
149-Damaged Contents

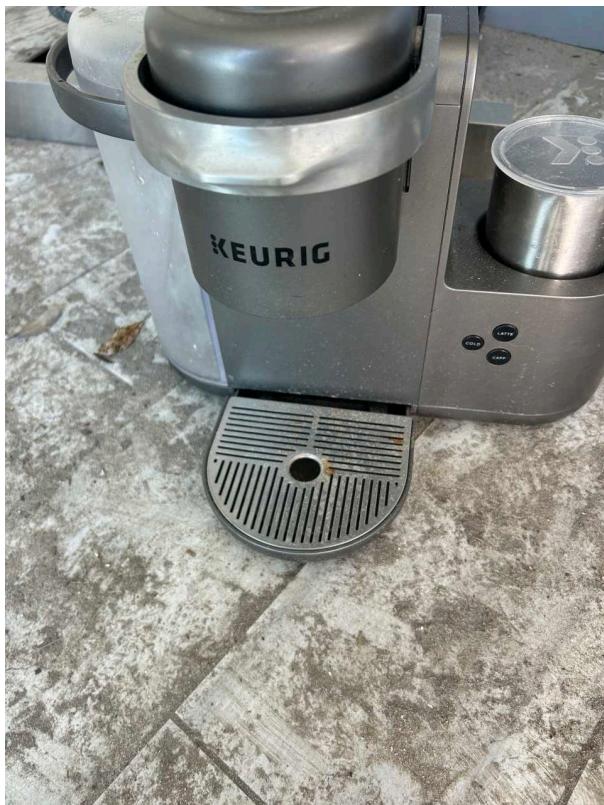
151-Damaged Contents

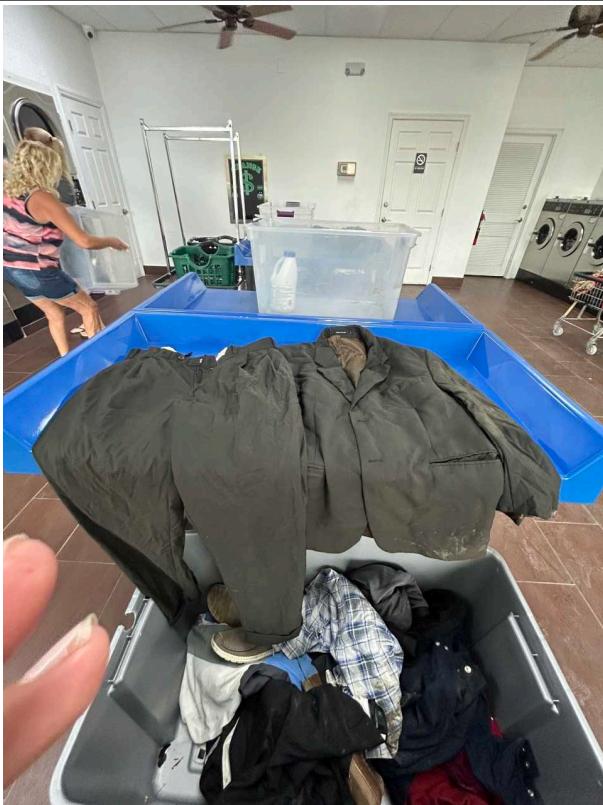
152-Damaged Contents

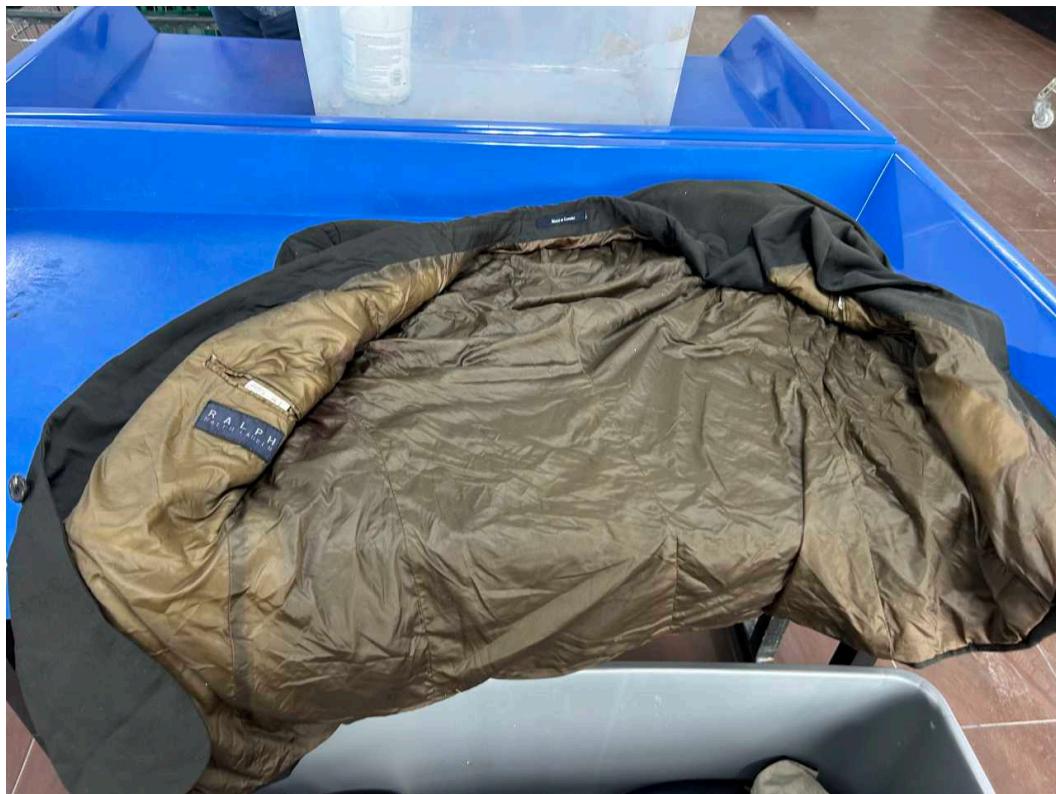
153-Damaged Contents

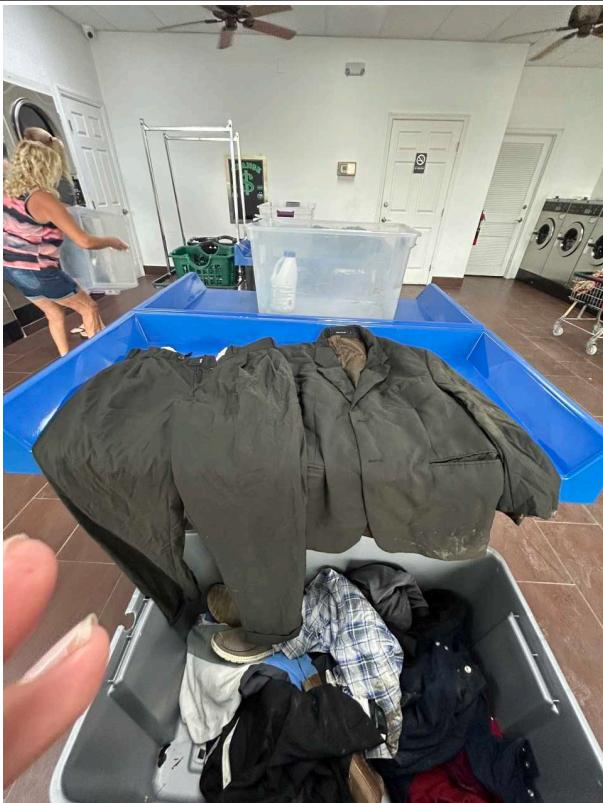
154-Damaged Contents

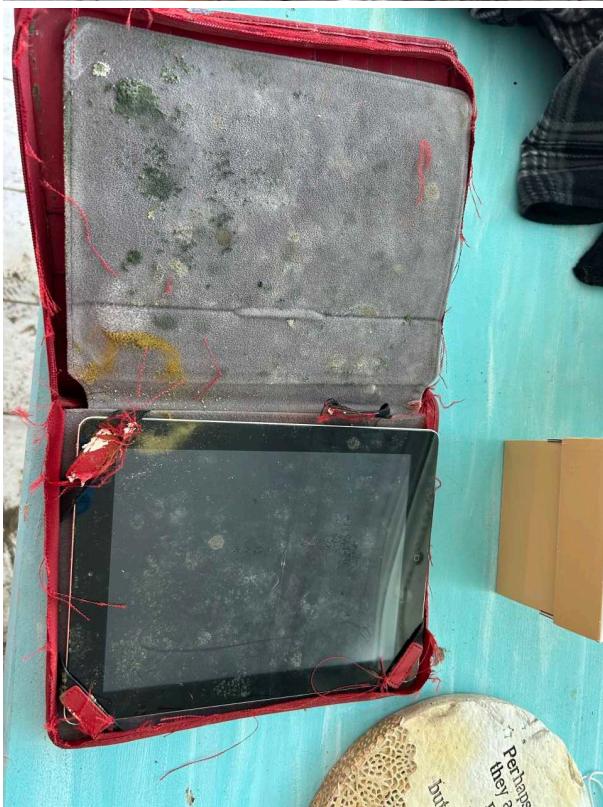
163-Damaged Contents

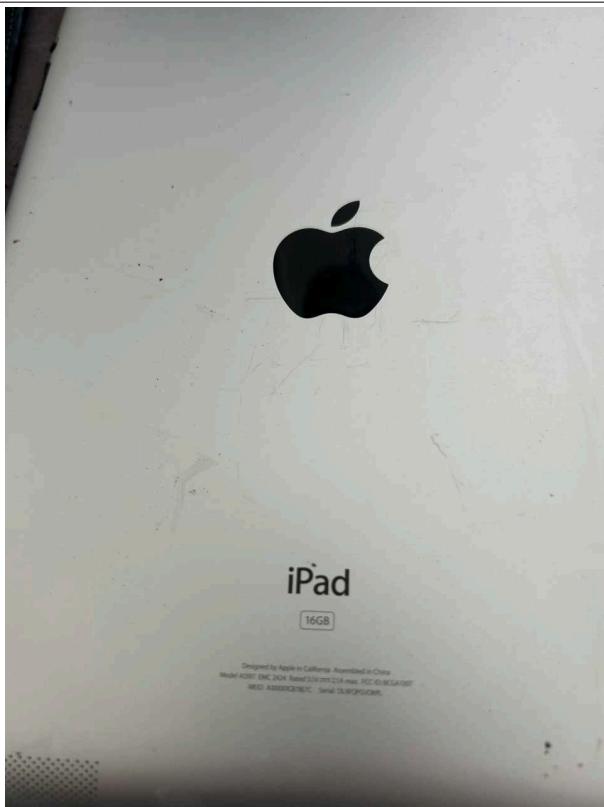
164-Damaged Contents

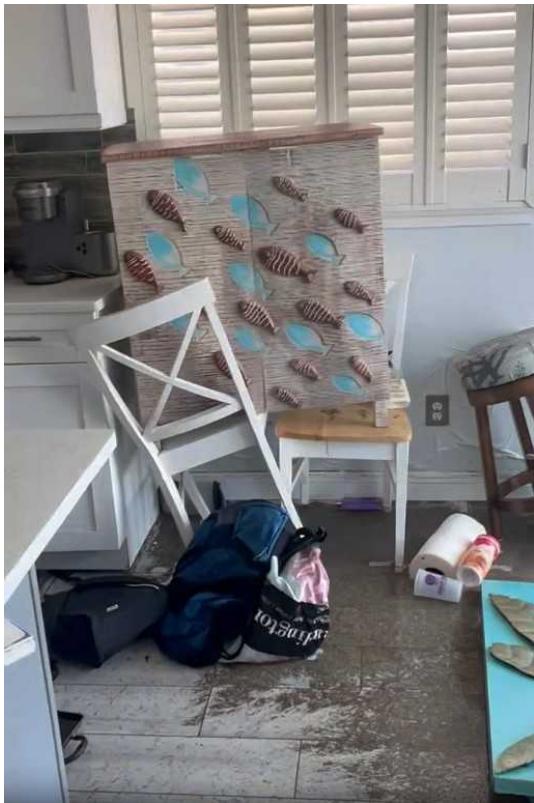
165-Damaged Contents

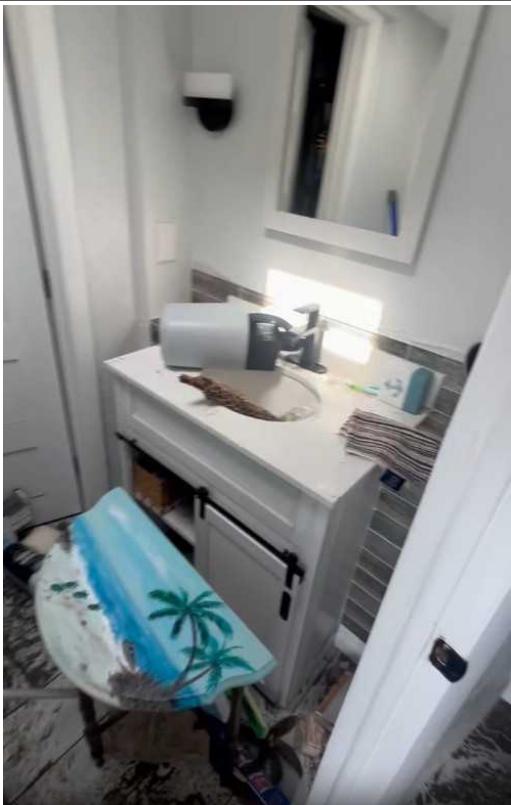
166-Damaged Contents

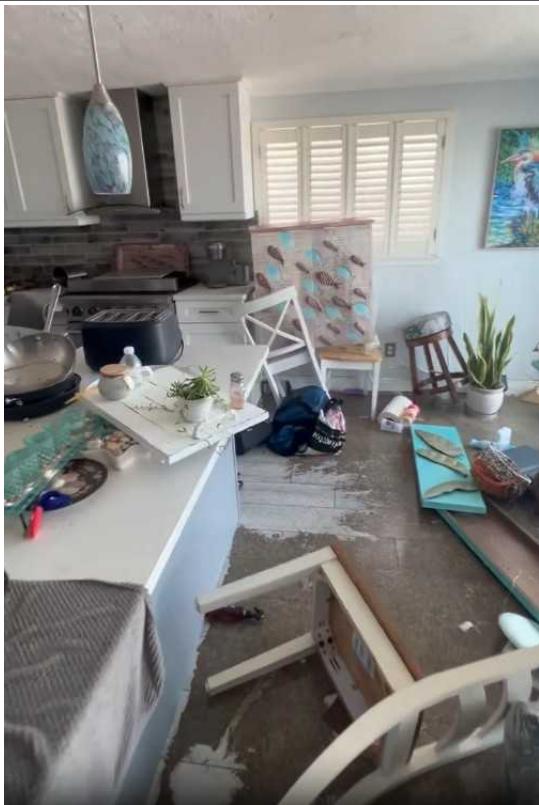
168-Damaged Contents
