Policyholder:	SUSAN COTTLE, STEVE COTTLE	Loss Address:	960 182ND AVE E, REDINGTON SHORES,
Policy Number:	9904123014		FL,
Claim Number:	9904123014-09262024		33708-1039,
Date of Loss:	9/26/2024	Adjuster:	David Quenelle
Carrier:	American Bankers

CARRIER CONCERNS **REVISED FINAL REPORT**

NARRATIVE REPORT **DWELLING / UNIT OWNER**

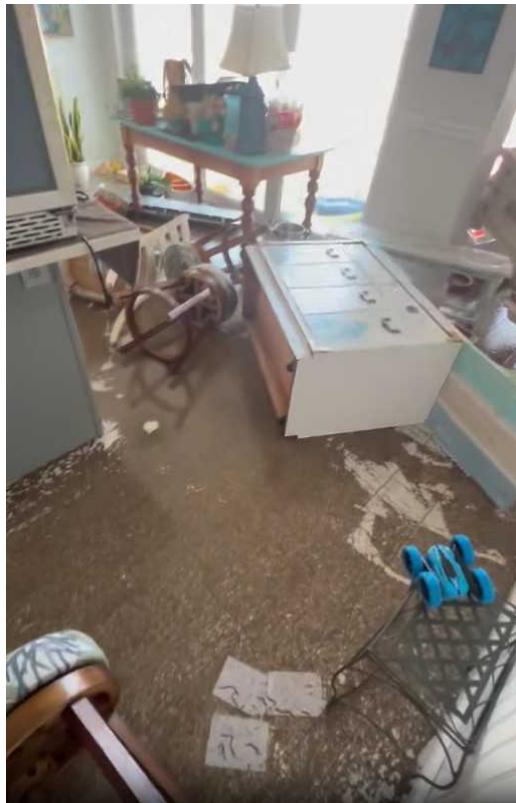
169-Damaged Contents

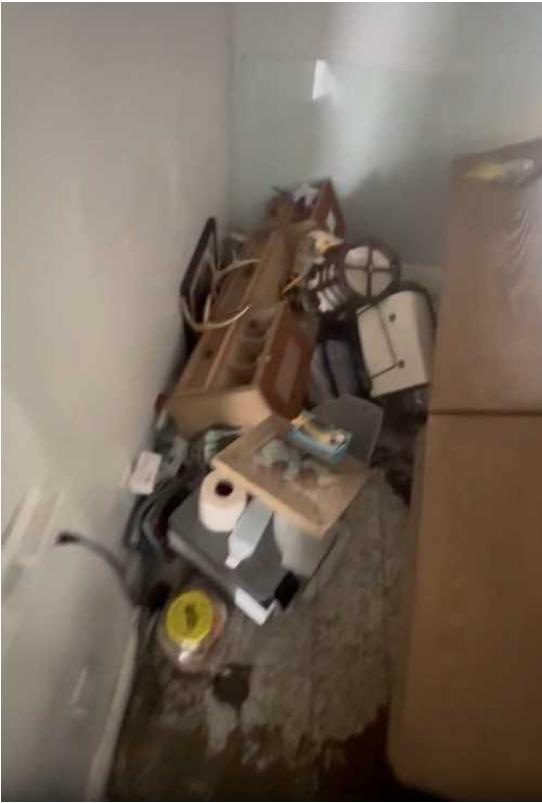
171-Damaged Contents

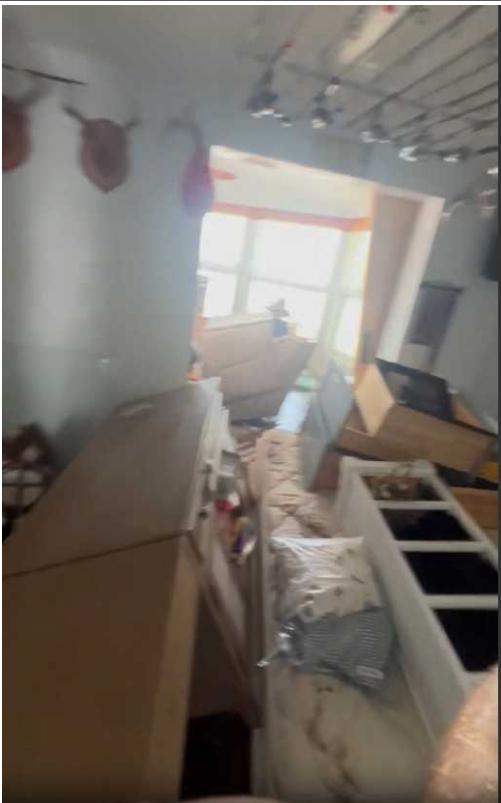
172-Damaged Contents

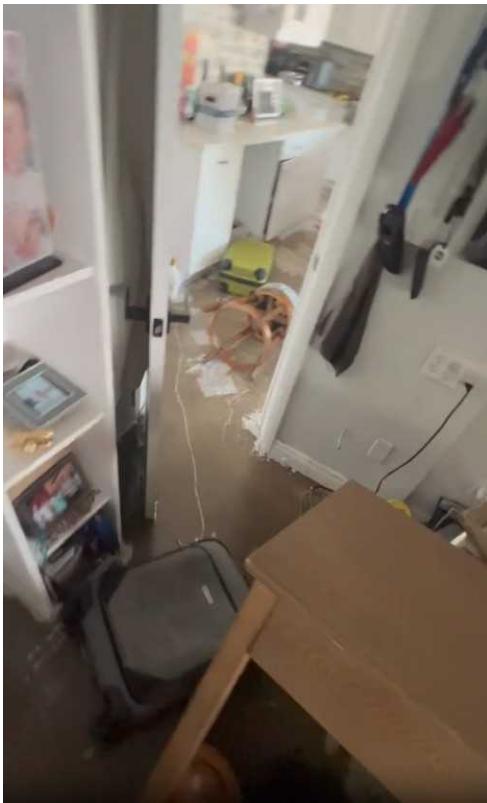
173-Damaged Contents

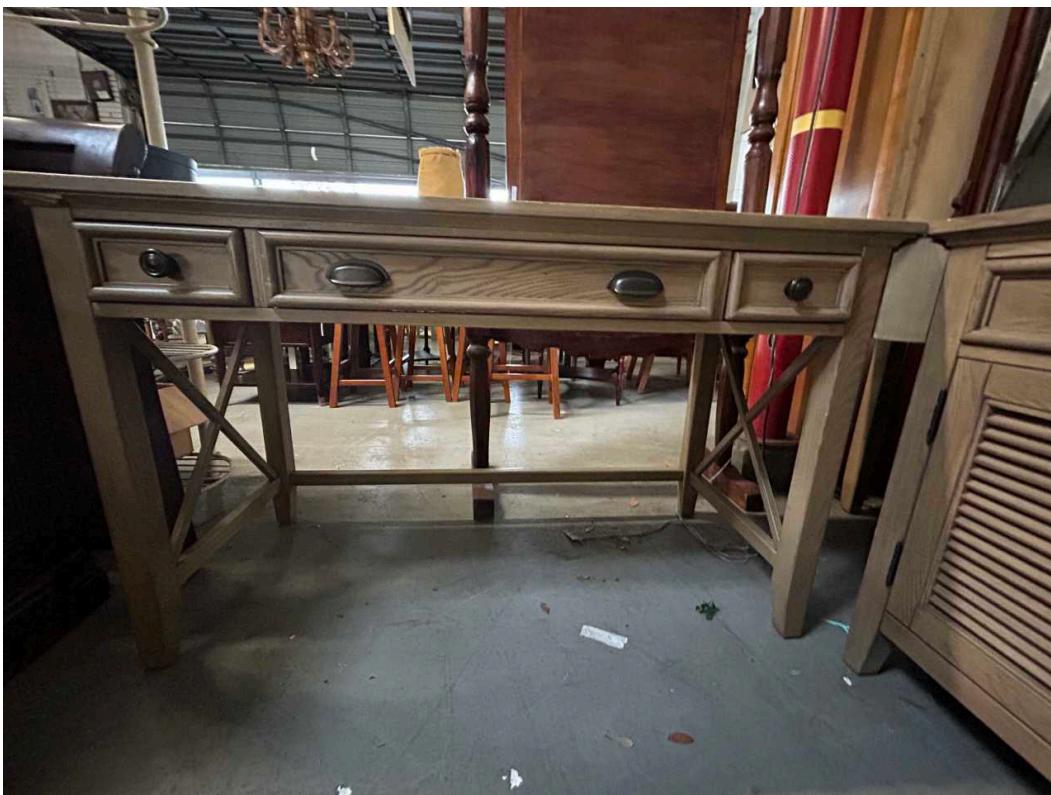
176-Damaged Contents

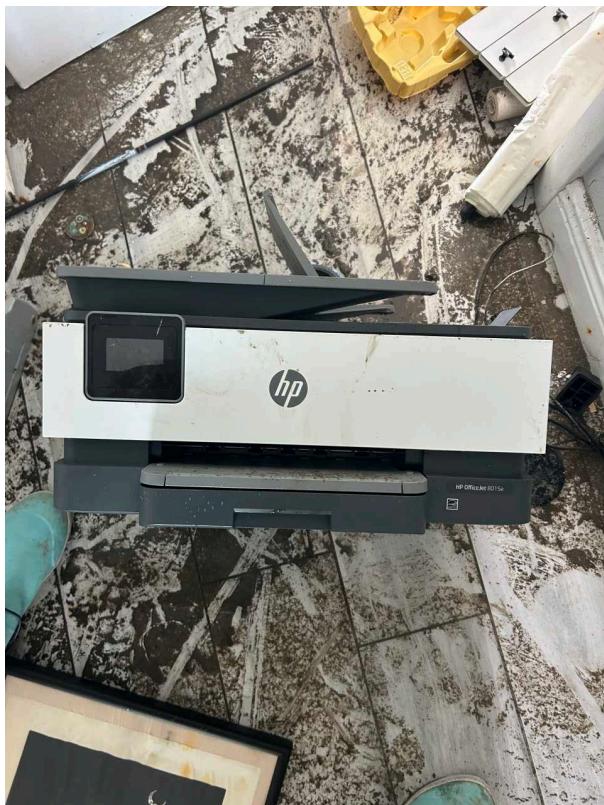
177-Damaged Contents

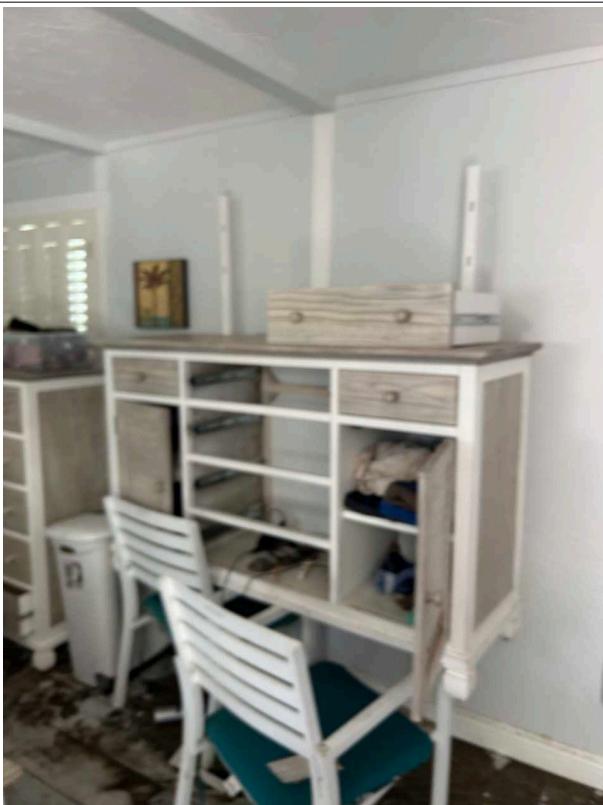
178-Damaged Contents

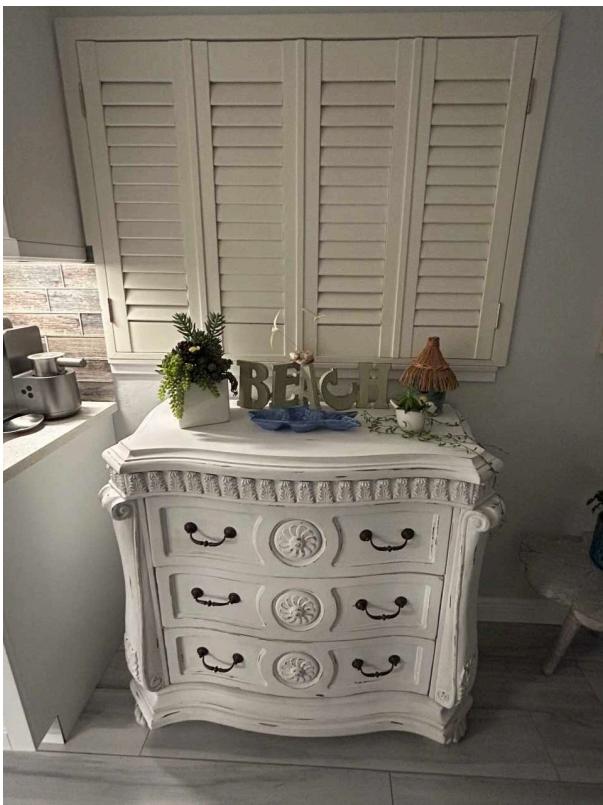
179-Damaged Contents

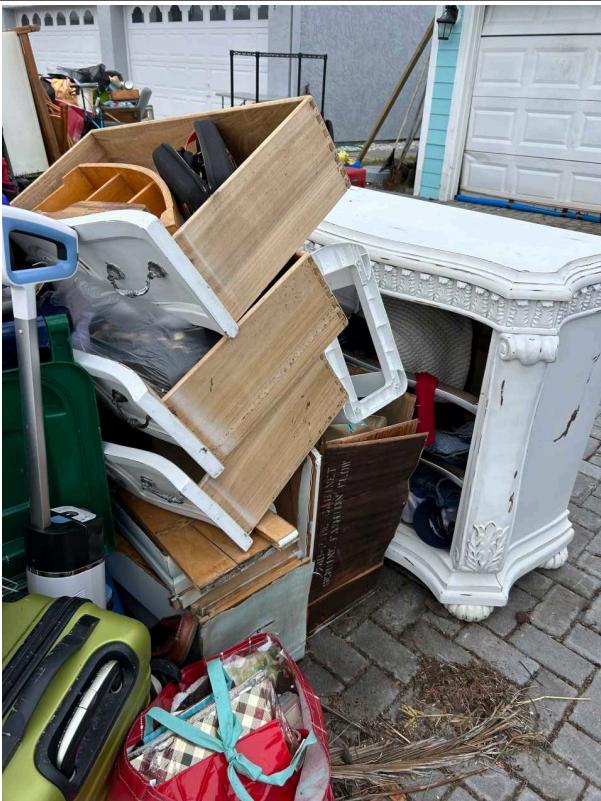
180-Damaged Contents

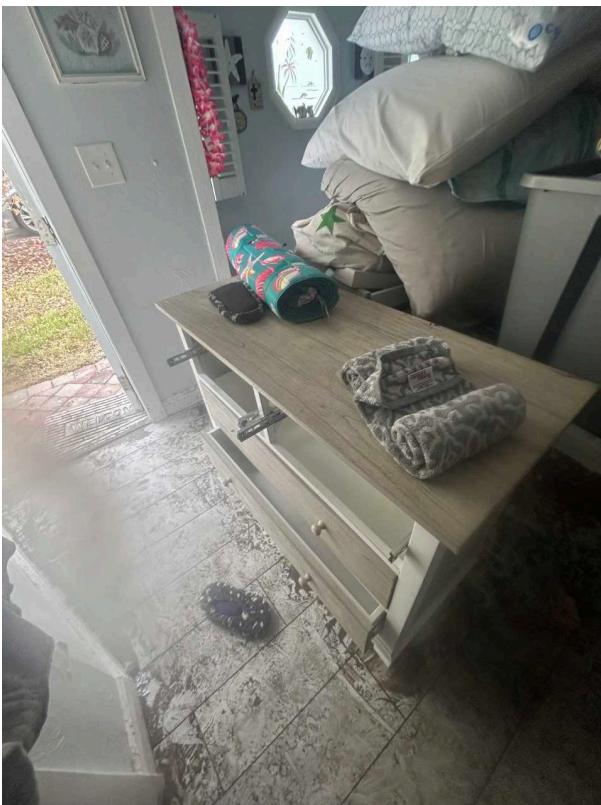
181-Damaged Contents

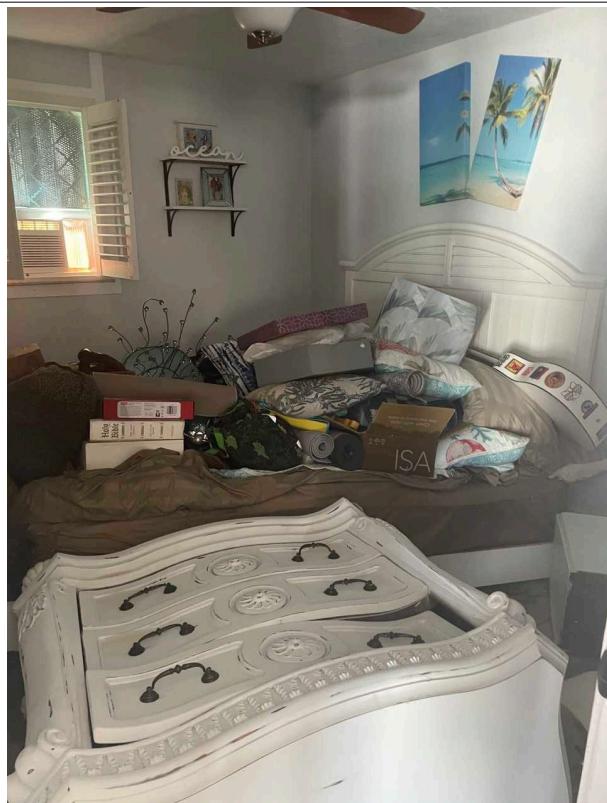
182-Damaged Contents

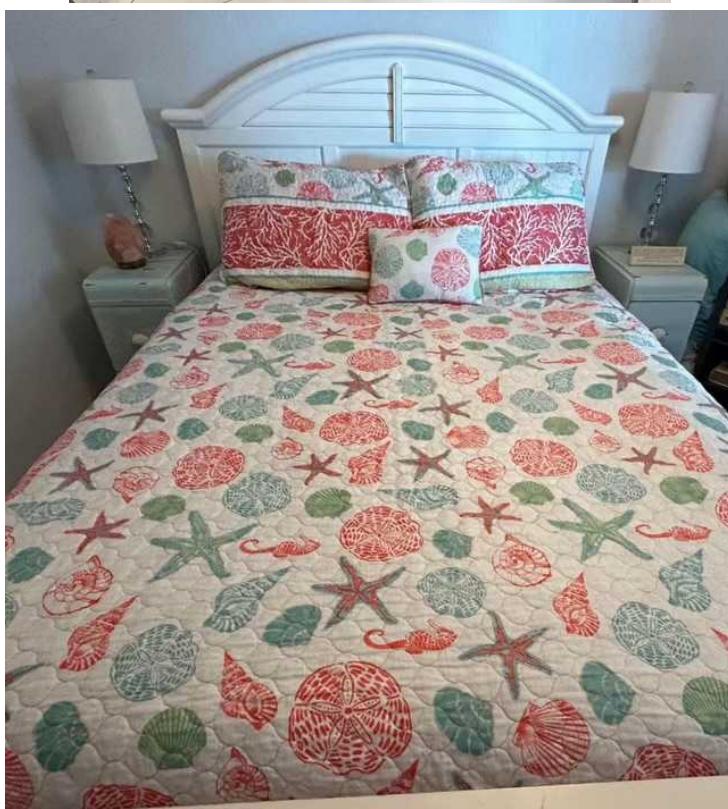
183-Damaged Contents

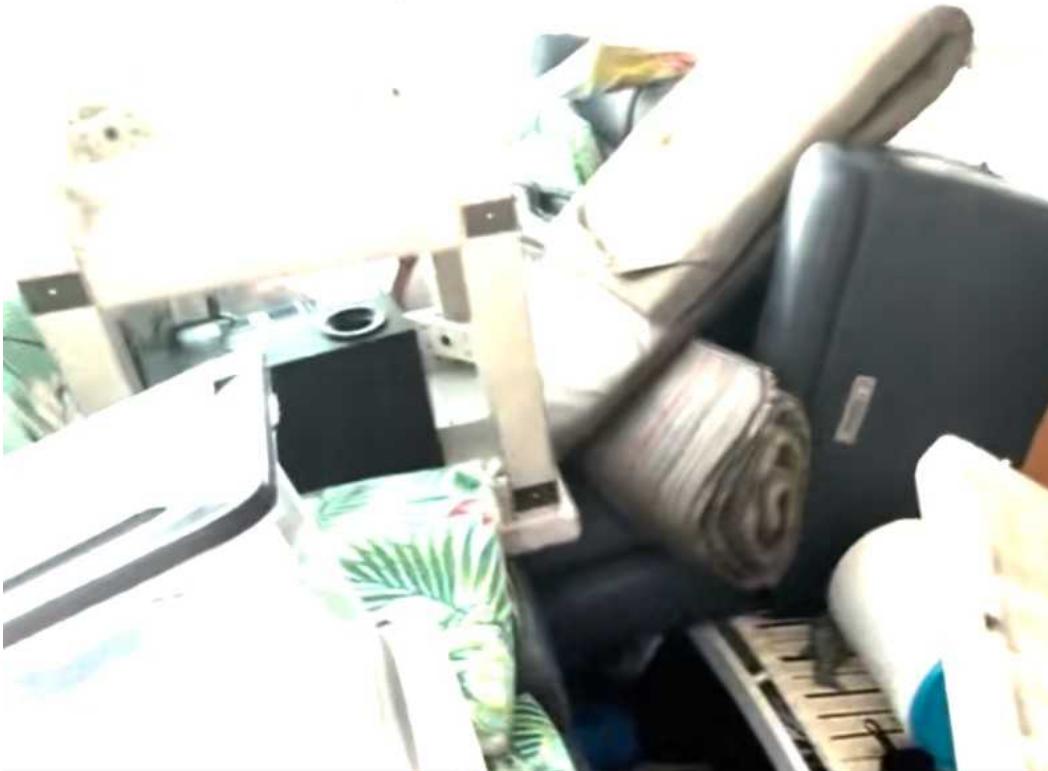
184-Damaged Contents

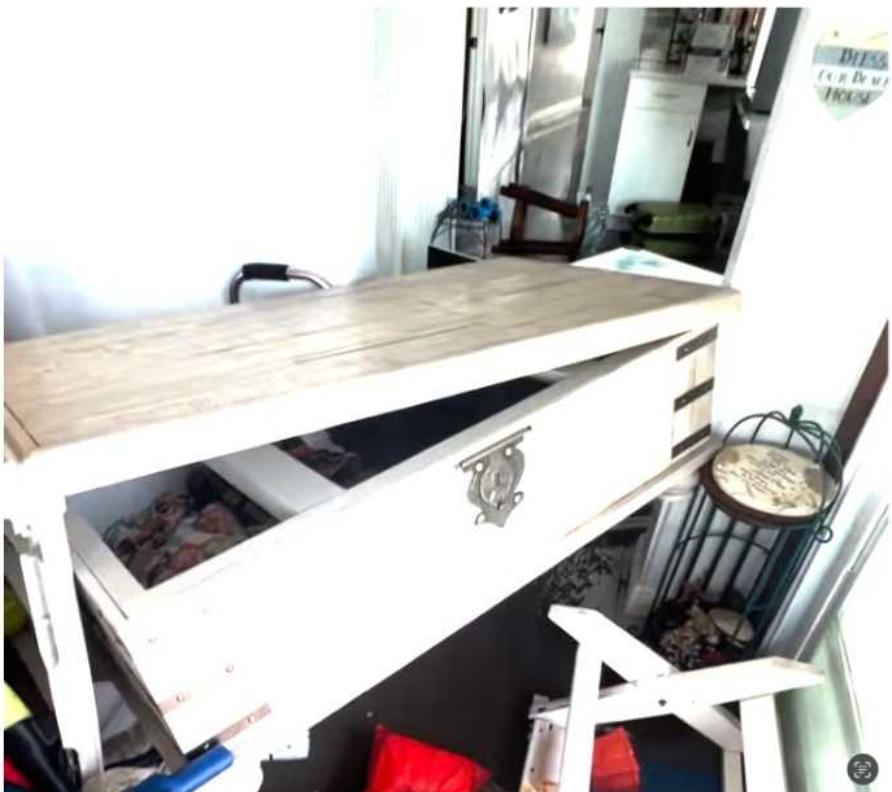
185-Damaged Contents

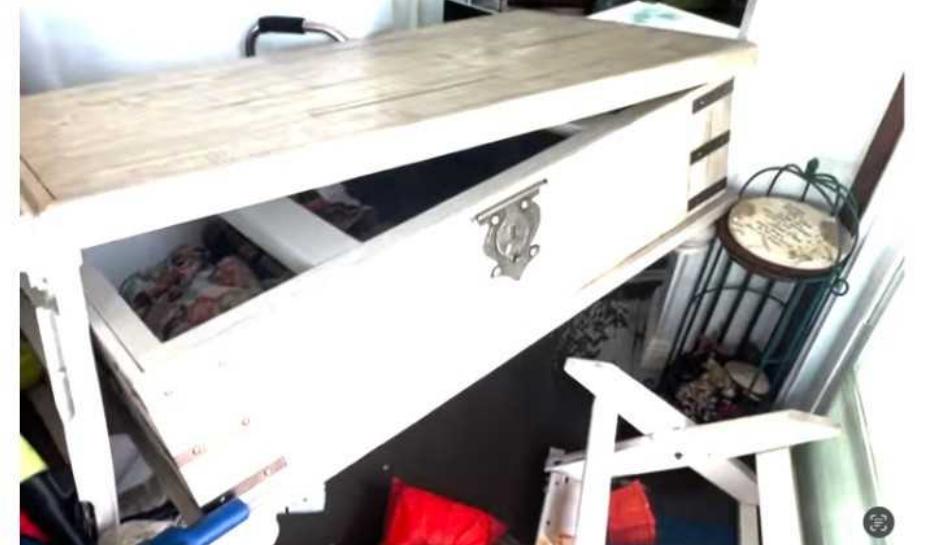
186-Damaged Contents

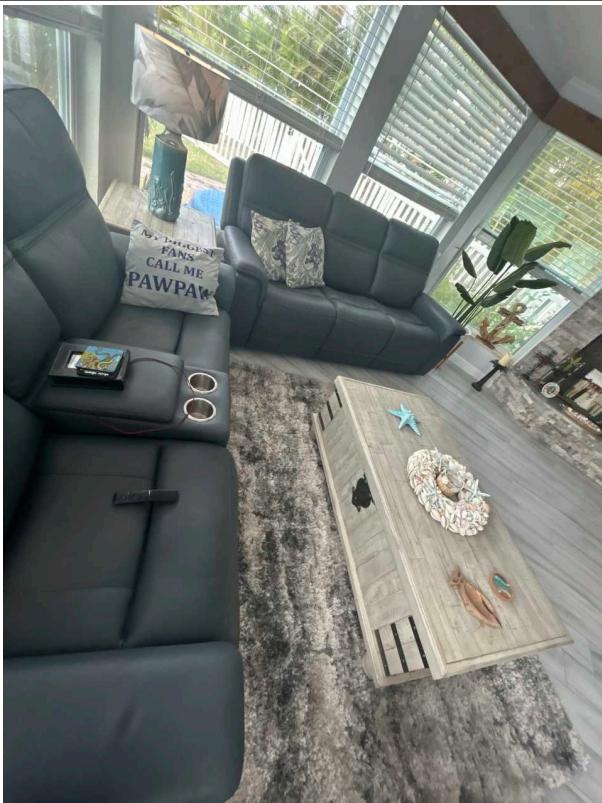
187-Damaged Contents

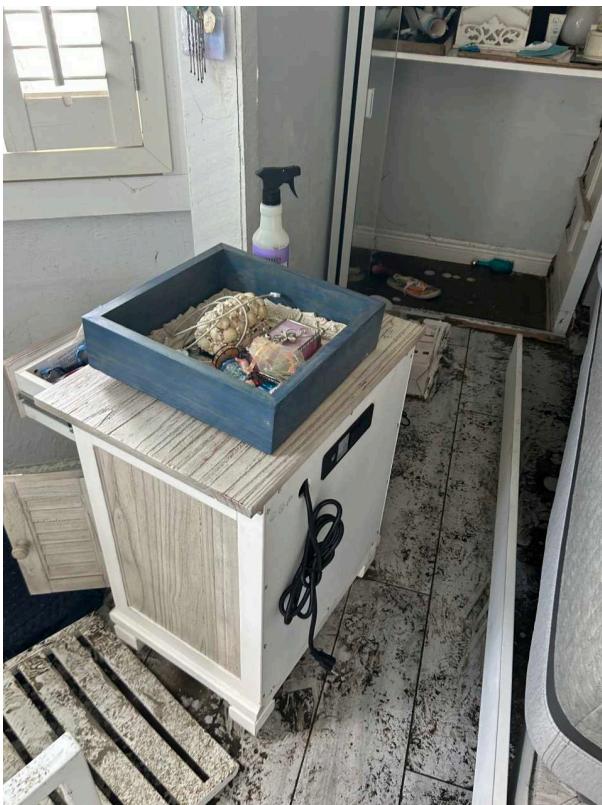
188-Damaged Contents

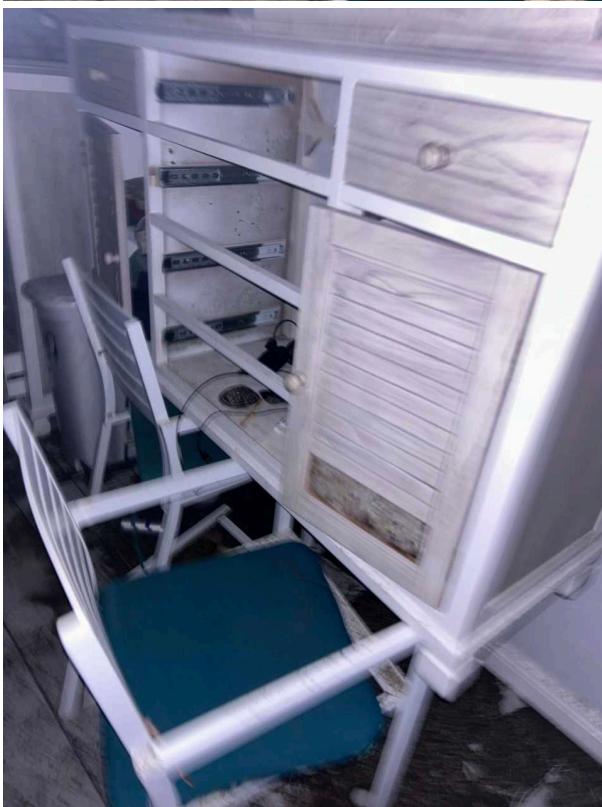
190-Damaged Contents

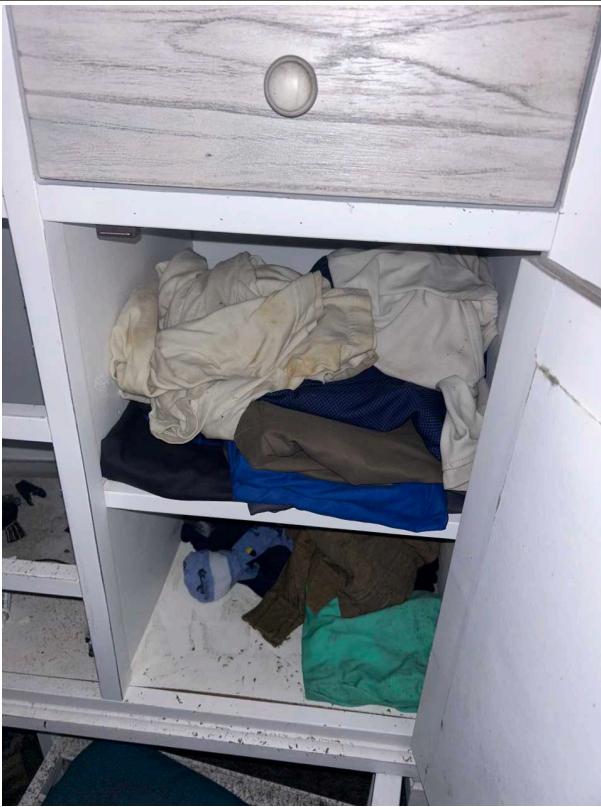
191-Damaged Contents

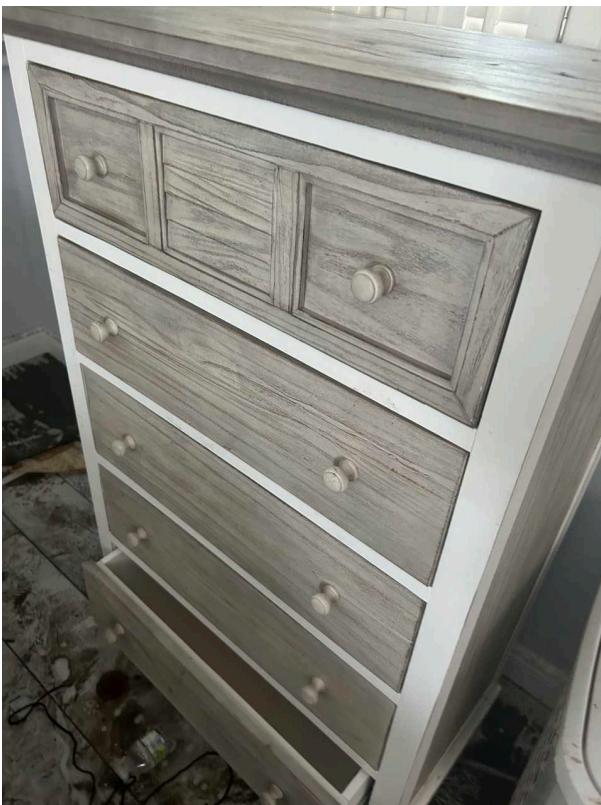
192-Damaged Contents

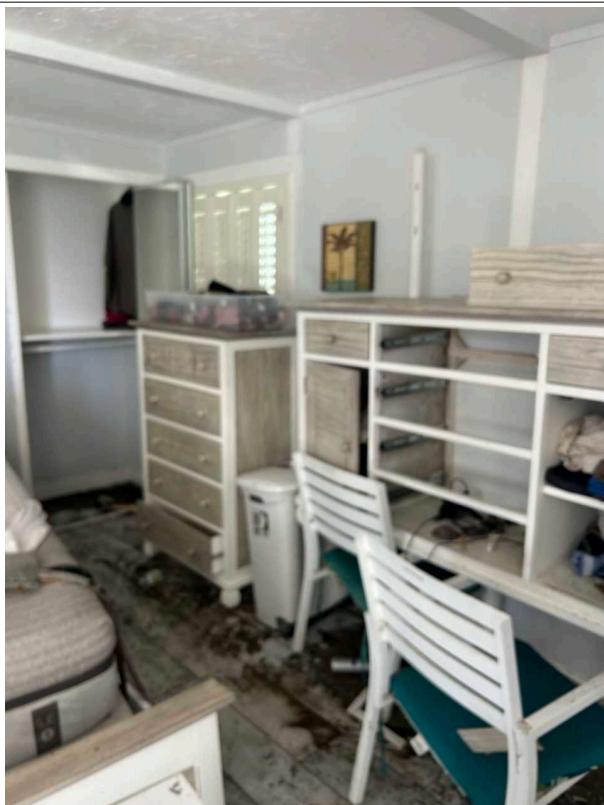
193-Damaged Contents

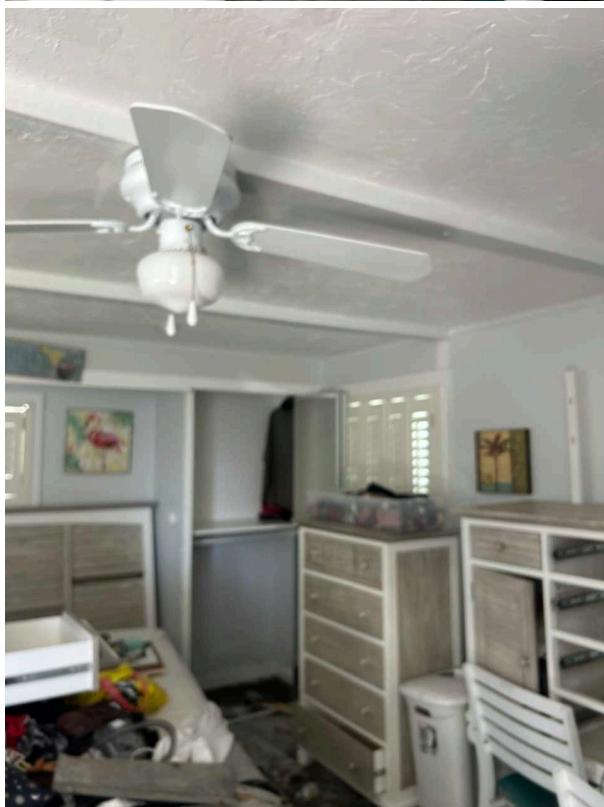
194-Damaged Contents

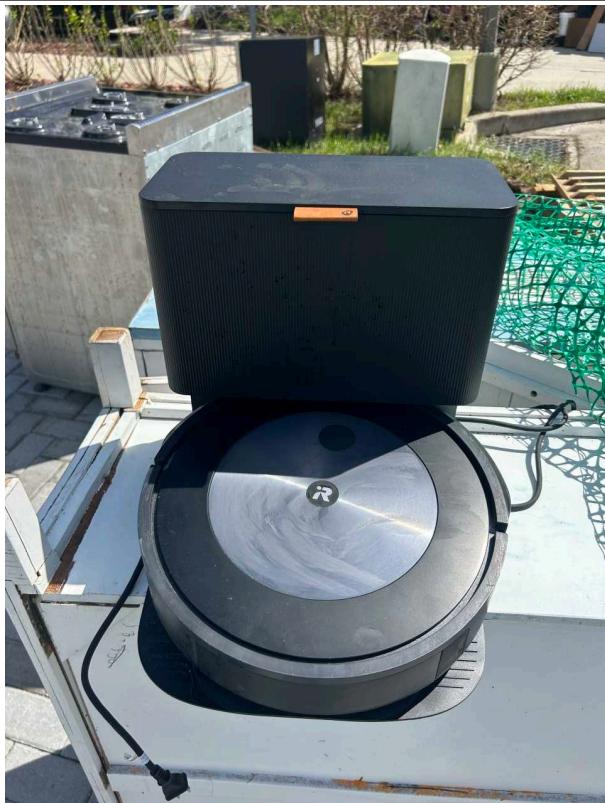
195-Damaged Contents

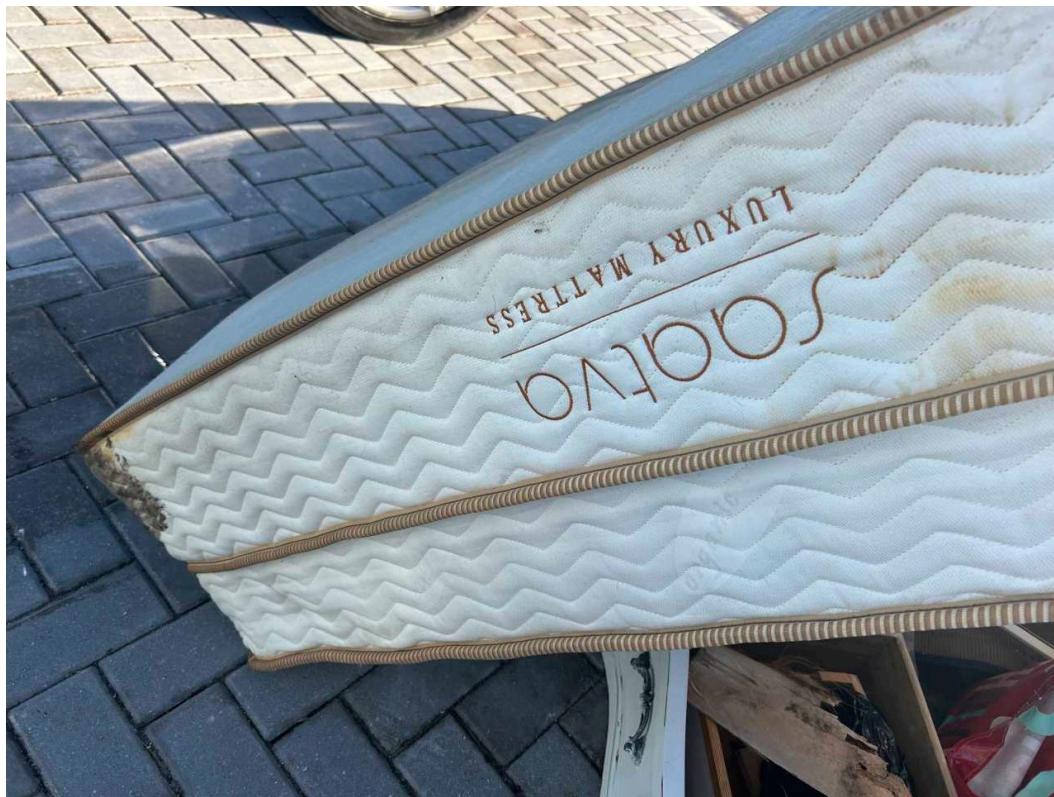
196-Damaged Contents

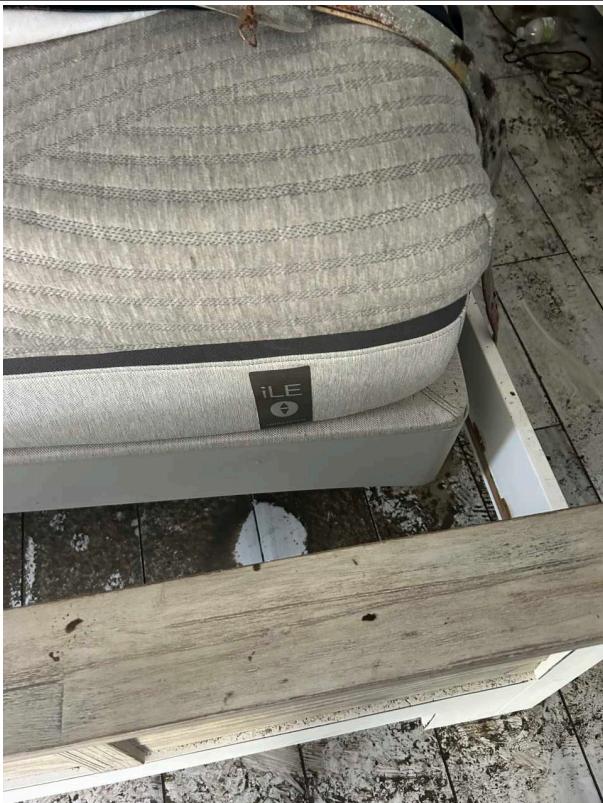
197-Damaged Contents

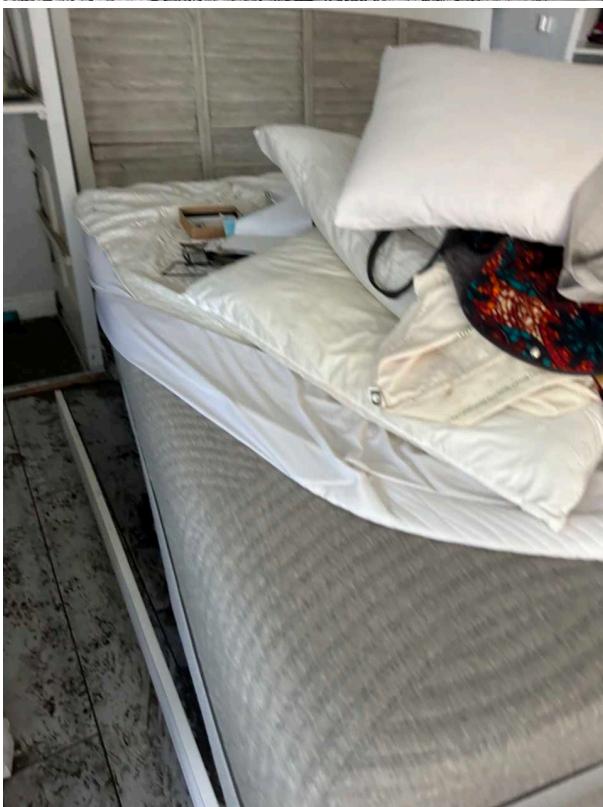
198-Damaged Contents

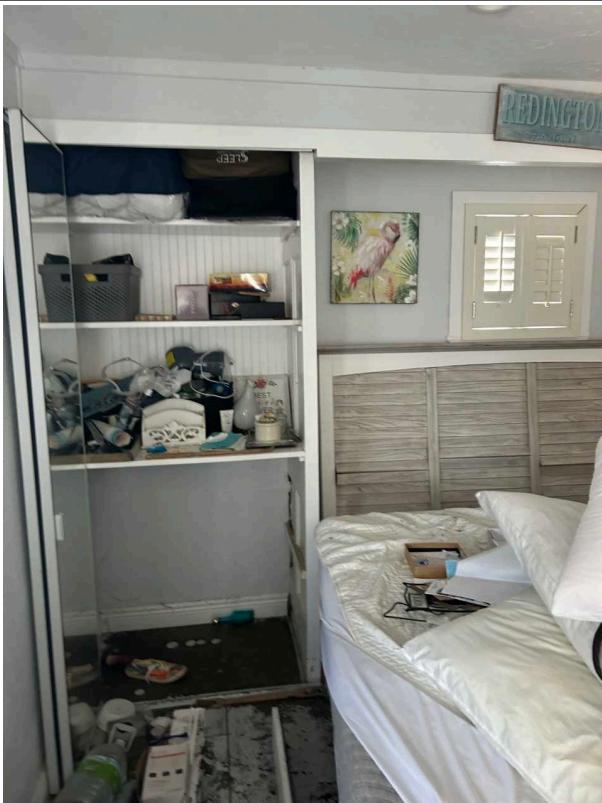
199-Damaged Contents

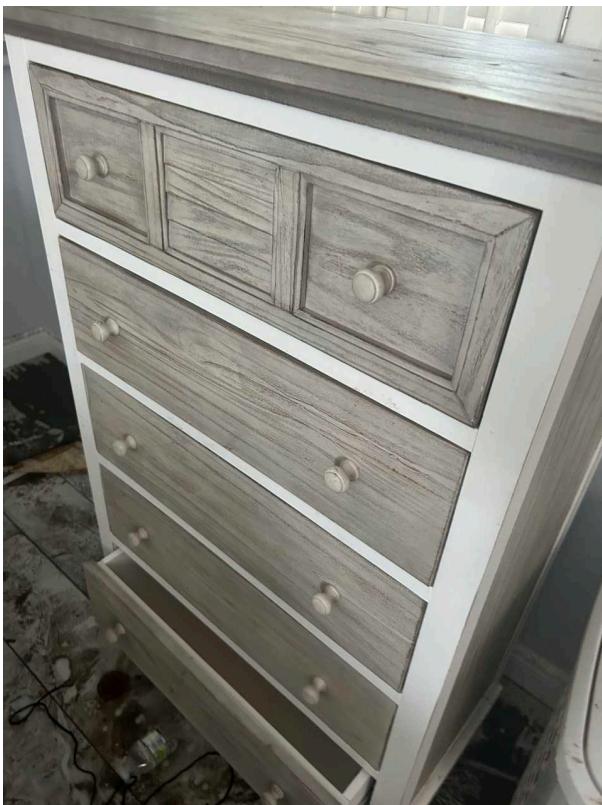
200-Damaged Contents

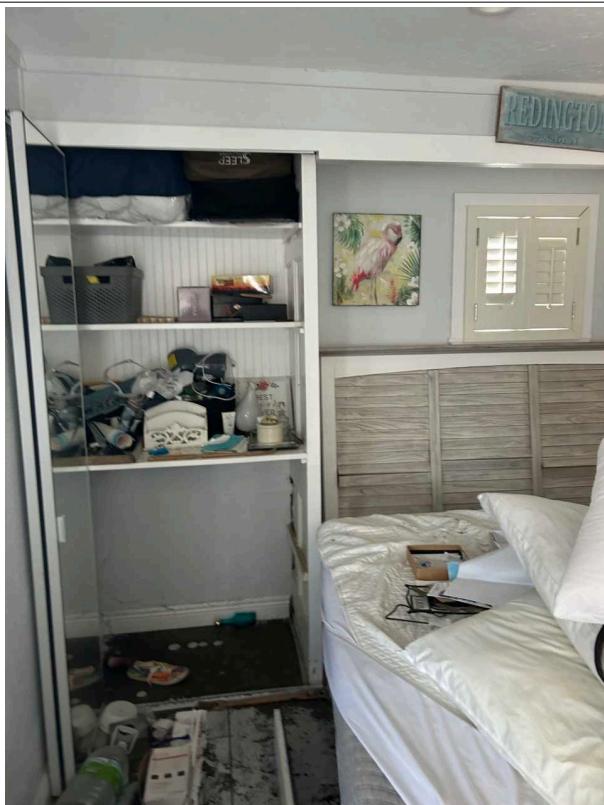
201-Damaged Contents

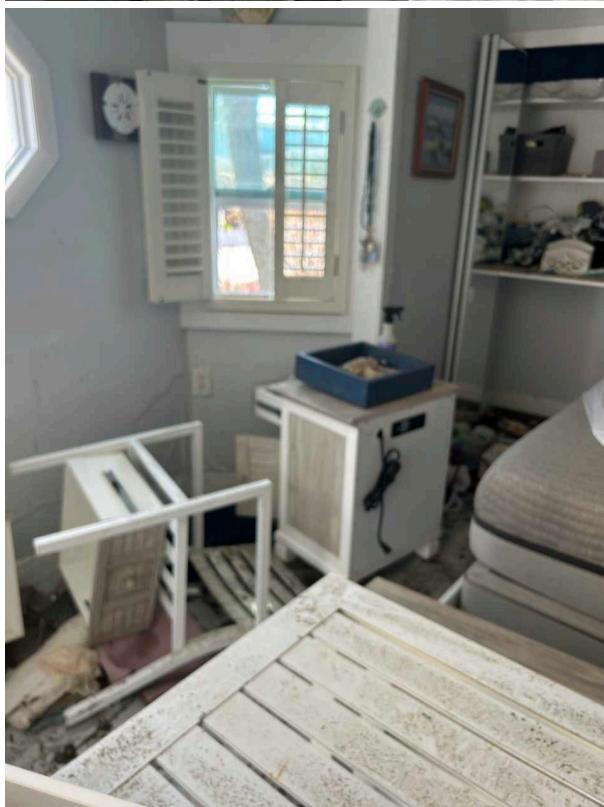
202-Damaged Contents

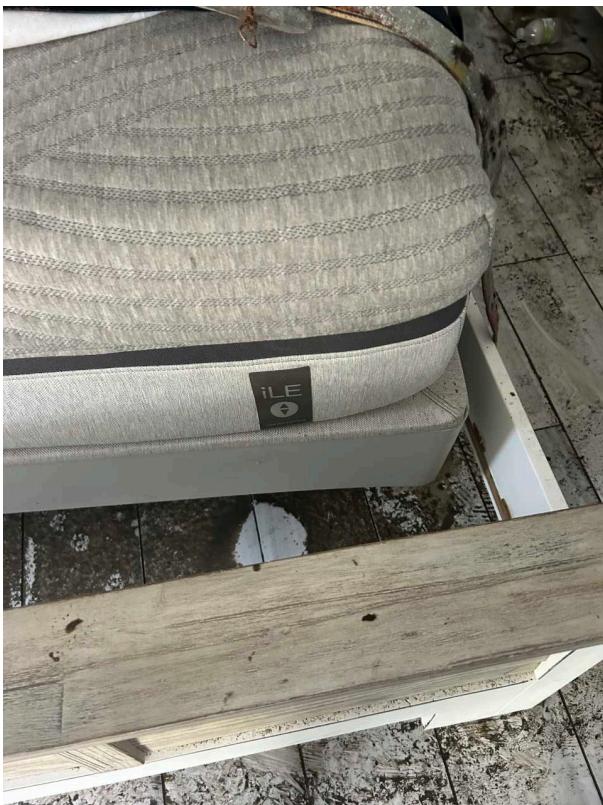
204-Damaged Contents
