Annex C - Drainage Impact Assessment (DIA) of Garden Road and Cotton Tree Drive

There are two key components in the DIA of a road. First is to investigate whether there are any additional lateral or upstream inflows to the road and to provide interception roadside channels or inlets to prevent them flowing onto the road. Second is to assess the adequacy of the existing drainage facilities of the road and check them with reference to RD/GN/035. Garden road and Cotton Tree Drive are used as a study case and the steps of analysis are shown below.

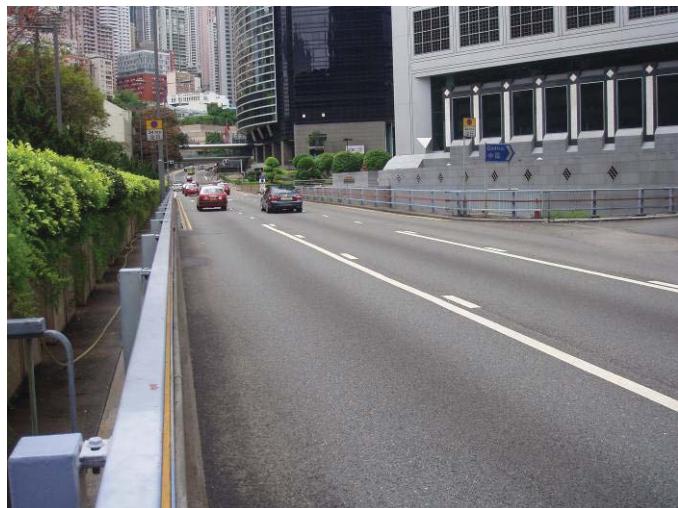
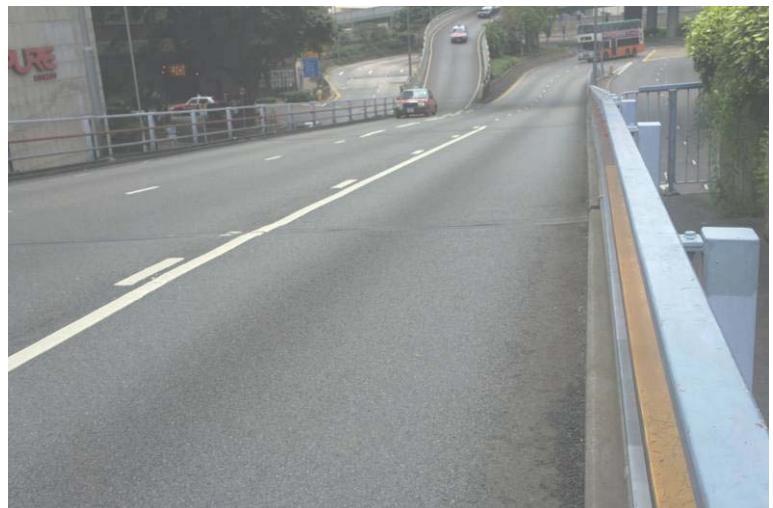
Note 39

There is no gully on a long section of the road pavement.

No gully on a long section of road pavement

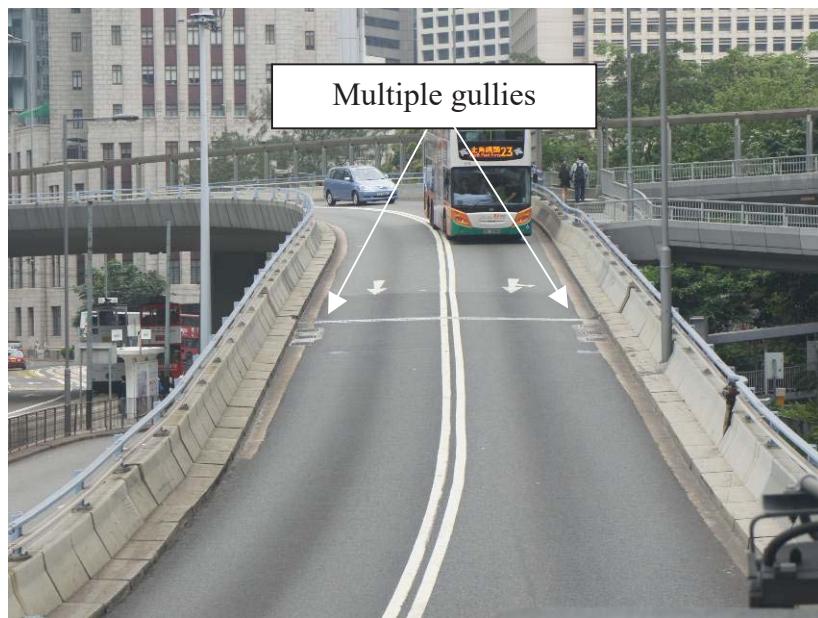
Note 40

Multiple gullies are provided at both sides of the elevated road section with reverse of crossfall direction.

Multiple gullies at reverse of crossfall direction

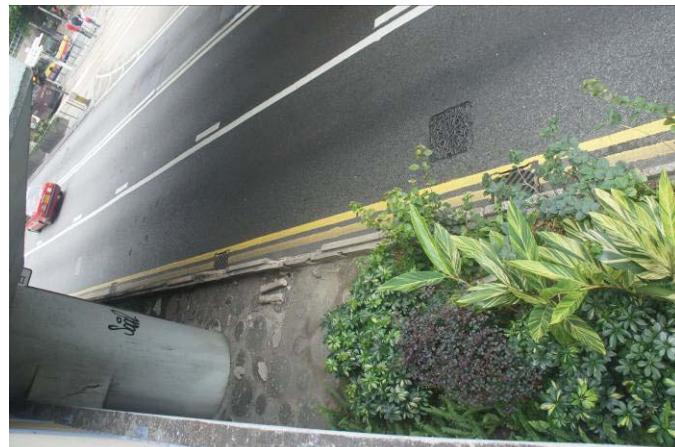
Note 41

Multiple gullies are provided near the junction with elevated road.

Multiple gullies near junction

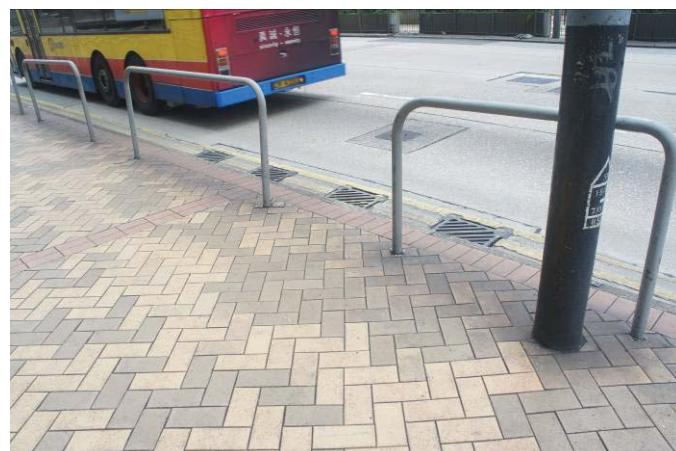
Note 42

Multiple gullies are provided near the junction with branch road.

Multiple gullies near junction

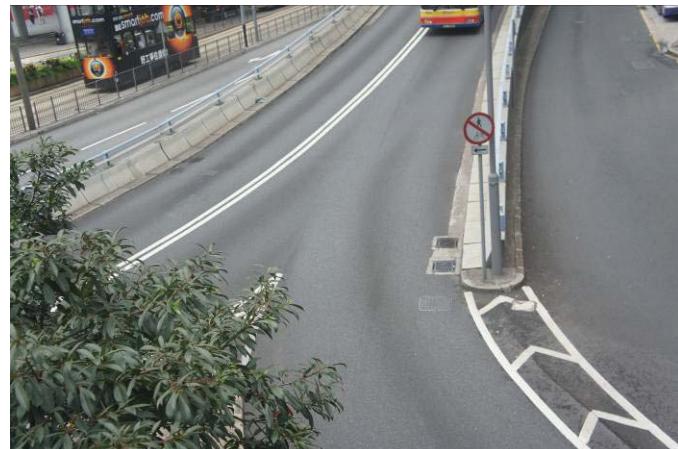
Note 43

Double gullies are provided at the junction with elevated road.

Double gullies at junction

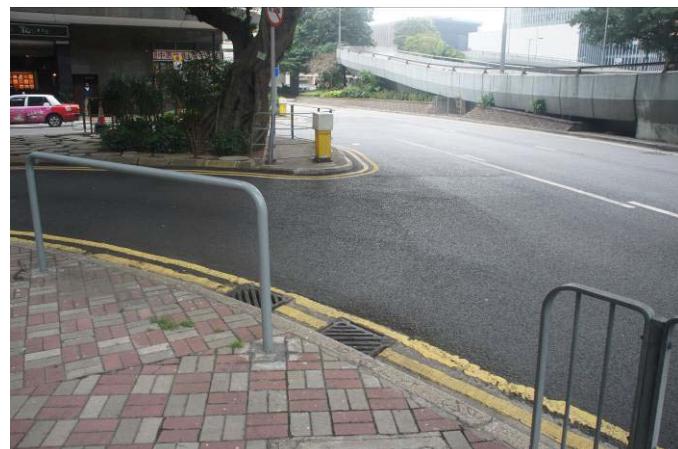
Note 44

Double gullies are provided at the junction with branch road.

Double gullies at junction

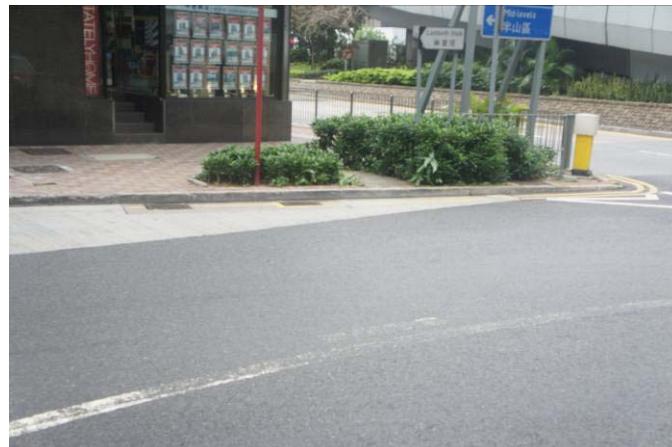
Note 45

Double gullies are provided at the junction with branch road.

Double gullies at junction

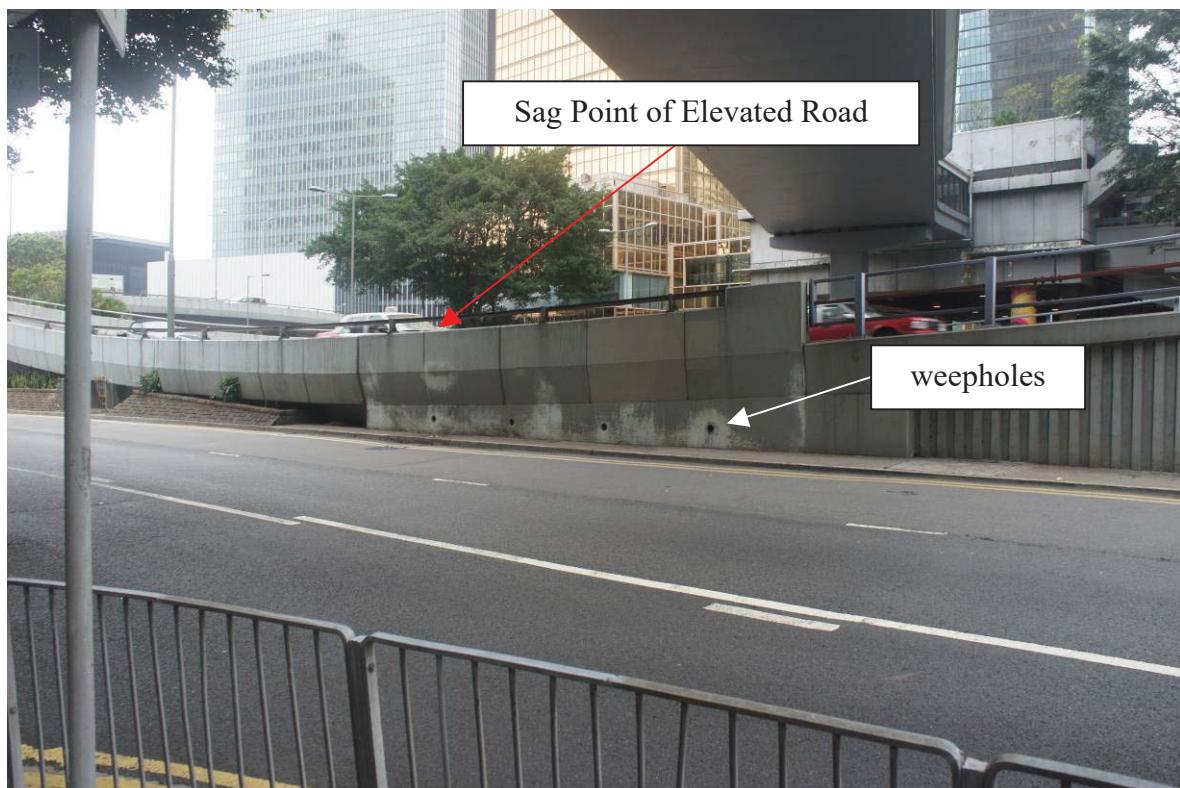
Note 46

There are a number of weepholes on the abutment wall of the elevated road. After checking with HyD, it is not expected that the stormwater runoff accumulated at the sag point will discharge onto the adjacent road pavement through these weepholes.

Weepholes on side wall of elevated road

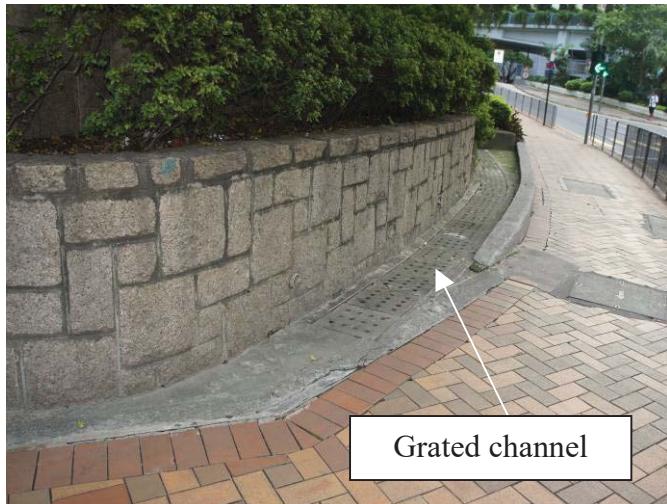
Note 47

There is an interception channel along the toe of the slope. It is expected that no stormwater runoff from the slope will run onto the pavement.

Interception channel along slope toe

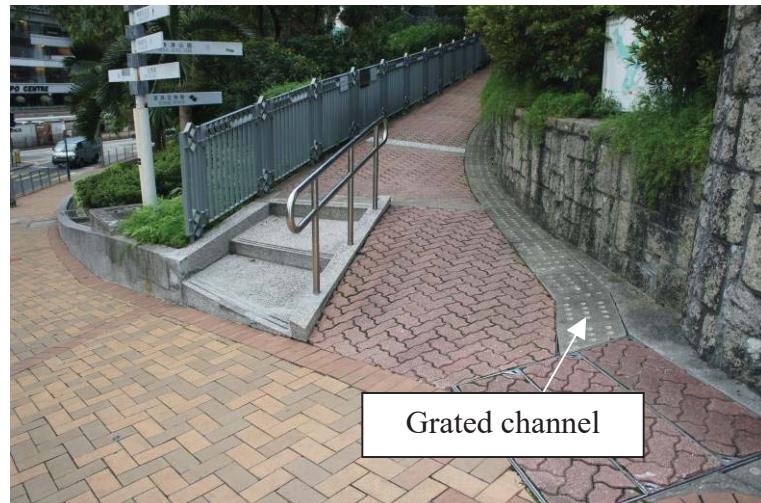
Note 48

There is an interception channel next to the entrance/exit of the park. It is expected that no stormwater runoff from the park will run onto the pavement.

Interception channel at entrance/exit

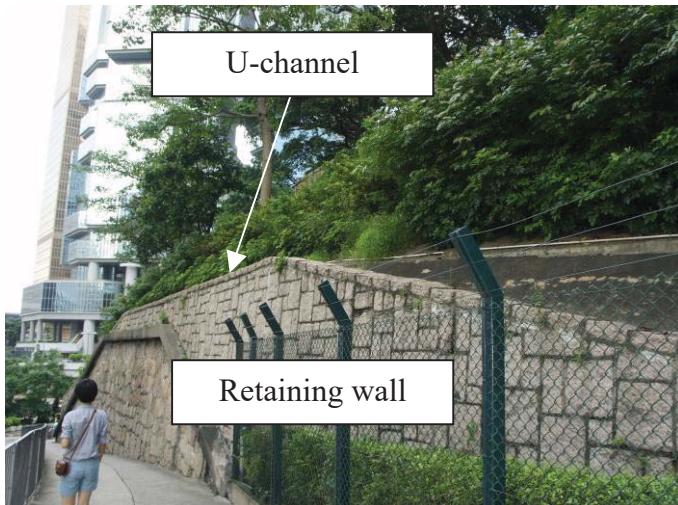
Note 49

There is a retaining wall at the toe of the slope and an interception channel at the top of the wall. It is expected that no stormwater runoff from the slope will run onto the pavement.

Retaining wall and interception channel

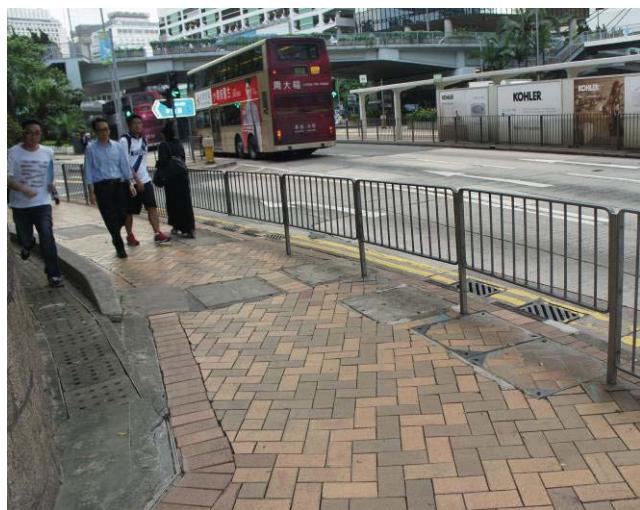
Note 50

Many gullies are provided near the junction with branch road.

Many gullies near junction

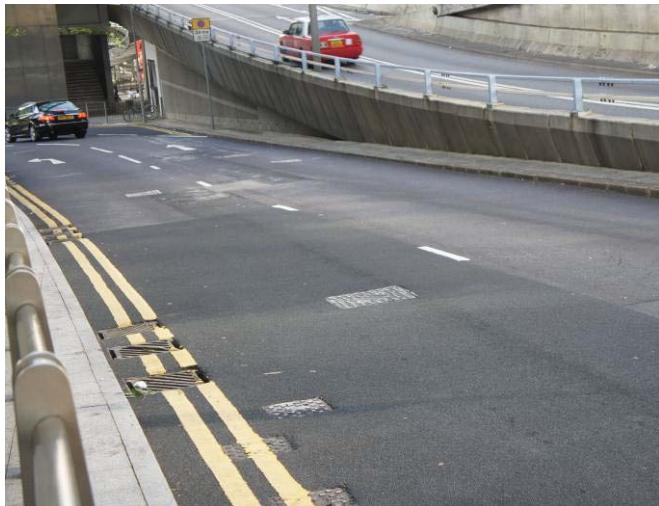
Note 51

Many gullies are provided along the road section.

Many gullies at road section

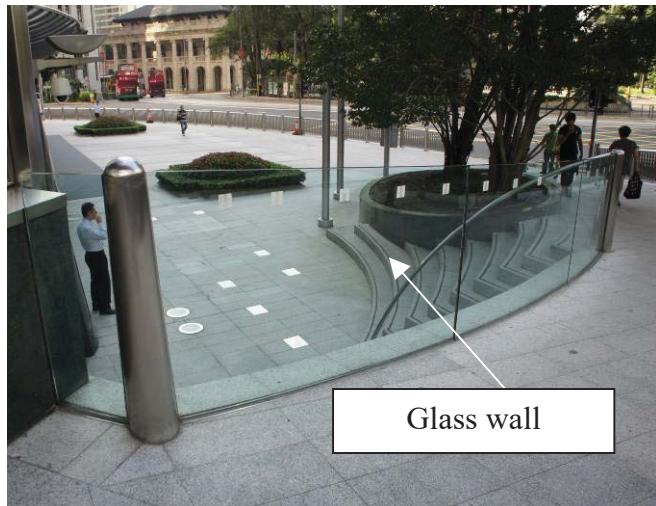
Note 52

There is glass wall along the footpath and there are two grated channels at entrance.exit of the development.

Glass wall and interception channel

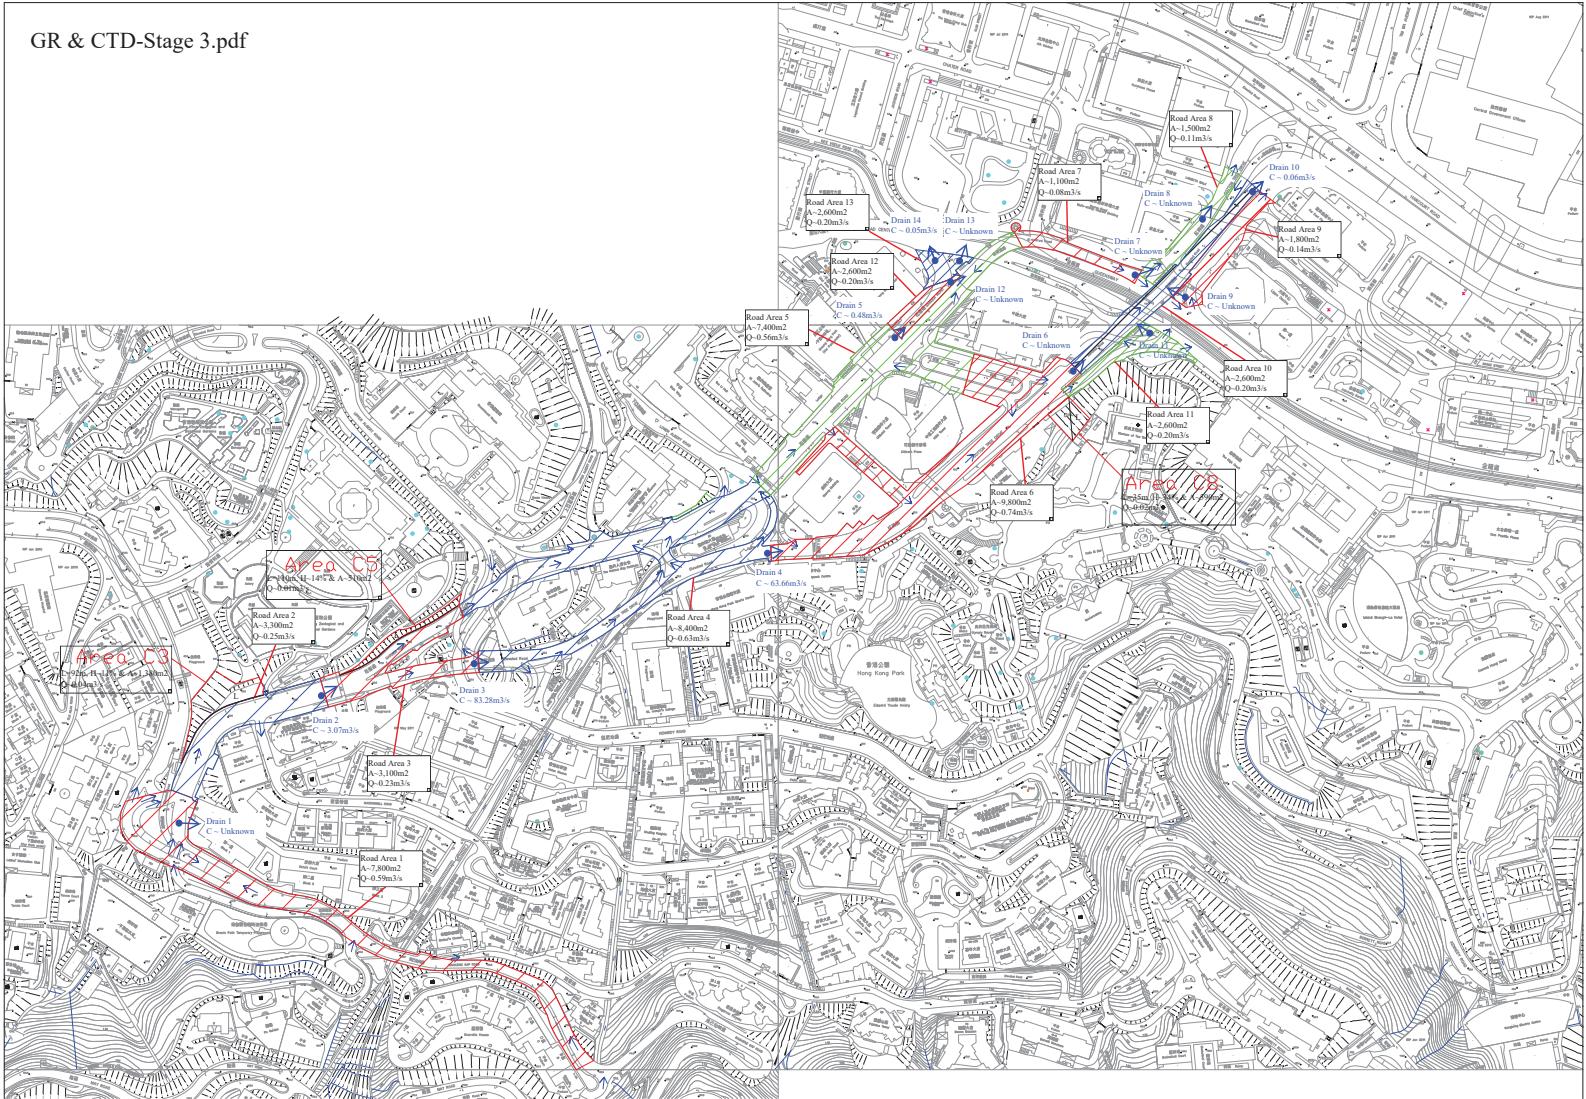
GR & CTD-Stage 3.pdf

For tentative locations of Drain 1 – Drain 14, please refer to plan No. GR & CTD -Stage 3.pdf. For detailed locations of the drains and manholes, please refer to the above drainage record plans.

Besides, as shown on plan No. GR & CTD-Stage 3.pdf,
Road Area 1, Area ~ 7,800m², Q=0.278CiA ~0.59 m³/s
Road Area 2, Area ~ 3,300m², Q=0.278CiA ~0.25 m³/s
Road Area 3, Area ~ 3,100m², Q=0.278CiA ~0.23 m³/s
Road Area 4, Area ~ 8,400m², Q=0.278CiA ~0.63 m³/s
Road Area 5, Area ~ 7,400m², Q=0.278CiA ~0.56 m³/s
Road Area 6, Area ~ 9,800m², Q=0.278CiA ~0.74 m³/s
Road Area 7, Area ~ 1,100m², Q=0.278CiA ~0.08 m³/s
Road Area 8, Area ~ 1,500m², Q=0.278CiA ~0.11 m³/s
Road Area 9, Area ~ 1,800m², Q=0.278CiA ~0.14 m³/s
Road Area 10, Area ~ 2,600m², Q=0.278CiA ~0.20 m³/s
Road Area 11, Area ~ 1,400m², Q=0.278CiA ~0.11 m³/s
Road Area 12, Area ~ 800m², Q=0.278CiA ~0.06 m³/s
Road Area 13, Area ~ 700m², Q=0.278CiA ~0.05 m³/s

To sum up, it is considered that Drains 1, 2, 5, 6, 10, 11 and 12 are incapable to handle the stormwater runoff from the concerned road sections and upland catchments, while the adequacy of Drains 13 and 14 are not known. It is suggested to liaise with DSD to further investigate whether these drains are required to be upgraded.

2. Based on this assessment, it is preliminarily identified that the capacity of Drains 1, 2, 5, 6, 10, 11 and 12 are inadequate to convey the stormwater runoff from the concerned road pavements and additional catchments, while the adequacy of Drains 13 and 14 are not known due to insufficient data. Further detailed assessment should be conducted as required to confirm this finding and investigate the missing invert levels of the concerned drains. If essential, DSD may be consulted to resolve the problem together.
3. To provide additional gullies on the two roads, so far if possible, in order to satisfy the maximum gully spacing as recommended in Section 3.6 of RD/GN/035.

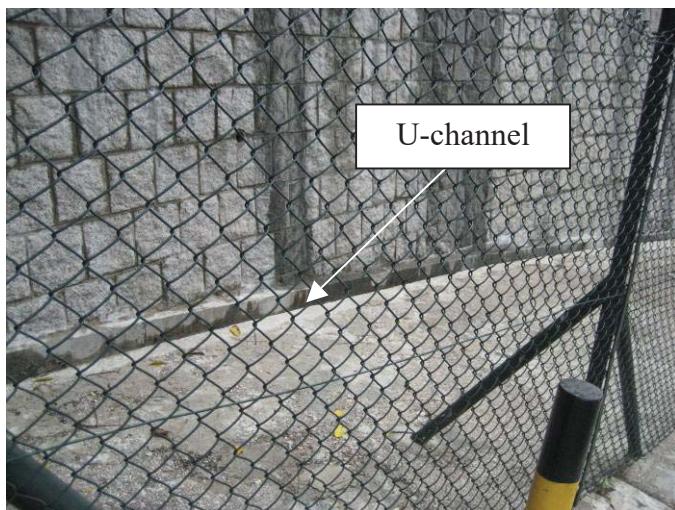
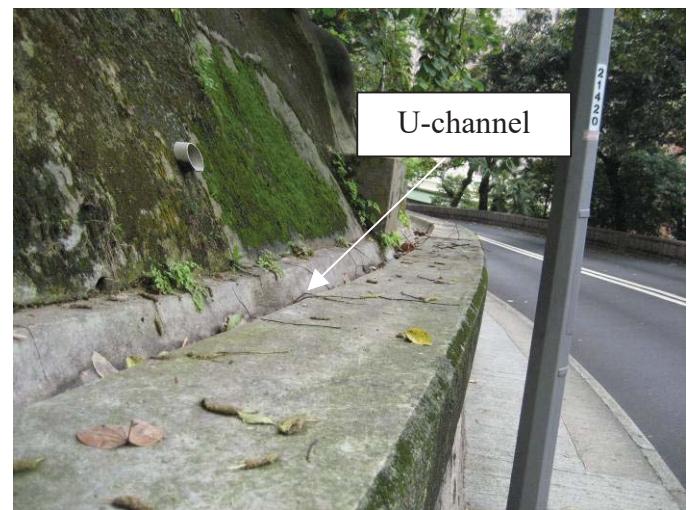
Note 1

As there is an interception channel along the toe of slope, it is expected that the stormwater runoff in Area C1 will not run onto the road pavement.

Interception channel along slope toe

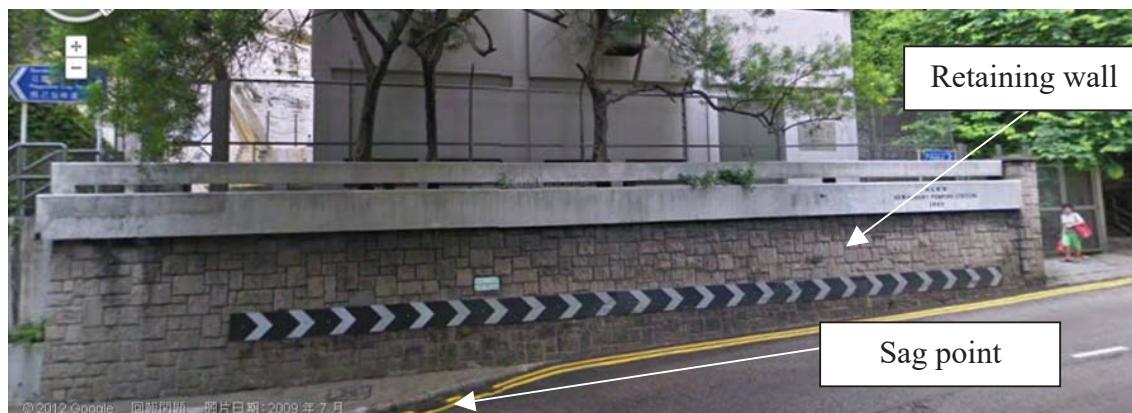
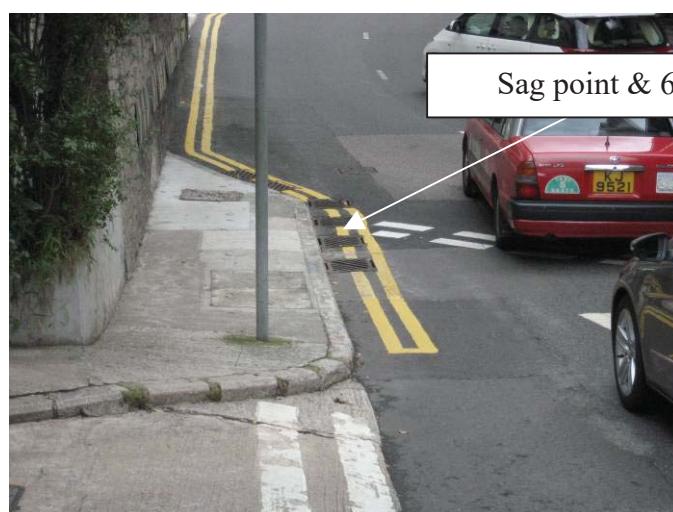
Note 2

There is a retaining wall at the toe of slope. It is expected that the stormwater runoff in Area C2 will likely be blocked by the retaining wall and will not run onto the road pavement. Besides, there is a sag point at the road section immediately next to the retaining wall and six gullies are provided at there.

Retaining wall and multiple gullies

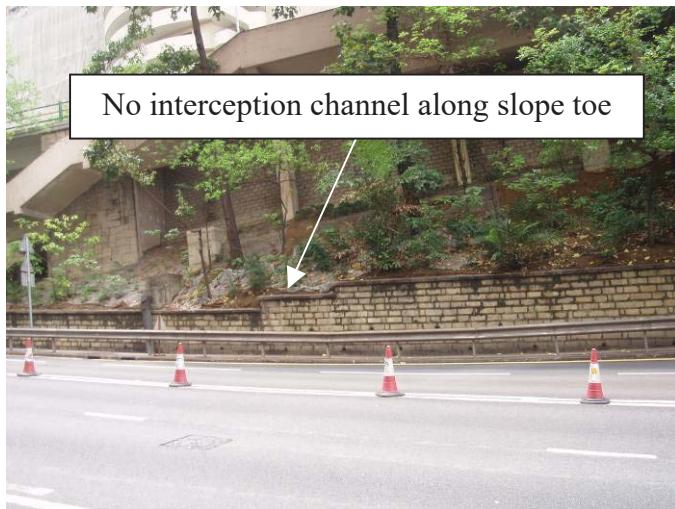
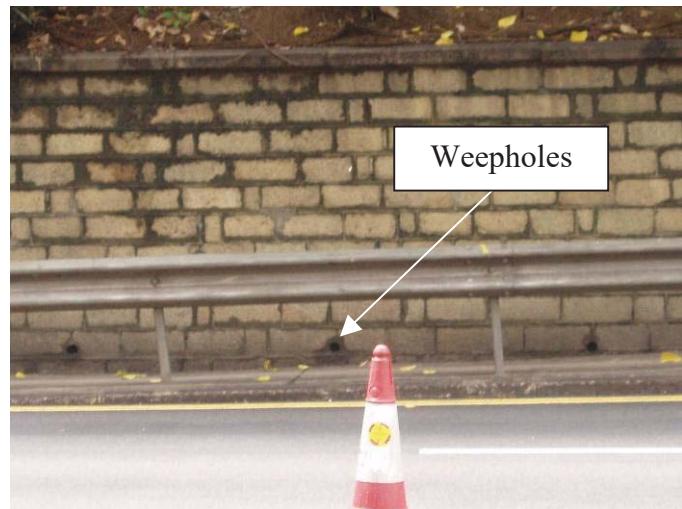
Note 3

There is no interception channel along the toe of slope but many weepholes on the retaining wall. It is expected that the stormwater runoff in Area C3 will run onto the road pavement.

No interception channel along slope toe but holes on retaining wall

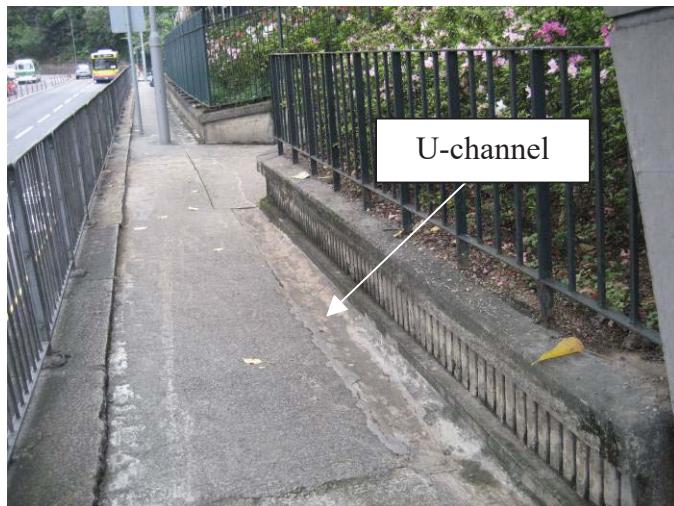
Note 4

As there is an interception channel along the toe of slope, it is expected that the stormwater runoff in Area C4 will not run onto the road pavement.

Interception channel along slope toe

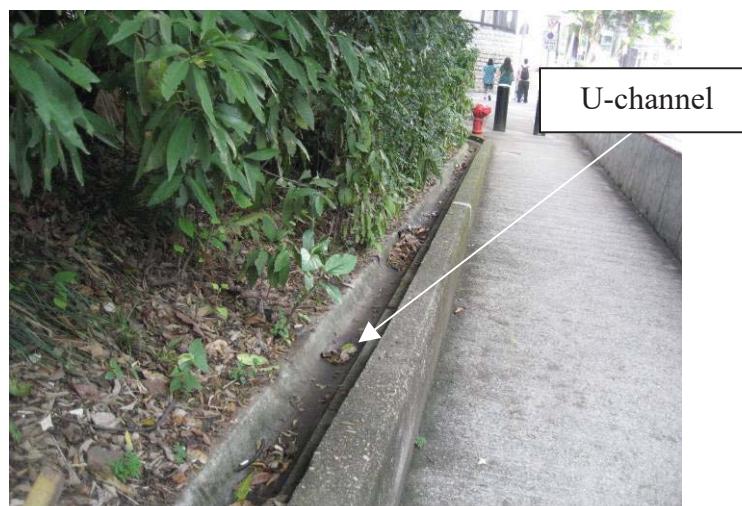
Note 6

As there is an interception channel along the toe of slope, it is expected that the stormwater runoff in Area C6 will not run onto the road pavement.

Interception channel along slope toe

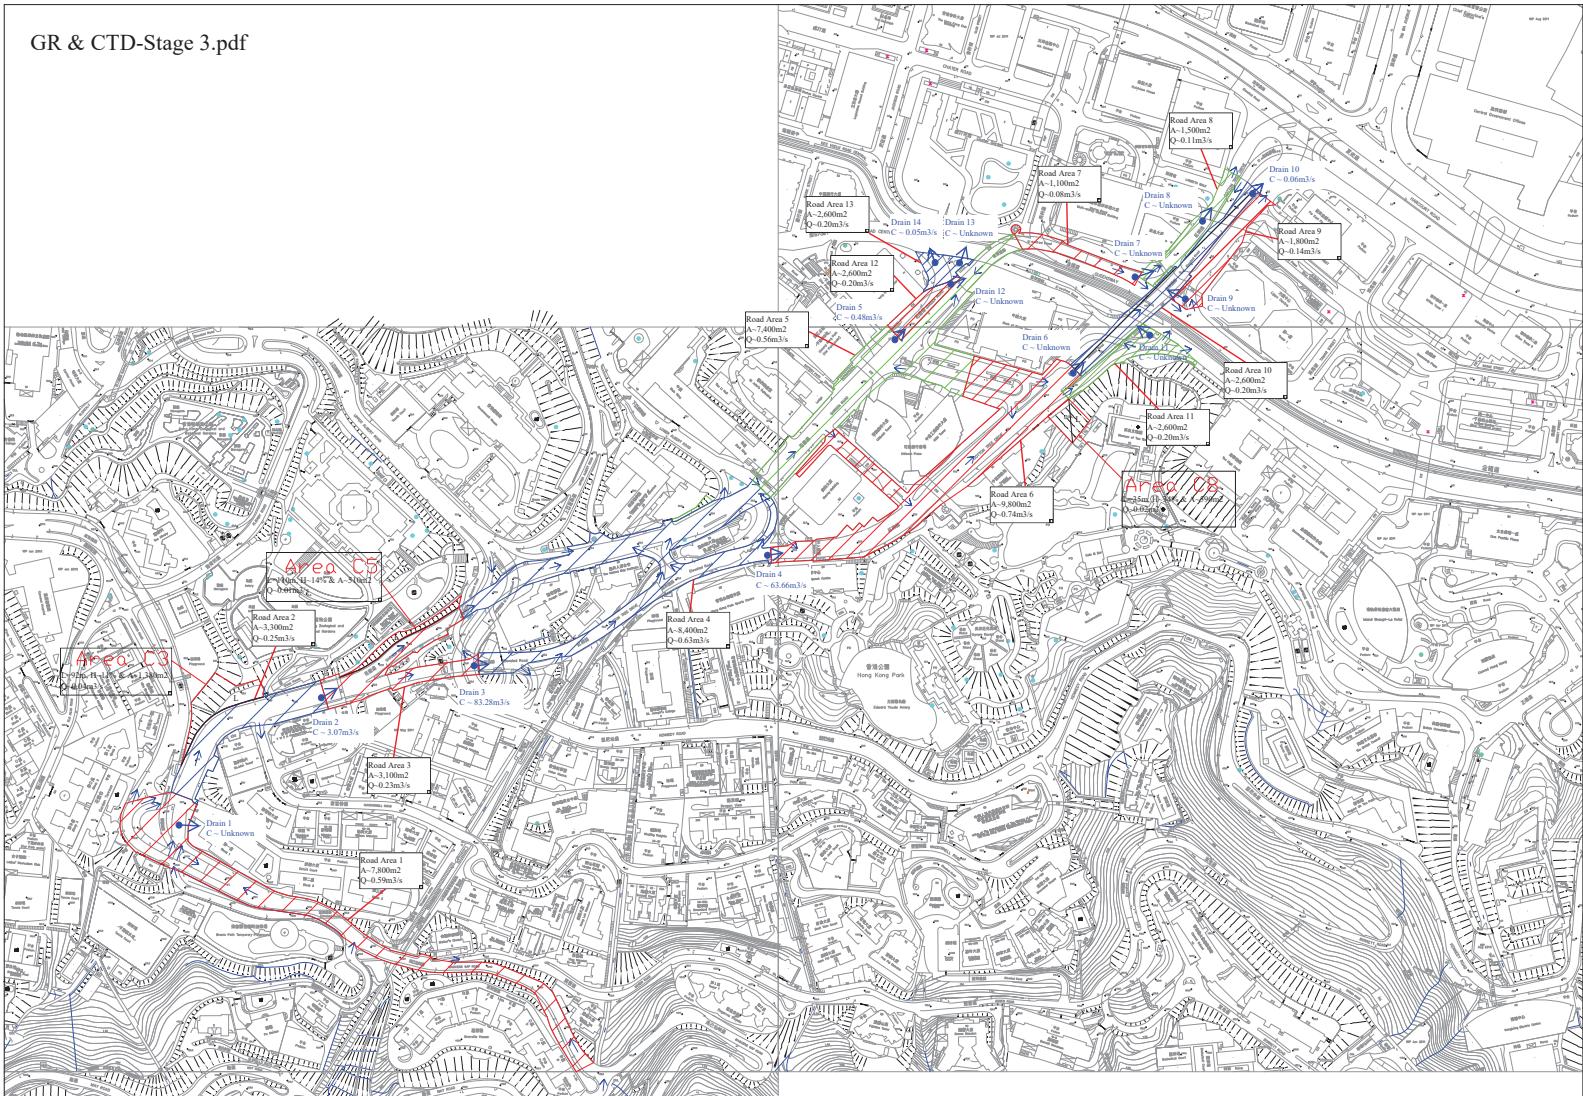
Adequacy of Drains 1 - 9 & 11-14

For Drains 1–9 and 11–14, it appears that they may not be exclusively for the concerned road sections and upland catchments but may also convey stormwater runoff from some other catchments. Therefore, it is not certain whether they are adequate to convey the stormwater from the concerned road sections and upland catchments (i.e. Road Areas 1 – 9 & 11 – 13 and Areas C3, C5 and C8) even though their capacities may be larger than the stormwater runoff from the concerned road sections and upland catchments. In such situation, it is recommended to consult DSD to acquire their advice and findings from their relevant drainage studies. For this DIA, DSD has provided their advice on whether Drains 1 – 9 and 11 – 12 are adequate to handle the stormwater runoff under a 1 in 50 year rainfall intensity based on their past Drainage Master Plan study in the Northern Hong Kong Island. (please refer to “Adequacy of Drains 1–9 and 11–14.pdf”).

Result of 1 in 50 Yrs Design Period

Node No.	Flood Depth (m)	Node No.	Flood Depth (m)	Pipe Size (mm)	Handle 50 Yrs Design Storm ?
Drain 1	SMH7048886	0.105	SGJ7013053	0	300	No
Drain 2	SMH7029358	0	SMH7029361	0.121	525 x 675	No
Drain 3	SMH7029253	0	SMH7029254	0	2400	Yes
Drain 4	SMH7029308	0	SMH7029438	0	2400	Yes
Drain 5	SMH7029420	0.102	SMH7031104	0.101	450	No
Drain 6	SGJ7019992	0	SMH7055356	0.147	2400 x 2400	No
Drain 7	SMH7031357	0	SMH7031122	0	2745 x 2440	Yes
Drain 8	SMH7031122	0	SMH7031480	0	2745 x 2440	Yes
Drain 9	SMH7031130	0	SMH7031358	0	450	Yes
Drain 11	SMH7029500	0	DownStream	0.134	450	No
Drain 12	SMH7031101	0.101	SMH7031317	0	450	No
Drain 13	SMH7031096	no record *	SMH7031091	no record *	450	-
Drain 14	SMH7031316	no record *	SMH7031089	no record *	225	-
