Larsen C - AWS Deployments for Konrad Steffen

AWS Site 3 – 17th December 2008

AWS Site 2 – 22nd December 2008

AWS Site $1 - 22^{nd}/23^{rd}$ December 2008

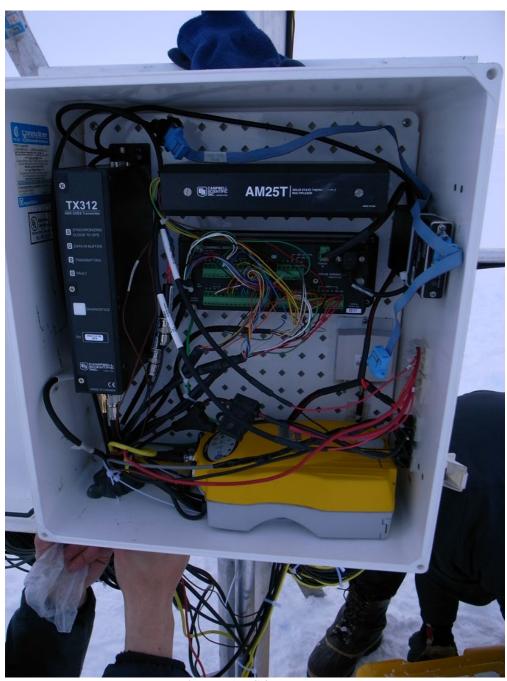
Inside the AWS 3 Logger Box

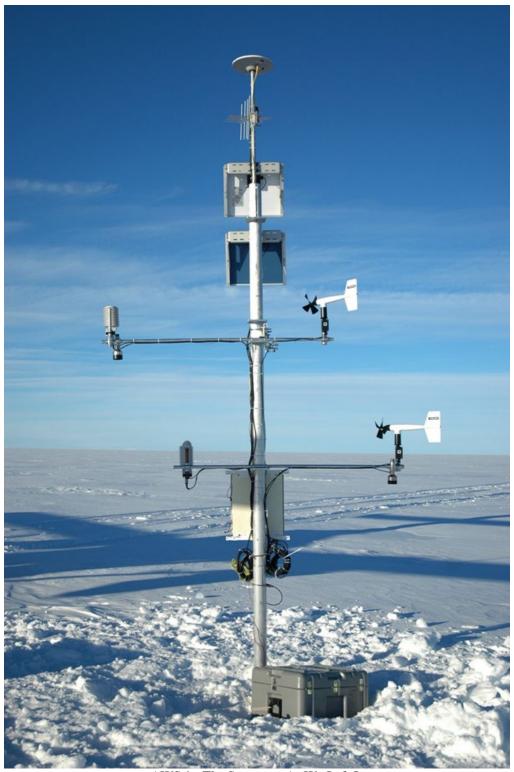
This deployment went well as we were really starting to get to grips with the construction of the main framework. The work was considerably quicker than either of the previous sites, despite tiredness creeping in after a long day.

AWS 1 - The Structure As We Left It
