Maintenance sheet version 9 for accumulation area (single mast, two levels)

| Station name | HUM |
| Date | 2022-06-19 |

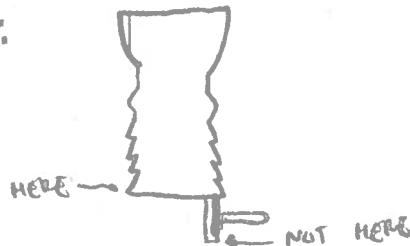
THIS TRIP HAS BEEN MEASURING BOTTOM OF ASPIRATED SECTION OF CASING:
