# The Construction History and Assessment of Two Heritage Industrial Buildings in Wrocław

*Piotr Berkowski\*, Grzegorz Dmochowski, Jacek Barański, and Jerzy Szołomicki*

Faculty of Civil Engineering, Wrocław University of Science and Technology, Wyb. Wyspiańskiego 27, 50-370 Wrocław, Poland

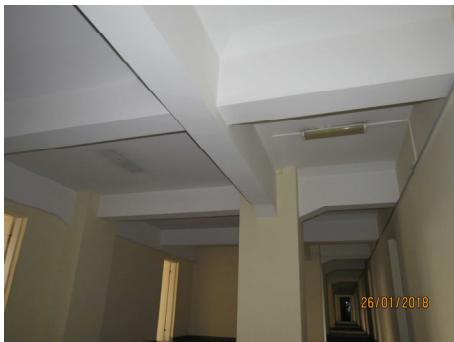
**Fig. 3.** The system of the RC beams and ribbed slab in the flour warehouse.

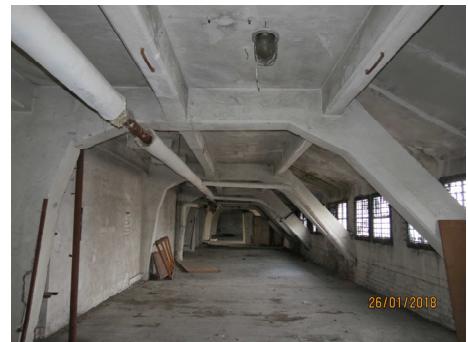
**Fig. 4.** The RC frame on the attic floors in the flour warehouse.

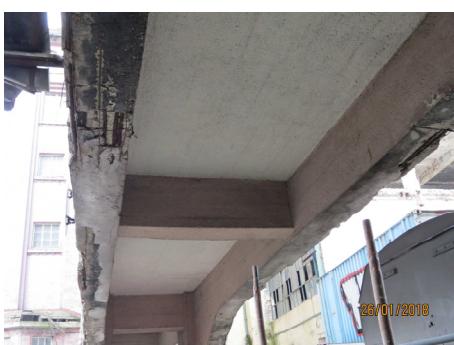
**Fig. 7.** The RC ground floor structure in the connecting building.

On the ground level the main supporting structure was made in the form of two double-span, arched reinforced concrete frames, which were based on the reinforced concrete pillars (Figs. 6, 7) due to the need to maintain an open communication space. Above the ground level, the structure of the building is one-bay and is also made of reinforced concrete with load-bearing longitudinal walls that are strengthened with pilasters that are connected to beams. They work as a stiffening structure (Fig. 8).

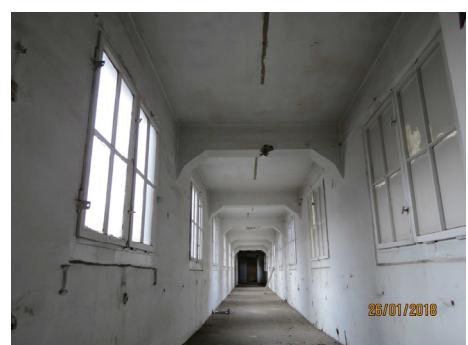
**Fig. 8.** The RC frames in the connecting building.

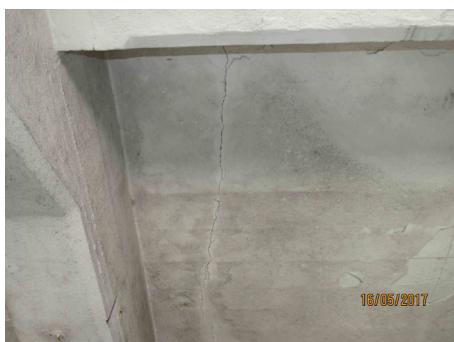
Numerous different examples of damage, typical for concrete structures of such an age and history of exploitation, were found during a visual inspection of both buildings. For example, all the floor slabs in the flour warehouse building, as well as roof coverings, have cracks in many places (Fig. 16). Generally, they were caused by the corrosion of reinforcing bars, the large spacing of bars in relation to the small thickness of the slabs and also the lack of top or diagonal reinforcement at the side supports.

**Fig. 16.** Cracks in the RC roof slab over the 6<sup>th</sup> floor in the flour warehouse.

None of this damage is currently dangerous for the structural safety of the presented buildings, however, repair work will be necessary during the refurbishment process.

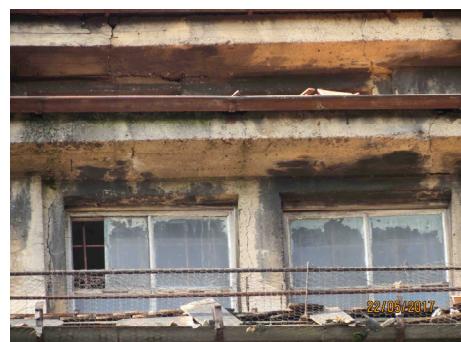
**Fig. 17.** Corrosion of the outer surface of concrete window frames in the flour warehouse.

Concrete elements that were exposed to environmental hazards, such as water penetration, freezing or atmospheric pollution, etc., were obviously damaged the most. This damage was found in the flour warehouse's window frames (Fig. 17) on the attic floor and in several parts of the connecting building's frames (Figs. 18, 19).

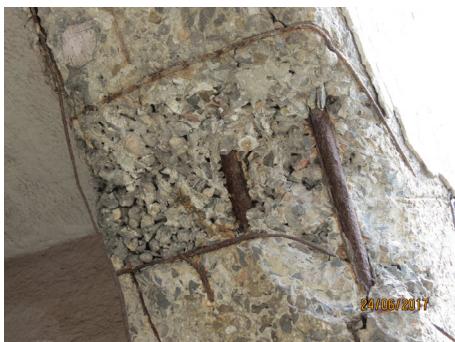
**Fig. 18.** Concrete destruction in the bearing frame of the connecting building.

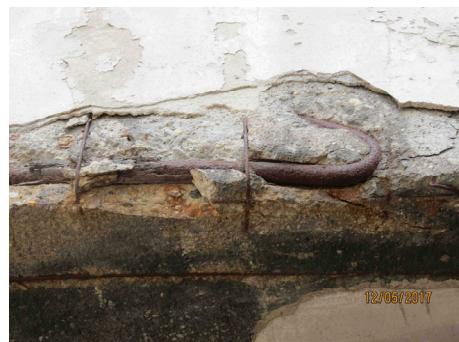
**Fig. 19.** Concrete and steel corrosion in the bearing frame of the connecting building.

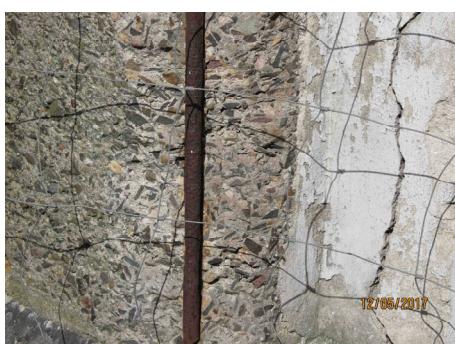
The results of simple sclerometer tests showed that the reinforced concrete elements in the buildings were made of concrete of very different quality. In these elements, such as the ceilings as well as pillars, concrete from C12/15 to C30/37 was found. The low quality of concrete (especially due to aggregate segregation and a lack of proper compaction) was also confirmed by direct observations carried out during a visual inspection (Fig. 20). On the basis of the sclerometric tests, it was assumed in the control calculations that the concrete in the ceilings and pillars corresponds to at least a class of C16/20.

**Fig. 20.** Concrete structure in the bearing frame of the connecting building.

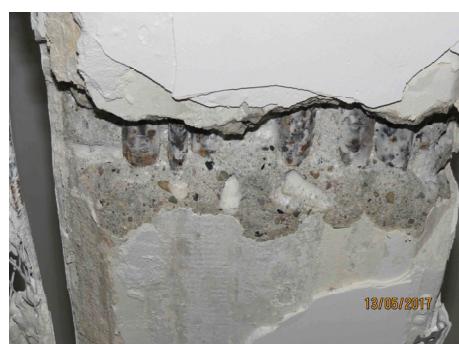
**Fig. 21.** Reinforcement in the main slab beams of the flour warehouse.

According to studies presented in [9, 10], at the beginning of the 20<sup>th</sup> century cast iron with a tensile strength of  $R_m = 370\text{--}460 \text{ MPa}$  was used as a reinforcement. The results of reinforcing steel tests carried out in recent years in several buildings in Wroclaw confirmed this data [10]. Therefore, to determine the strength of the reinforcing steel used in the assessed objects (Fig. 21), some specimens of reinforcing bars were taken and broken in

a testing machine. The results of some tests are shown in Figure 22. The following tensile strength results were obtained:  $R_{m1} = 445 \text{ MPa}$ ,  $R_{m2} = 436 \text{ MPa}$ ,  $R_{m3} = 394 \text{ MPa}$ ,  $R_{m4} = 415 \text{ MPa}$ ,  $R_{m5} = 397 \text{ MPa}$ ,  $R_{m6} = 397 \text{ MPa}$ . To determine the design yield value, a systematic calculation was used for the same concrete structures. The obtained results were as follows:  $R_{\text{max}} = 414 \text{ MPa}$ ,  $s = 22 \text{ MPa}$ ,  $R_G = 414 - 1.64 \cdot 22 = 378 \text{ MPa}$ ,  $f_{yk} = 0.8 \cdot 378 = 302 \text{ MPa}$ ,  $f_{yd} = 302 / 1.5 = 201 \text{ MPa}$ . The calculation yield limit  $f_{yd} = 210 \text{ MPa}$ , corresponding to the Polish AI class of reinforcement steel, was adopted for the verification calculations.
