Bayesian assessment of surface recession patterns in brick buildings with critical factors identification

E. Menéndez^{a,*}, L.M. Gil Martín^b, Y. Salem^a, L. Jalón^b, E. Hernández-Montes^b, M.C. Alonso^a

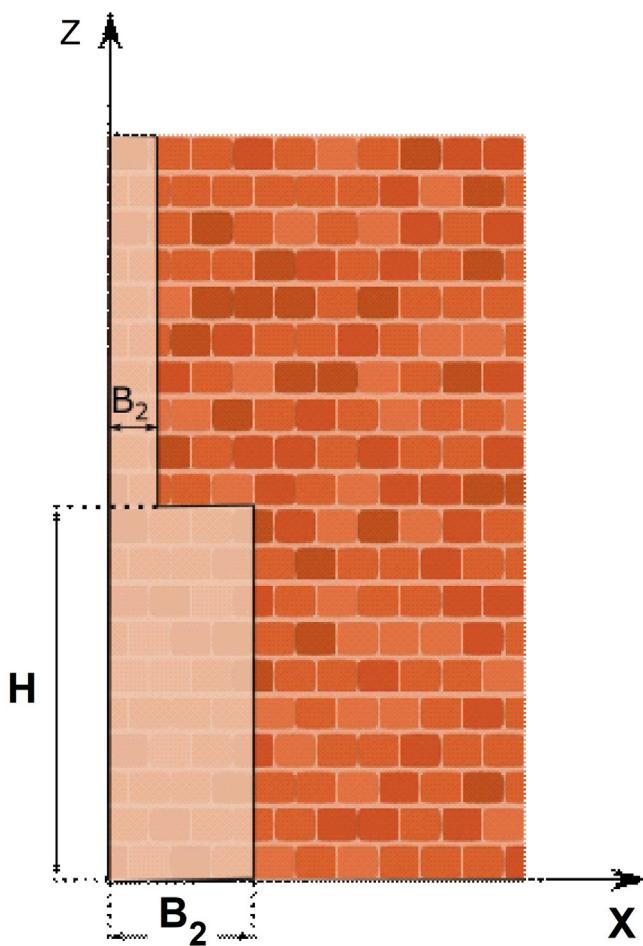
Fig. 2 – Candidate degradation pattern.

Among all the possible candidate regression profiles (parabolic, triangular, bilinear, rectangular, ...) [9], it has been proved that the one that best fit to the two cases studied of brick wall is the rectangular one. So, the parameterized degradation pattern depicted in [Fig. 2](#) has been assumed. In [Fig. 2](#), two different deteriorated areas can be seen being B_1 and B_2 the wall's thickness losses and H the height of the wall most affected by degradation, respectively. However, the

Fig. 10 represents the forward model simulation results using the posterior PDFs of the model parameters as inputs in Eq. (2) for the two buildings studied. It can be observed that the candidate degradation profile (see **Fig. 2**) represents the experimental data reasonably well in both cases. In addition, note that model output represents the variability and complexity in the data as two uncertainties, one in the non-deteriorated data where the uncertainty is less than the deteriorated data, which presents the highest variability and complexity. Finally, it can be concluded that the mean degradation depth is similar in both buildings, however the mean degradation height is higher in Puerta Elvira ($H = 0.8$ m) than in the Pabellón Gemelo of the Residencia de Estudiantes ($H = 0.25$ m).

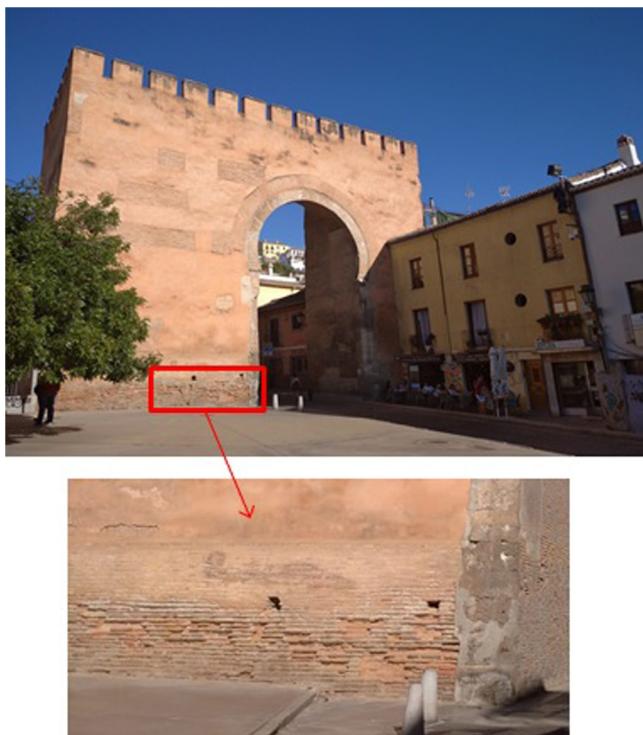
Fig. 3 – Puerta Elvira, Granada (Spain). Detail of the bricks.

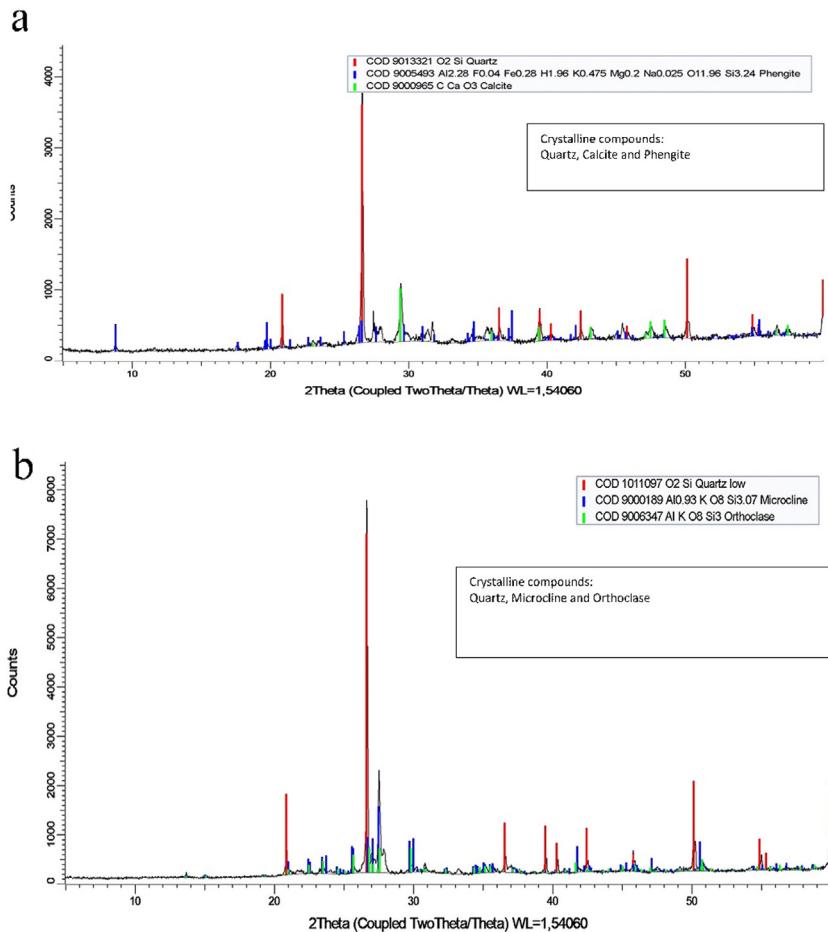
**Fig. 5 – XRD pattern of brick from: (a) Puerta Elvira. (b) Residencia de Estudiantes.**

The results of the X-ray diffraction tests are represented in Fig. 5. Table 2 shows the major and minor components observed by X-ray diffraction.

Fig. 5a and b, and Table 2 show that the mineralogical composition in both bricks is similar. Quartz is the majority component in both samples. On the other hand, micas and feldspars are the minor crystalline components.

In addition, it should be noted that a significant amount of calcium carbonate can be observed in the form of calcite in brick from Puerta Elvira. This calcite cannot be associated with the composition of the brick.

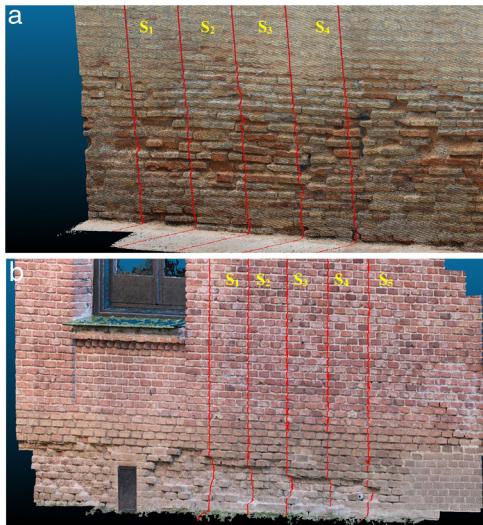
**Fig. 6 – Photogrammetric point cloud representation with the degradation profiles (S₁, S₂, S₃, S₄, S₅) of Puerta Elvira (a) and Pabellón Gemelo of the Residencia de Estudiantes (b).**

At present, the brick facades show evidence of deterioration, mainly in the lower part of the walls. The deleterious effects cause damage that can be seen in the rounded corners of the bricks as shown in Fig. 6.

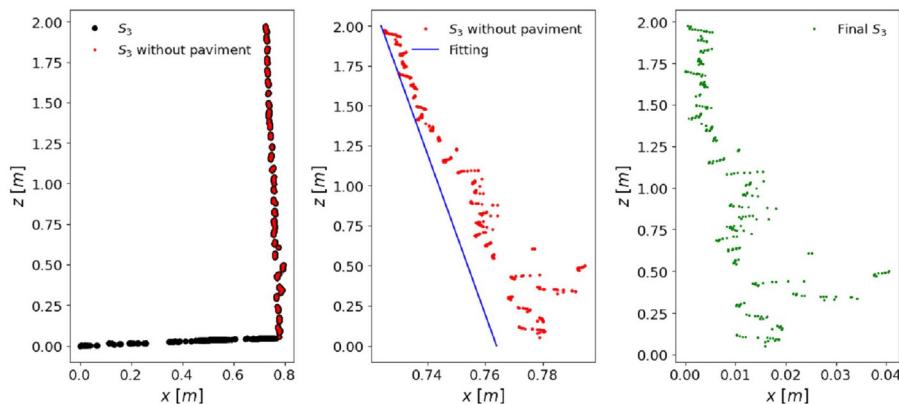
Fig. 7 – Data processing of Puerta Elvira.

The degradation profiles have been obtained from the PPC using the CloudCompare software [35]. Preliminary data processing was carried out, removing the pavement and making a projection on the tangent line to the smallest deteriorated area. For illustrative purposes, the data processing is represented in **Fig. 7** for Puerta Elvira.

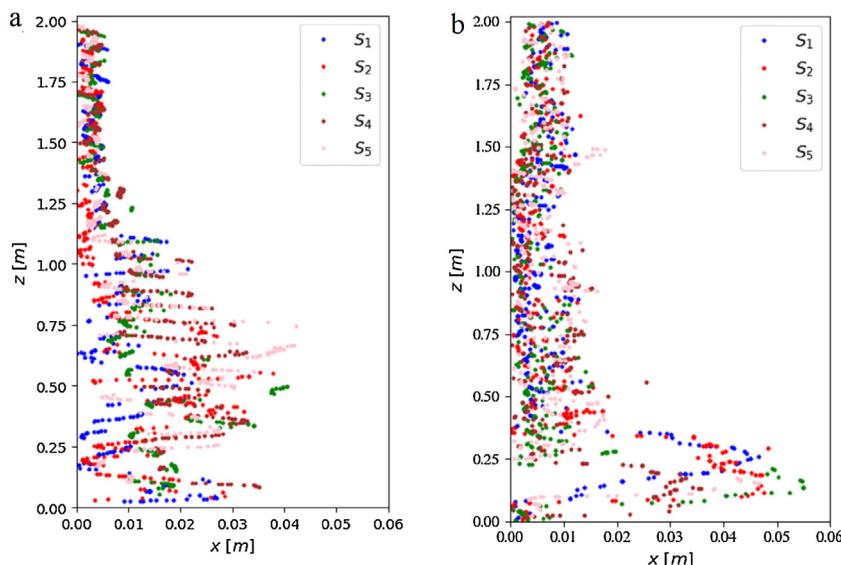
The final degradation is represented in **Fig. 8** for the two buildings studied. The difficulty in fitting the values of the geometry degradation parameters $\theta = \{B, H\}$ can be seen simply by observing the data. So, the plausible values of the geometry degradation parameters $\theta = \{B, H\}$ have been obtained in the form of the Probability Density Function $p(\theta|z_D)$ using the Bayesian methodology proposed.

Fig. 8 – Measured degradation profiles of (a) Puerta Elvira and (b) Pabellón Gemelo de Residencia de Estudiantes.

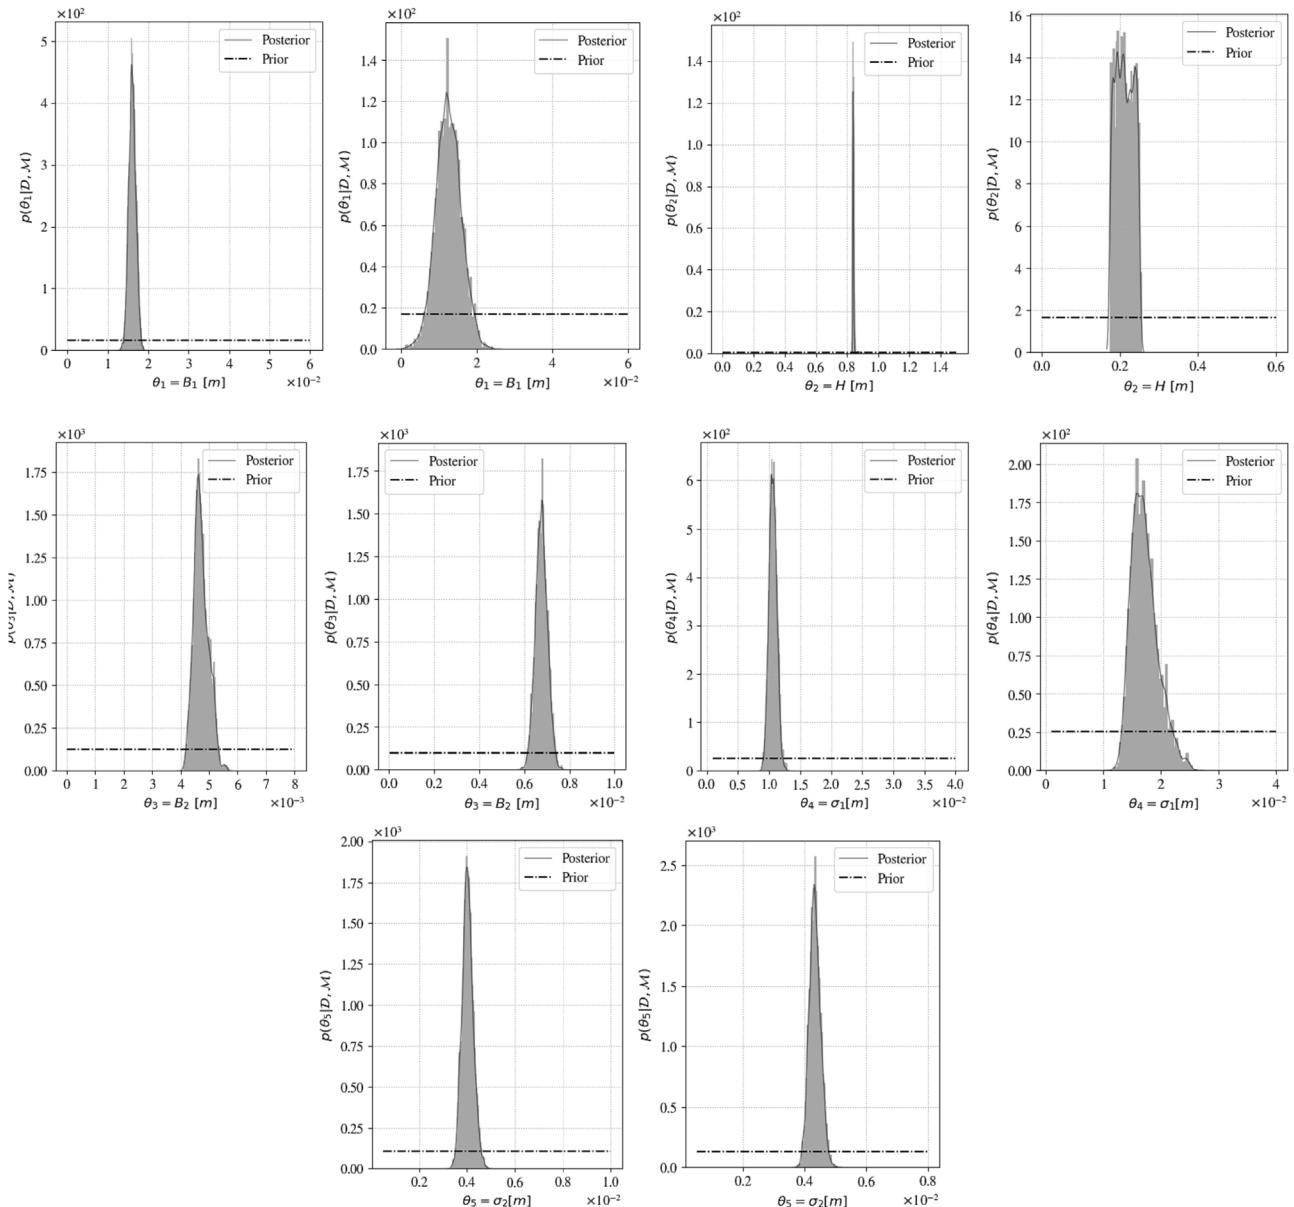
Fig. 9 – Prior and posterior probability density functions of the model parameters defining the surface recession pattern for Puerta Elvira (left) and the Pabellón Gemelo of the Residencia de Estudiantes (right).

Samples from the posterior PDFs ($p(\theta|Z_D)$) of the model parameters were obtained by using the M-H algorithm with 30,000 realizations in both buildings. The prior and the posterior PDF results of each individual parameter ($\Theta_1 = B_1, \Theta_2 = H, \Theta_3 = B_2, \Theta_4 = \sigma_{e1}, \Theta_5 = \sigma_{e2}$) are represented in **Fig. 9** for Puerta Elvira and Residencia de Estudiantes. The reduction in uncertainty from the prior PDF (dashed line) to the posterior PDF (solid line) is worth noting.

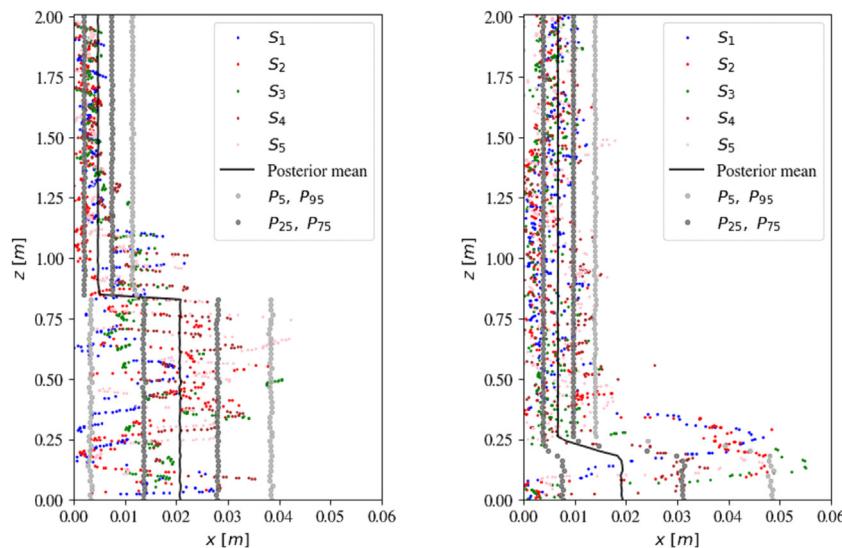
Fig. 10 shows that the posterior mean degradation of the brick walls is larger in the case of Puerta Elvira than the Residencia de Estudiantes. The most significant difference is the degradation height, which is four times greater at Puerta Elvira. By assuming uniform degradation over time, **Fig. 10** leads to the velocities of mean degradation indicated in **Table 8**.

Fig. 10 – Posterior mean degradation and confidence intervals (P_5 , P_{25} , P_{75} , P_{95}) against the experimental degradation data (S_1 , S_2 , S_3 , S_4 , S_5) for Puerta Elvira (left) and the Pabellón Gemelo of the Residencia de Estudiantes (right).

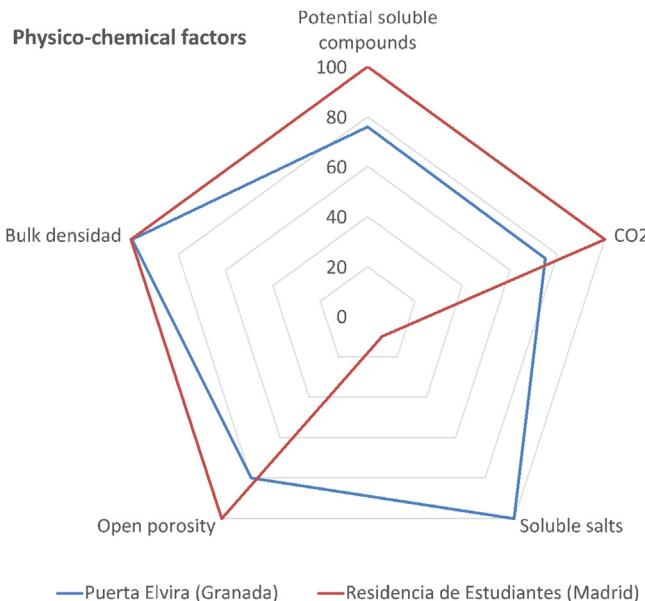
Fig. 11 – Representation of physico-chemical factors.

In Fig. 11, the physico-chemical factors are represented. It can be seen that the determining parameter in these factors are the soluble salts, while the rest of the parameters are quite similar. Table 4 indicates a much higher amount of both salts and alkalis leached in the samples from Puerta

Elvira. This excess of alkali can produce efflorescence, which is responsible for the progressive deterioration of the bricks [36]. However, the wall of the Residencia de Estudiantes is located on a meadow, which a priori should be more aggressive. The explanation for these results is the use of de-icing salts at Puerta Elvira and the higher porosity of this brick compared with the bricks of the Residencia de Estudiantes.

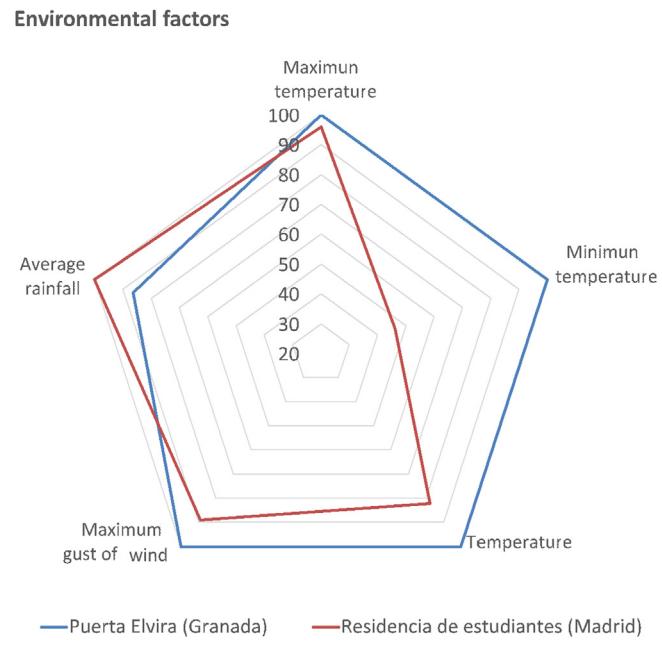
Fig. 12 – Representation of environmental factors.

Fig. 12 shows the different environmental factors that have been obtained in this study. In general, all the weather conditions, except rainfall, are more unfavorable in Granada. It has

been observed that the most significant factor in terms of differences between the two structures studied is the minimum temperature. Table 6 shows that the minimum temperatures in Granada are lower than in Madrid, which, despite having a continental climate with cold winters and hot summers, has higher minimum temperatures than Granada. In the case of Granada, these low winter temperatures are due to the proximity of the Sierra Nevada, with winds of greater intensity than in Madrid. The distance between the Sierra Nevada and Granada is 39.9 km, while the distance between the Sierra de Navacerrada and Madrid is 62 km.

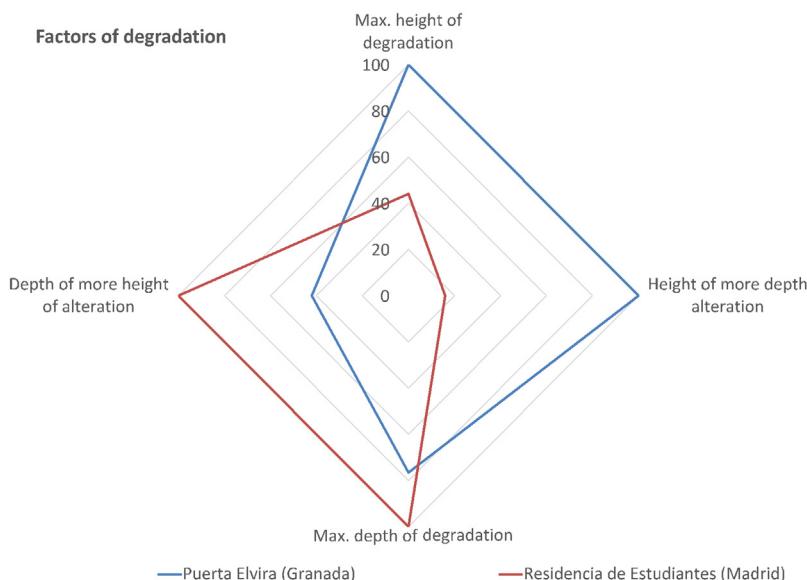
Fig. 13 – Representation of degradation factors.

In Fig. 13, the degradation factors have been represented. This figure clearly shows that Puerta Elvira is more degraded both in height and in surface. On the other hand, the Residencia de Estudiantes has greater degradation in depth than in height. This can be justified by the prairie soil at the Residencia de Estudiantes, which allows water access and freeze-thaw attack in winter, despite the bricks being less porous than those of Puerta Elvira.

As can be seen in Fig. 13, the effects of the degradation factors at Puerta Elvira and in the Residencia de Estudiantes are completely different from each other, but similar in terms of quantification. At Puerta Elvira, the influence of degradation on height is greater, while the greatest influence of degradation at the Residencia de Estudiantes corresponds to thickness.

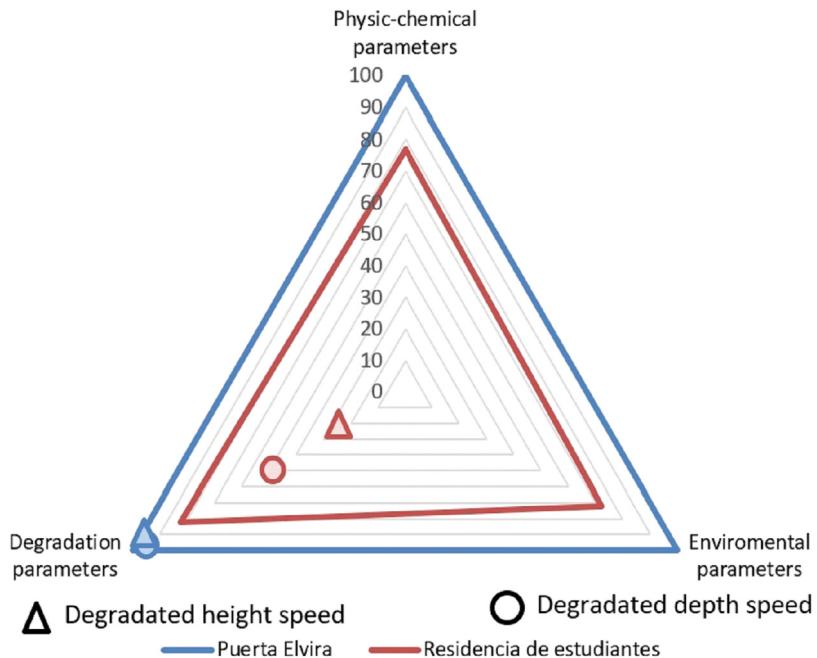
Fig. 14 – Weighted values of the main degradation factors.

Finally, in Fig. 14, the weighted values of the three groups of factors (physico-chemical, environmental, and degradation) are represented. This weighting has been carried out by adding the relative weight of each parameter for each factor and
