Application Development Center EMS-GRIVORY Answer to Technical Inquiry No.: 2014-0369

Material: Grivory GV-5 FWA blk Application: ultrasonic water meter

EMS-Water Meter (ovalix) lce Test

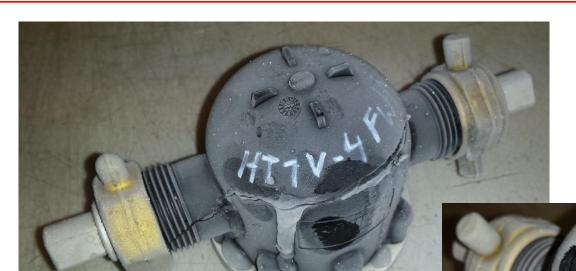
EMS-Water Meter (ovalix) Grivory HT1V-4 FWA (cascade)

Crack is shifted

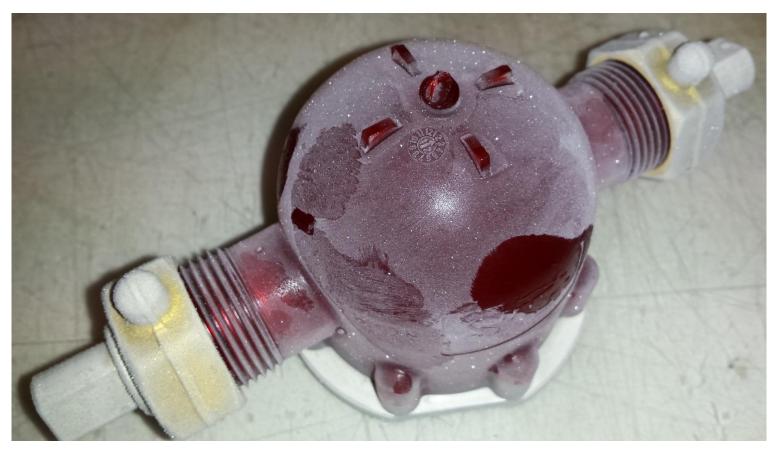
EMS-Water Meter (ovalix) Grilamid TR90

No failure
