Visit Report

Riifo

Application : Push quick fitting of piping system

Project number : 410-221125-1

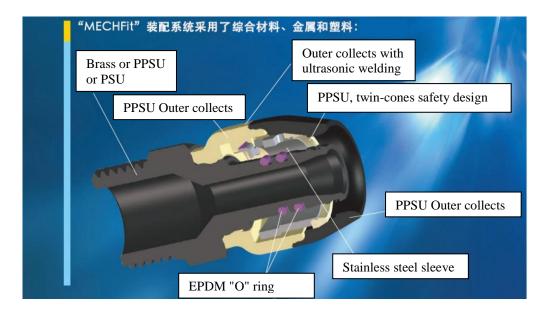
#1 Structure overview of push quick fitting

Well bonding strength of white and transparent parts thru ultrasonic weldline is required, potential risk of cracking during the test might happen due to bonding notches between the 2 parts.

Ultrasonic welding area, notches between the 2 parts
