Visit Report

Meikexin

Location Quanzhou, Fujian Application Embedded pole housing

Project number PDS not initiated yet Material Grivory GVX-5H BK

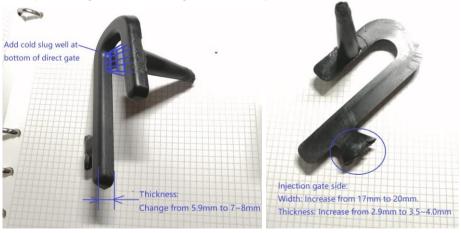
- Need around two years to finish relative tests (electrical performance testing / environment testing / mechanical performance testing).
- At this trial met drooling issue, the main reason is moisture content too high (0.1456%, checked by Aboni), we optimized injection parameters (back pressure / hot tip temperature / screw loosening), the drooling issue improved, but can't solved completely. Due to customer worry that void will produced in part inside, they refuse to use lower back pressure.

- We suggest molder to improve some items:
 - 1) Need prepare more raw material for trial and injection parameters optimization, otherwise can't better samples. (This time not enough material to optimize injection parameters, even purging barrel and screw.

- 2) Need use desiccant dryer to dry material and assure moisture contact $\leq 0.1\%$ (checked by Aboni), (molder use hot oven in this trial (115°C/6~7hrs), not follow our requirement).

- 3) Use valve pin hot tip instead of open type hot tip, it can well solve drooling issue.
- 4) One part weight about 3.0kg, the existing gate size too small, need to change it.
