## USER INTERFACE AND USER EXPERIENCE DESIGN LAB EXPERIMENT 1

NAME: M GAGANTEJSAI  
REG NO: 23MIS0661

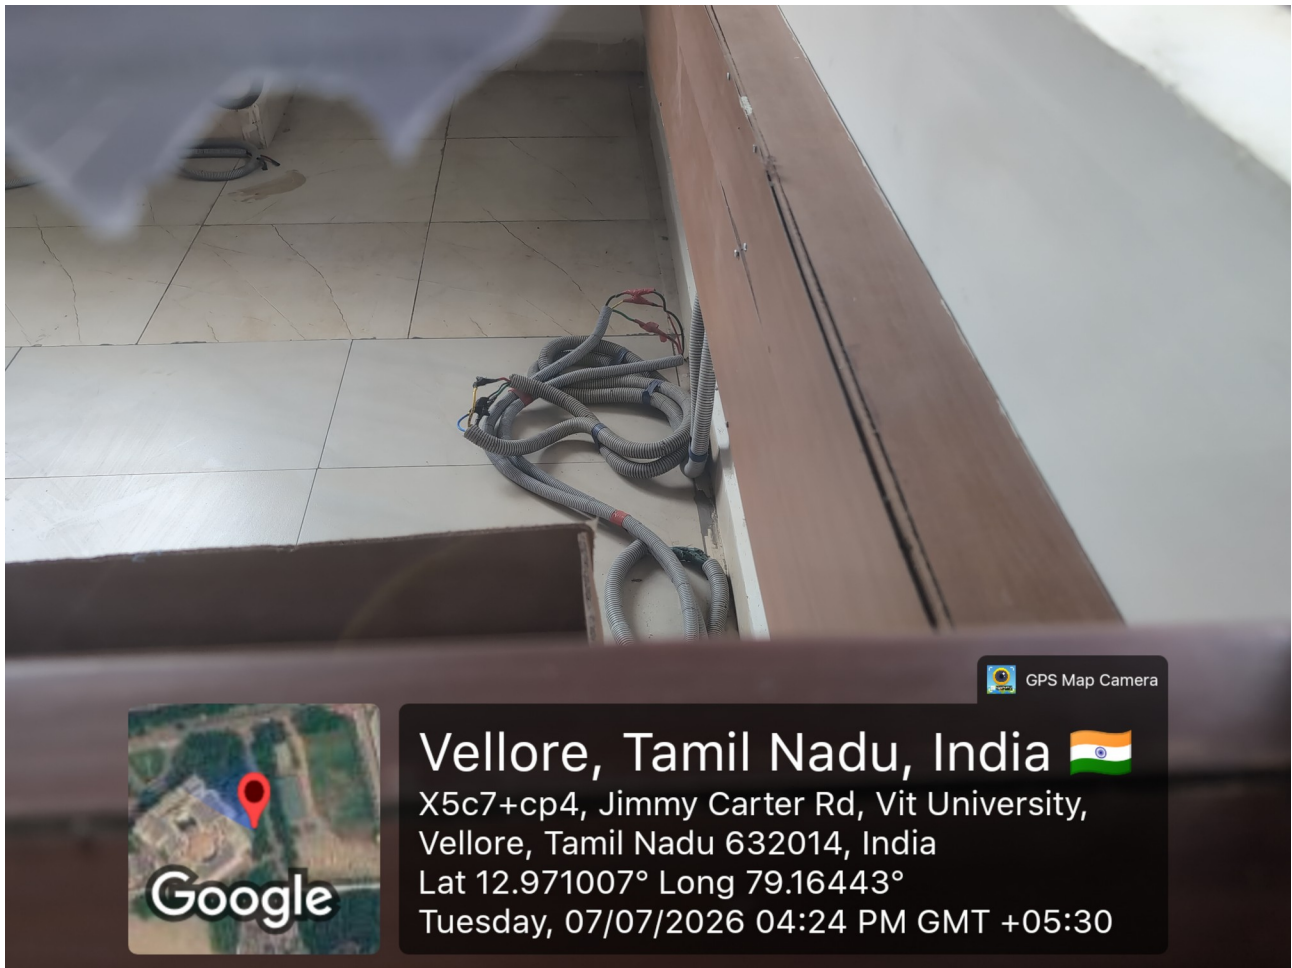
### Bad Design 1: **Loose Electrical Conduits on Floor**

Electrical conduits are left loose on the classroom floor instead of being properly enclosed.

Creates a tripping hazard. May damage electrical cables. Difficult to clean around. Unsafe during emergencies.

**Suggested Improvement:** Route cables through wall conduits. Install cable trays. Cover exposed wiring. Place warning signs until repaired.

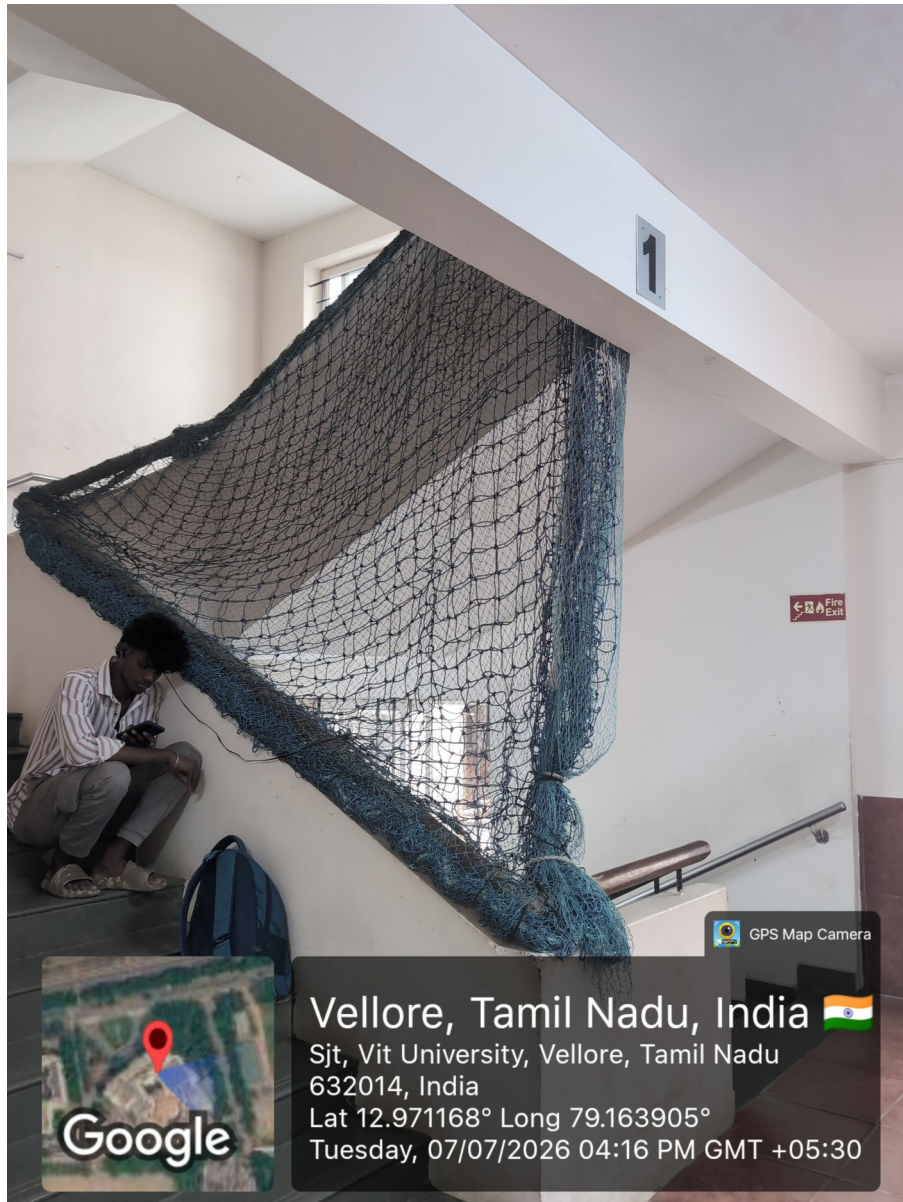
## Bad Design 2: Staircase Safety Net

**Description :** A large safety net covers a staircase and partially blocks visibility and movement.

**Reasons:** Reduces visibility. Can confuse users during evacuation. Makes the staircase feel obstructed. Difficult for maintenance.

**Suggested Improvement:** Install properly tensioned side safety mesh. Keep the walking path completely clear. Ensure emergency exits remain unobstructed.

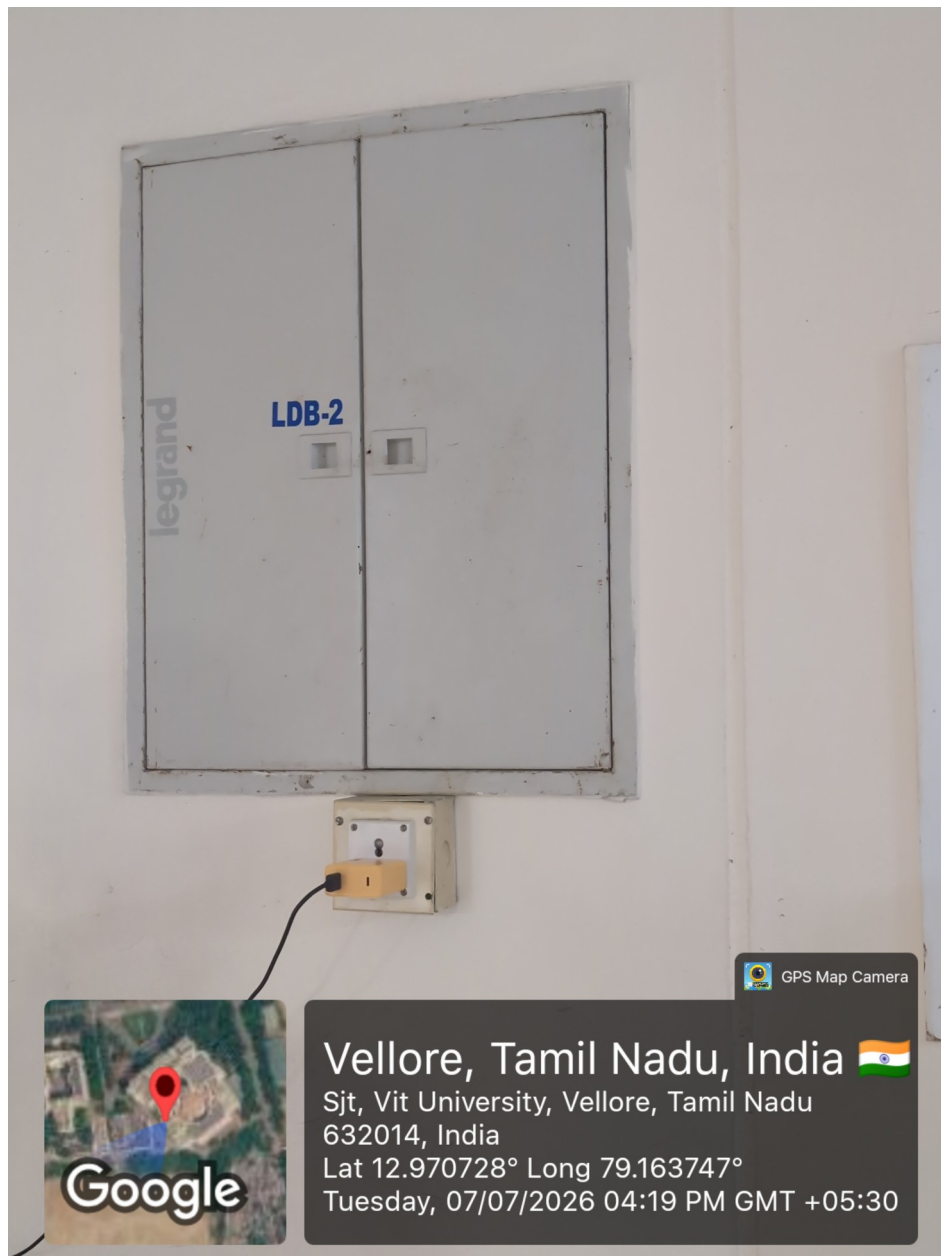
### Bad Design 3 : Electrical Distribution Board with Socket Below

**Description :** An electrical socket is installed directly beneath the electrical distribution board.

**Reasons:** Difficult to access safely. Plug cable hangs awkwardly. Risk while operating the panel. Poor ergonomic placement.

**Suggested Improvement:** Relocate socket away from the panel. Provide dedicated maintenance outlets. Label electrical equipment clearly.

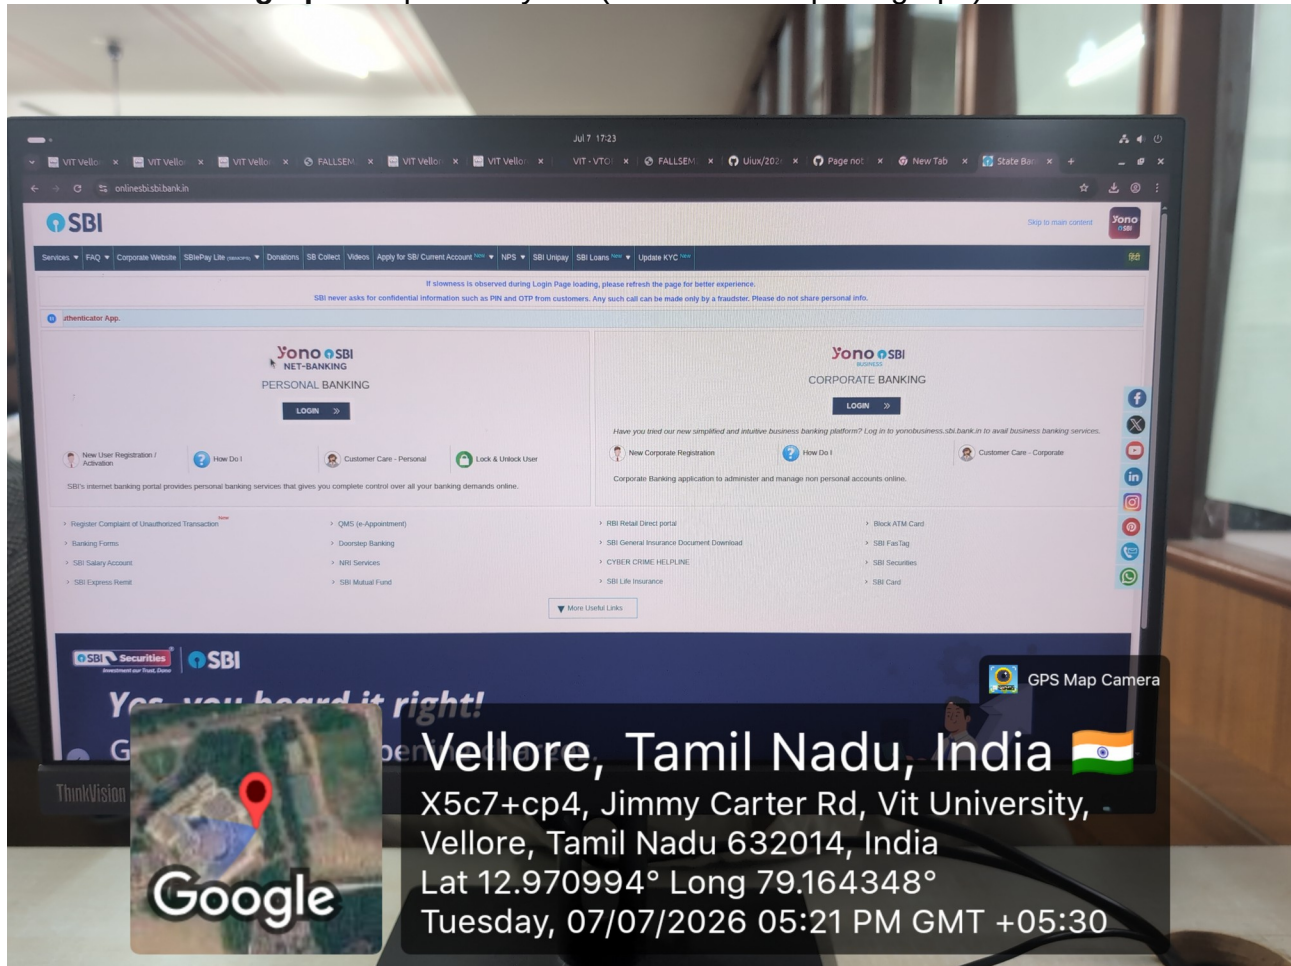
#### Bad Design 4: Cluttered Online Banking Homepage (SBI Net Banking)

**Description:** The SBI Net Banking homepage contains too many menus, links, announcements, login options, and icons on a single page. The interface appears crowded, making it difficult for users to quickly find the required service.

**Reasons why the design is bad:** Too much information displayed on one screen, causing cognitive overload. Personal Banking and Corporate Banking sections compete equally for attention. Small font size reduces readability. Multiple navigation menus and links make the interface confusing for first-time users. Important actions (such as Login) do not stand out sufficiently. Excessive use of banners and links distracts users from completing their primary task.

**Suggested Improvement:** Simplify the homepage by reducing unnecessary information. Increase font size and improve spacing between sections. Highlight the main Login button with better visual hierarchy. Group related services into expandable categories. Reduce visual clutter and improve the overall layout for easier navigation.
