## 1. VESSEL INSPECTION DETAILS

| Vessel ID: | P1090400 |
| Report Number: | NautiCAI-2026-04-12-001 |
| Inspection Type: | Automated Underwater Hull Assessment |

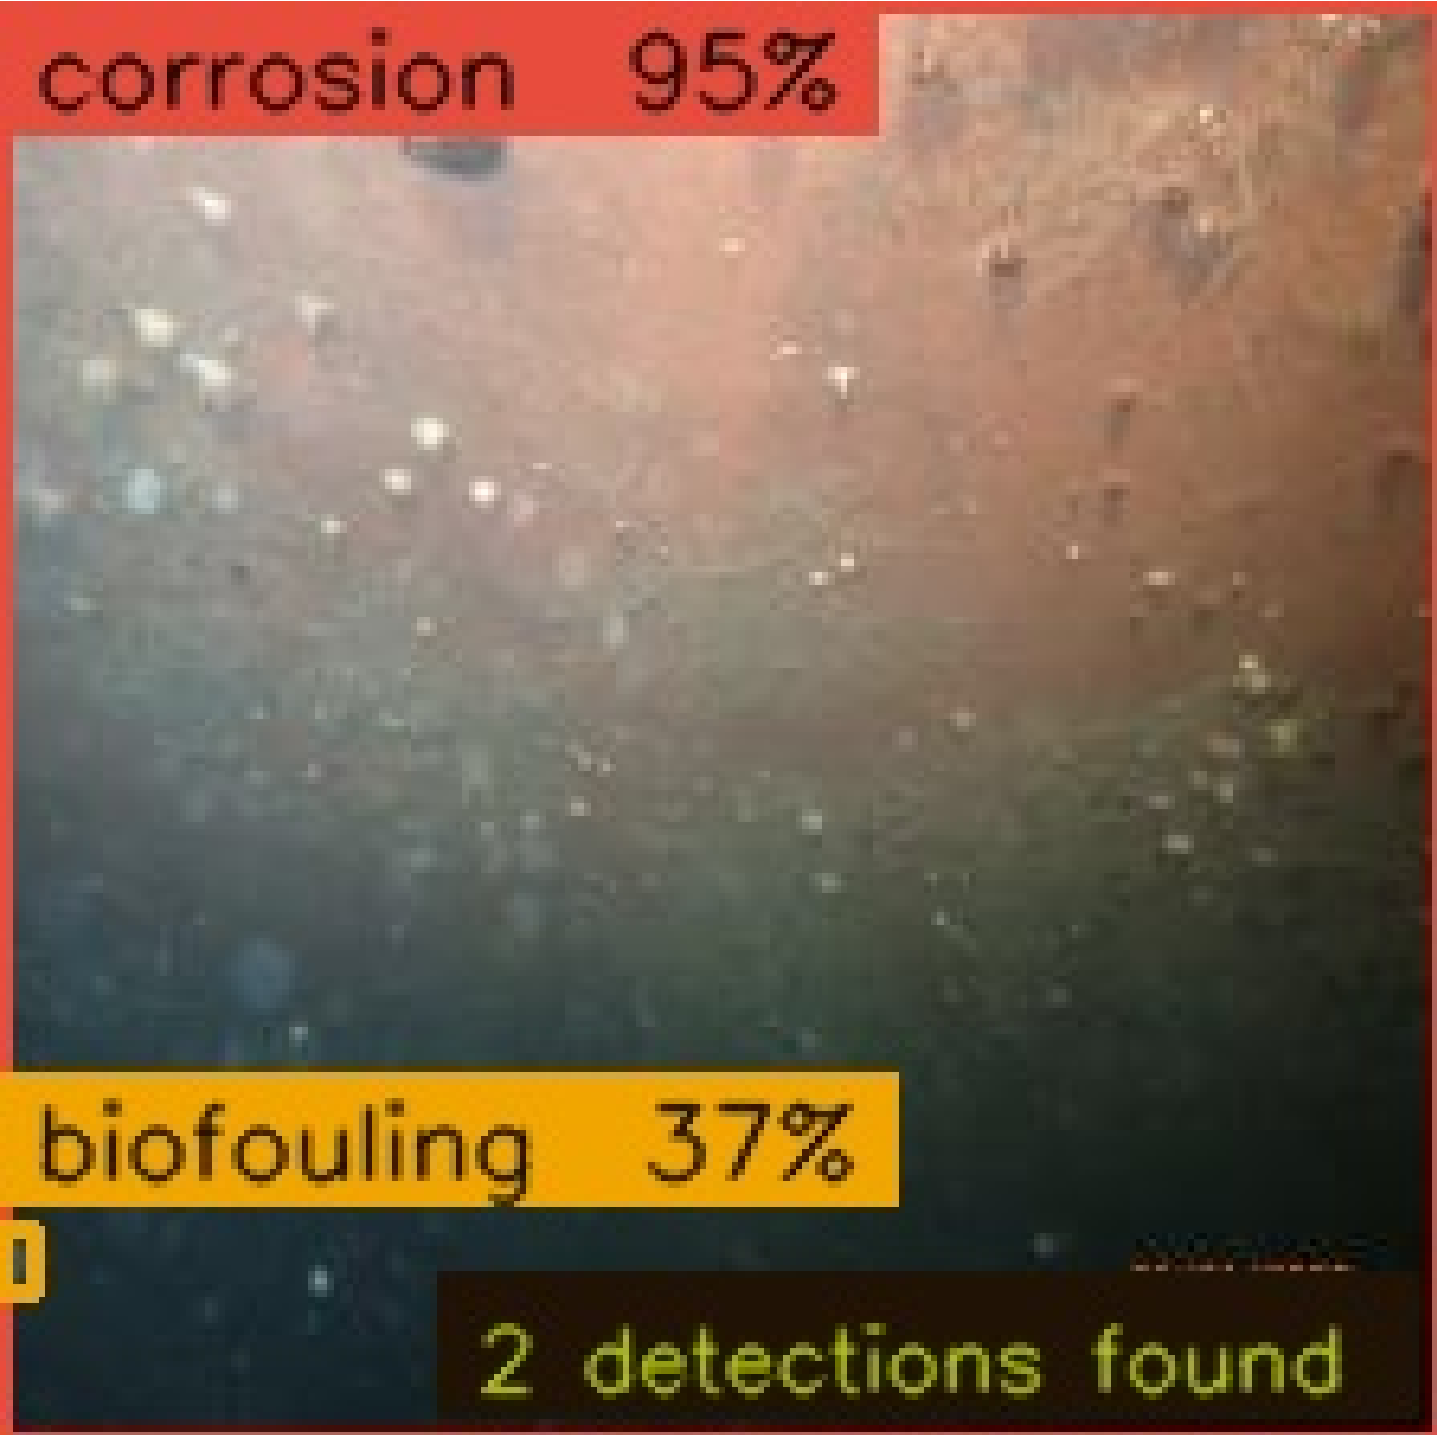
| Fouling Areas Identified: | 2 |

**FR-4 (Heavy Macrofouling - Critical!)**

Annotated inspection result - hull image with AI detections

**Required Action: URGENT: Immediate dry-dock cleaning required!**
