## 1. VESSEL INSPECTION DETAILS

| Vessel ID: | P1090466 |
| Report Number: | NautiCAI-2026-04-12-001 |
| Inspection Type: | Automated Underwater Hull Assessment |

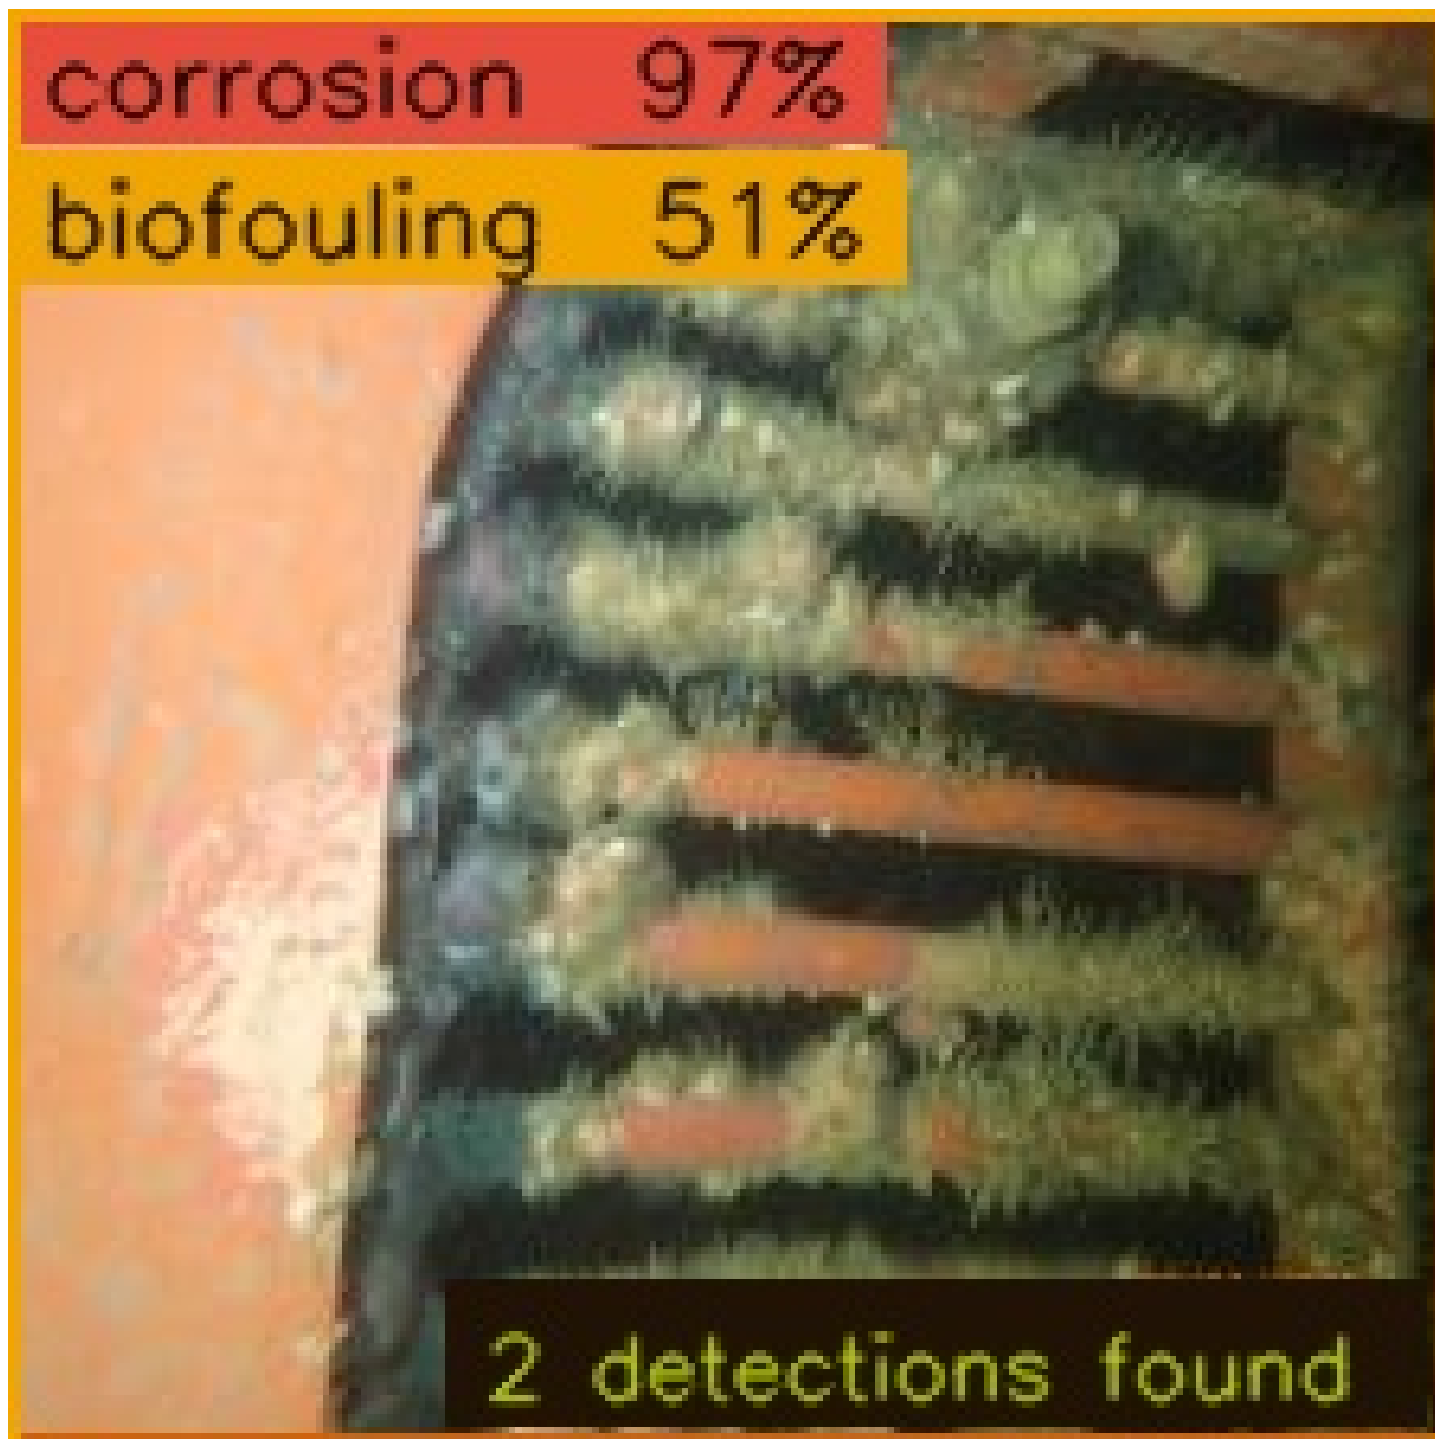
| Fouling Areas Identified: | 2 |

**FR-4 (Heavy Macrofouling - Critical!)**

Annotated inspection result - hull image with AI detections

**Required Action: URGENT: Immediate dry-dock cleaning required!**
