## 1. VESSEL INSPECTION DETAILS

| Report Number: | NautiCAI-2026-04-12-001 |
| Inspection Type: | Automated Underwater Hull Assessment |

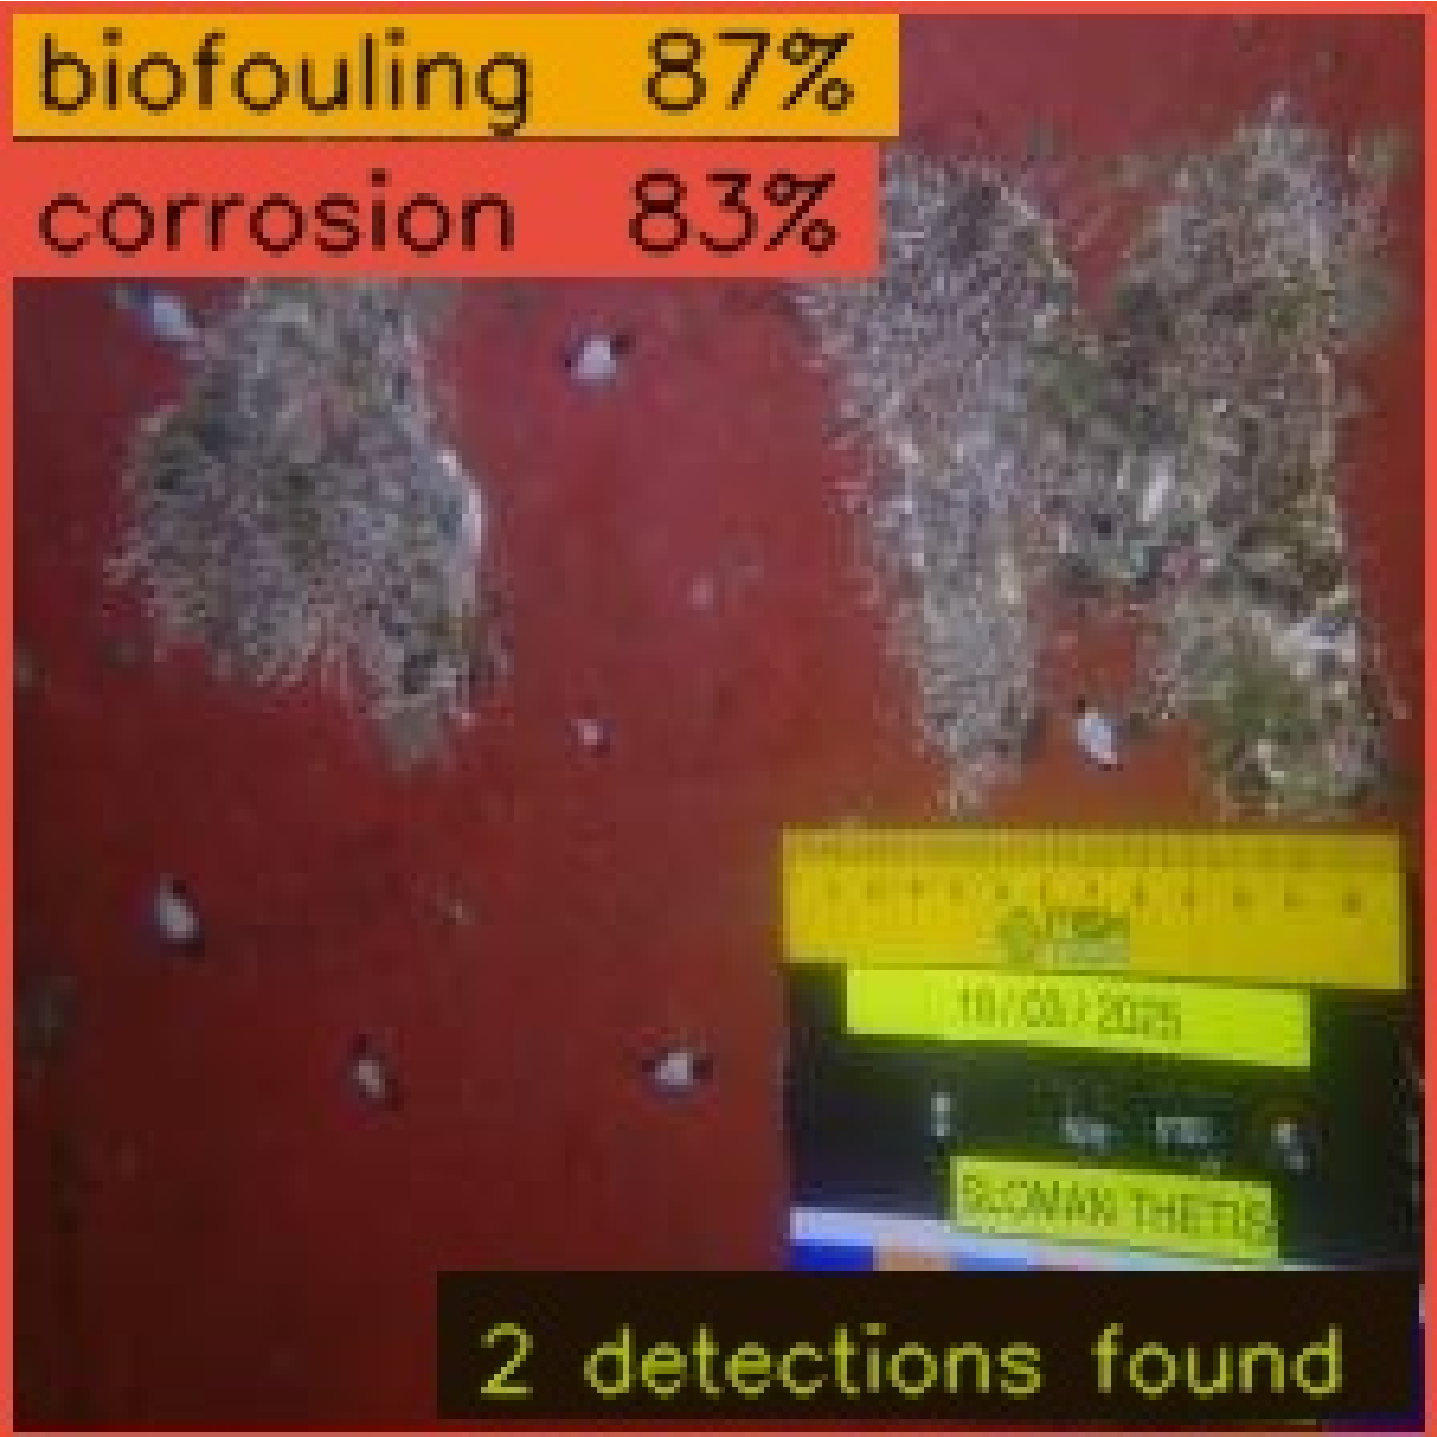
| Fouling Areas Identified: | 2 |

**FR-4 (Heavy Macrofouling - Critical!)**

Annotated inspection result - hull image with AI detections

Required Action: URGENT: Immediate dry-dock cleaning required!
