1. VESSEL INSPECTION DETAILS

| Report Number: | NautiCAI-2026-04-12-001 |
| Inspection Type: | Automated Underwater Hull Assessment |

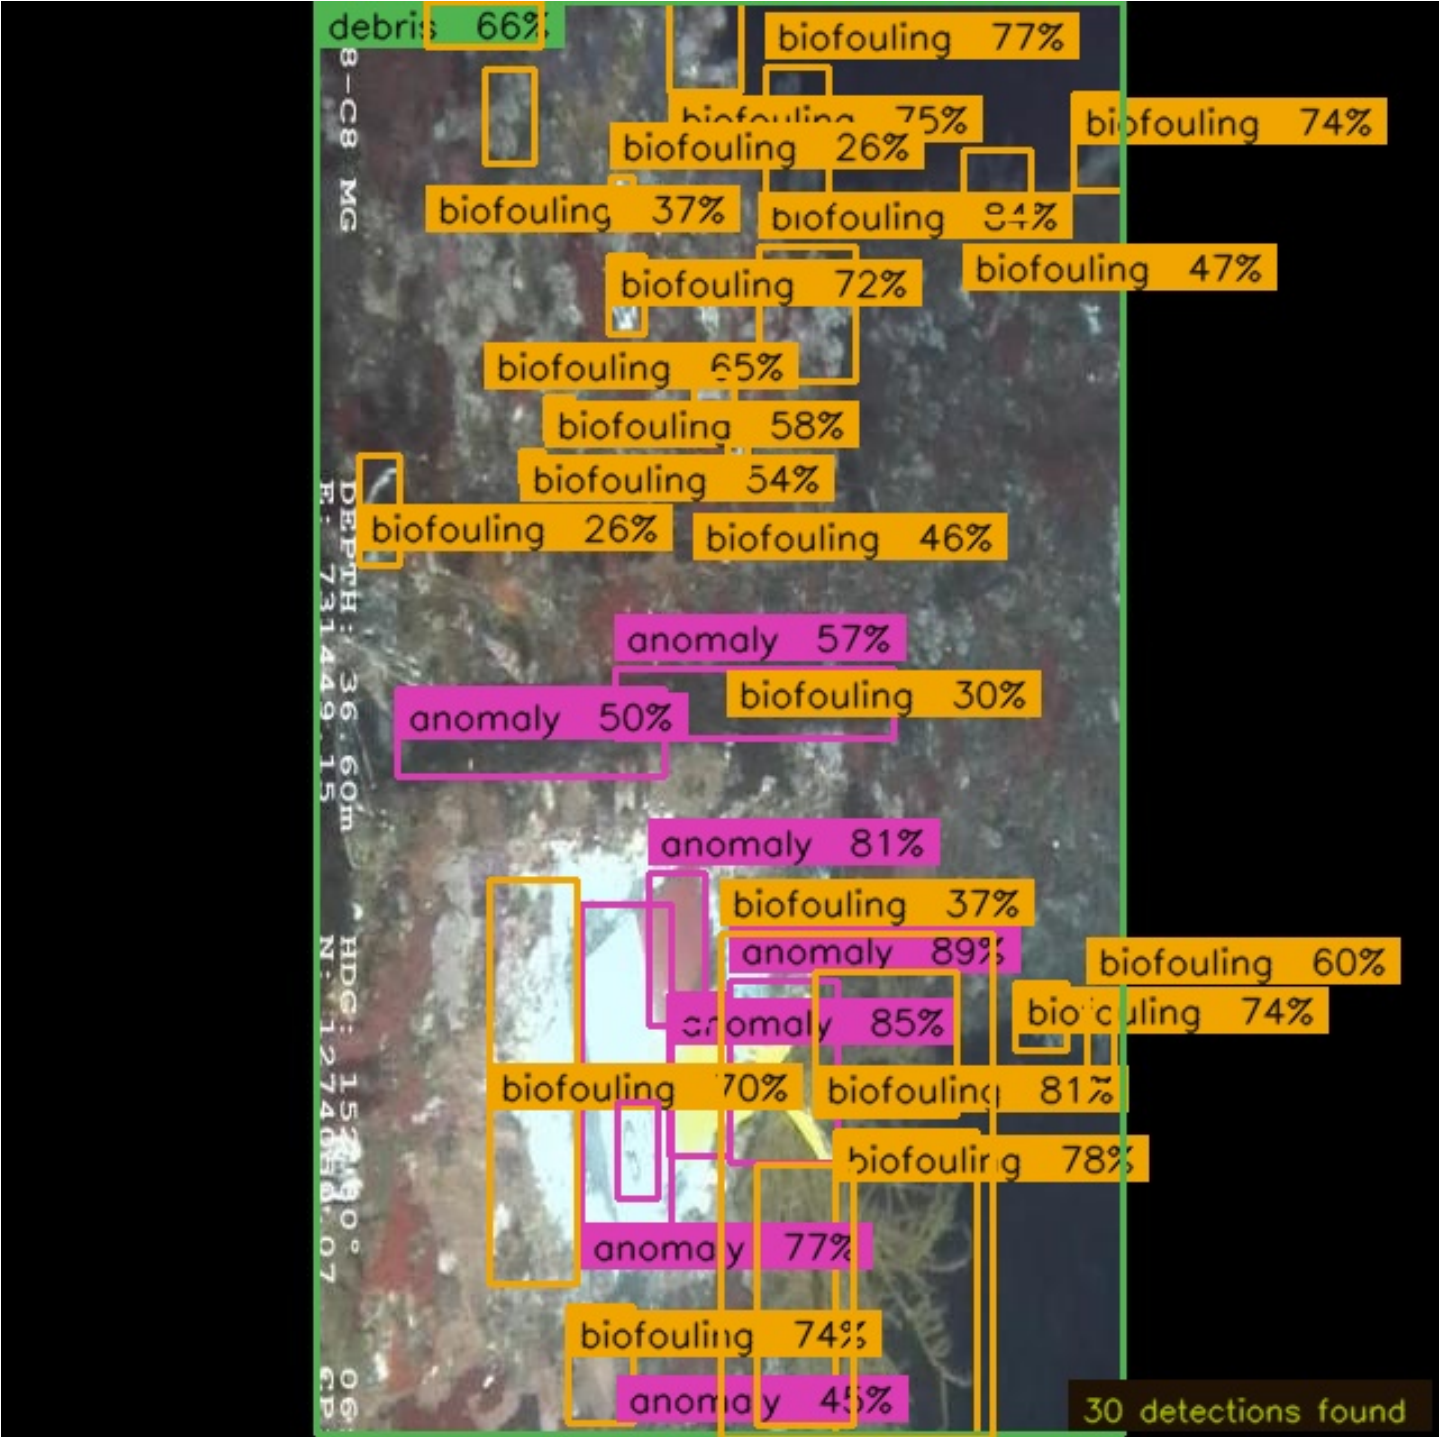
| Overall Condition: | High |
| Fouling Areas Identified: | 30 |

FR-4 (Heavy Macrofouling - Critical!)

Annotated inspection result - hull image with AI detections

!! IMMEDIATE CLEANING REQUIRED !!

Required Action: URGENT: Immediate dry-dock cleaning required!
