1. VESSEL INSPECTION DETAILS (COMBINED REPORT)

| Vessel ID: | hull4 |
| Report Number: | NautiCAI-2026-05-07-001 |
| Inspection Type: | Automated Underwater Hull Assessment (Multi-Image) |

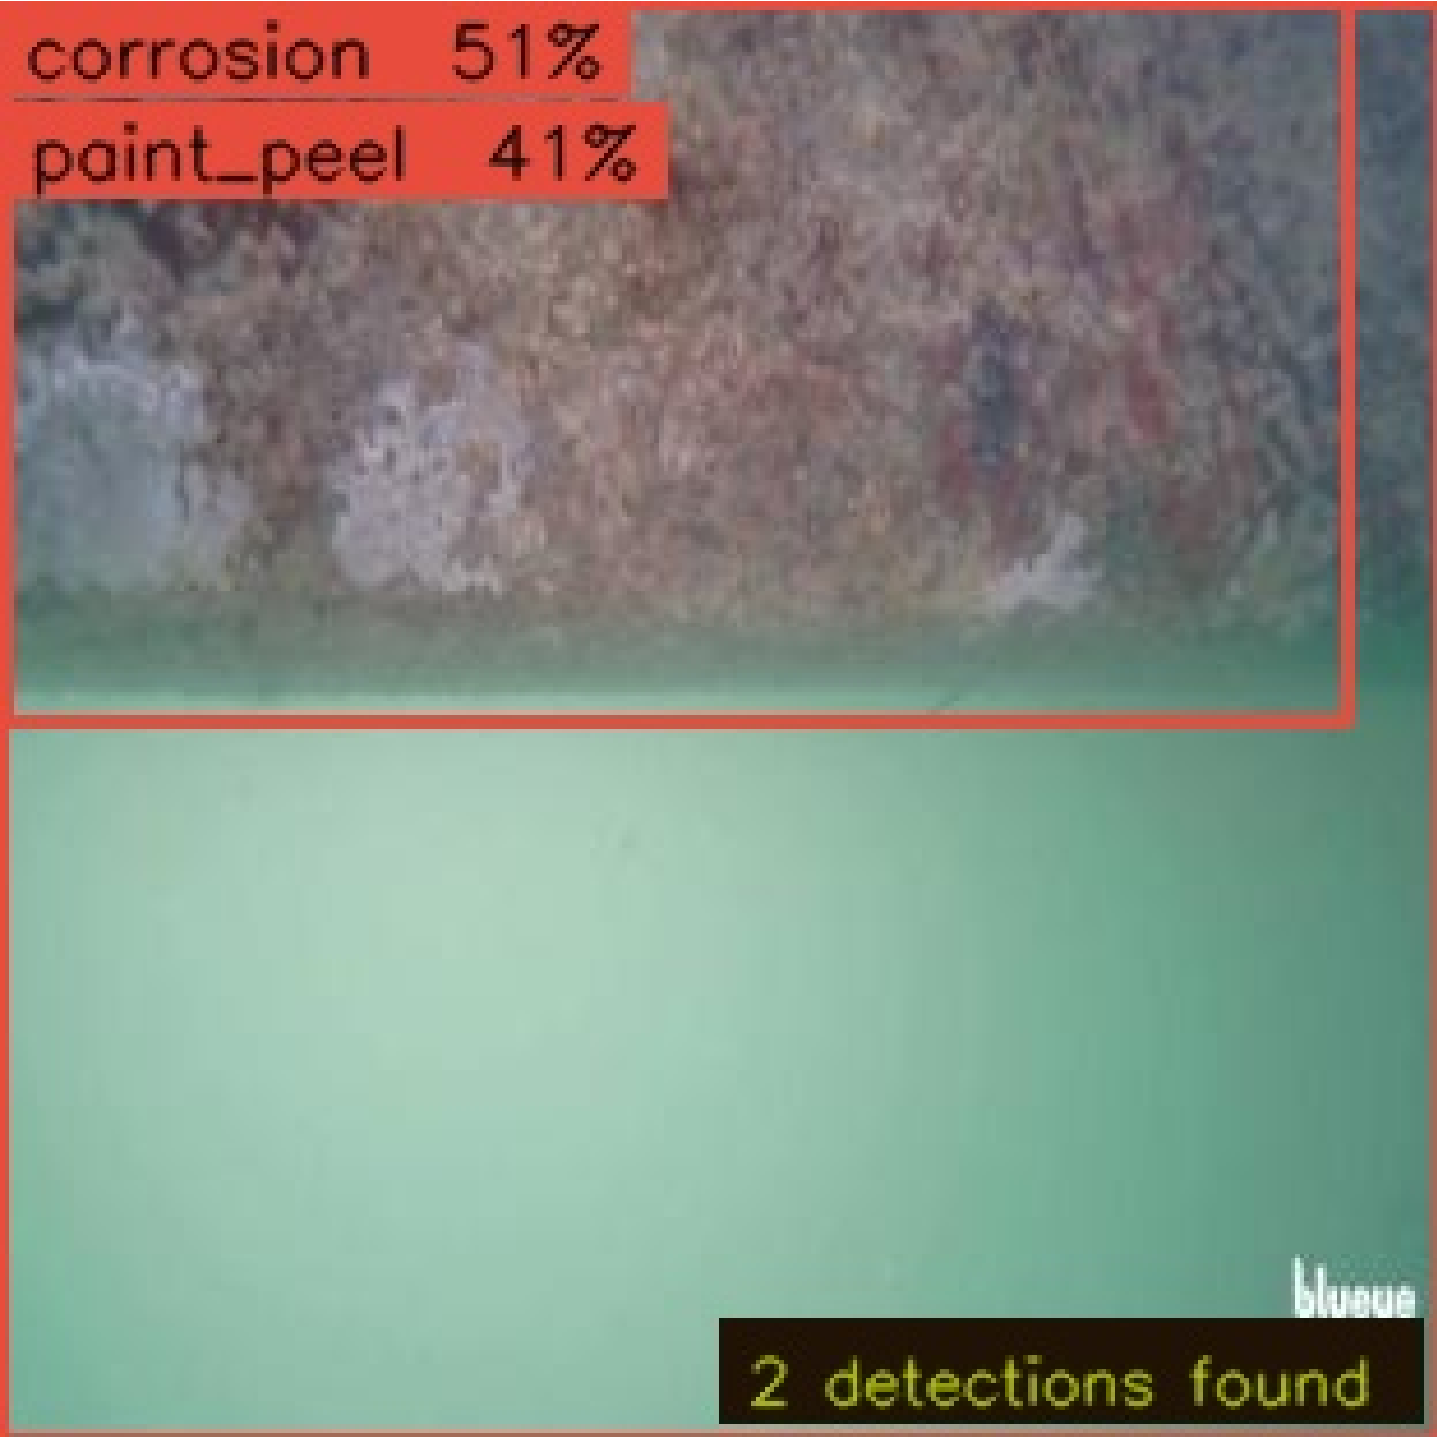
Inspection frame - Image 1 of 3 (annotated)

| Overall Condition: | High |
| Fouling Areas Identified: | 2 |

FR-4 (Heavy Macrofouling - Critical!)

!! IMMEDIATE CLEANING REQUIRED !!

Required Action: URGENT: Immediate dry-dock cleaning required!

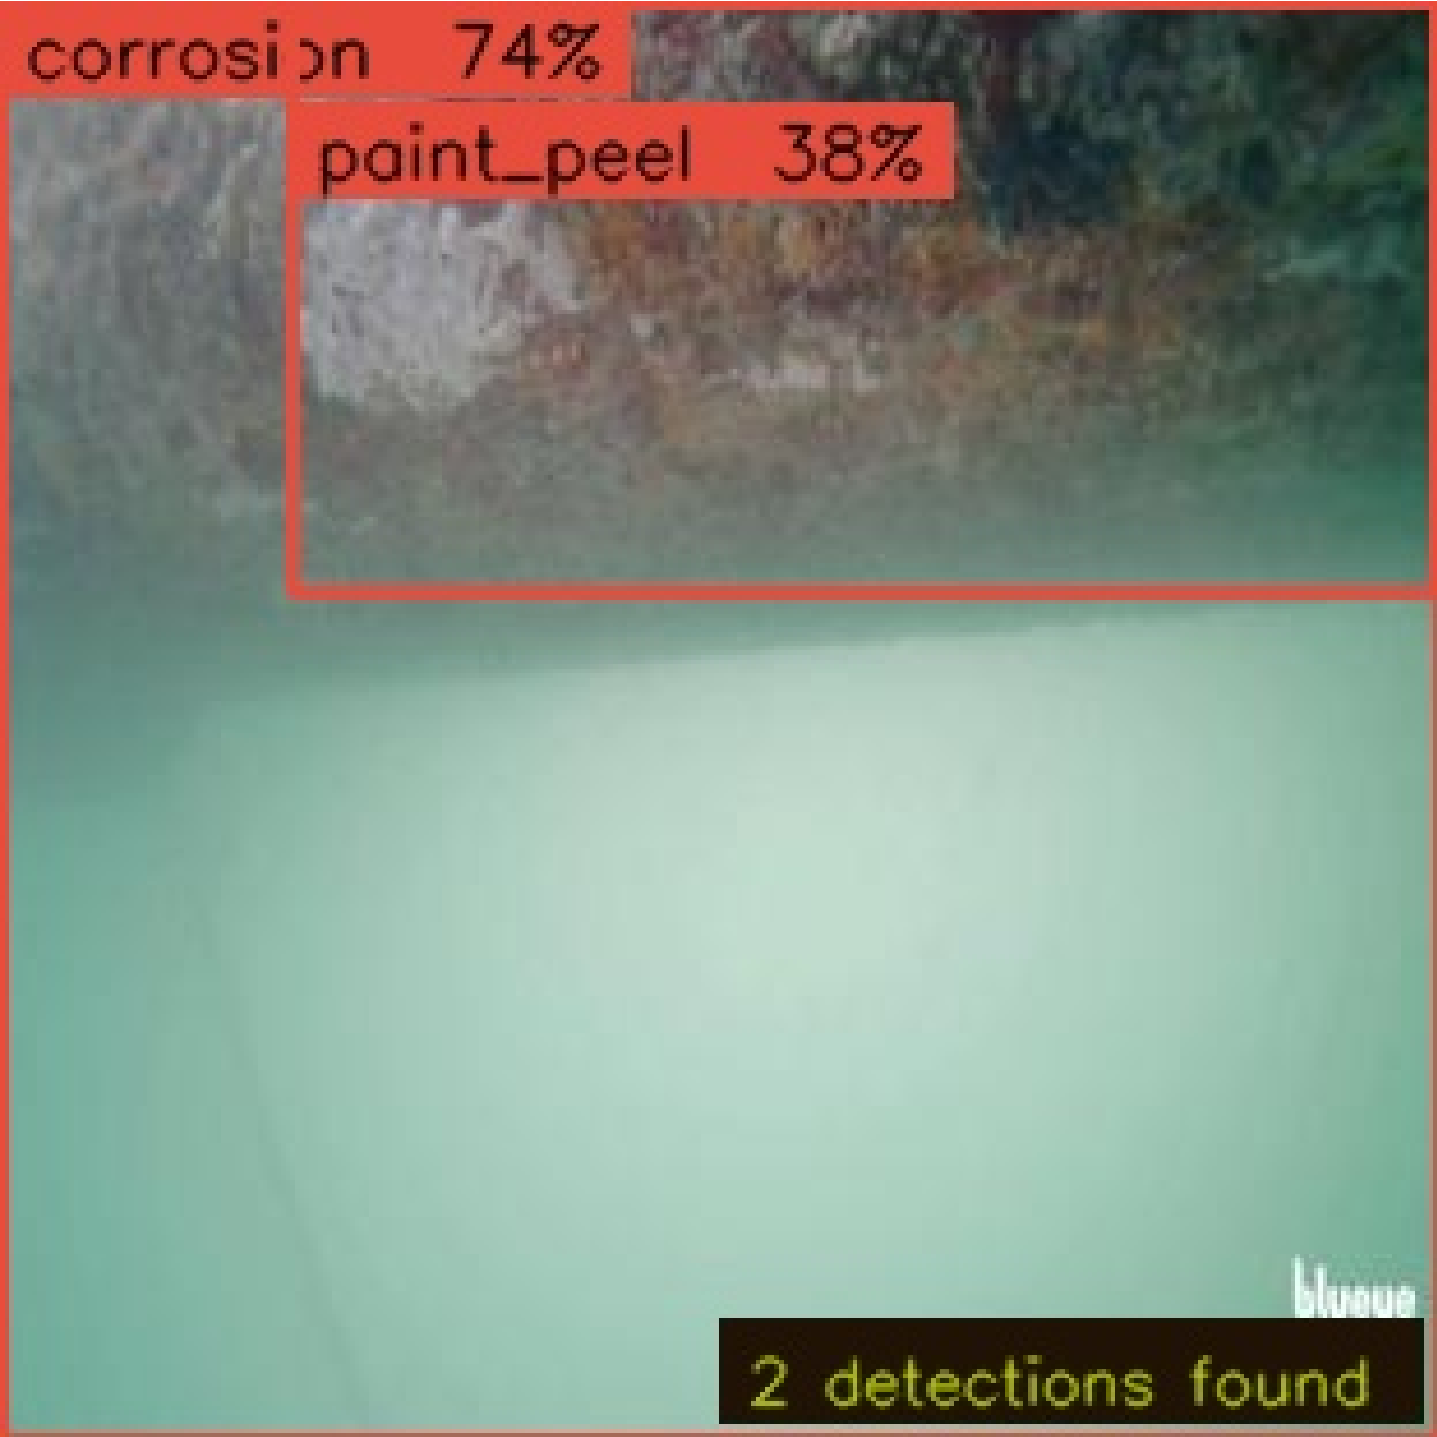
Inspection frame - Image 2 of 3 (annotated)

Overall Condition: High

Fouling Areas Identified: 2

FR-4 (Heavy Macrofouling - Critical!)

!! IMMEDIATE CLEANING REQUIRED !!

Required Action: URGENT: Immediate dry-dock cleaning required!

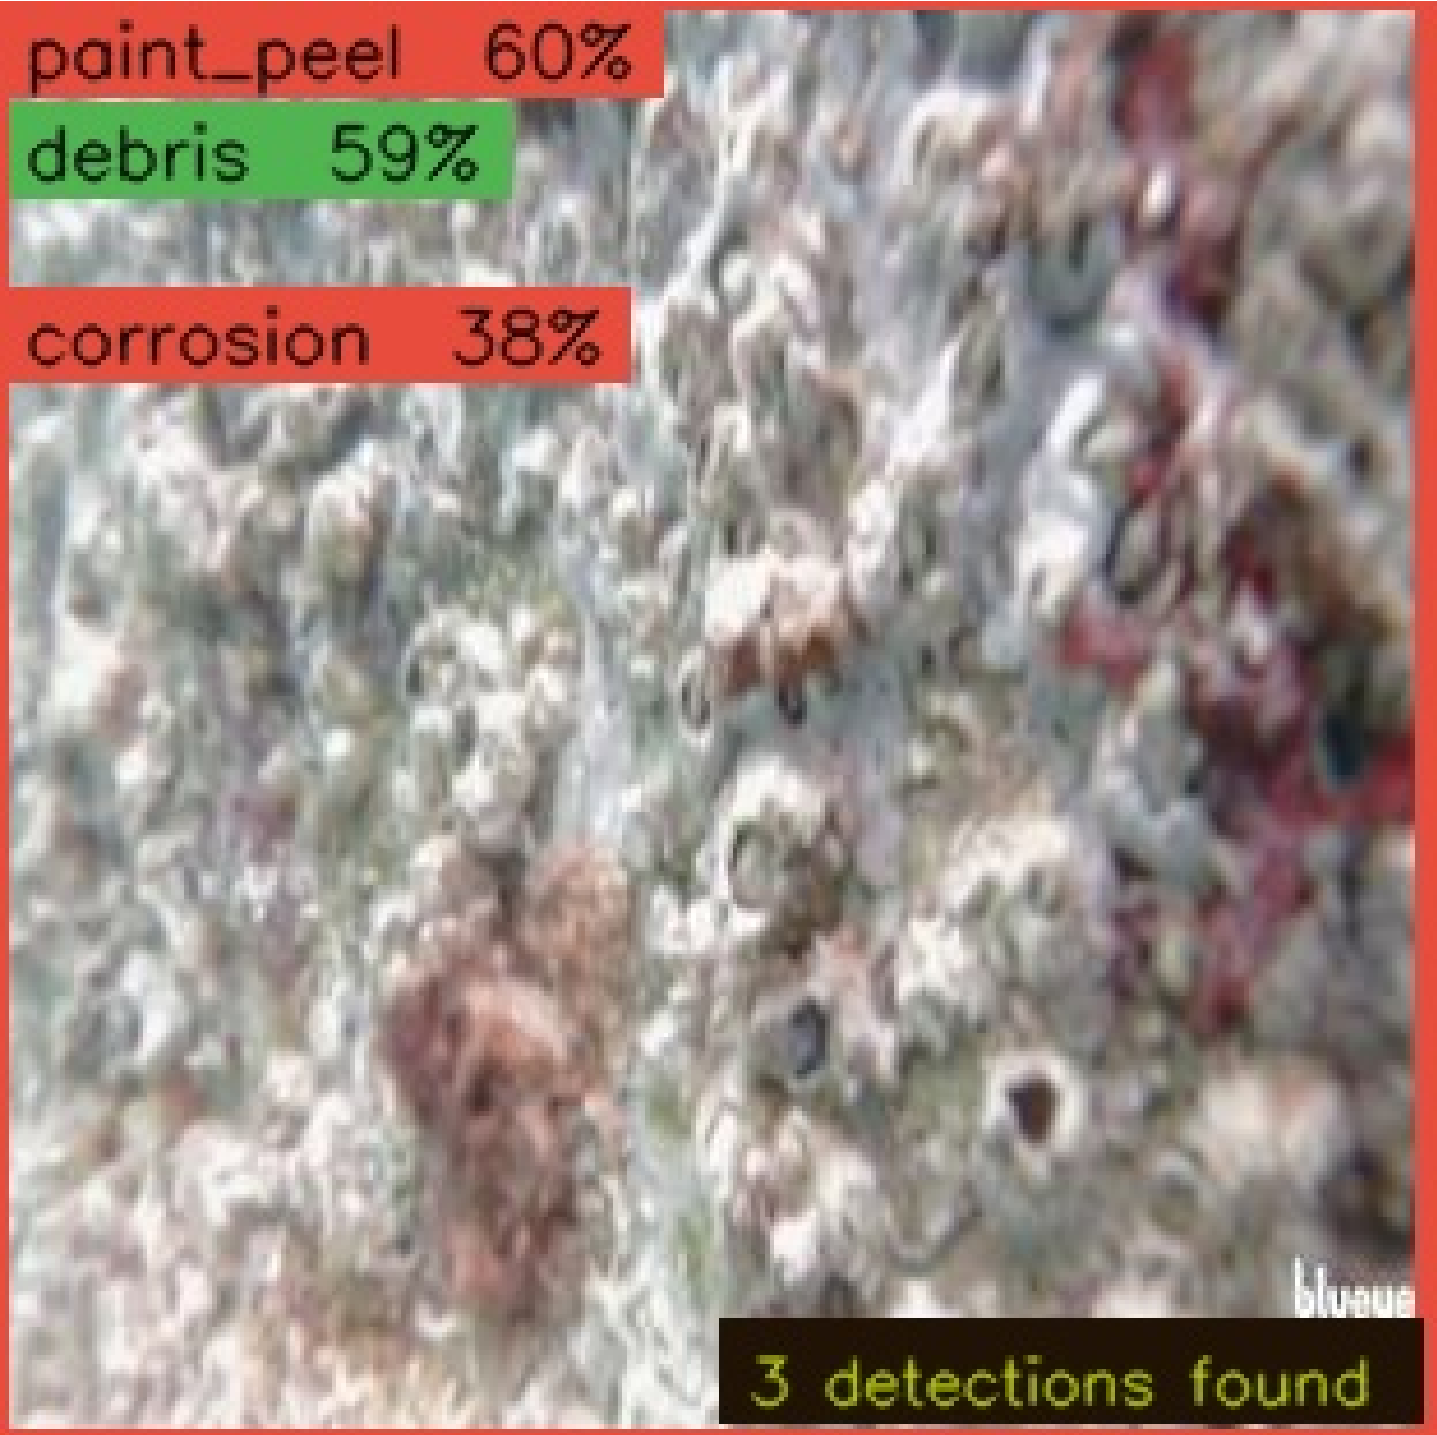
Inspection frame - Image 3 of 3 (annotated)

Overall Condition: High

Fouling Areas Identified: 3

FR-4 (Heavy Macrofouling - Critical!)

!! IMMEDIATE CLEANING REQUIRED !!

Required Action: URGENT: Immediate dry-dock cleaning required!
