## 1. VESSEL INSPECTION DETAILS

| Vessel ID: | P1090396 |
| Report Number: | NautiCAI-2026-04-12-001 |
| Inspection Type: | Automated Underwater Hull Assessment |

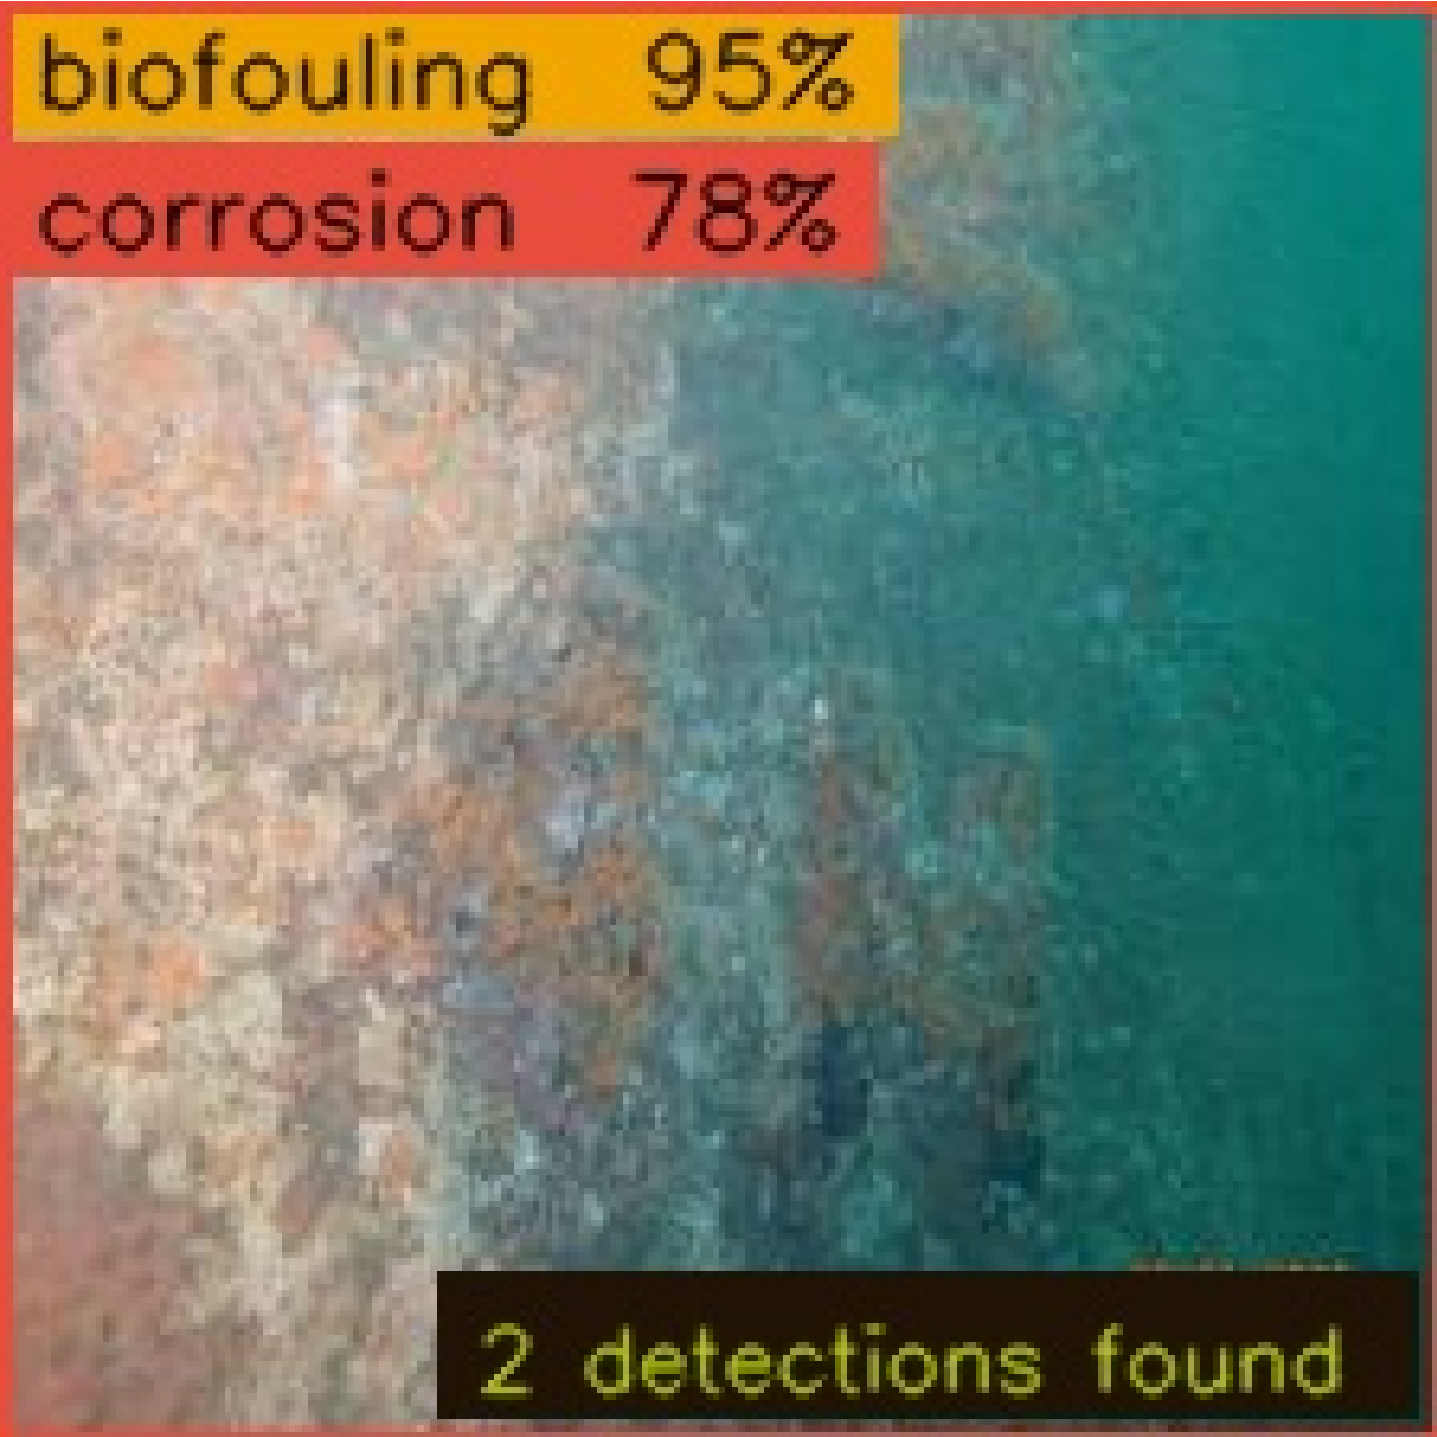
| Fouling Areas Identified: | 2 |

**FR-4 (Heavy Macrofouling - Critical!)**

Annotated inspection result - hull image with AI detections

Required Action: URGENT: Immediate dry-dock cleaning required!
