## 1. VESSEL INSPECTION DETAILS

| Vessel ID: | P1090402 |
| Report Number: | NautiCAI-2026-04-12-001 |
| Inspection Type: | Automated Underwater Hull Assessment |

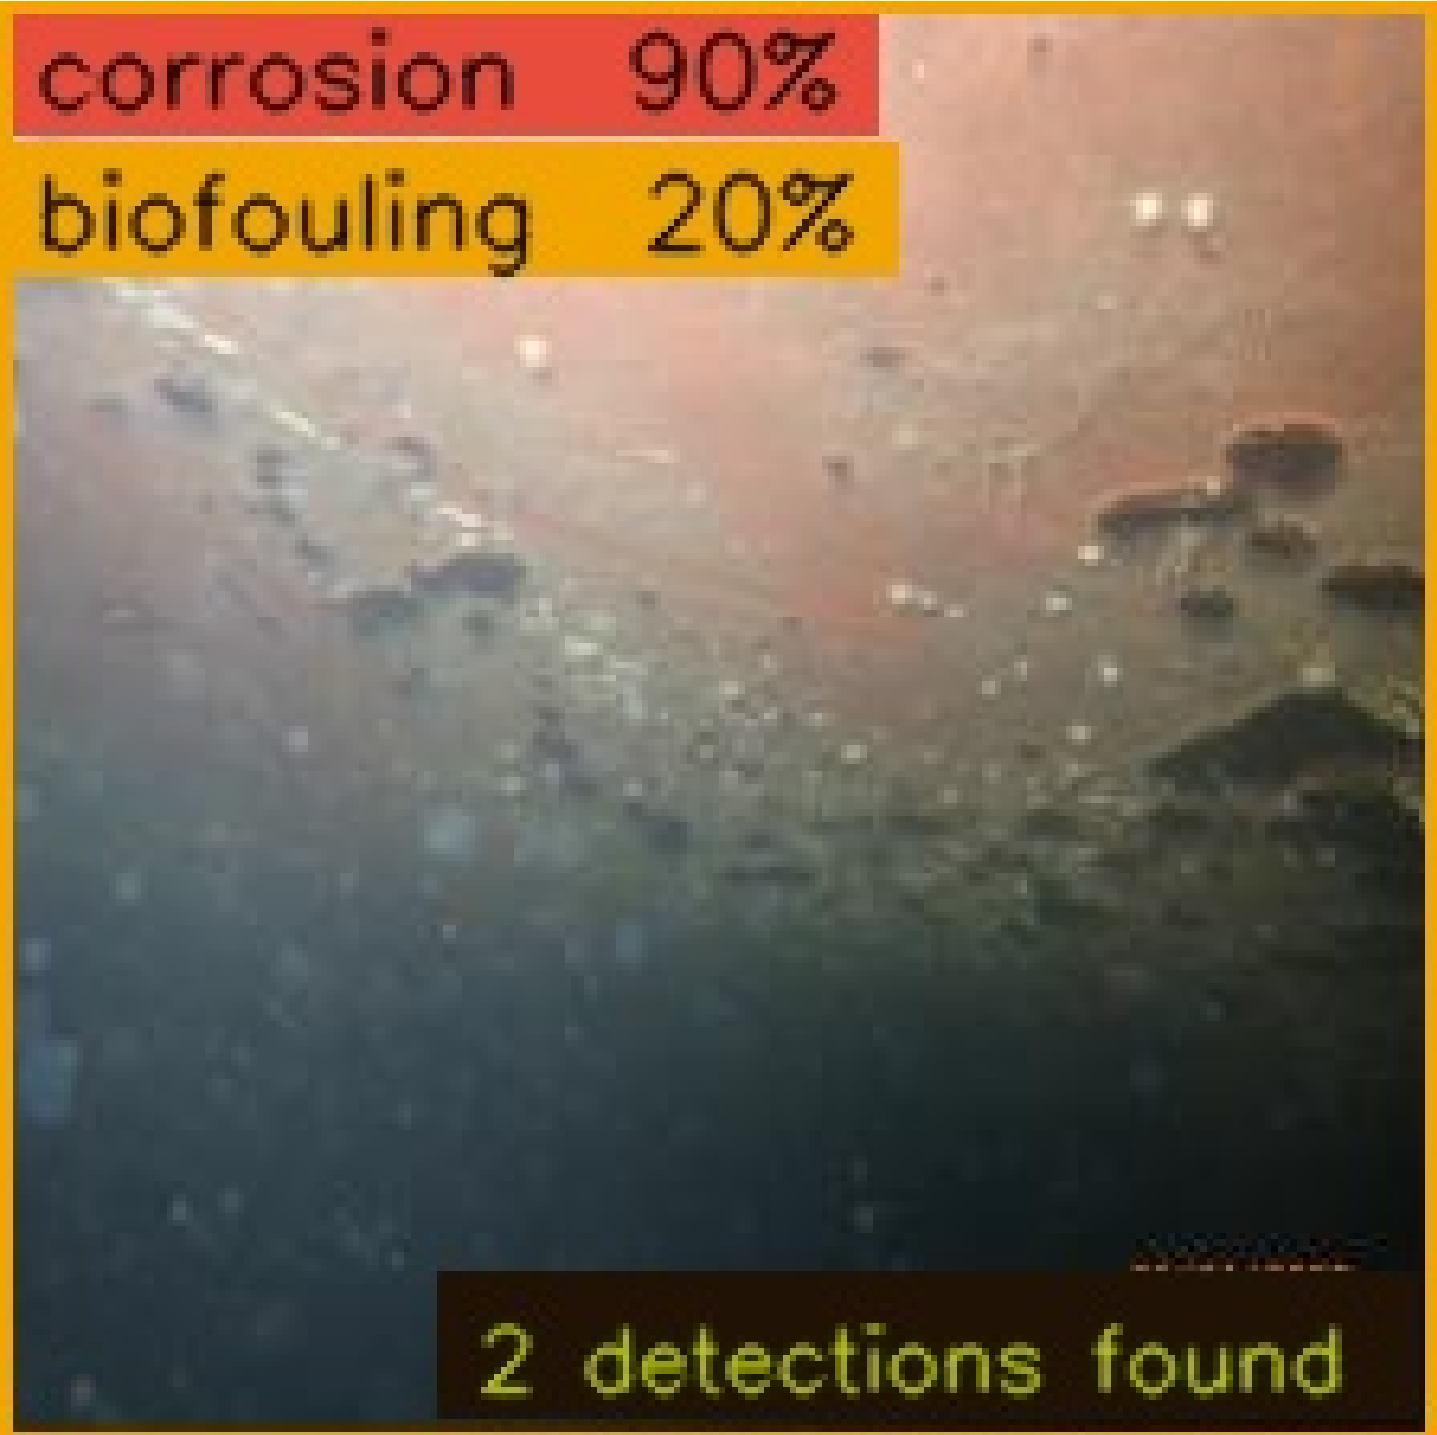
| Fouling Areas Identified: | 2 |

**FR-4 (Heavy Macrofouling - Critical!)**

Annotated inspection result - hull image with AI detections

Required Action: URGENT: Immediate dry-dock cleaning required!
