1. VESSEL INSPECTION DETAILS

| Vessel ID: | Teststar |
| Report Number: | NautiCAI-2026-04-28-001 |
| Inspection Type: | Automated Underwater Hull Assessment |

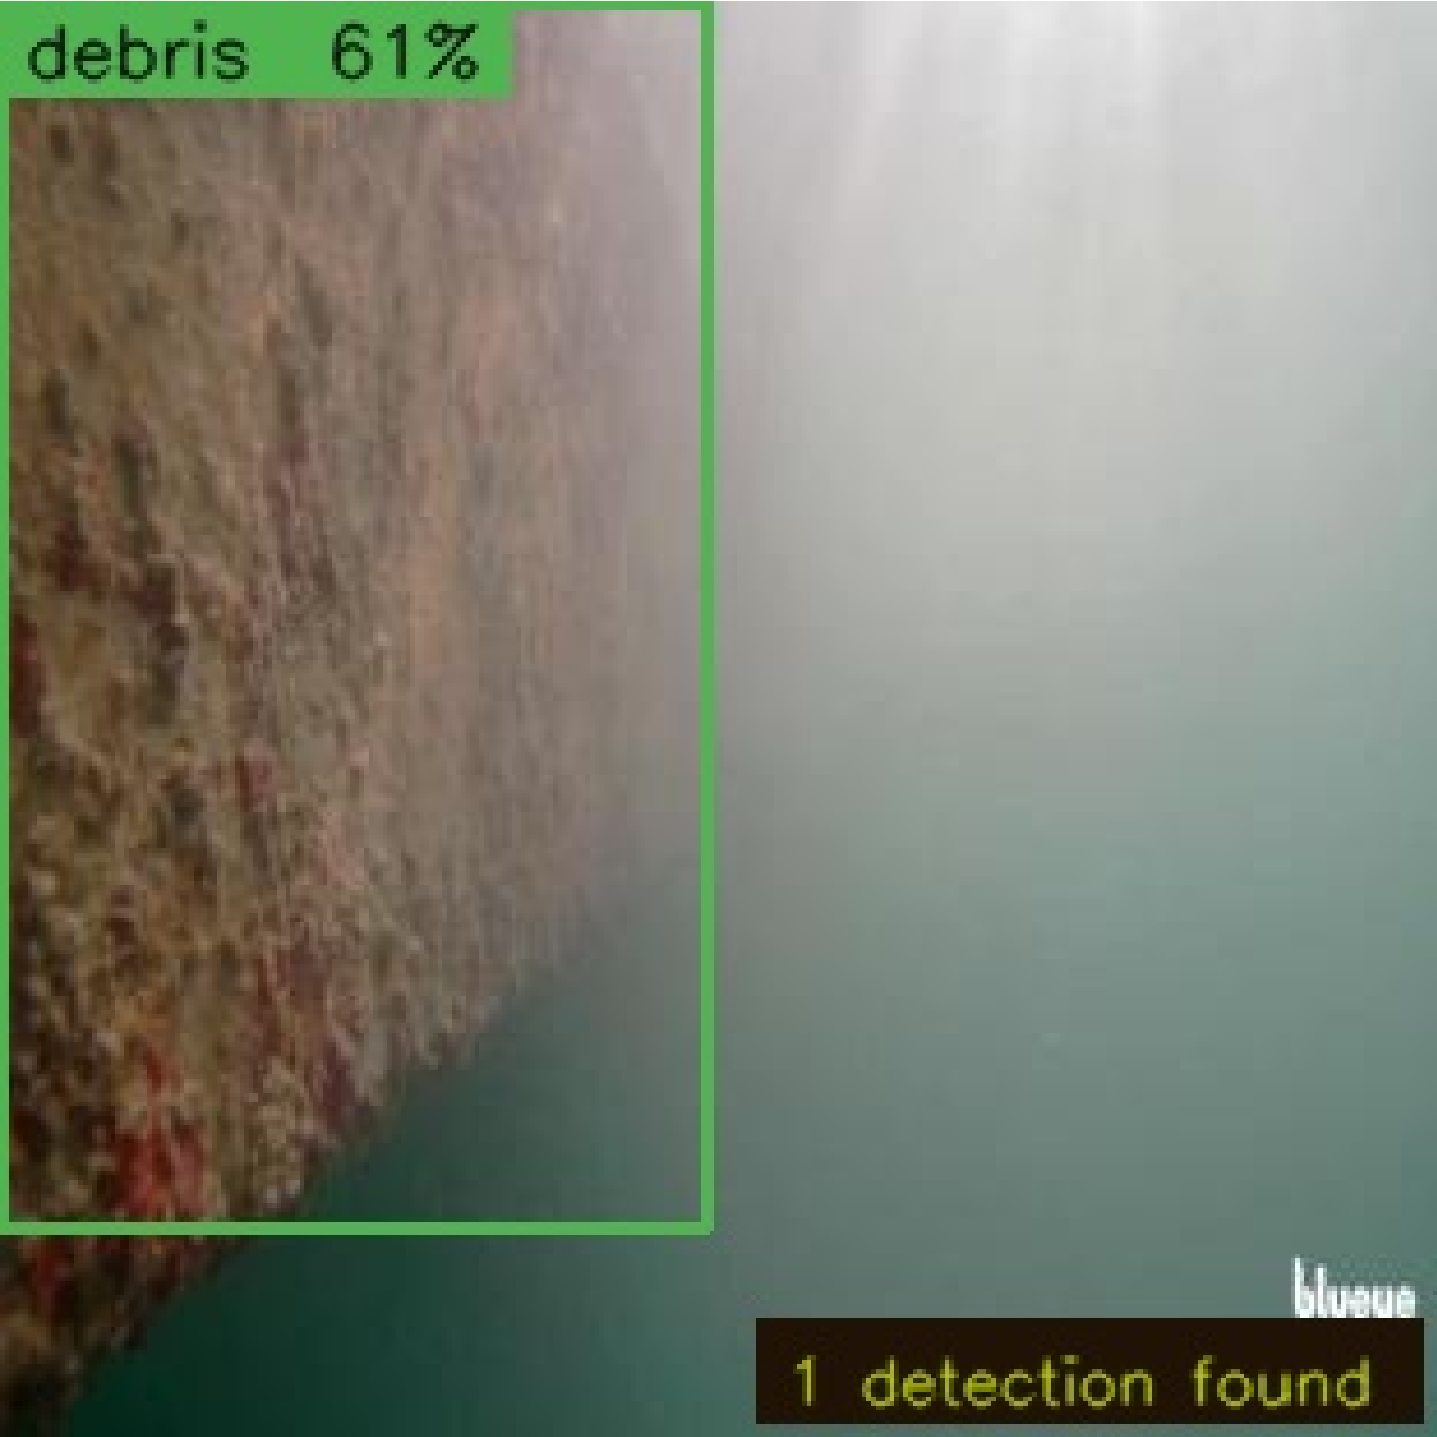
| Fouling Areas Identified: | 1 |

FR-4 (Heavy Macrofouling - Critical!)

Annotated inspection result - hull image with AI detections

Required Action: URGENT: Immediate dry-dock cleaning required!
